# Inspection Photos

ID: 324565

Operator: TABULA RASA ENERGY

Inspection Date: 7/8/2020

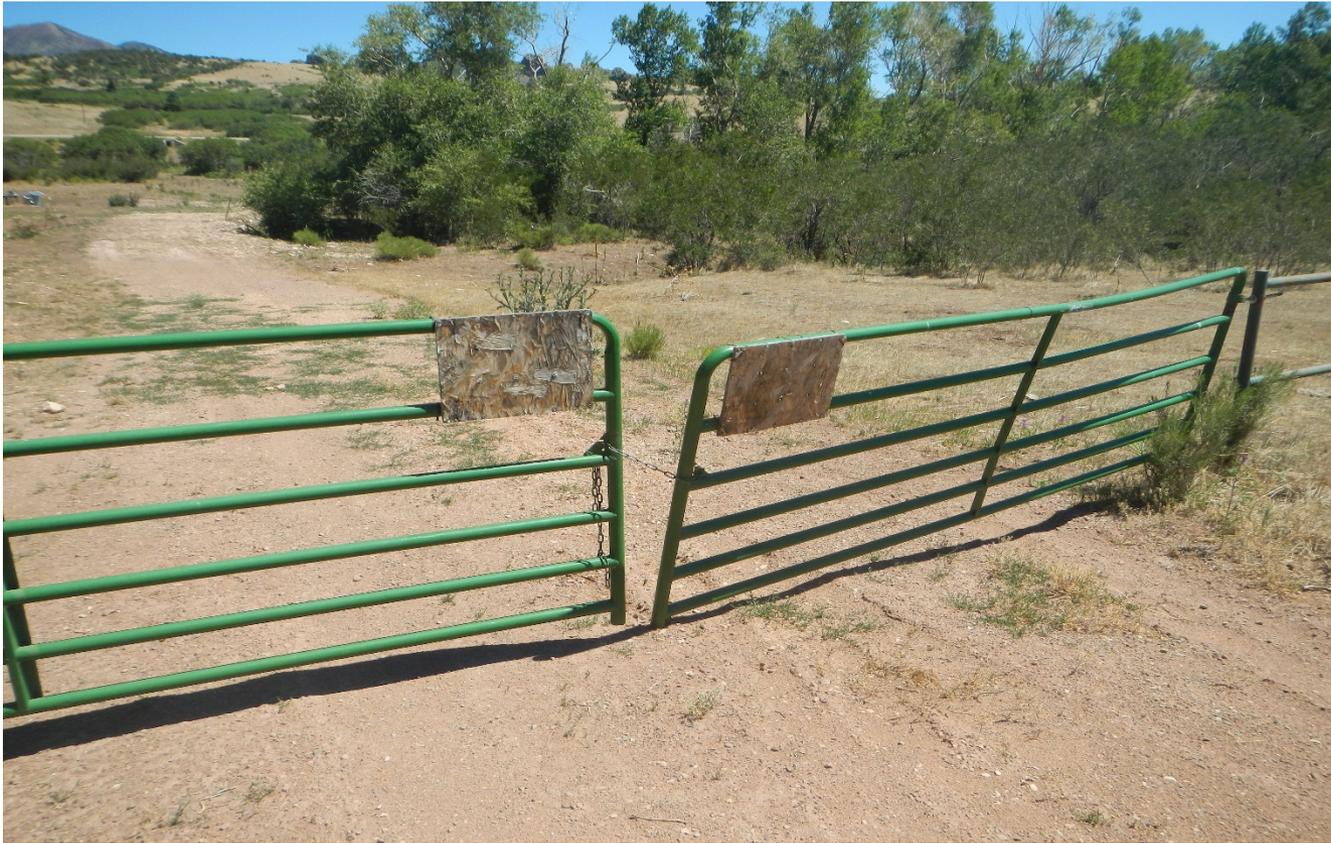
**Photo 1.** The gate at the beginning of the access road has fallen off the hinges and needs to be repaired.

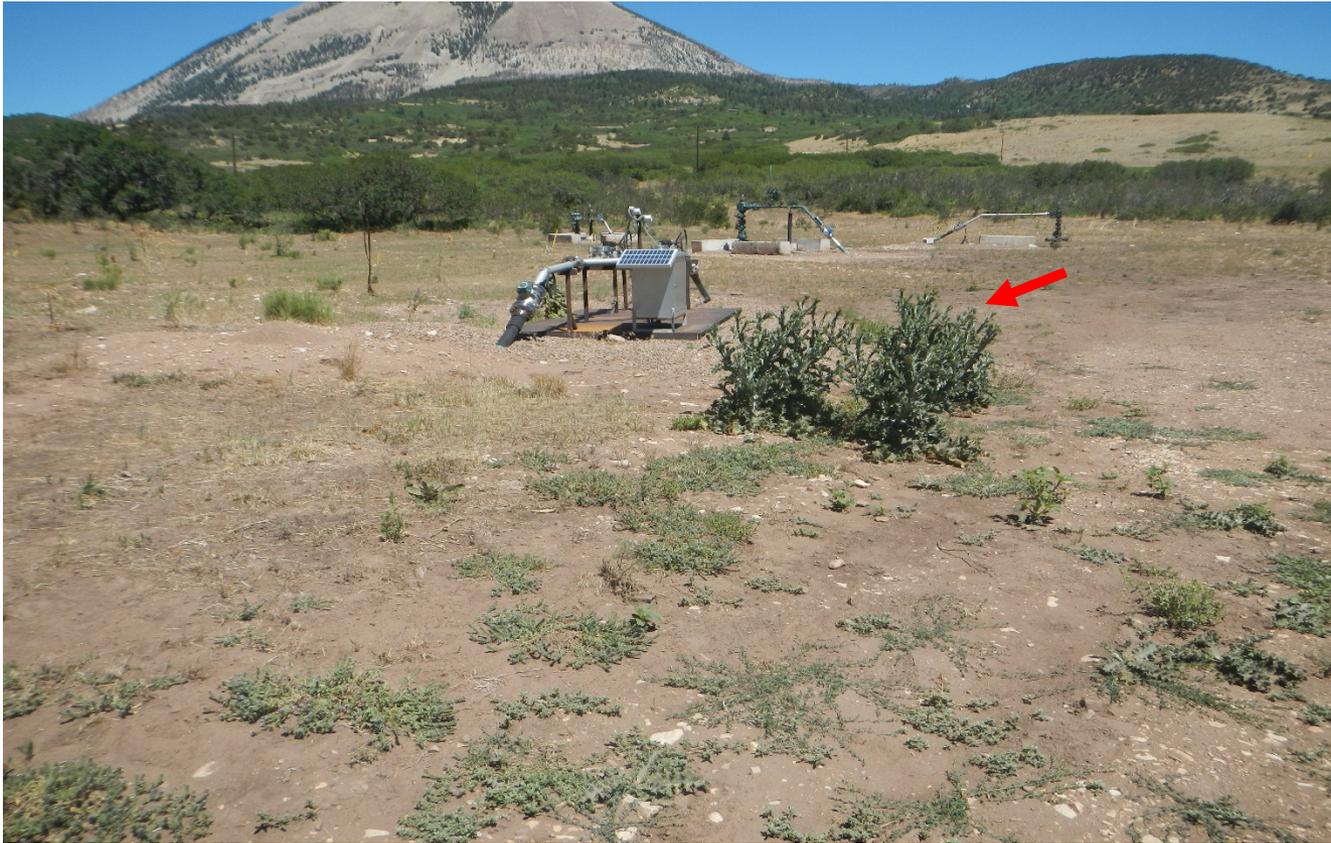
**Photo 2.** Facing northwest toward the location. There are noxious weeds at the location. Arrow points to Musk thistle, List B noxious weed.

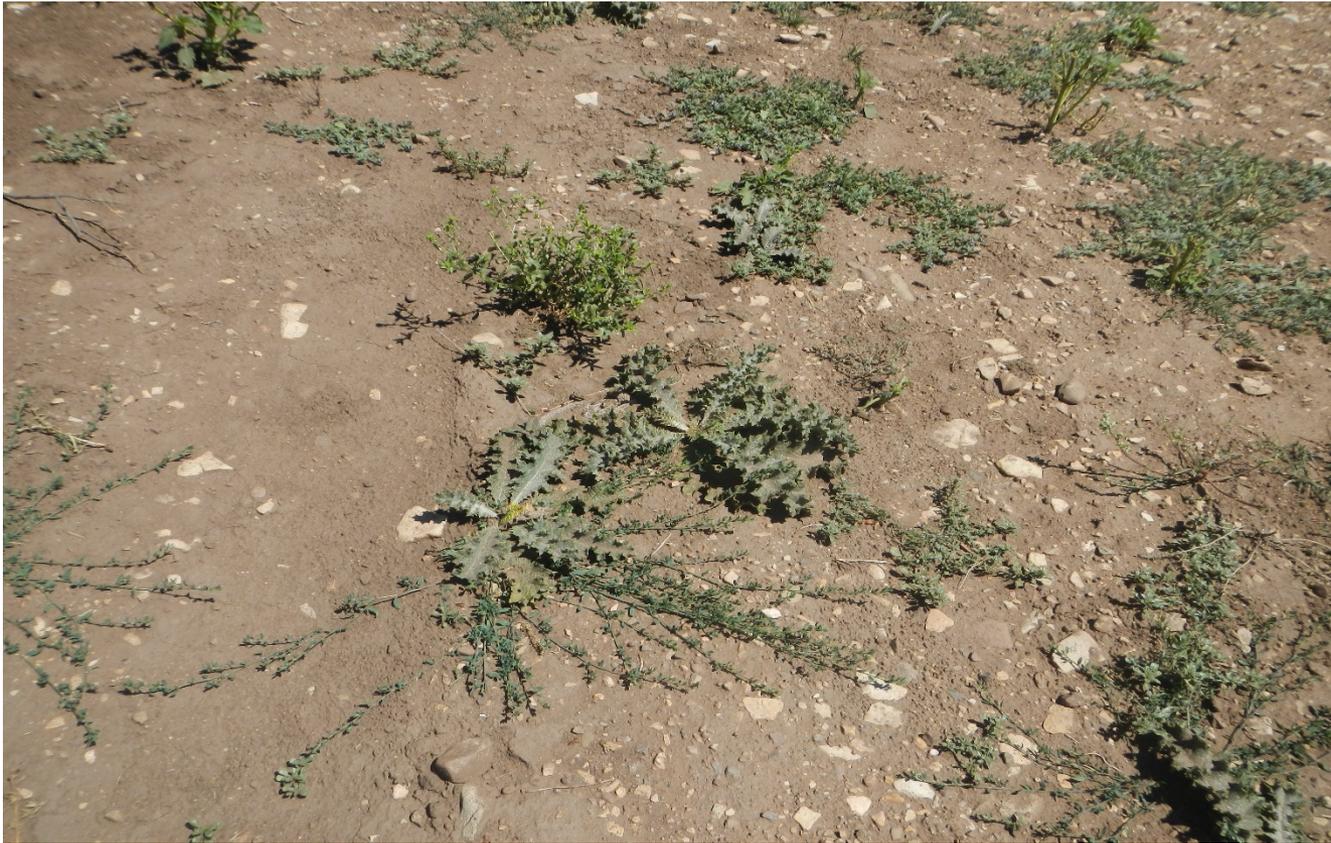
**Photo 3.** There are numerous Musk thistle rosettes observed at the location which need to be controlled.

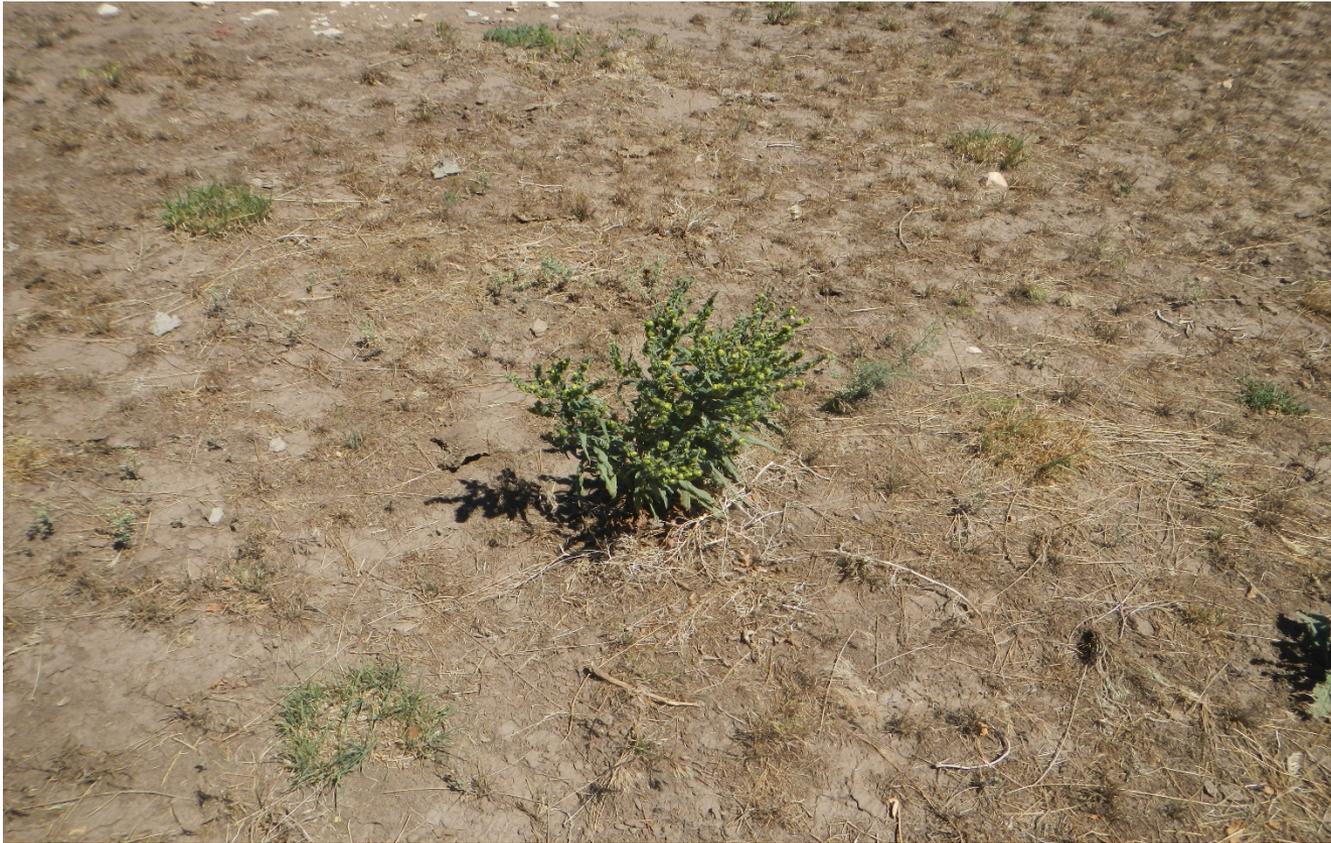
**Photo 4.** This noxious weed is Houndstoungeweed which seed has developed which needs to be bagged and removed.

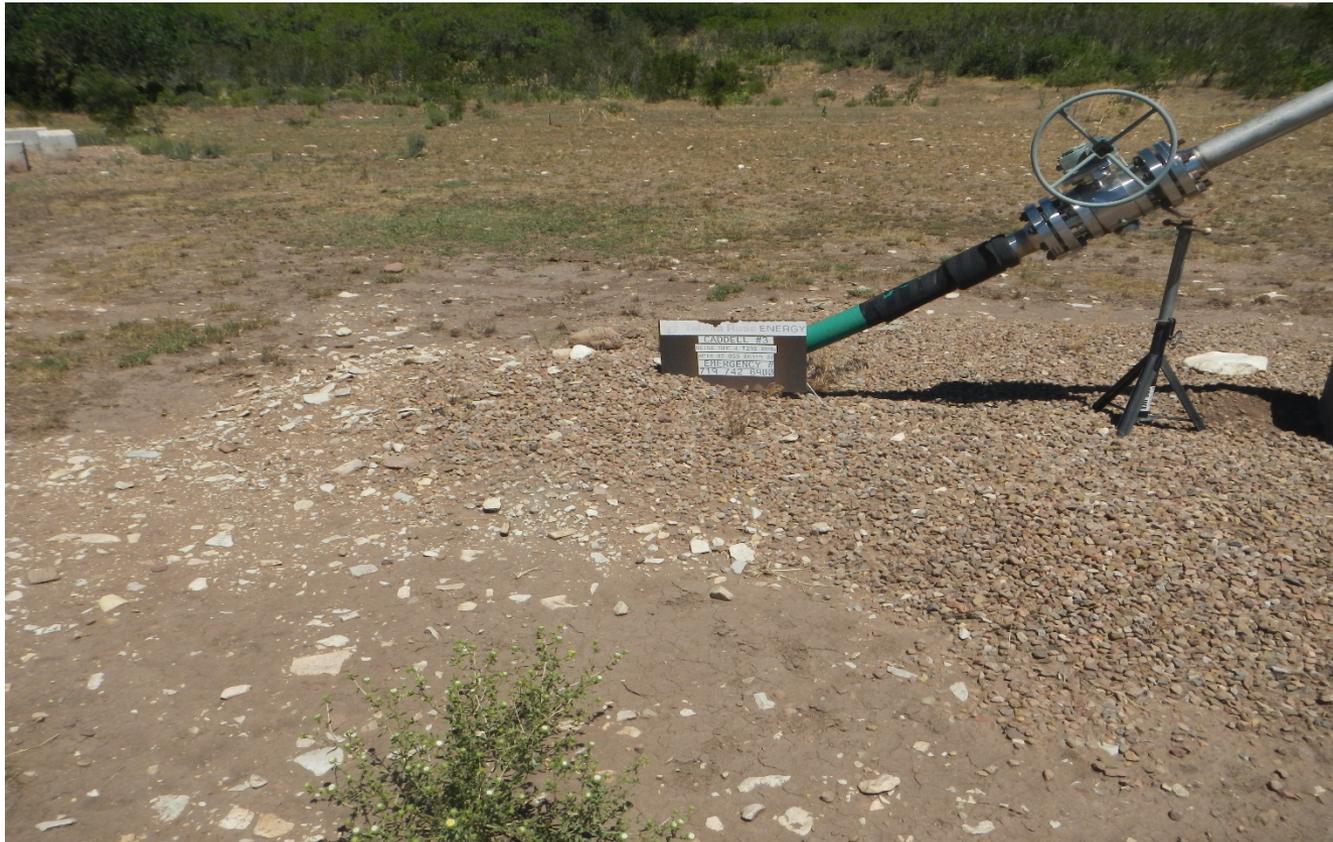
**Photo 5.** The well sign is posted at the well head.
