Inspection Photos

API: 055-06306

Operator: MANZANO LLC

Inspection Date: 7/8/2020

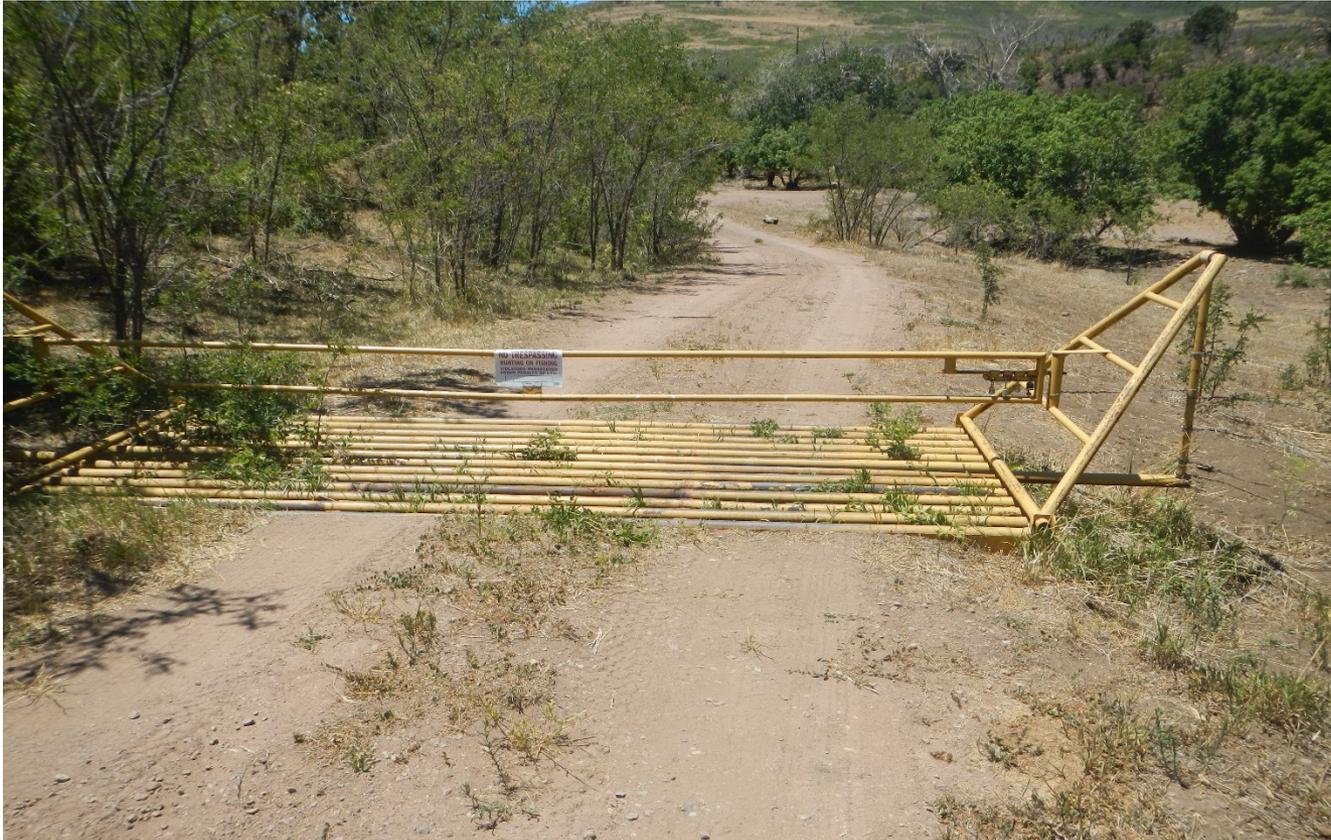
Photo 1. Facing west at the beginning of the access road. The access road has not been reclaimed and the cattle guard and gate remain.

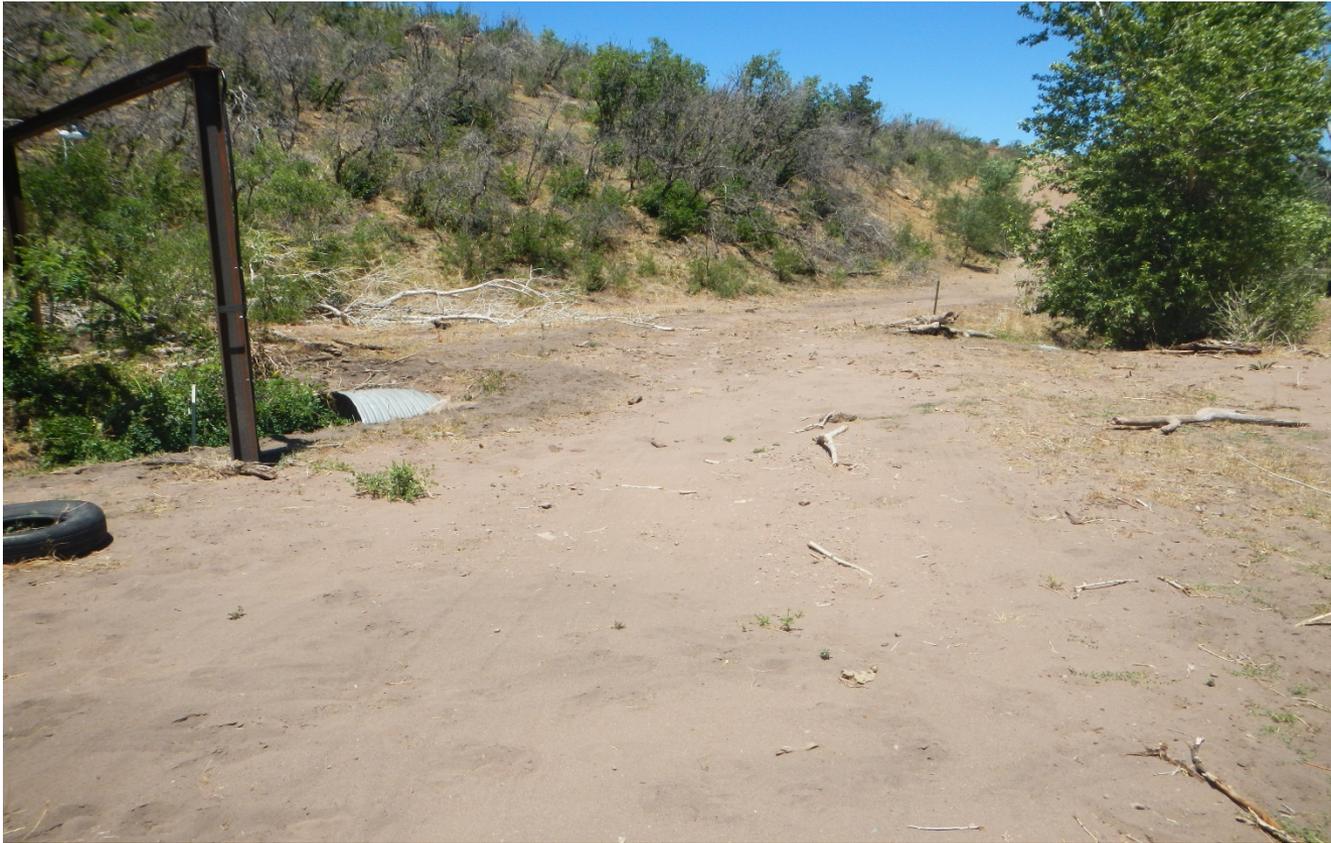
Photo 2. Facing northeast where road crosses the stream. Road was not reclaimed and culvert remains.

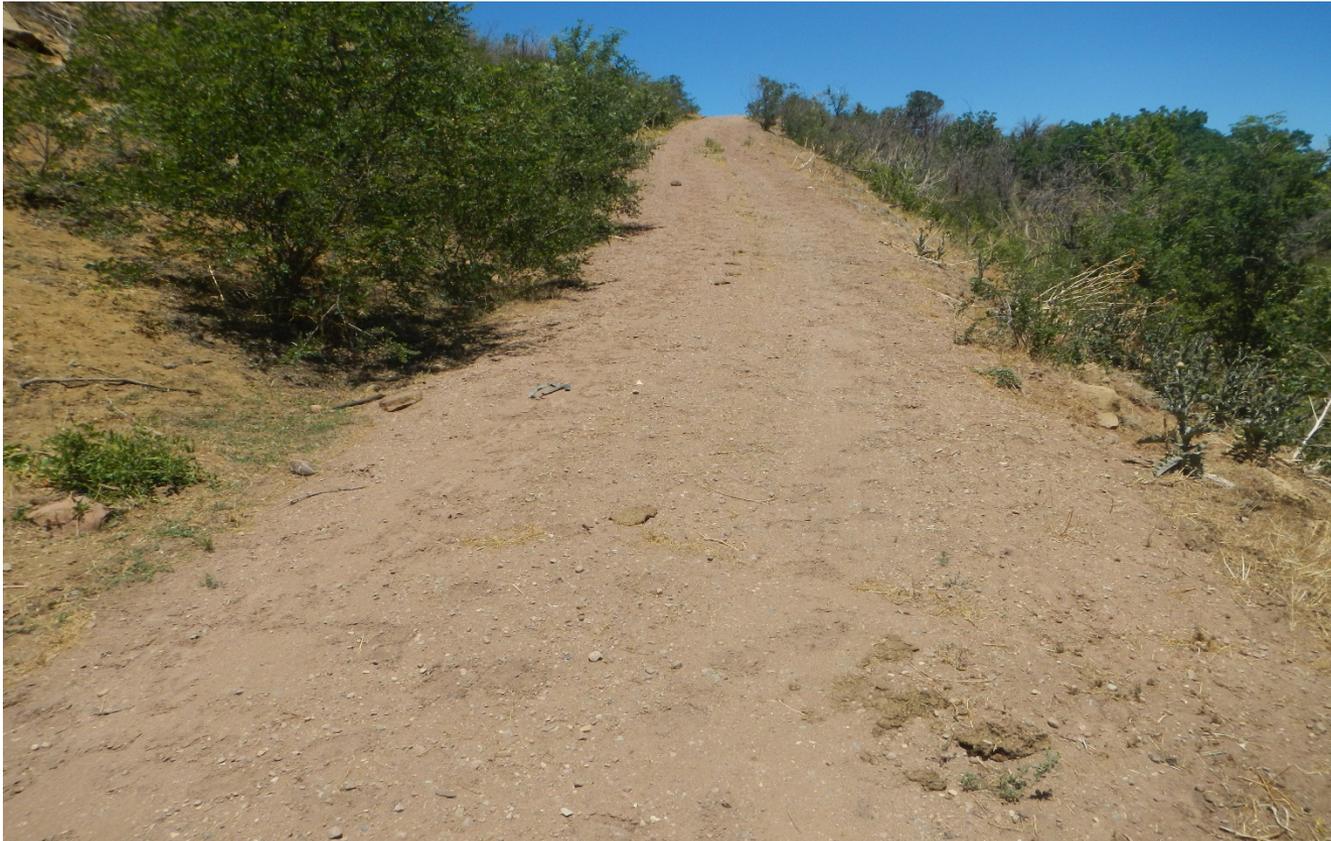
Photo 3. Facing northeast along the access road ascending the hill side. Access road has not been recontoured and reclaimed.

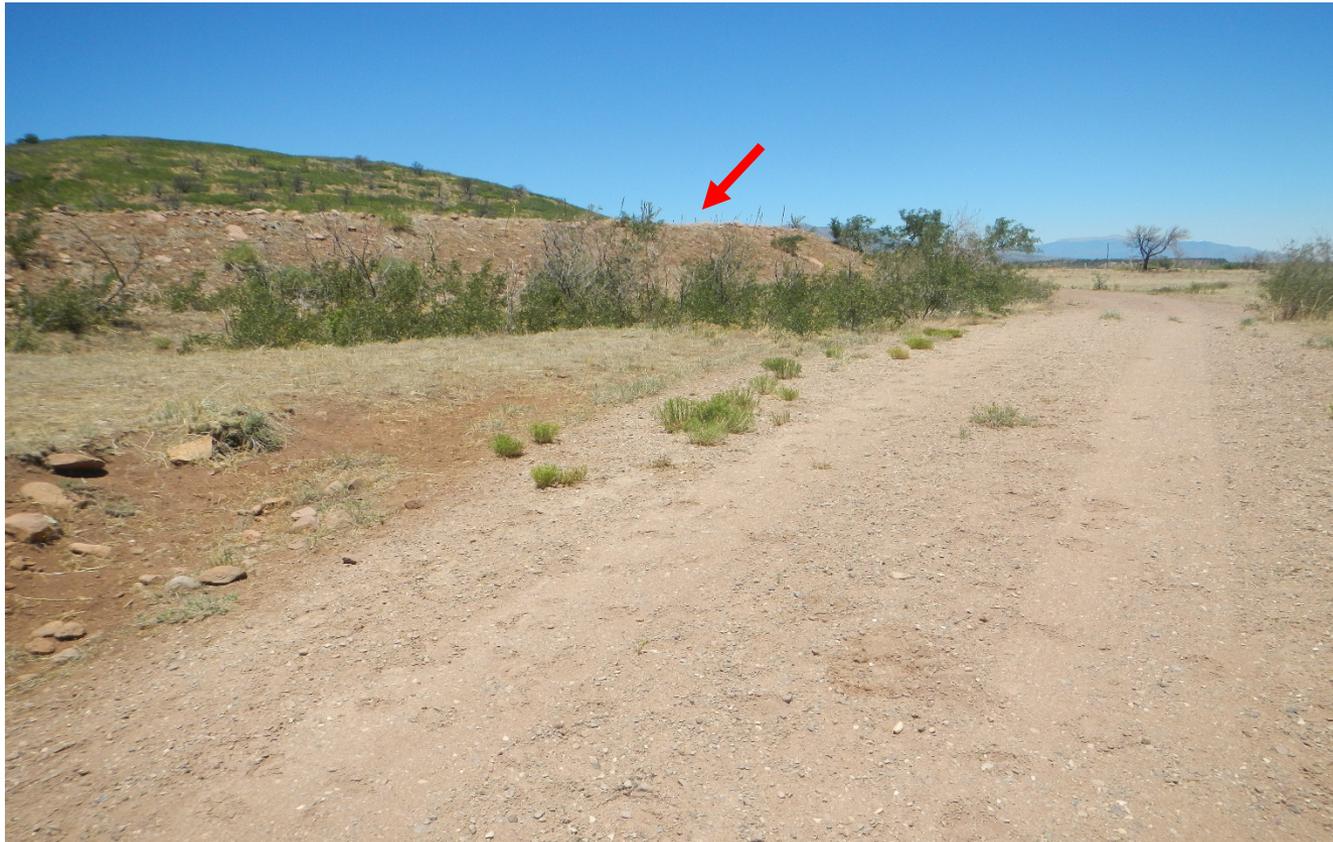
Photo 4. Facing north along access road. Arrow points to the well pad which is not recontoured.

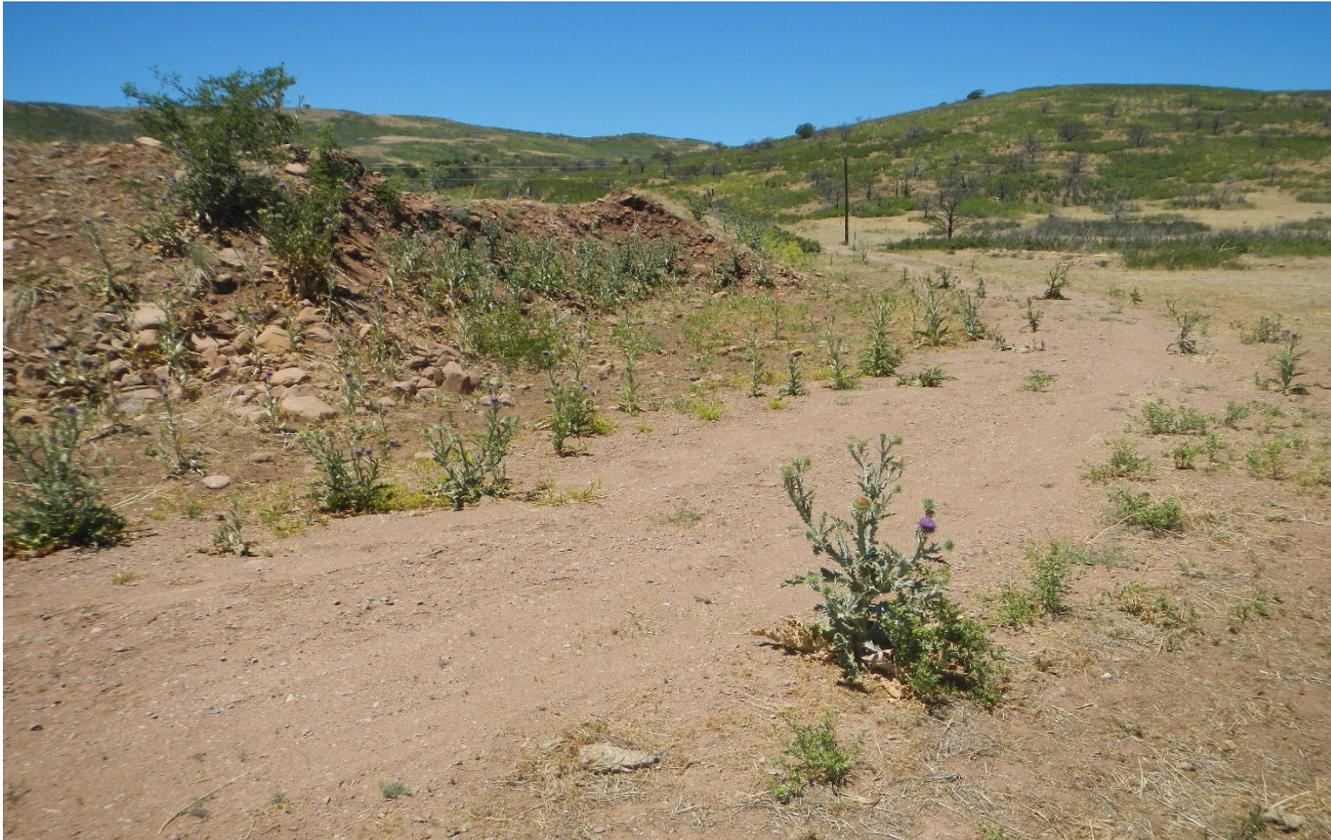
Photo 5. Facing northwest toward the fill slope of the location. There are numerous Musk thistle noxious weeds in this area of the well pad and access road.

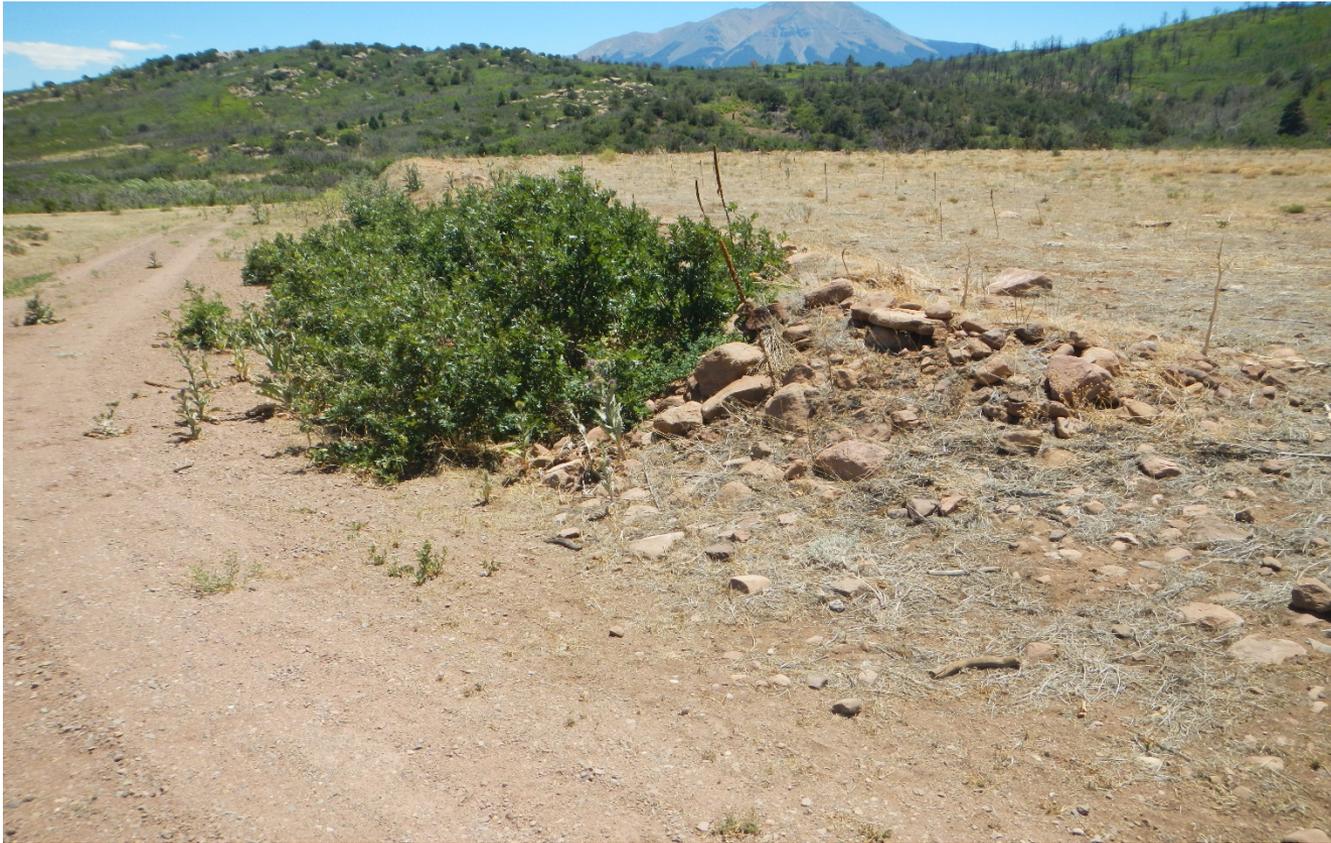
Photo 6. Facing southeast toward the access road and location shown in the right side of the photo.

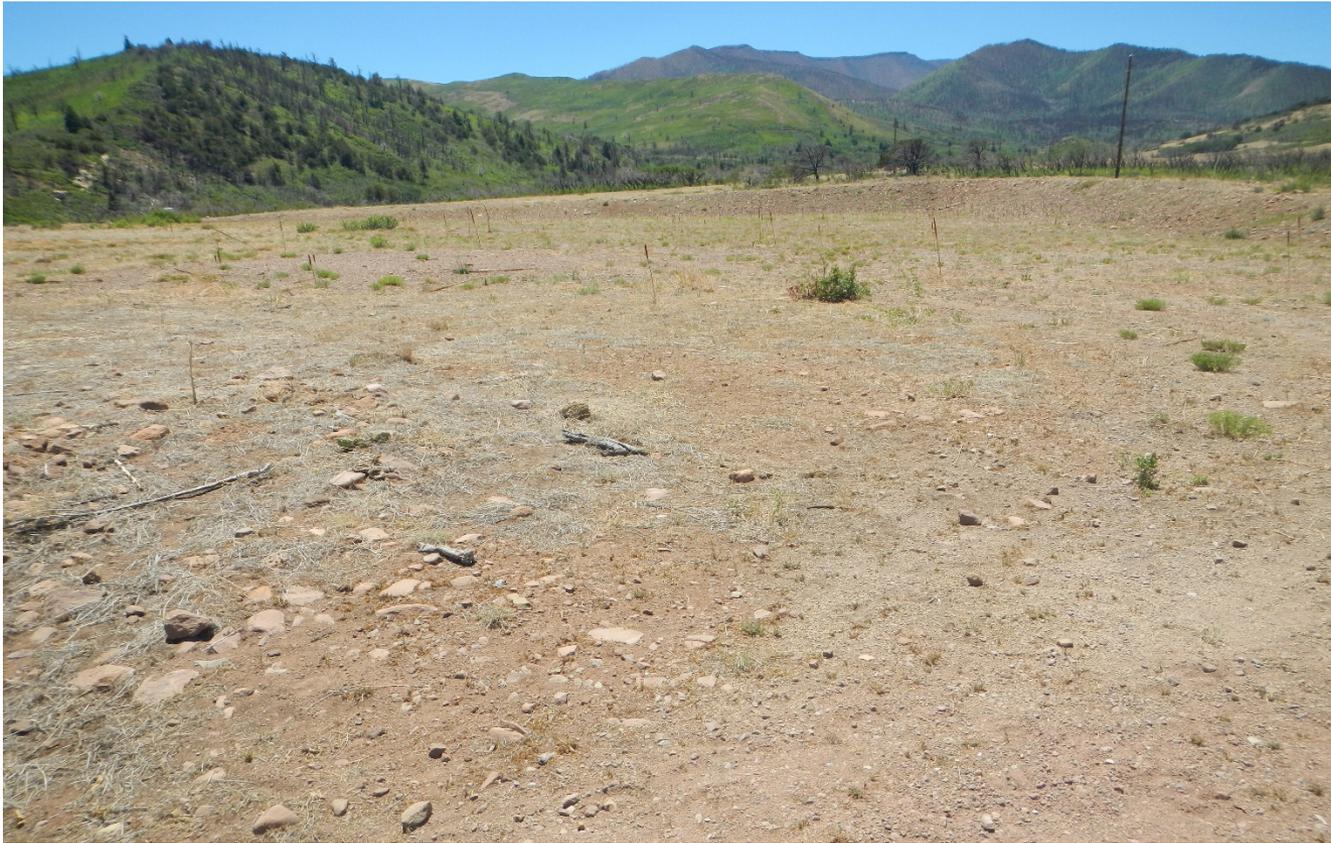
Photo 7. Facing southwest toward the location. The location has not been recontoured and reclaimed.

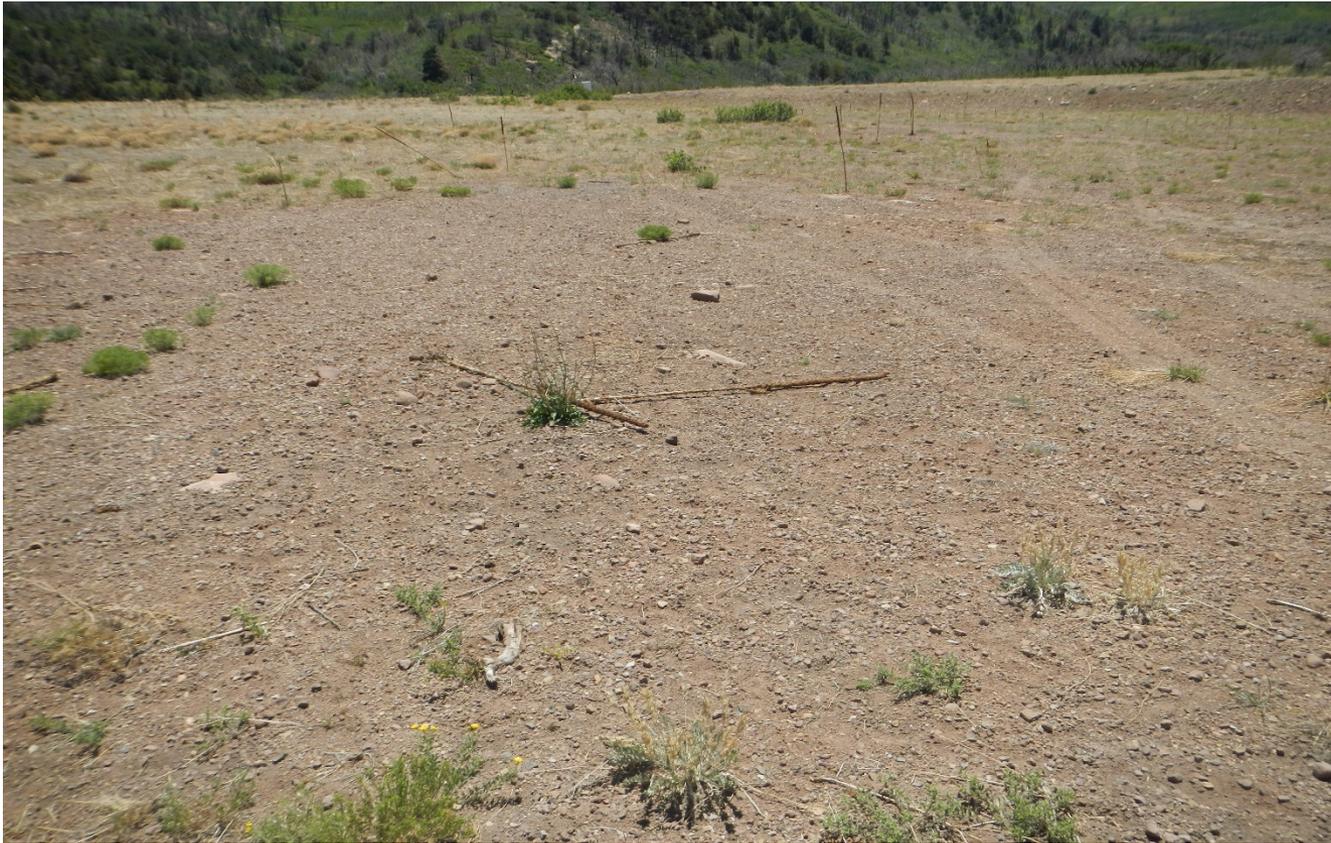
Photo 8. Gravel remains throughout the location.

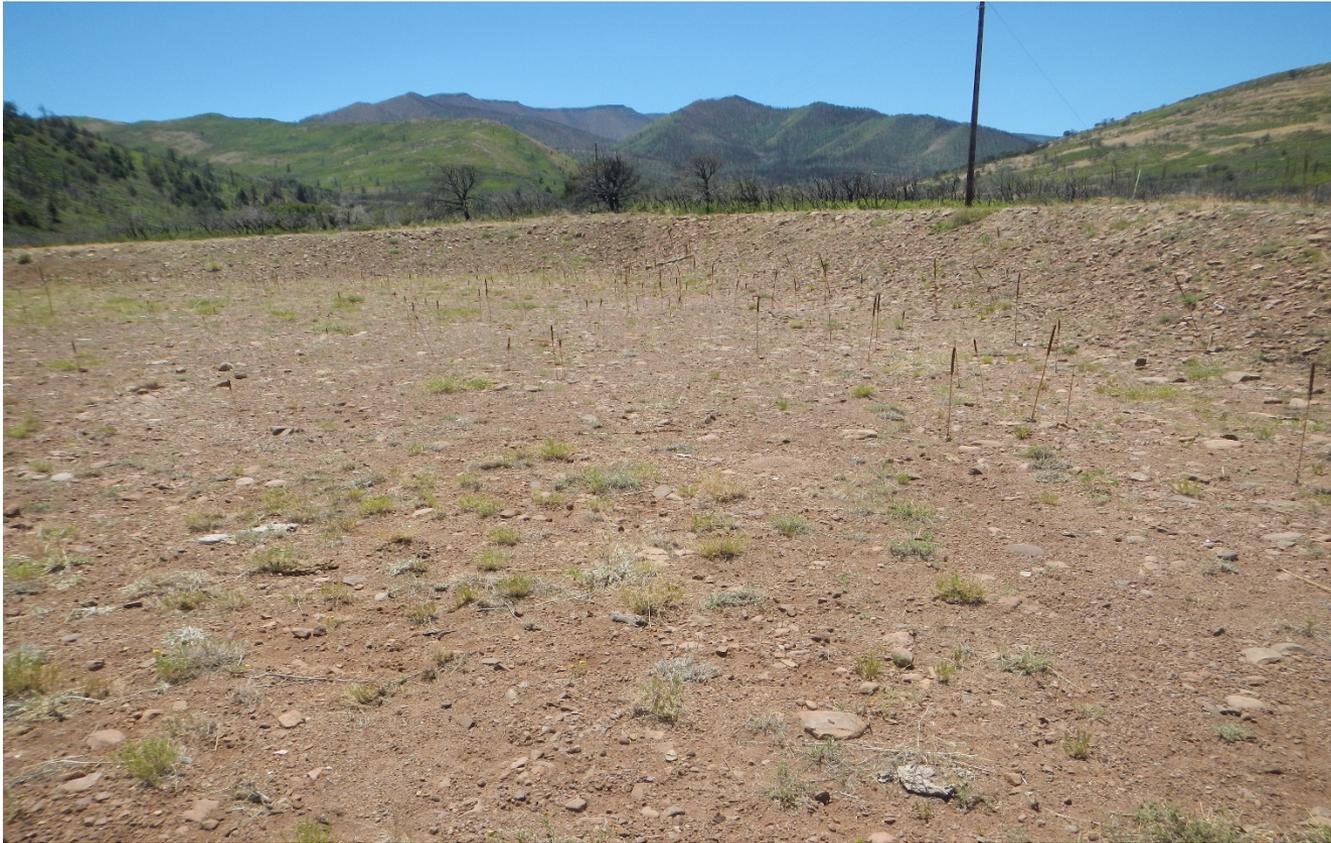
Photo 9. Facing southwest toward the cut slope of the location which is approximately 12 ft. height.

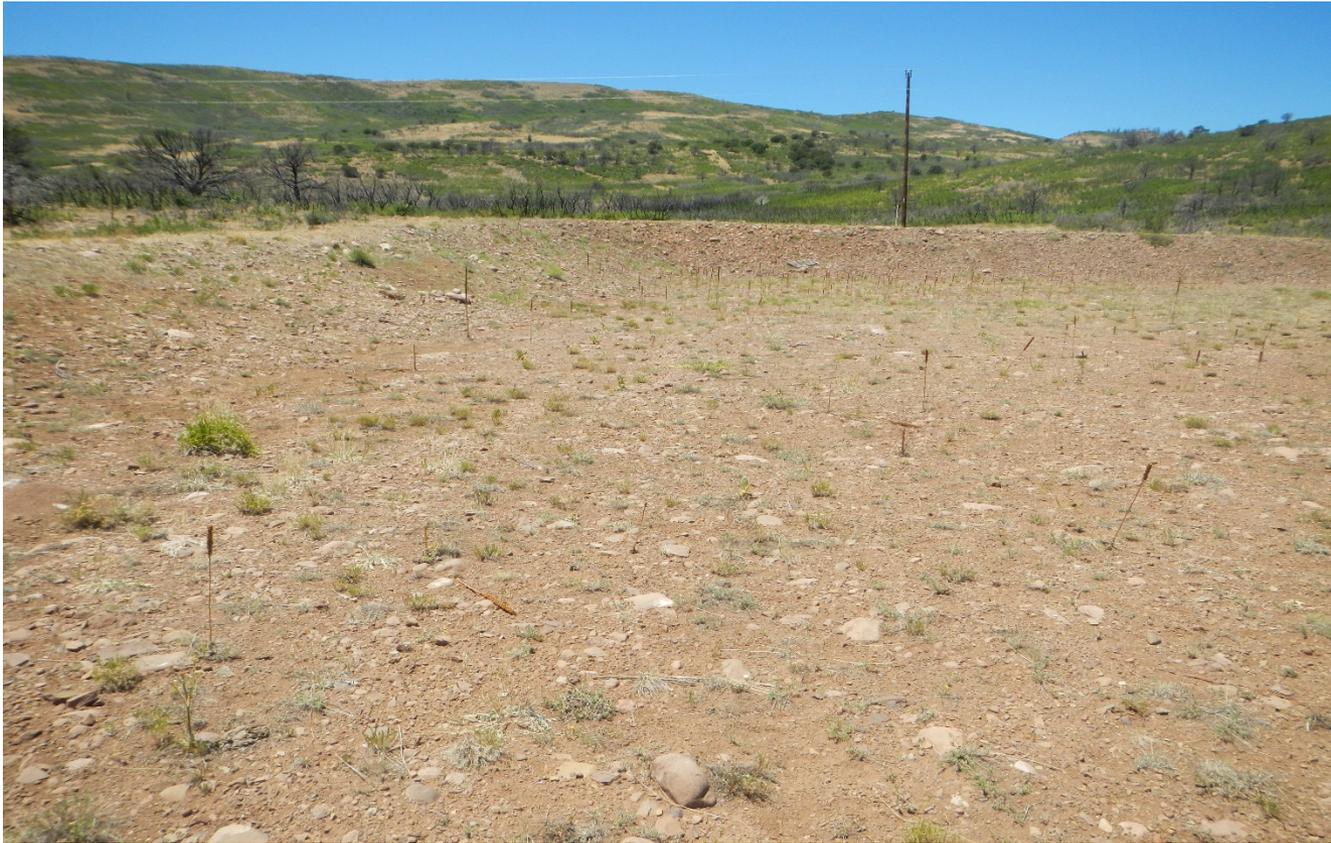
Photo 10. Facing northwest toward the cut slope of the location which is approximately 12 ft. height.

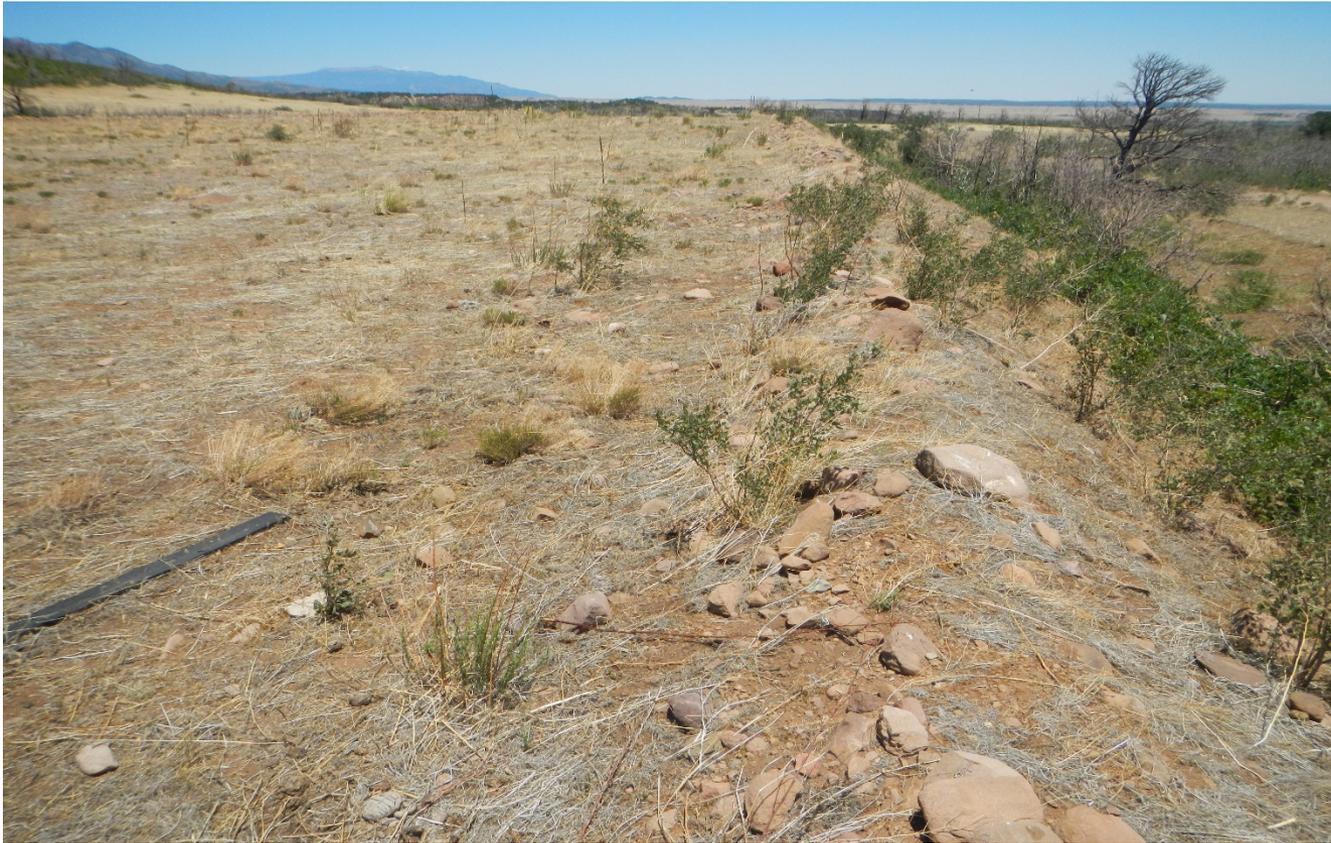
Photo 11. Facing northeast along the fill slope of the well pad.

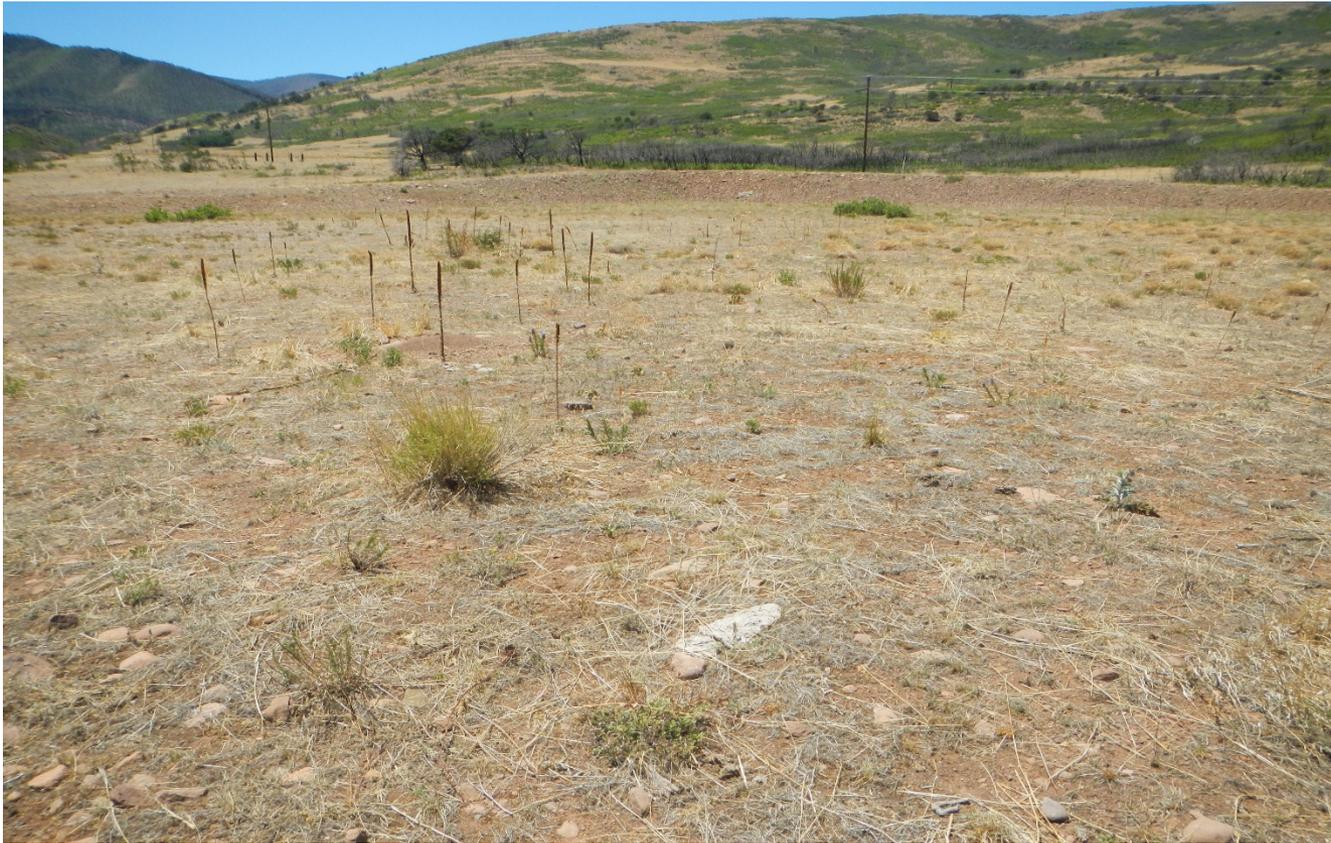
Photo 12. East side of the location facing west.

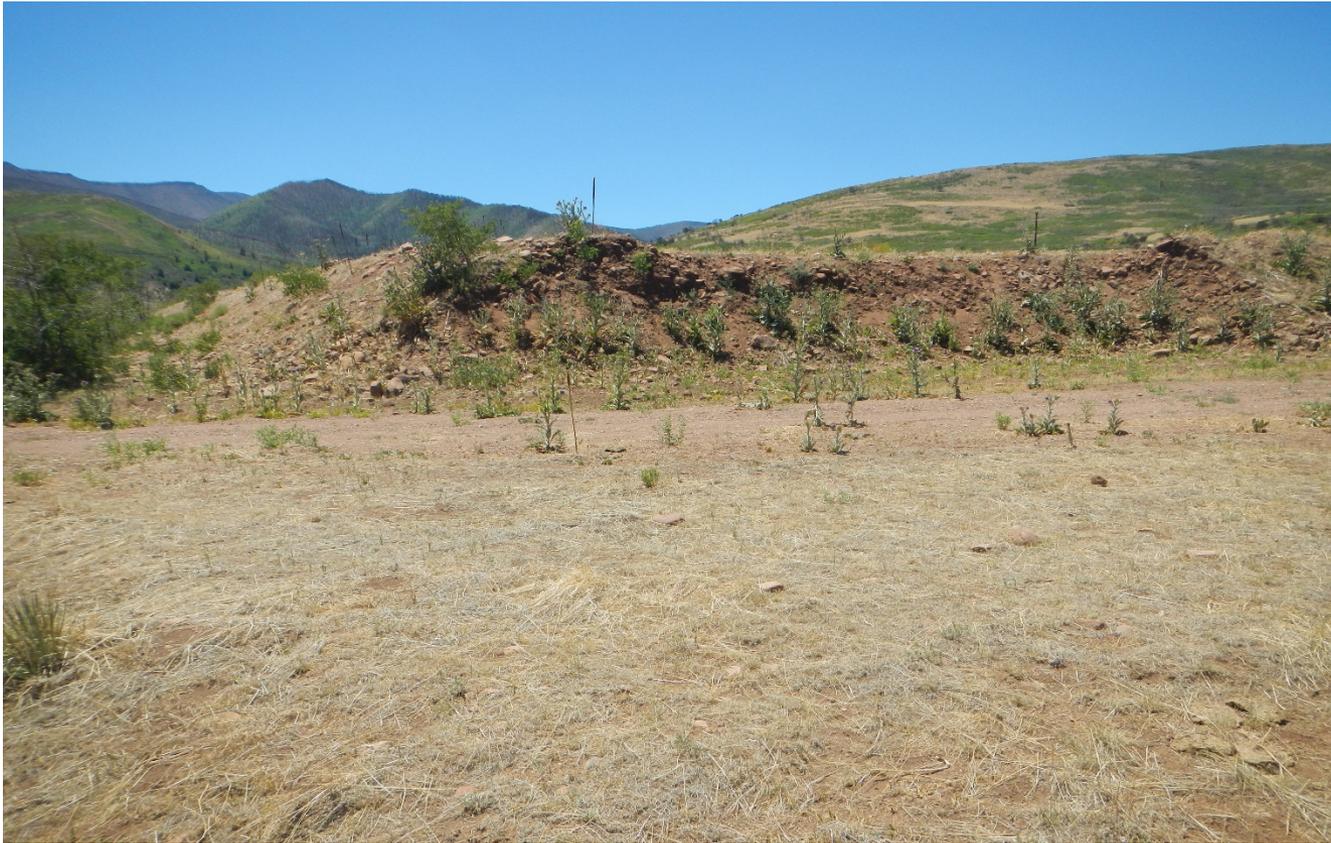
Photo 13. Facing east toward the fill slope. This area of the fill slope has been partially excavated and consists of numerous noxious weeds.

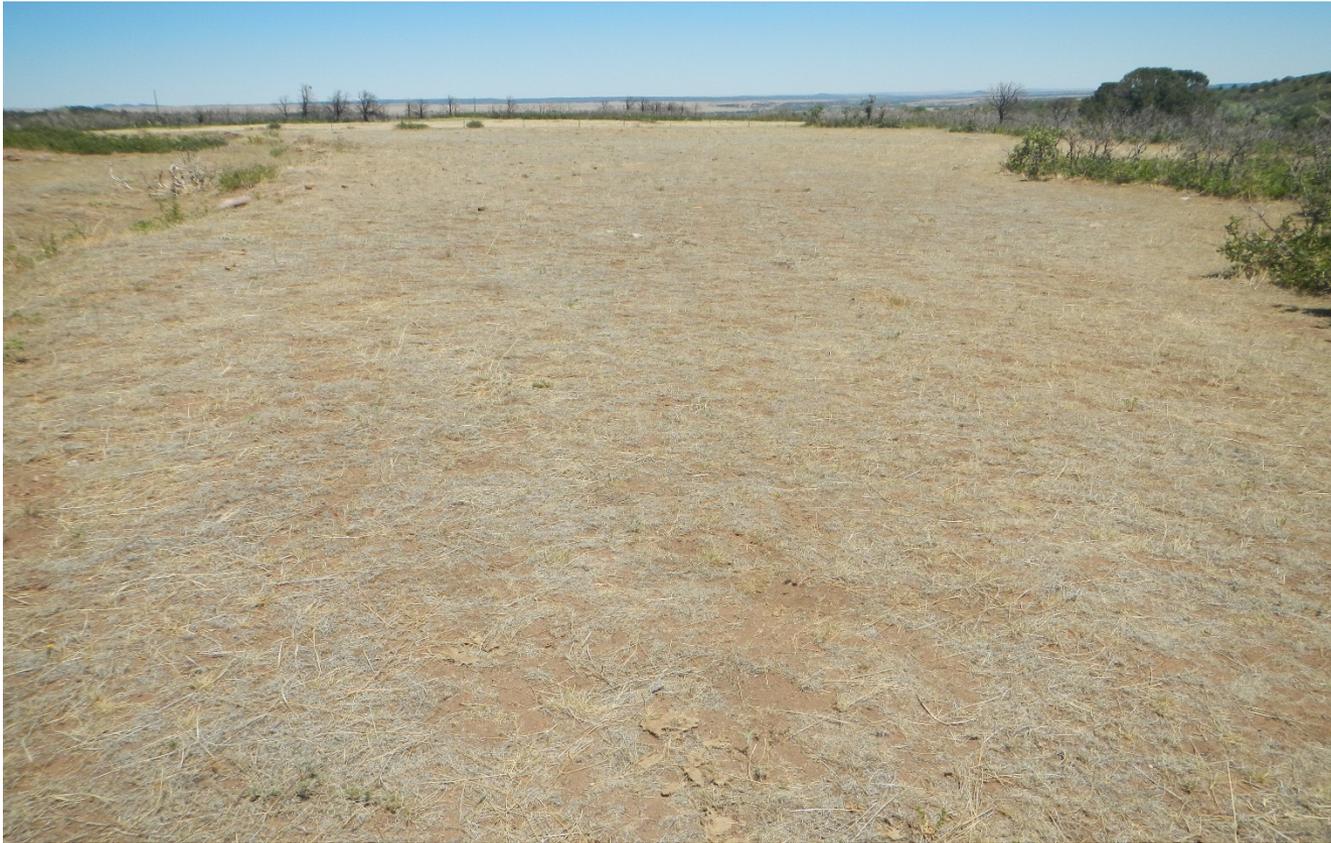
Photo 14. Facing east toward the surrounding undisturbed area.
