Inspection Photos
Location Name: TINA 32-27
API#: 05-071-06796
INSP. #: 695102935

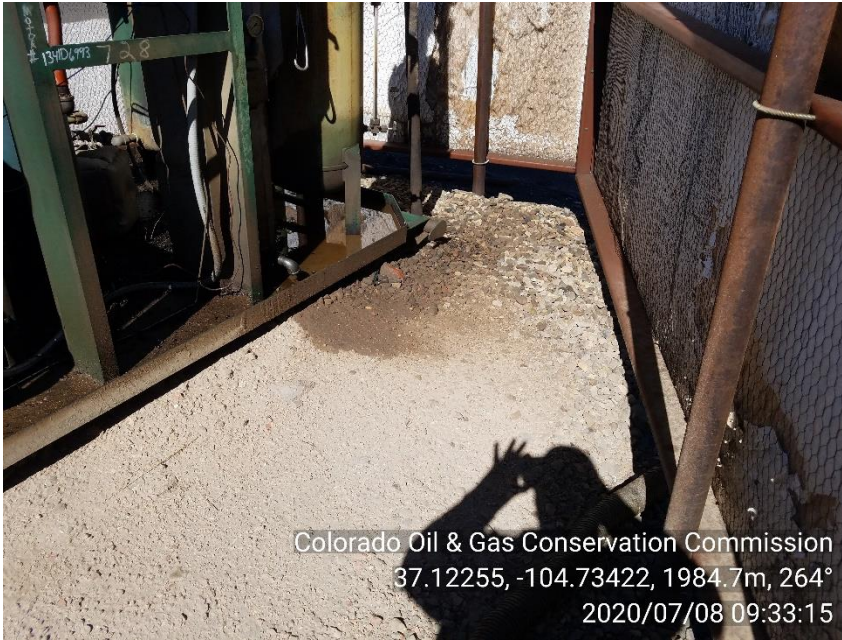
PHOTO 3: AREA OF IMPACTED SOIL NEAR LOW CORNER OF COMPRESSOR SKID. Conduct maintenance on equipment, cleanup stained material and review self inspection processes PER RULE 1002.f.(2)F. CA DATE 7-20-20.

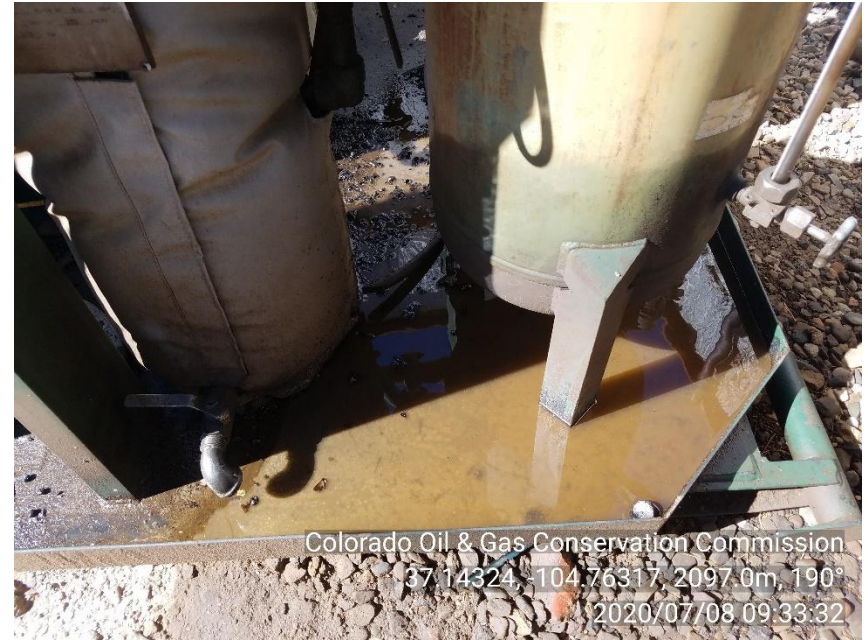
PHOTO 4: STANDING OILY FLUID IN COMPRESSOR SKID. Comply with general provisions of the oil and gas act for wildlife protection. CA DATE 7-20-20.

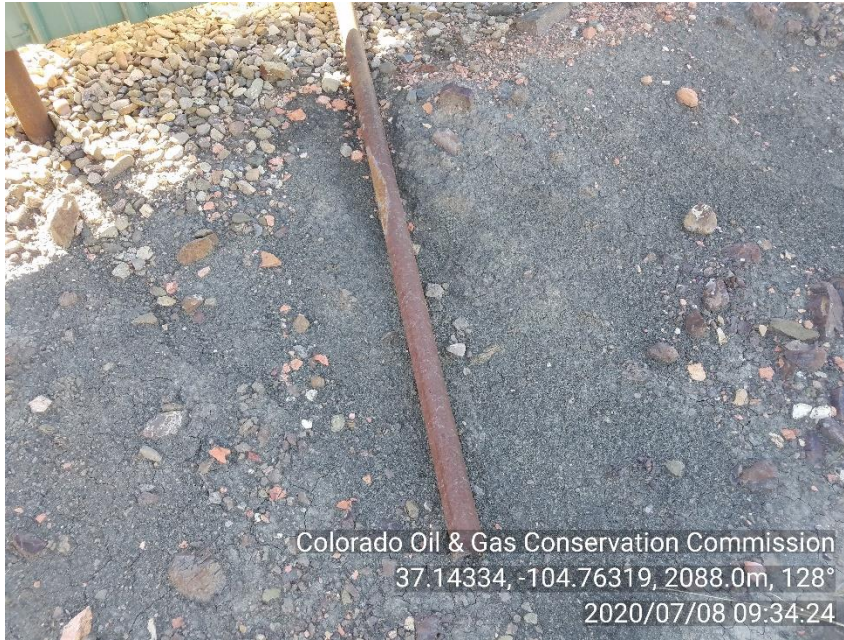
PHOTO 5: UNUSED EQUIPMENT STORED ON LOCATION. REMOVE UNUSED EQUIPMENT PER RULE 603.f. CA DATE 10-13-2020

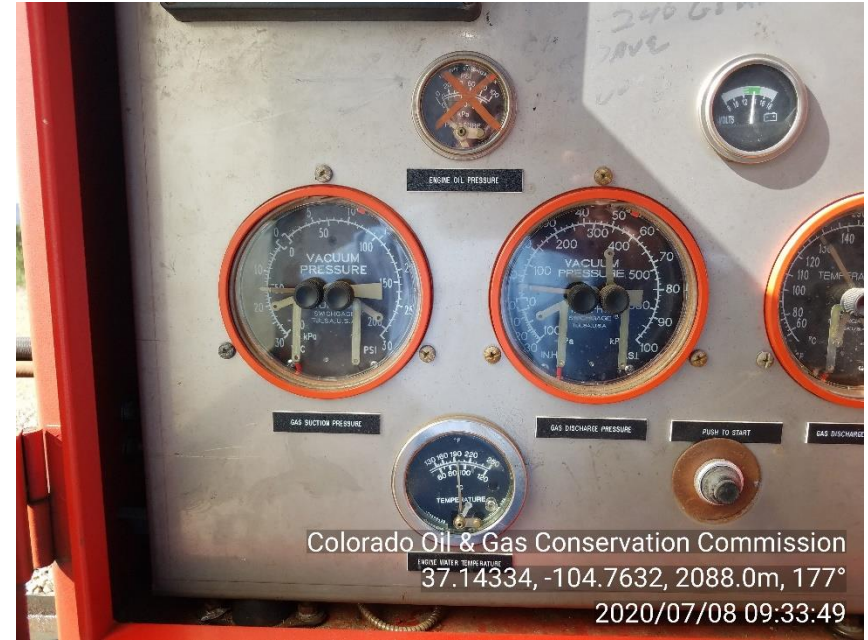
PHOTO 6: FORM 4 HAS BEEN APPROVED DOC #402095372
