Inspection Photos

Location Name: MARALEX RESOURCES INC SOUTH SHALE RIDGE-68S98W /13NWNW

Location ID: 312601

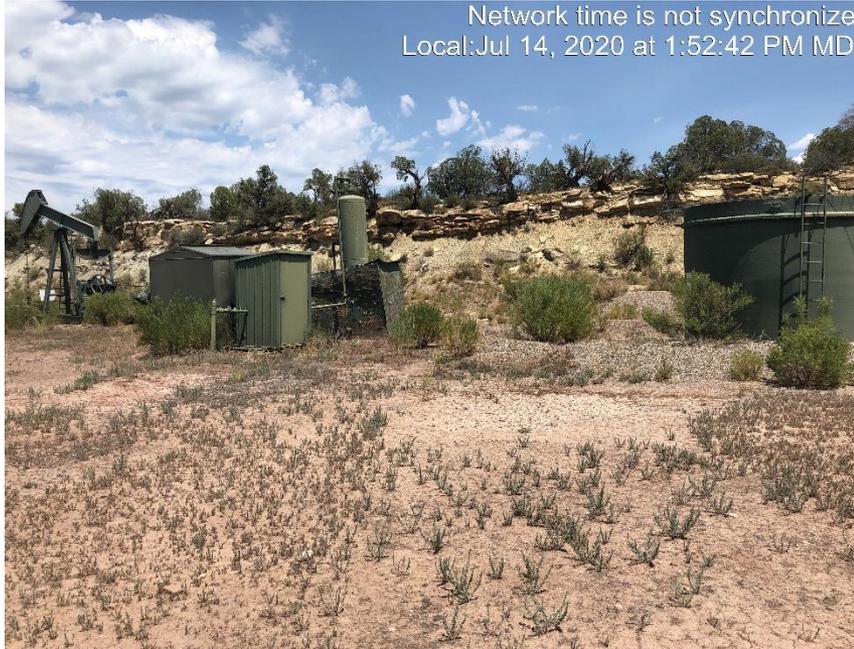
Photo #1521 from entrance to location

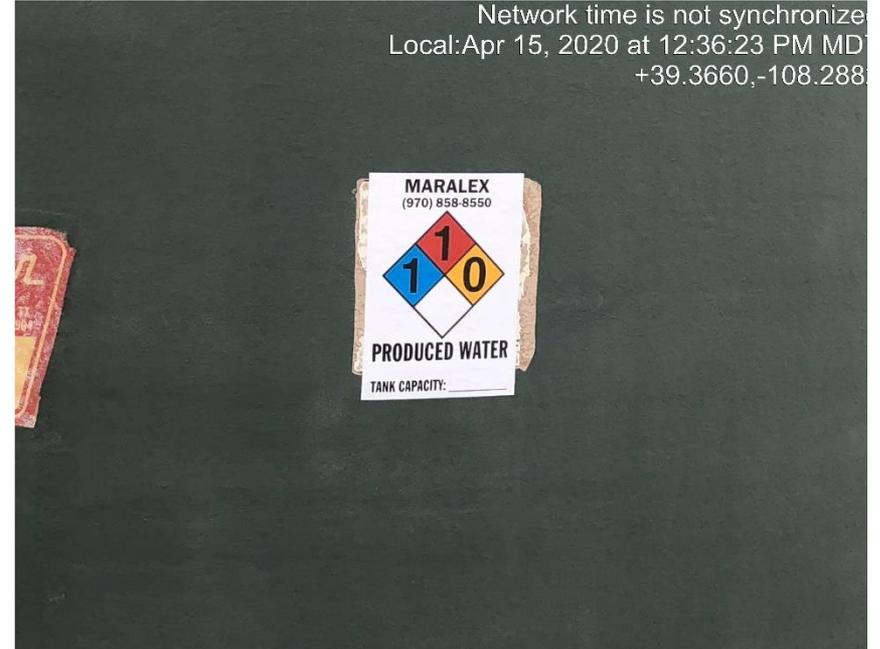
Photo #0979 from inspection #699800920 inspection conducted on 4/15/20.

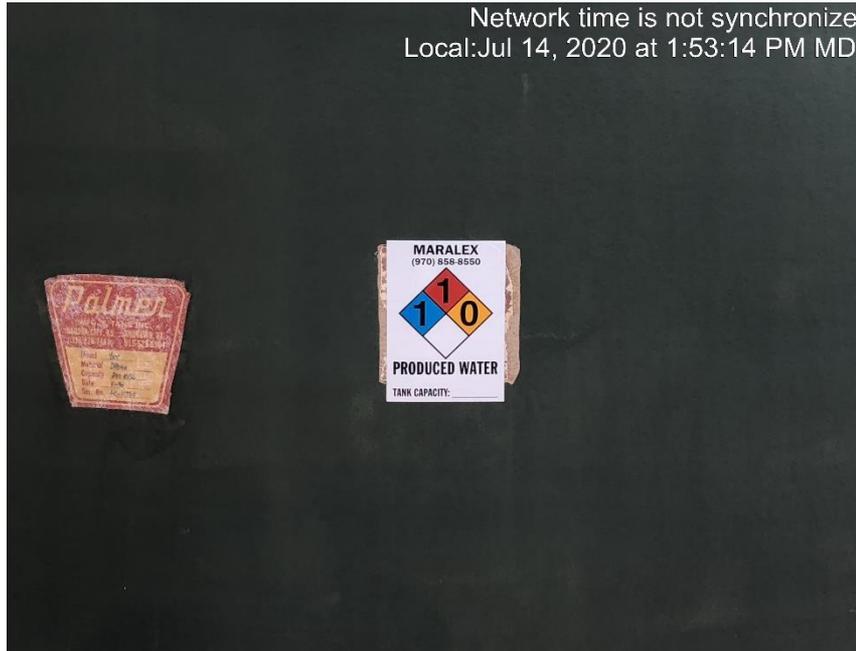
Photo #1522 Tank capacity not labeled.

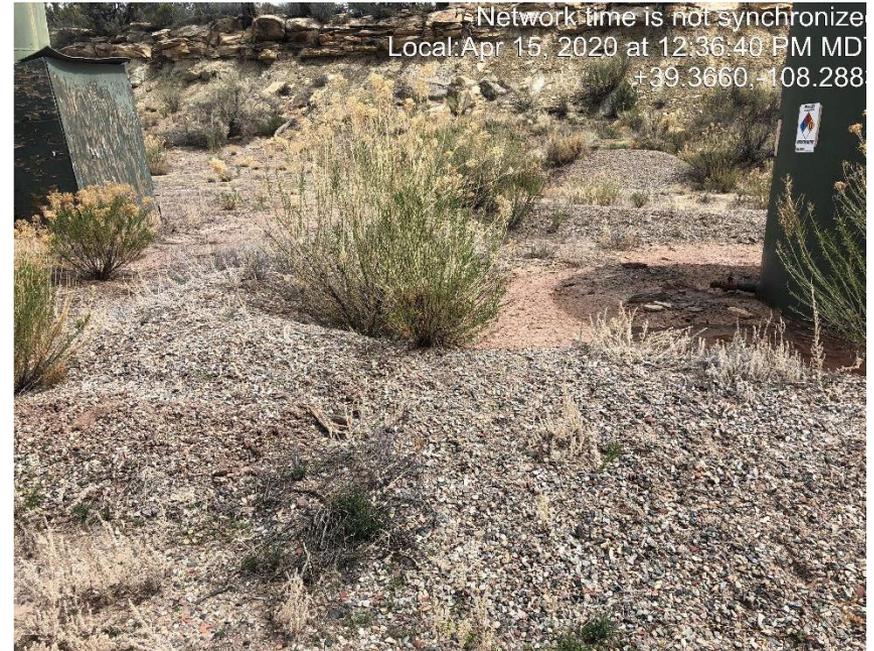
Photo #0980 from inspection #699800920 inspection conducted on 4/15/20.

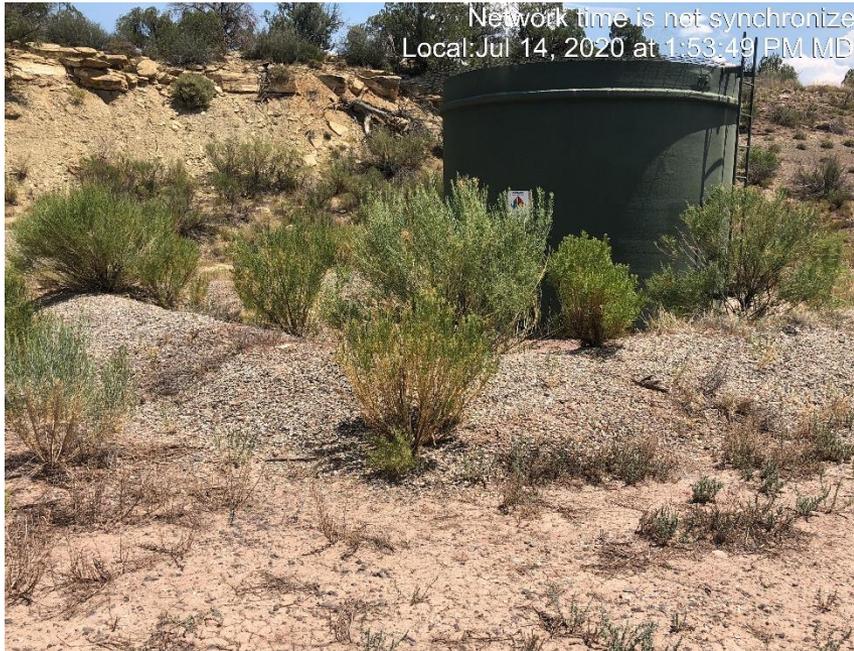
Photo #1524 Multiple places with debris on location.

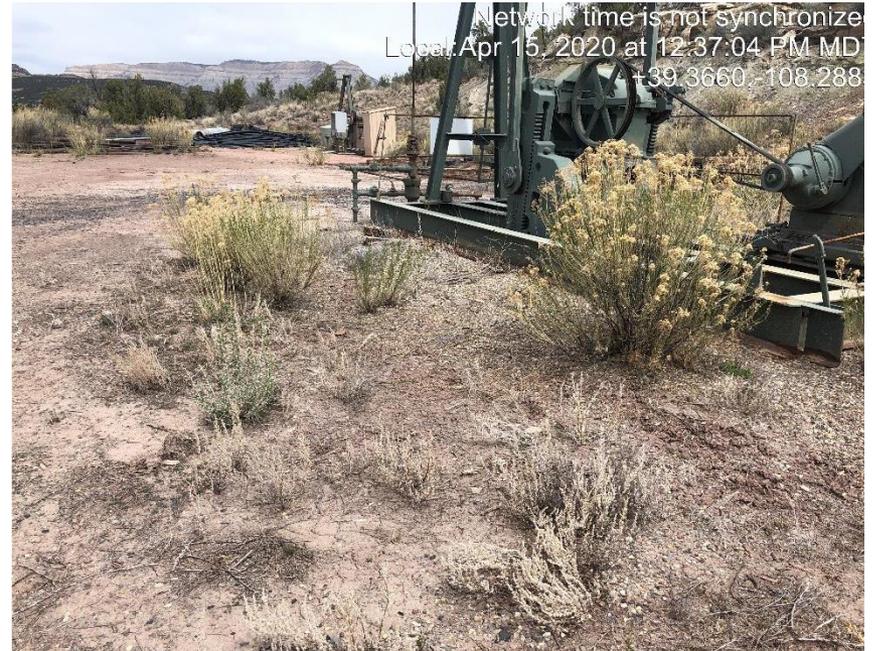
Photo #0981 from inspection #699800920 inspection conducted on 4/15/20.

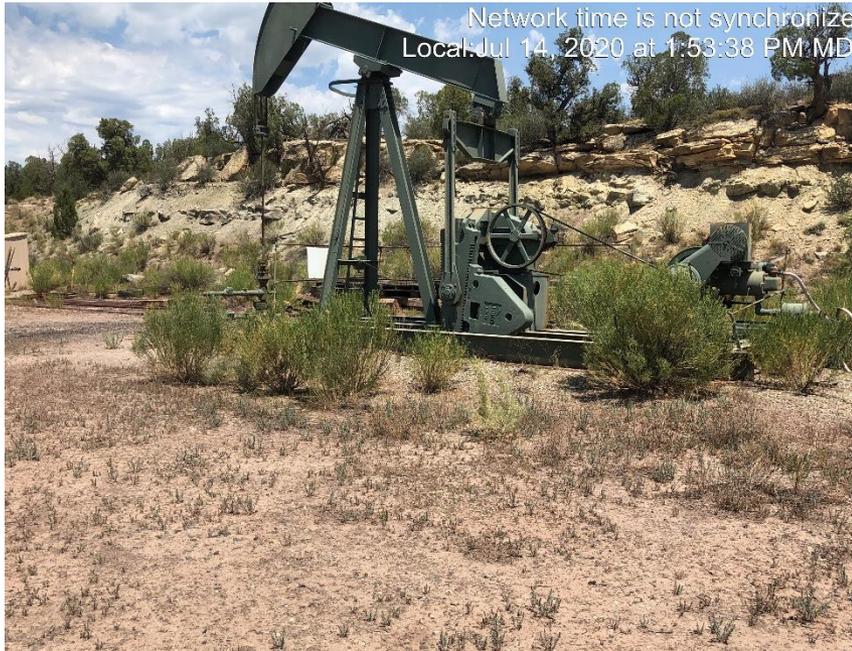
Photo #1523 Multiple places with debris on location.
