# Inspection Photos

7/14/2020

Operator: CAERUS PICEANCE LLC - 10456

Location ID: 335667

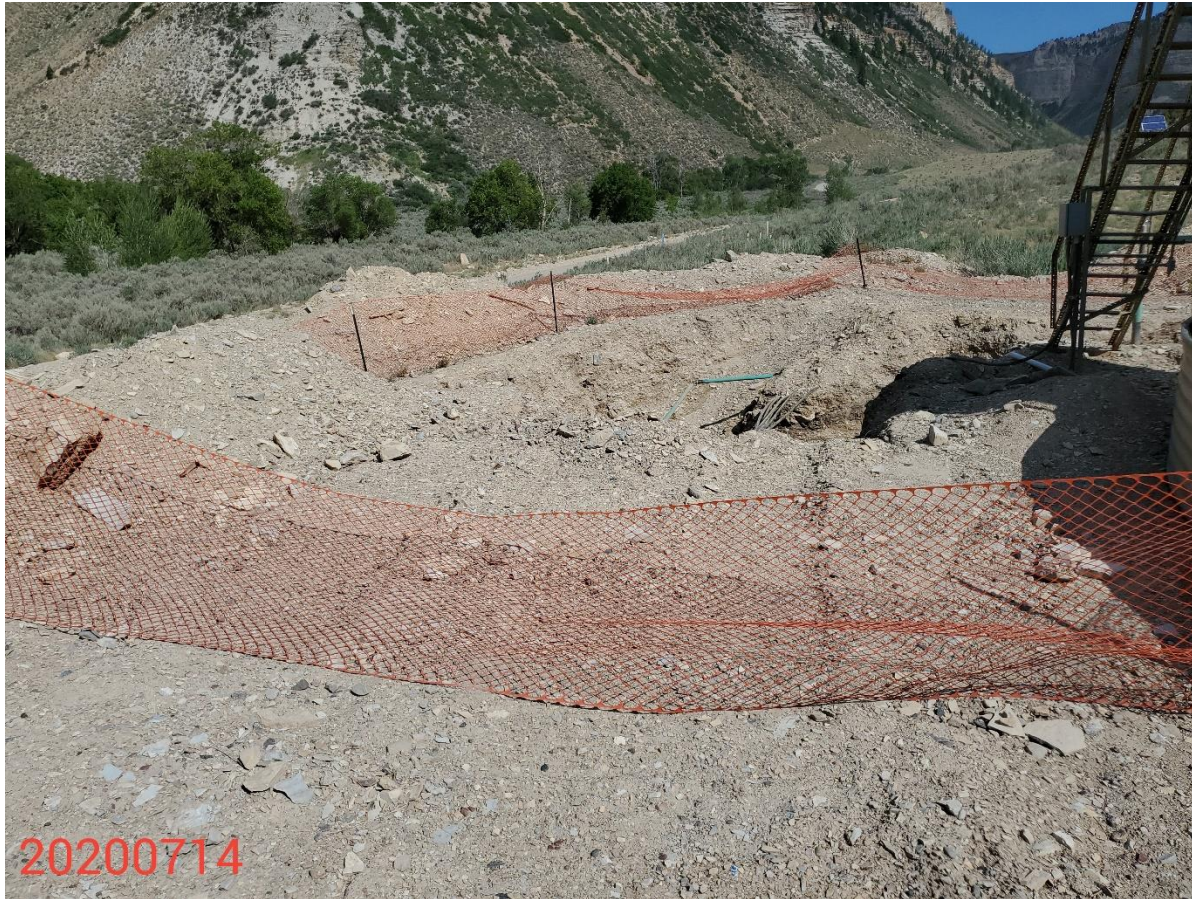
**Photo 1:** Photo taken from the northwest end of the Location, facing north. Photo shows excavated areas due to dumpline spill.

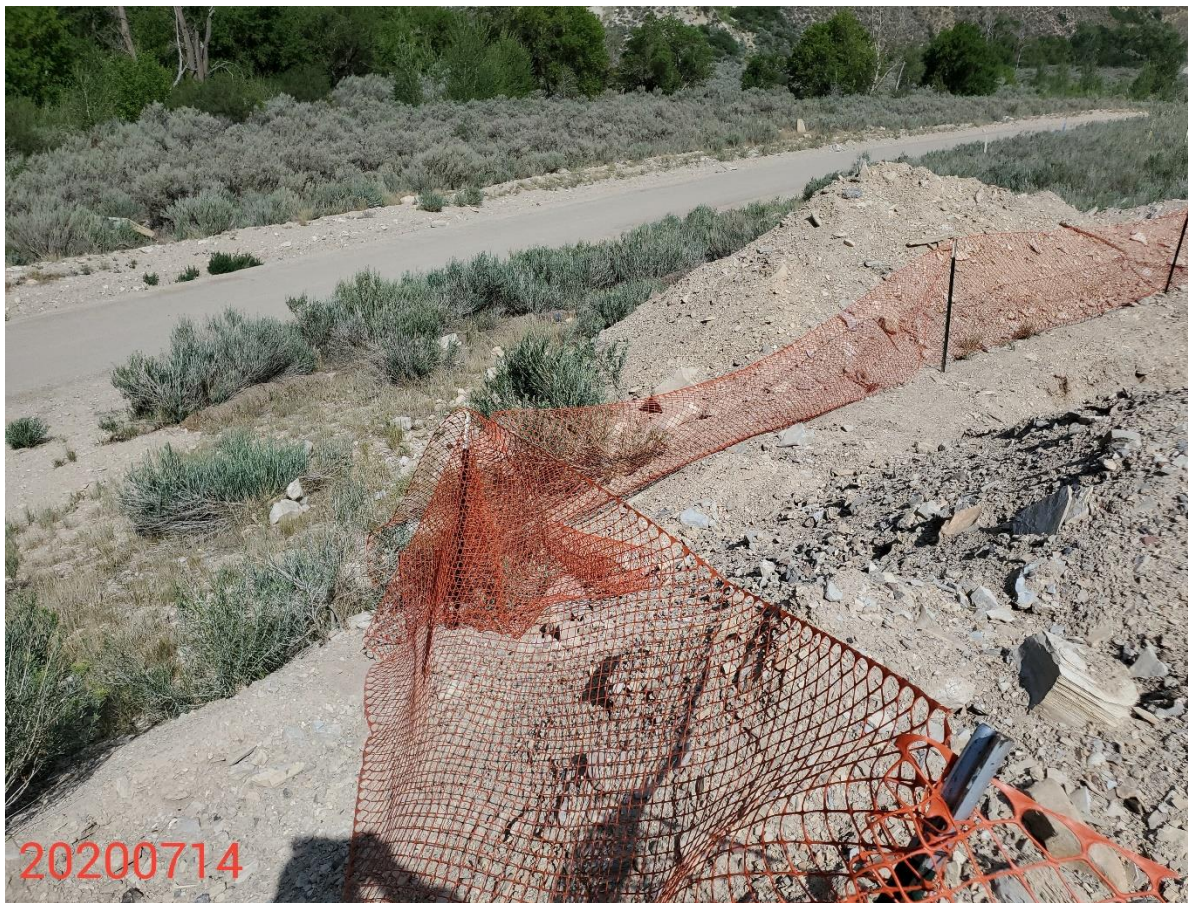
**Photo 2:** Photo taken from the northwest end of the Location, facing northwest. Photo shows excavated areas due to dumpline spill, and the soil stockpiles.

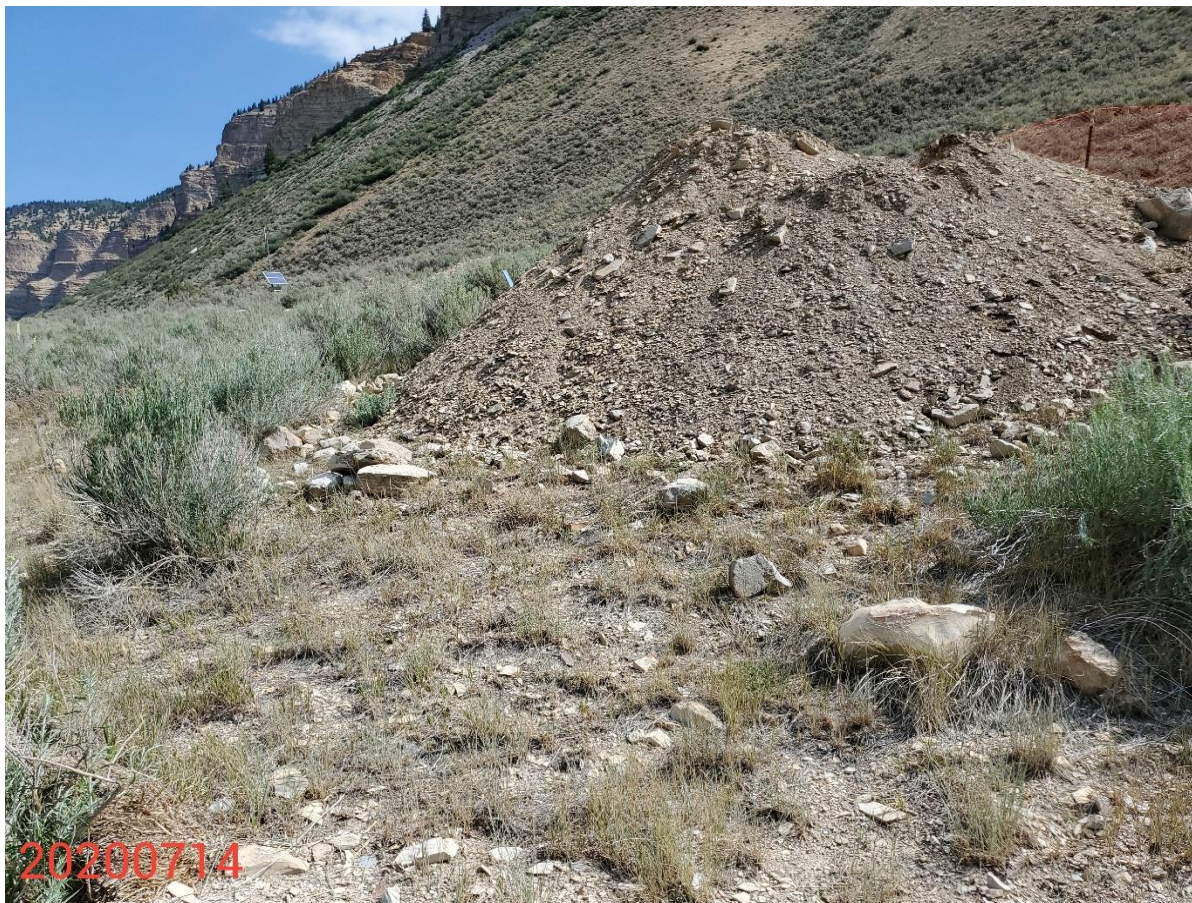
**Photo 3:** Photo taken from the west end of the Location, facing northeast. Photo shows BMPs to prevent sediment transport from the soil stockpiles are missing or insufficient.

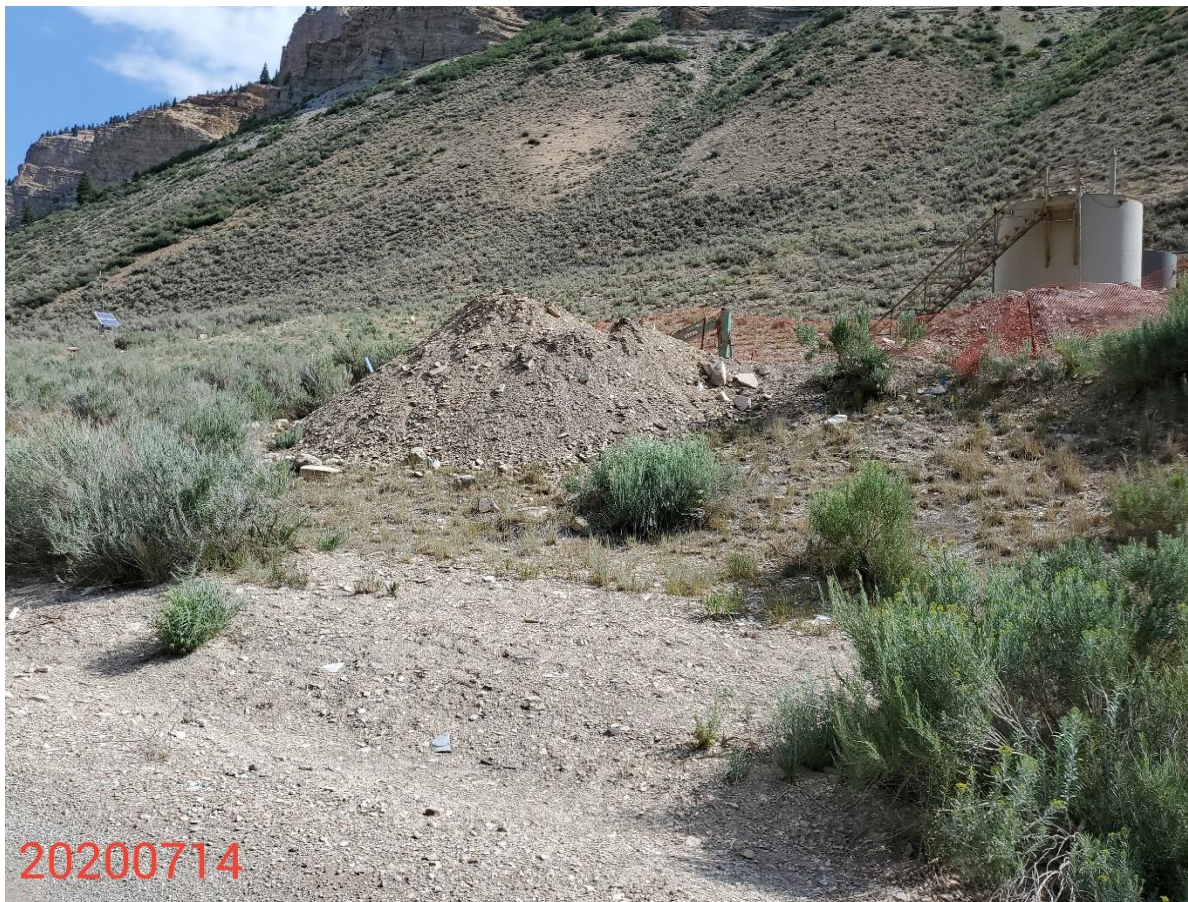
**Photo 4:** Photo taken from the west of the Location, facing northeast. Photo shows BMPs to prevent sediment transport from the soil stockpiles are missing or insufficient.

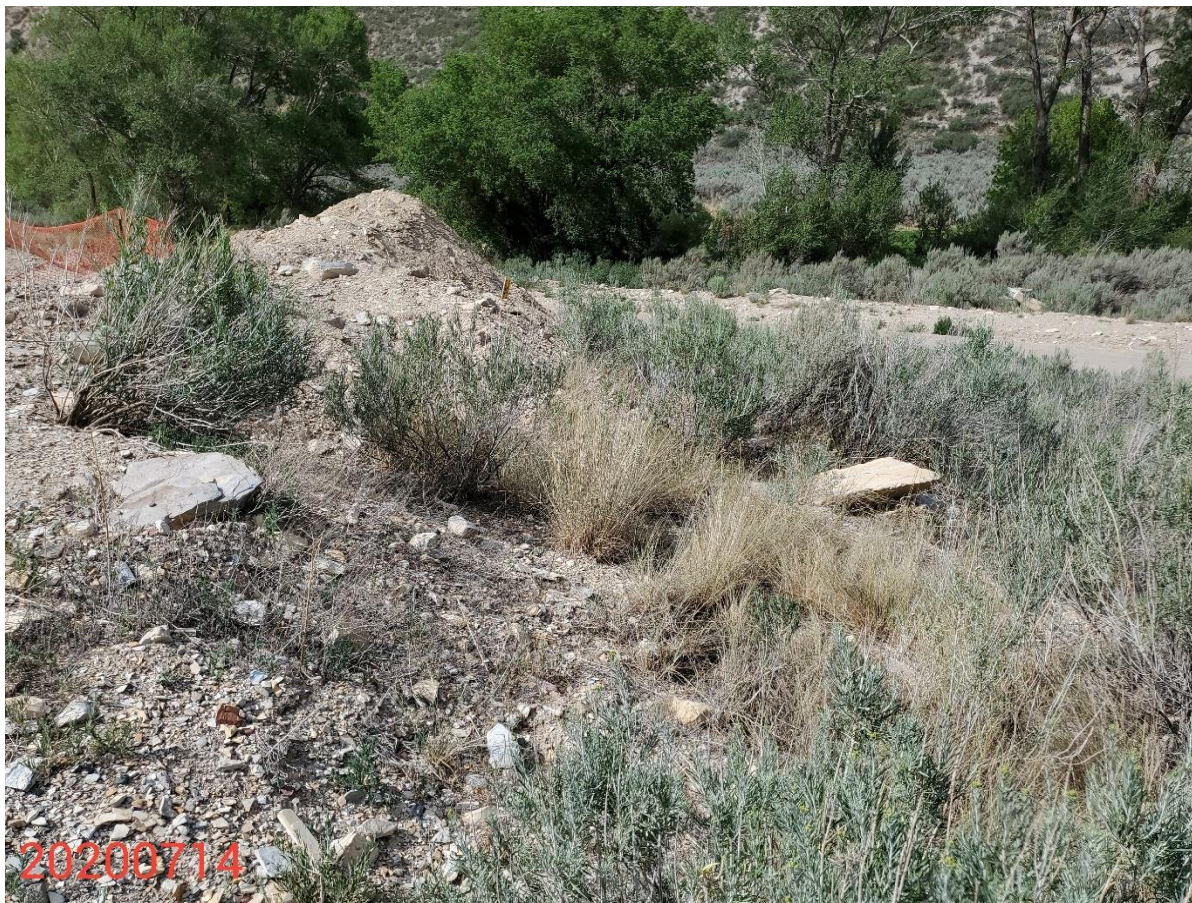
**Photo 5:** Photo taken from the north end of the Location, facing west. Photo shows BMPs to prevent sediment transport from the soil stockpiles are missing or insufficient.

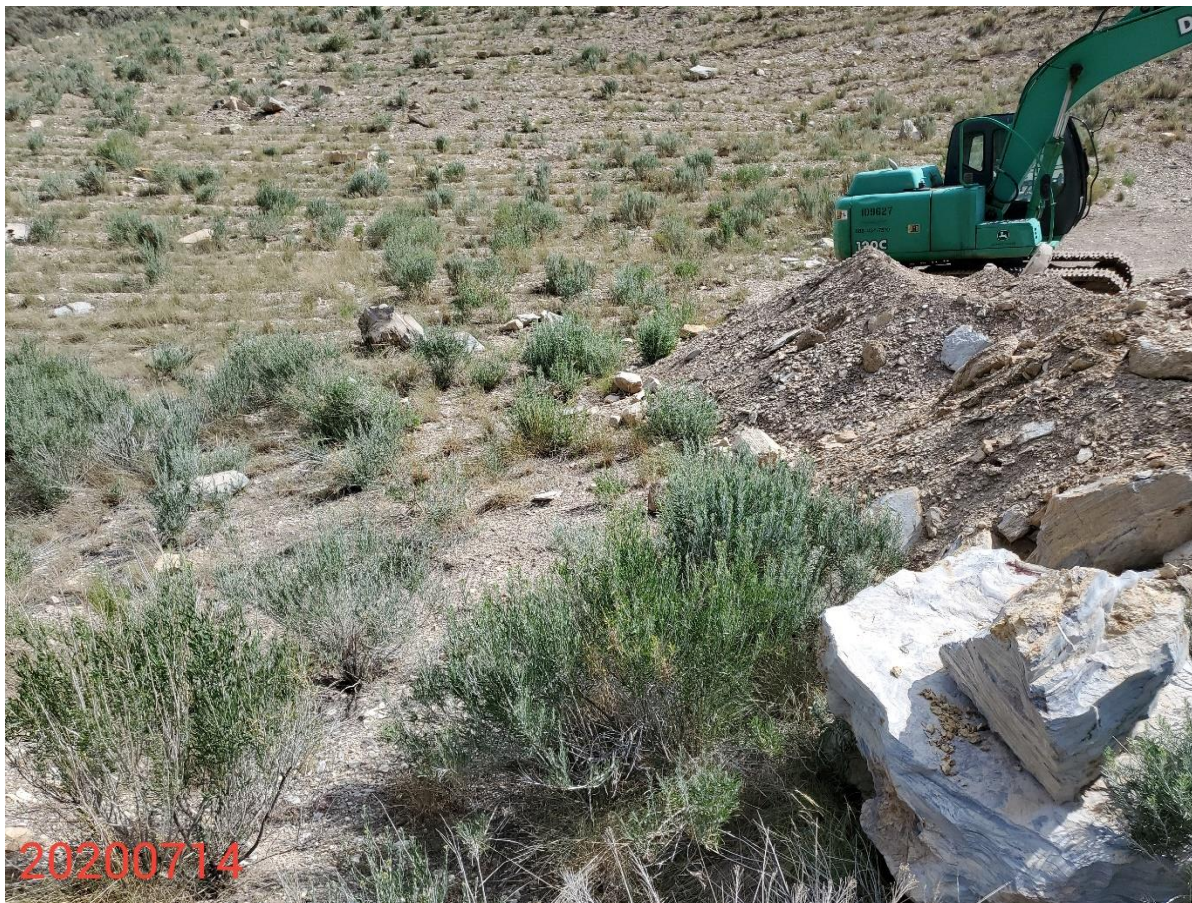
**Photo 6:** Photo taken from the north end of the Location, facing east. Photo shows BMPs to prevent sediment transport from the soil stockpiles are missing or insufficient.

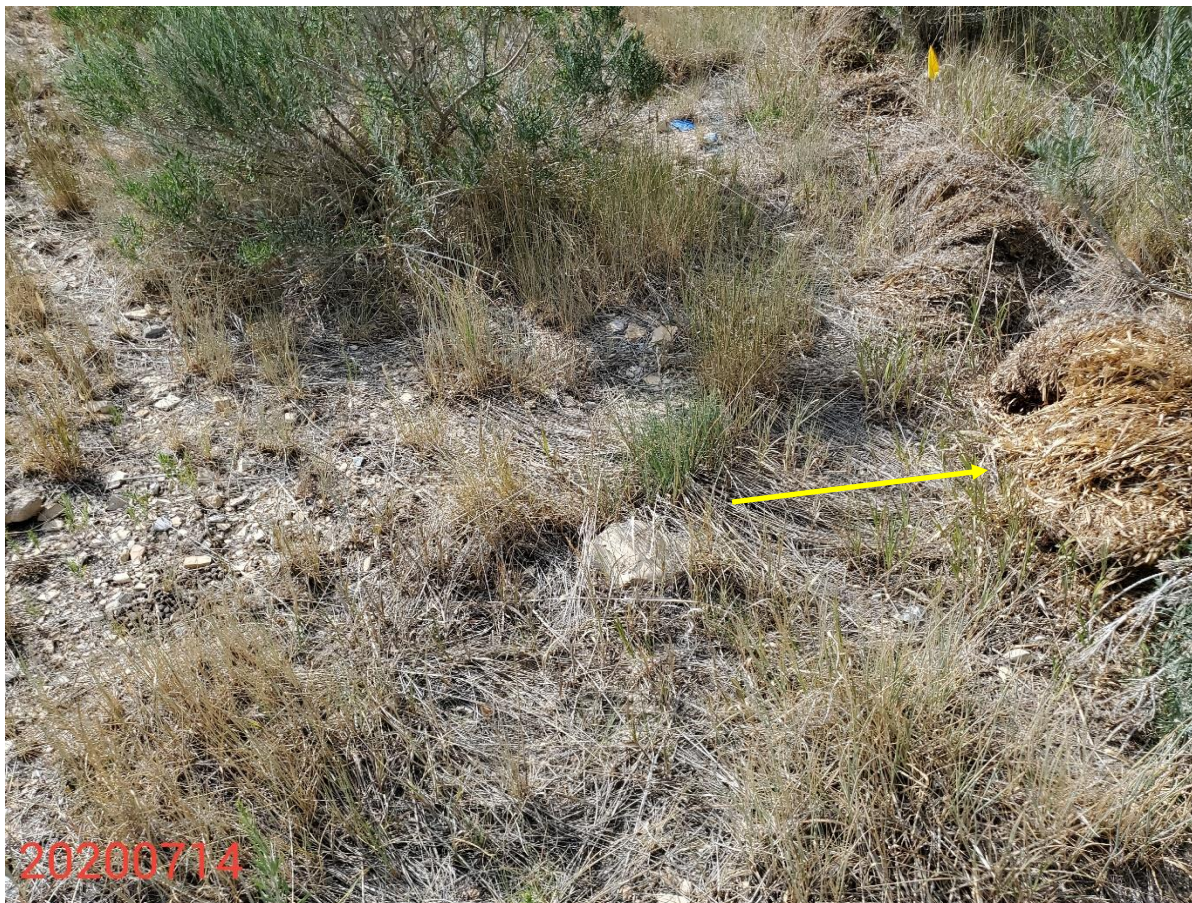
**Photo 7:** Photo taken with use of a west end of the Location. Photo shows straw hay bale BMPs along the west end of the Location is has not been maintained and is not in proper functioning condition.

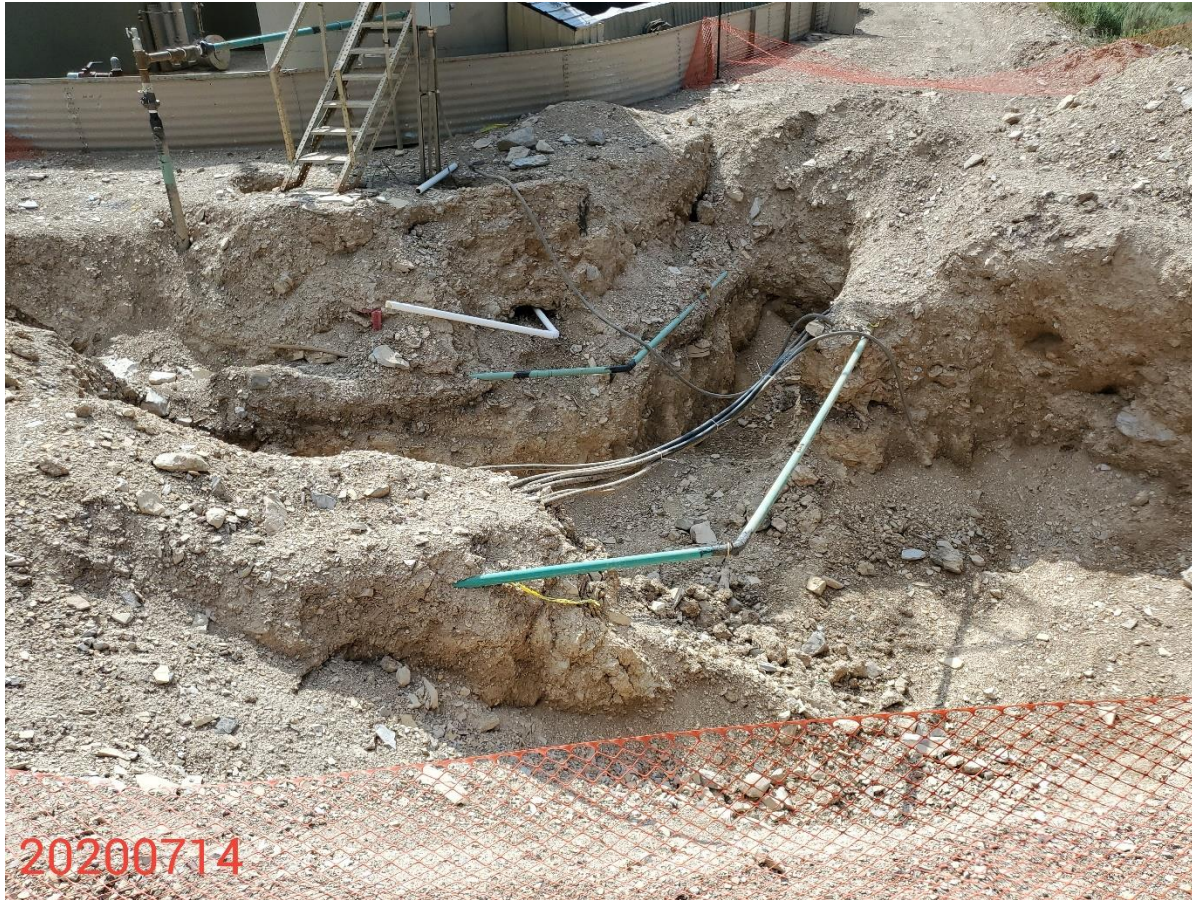
**Photo 8:** Photo taken from the northwest end of the Location. Photo shows excavated areas due to dumpline spill.

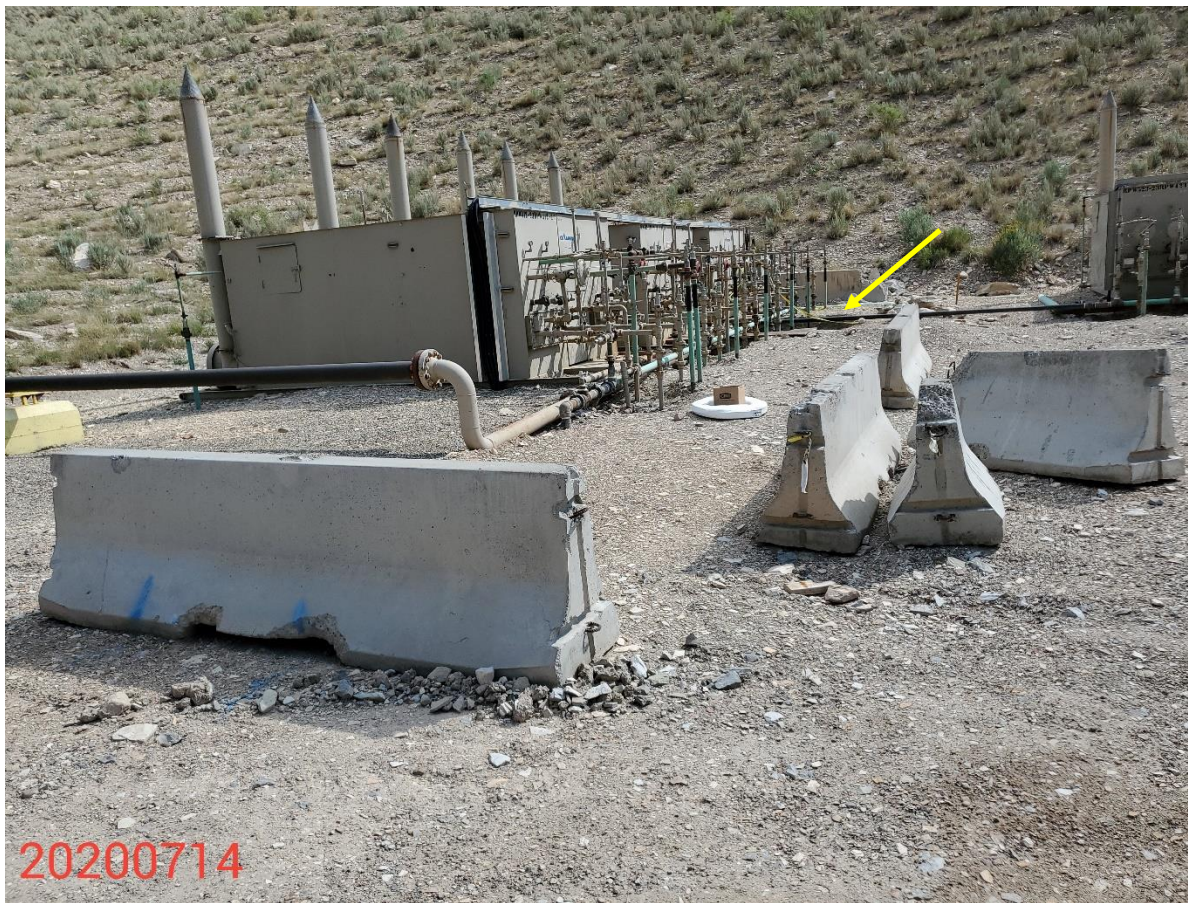
**Photo 9:** Photo taken from the northeast end of the Location, facing east. Photo shows equipment and 2<sup>nd</sup> area of the Location where excavation activities are evident.

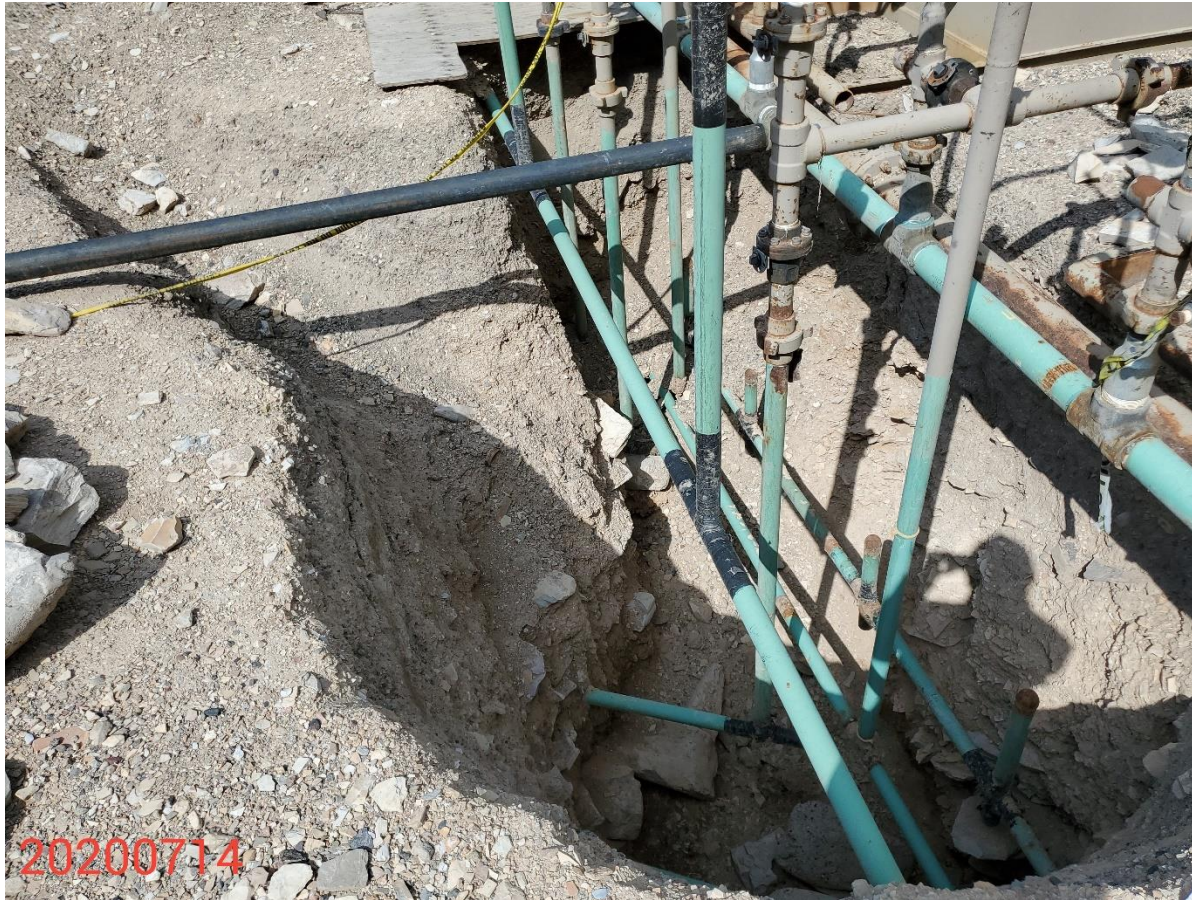
**Photo 10:** Photo shows excavated area on the northeast end of the Location.

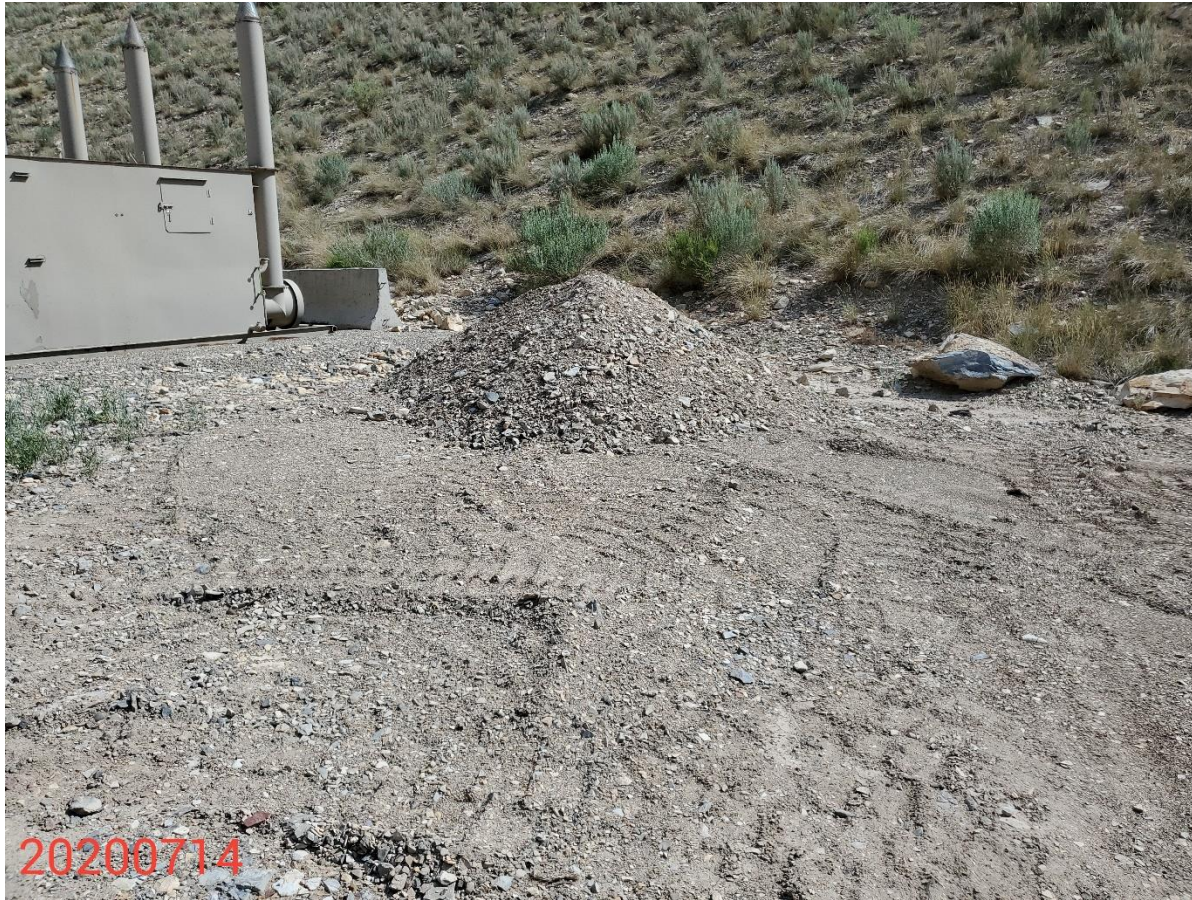
**Photo 11:** Photo of soil stockpile on the northeast end of the Location.

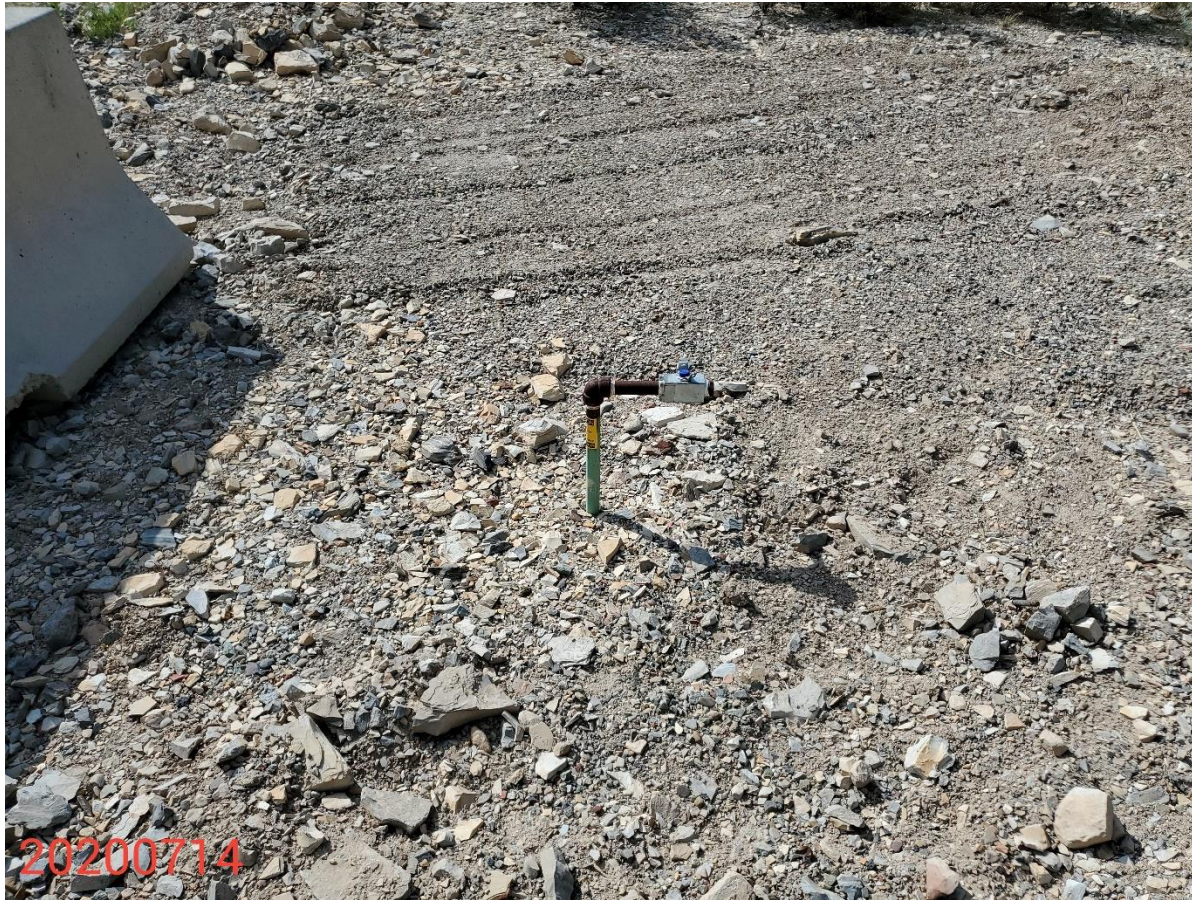
**Photo 12:** Photo of riser on the west end of the Location.

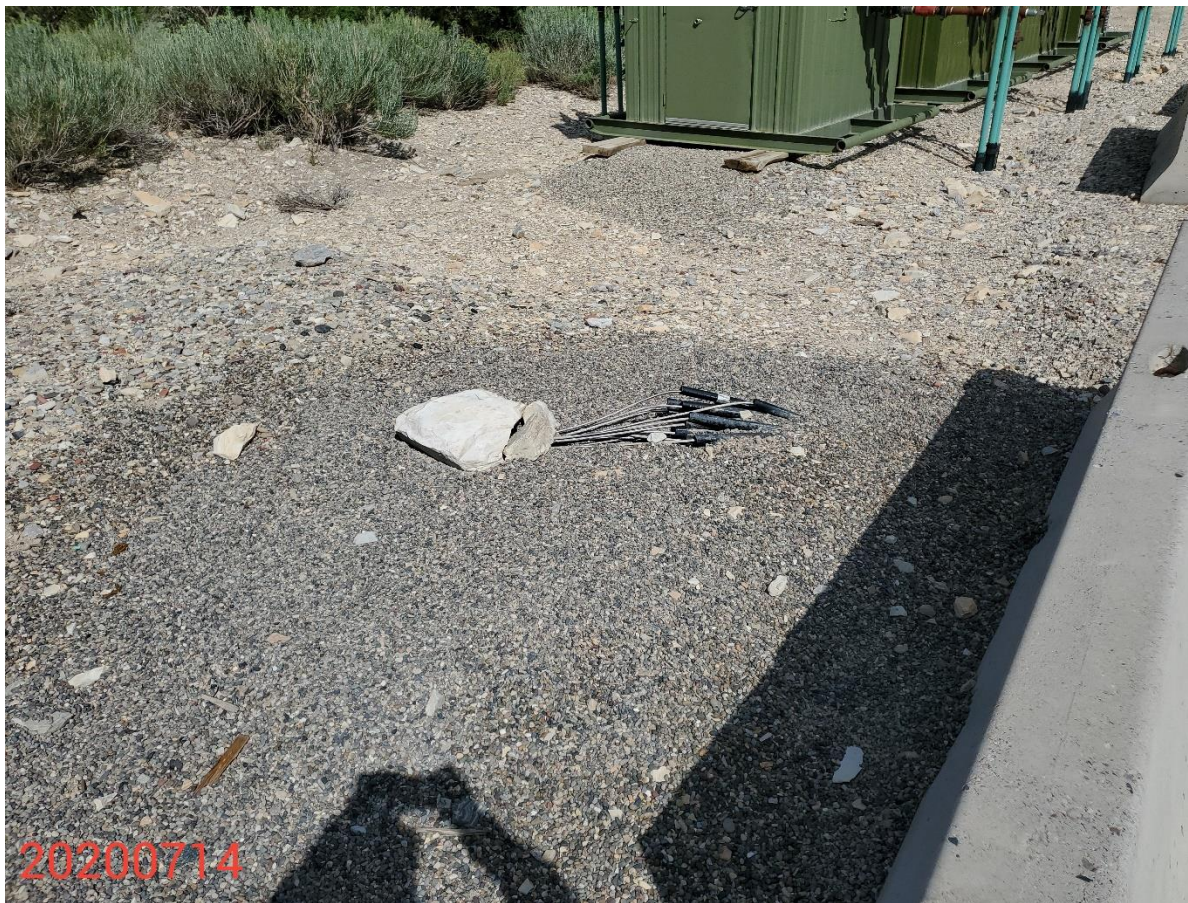
**Photo 12:** Photo shows what appears to be processed piping on the west end of the Location. It is unclear as to what the current application and future use of the equipment is on the Location.
