Inspection Photos

Operator: Kinder Morgan
API: 083-06624
Date: 7/9/2020

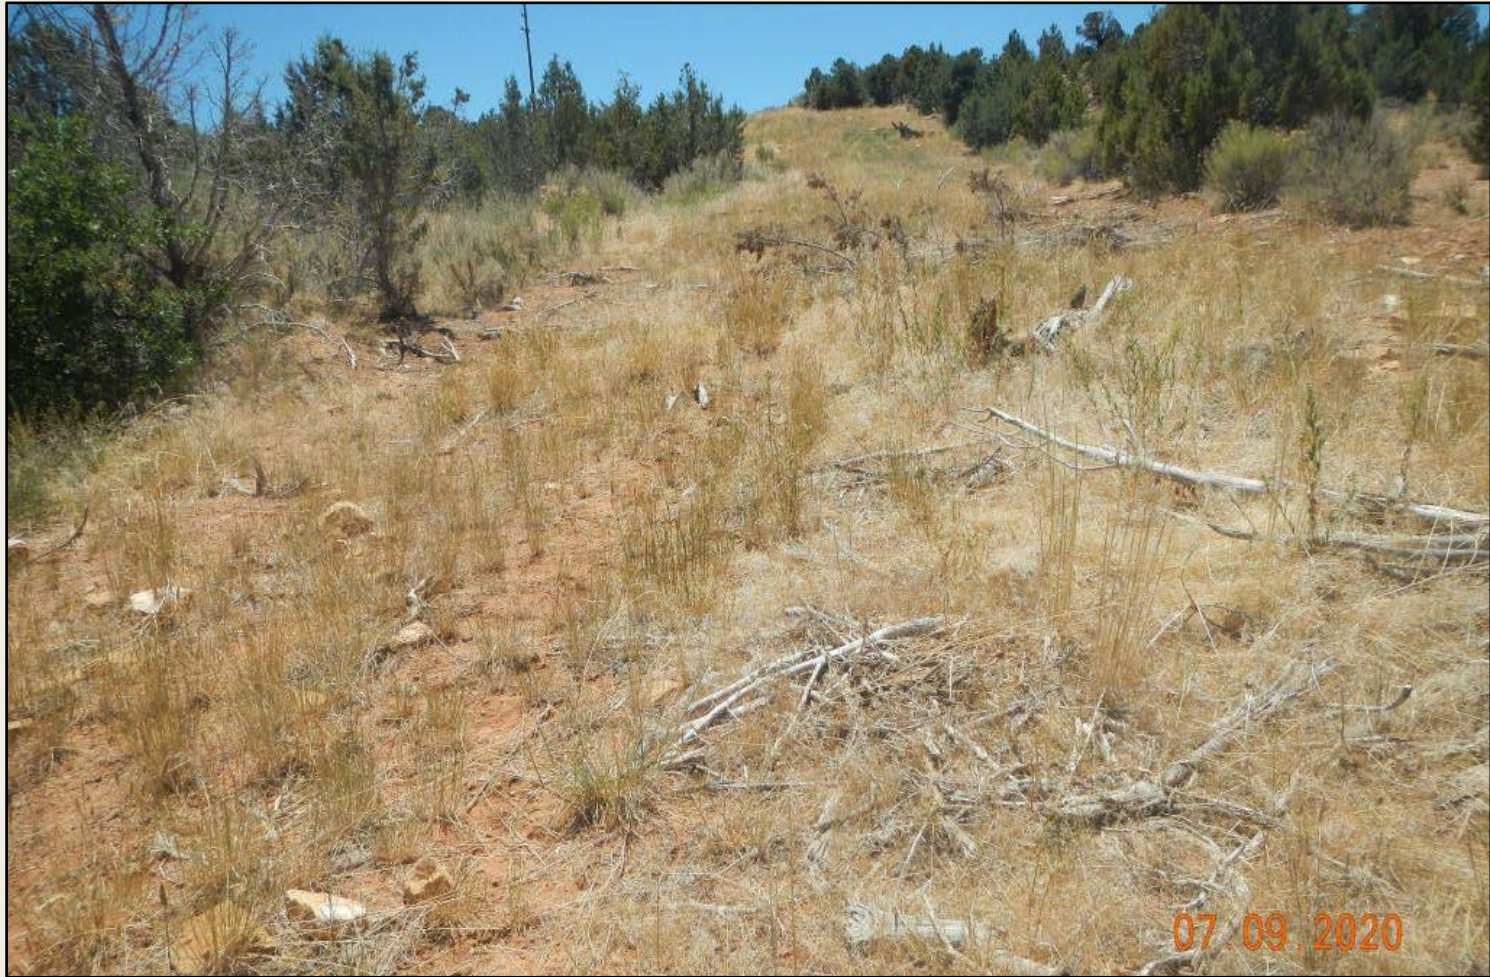
Photo 1. View of the access road facing southward. Revegetation appears to be progressing with crested wheatgrass, fourwing saltbush, smooth brome, and western wheatgrass.

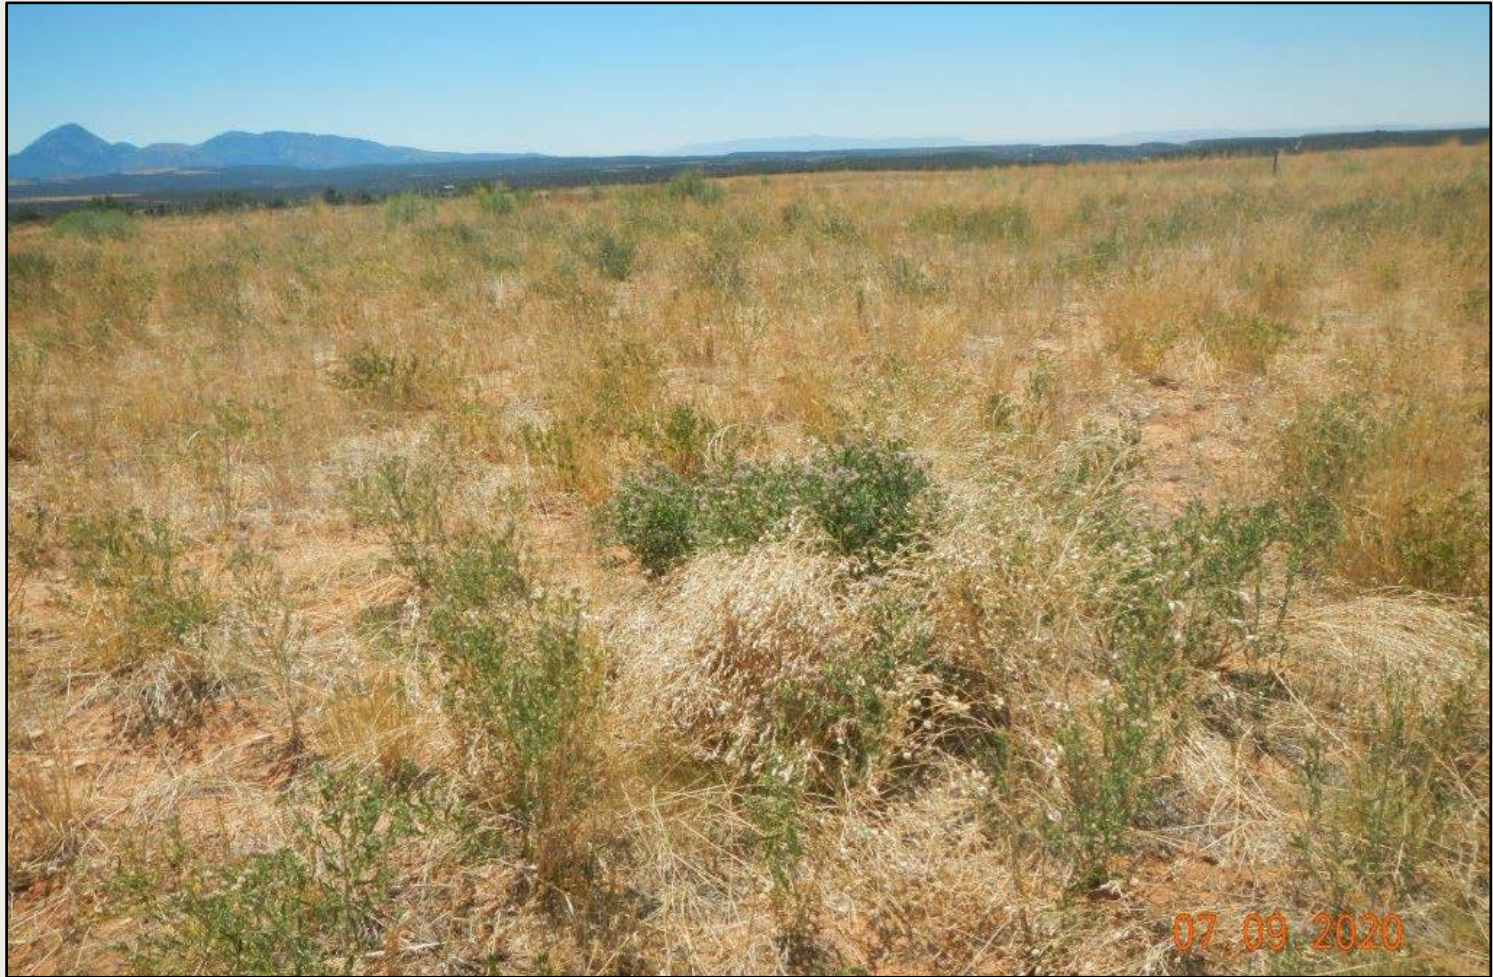
Photo 2. View of the project area from the northwestern corner facing center.

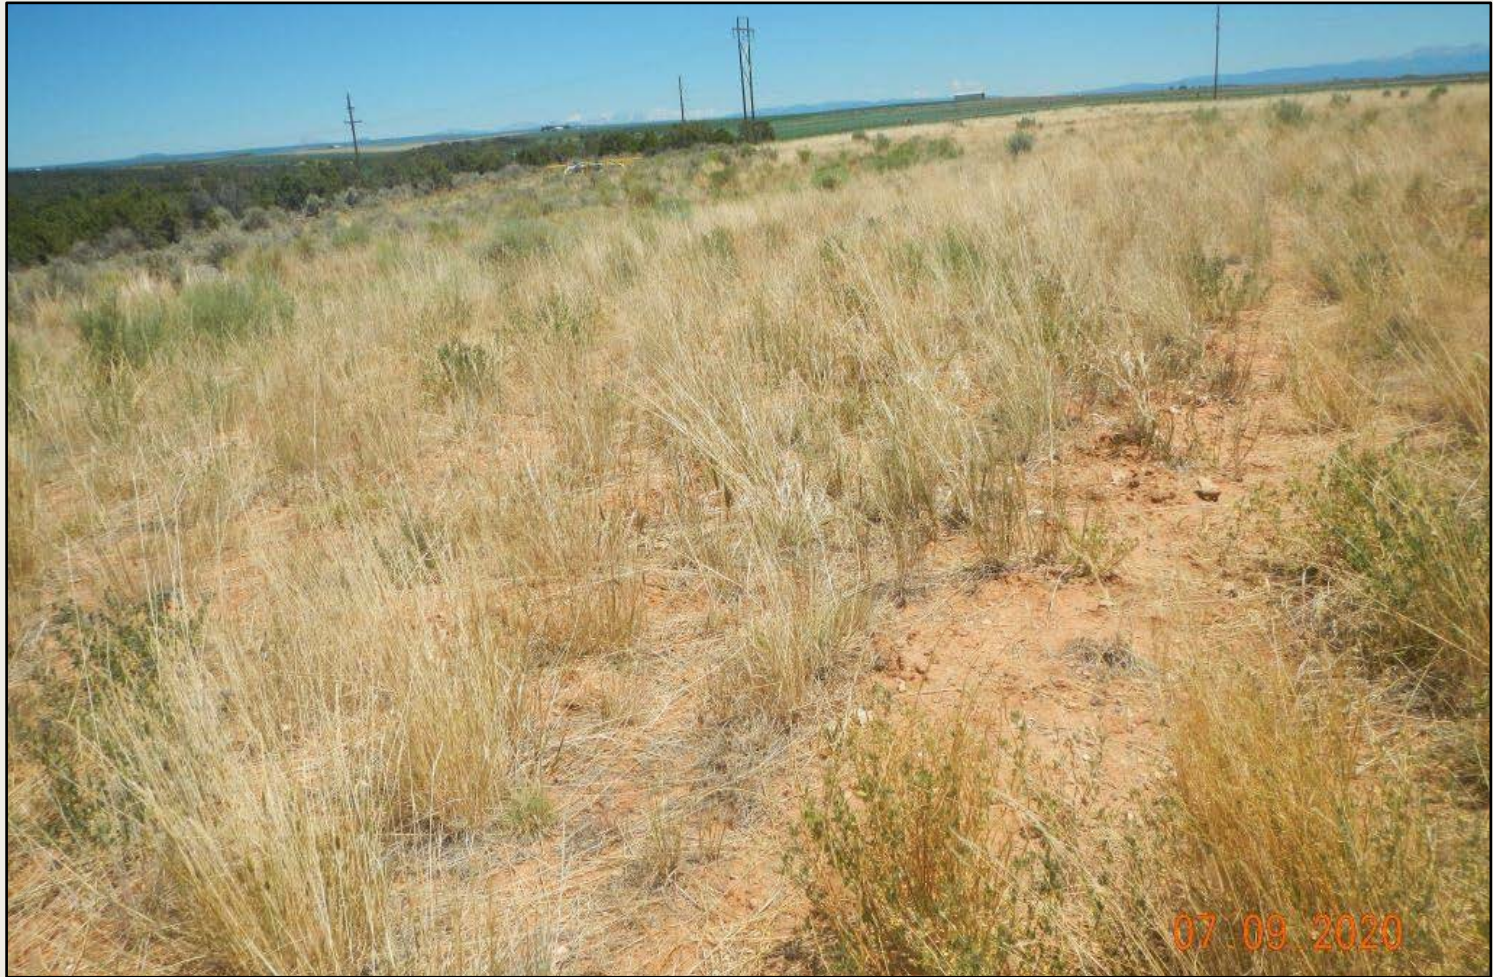
Photo 3. View of the northern project area from the northwestern corner facing eastward.

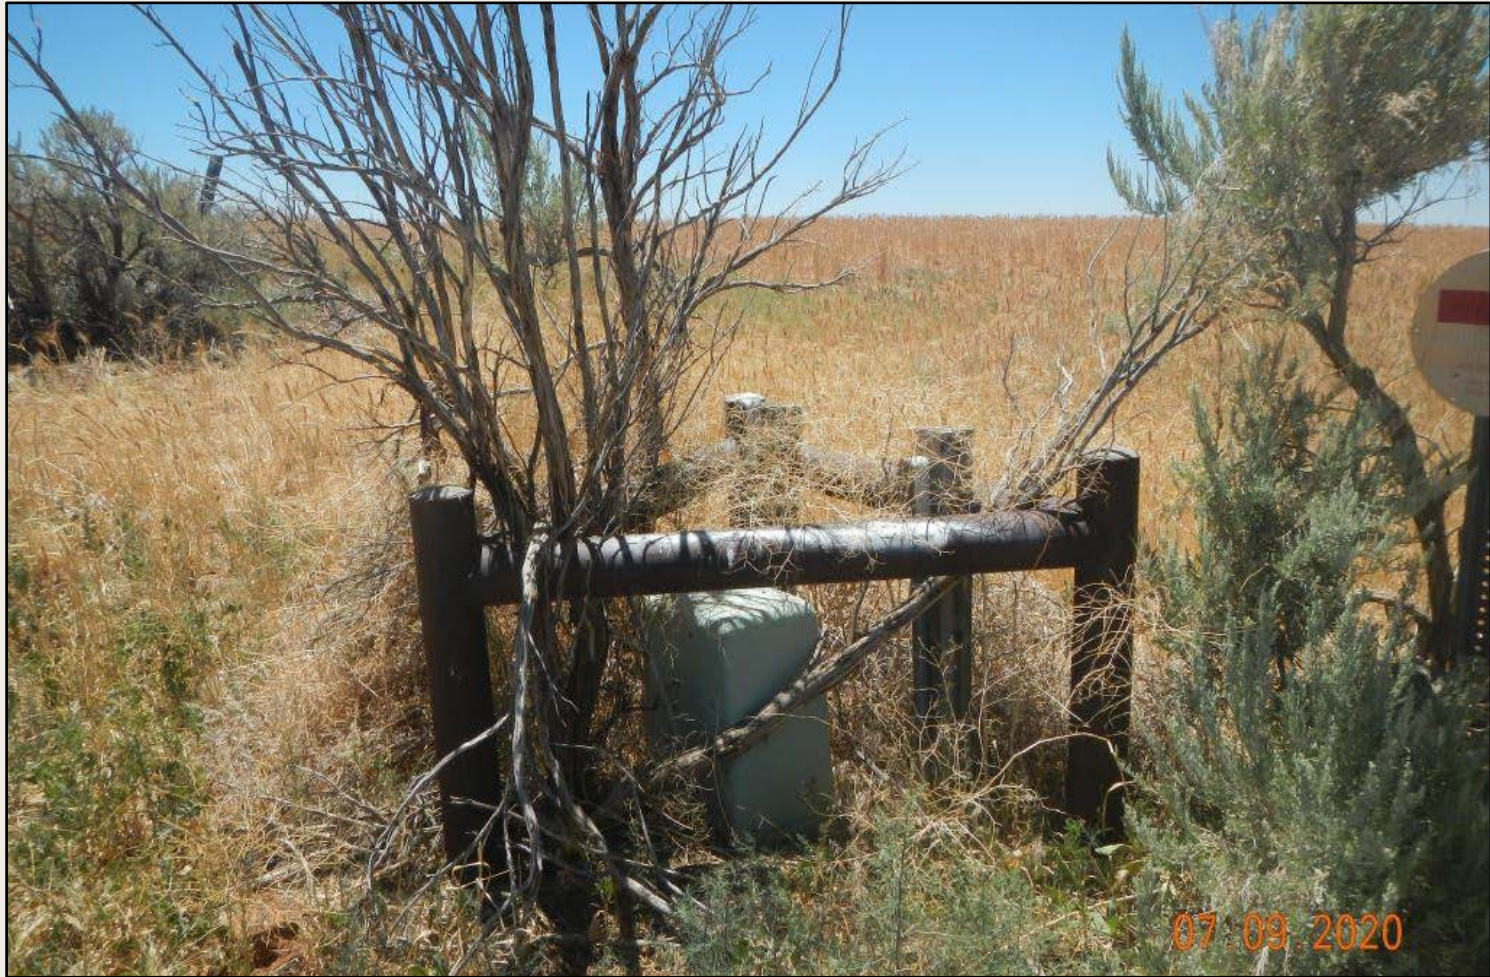
Photo 4. View of riser at the entrance to the former well pad, is not maintained and appears to be associated with the plugged well. Riser should be removed.

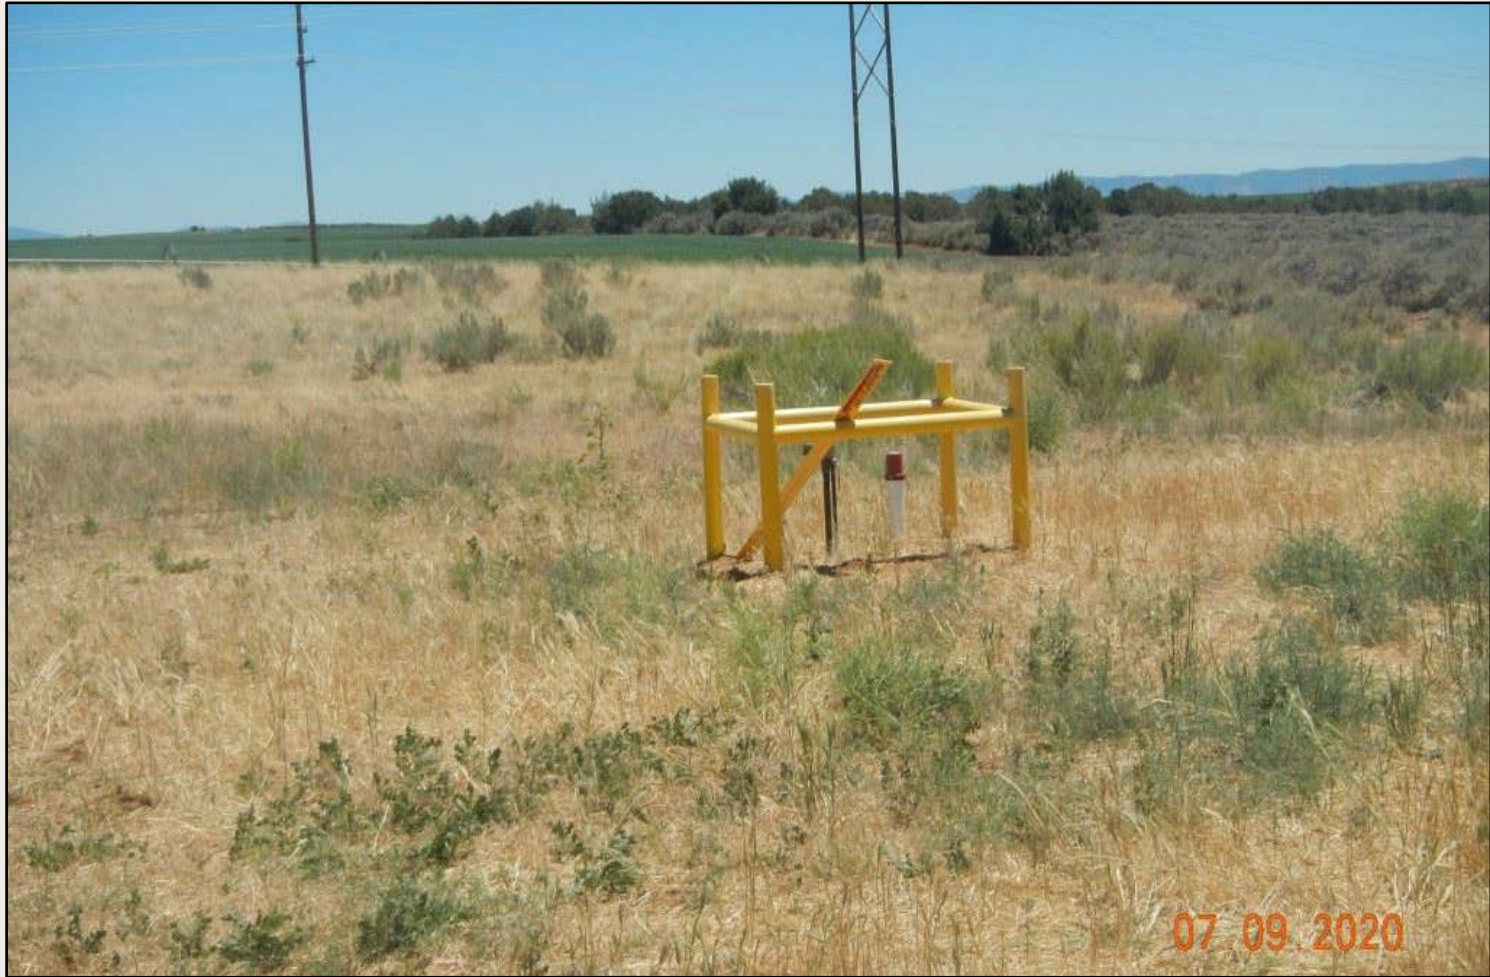
Photo 5. View of riser in the southeastern project area. Flowline maps do not illustrate active lines in the area. Riser needs to be removed.

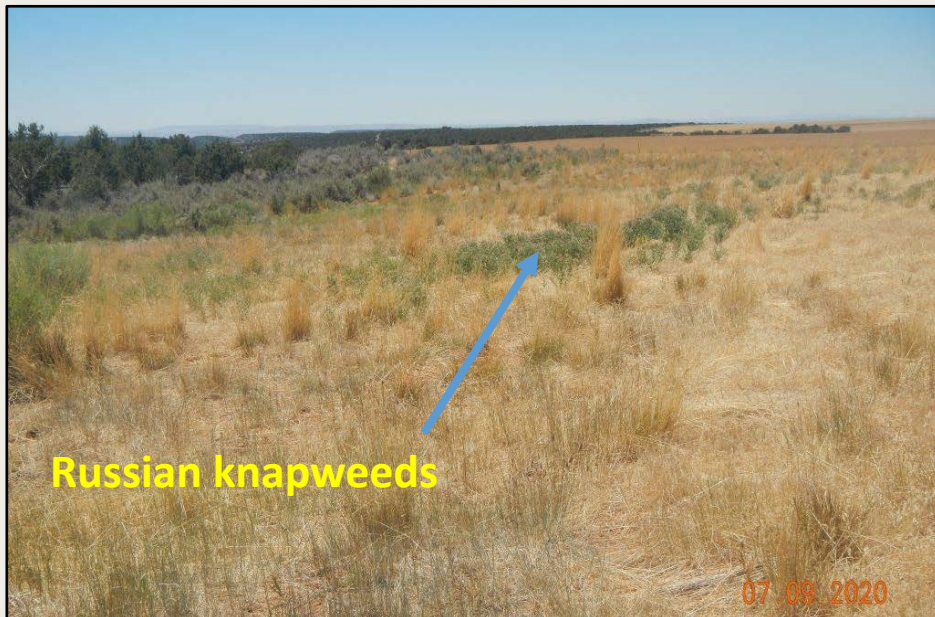
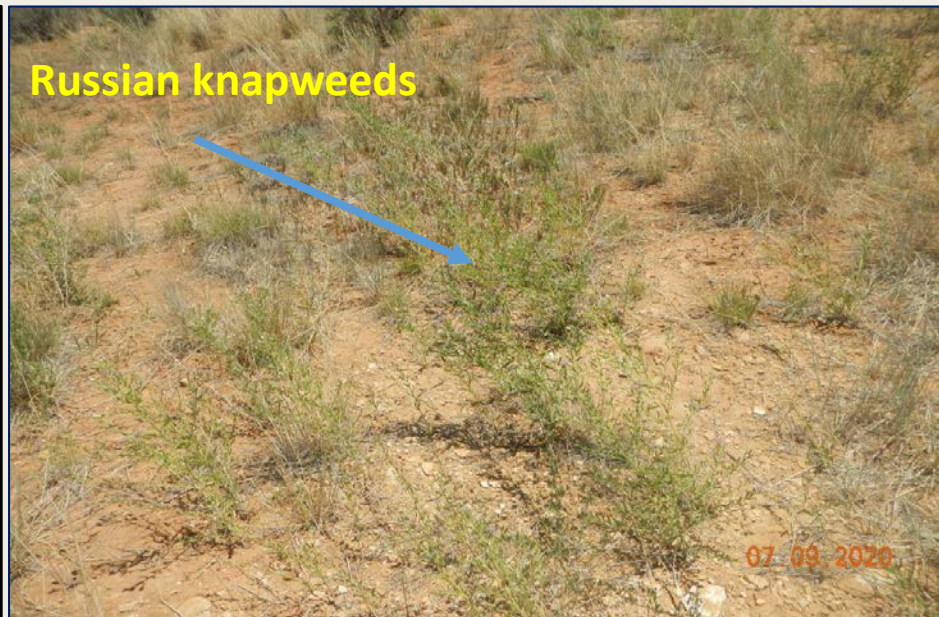
Photos 6/7. View of Russian knapweeds within the project area. Approximately 3000 individuals observed.

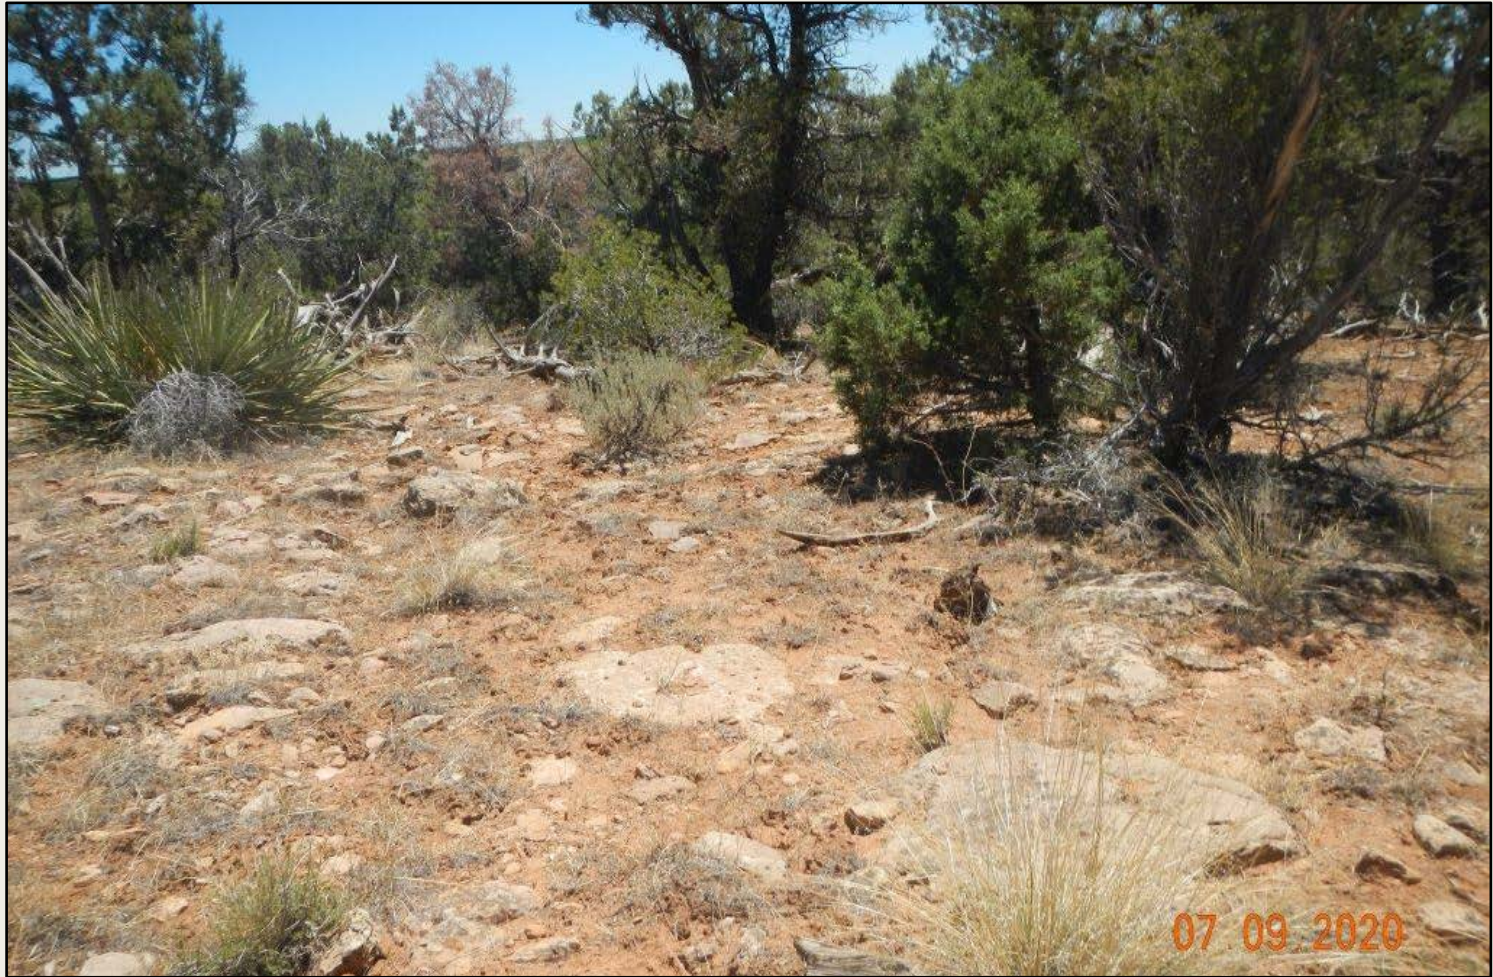
Photo 8. View of reference area vegetation comprised of pinyon and juniper woodland, with sagebrush, yucca, antelope bitterbrush, Indian ricegrass, and Navajo tea in the understory.
