Location Name: – Schneider Energy Services, Inc. - Facility ID 313815 – Rem #3215
Inspection Date: 07/14/2020

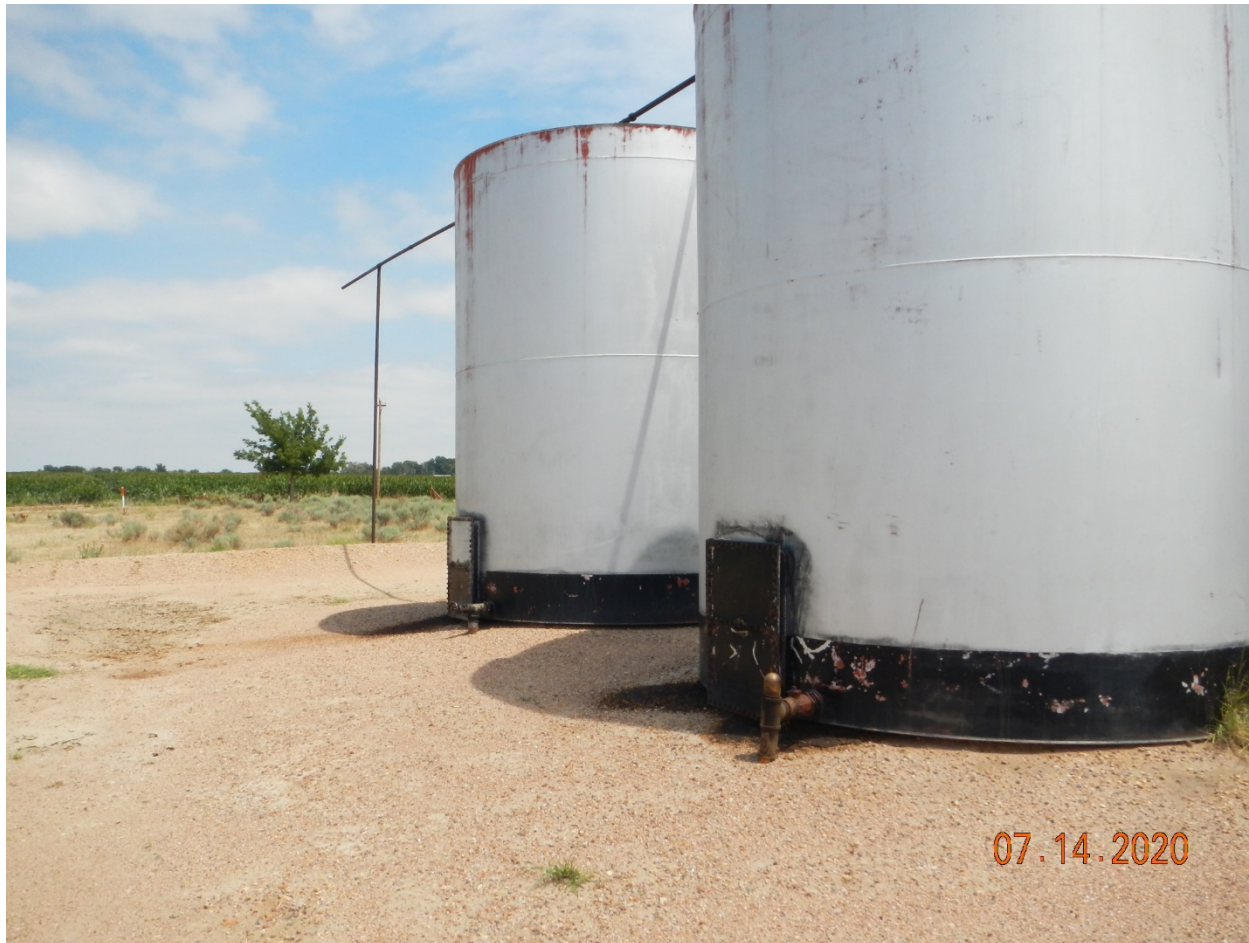
Photo # 2 – West side of tank battery, oily soil under tanks and valves

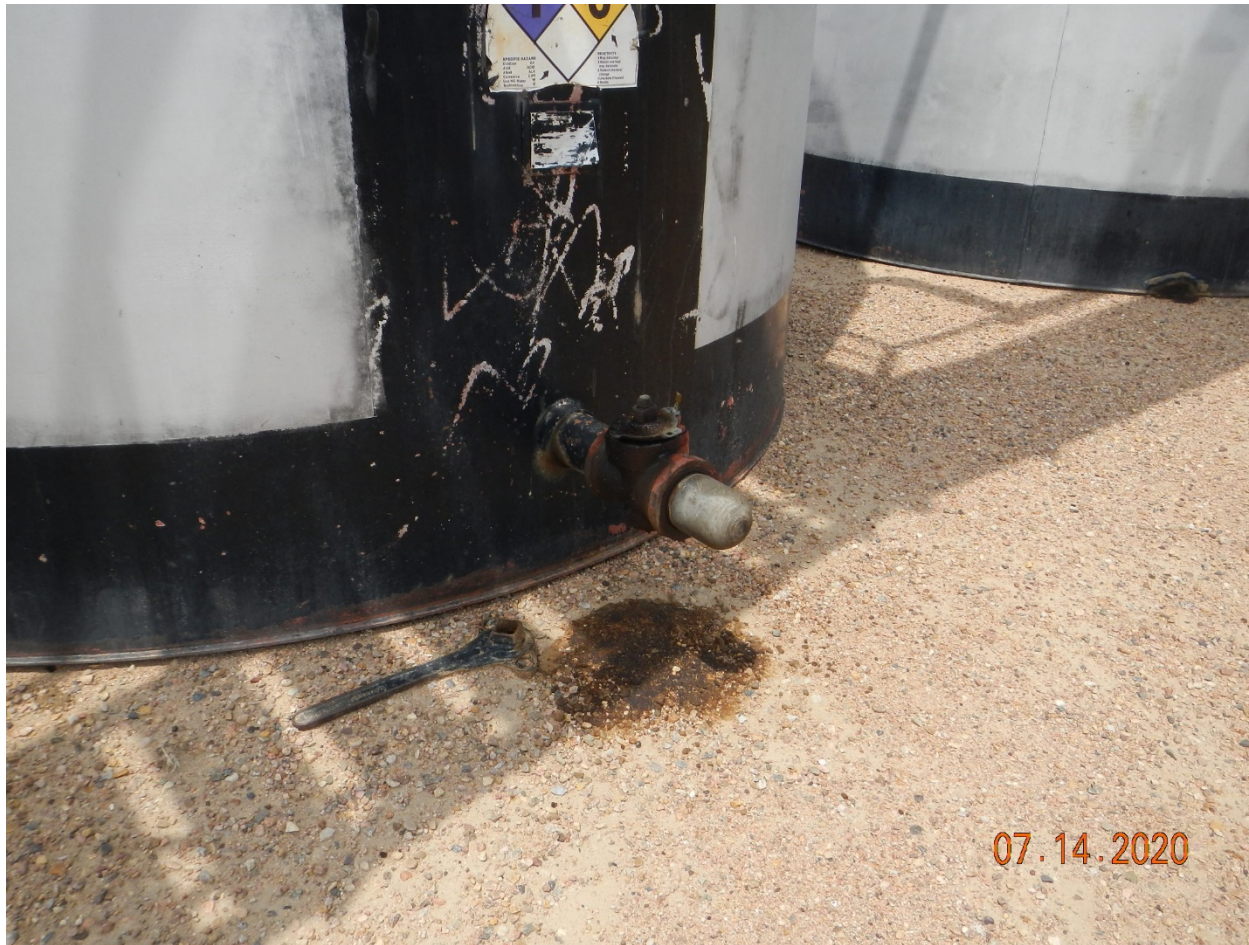
Photo # 3 – East side of tank battery, oily soil under valves and bottom of north tank

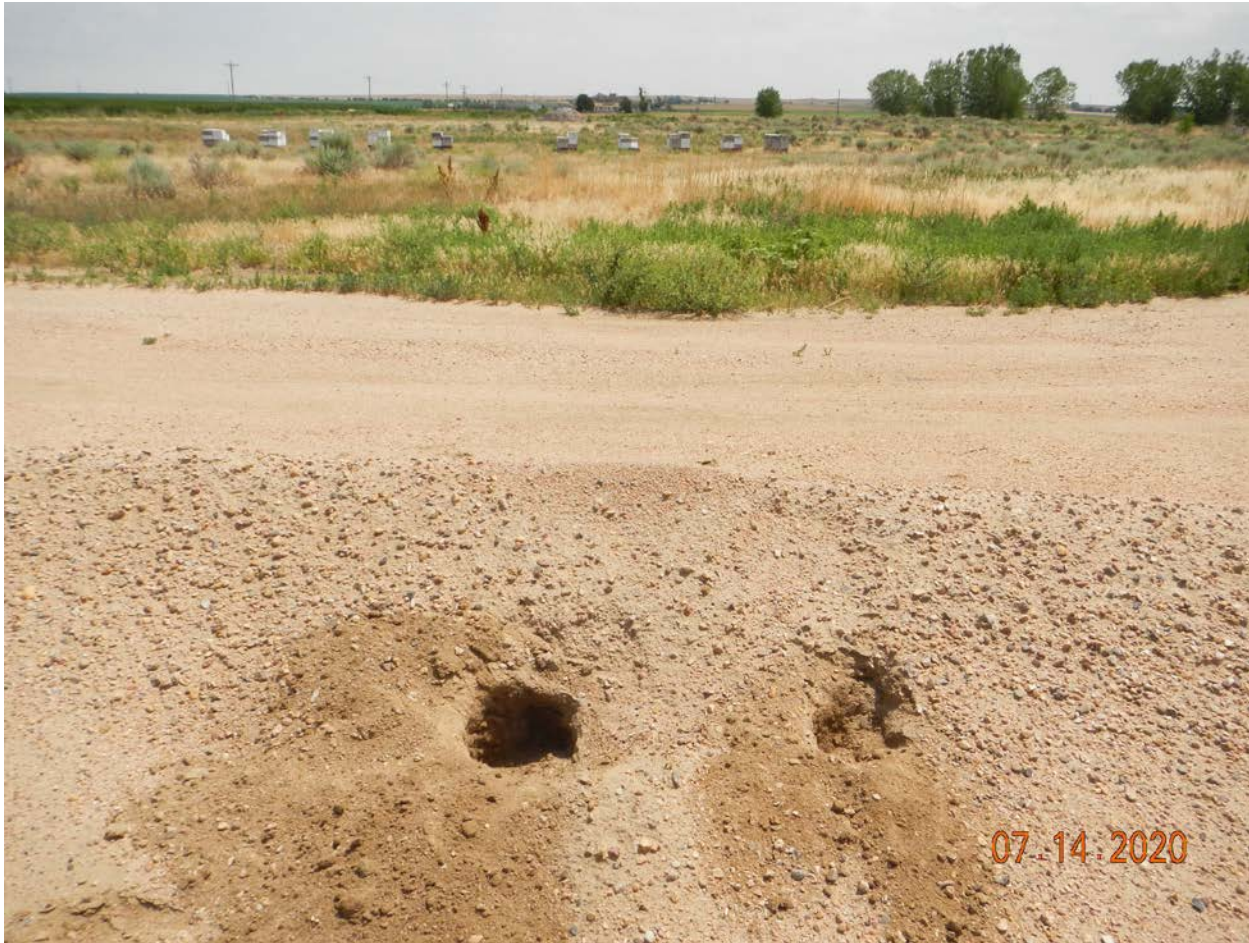
Photo # 4 – East side berm of tank battery, animal burrows

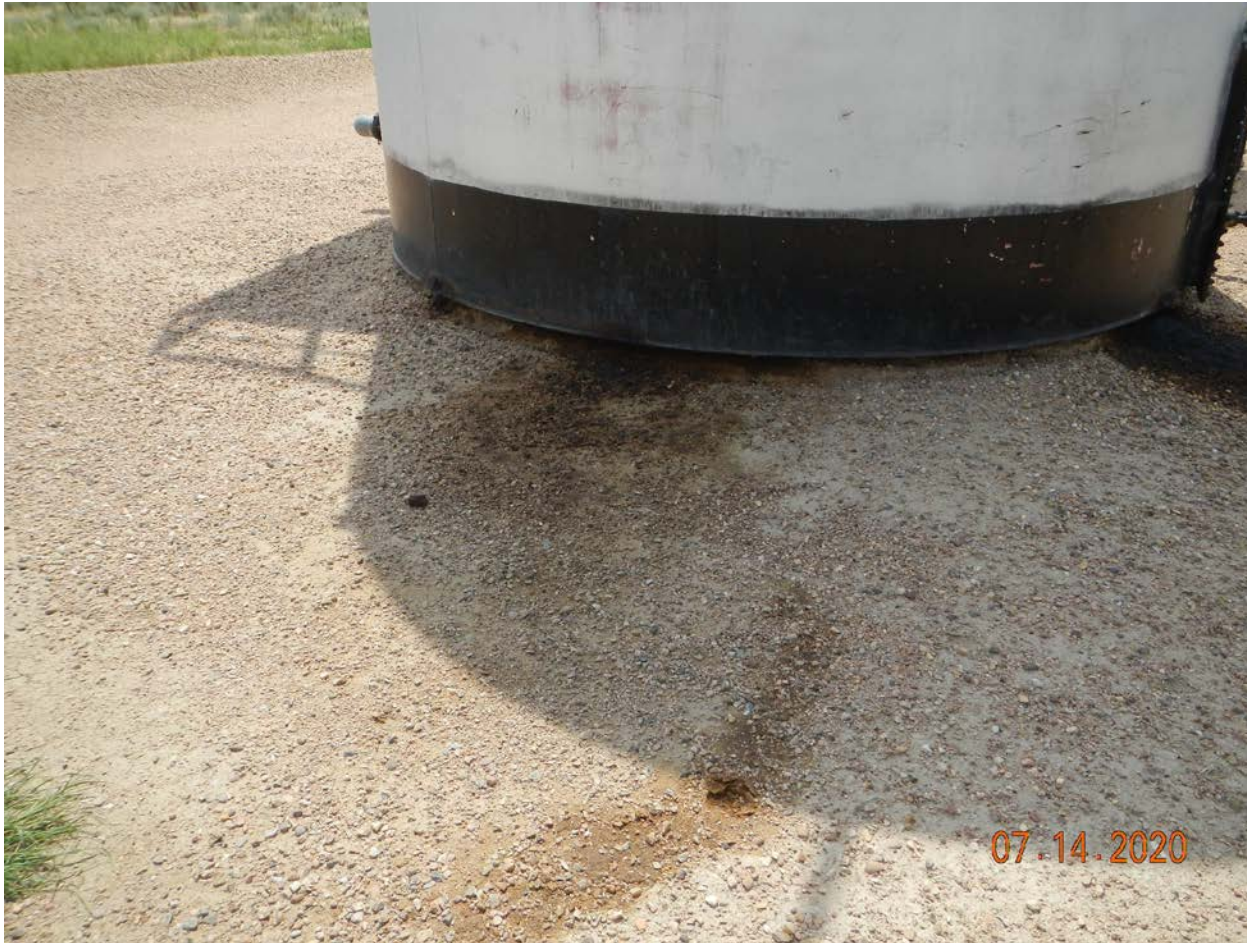
Photo # 5 – North side of northern tank, oil stained soil and tanks leaking from corrosion holes

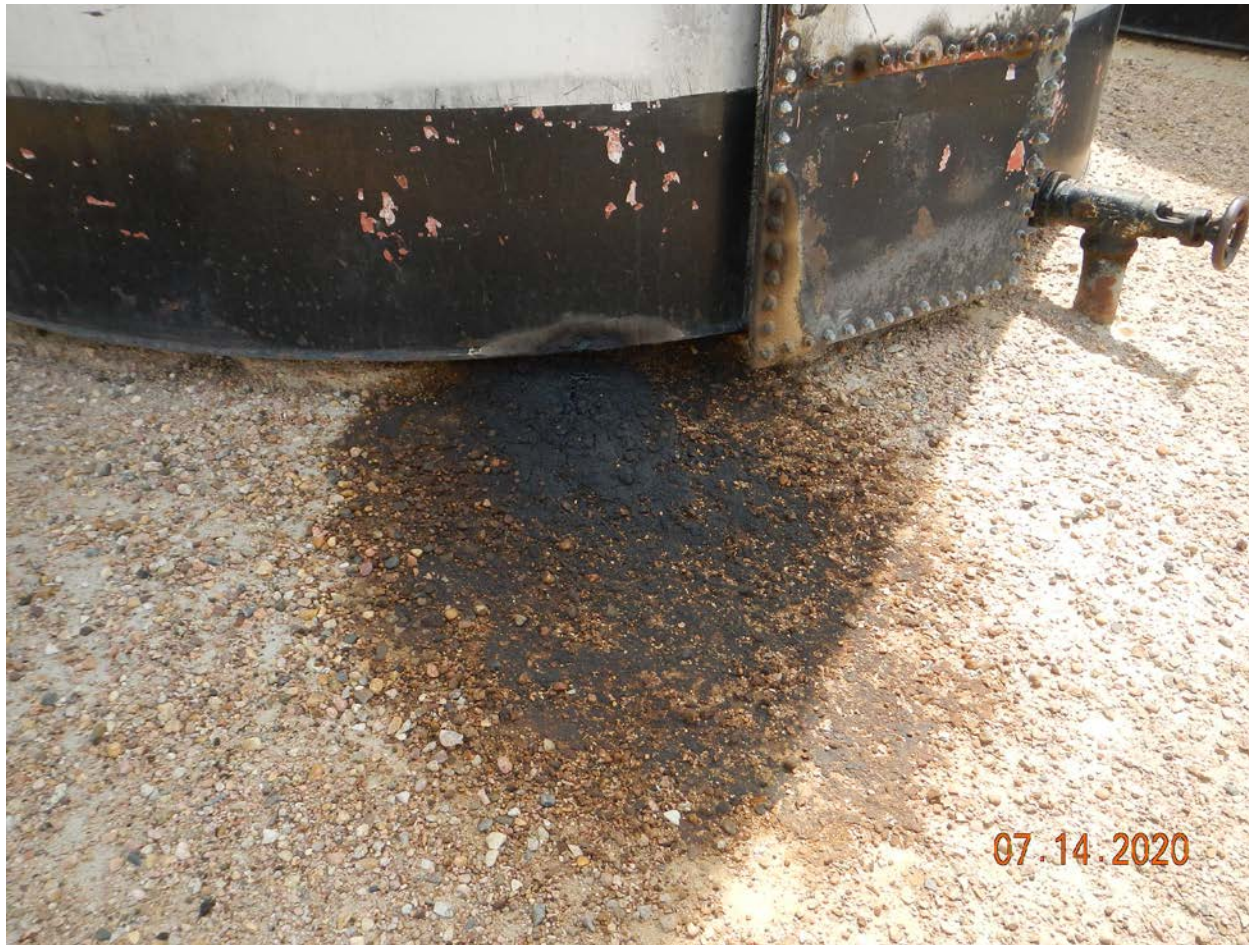
Photo # 6 – Northwest side of northern tank, oil stained soil and tank leaking from corrosion holes

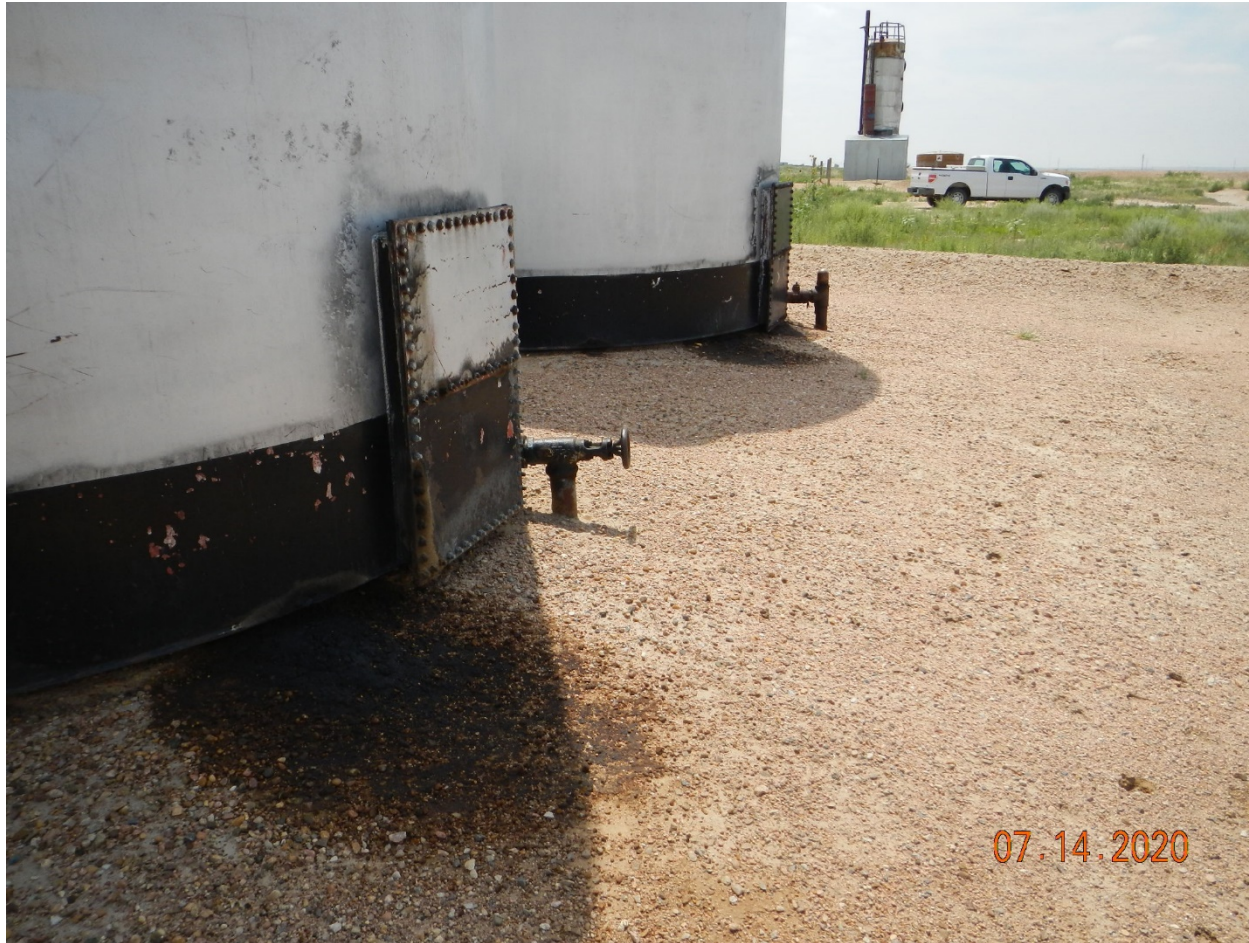
Photo # 7 – Northwest side of northern tank, oil stained soil and tank leaking from corrosion holes (also south tank)

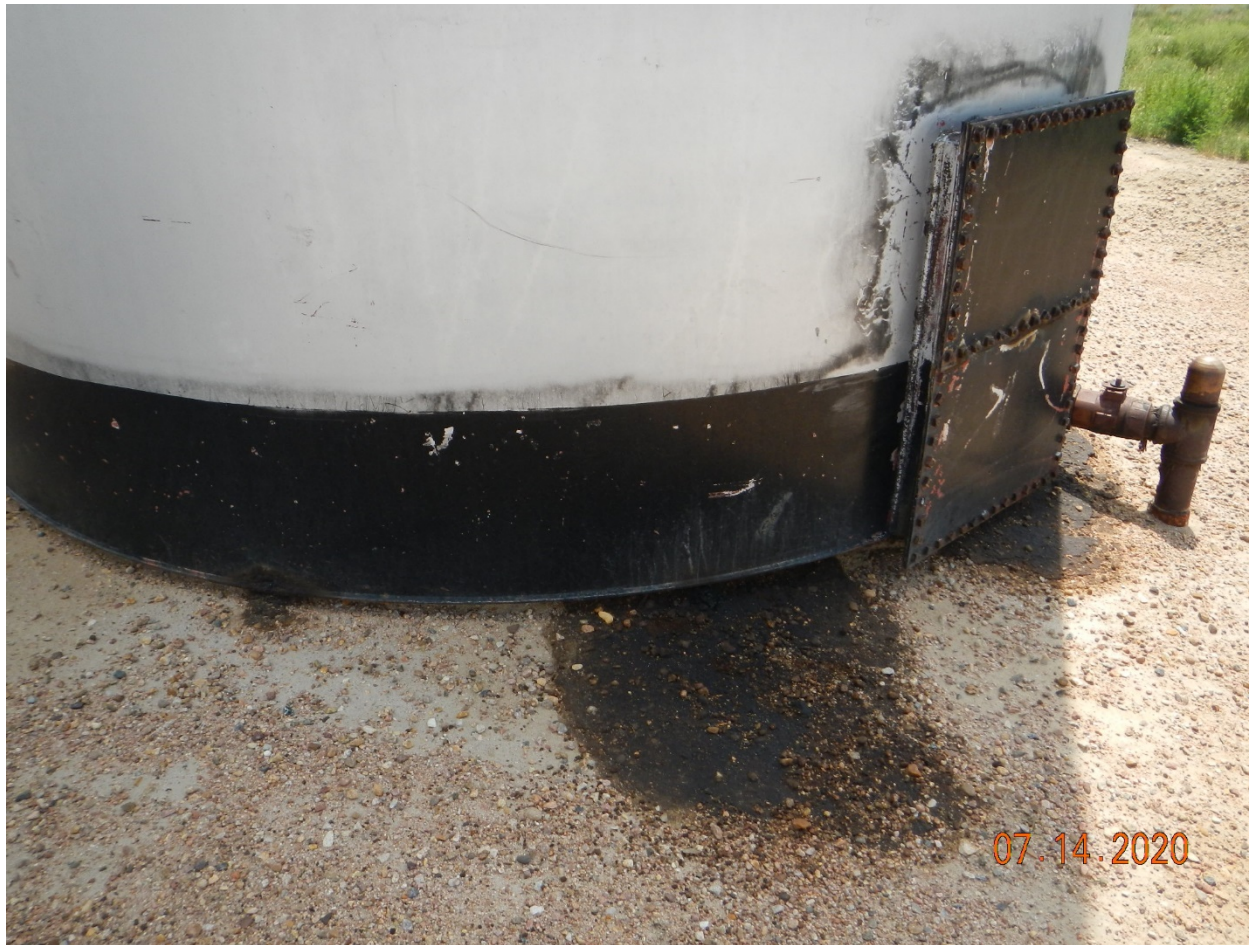
Photo # 8 – Northwest side of southern tank, oil stained soil and tank leaking from corrosion holes

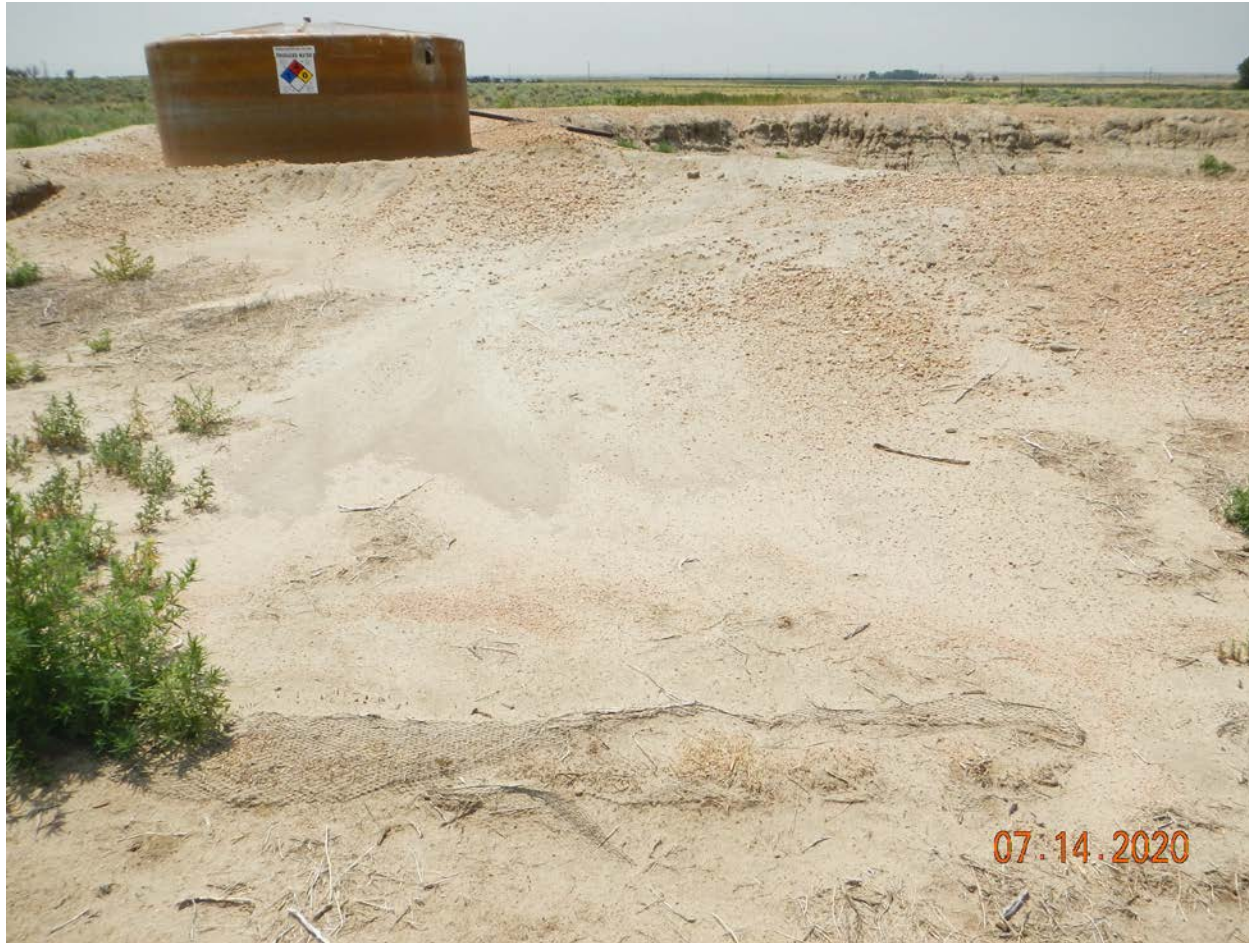
Photo # 10 – BMPs need to be maintained north of skim tank

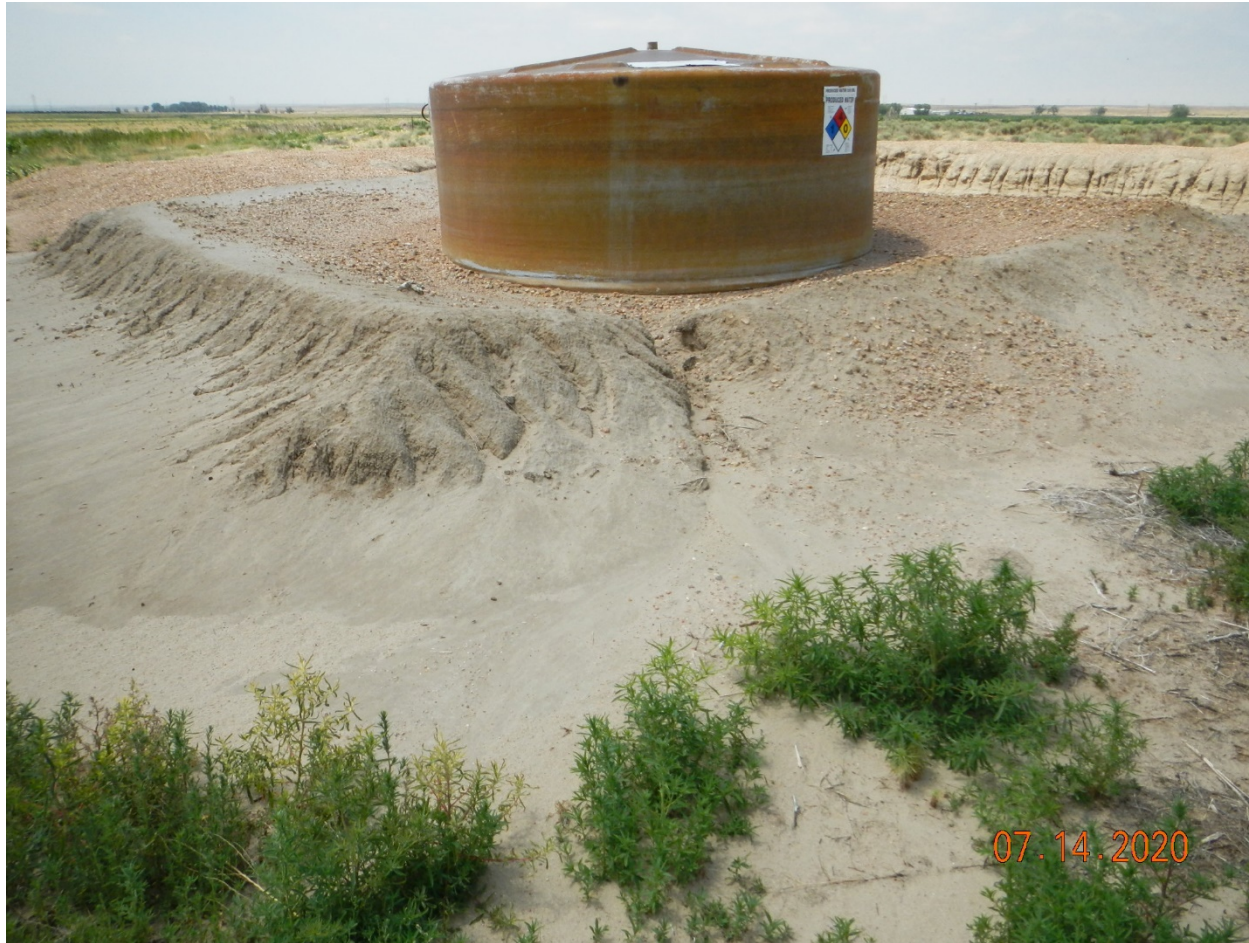
Photo # 11 – Berms need to be maintained north of skim tank

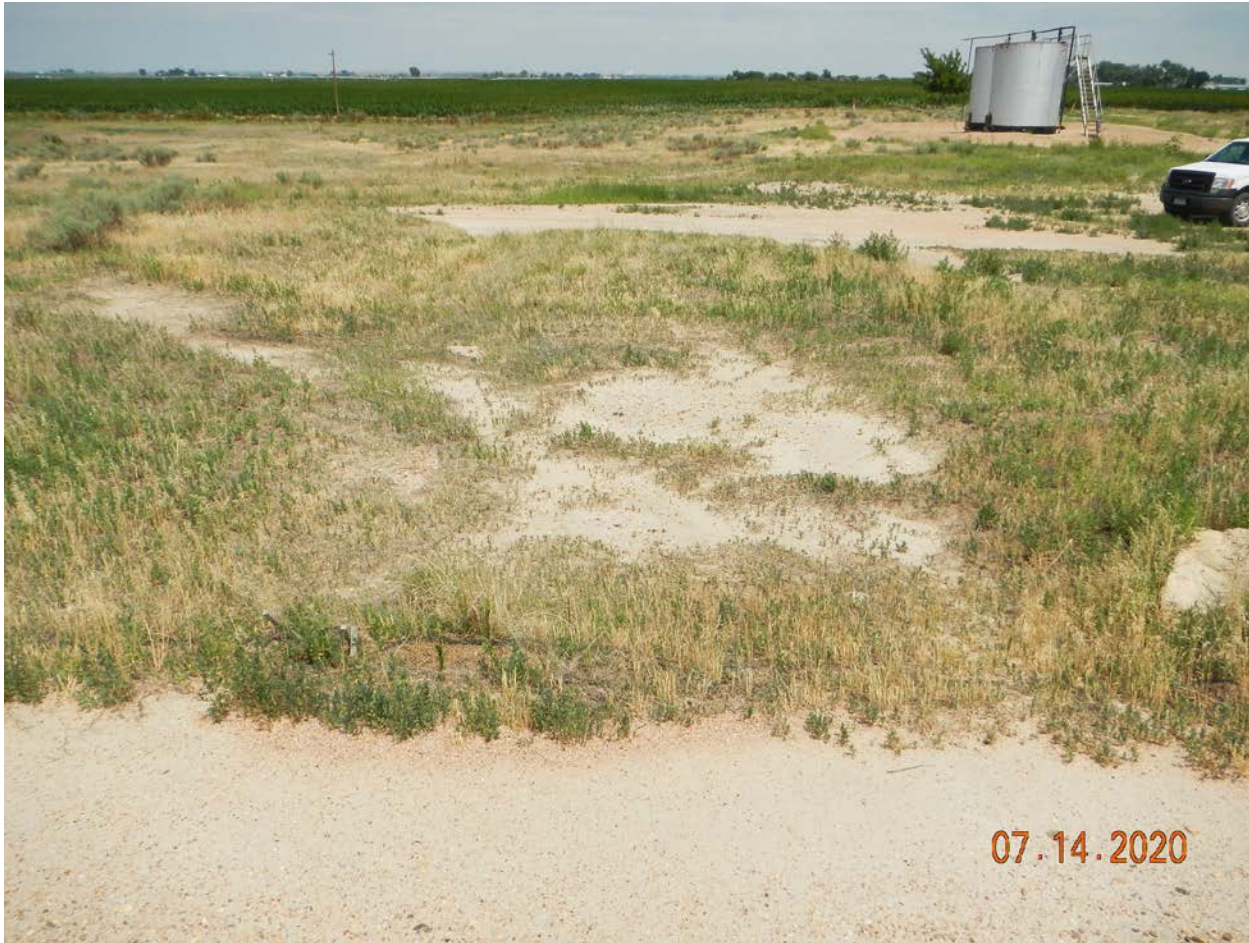
Photo # 15 – View north from Pit 102699, BMPs require maintenance
