Inspection Photos

API: 017-07727

Operator: HIGH PLAINS ENERGY LLC

Inspection Date: 7/13/2020

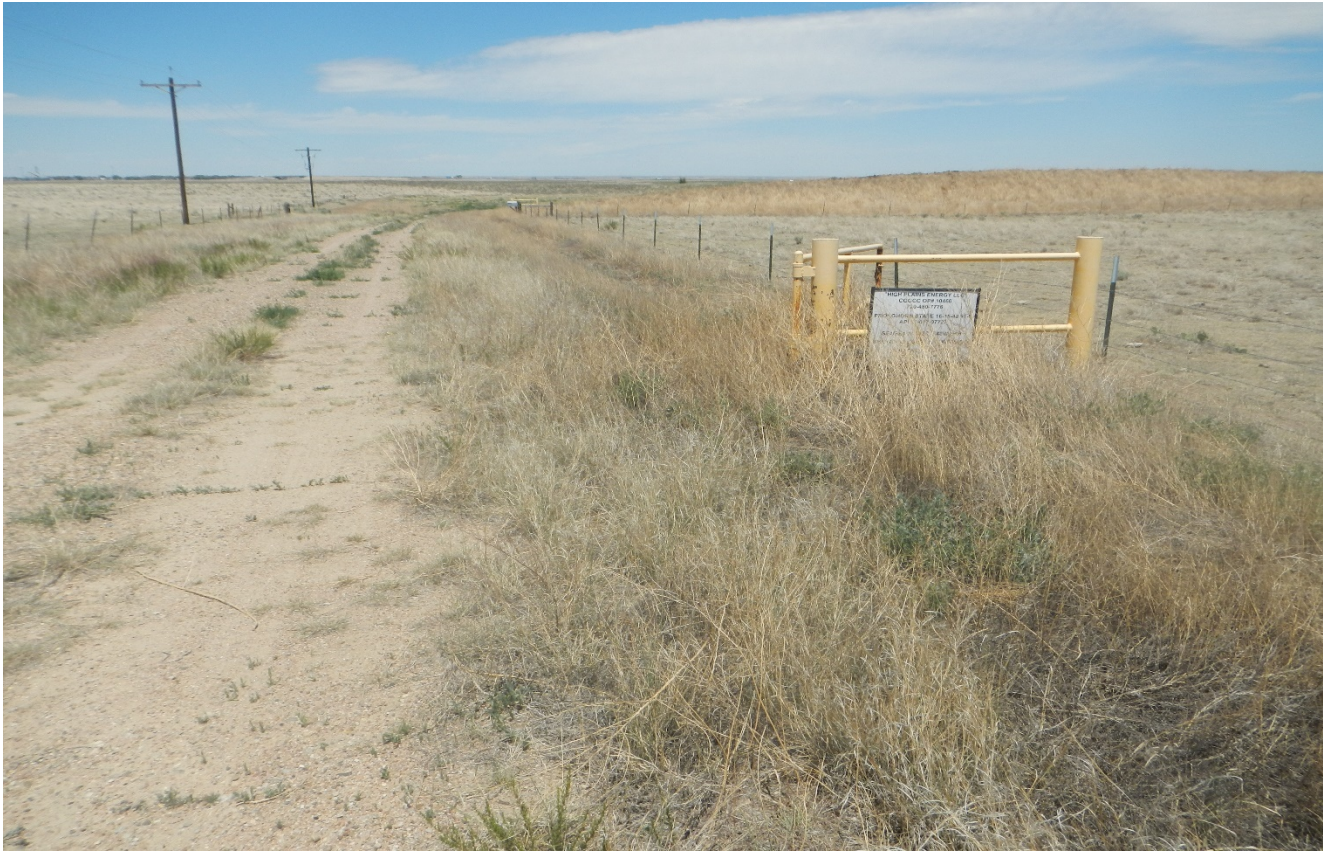
Photo 1. Facing north along the access road toward the location. Location sign is posted next to access road.

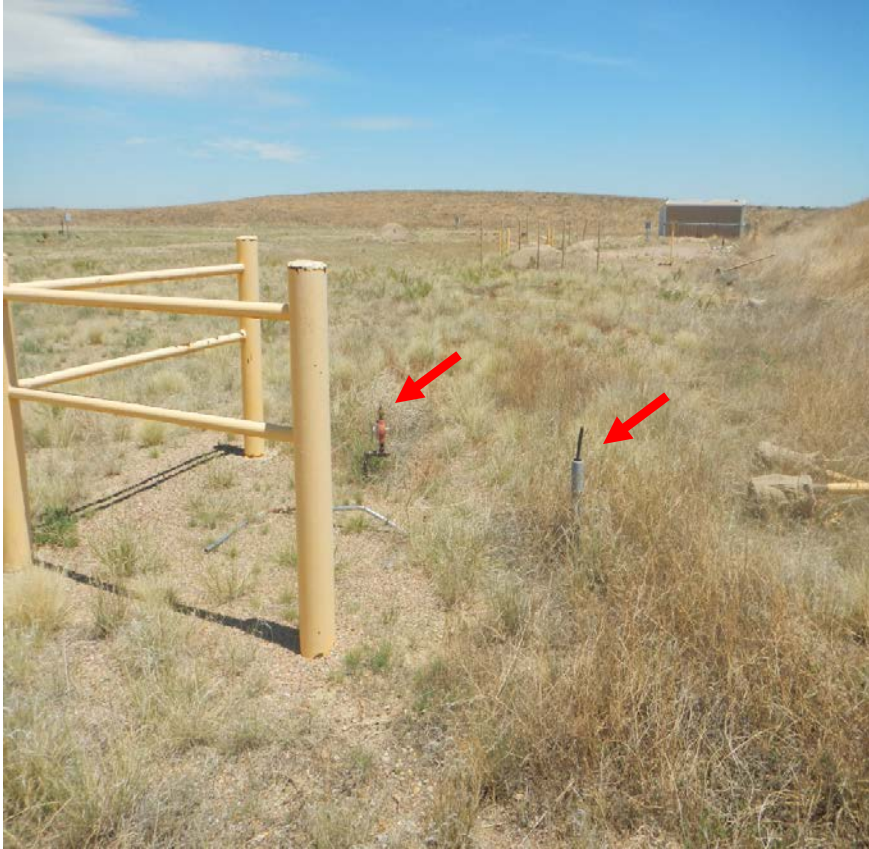
Photo 2. Facing northeast toward the location. There are pipe risers shown at red arrow.

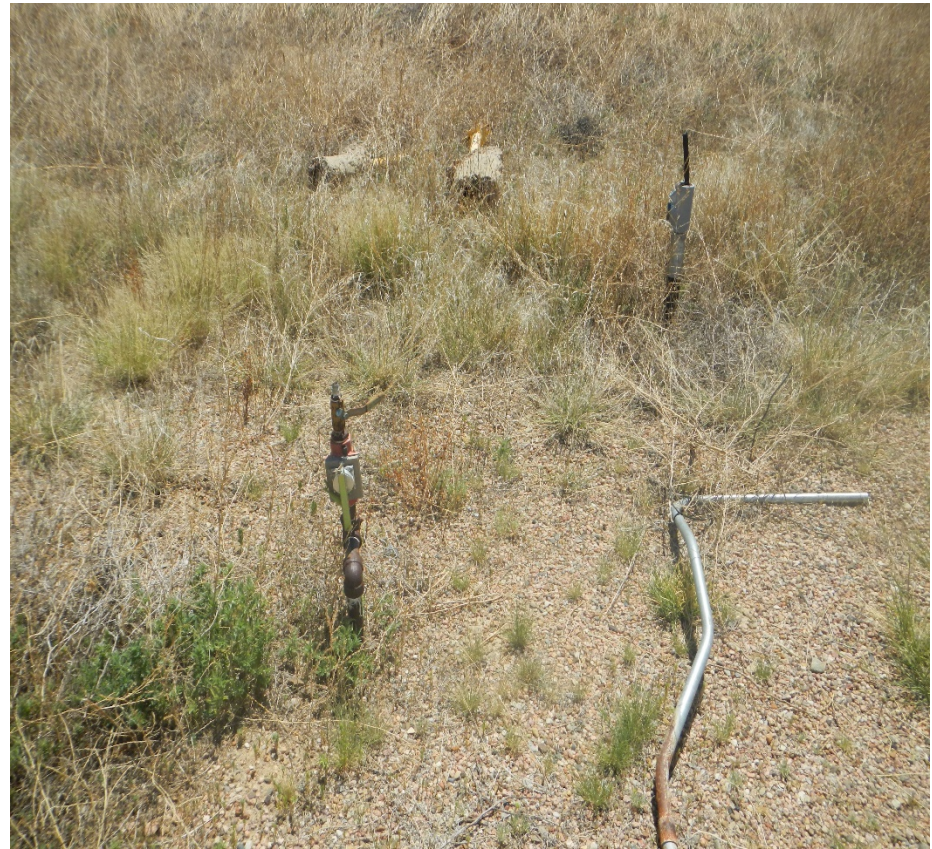
Photo 3. View of pipe risers with no LOTO.

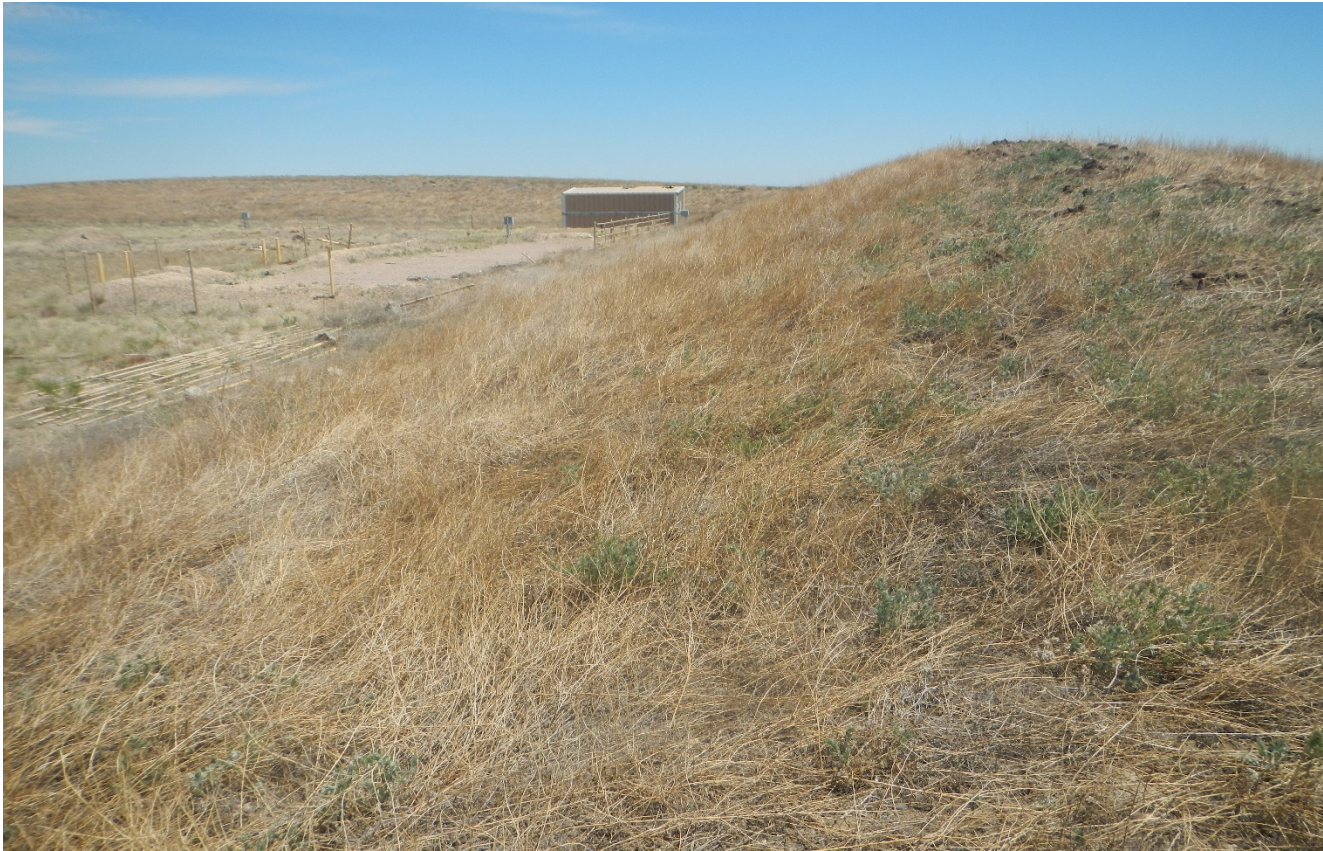
Photo 4. Facing east along the soil pile. The soil pile has not been replaced and recontoured. There are undesirable weeds growing throughout the soil stock piles. There is an accumulation of weed debris throughout the soil stockpiles.

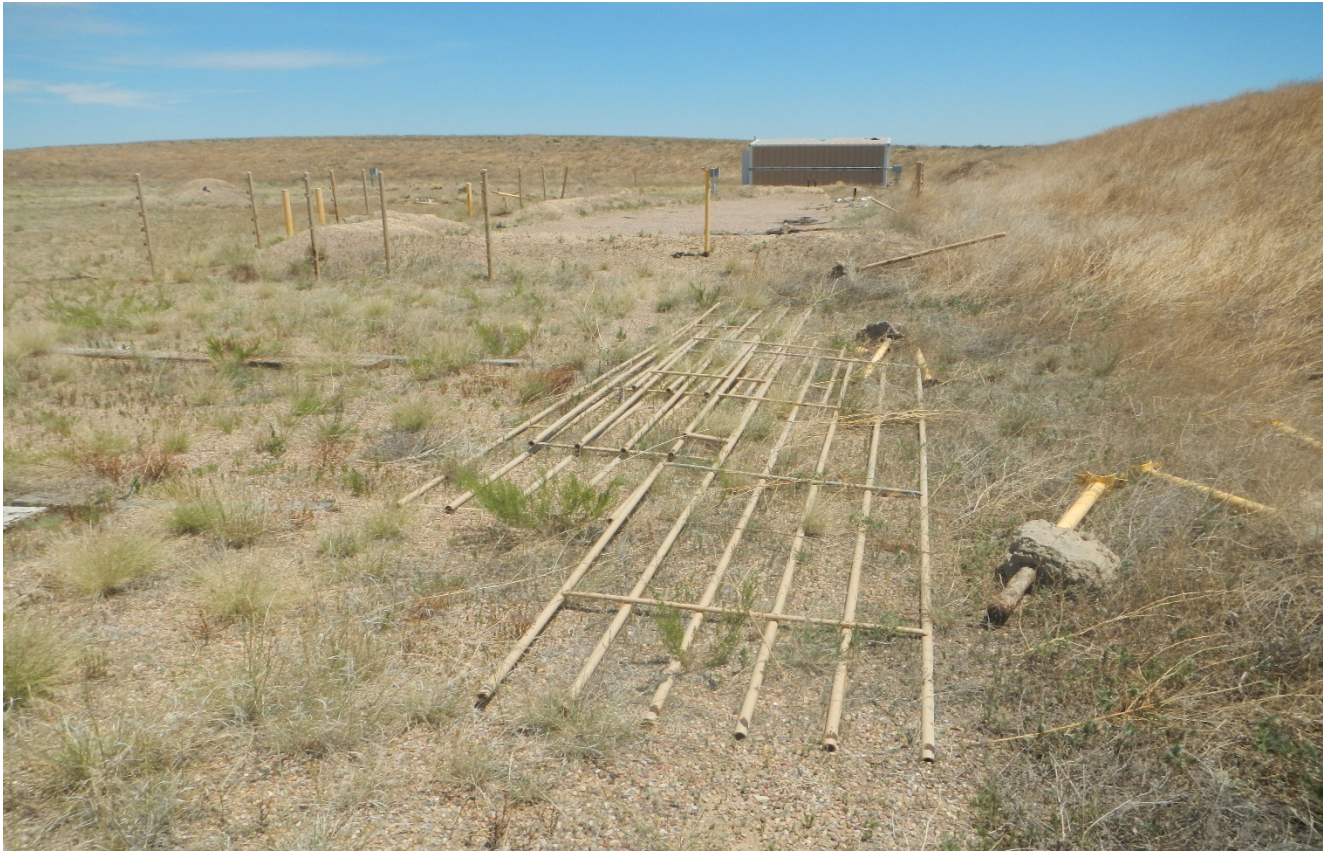
Photo 5. Facing east at the location. There is numerous unused equipment laying on the ground.

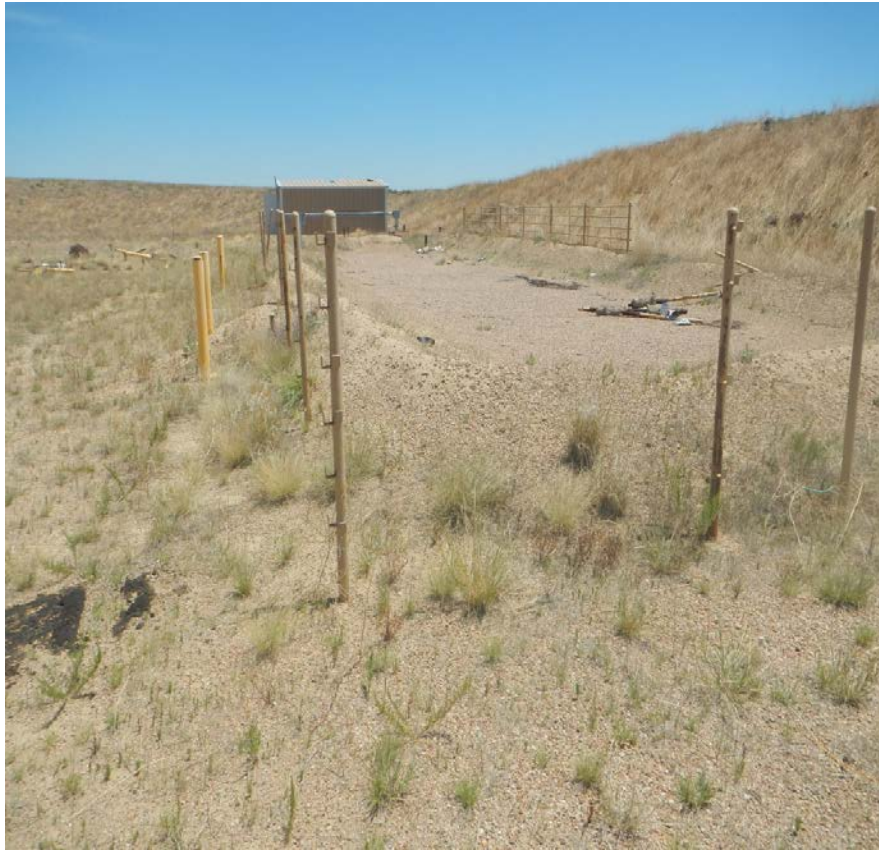
Photo 6. There is tank berms that remain and unused fence posts.

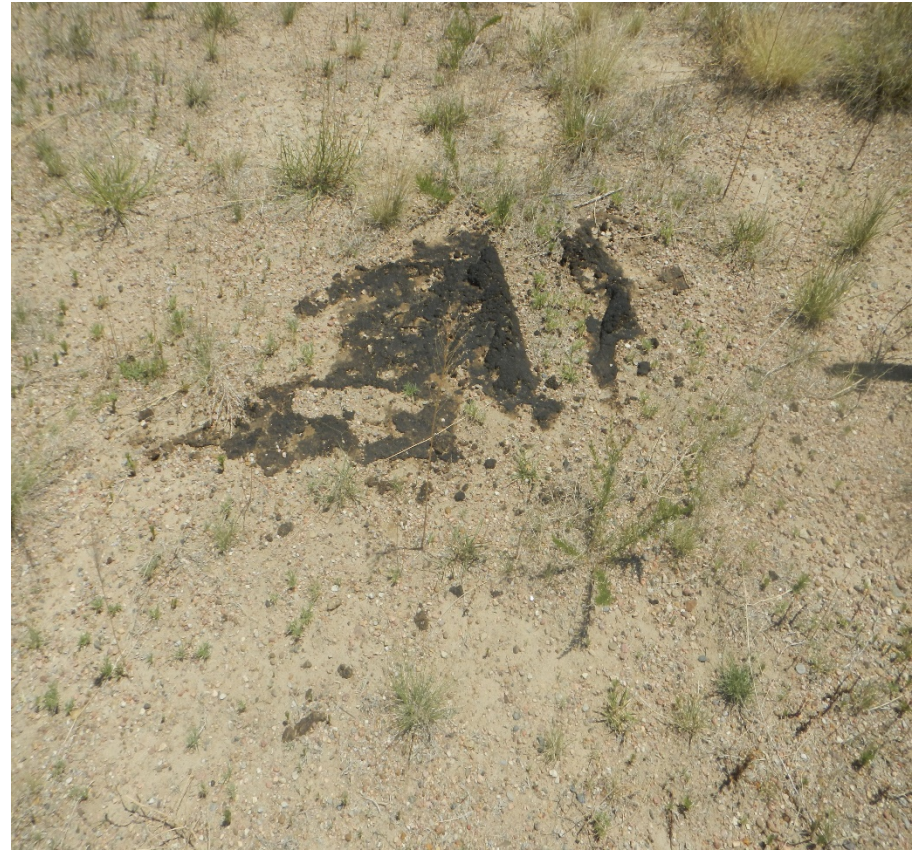
Photo 7. There is oily waste observed near the berm shown in previous photo.

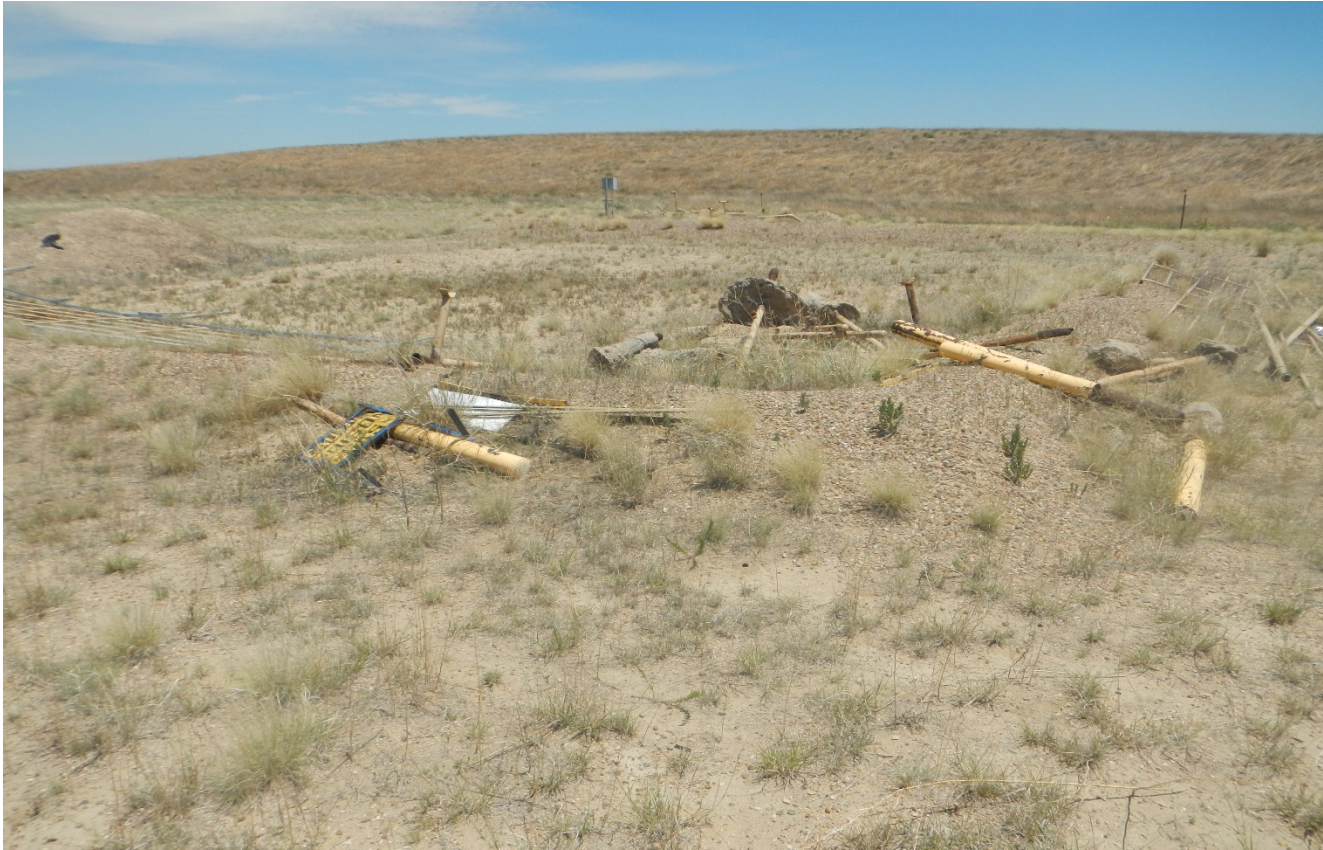
Photo 8. There is various unused equipment and debris laying on the ground. There is a berm that remains in this area.

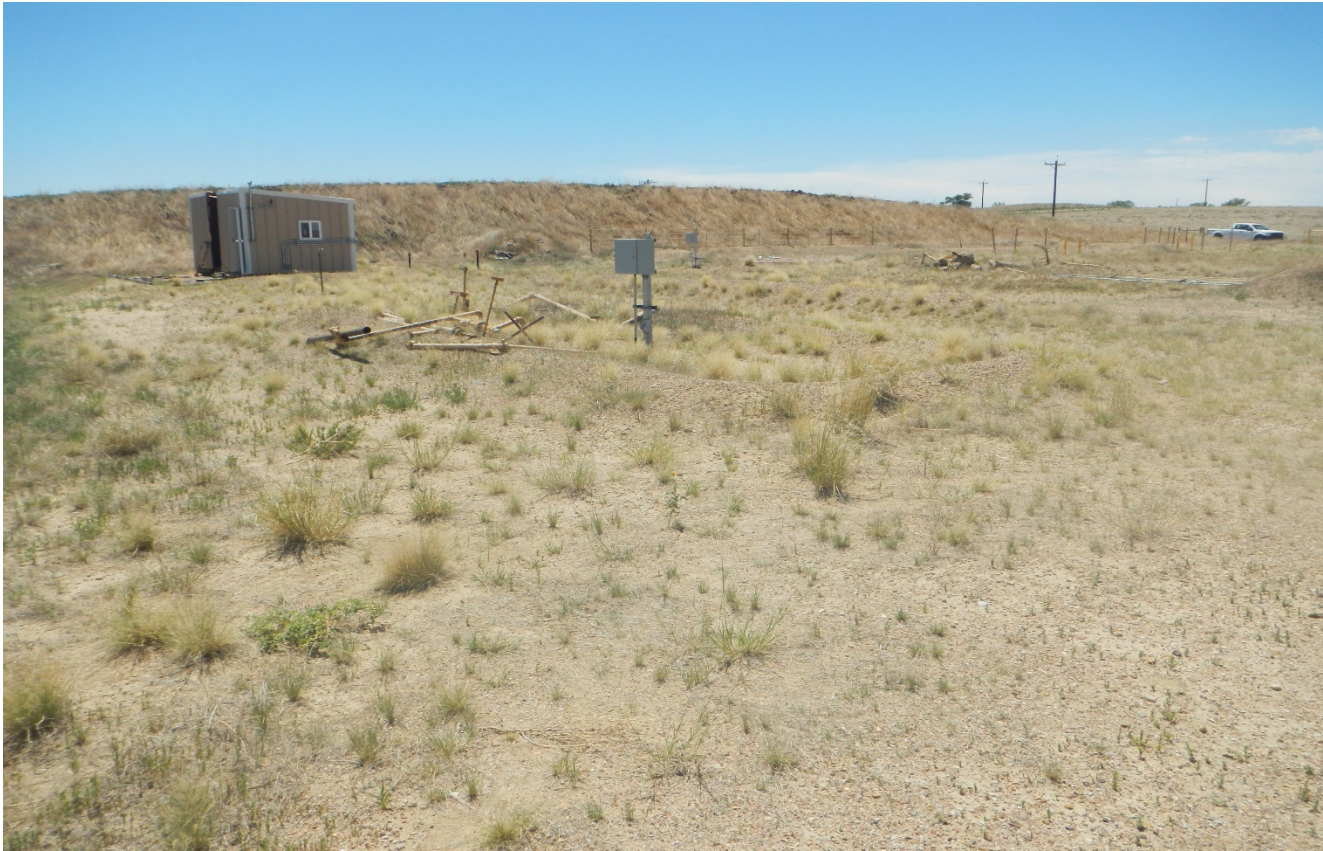
Photo 9. Facing southwest toward the location. There are multiple berm areas, unused equipment, debris, electrical equipment, and storage shed in disrepair.

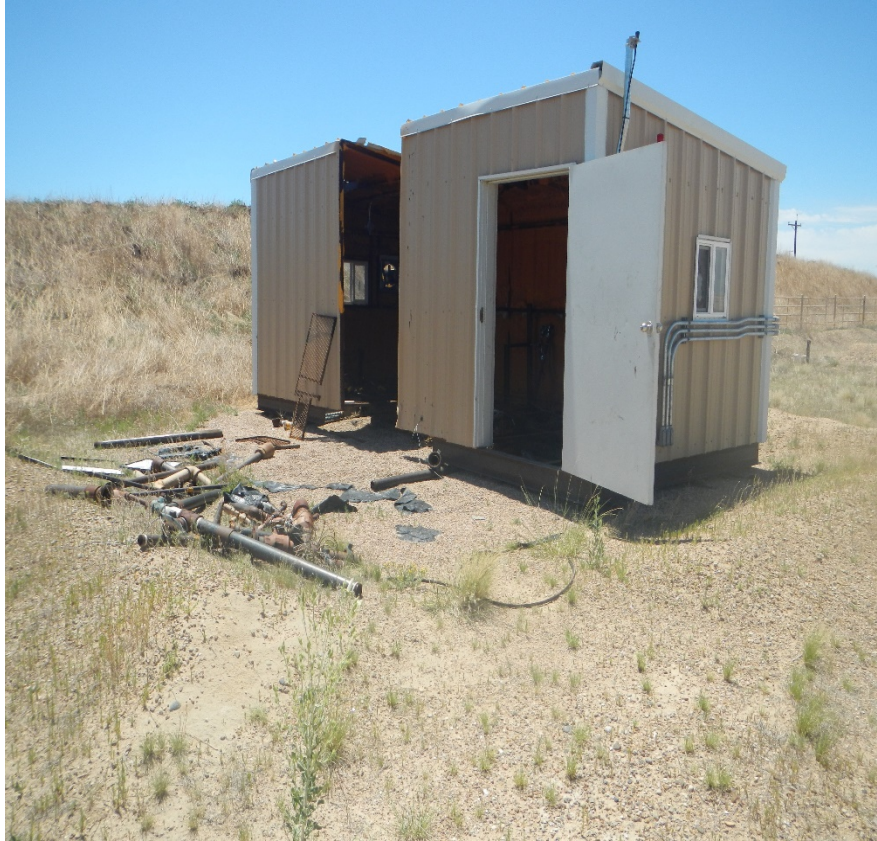
Photo 10. There is a shed in disrepair at the southeast side of the location. Various unused equipment remains near the shed.

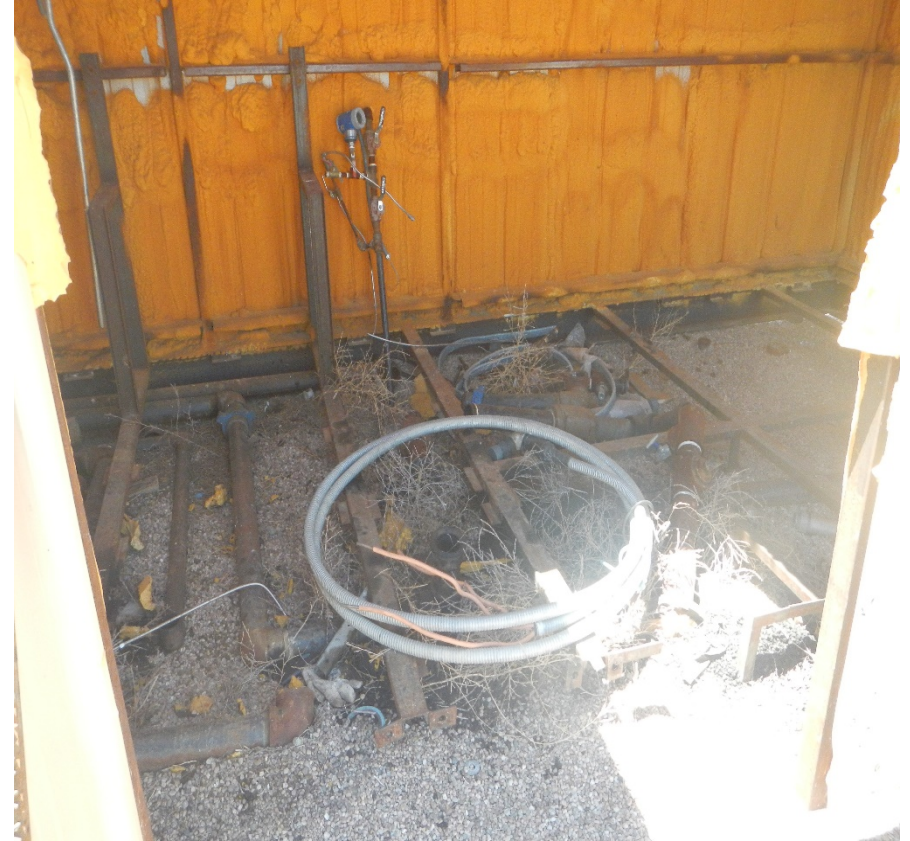
Photo 11. View of inside the shed. There is various piping risers, and supplies inside the shed.

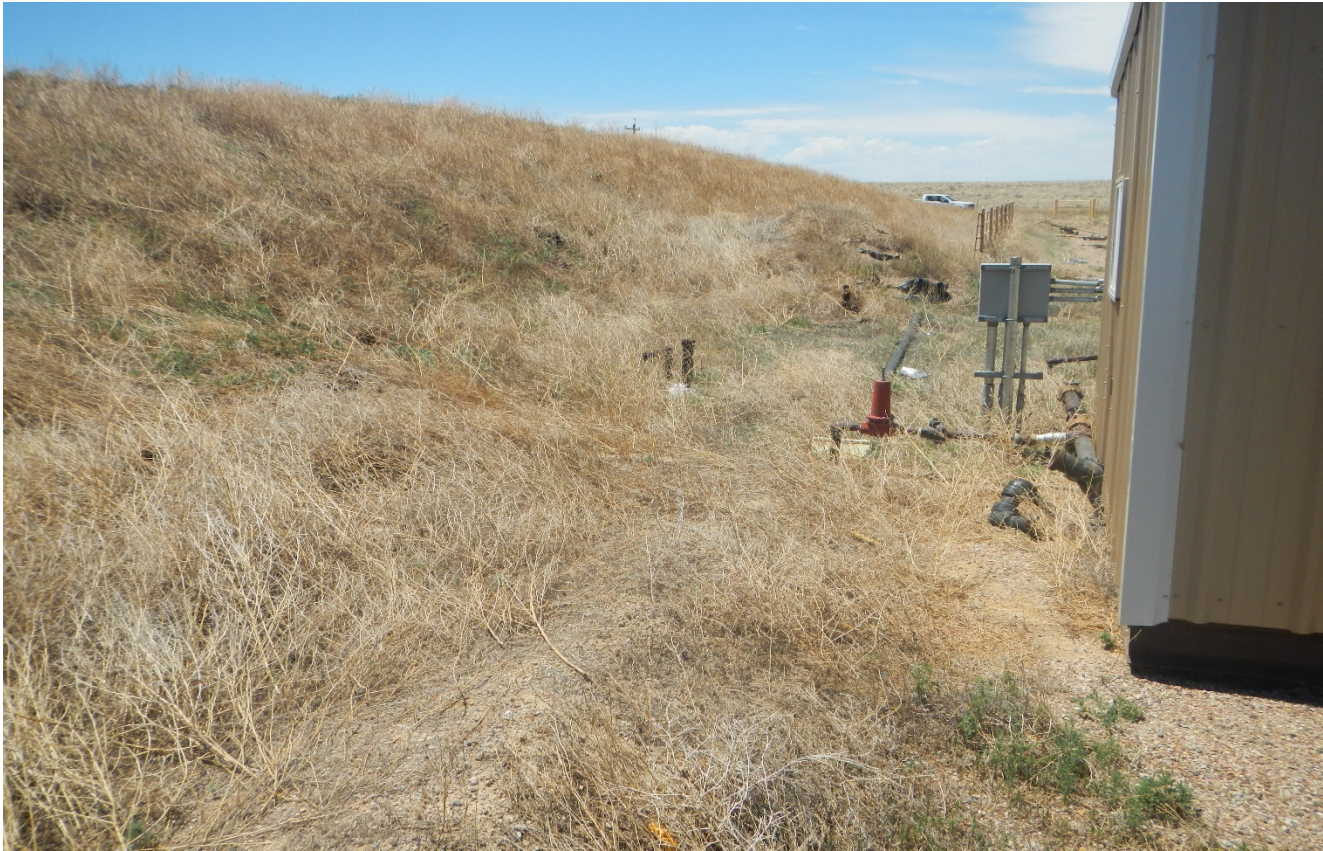
Photo 12. Facing west at the south side of the location. There is weed debris along the soil stockpile which is a potential fire hazard. Various supplies, unused equipment is laying on the ground.

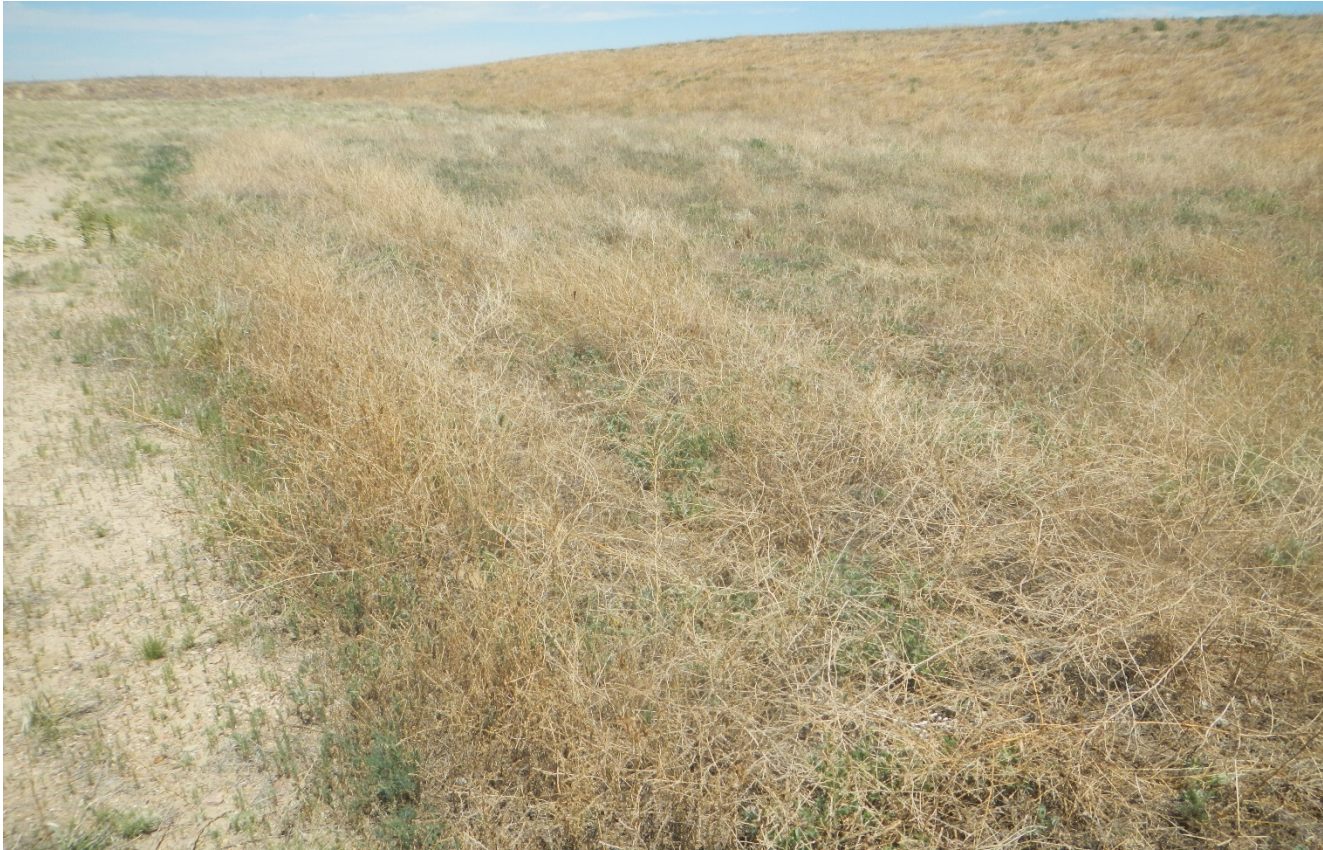
Photo 13. Facing northeast toward the east side of the pad. There is undesirable weeds (*Kochia* sp.) growing throughout this area. There is weed debris which is a potential fire hazard.

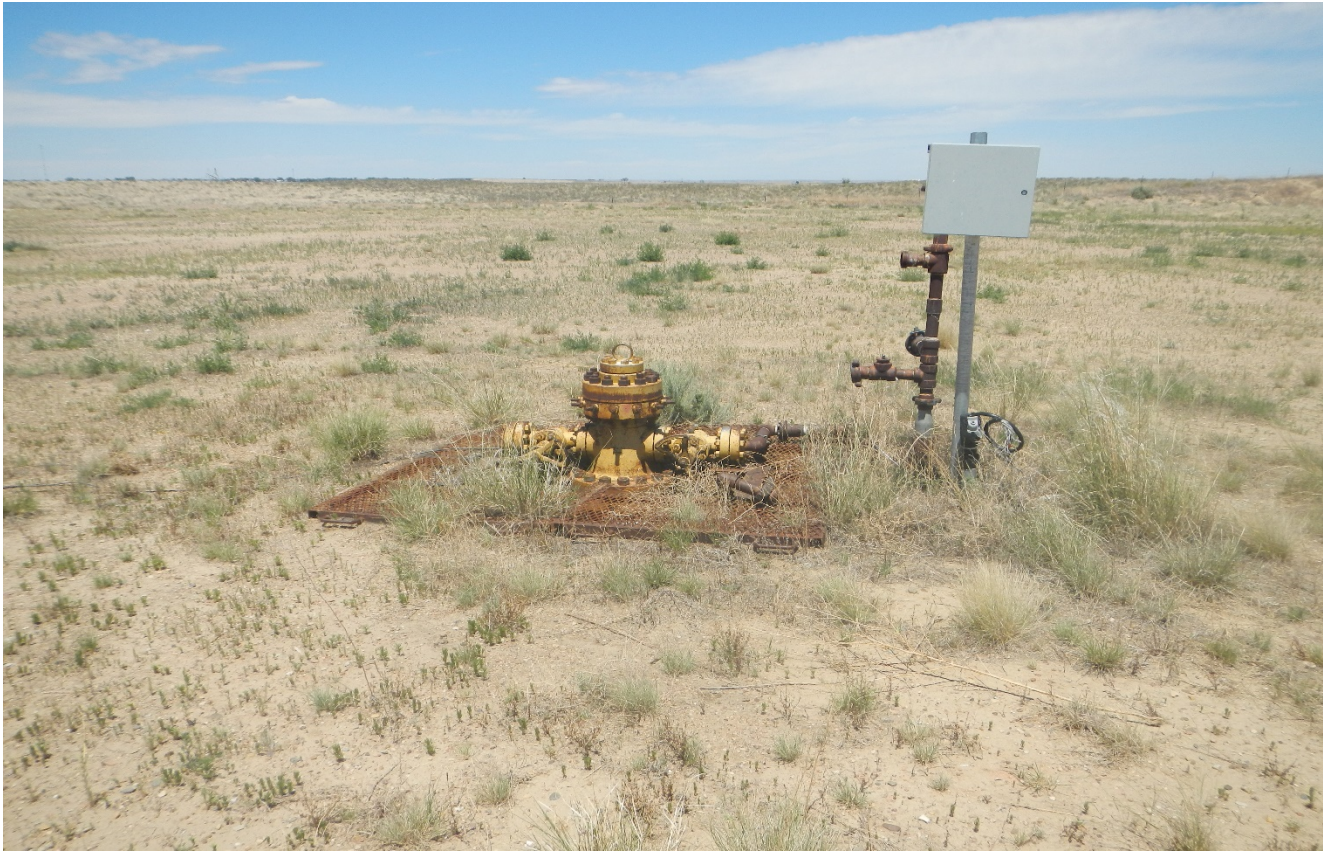
Photo 14. Facing toward the wellhead at the center of the location.

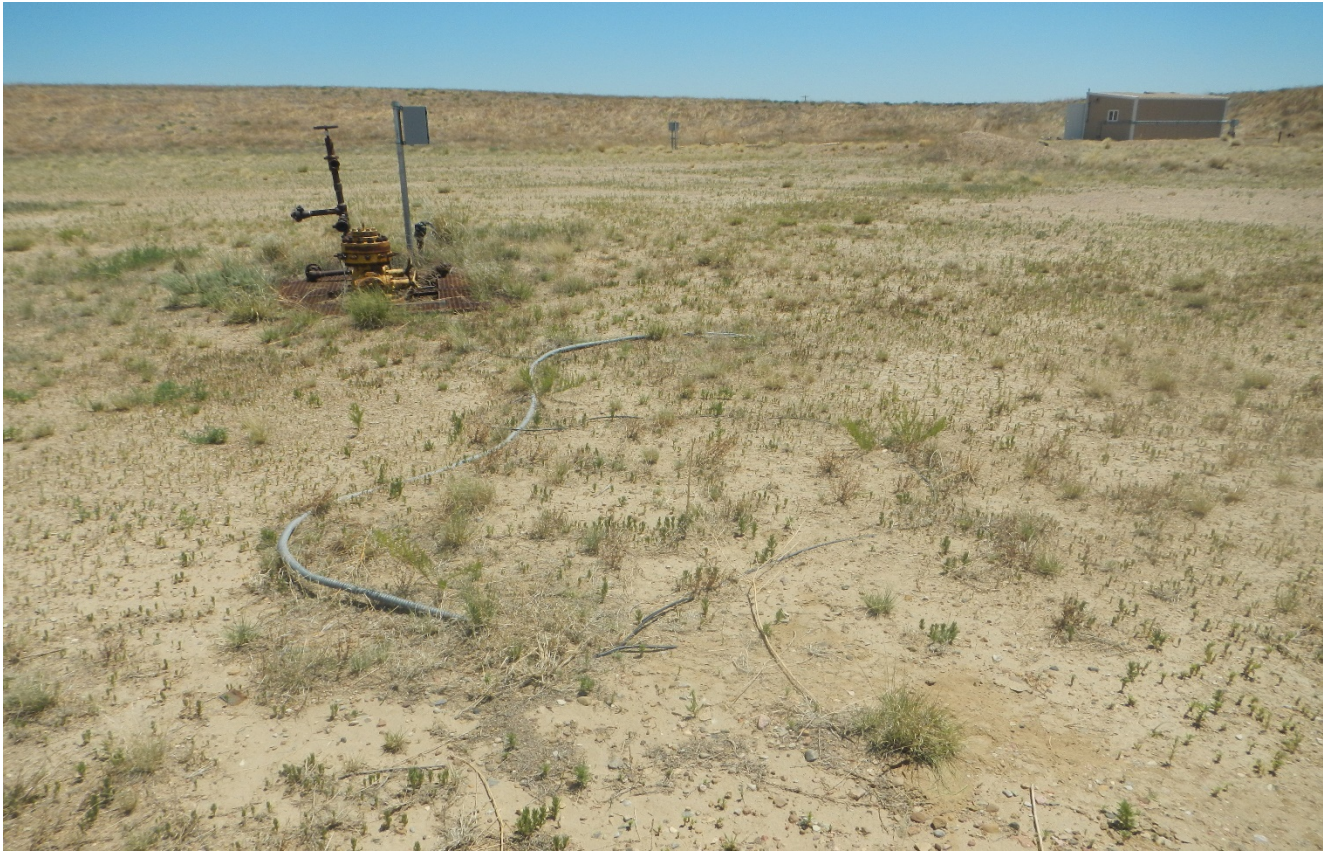
Photo 15. There is electrical wires extending out of the ground near the wellhead.

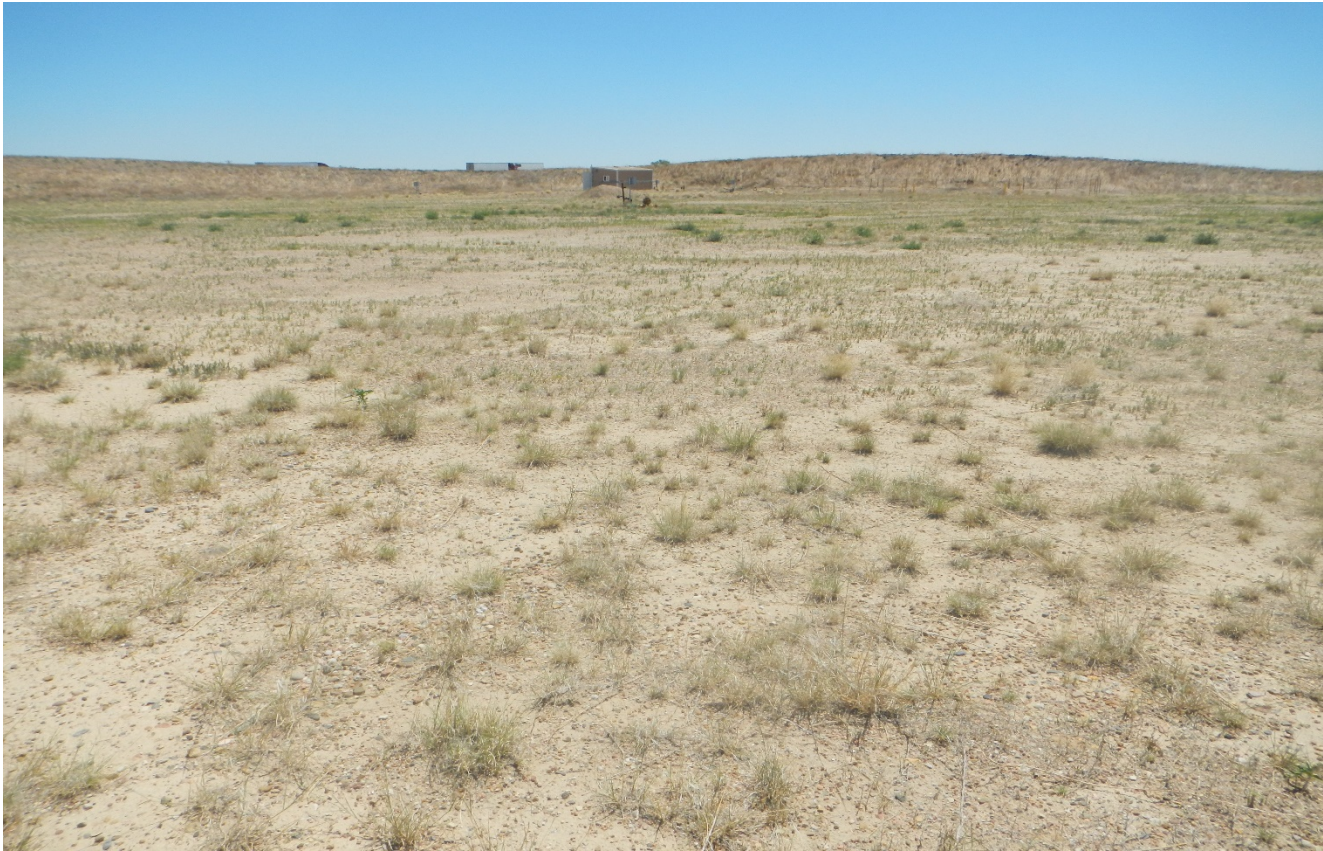
Photo 16. Facing southeast toward the location. Interim reclamation has not been performed. Unused areas of the location have not been reclaimed.

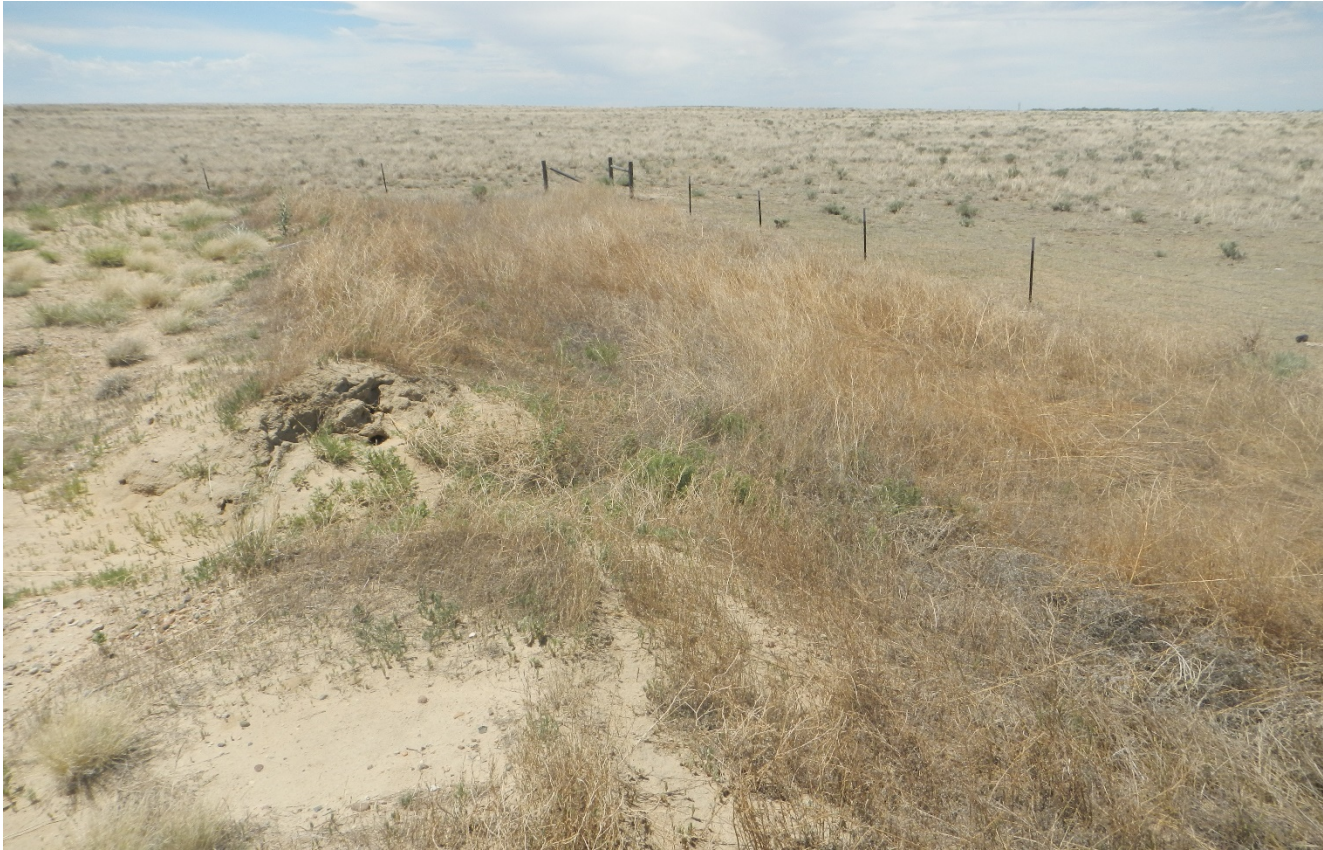
Photo 17. Facing toward the northwest side of the location. There is erosion that has occurred off the fill slope and undesirable weed growth along the perimeter.

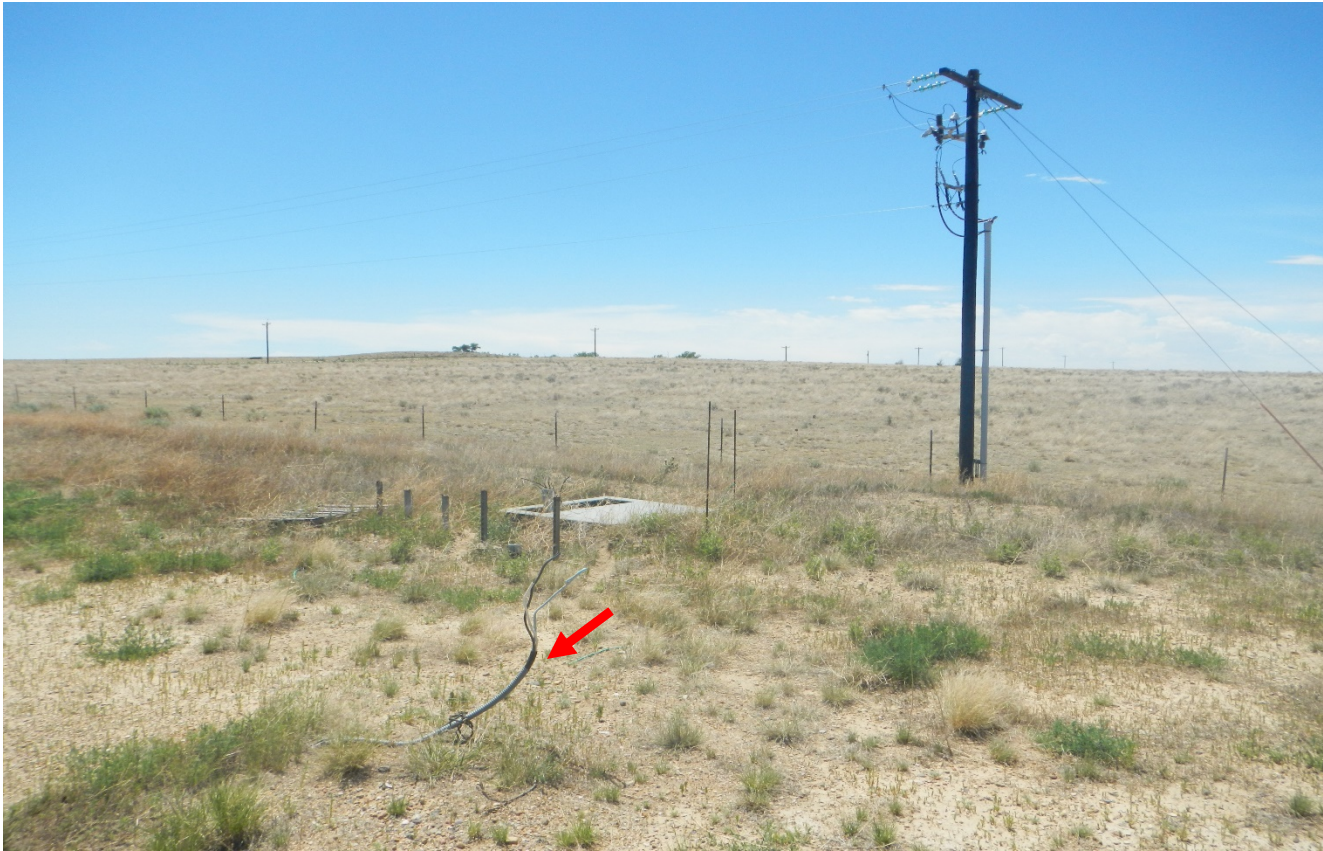
Photo 18. Facing toward west side of the location. There is electrical wiring extending out of the ground in this area. There is a cellar with exposed electrical wiring inside.

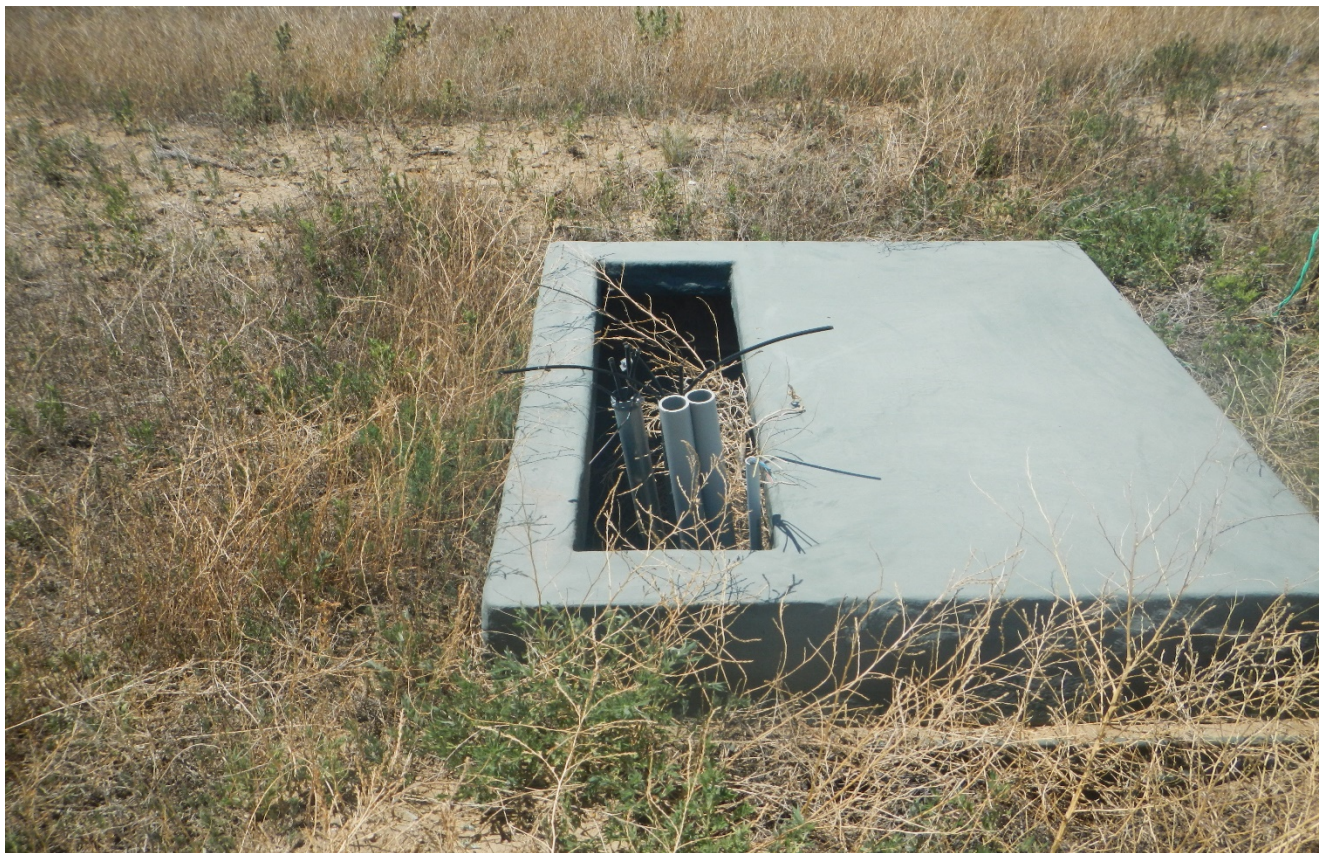
Photo 19. This cellar electrical box has exposed electrical wires.

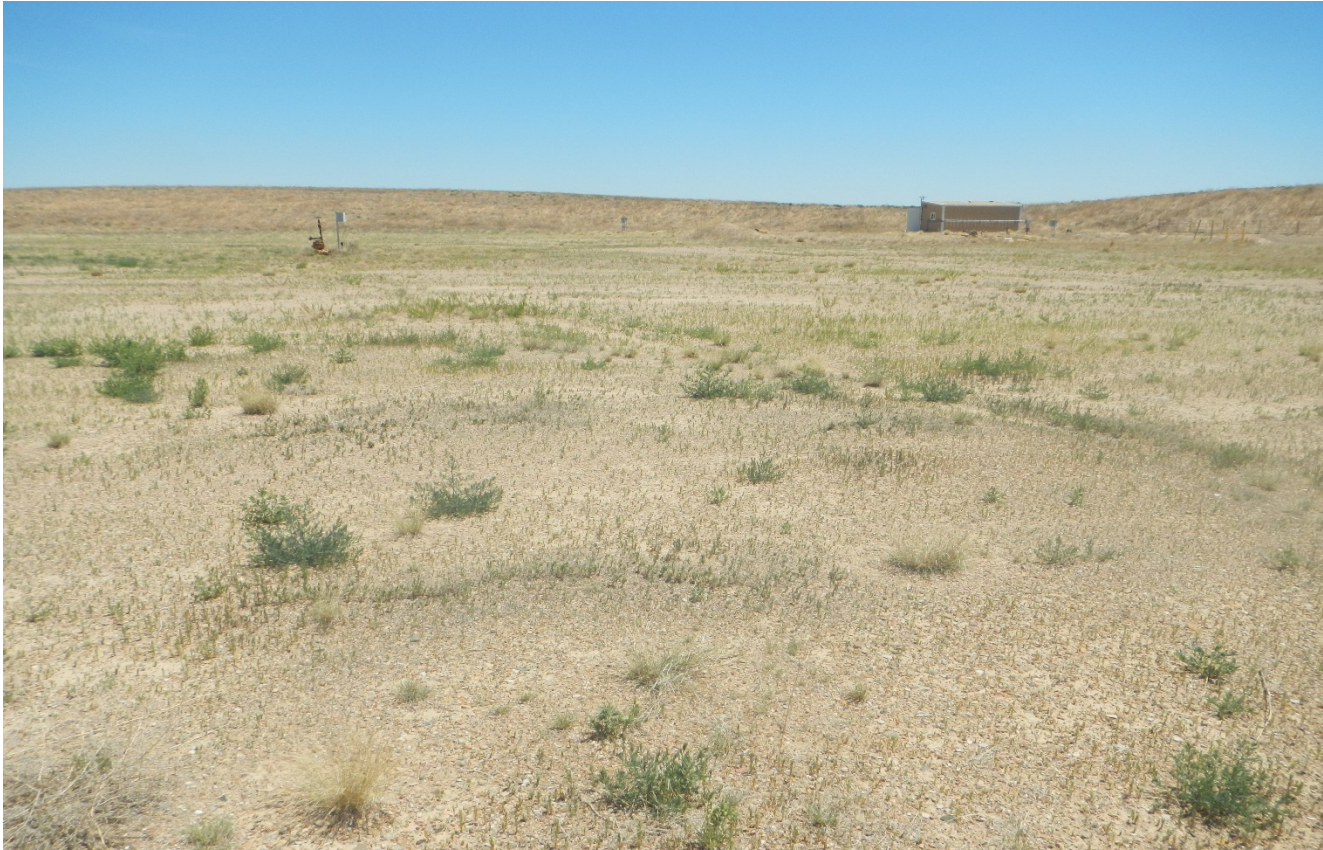
Photo 20. East side o the location facing southeast. Unused areas of the location have not been reclaimed.
