Inspection Photos

API: 017-07268

Operator: WIEPKING-FULLERTON ENERGY LLC

Inspection Date: 7/13/2020

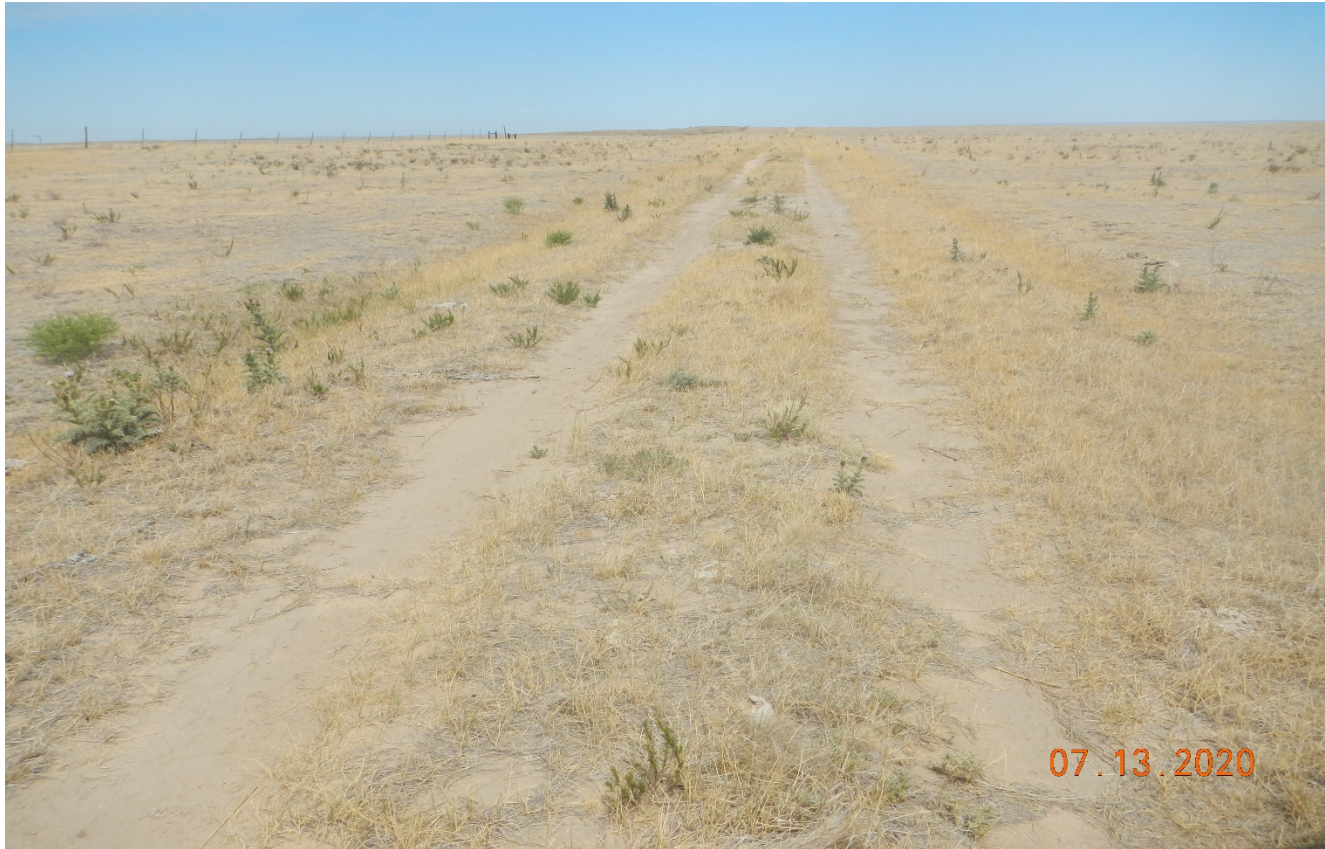
Photo 1. Facing east along the former two track access road which remains per approved variance.

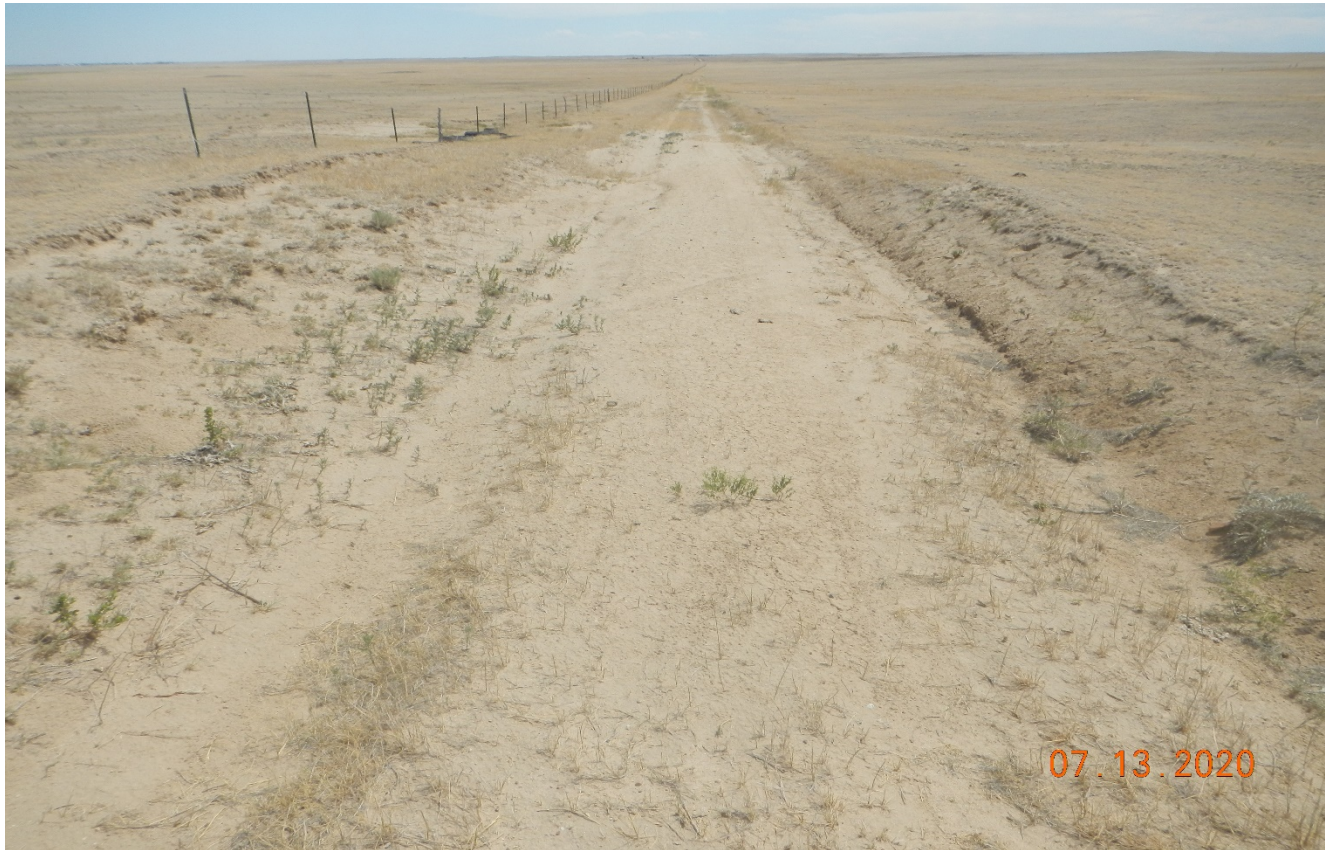
Photo 2. Facing south along portion of the access road which remains. This area of previous erosion has been regraded.

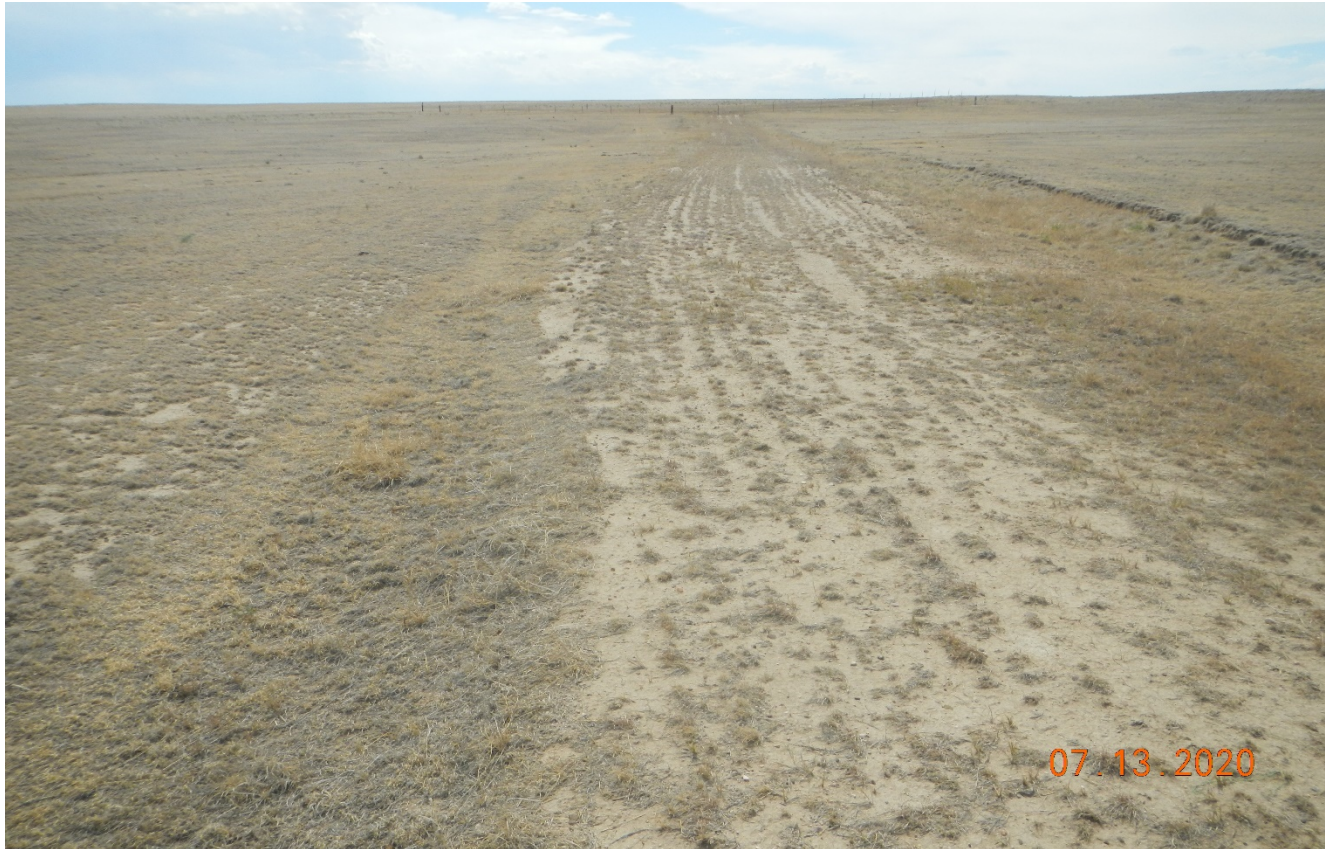
Photo 3. Facing west along the portion of the access road which has been reclaimed. This portion of the road has not reached 80% revegetation.

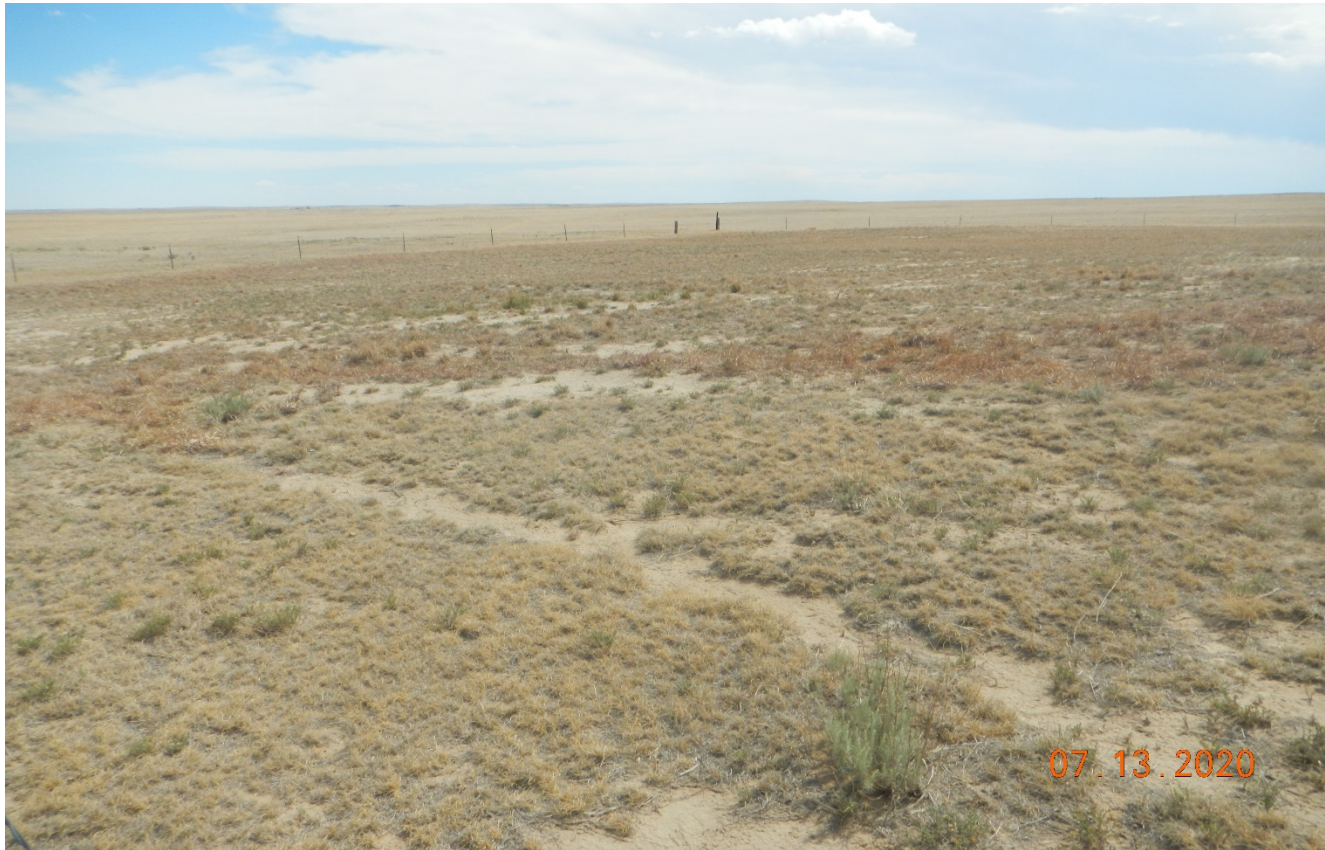
Photo 4. Facing southwest toward the location. Vegetation is well established throughout the location. The perimeter of the location is fenced.

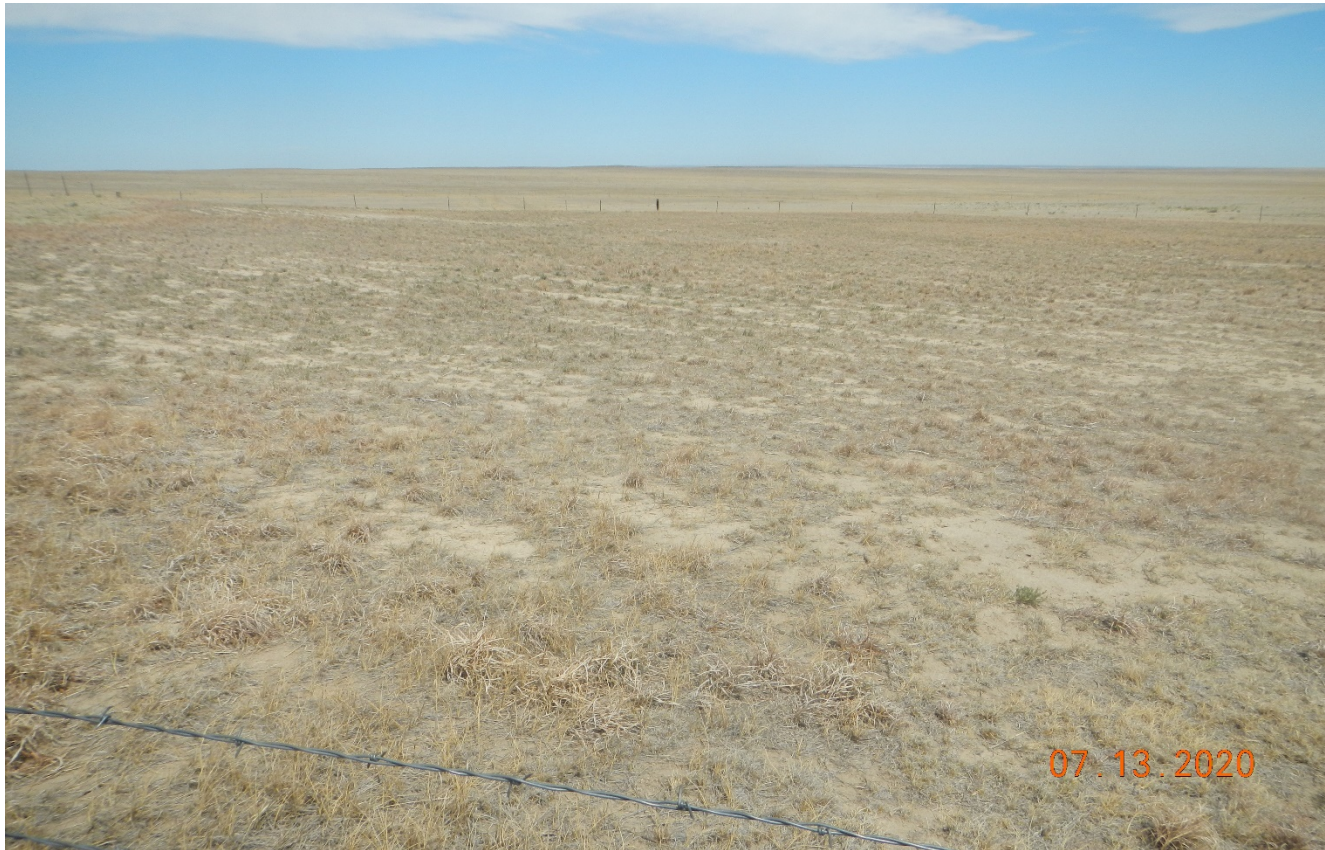
Photo 5. Facing southeast at the location.

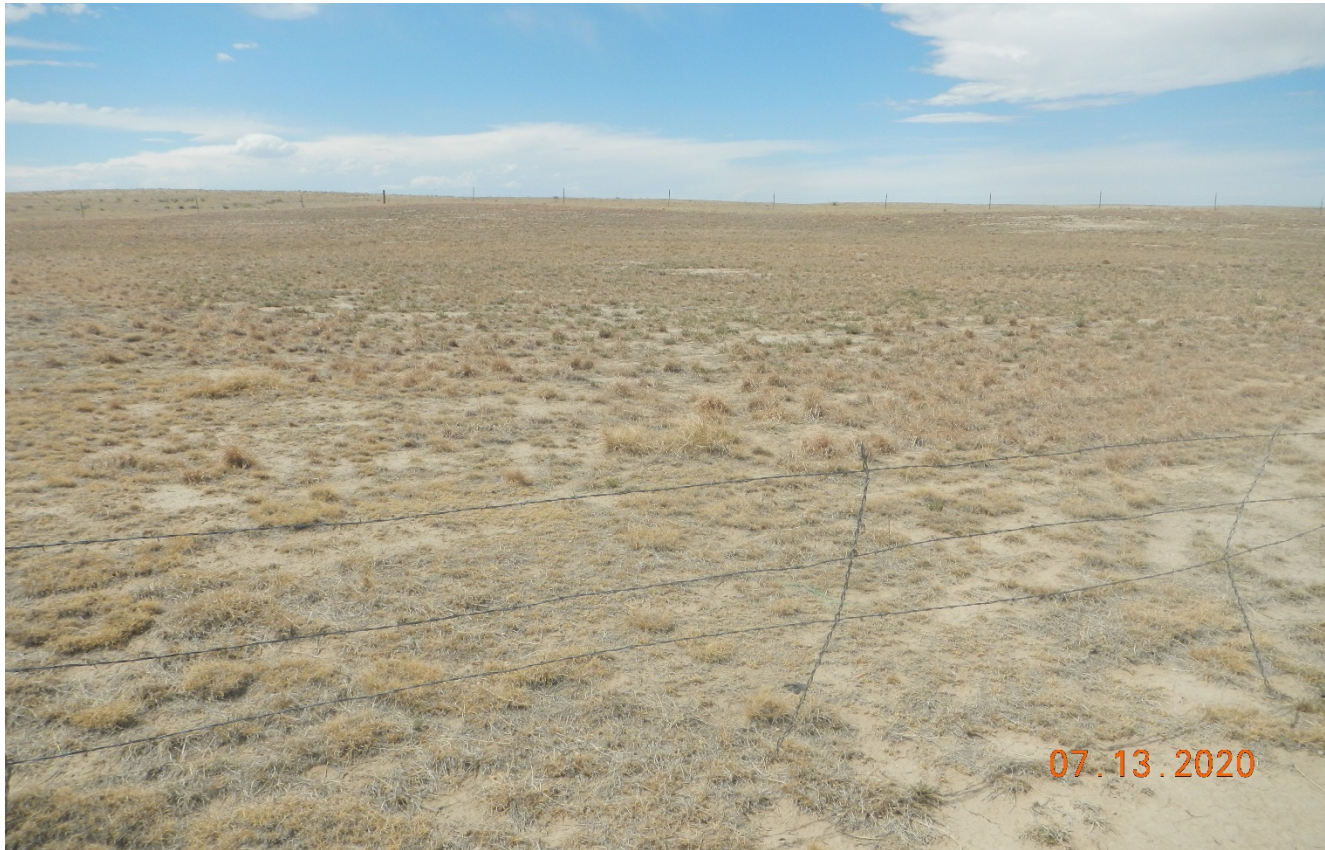
Photo 6. Facing northeast toward the location. Vegetation is well established throughout the location.
