Inspection Photos
Operator: Patara
API: 113-06107
Date: 7/14/2020

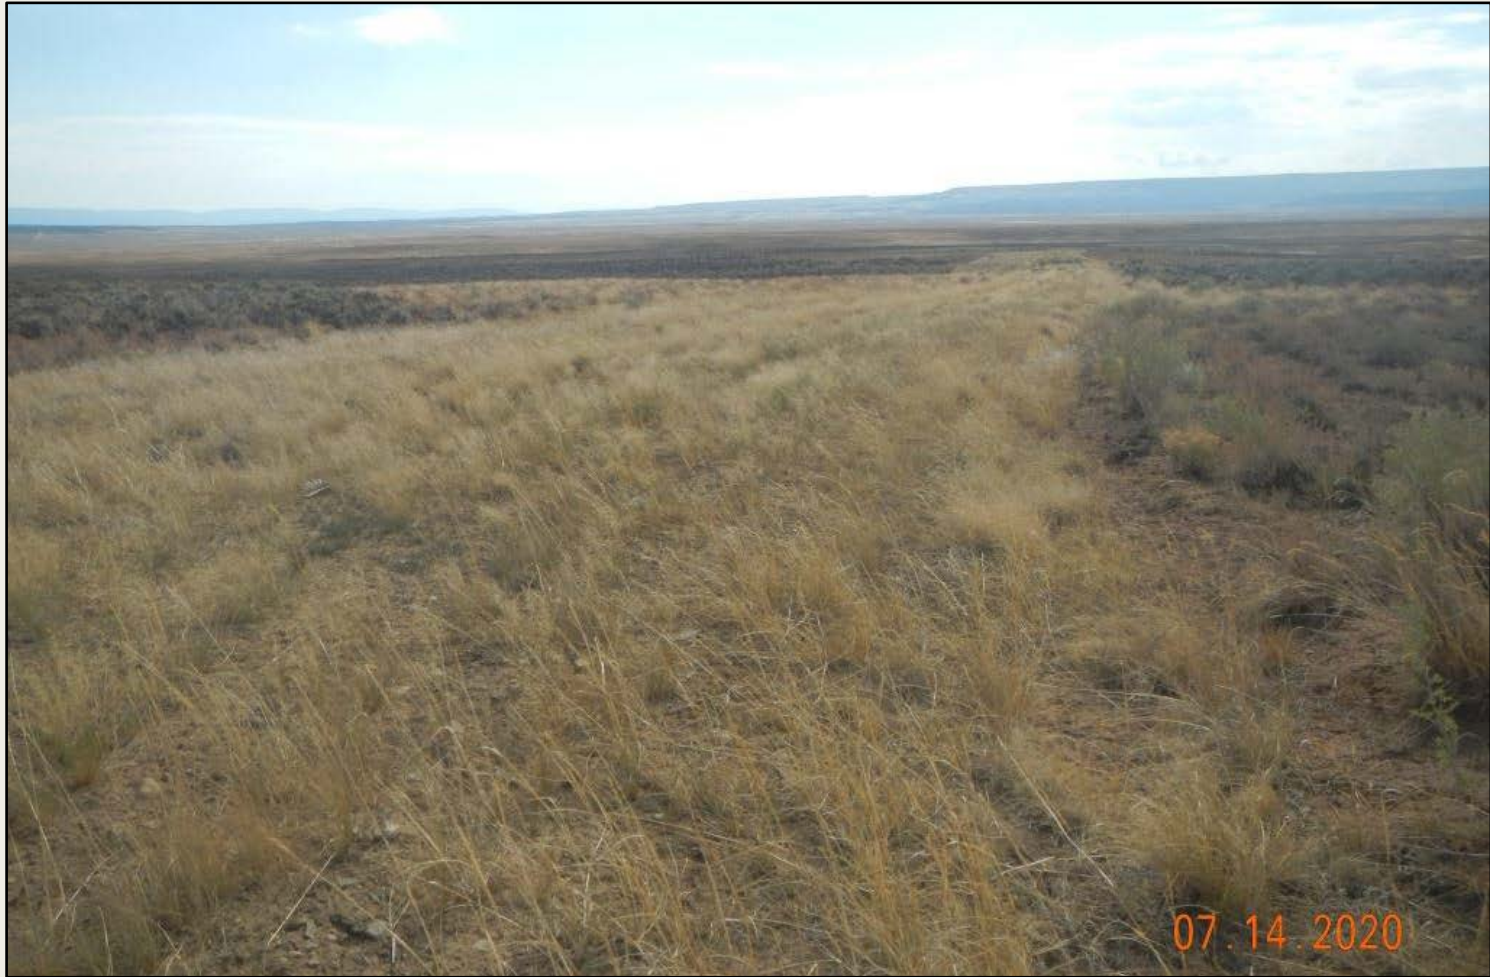
Photo 1. View of revegetation along the approximately 0.75 mile-long access road facing eastward. Revegetation is progressing with grasses such as western wheatgrass, Indian ricegrass, and crested wheatgrass.

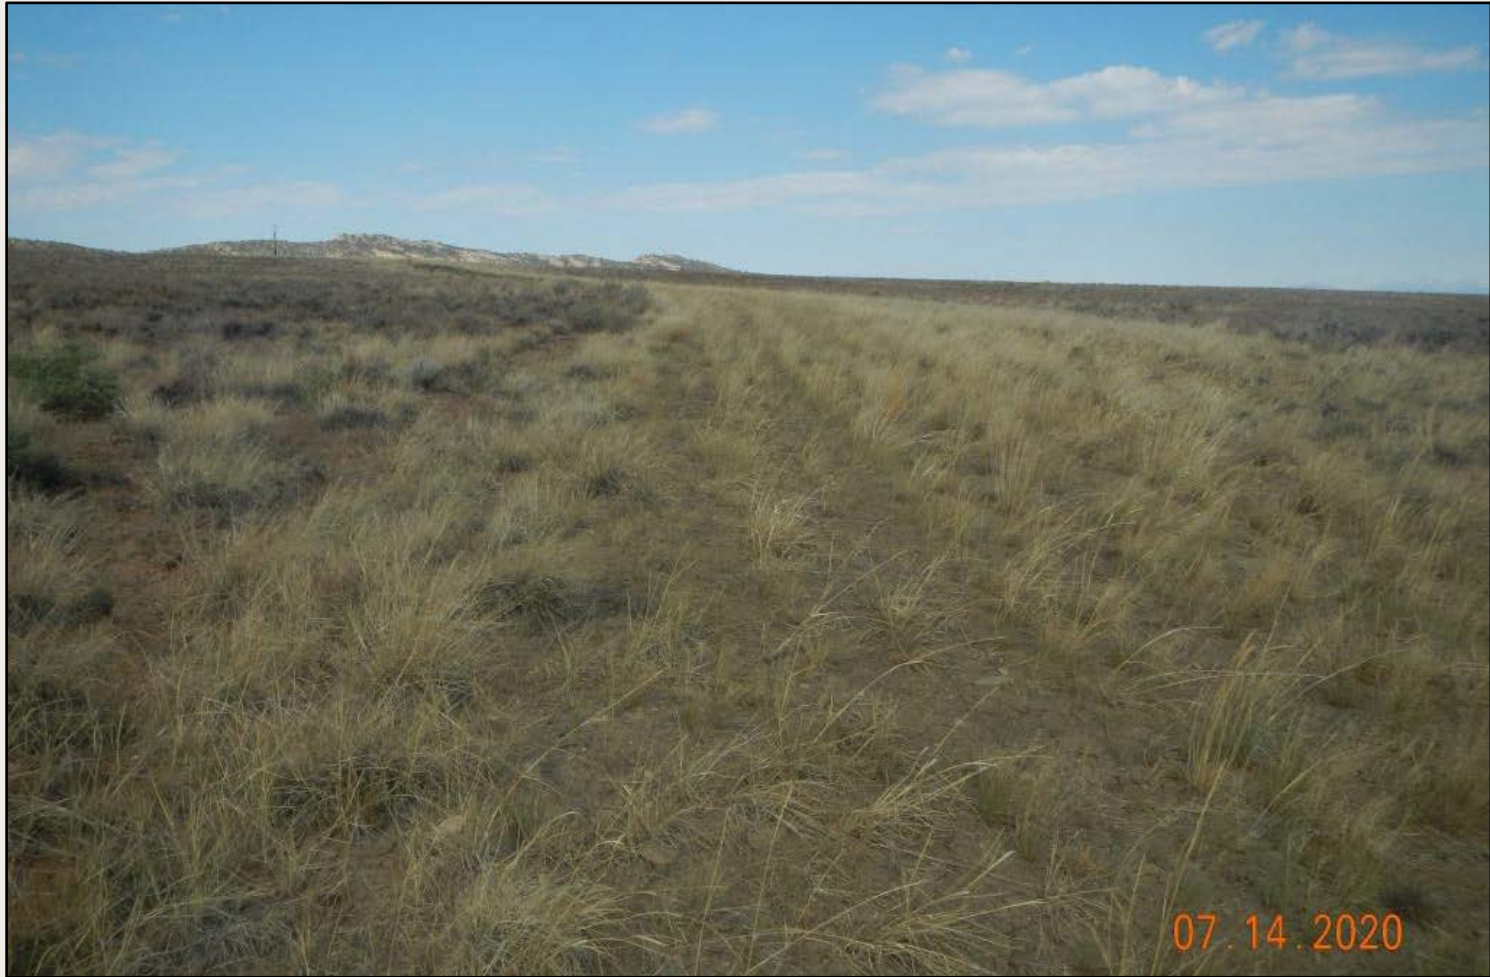
Photo 2. View of revegetation along the approximately 0.75 mile-long access road facing westward.

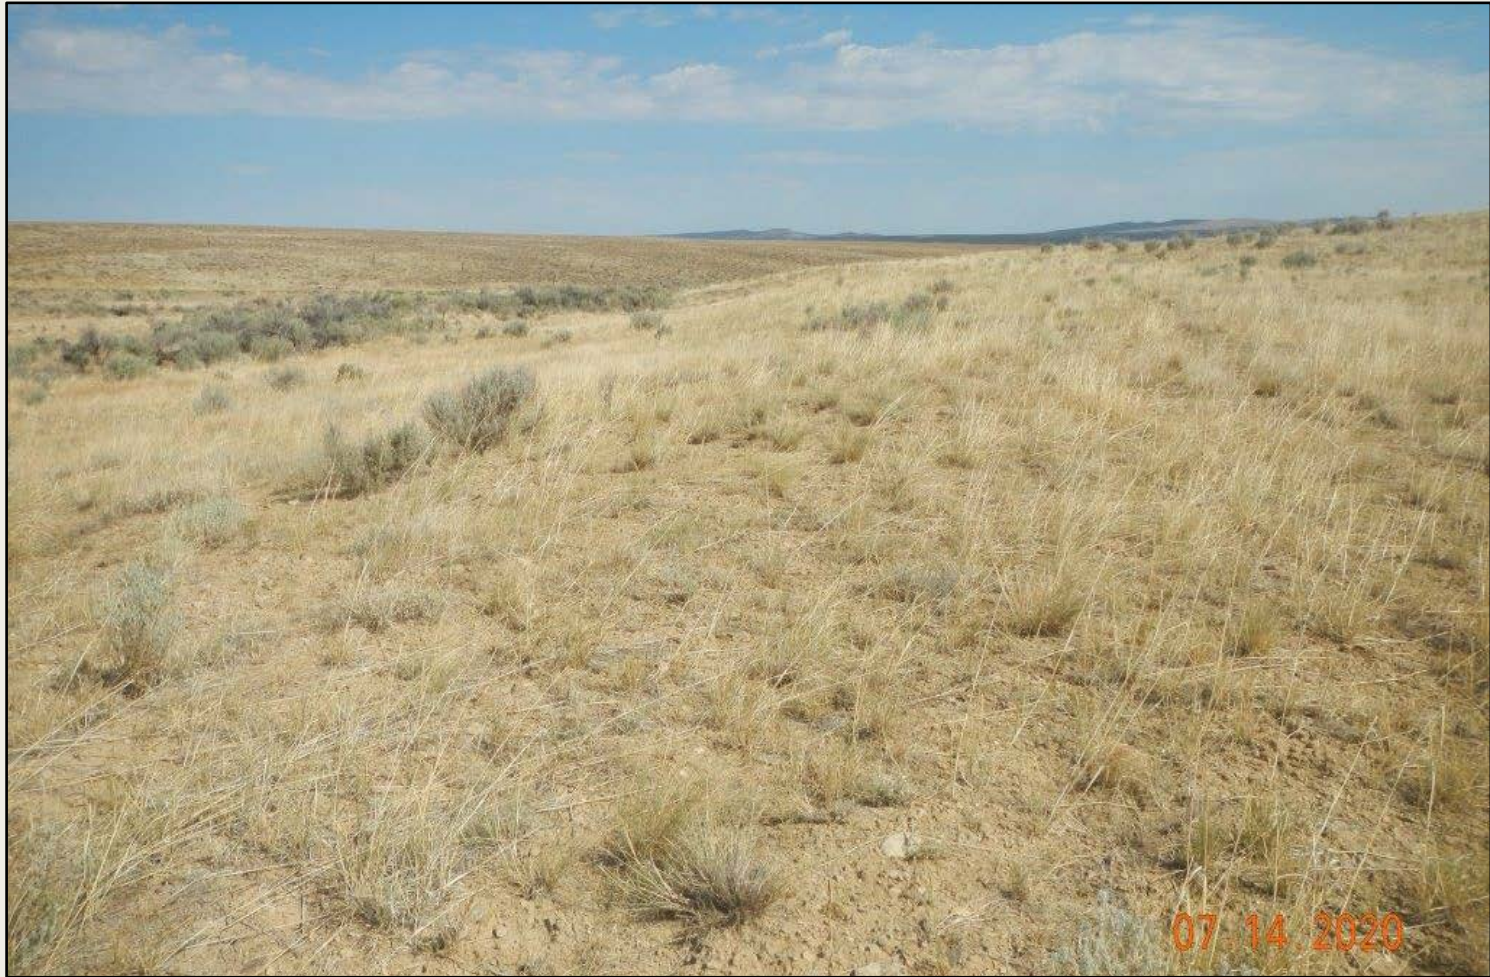
Photo 3. View of the western portion of the reclaimed well pad facing northward from the southwestern corner. Revegetation is established and shrubs such as sagebrush and winterfat are becoming established.

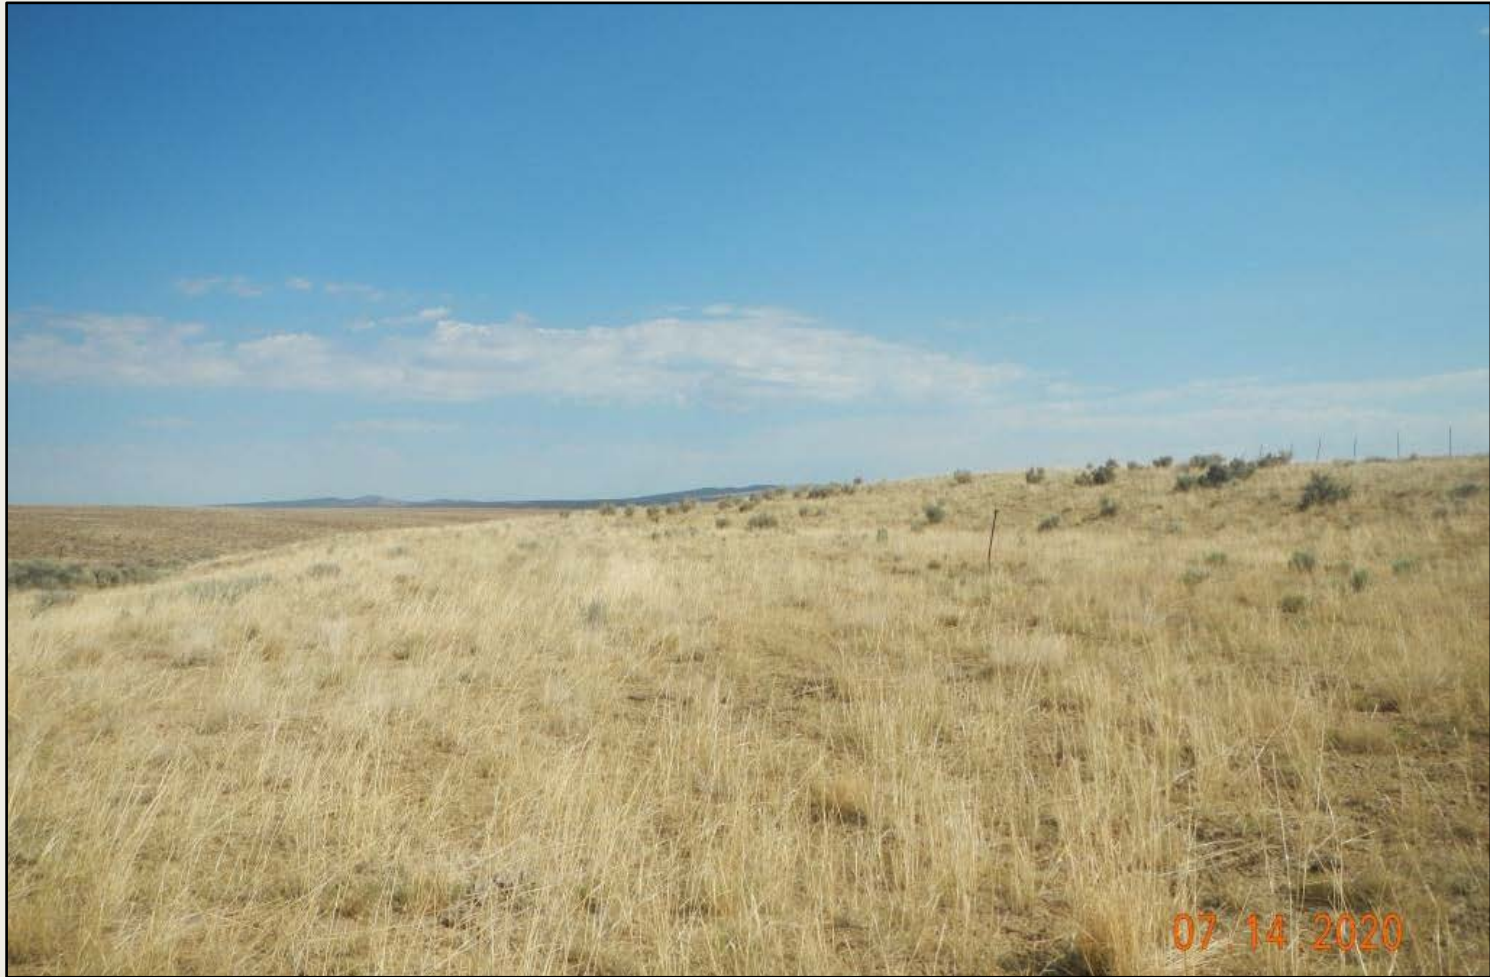
Photo 4. View of the reclaimed well pad from the southwestern corner facing center.

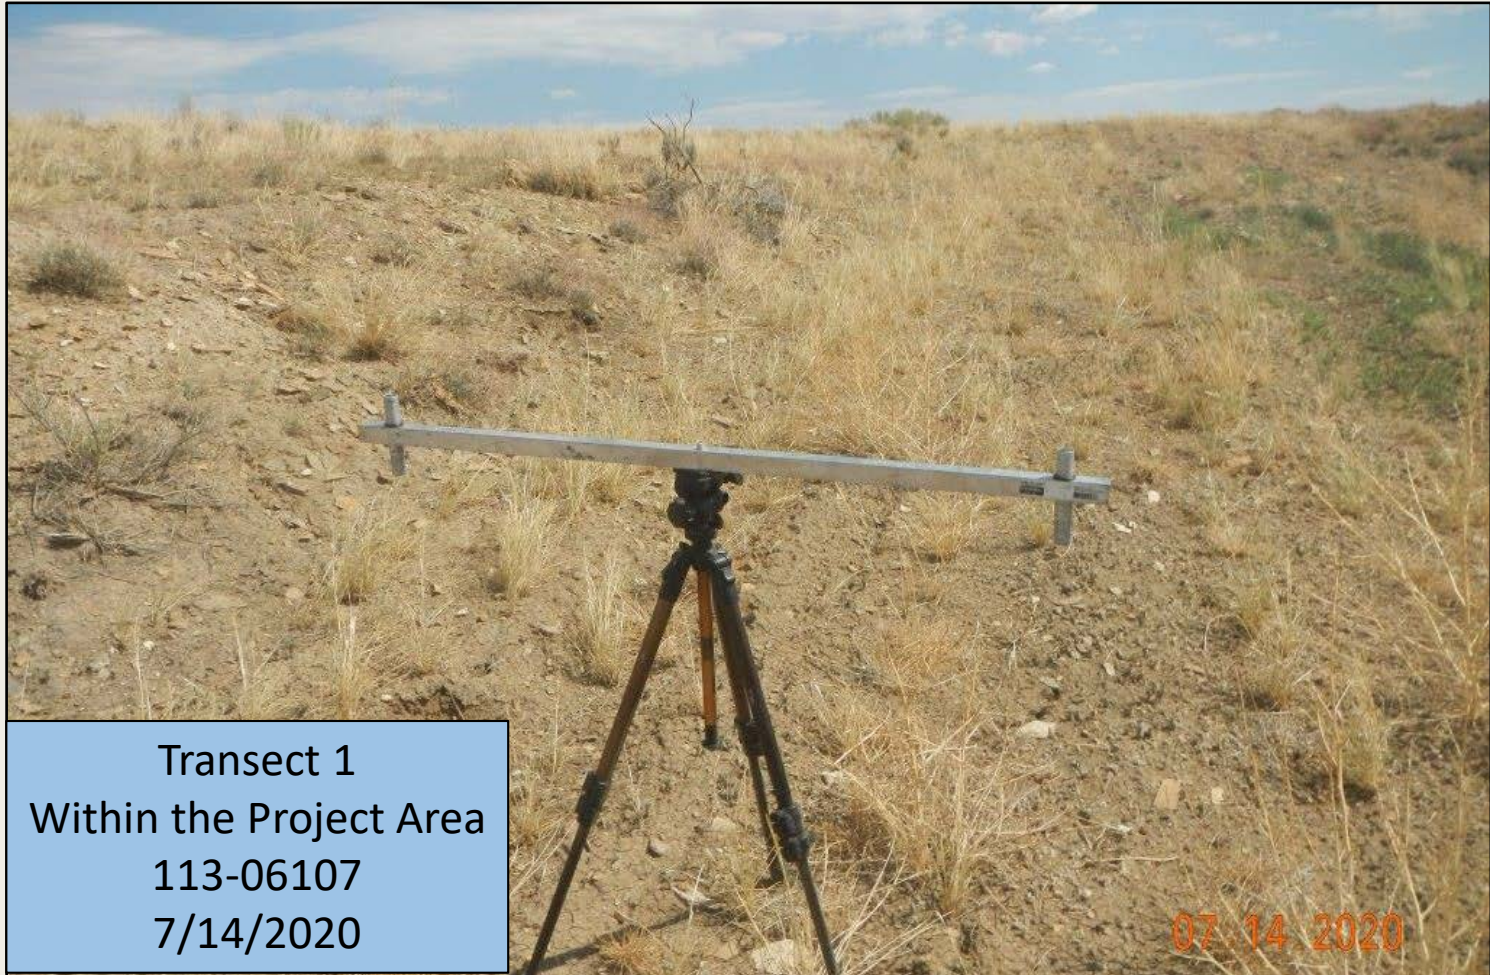
Photo 5. View from the beginning of Transect 1- within the project area (along the access road) facing northward.

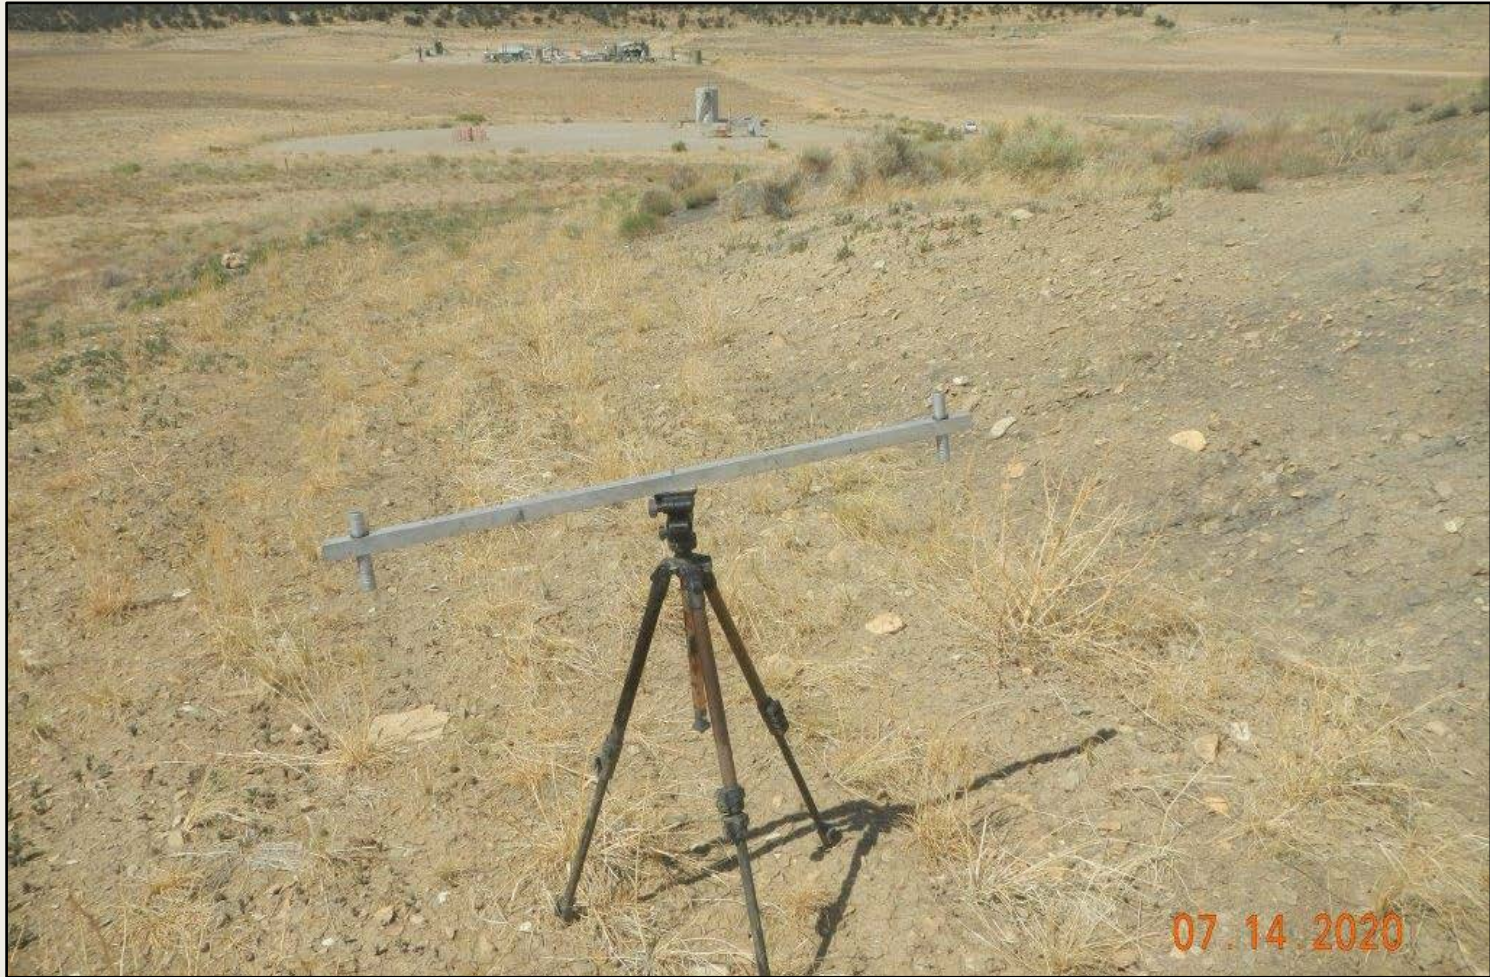
Photo 6. View from the end of Transect 1, facing southward.

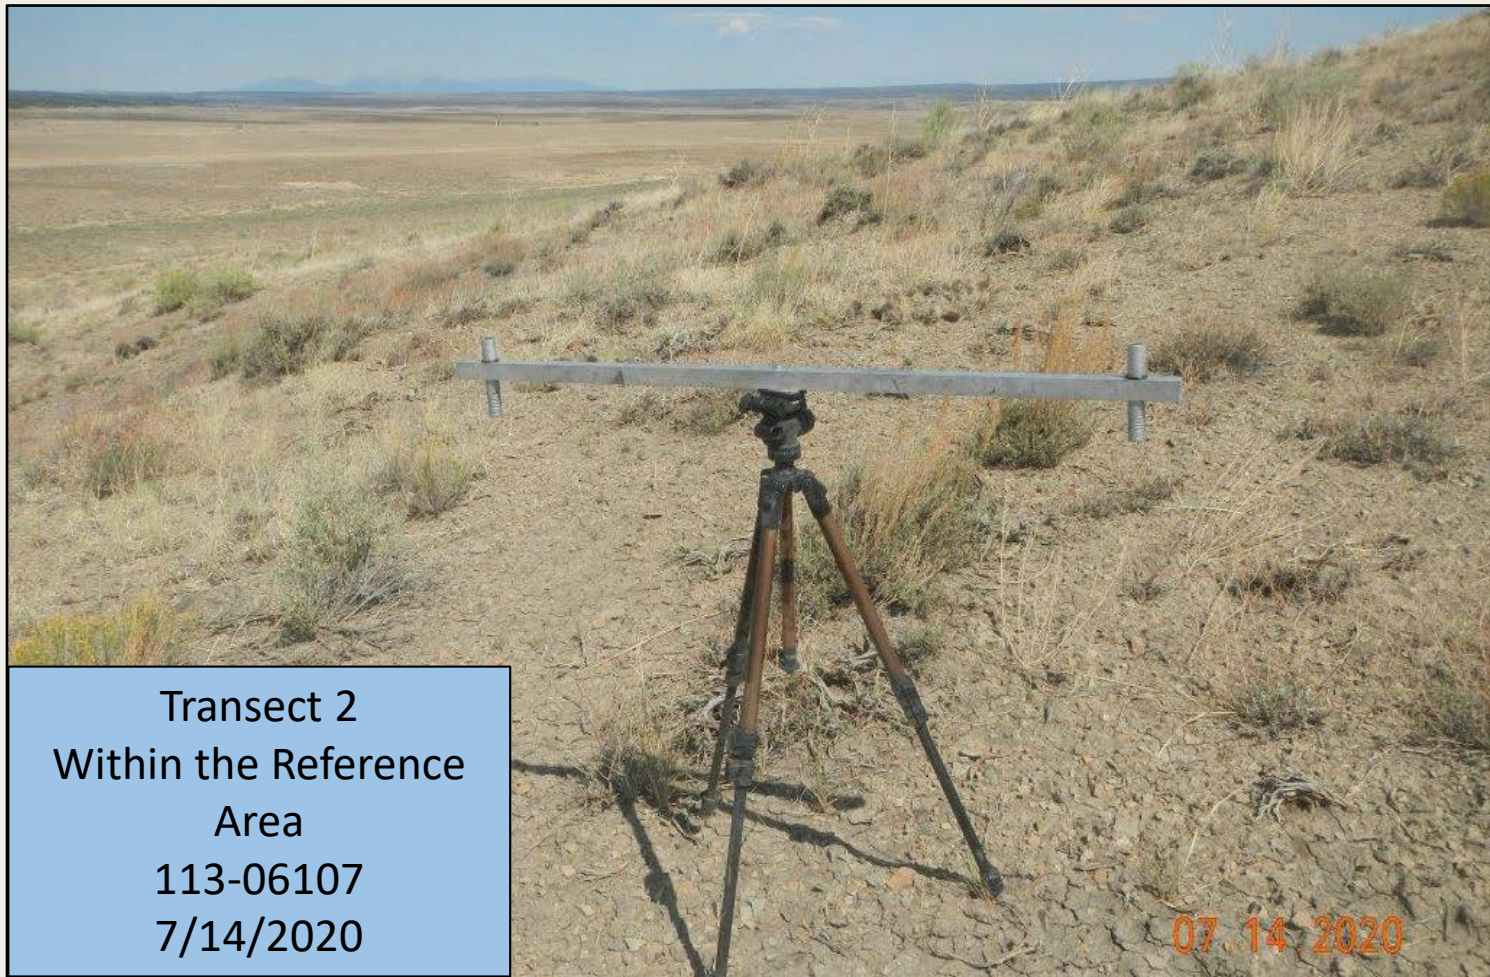
Photo 7. View of reference area vegetation comprised of black sage/matt saltbush vegetation community, facing northwestward.

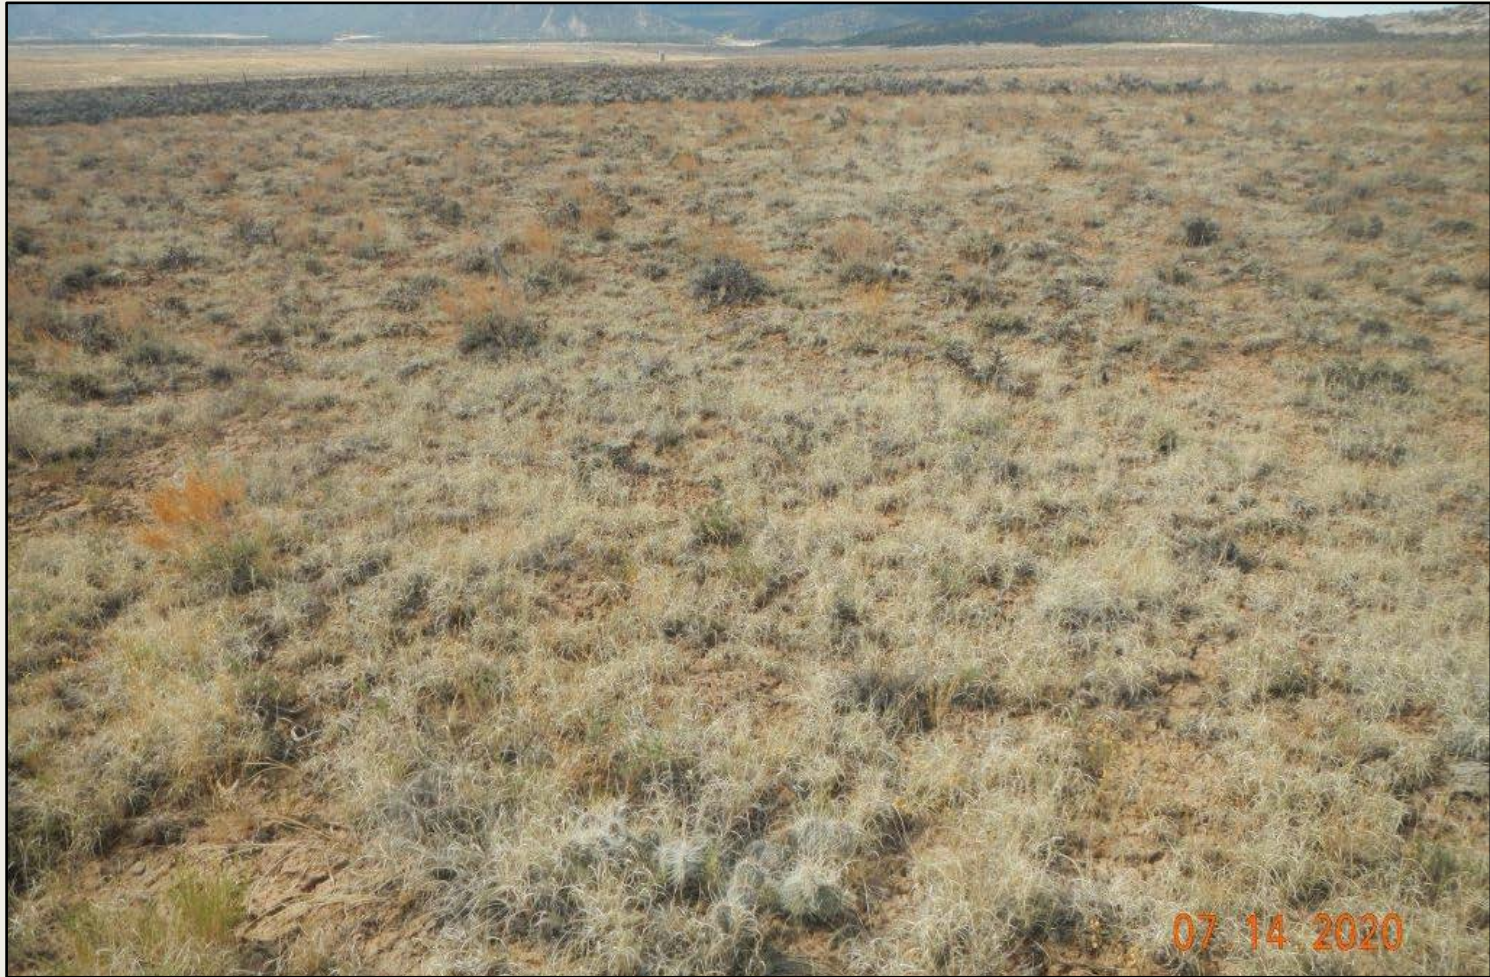
Photo 8. View of reference area east of the transect, comprised of black sage/James galleta dominated grass and shrubland.
