Inspection Photos
Operator: Patara
API: 113-06163
Date: 7/14/2020

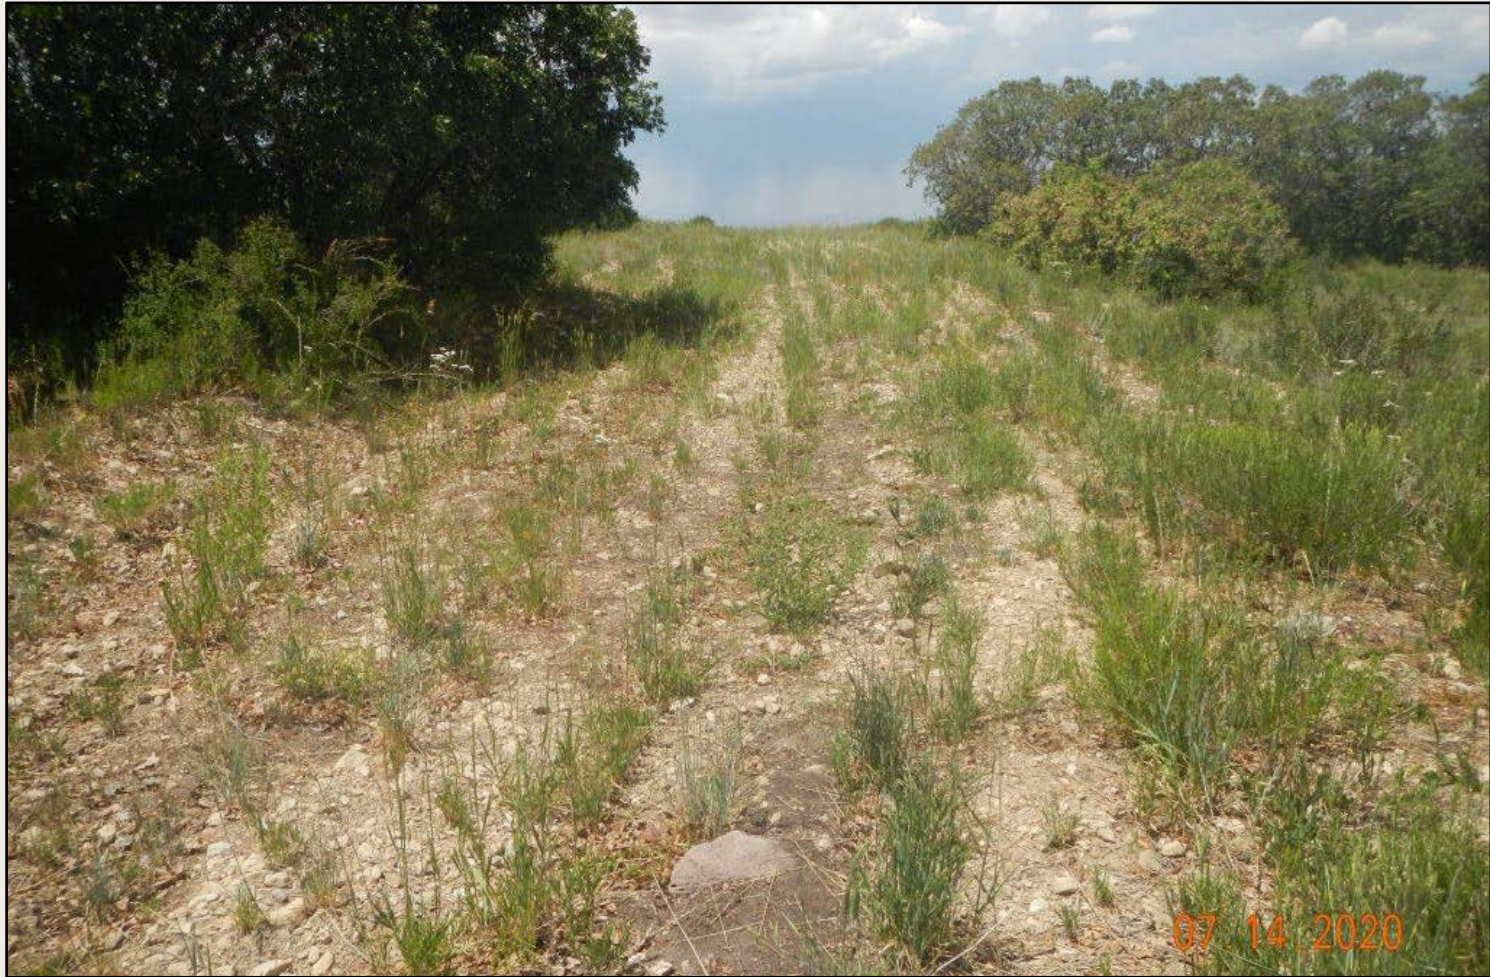
Photo 1. View of revegetation along the access road, from the beginning access, facing northwestward. Revegetation is progressing with grasses such as western wheatgrass, squirreltail, smooth brome, and crested wheatgrass.

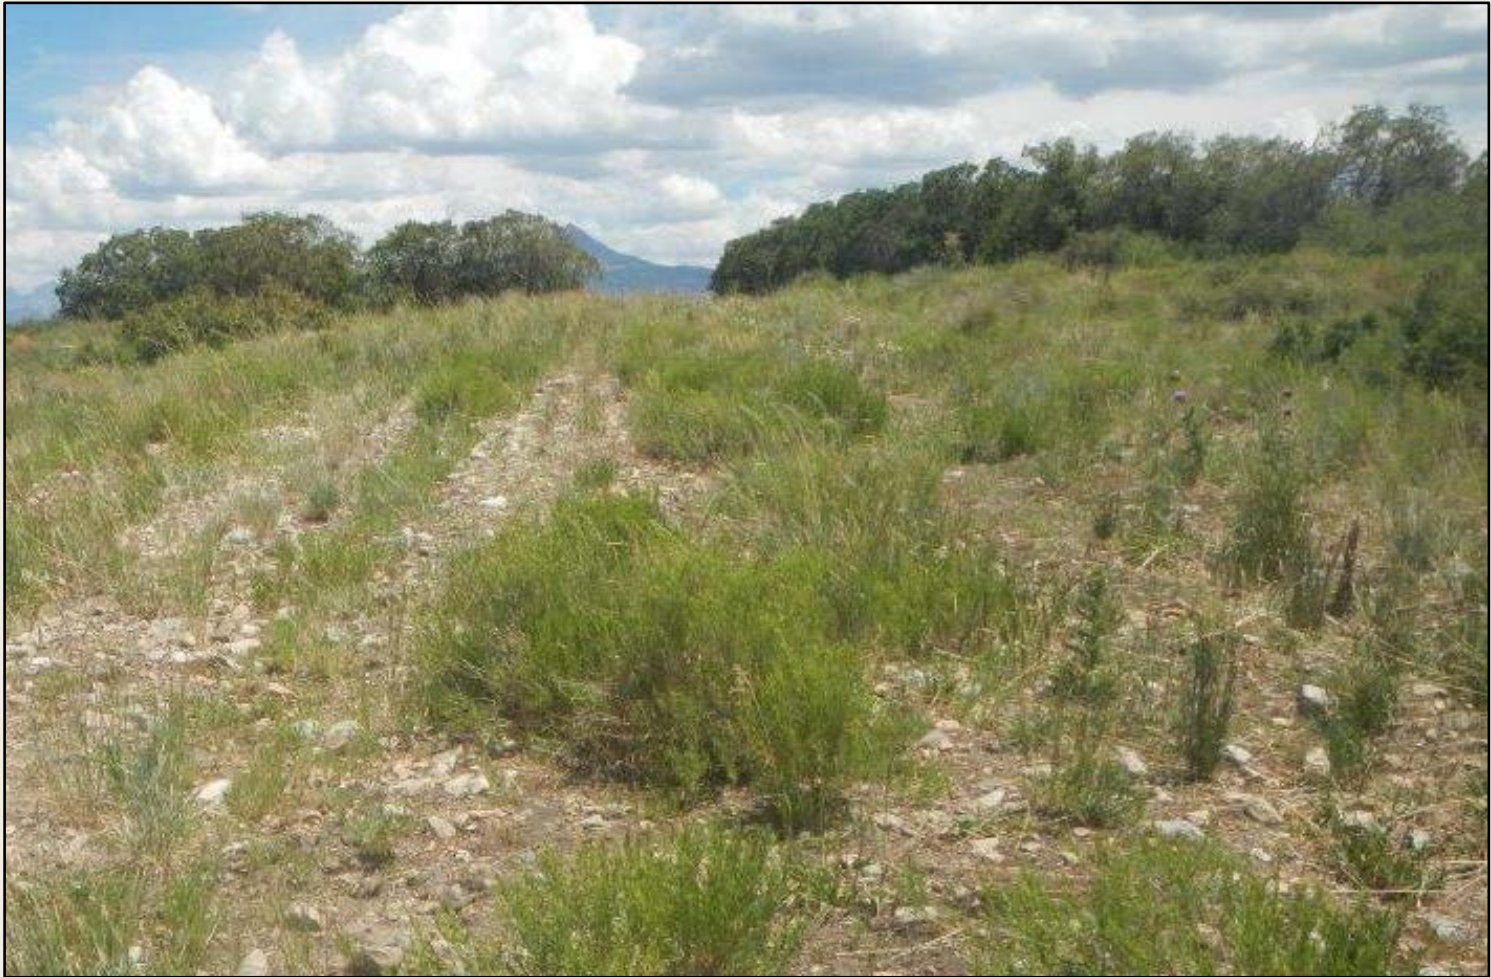
Photo 2. View of the access road from the former well pad entrance, facing southeastward.

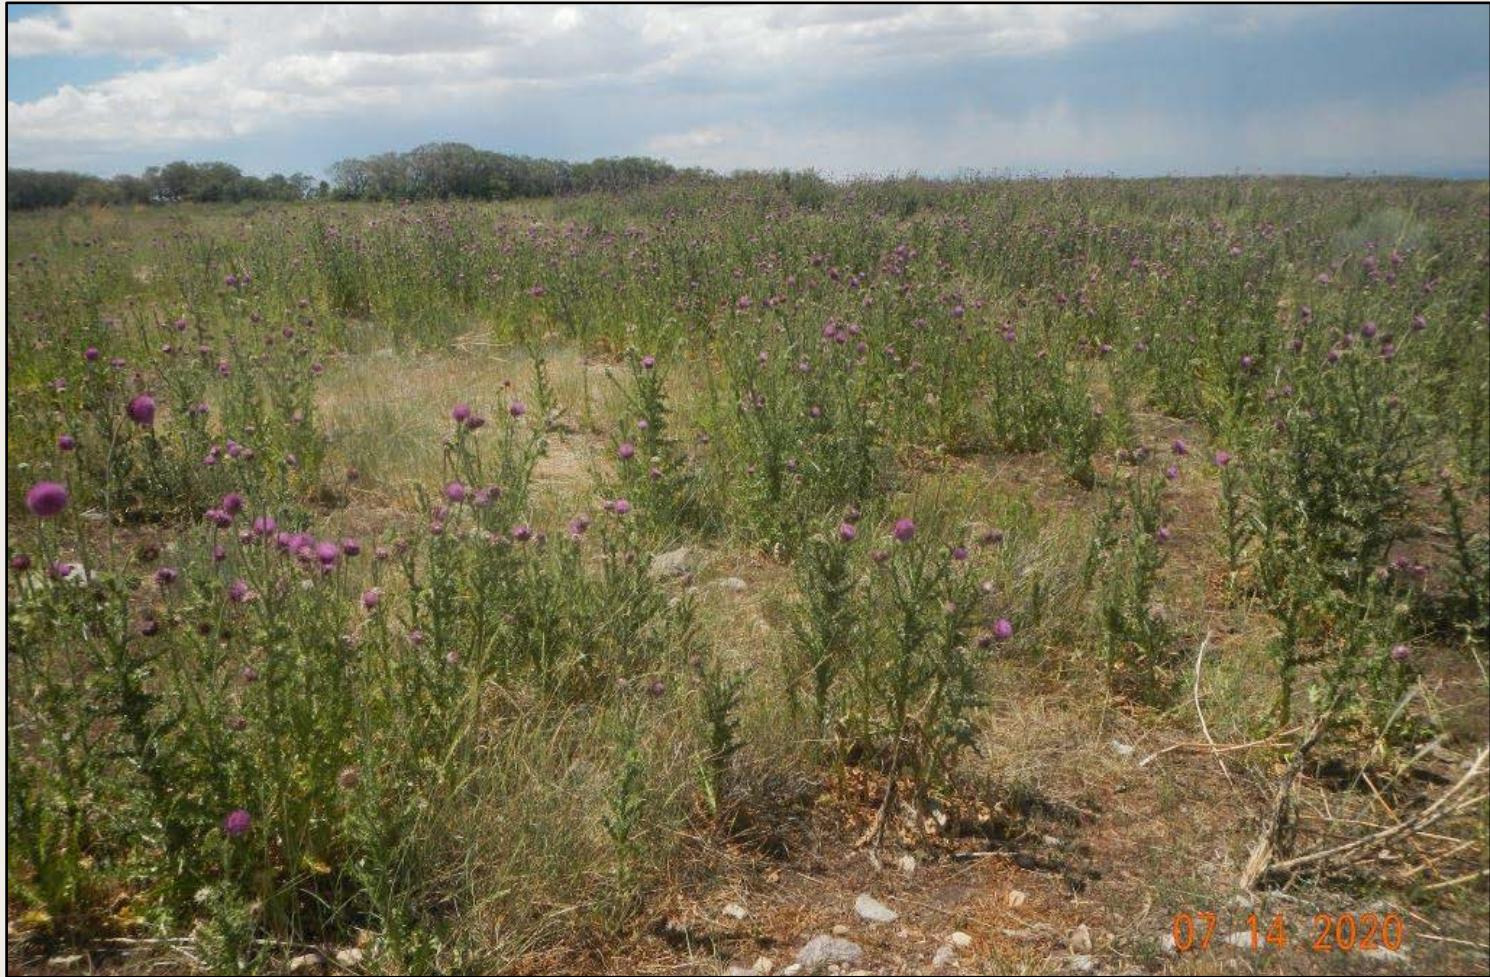
Photo 3. View of the well pad from the well pad entrance facing center. Although vegetation was well established. Thousands of musk thistles have proliferated.

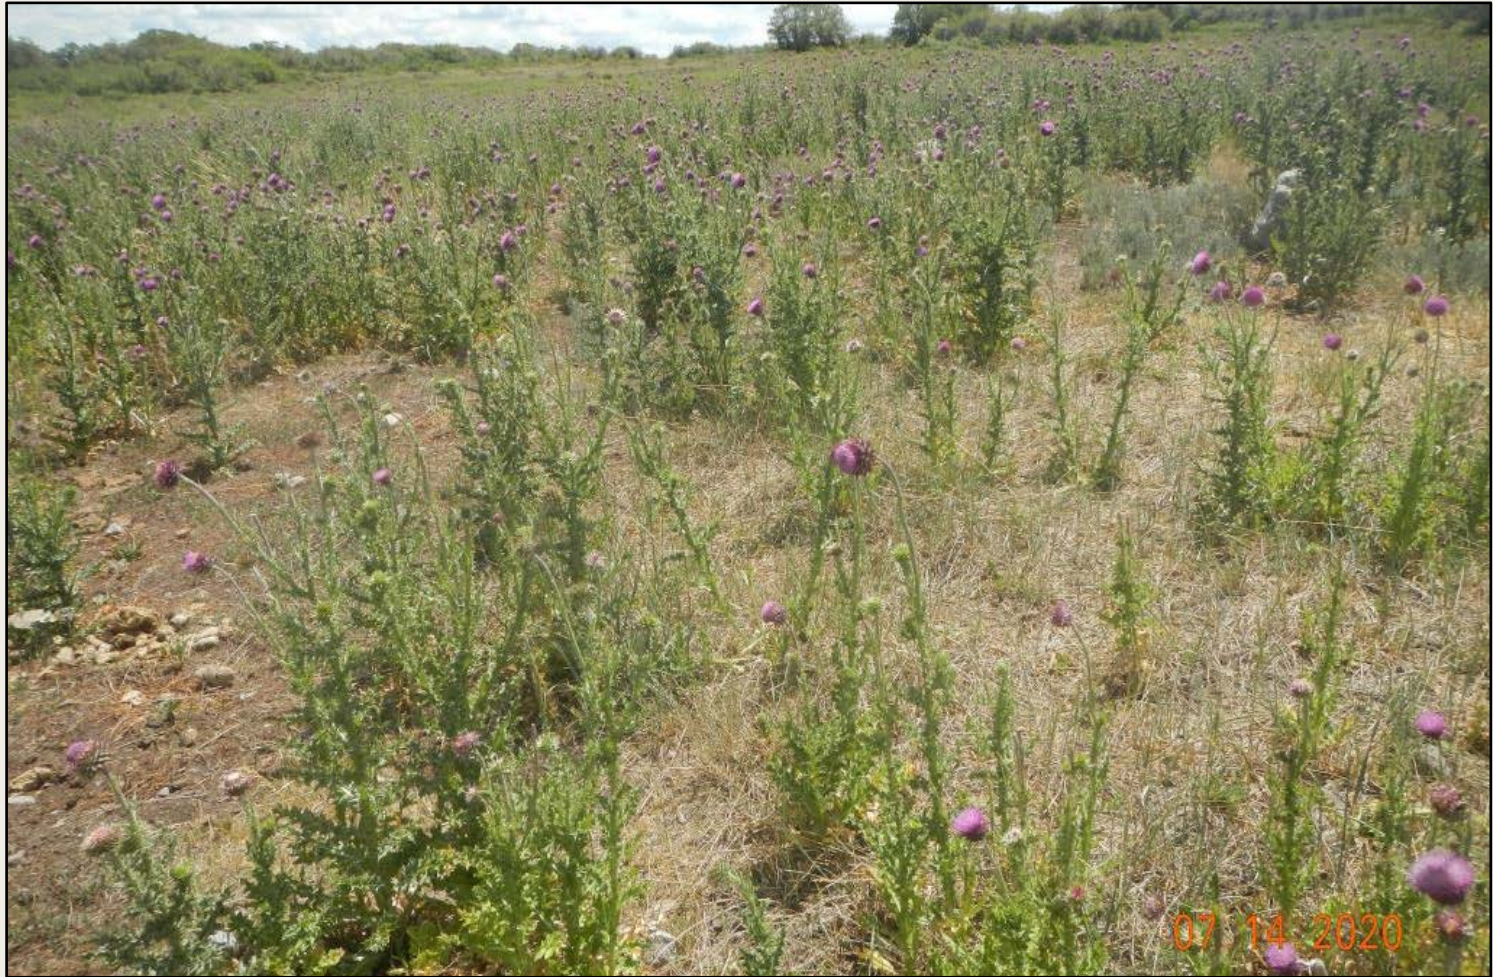
Photo 4. View of the southern portion of the former well pad facing westward.

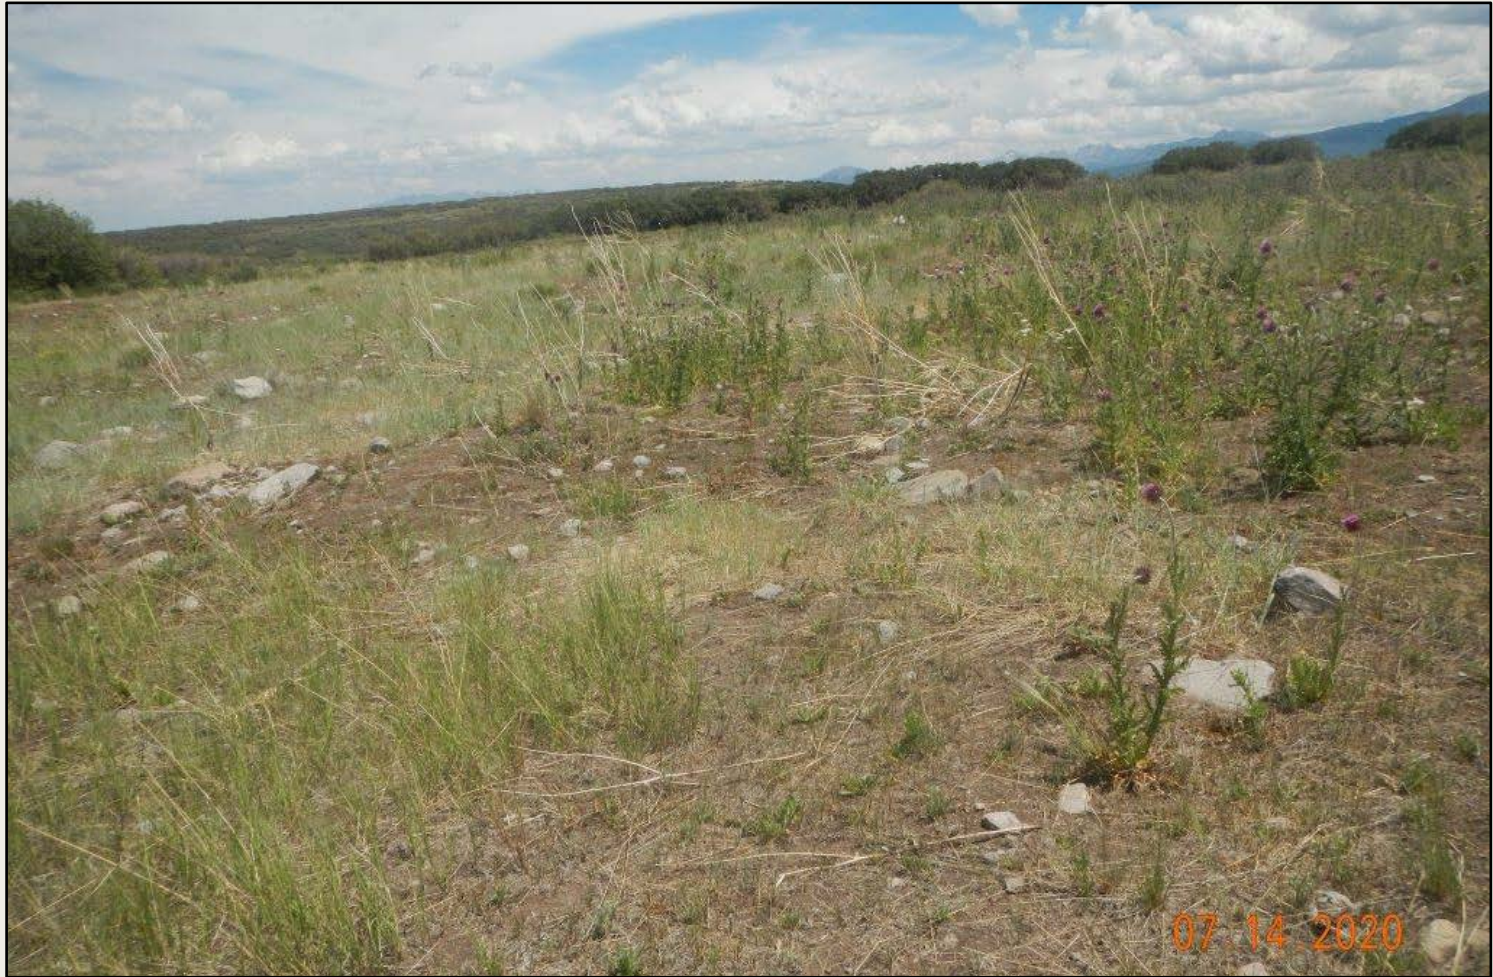
Photo 5. View of the western project area from the southwestern corner facing northward.

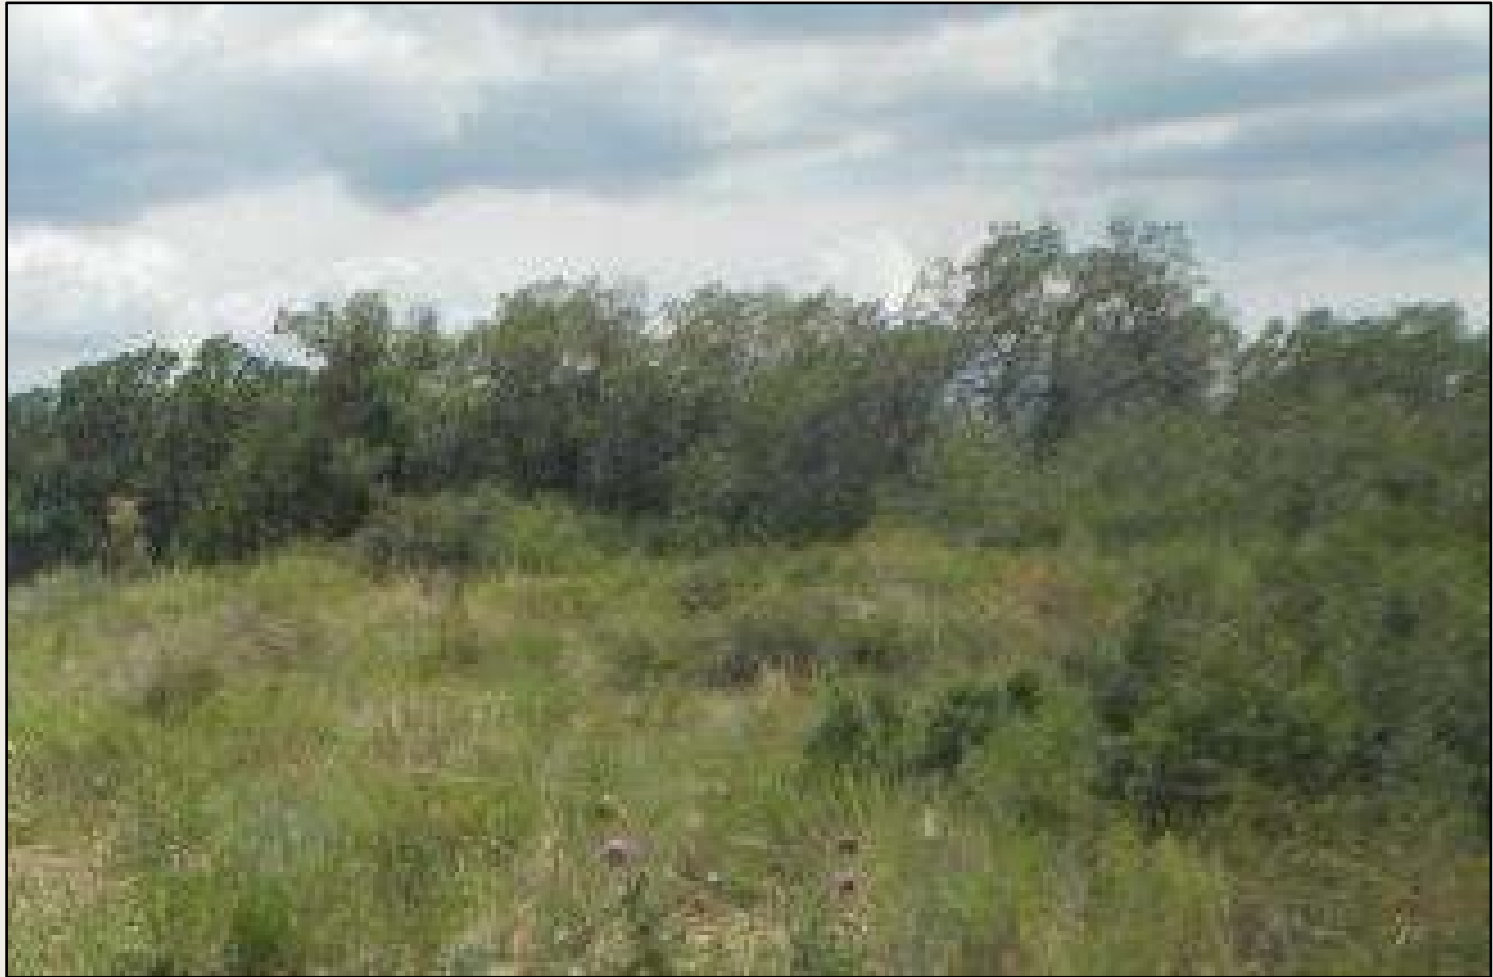
Photo 6. View of reference area comprised of gambel oak woodland with understory of black sagebrush, potentilla, fringed sage, and squirreltail.
