Inspection Photos
Operator: Patara
API: 113-06207
Date: 7/16/2020

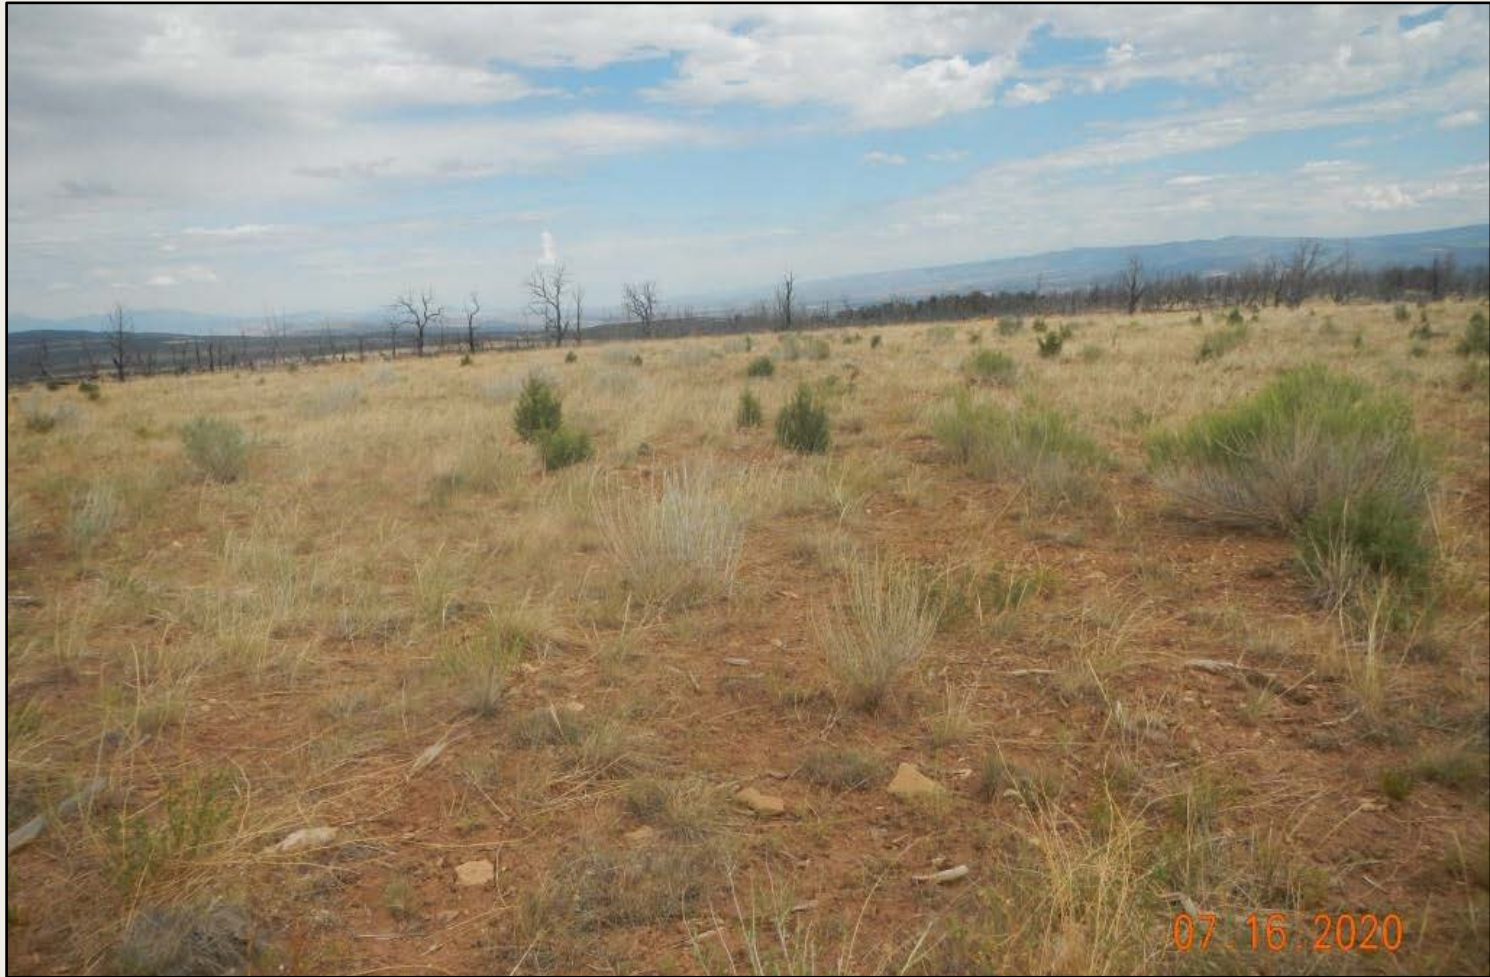
Photo 1. View of the reclaimed well pad from the well pad entrance westward. Revegetation is established with grasses such as western wheatgrass, Indian ricegrass, and shrubs/sub-shrubs such as rubber rabbitbrush and *Heterotheca villosa*. Young juniper trees are also becoming established.

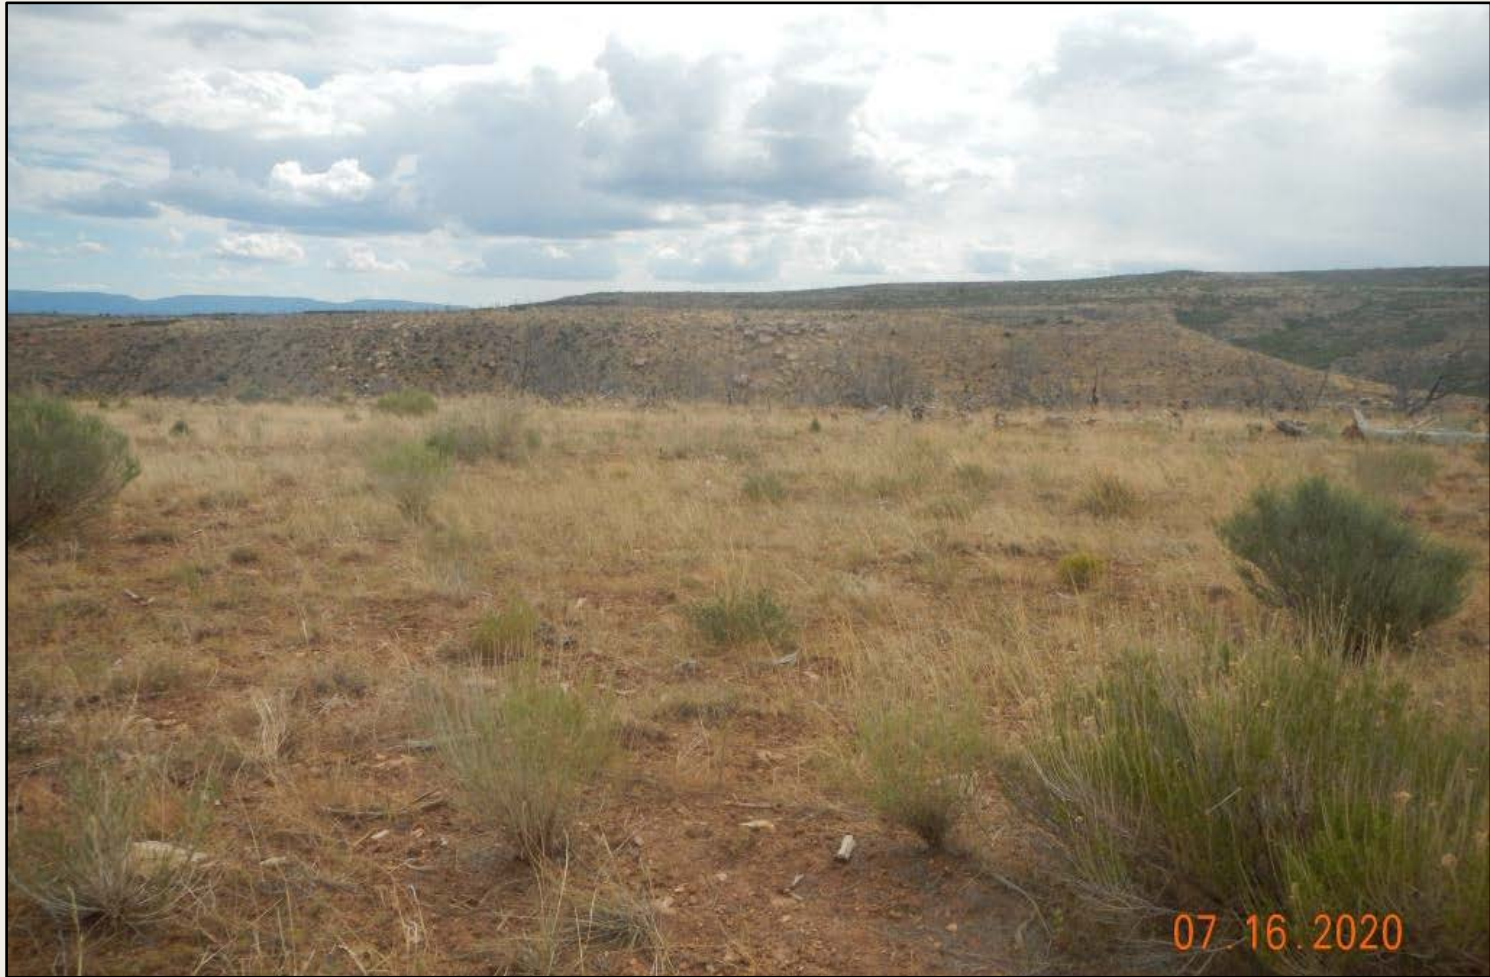
Photo 2. View of the eastern project area from the southern edge facing northeastward.

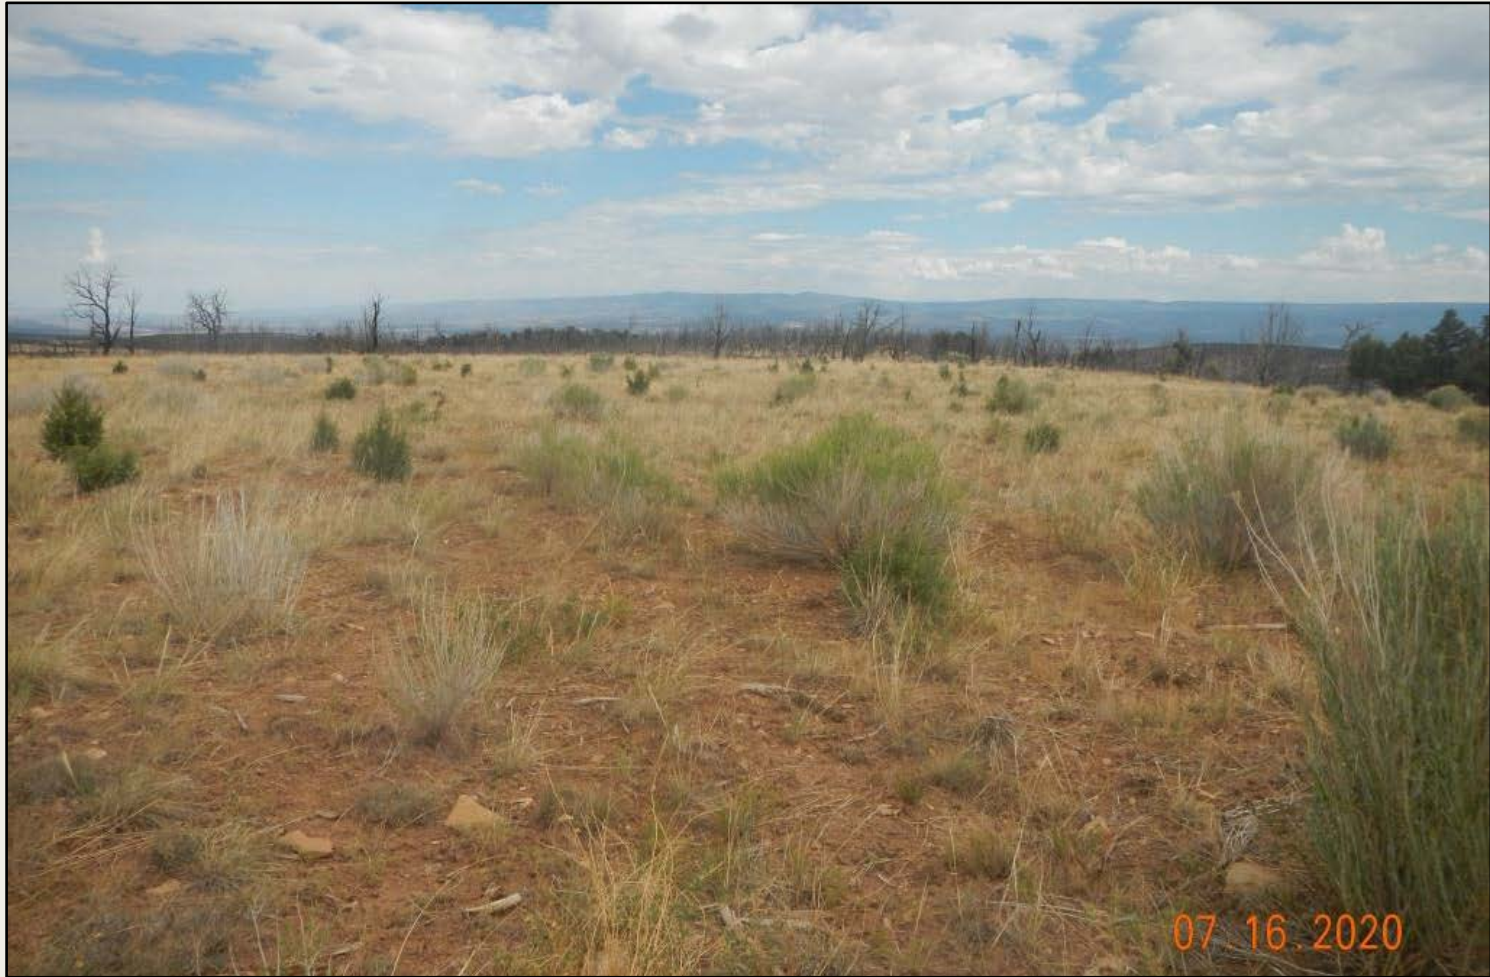
Photo 3. Another view of revegetation on the well pad, facing northward.

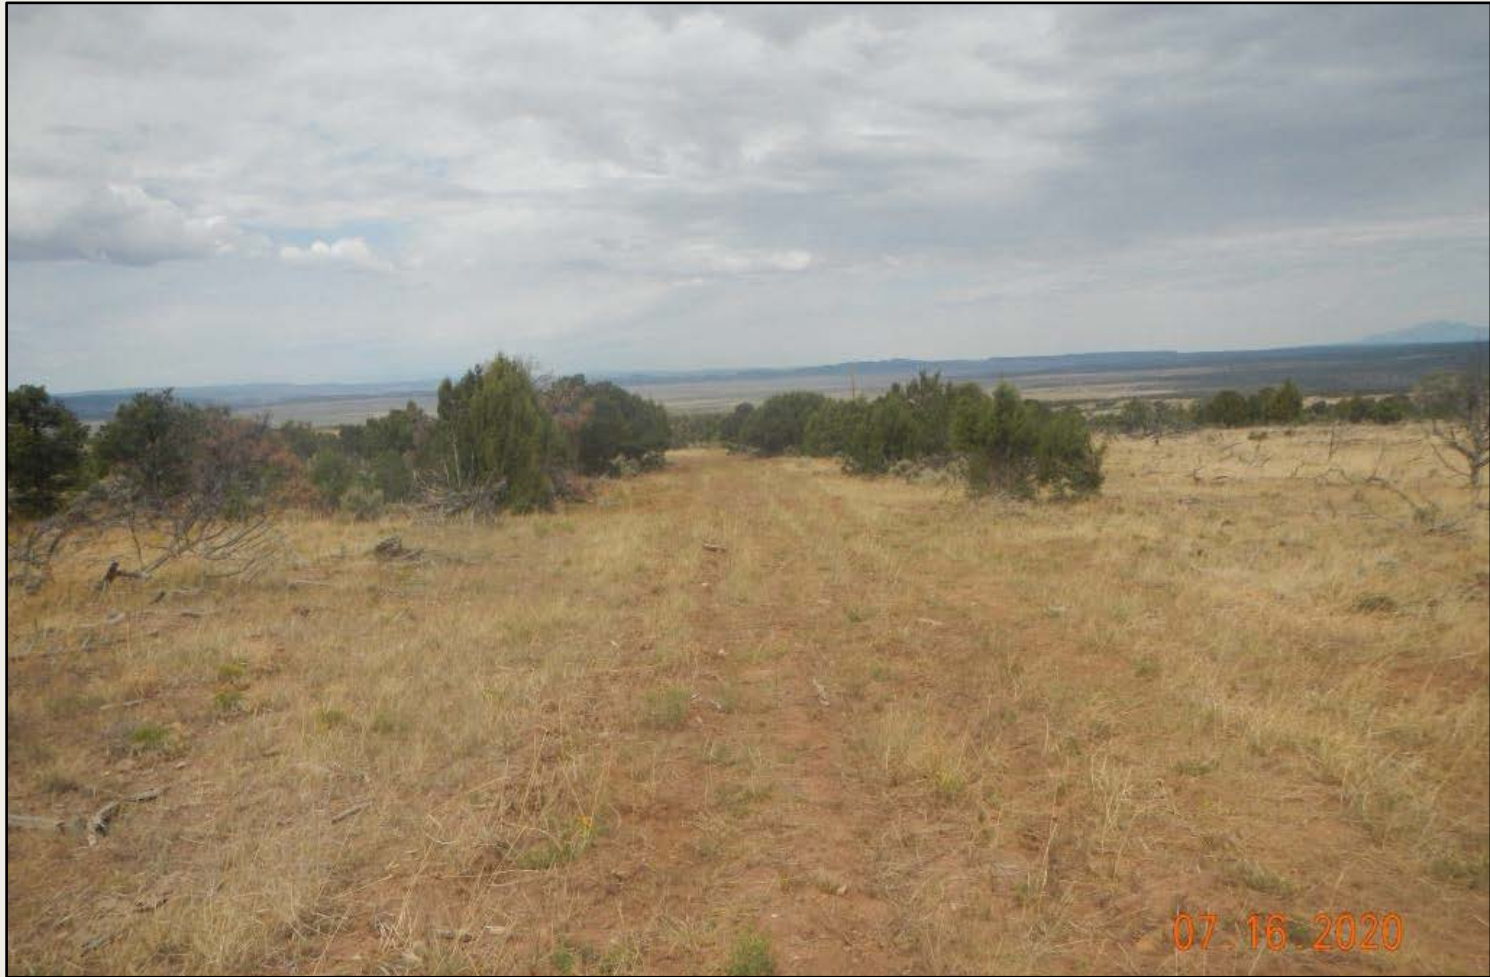
Photo 4. View of the reclaimed access road from the well pad entrance facing southward.

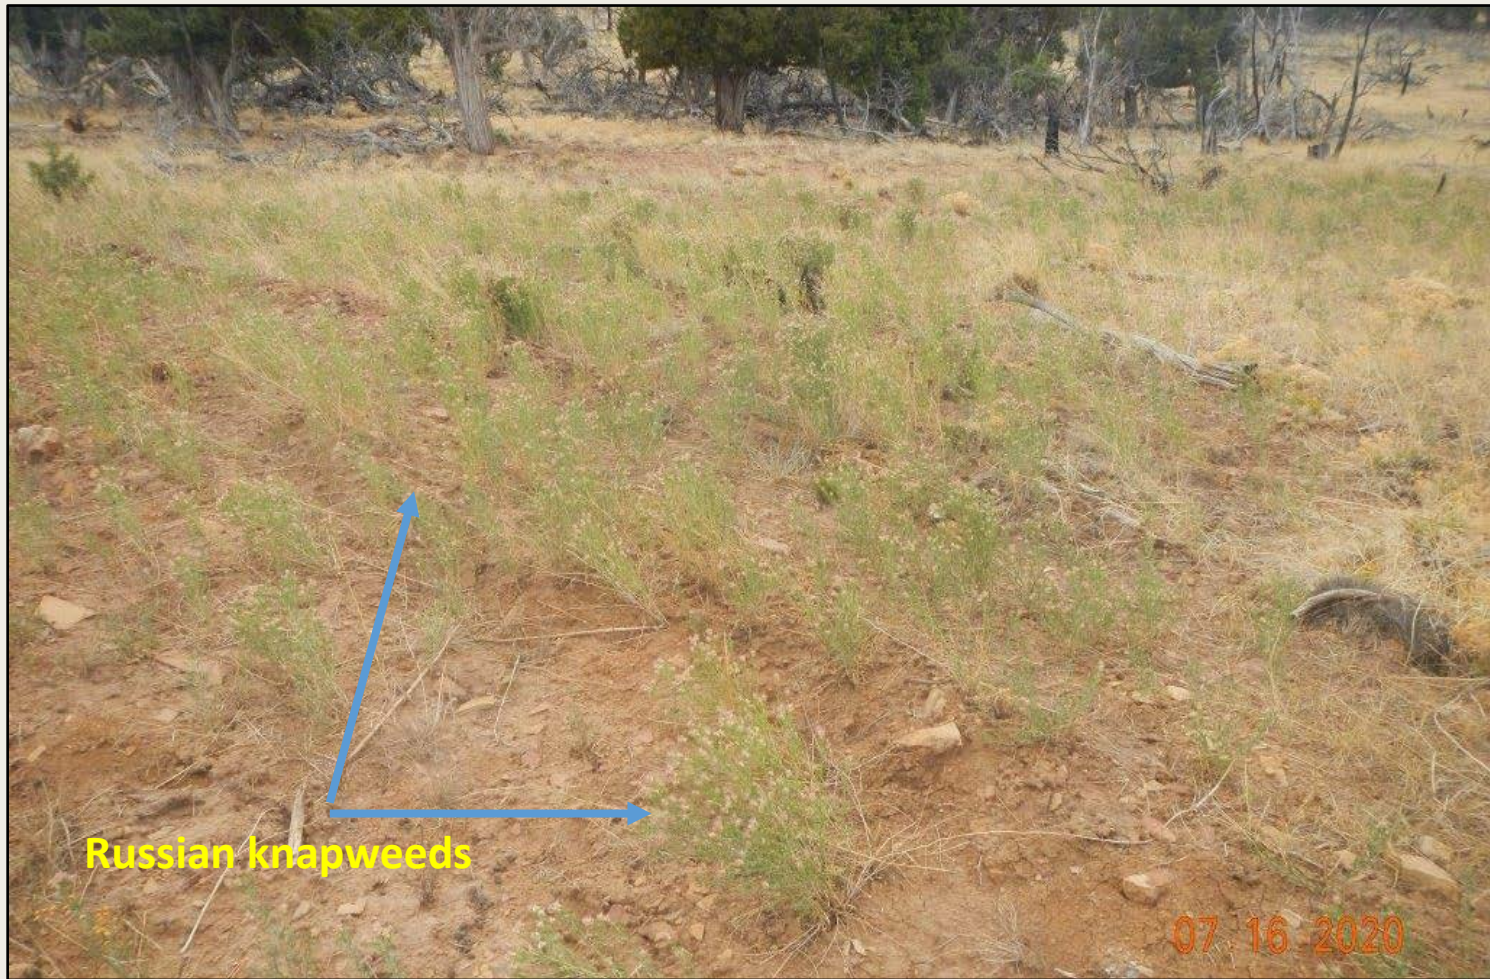
Photo 5. View of Russian knapweeds observed along the access road.

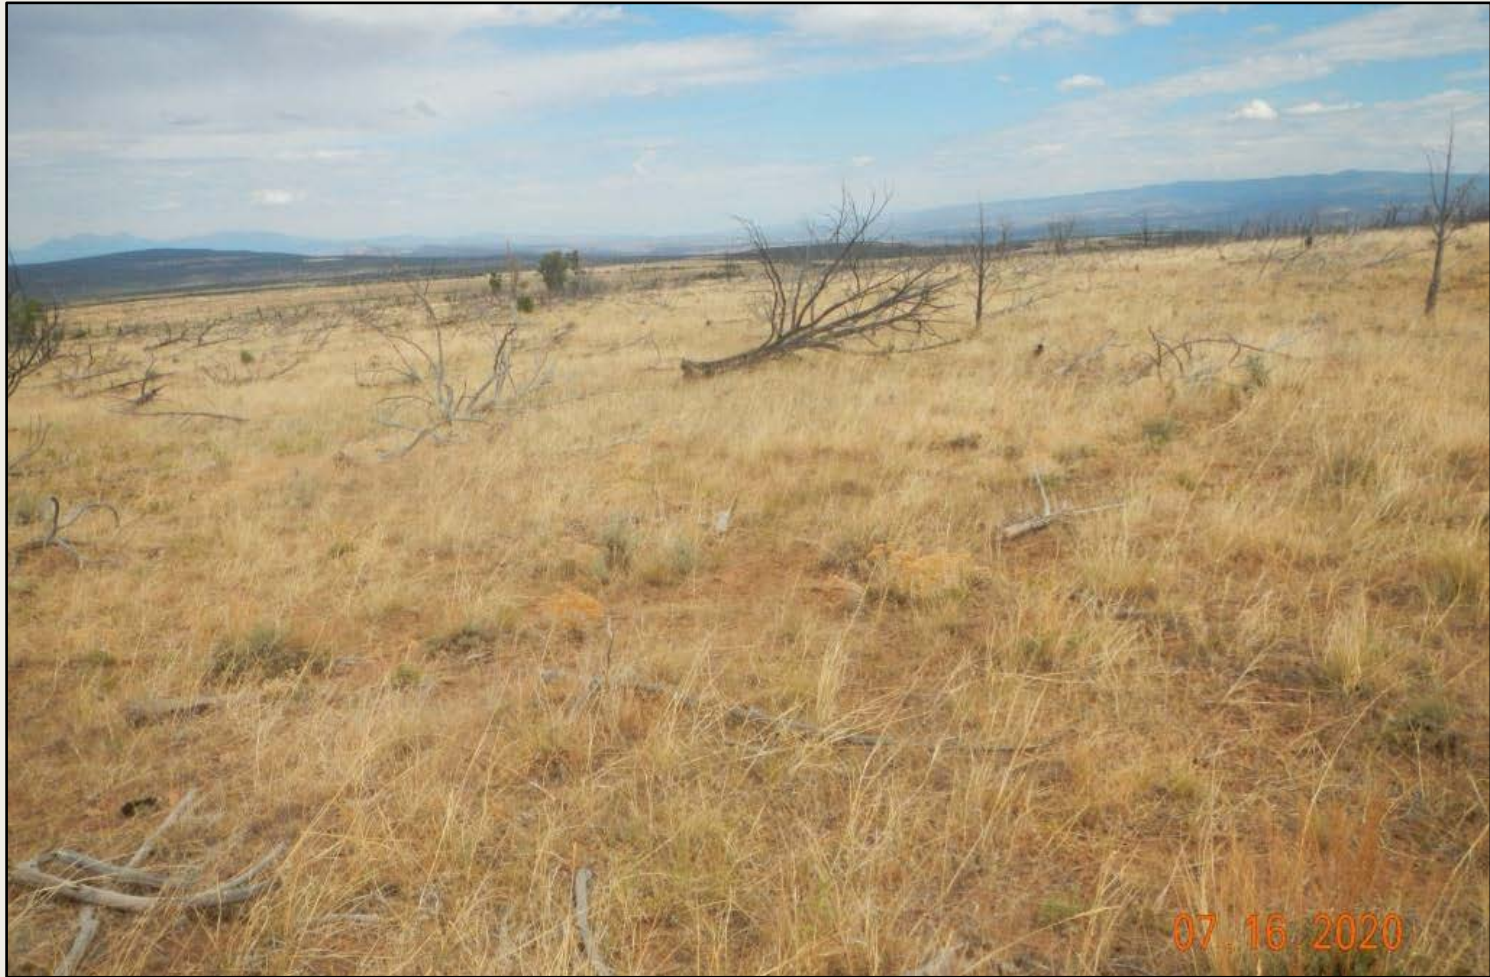
Photo 6. View of reference area comprised of pinyon juniper woodland in a post-fire recovery conditions with grasses, shrubs, and forbs in the understory, such as western wheatgrass, needleandthread grass, black sage, and snakeweed.
