Inspection Photos
Operator Name: LARAMIE ENERGY LLC
Facility ID: 312626

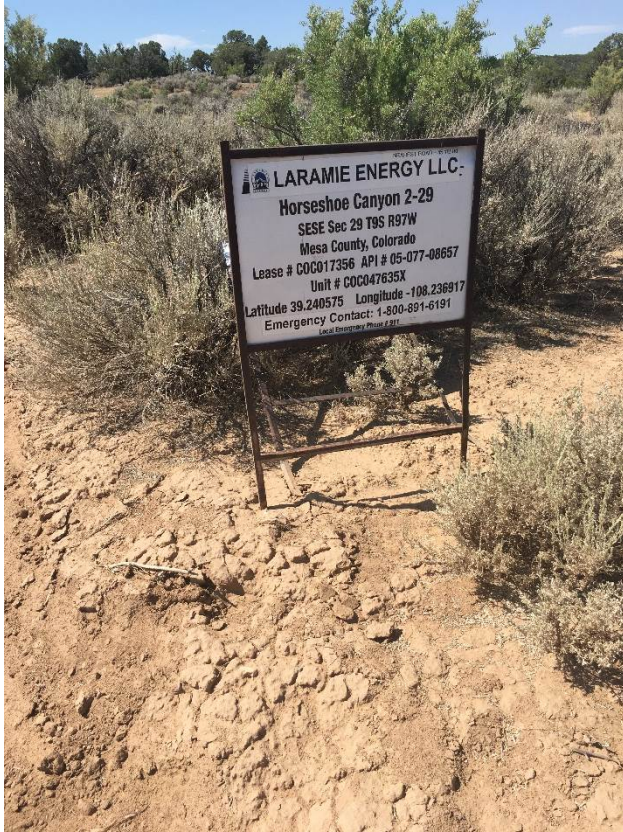
Entrance sign

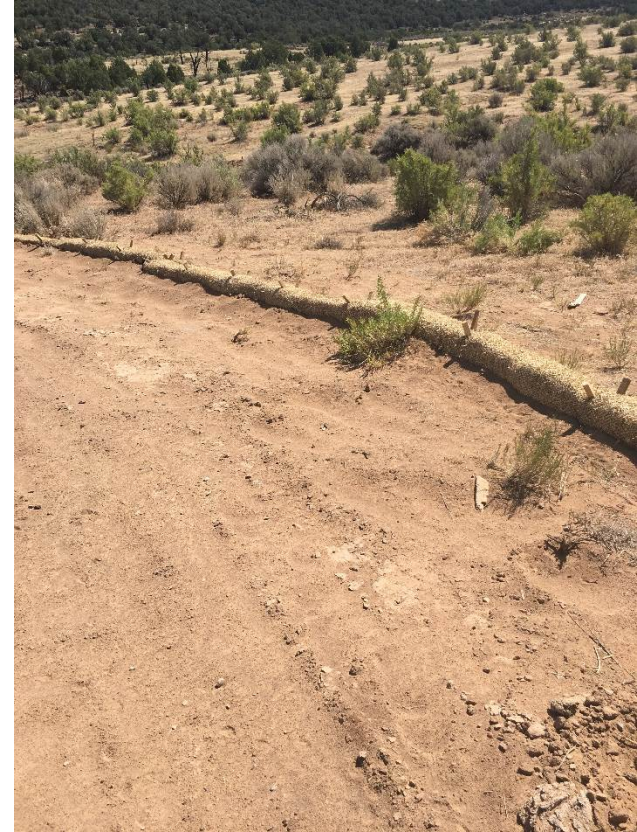
Stormwater BMP's installed

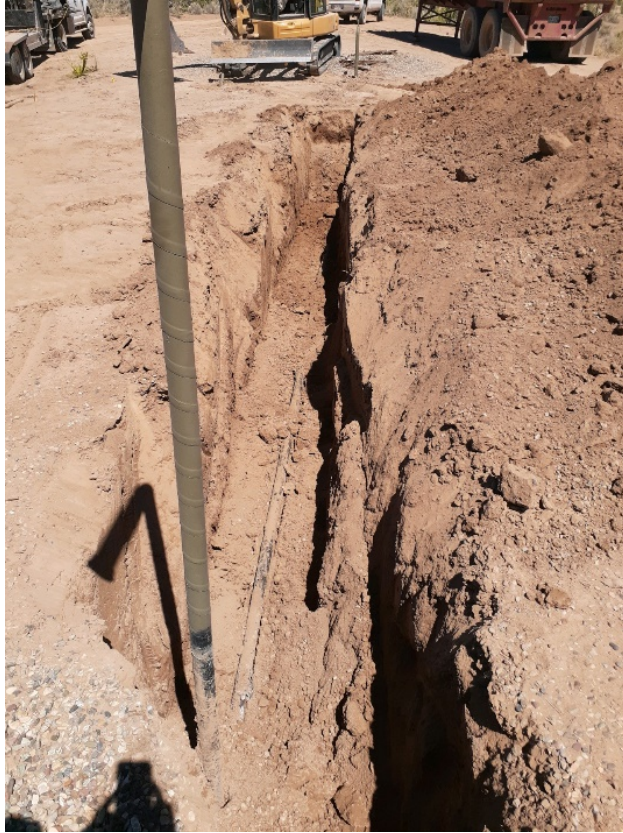
Flowline being exposed

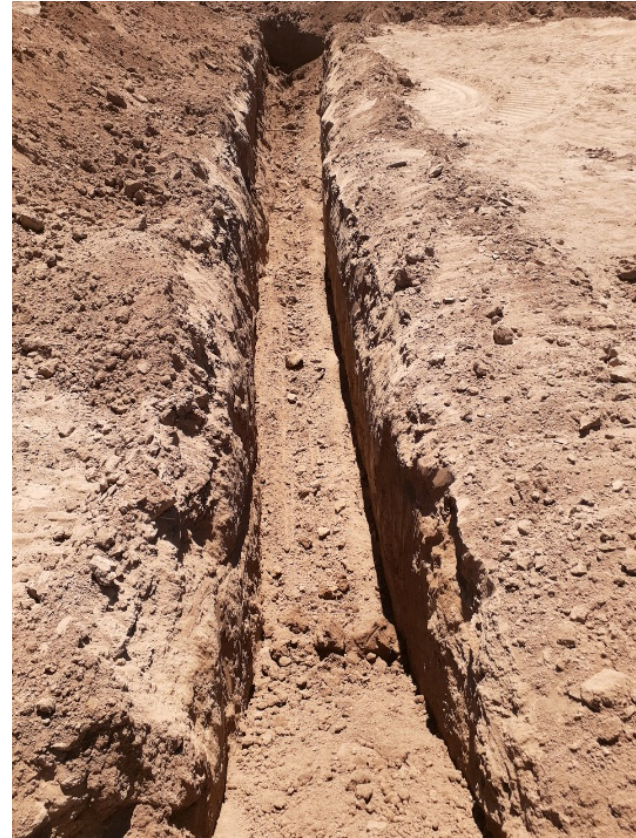
Flowline removed from excavation

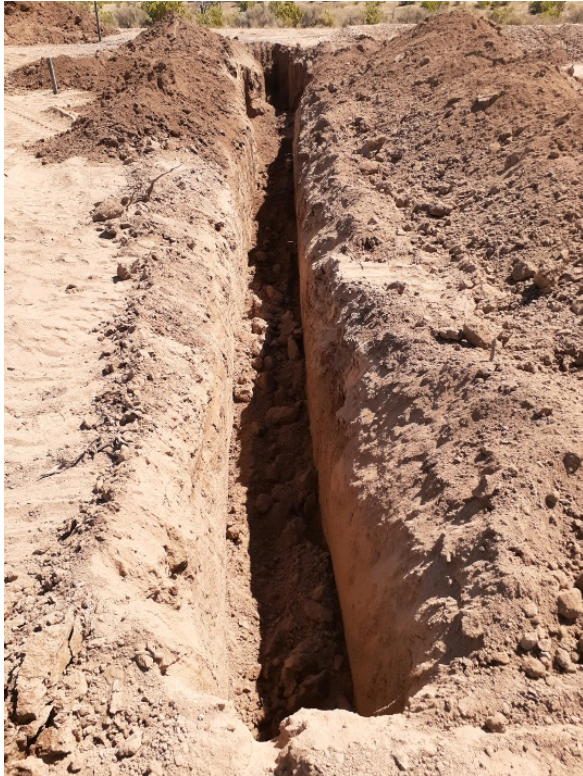
Flowline removed from excavation

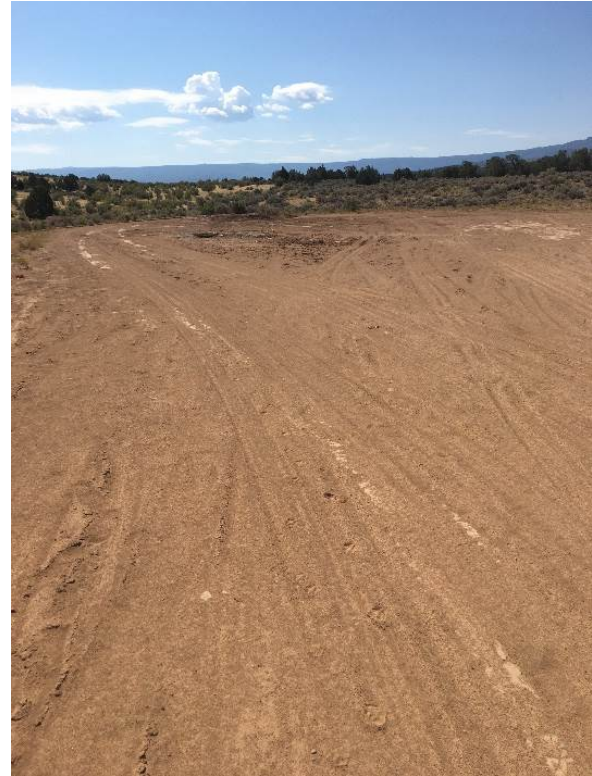
**Location picture after flowline removal,
No risers present**
