Inspection Photos
Operator Name: TEP Rocky Mountain LLC
Location: 314289

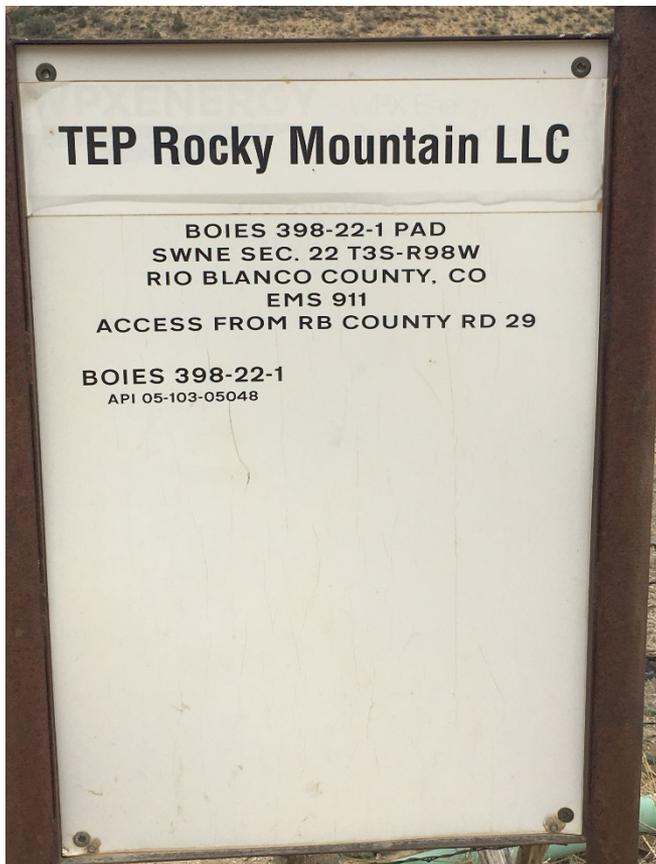
Entrance sign

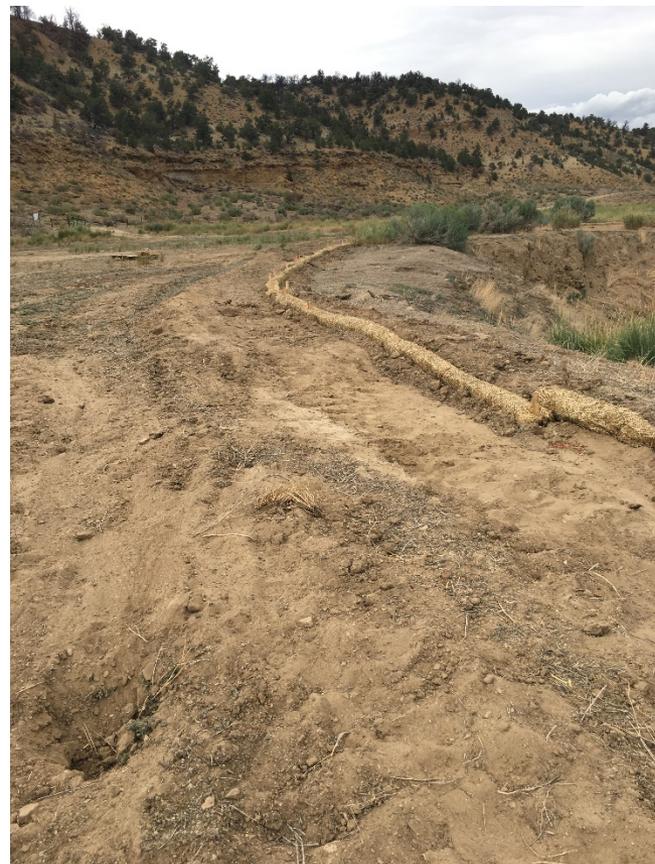
Stormwater BMP's installed

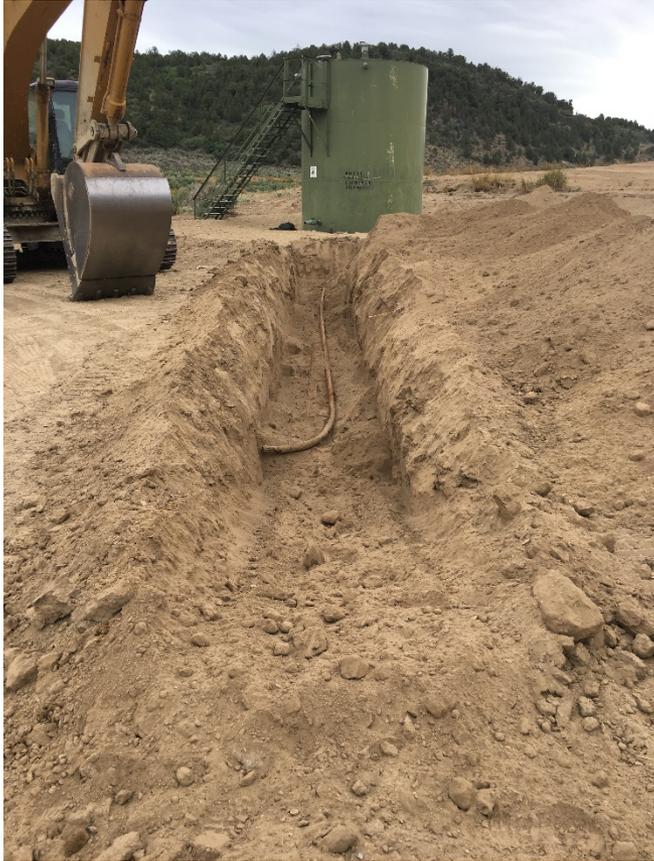
2" flowline in excavation ditch

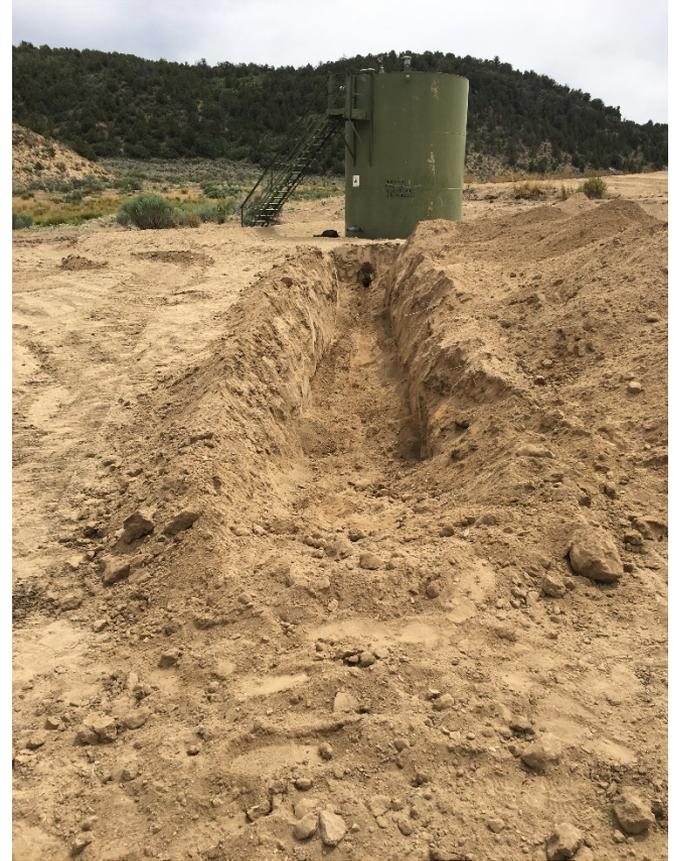
Flowline removed from excavation ditch

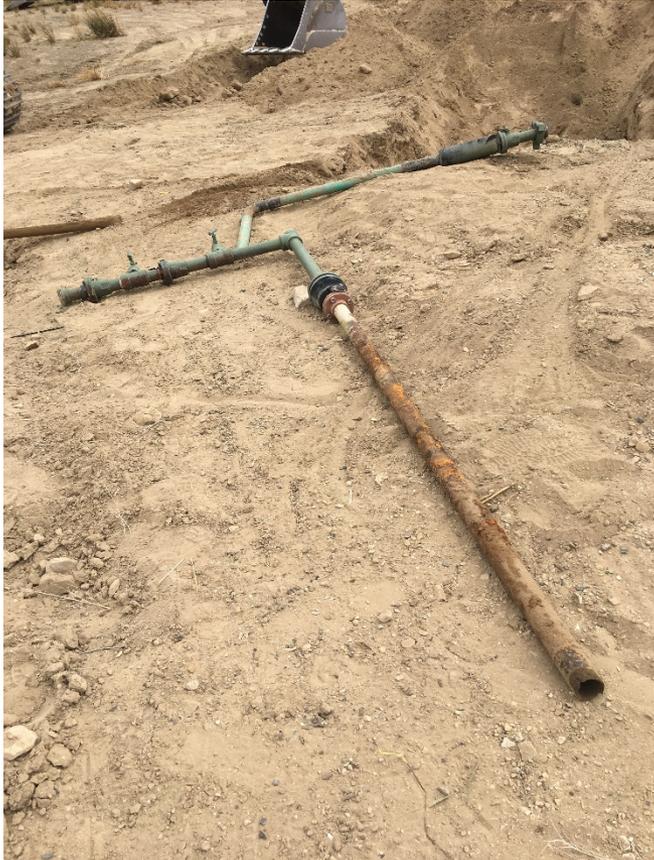
2" removed risers

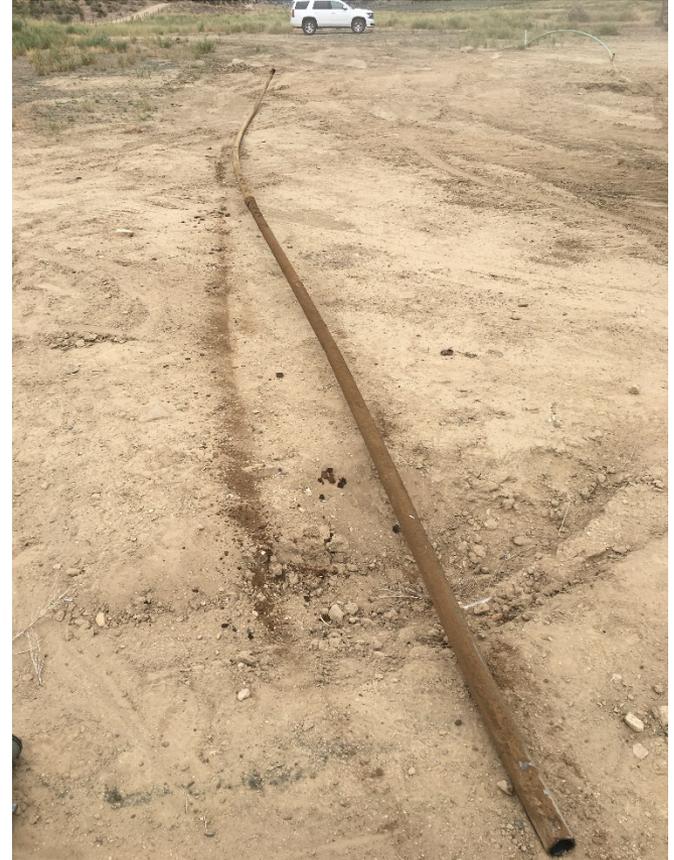
Flowlines removed from excavation

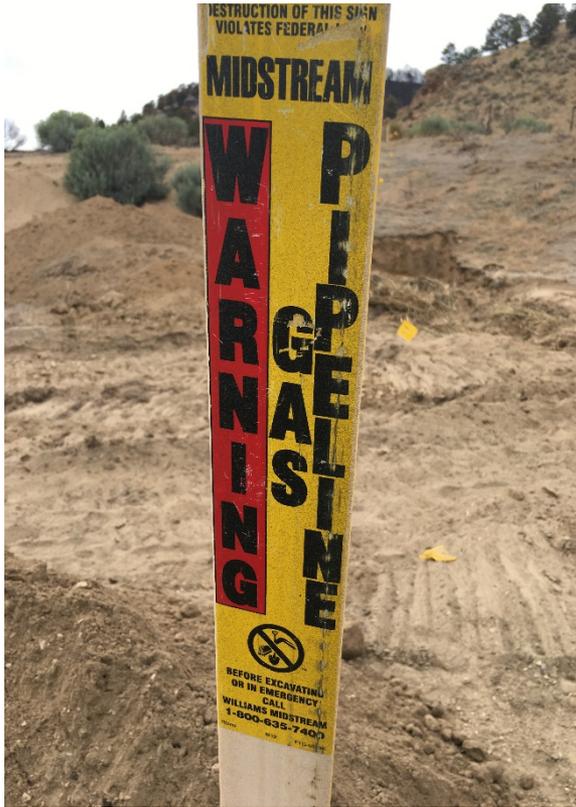
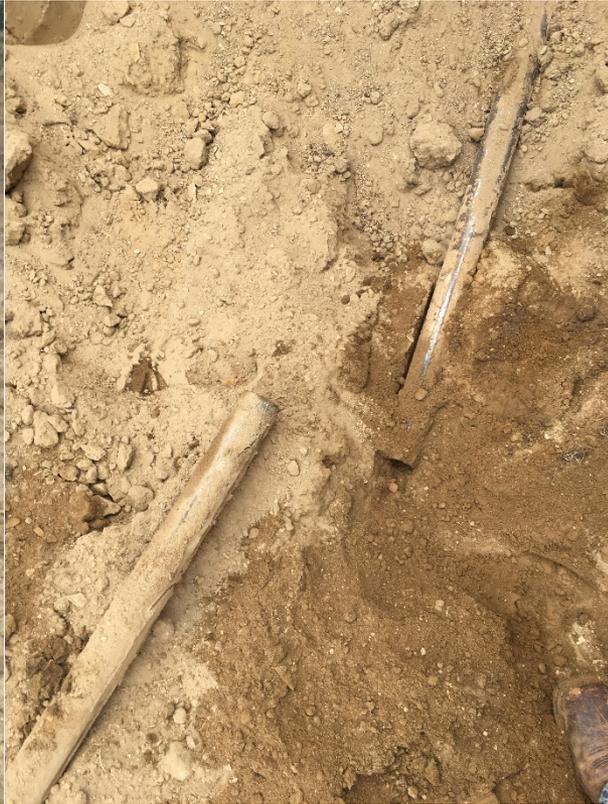
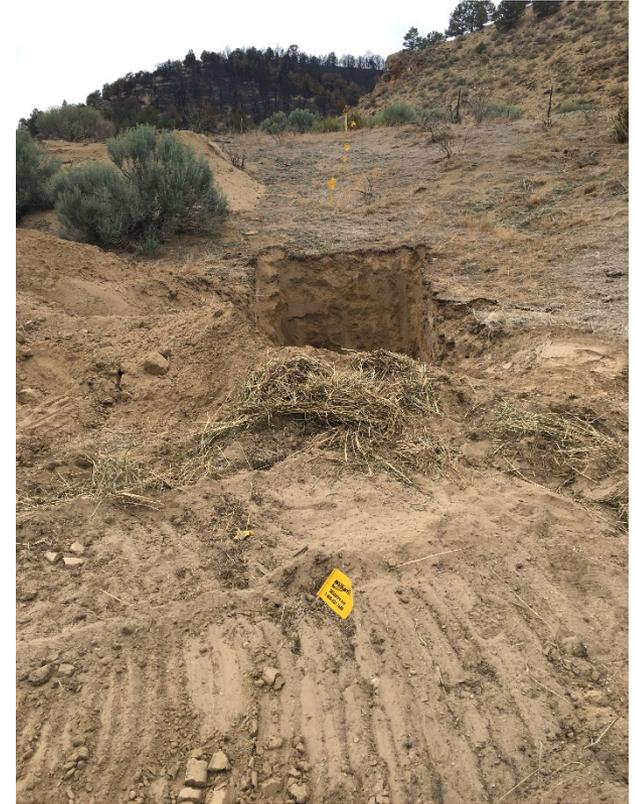
2" flowline cut on edge of location, Flowline is Williams midstream, Flowline will need to capped or plugged
