Issue Report

70 Ranch 10 West 454560

Report created on July 21, 2020

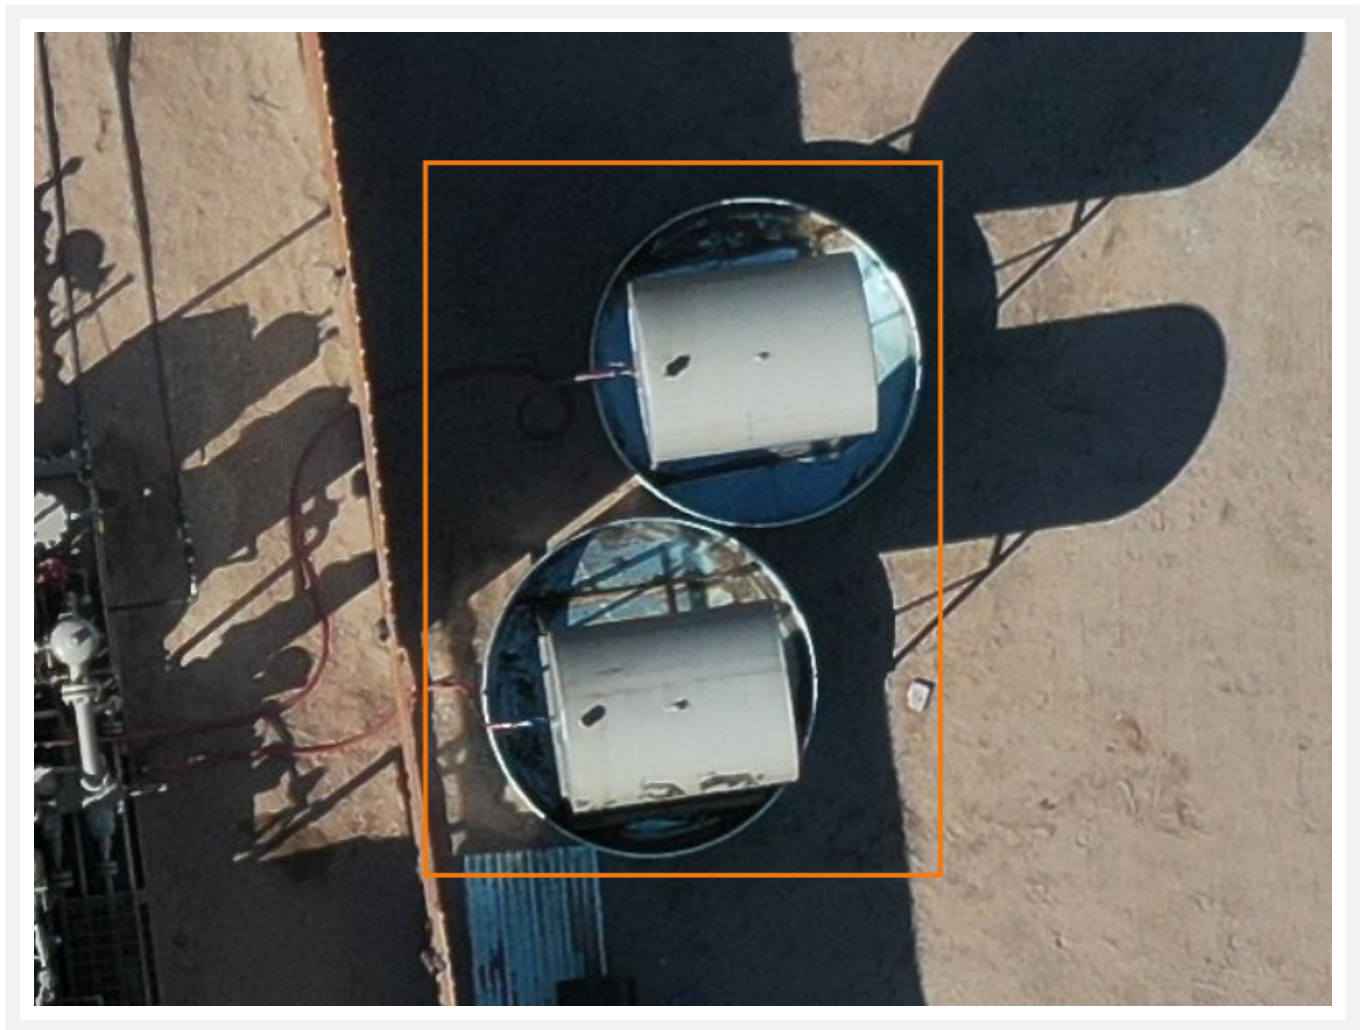
No. 1 OPEN***Captured:*** Jul 16, 2020 at 8:57am

Inadequate wildlife protection (netting) of secondary containments.

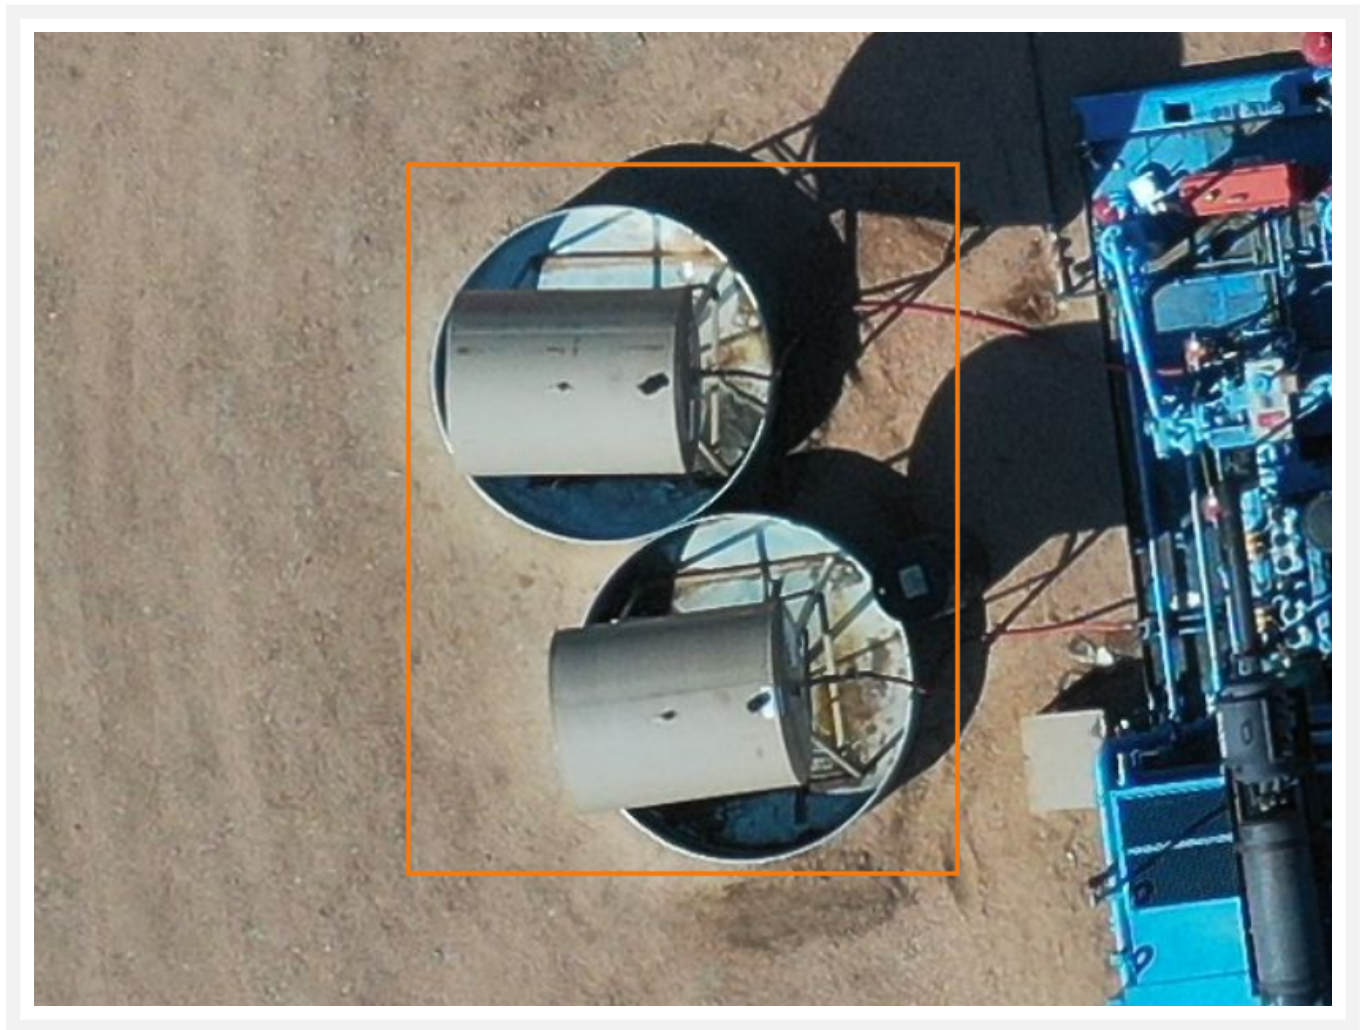
No. 2 OPEN***Captured:*** Jul 16, 2020 at 8:57am

Inadequate wildlife protections (netting) of secondary containments.

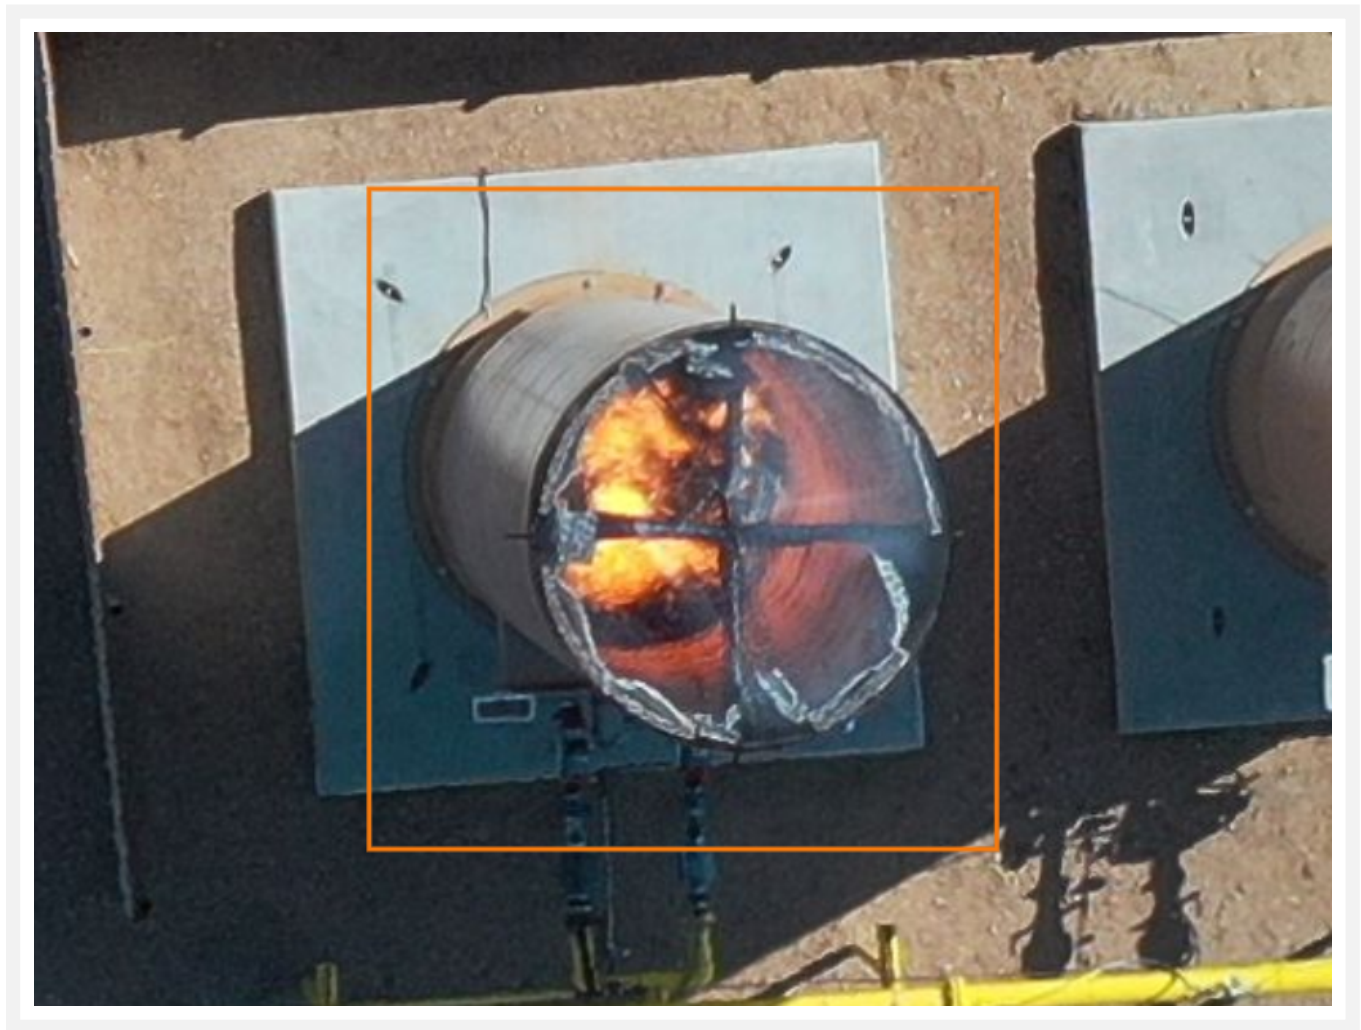
No. 3 OPEN***Captured:*** Jul 16, 2020 at 8:57am

Inadequate wildlife protection (bird protector) is broken or missing on top of ECD

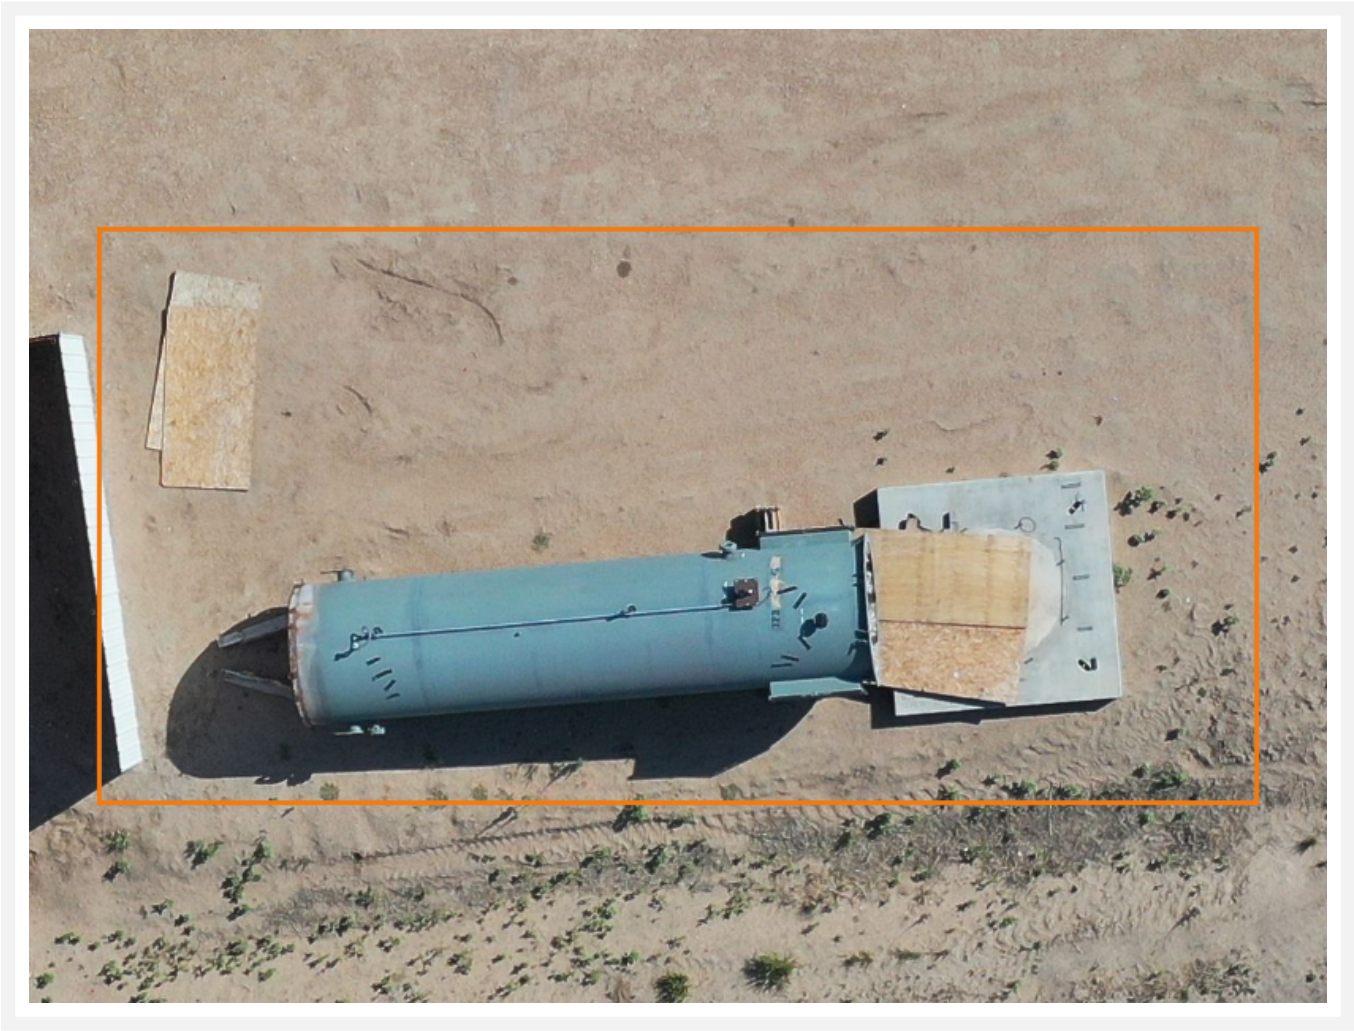
No. 4 OPEN

Unused equipment

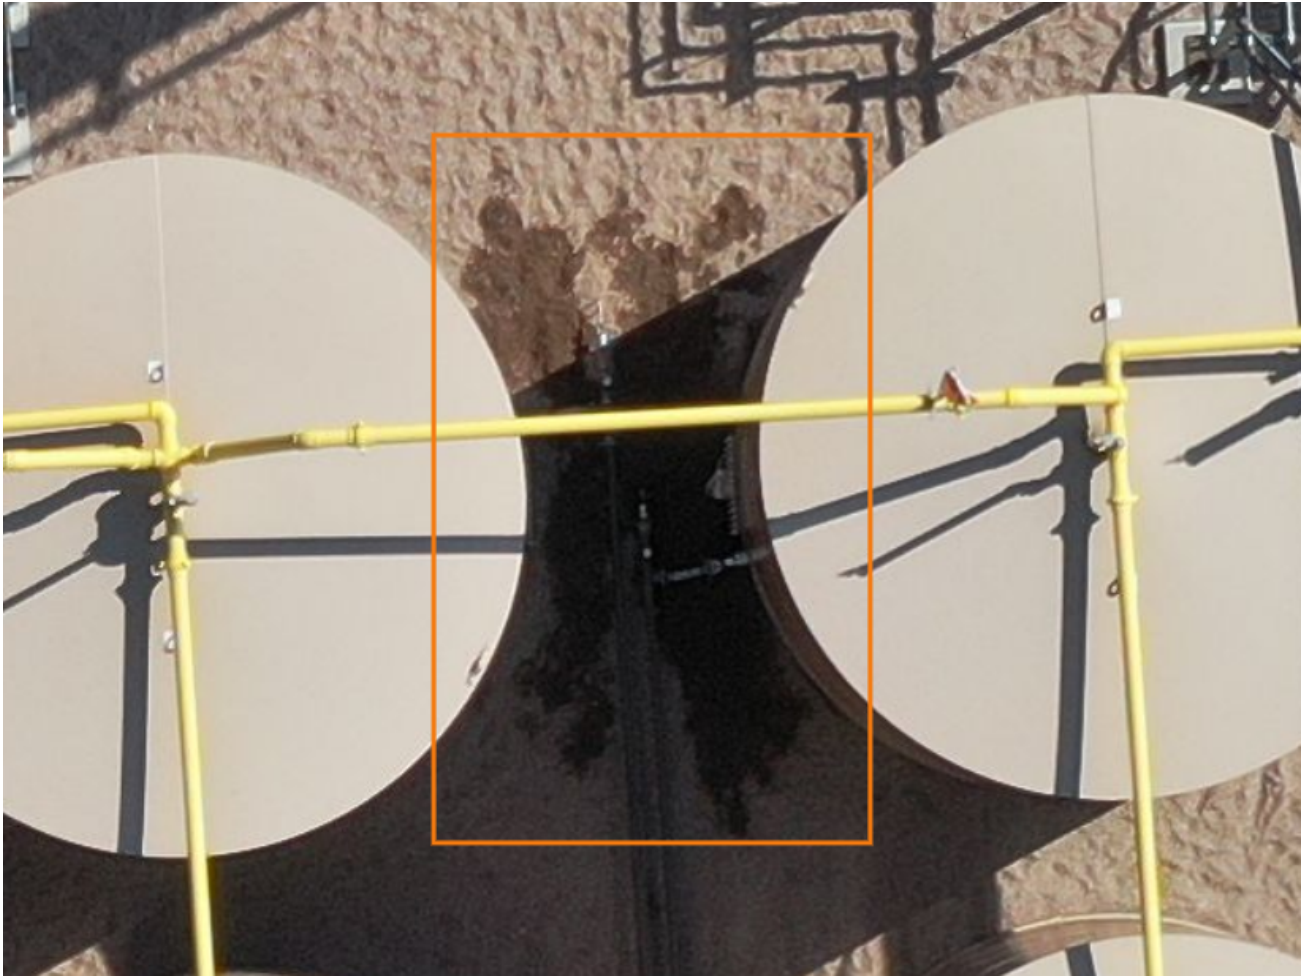
No. 5 OPEN***Captured:*** Jul 16, 2020 at 8:57am

Stained Soil

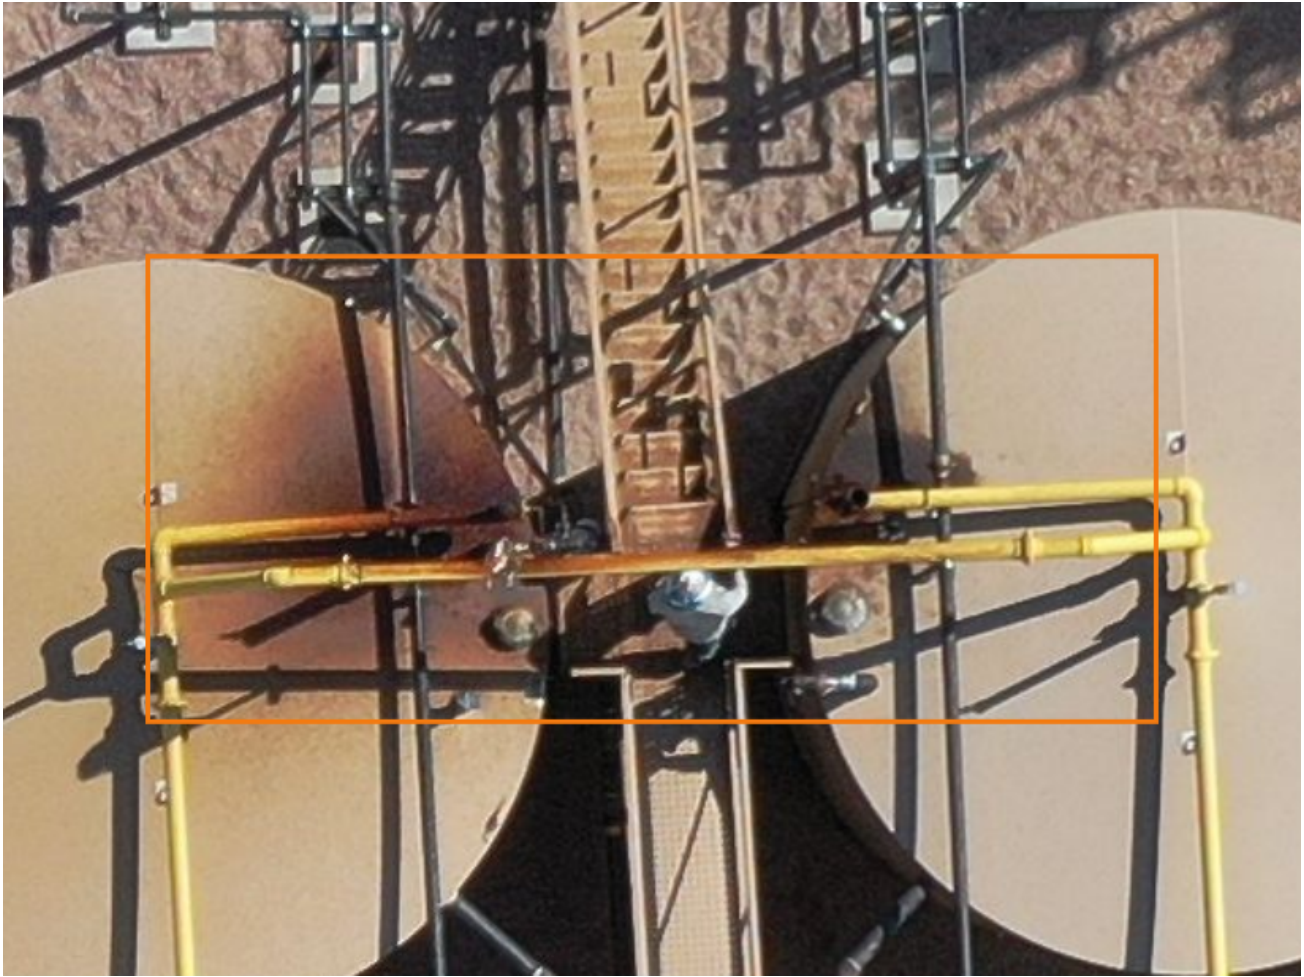
No. 6 OPEN***Captured:*** Jul 16, 2020 at 8:57am

Oily waste on top of production tanks

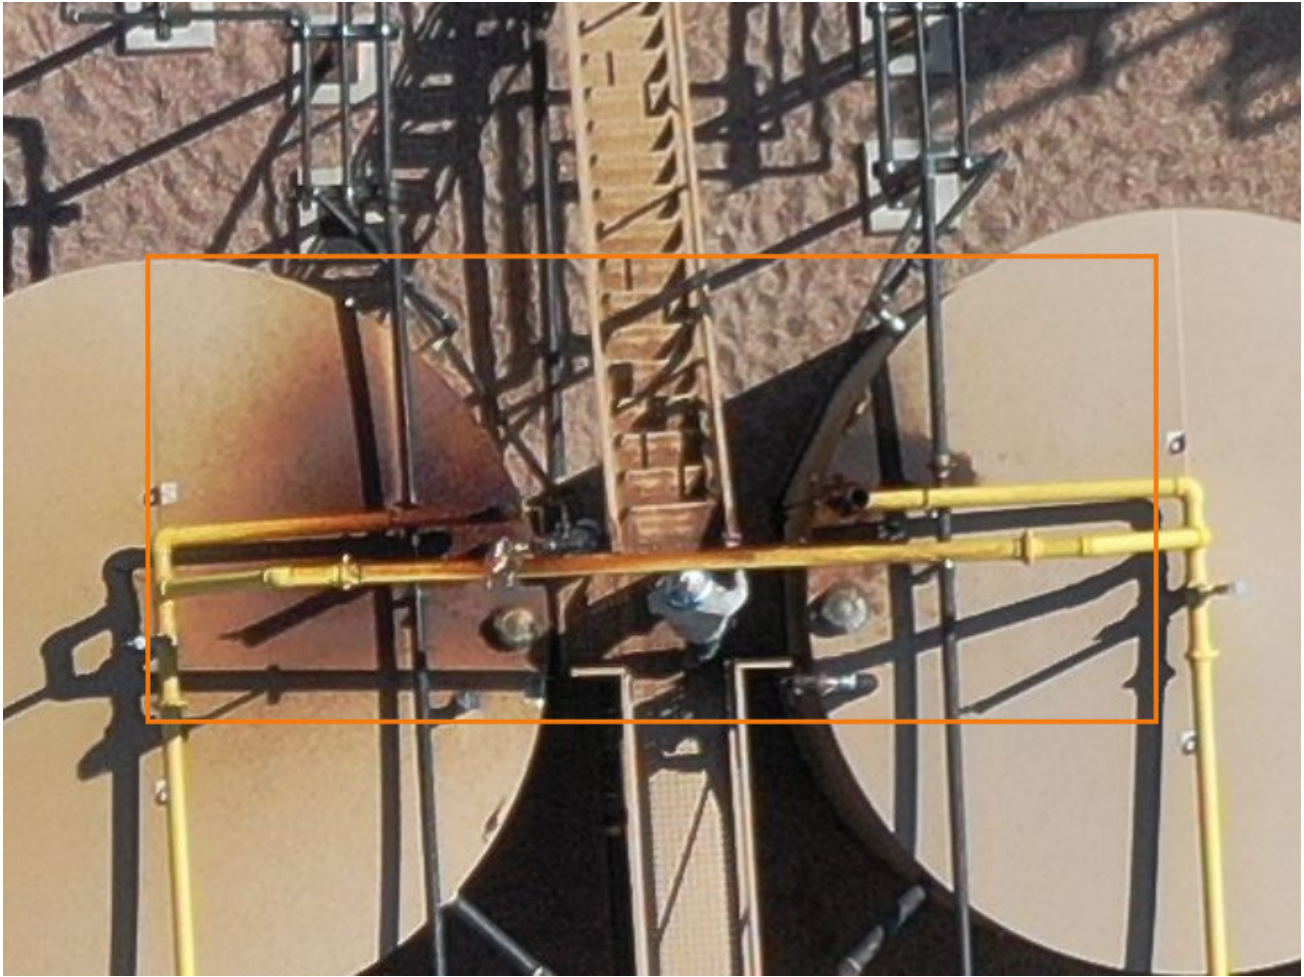
No. 7 OPEN***Captured:*** Jul 16, 2020 at 8:57am

Oily waste on top of production tanks

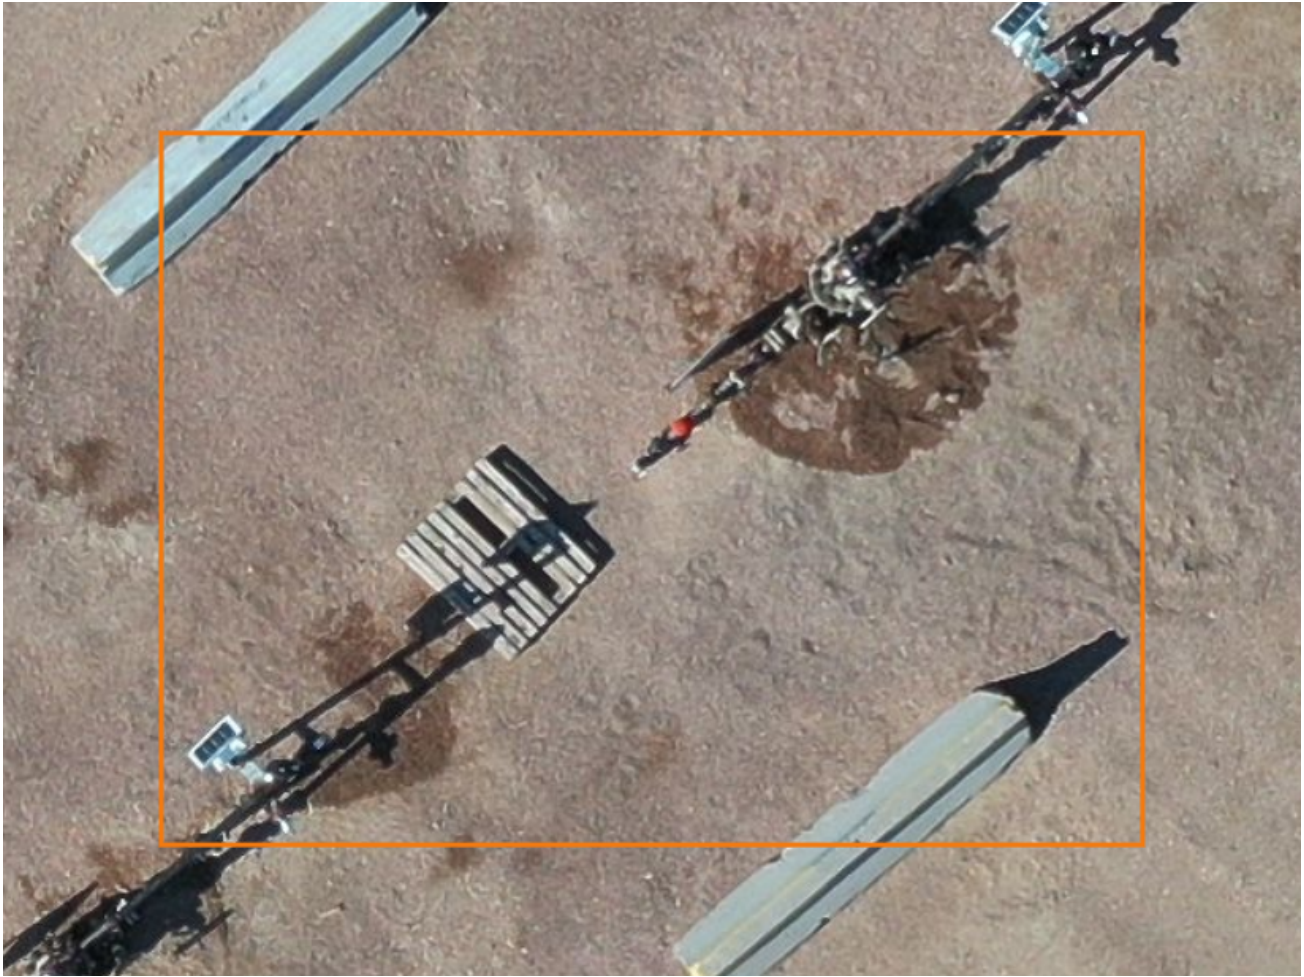
No. 8 OPEN***Captured:*** Jul 16, 2020 at 8:57am

Stained soil around wellheads

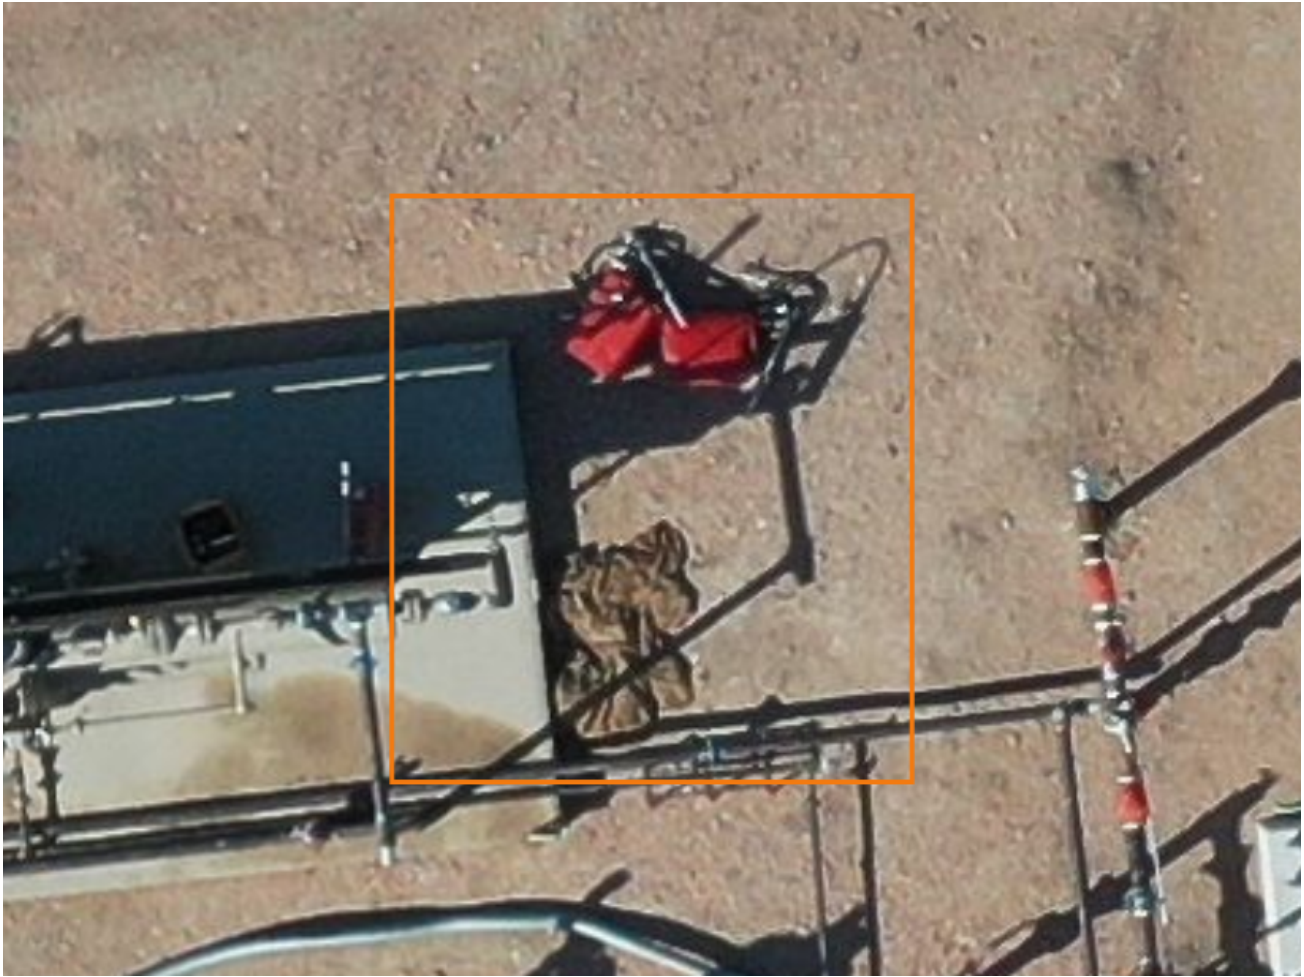
No. 9 OPEN***Captured:*** Jul 16, 2020 at 8:57am

Unused equipment/trash

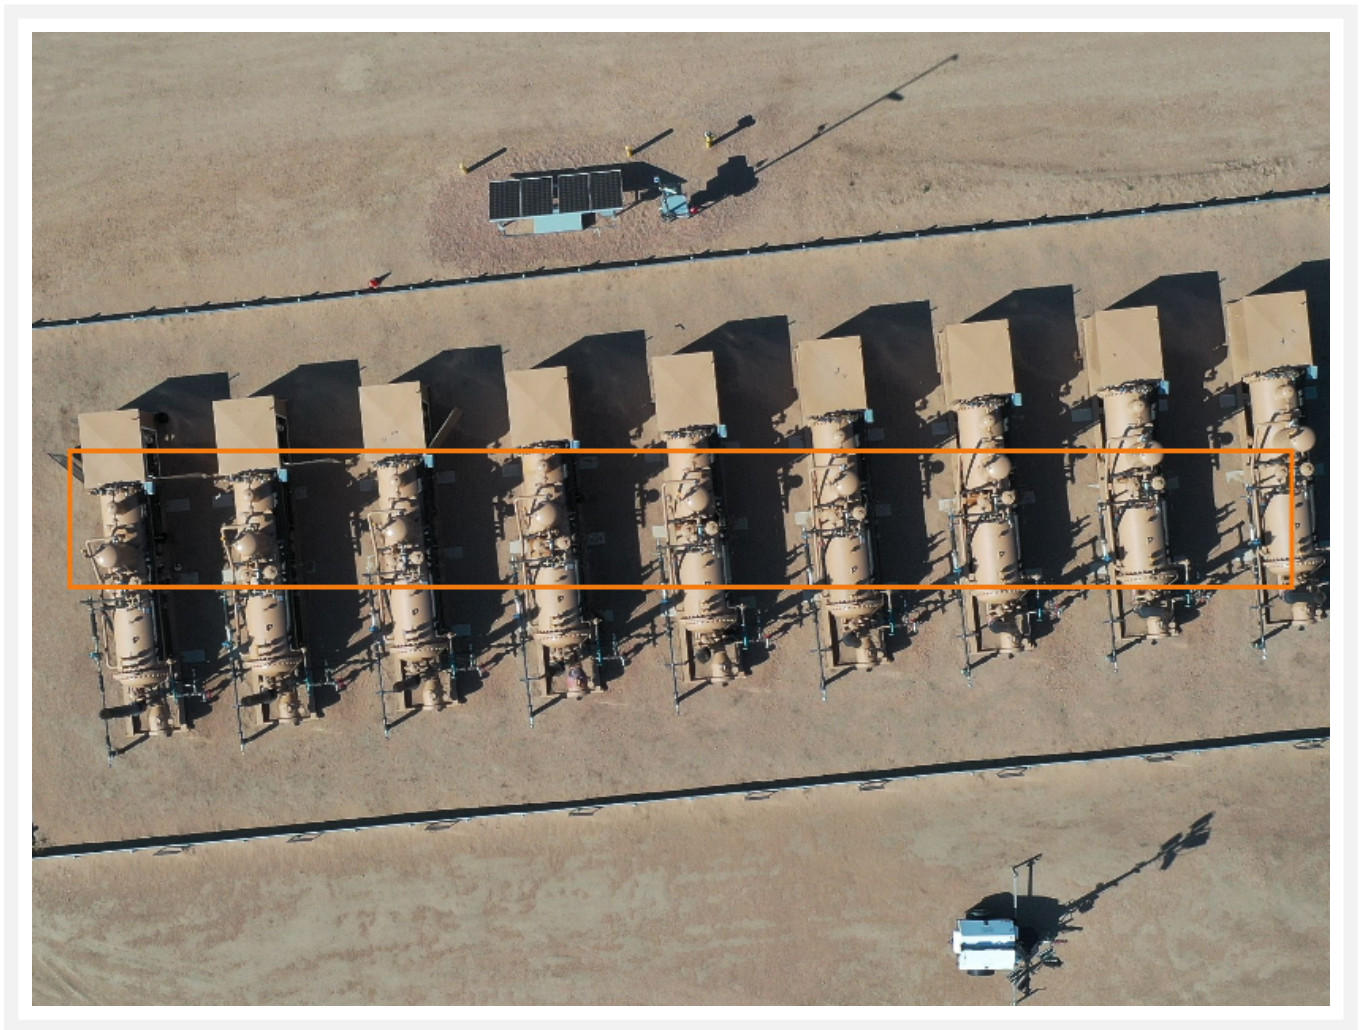
No. 10 OPEN***Captured: Jul 16, 2020 at 8:57am***

Appears to be leaking hammer unions at hi/low valves on various separators.
