## Inspection Photos

Location Name: MARALEX RESOURCES INC SOUTH SHALE RIDGE-68S98W/23SWNW

Location ID: 312610

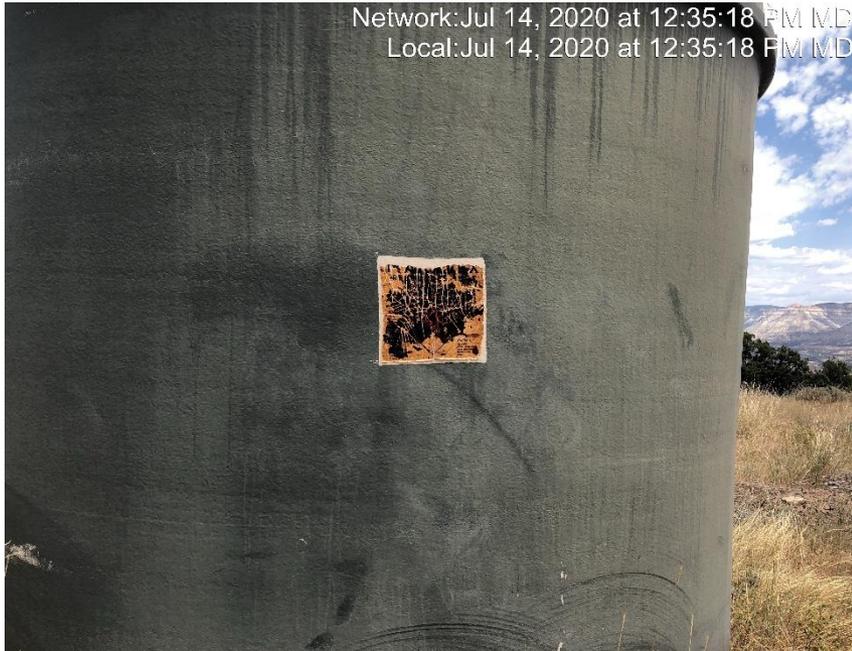
**Photo #1516 from Tank NFPA label weathered and not legible.**

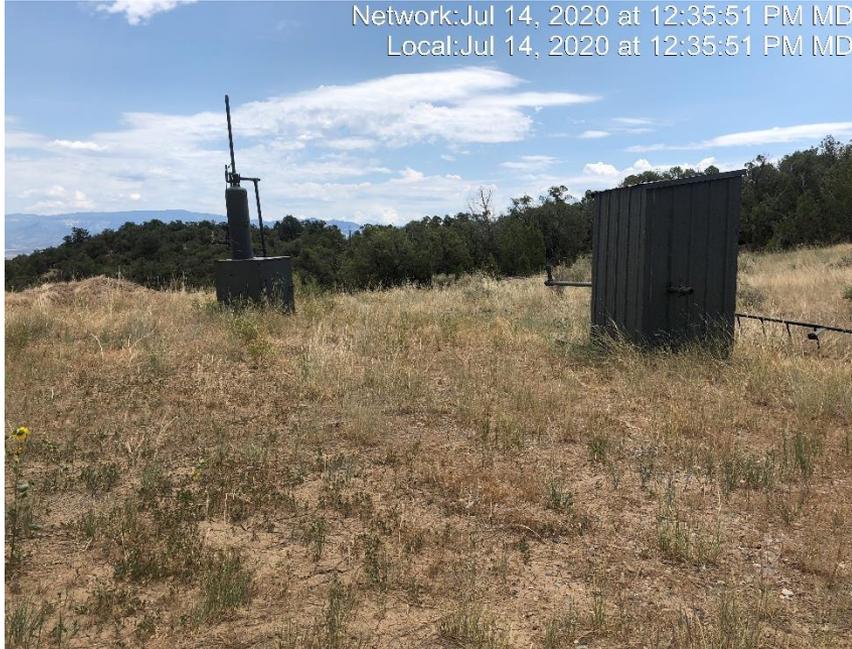
**Photo #1517 Multiple places with unused equipment on location.**

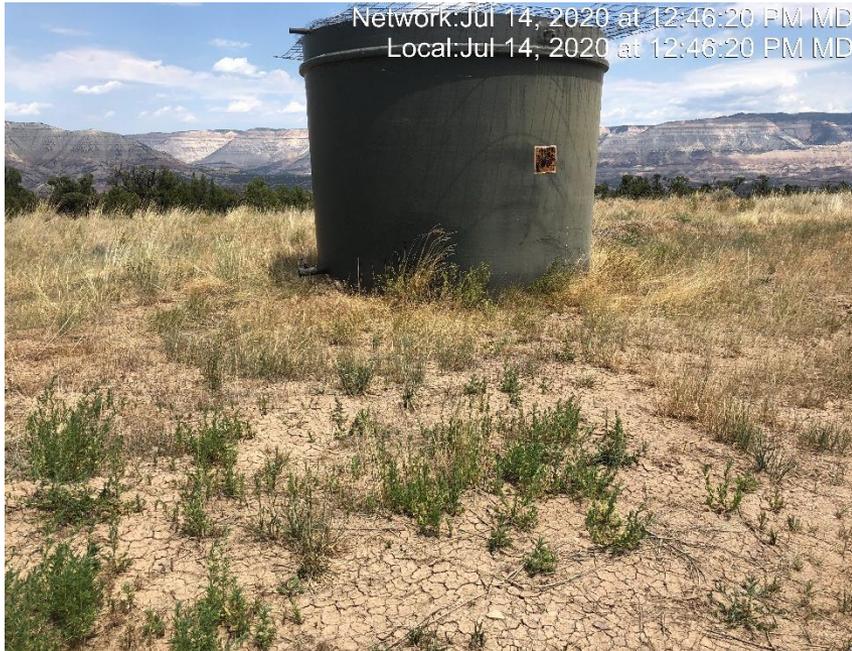
Photo #1520 Debris on location.

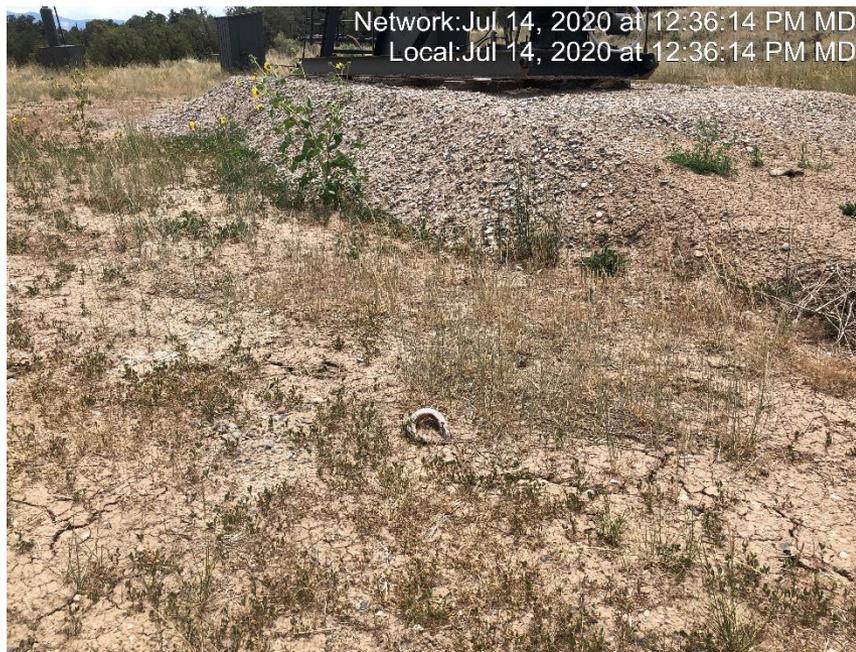
**Photo #1518 Unmarked deadman.**
