Inspection Photos

7/14/2020

Operator: CAERUS PICEANCE LLC - 10456

Location ID: 425805

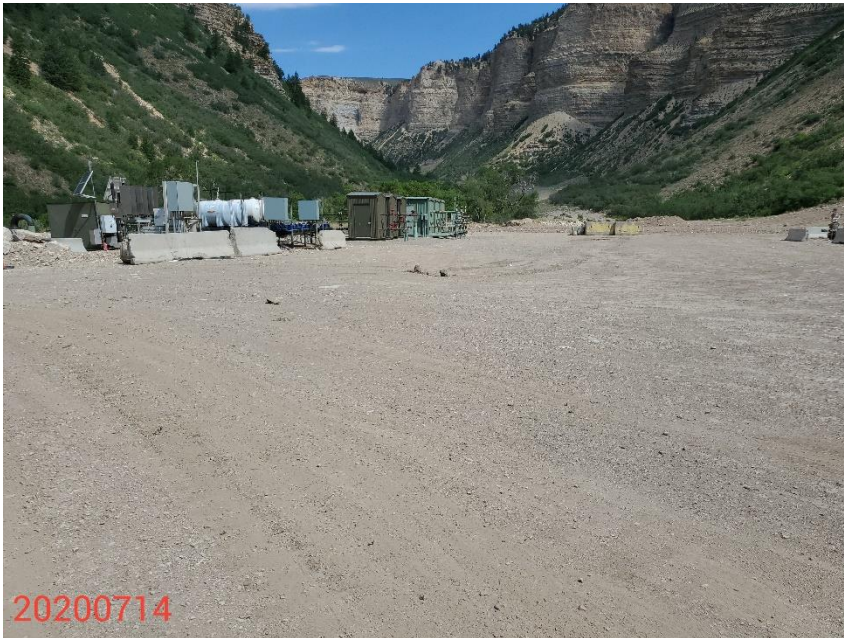
Photo 1: Photo taken from the west end of the Location, facing north. Photos 1-4 provide an overview of the Location from north, northeast, southeast to south. Photo shows interim reclamation activities of the Location are in process.

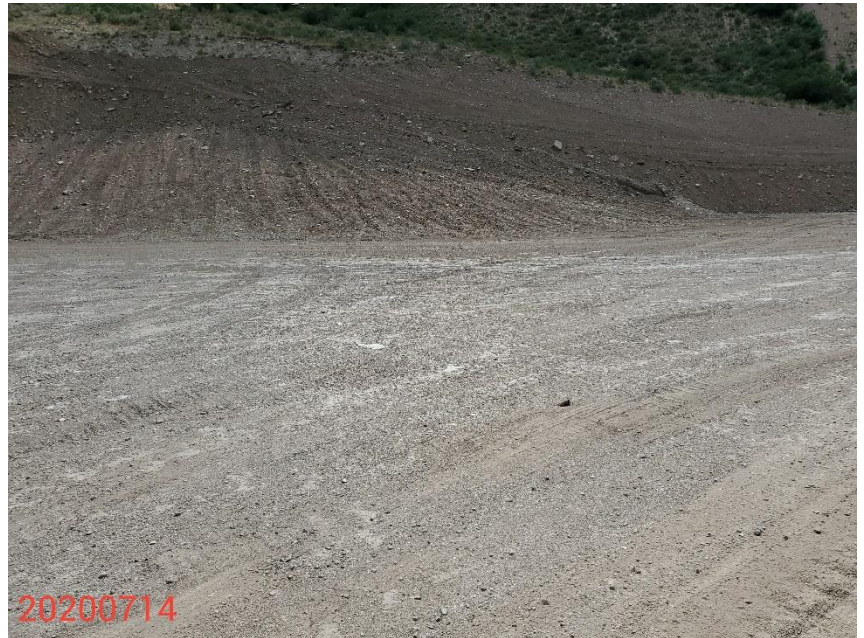
Photo 2: See comments under photo 1.

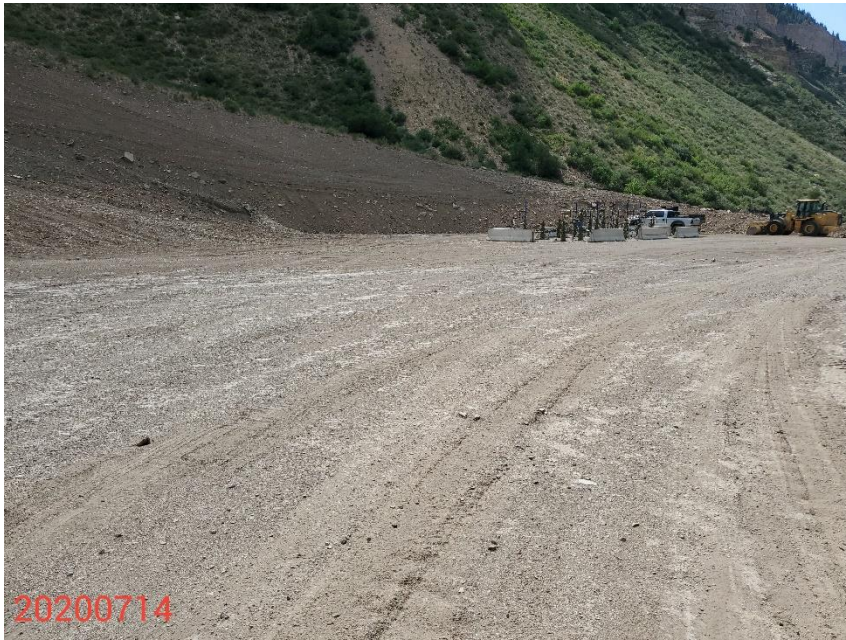
Photo 3: See comments under photo 1.

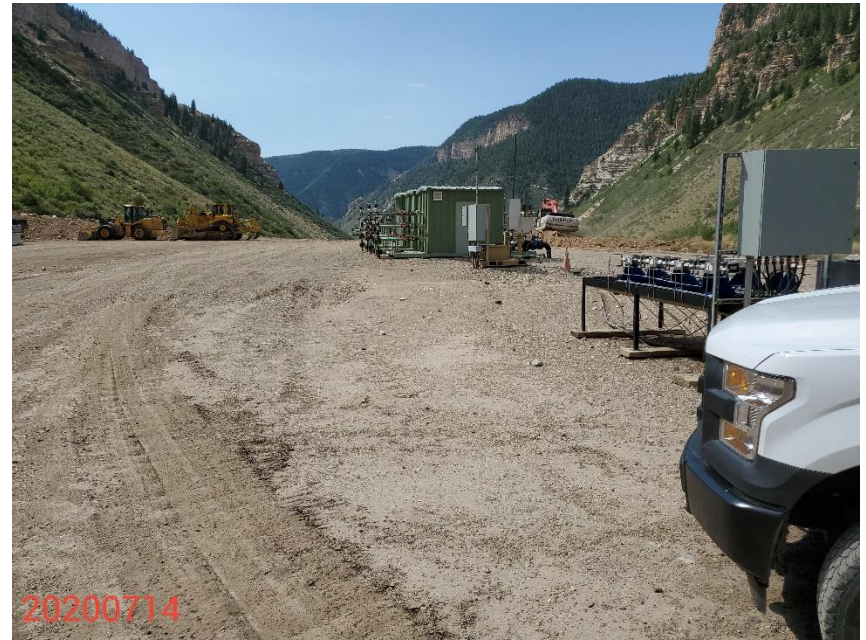
Photo 4: See comments under photo 1.

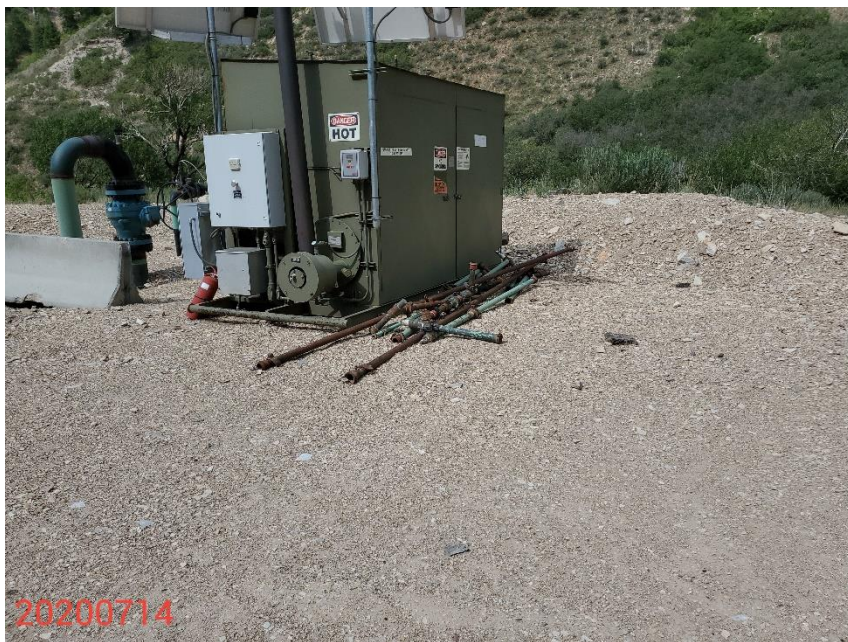
Photo 5: Photo taken from the northwest end of the Location, facing west. Photo shows unused pipe equipment stored on the Location.

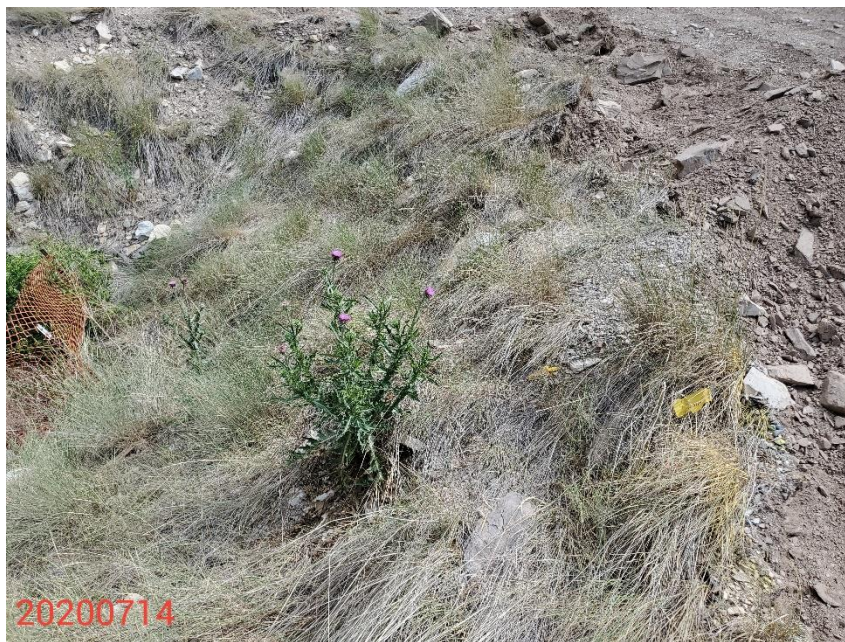
Photo 6: Photo taken from the northwest end of the Location. Photo shows Musk thistle plant. This is a Colorado State listed noxious weed.

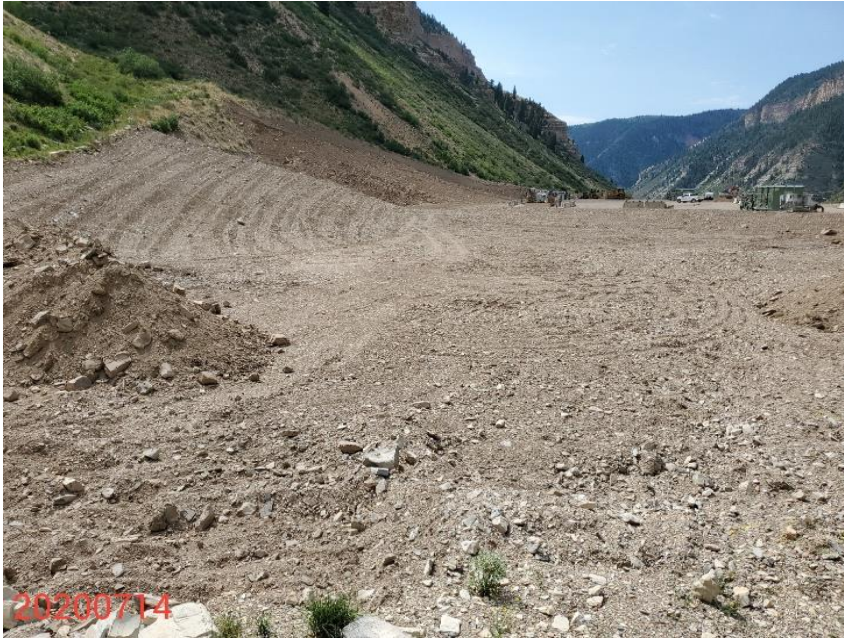
Photo 7: Photo taken from the north end of the Location facing south. Photo shows interim reclamation of the Location is in process.

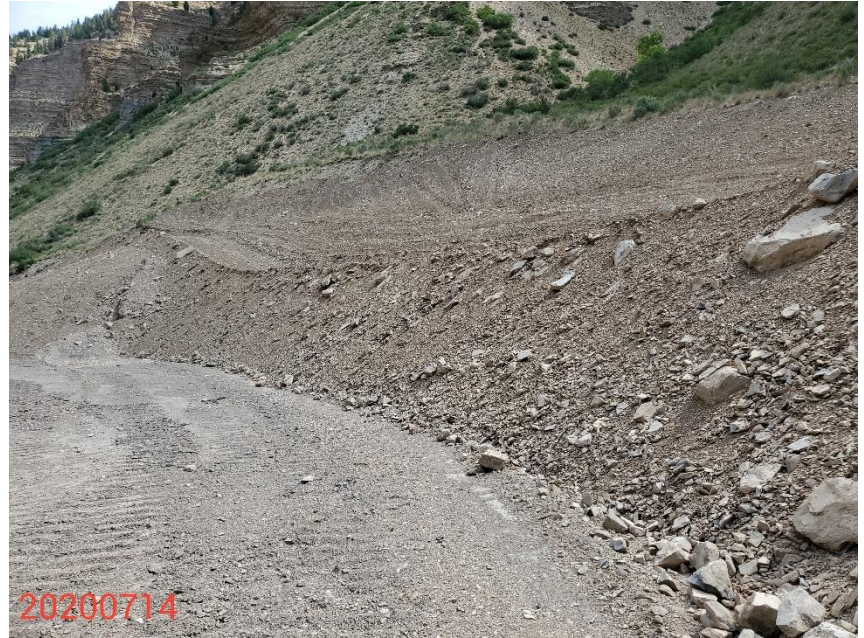
Photo 8: Photo taken from the south end of the Location facing north. Photo shows interim reclamation of the Location is in process.

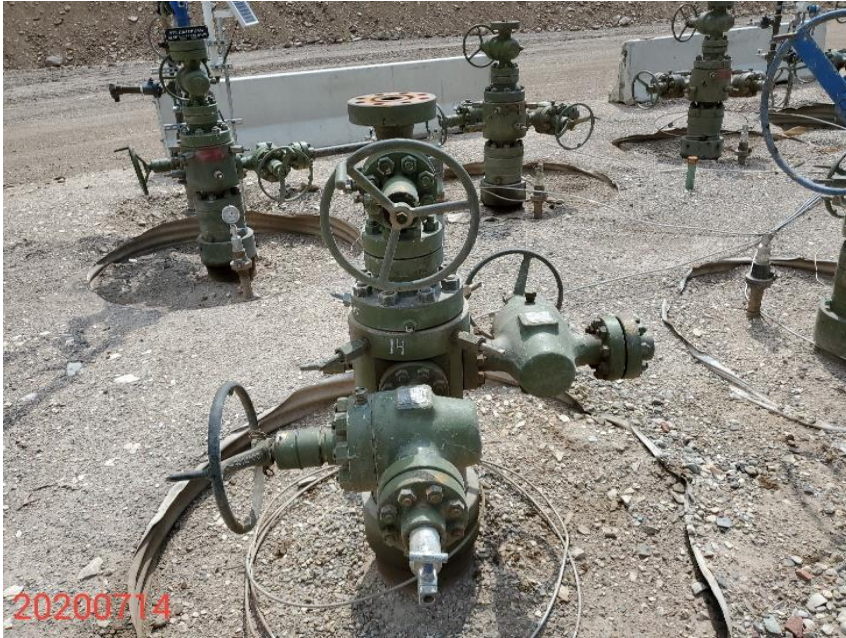
Photo 9: Photo is example of several wells on the Location missing signage.

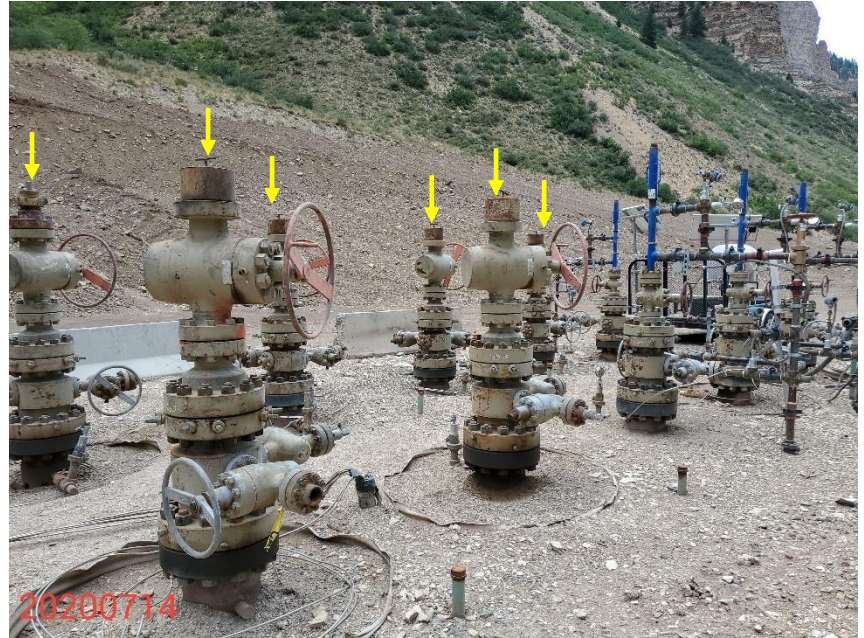
Photo 10: Photo is example of several wells on the Location observed with missing signage.

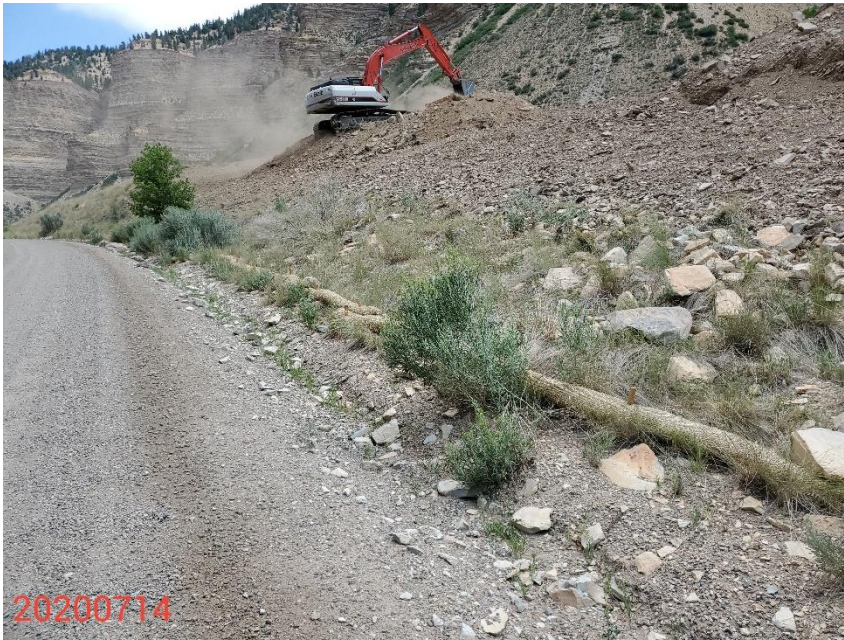
Photo 11: Photo taken from the access road, west of the Location facing north. Photo shows Operator implemented straw wattles along perimeter of the Location. Photo shows BMP has not been installed in accordance with good engineering practices and is not in proper functioning condition.

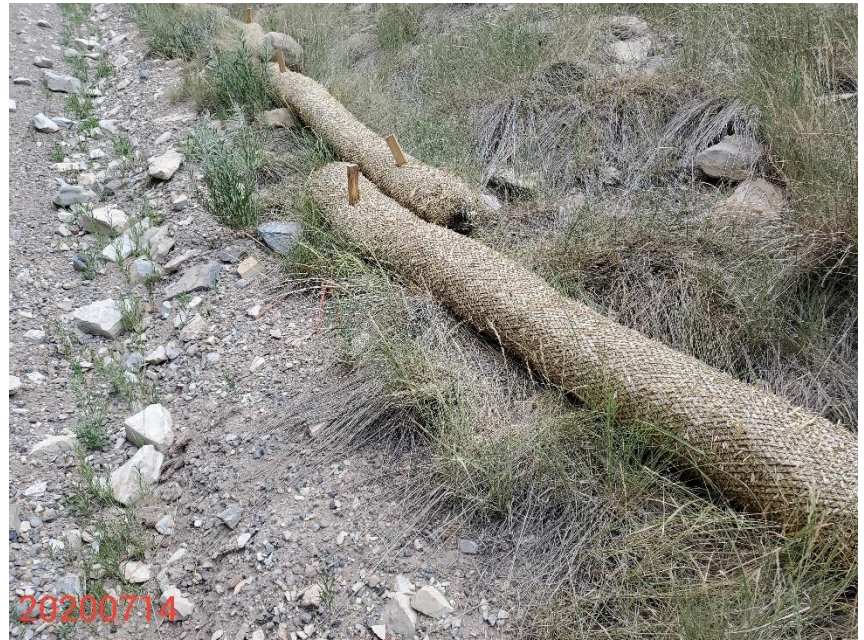
Photo 12: Photo taken from the access road, west of the Location facing north. Photo shows Operator implemented straw wattles along perimeter of the Location. Photo shows BMP has not been installed in accordance with good engineering practices and is not in proper functioning condition; Wattles require trenching and backfilling.
