Inspection Photos

API: 055-06214

Operator: PETROGLYPH OPERATING CO INC

Inspection Date: 7/22/2020

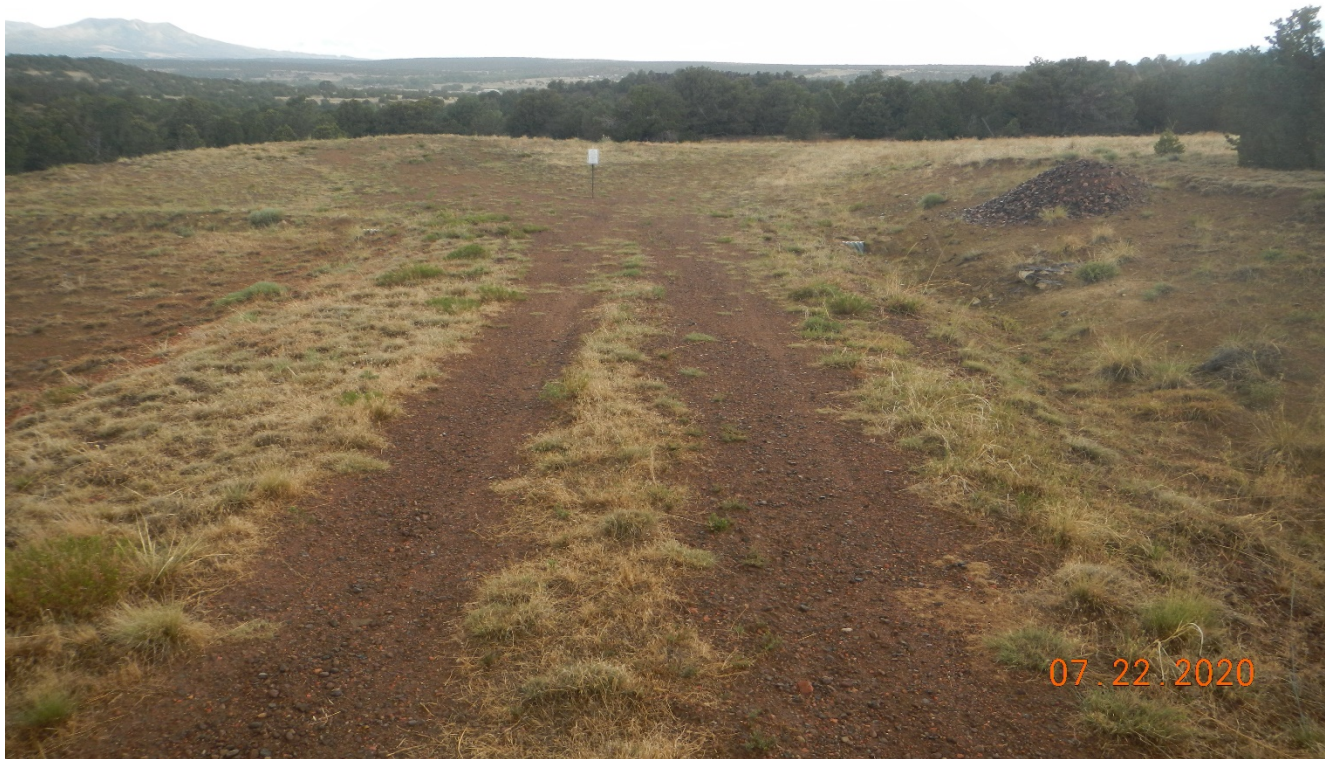
Photo 1. Facing northwest toward the location.

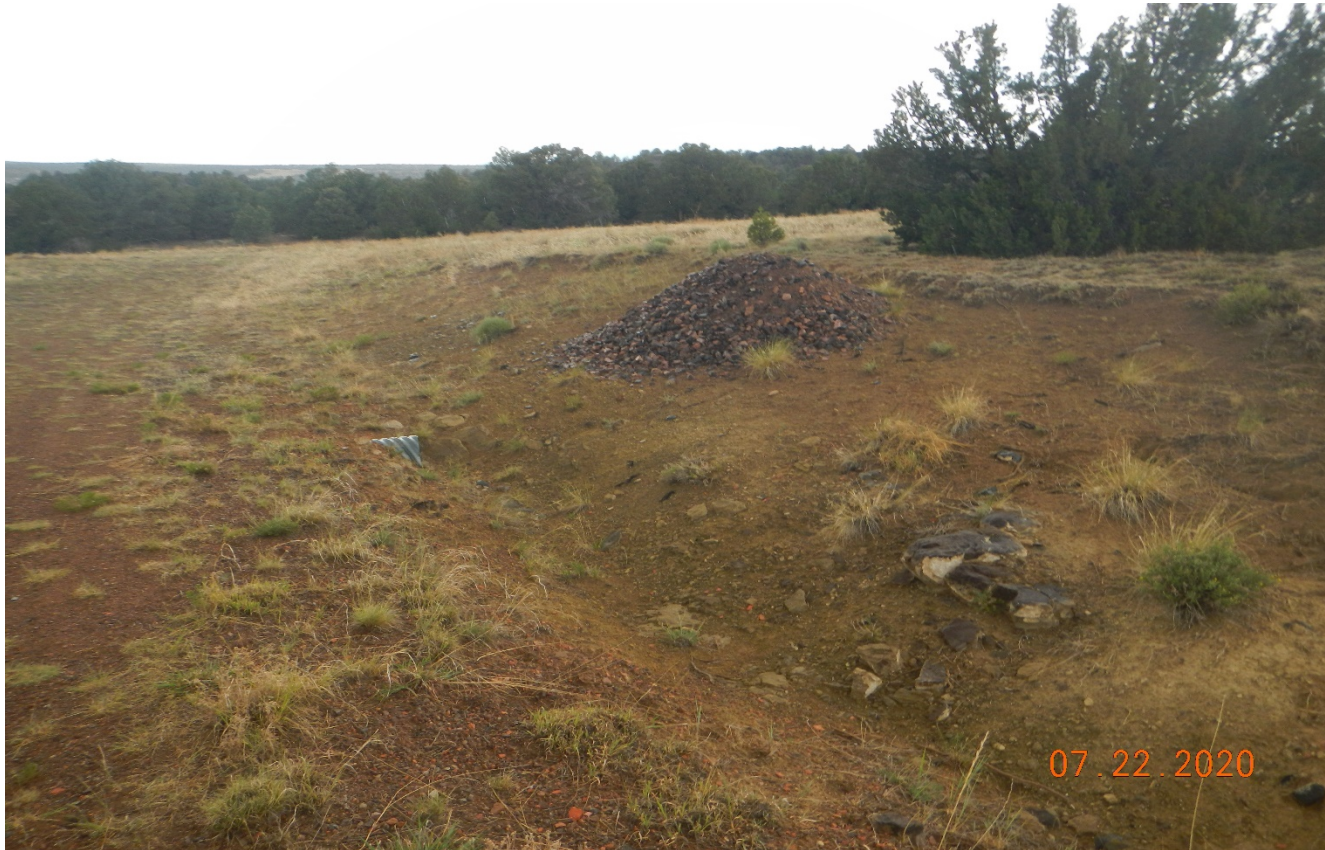
Photo 2. There is a pile of rock debris that remains along the slope.

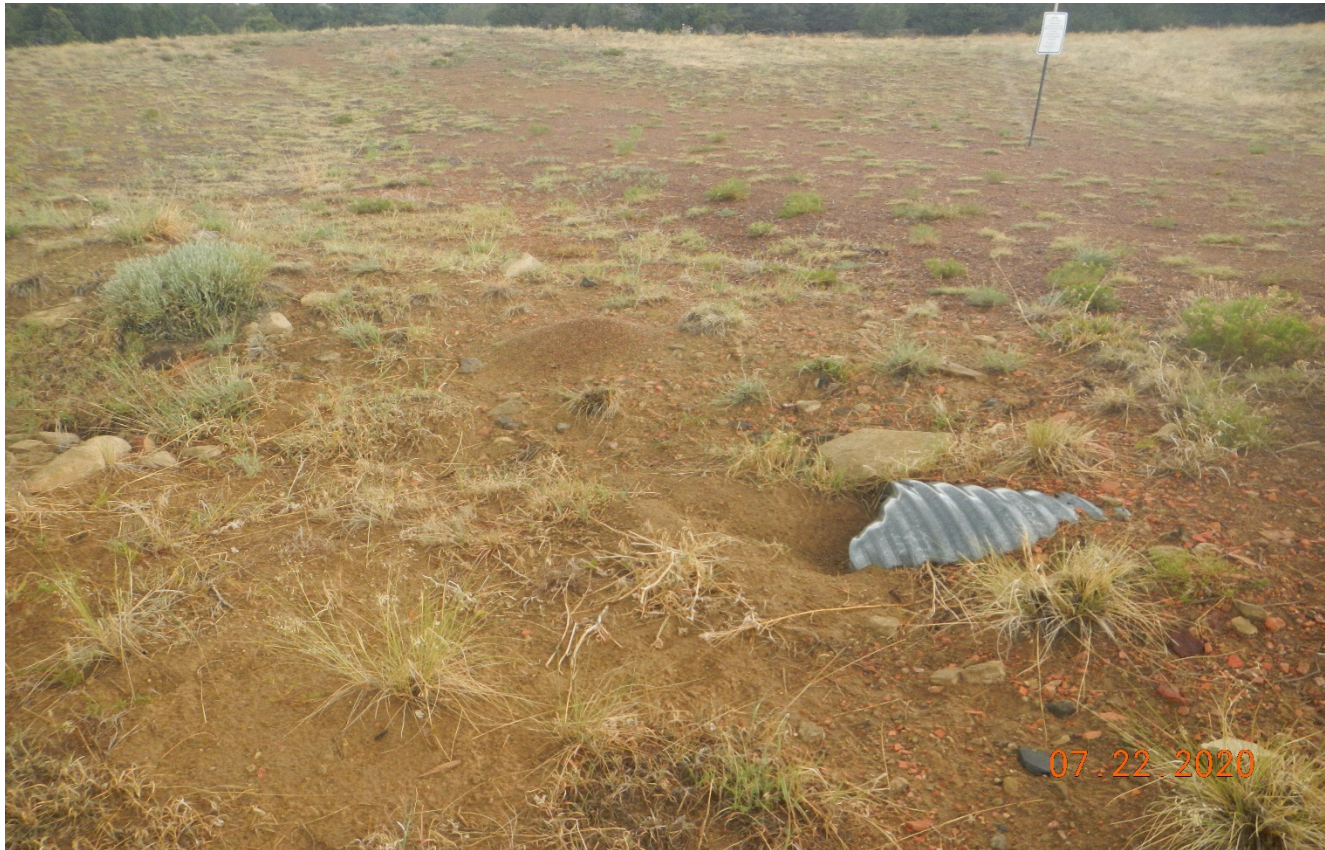
Photo 3. The outlet culvert has filled in with sediment and has not been maintained.

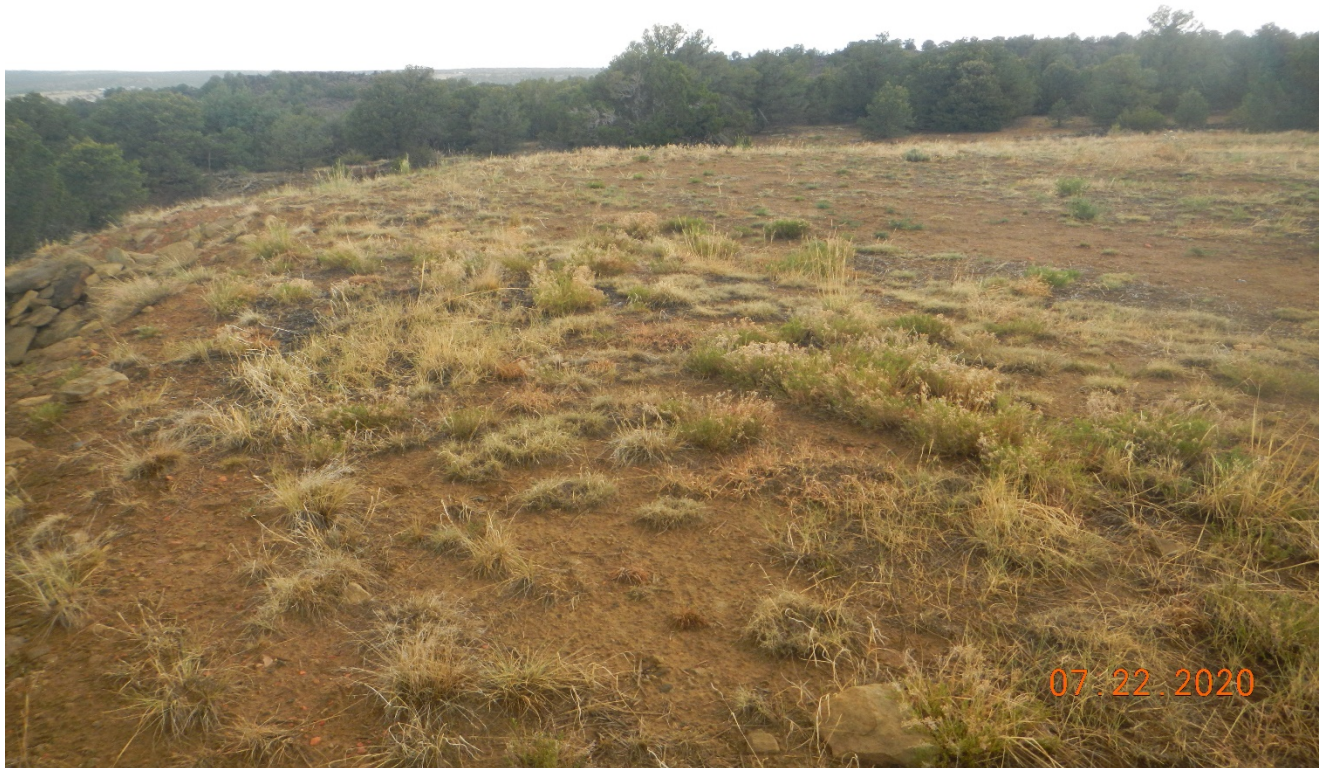
Photo 4. West side of the location facing north.

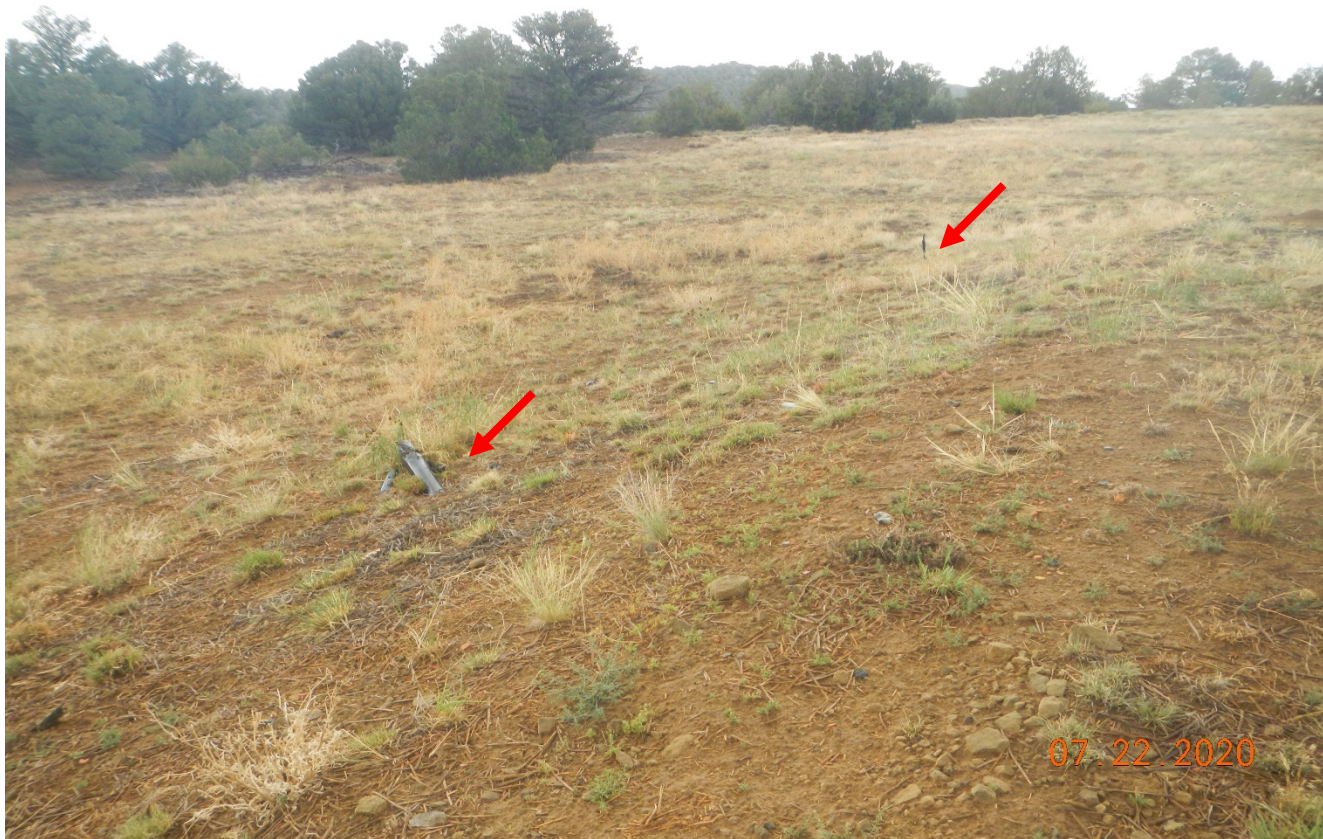
Photo 5. Facing northeast at the location. There is two plastic pipes that remain shown at red arrows.

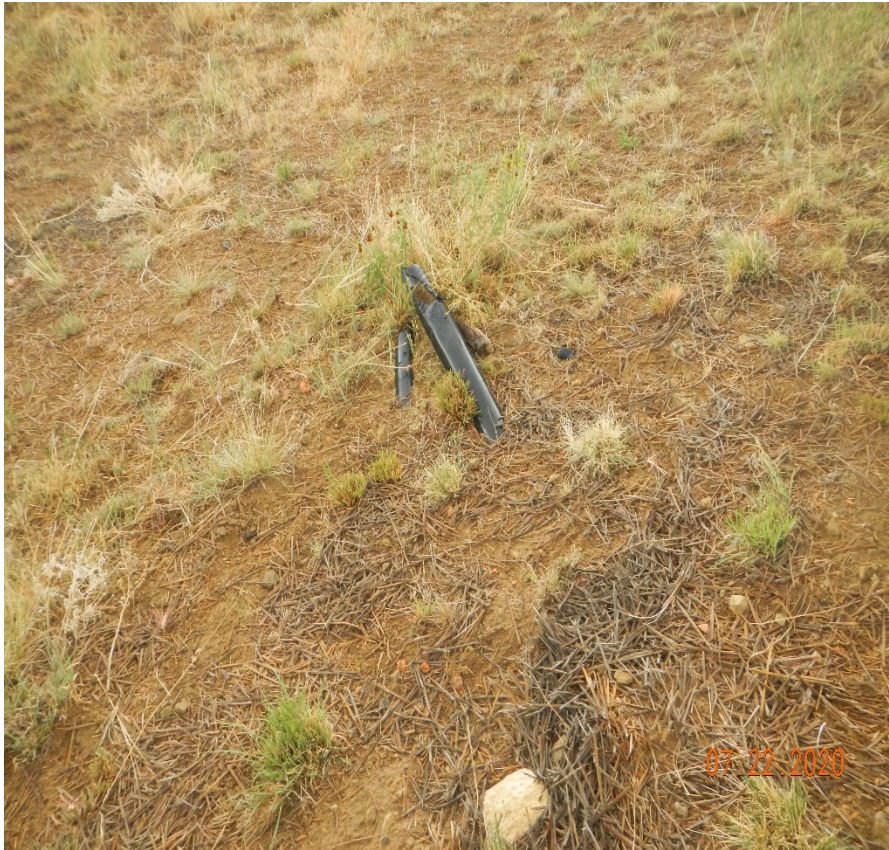
Photo 6. View of plastic pipe extending out of the ground shown in previous photo.

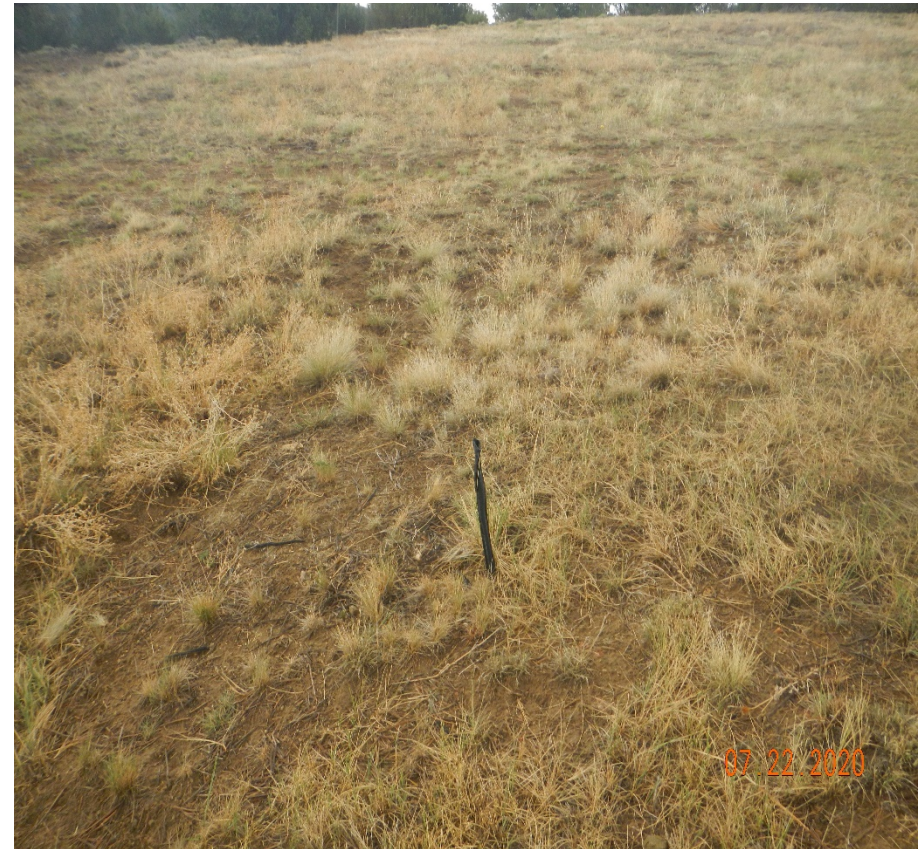
Photo 7. View of plastic pipe extending out of the ground shown in previous photo.

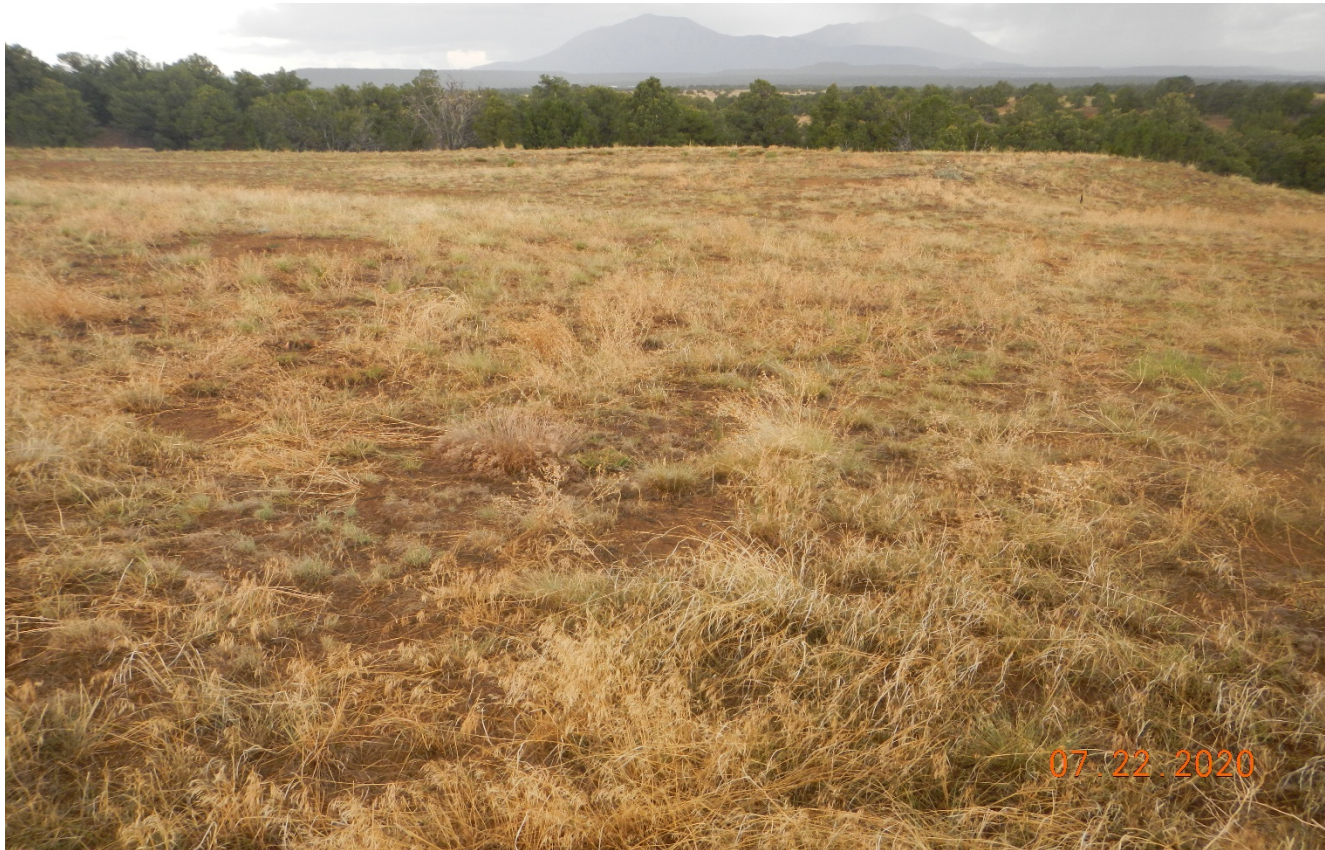
Photo 8. Facing south at the location. The vegetation is progressing throughout the location.
