Inspection Photos

API: 055-06157

Operator: PETROGLYPH OPERATING

Inspection Date: 7/27/2020

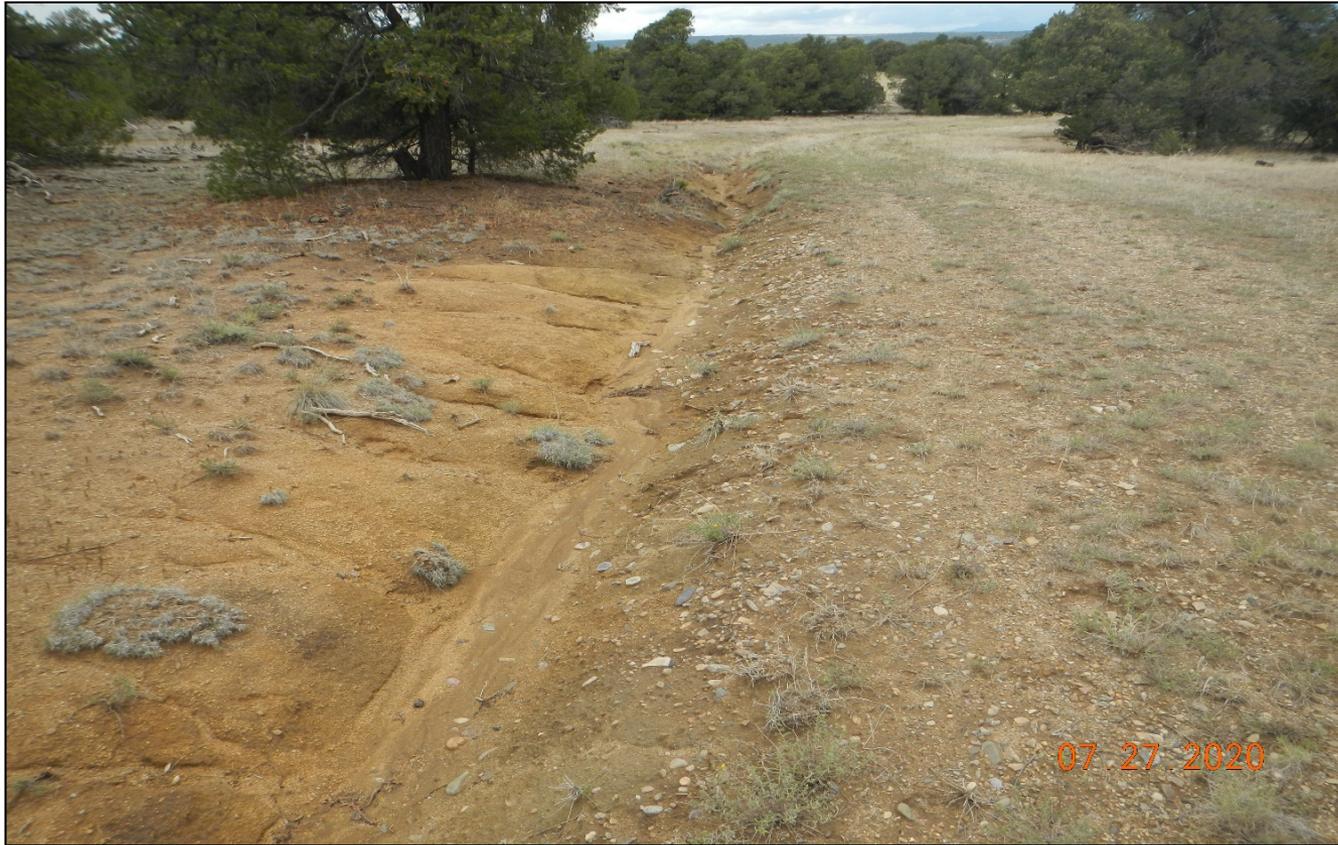
Photo 1. Facing northwest along the former access road. This area of erosion has not been repaired.

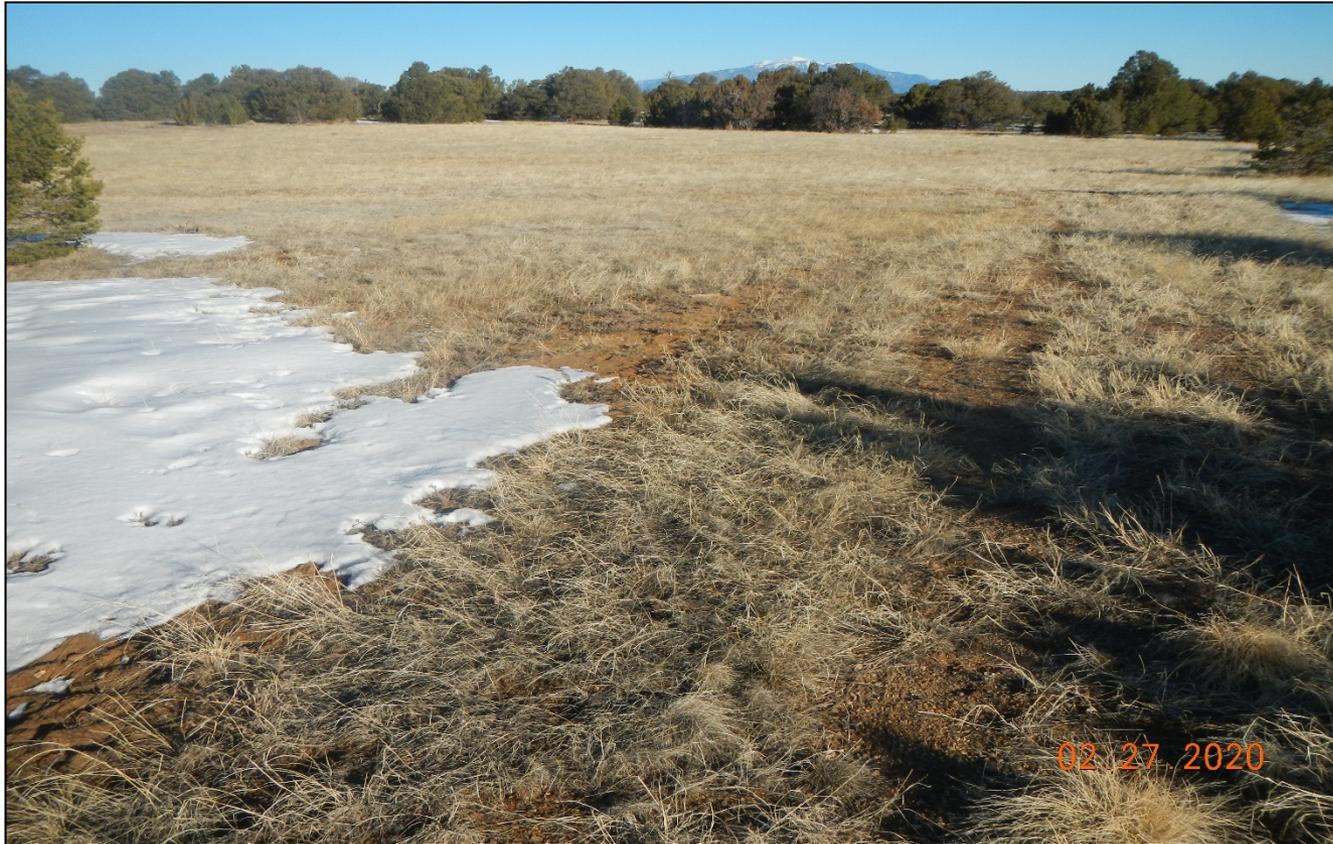
Photo 2. Facing north toward the location. Vegetation appears to be fully established at the location.

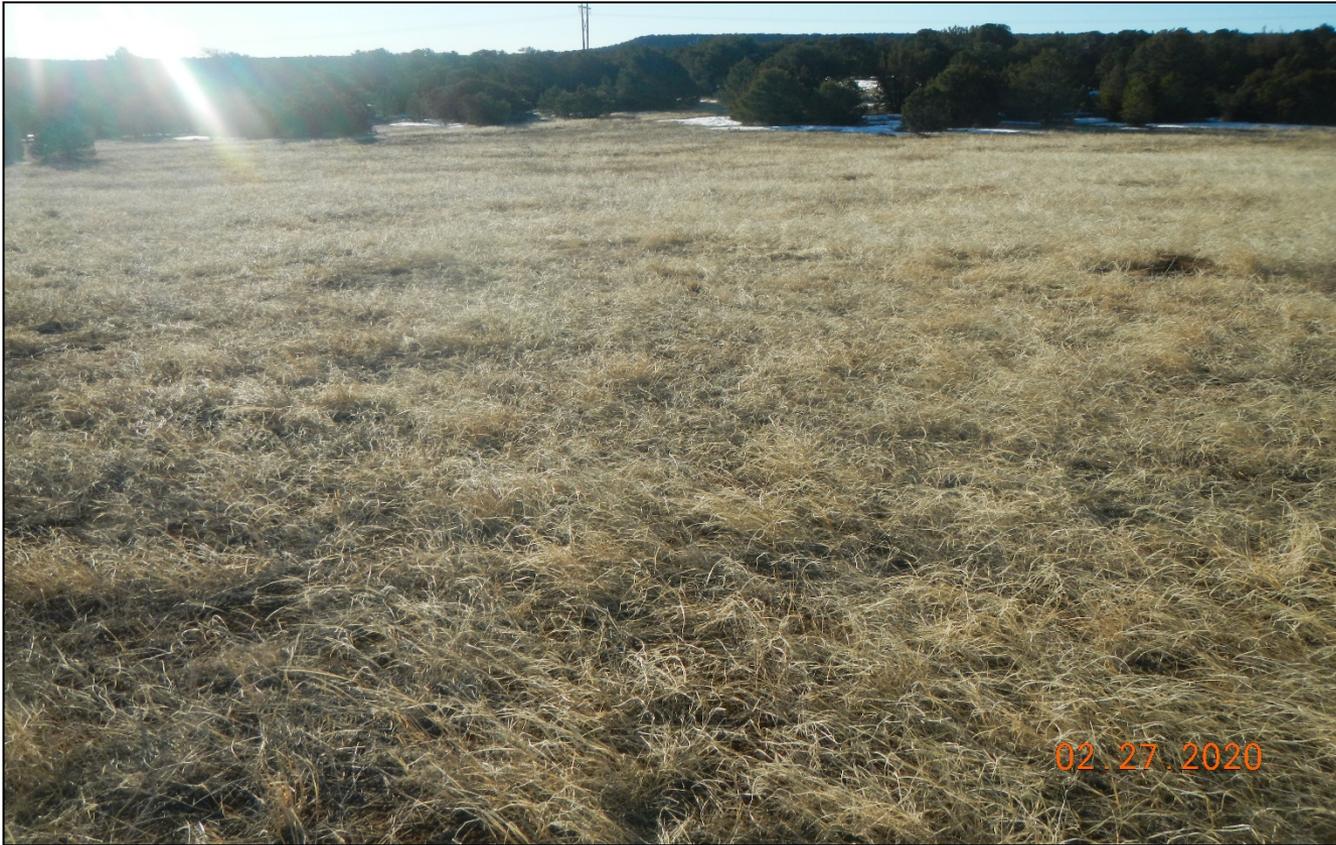
Photo 3. Facing south at the location. Vegetation appears to be fully established at the location.

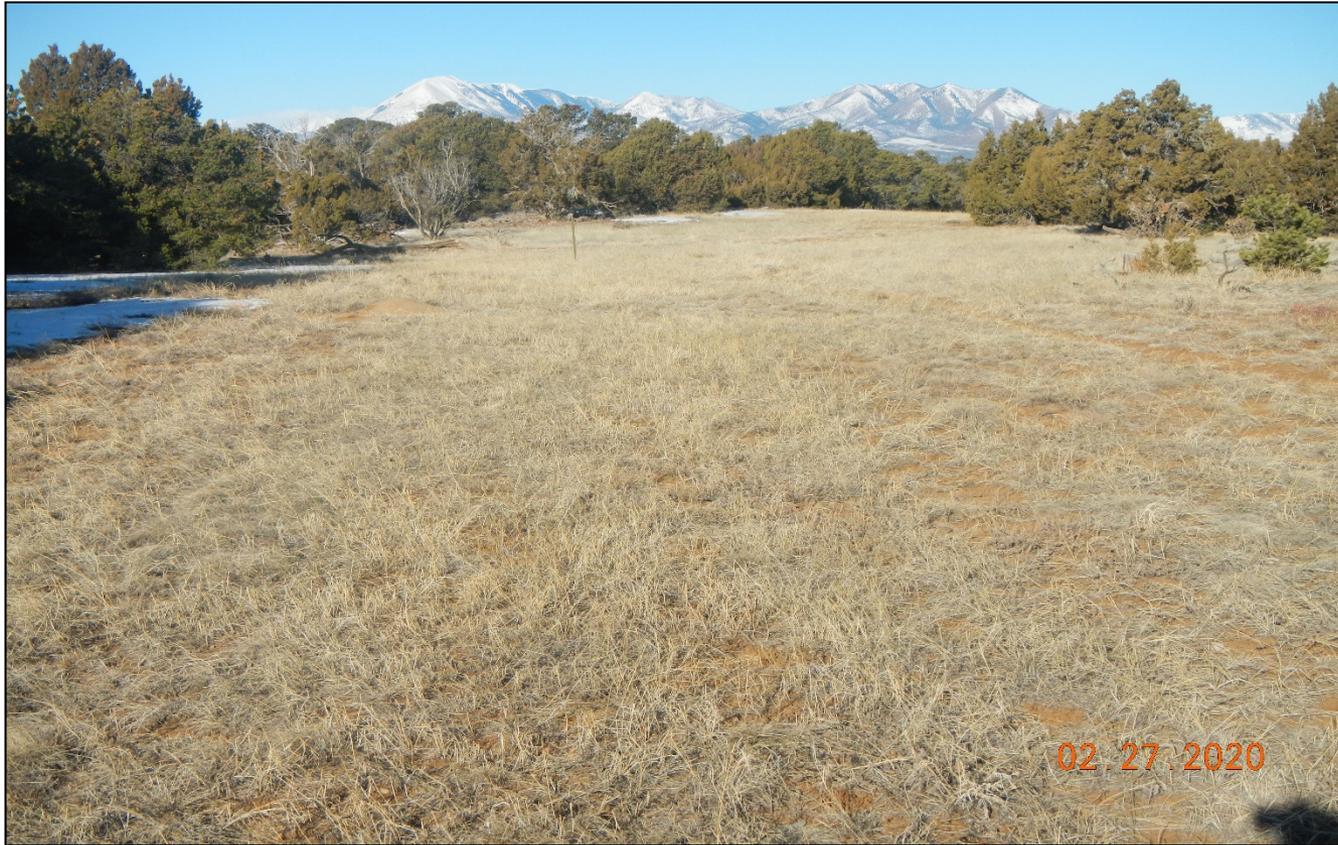
Photo 4. The disturbance area which heads northwest appears to be revegetated. This area was not fully inspected further.

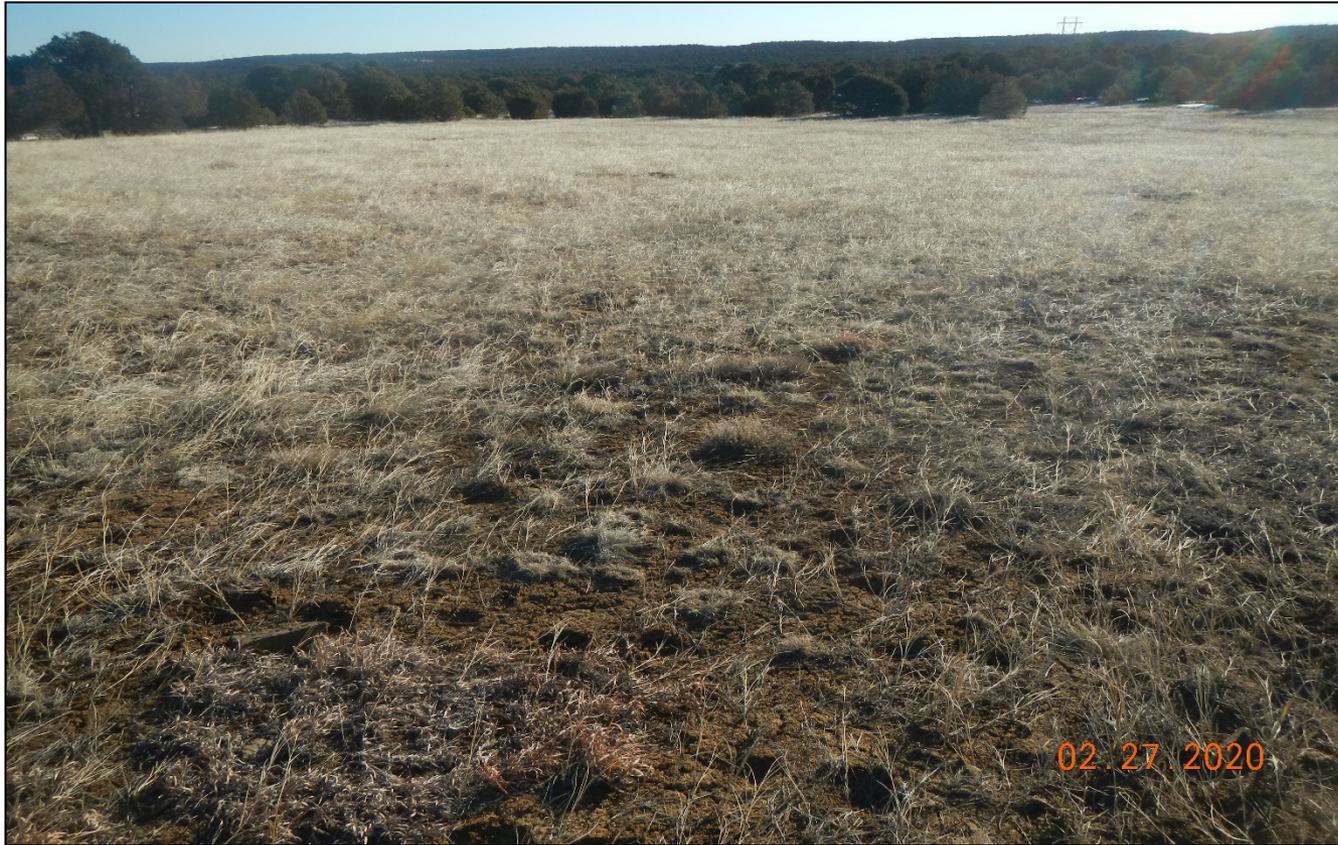
Photo 5. Facing east toward the location.
