Inspection Photos
Location Name: Champlin-Danford 44-32
Location ID: 320609

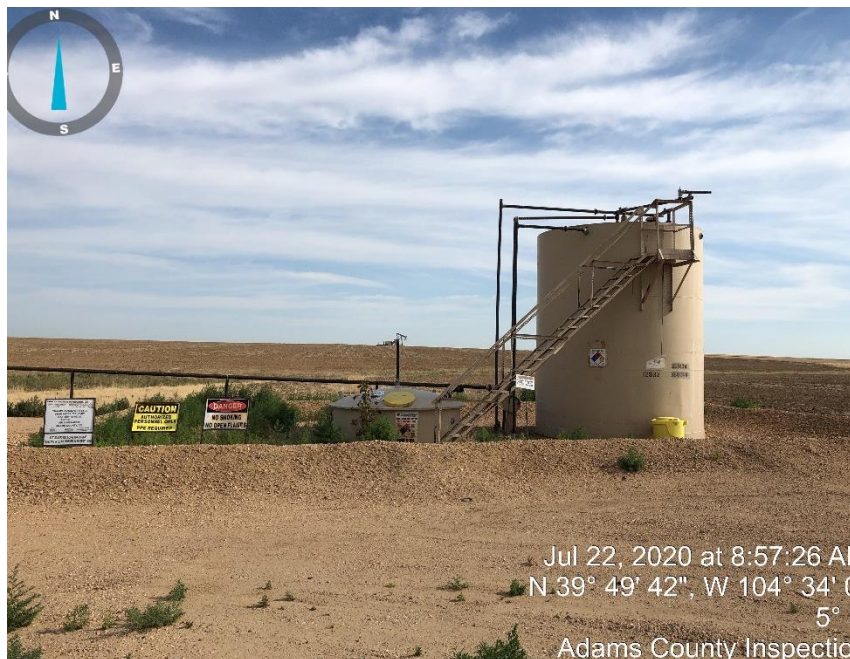
Photo #1 Tanks.

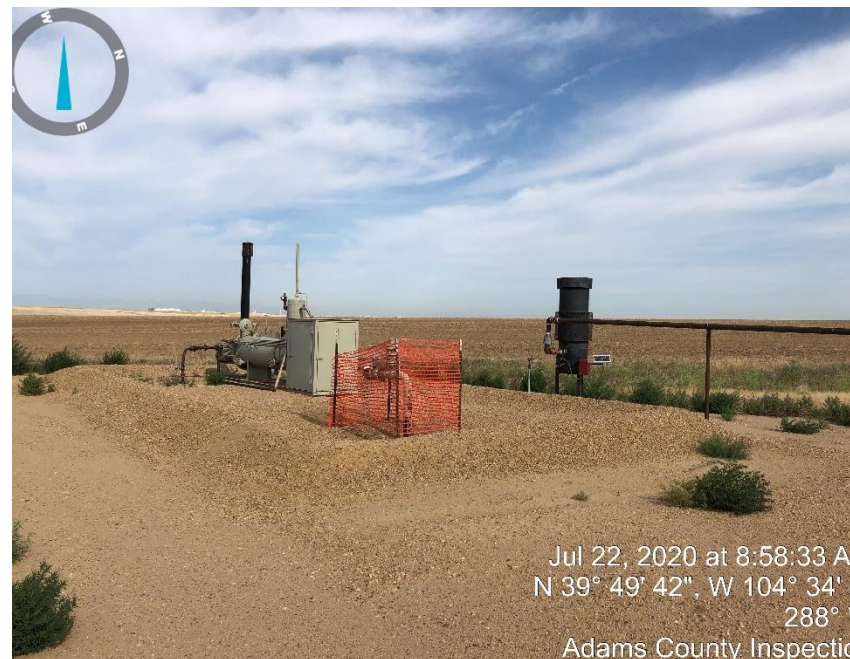
Photo #2 ECD & Separator.

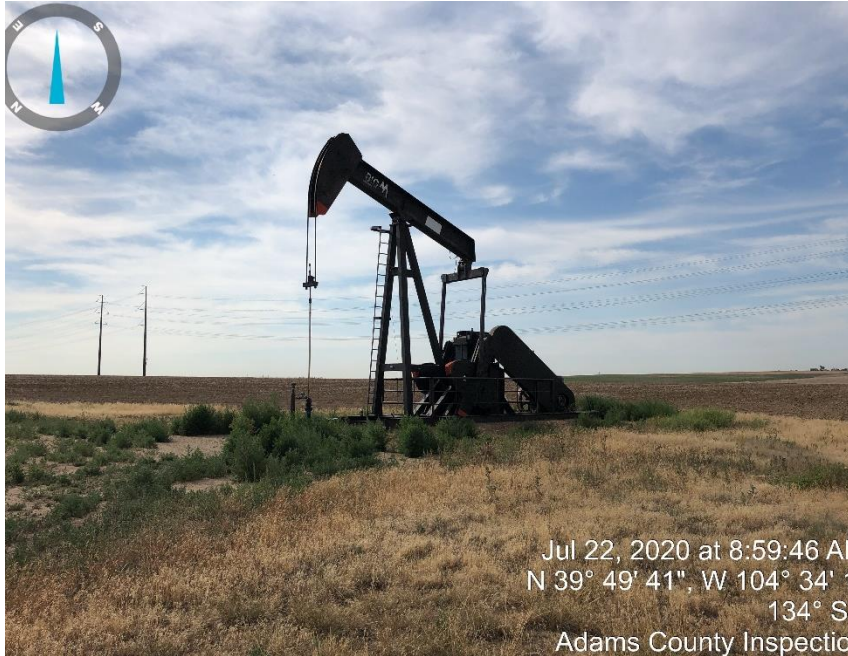
Photo #3 Pump Jack.

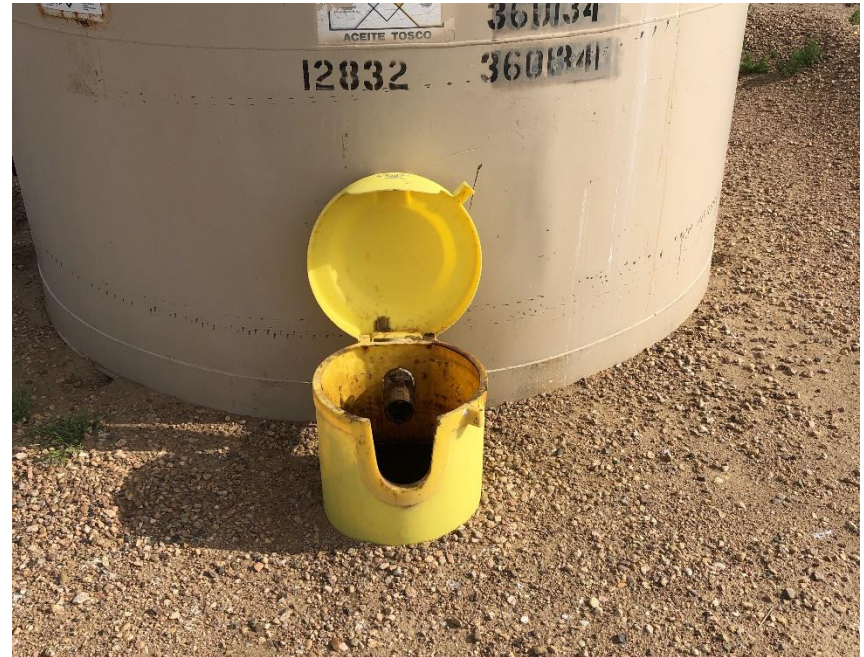
Photo #4 missing bull plug.
