Inspection Photos

Location Name: HUBER-TINKER 1-9

API#: 05-067-07545

INSP. #: 695103018

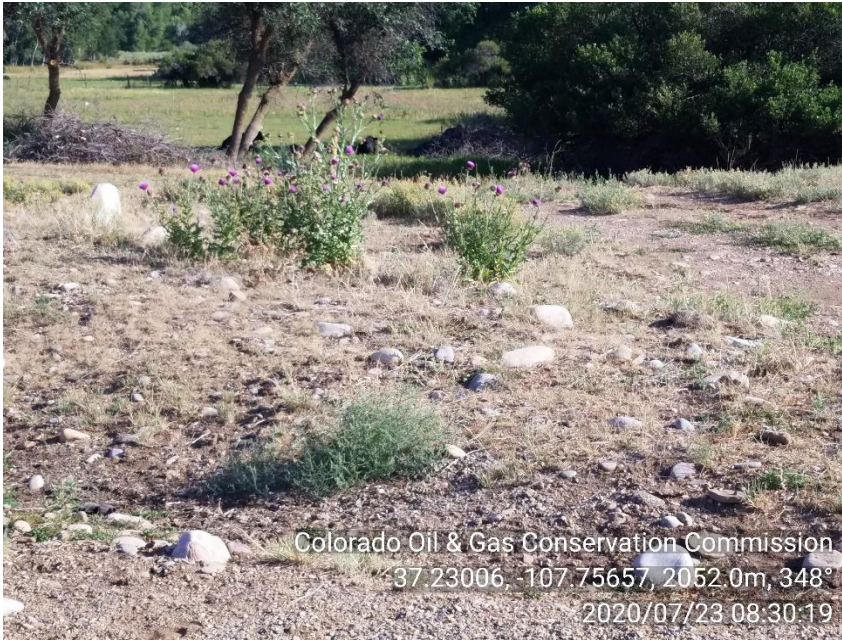
PHOTO 3: MATURE FLOWERING NOXIOUS WEEDS (THISLE) AROUND LOCATION ON THE INTERIM RECLAMATION AREA. CONTROL WEEDS (CA DATE REMAINS THE SAME AS PREVIOUS INSPECTION DOC#693901263 5-1-20

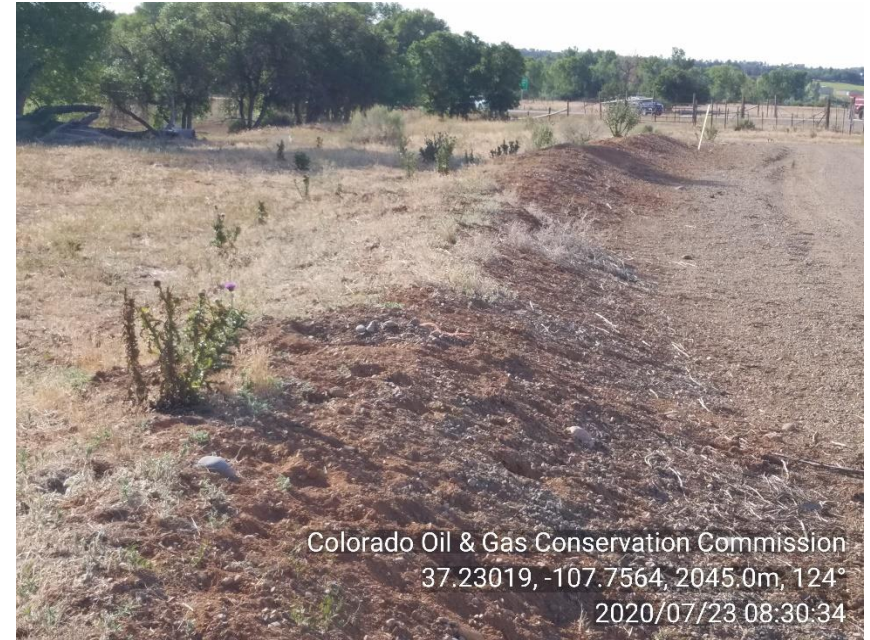
PHOTO 4: ANOTHER IMAGE OF MATURE FLOWERING NOXIOUS WEEDS (THISLE) FROM PHOTO 3.

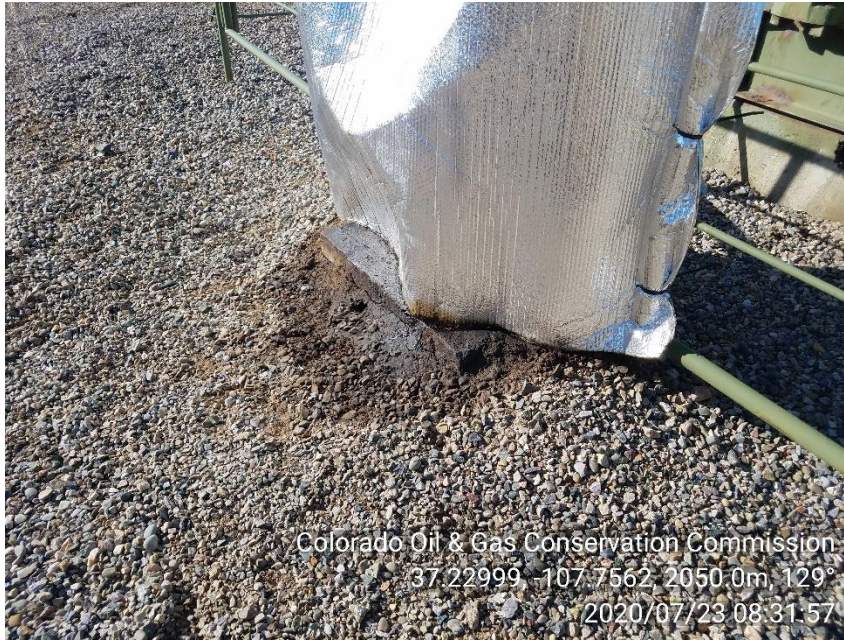
PHOTO 5: Natural gas powered engine exhaust is impacting soil/gravel around area of muffler.

Remove stained soil/gravel and dispose. Comply with Rule 1102.f.(2) for best self inspection, maintenance and housekeeping to prevent breakdown or failure of BMP's. ca date 10-23-20.

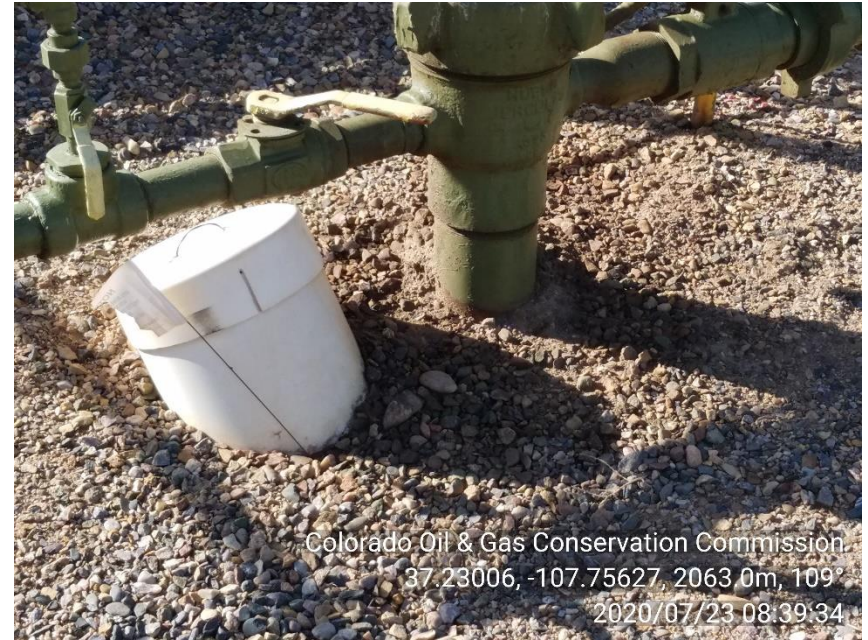
PHOTO 4: Approx 2' x 2' area of stained soil/gravel around base of wellhead. **Clean-up and dispose of stained soil/gravel per Rule 1102.f.(2) and Rule 907.e. ca date 10-23-20.**

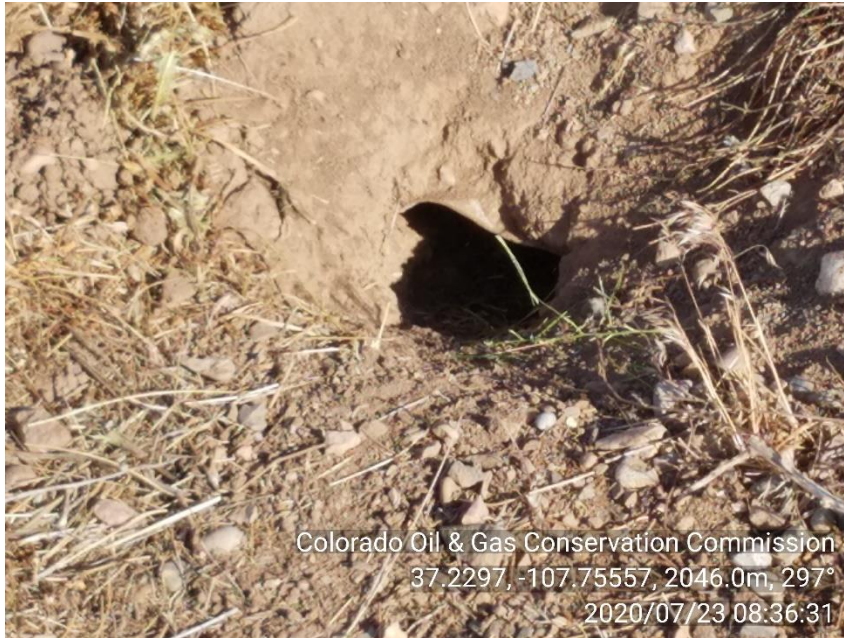
PHOTO 7: CULVERT AT ENTRANCE OF LOCATION IS ALMOST PLUGGED COMPLETELY. CLEAN AND MAINTAIN CULVERT IN ORDER TO PREVENT BREAKDOWN OF BMP'S. Install or repair required BMPs per Rule 1002.f.(2)C. CA DATE 10-23-20

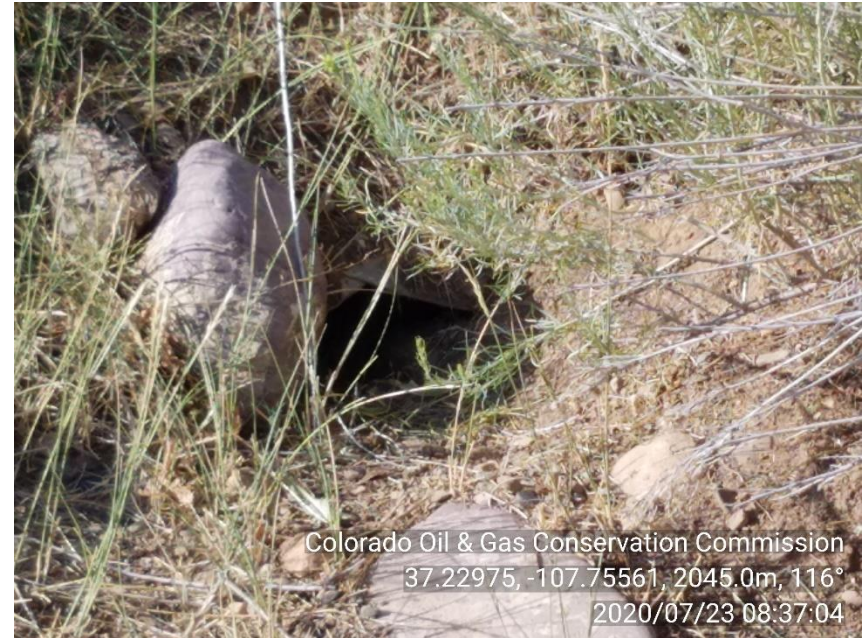
PHOTO 8: AN IMAGE OF THE OTHER SIDE OF CULVERT MENTIONED IN PHOTO 7.

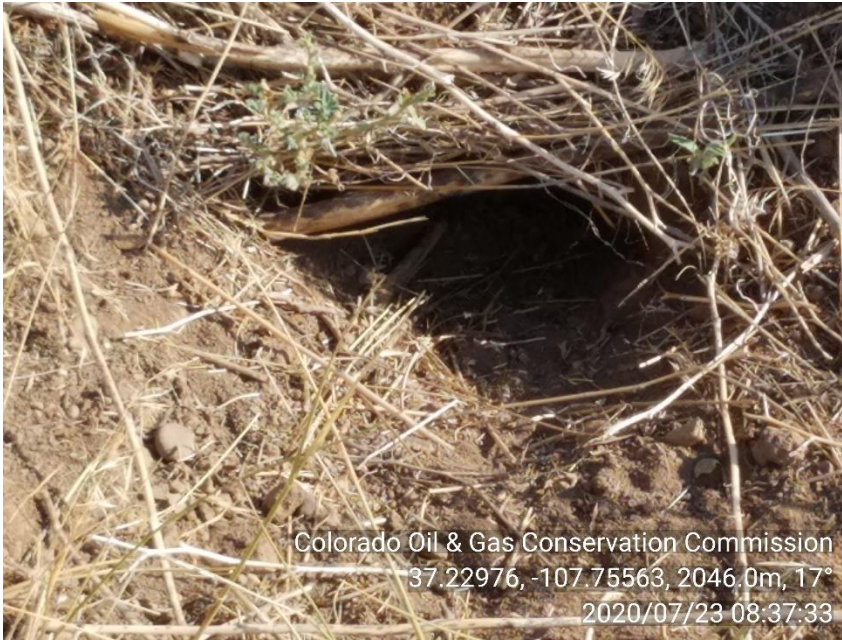
PHOTO 9: PHOTO OF THE CULVET JUST DOWN GRADE OF CULVERT IN PHOTO 7. FOLLOW CA LISTED ON PHOTO 7.

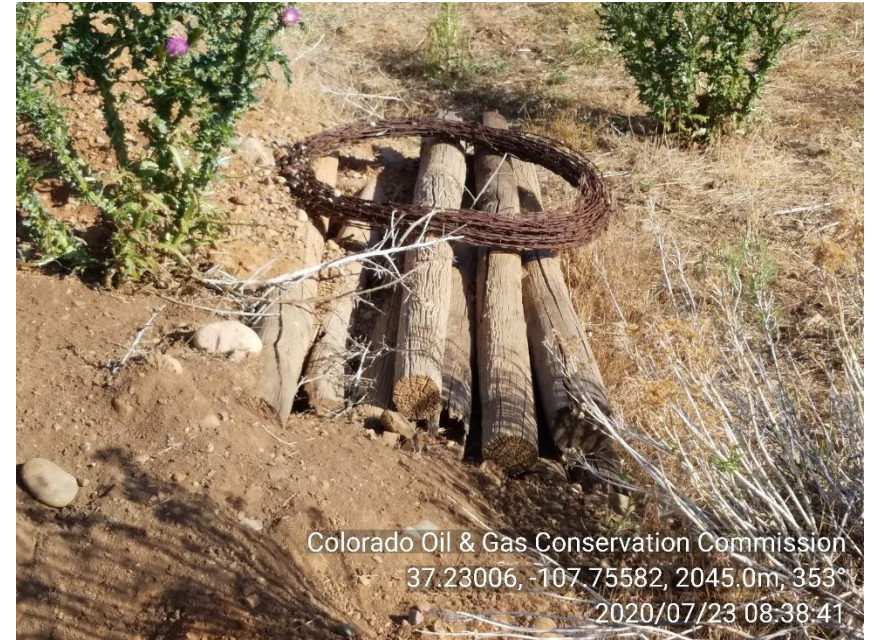
PHOTO 10: UNUSED EQUIPMENT STORED JUST OVER BERM ON INTERIM RECLAMATION AREA. REMOVE UNUSED EQUIPMENT, COMPLY WITH RULE 603.f. CA DATE 10-23-20.
