Inspection Photos
Location Name: HURT 1-4
API#: 05-067-06545
INSP. #: 695103024

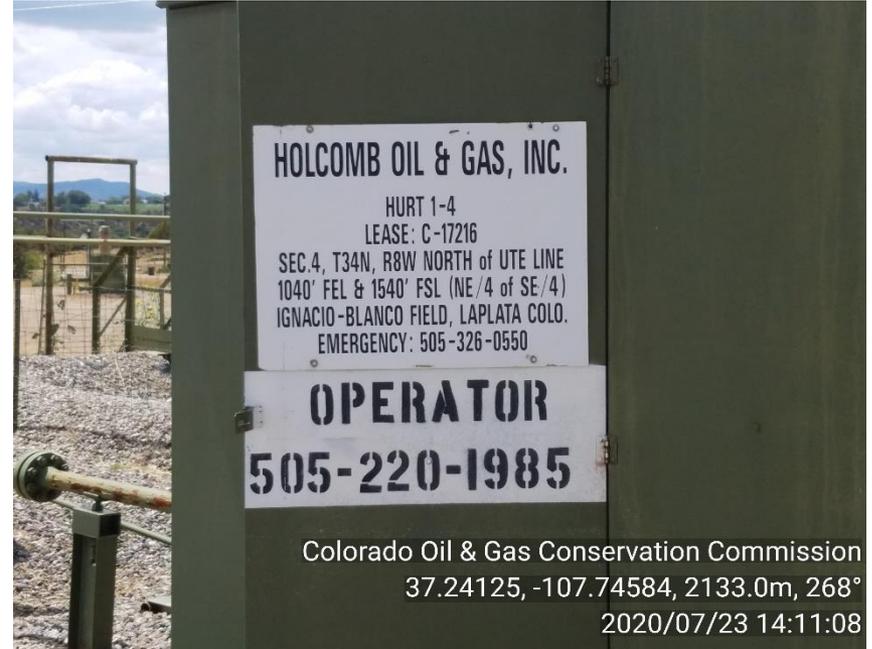
PHOTO 2: WELL SIGN IS POSTED ON GAS METER HOUSE, AT TIME OF INSPECTION METER HOUSE DOOR WAS TIED OPEN MAKING SIGN NOT VISIBLE. **POST SIGN IN COMPLIANCE WITH RULE 210.b. CA DATE 10-23-20**

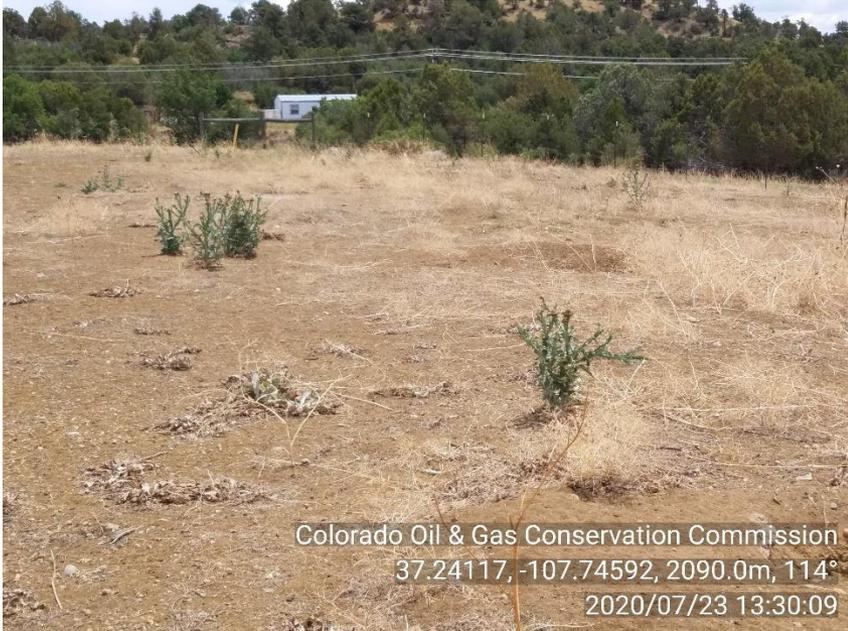
PHOTO 3: MATURE FLOWERING NOXIOUS WEEDS ALL AROUND LOCATION AND ON INTERIM RECLAMATION AREA.
CONTROL WEEDS CA DATE 7-27-20.

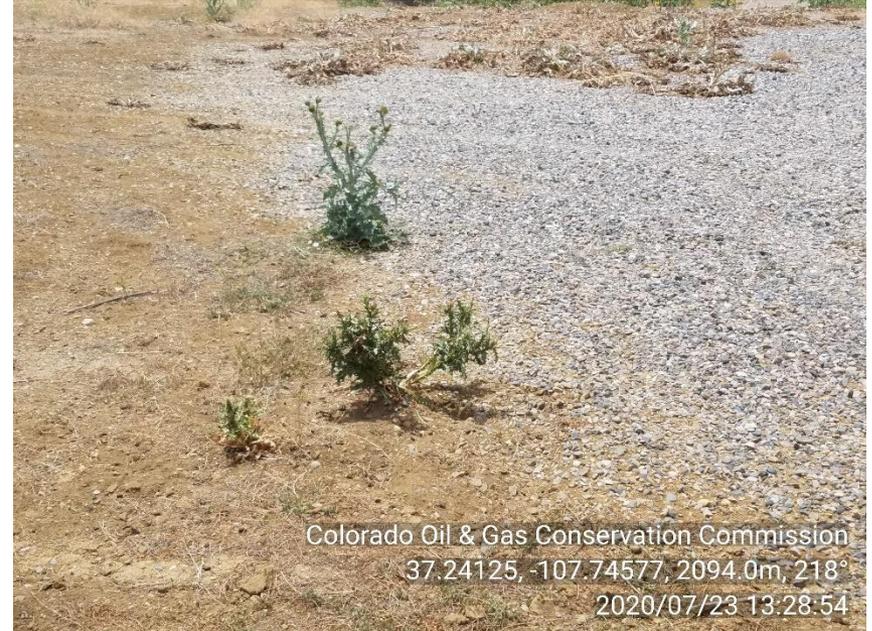
PHOTO 4: ANOTHER IMAGE OF NOXIOUS WEEDS

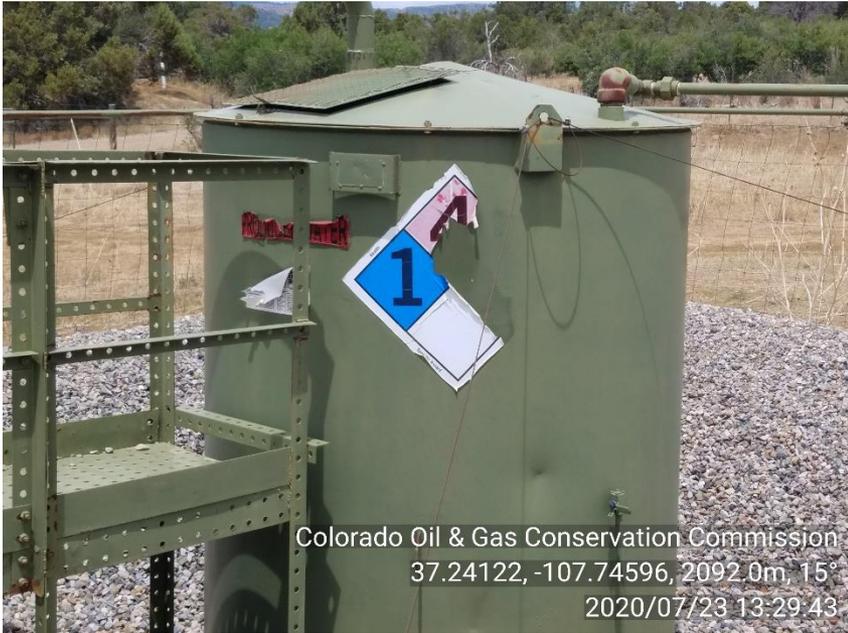
PHOTO 5: NFPA STICKER FAIDED AND FALLING APART. POST NFPA STICKERS IN COMPLIANCE WITH RULE 210.d. CA DATE 10-23-20.

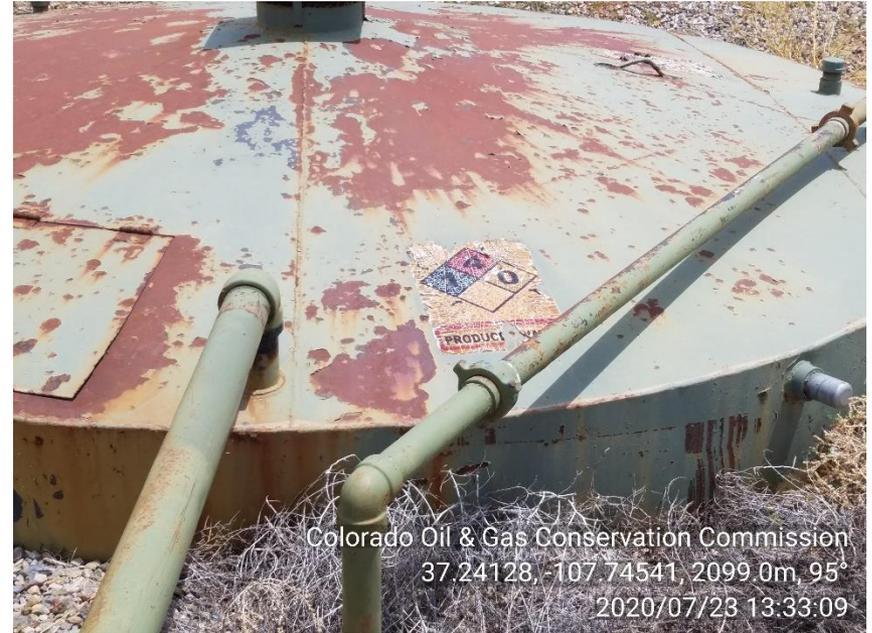
PHOTO 6: NFPA STICKER IS FAIDED AND ALMOST NOT LEGIBLE ALSO THERE IS NO TANK CAPACITY POSTED ON TANK. POST SIGNS IN COMPLIANCE WITH RULE 210.d ca date 10-23-20.
