Inspection Photos
Location Name: HUBER LEWIS 2-4
API#: 05-067-07674
INSP. #: 695103026

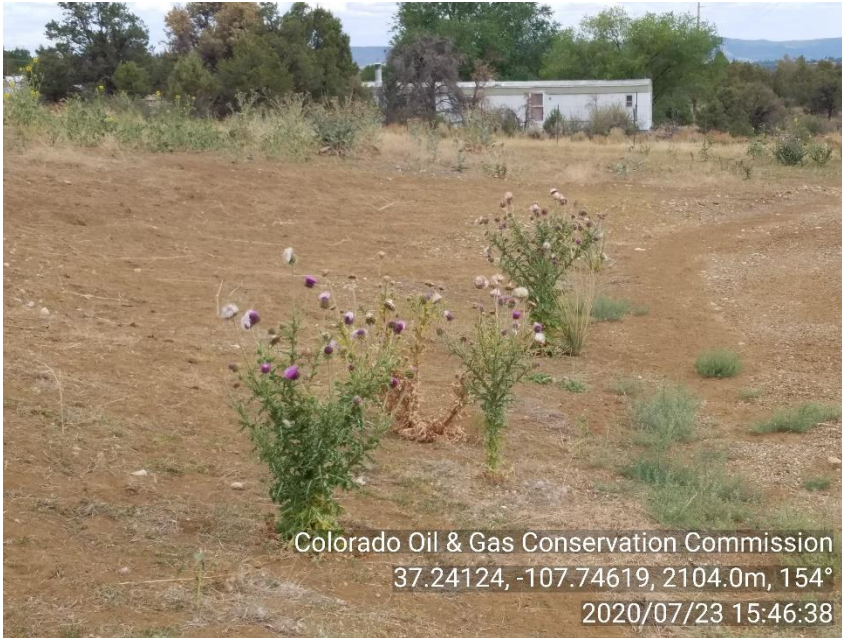
PHOTO 3: MATURE FLOWERING NOXIOUS WEEDS ALL AROUND LOCATION AND ON INTERIM RECLAMATION AREA.
CONTROL WEEDS CA DATE 7-27-20.

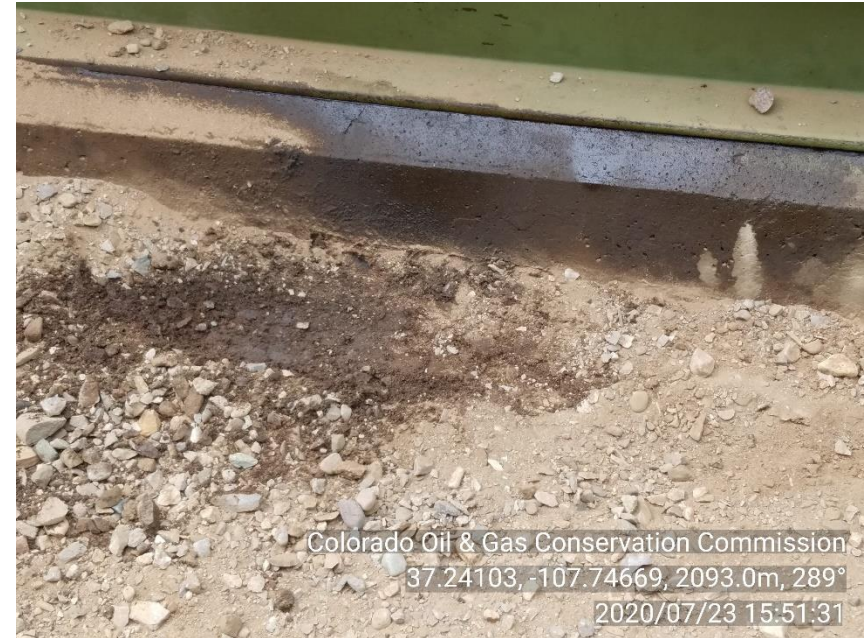
PHOTO 4: AFTER NOTICING WHAT APPEARS TO BE USED OIL RUNNING DOWN CONCRETE PUMPJACK PAD I KICKED FRESH LAID DIRT ASIDE AND REVEALED AN AREA OF IMPACTED SOIL ON GROUND NEXT TO PUMPJACK ENGINE. Conduct maintenance on equipment, cleanup stained material and review self inspection processes. CA DATE 10-23-20.
