Inspection Photos
July 24, 2020

Location Name: Pintail SWD Location ID 446527; Spill ID 477094

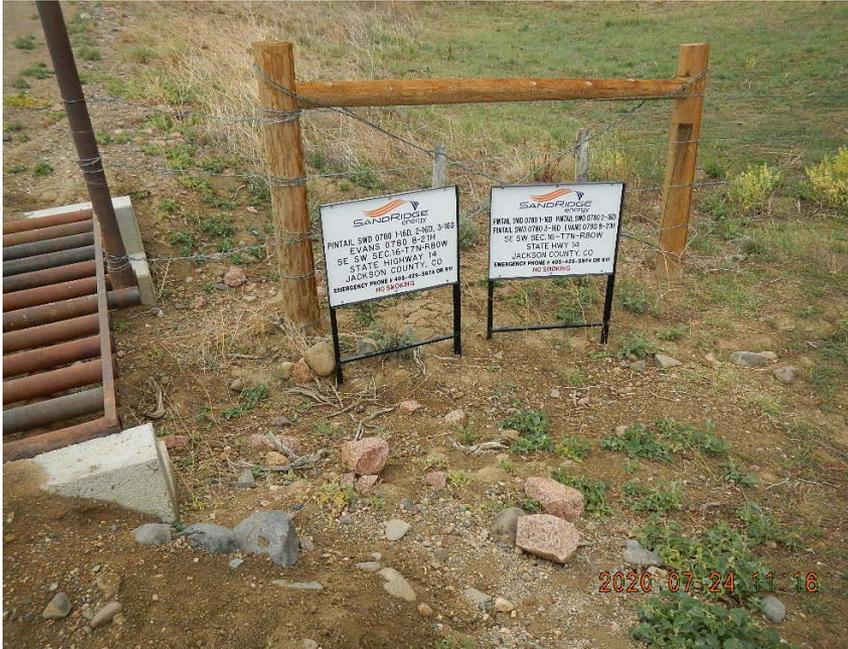
Sign at entrance to Location ID: 446527.

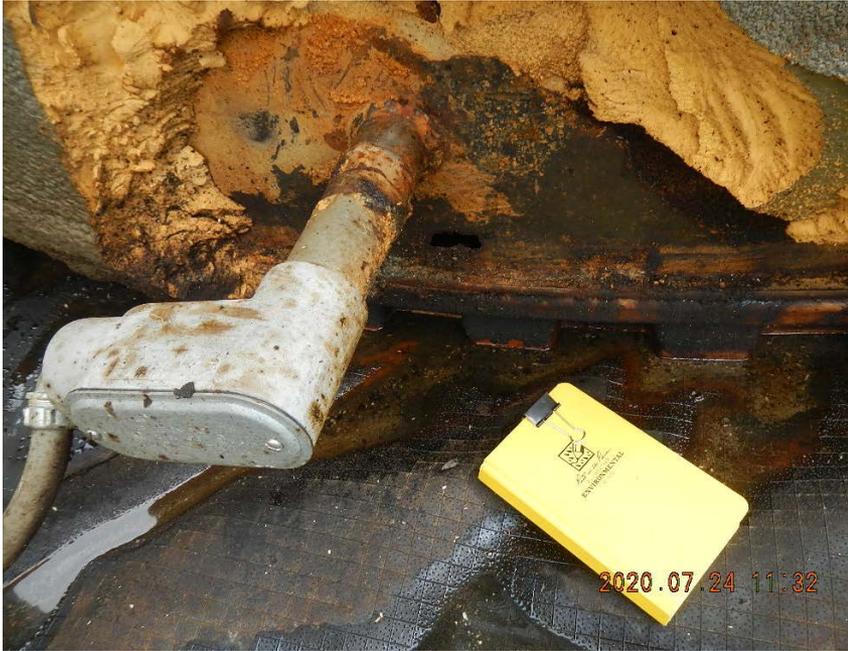
Approximate 1"x 1.5" hole in tank.

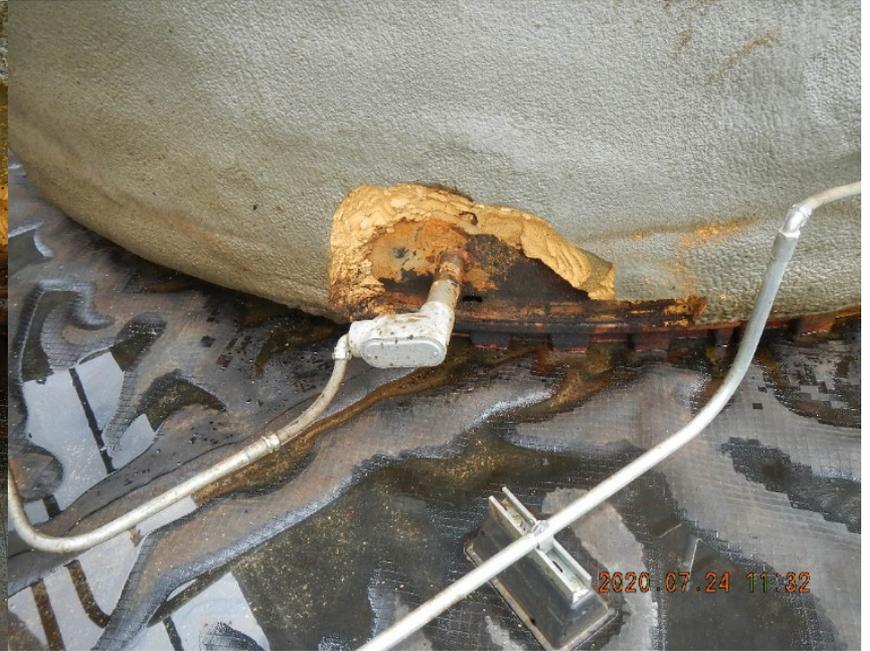
Approximate 1"x 1.5" hole in tank.

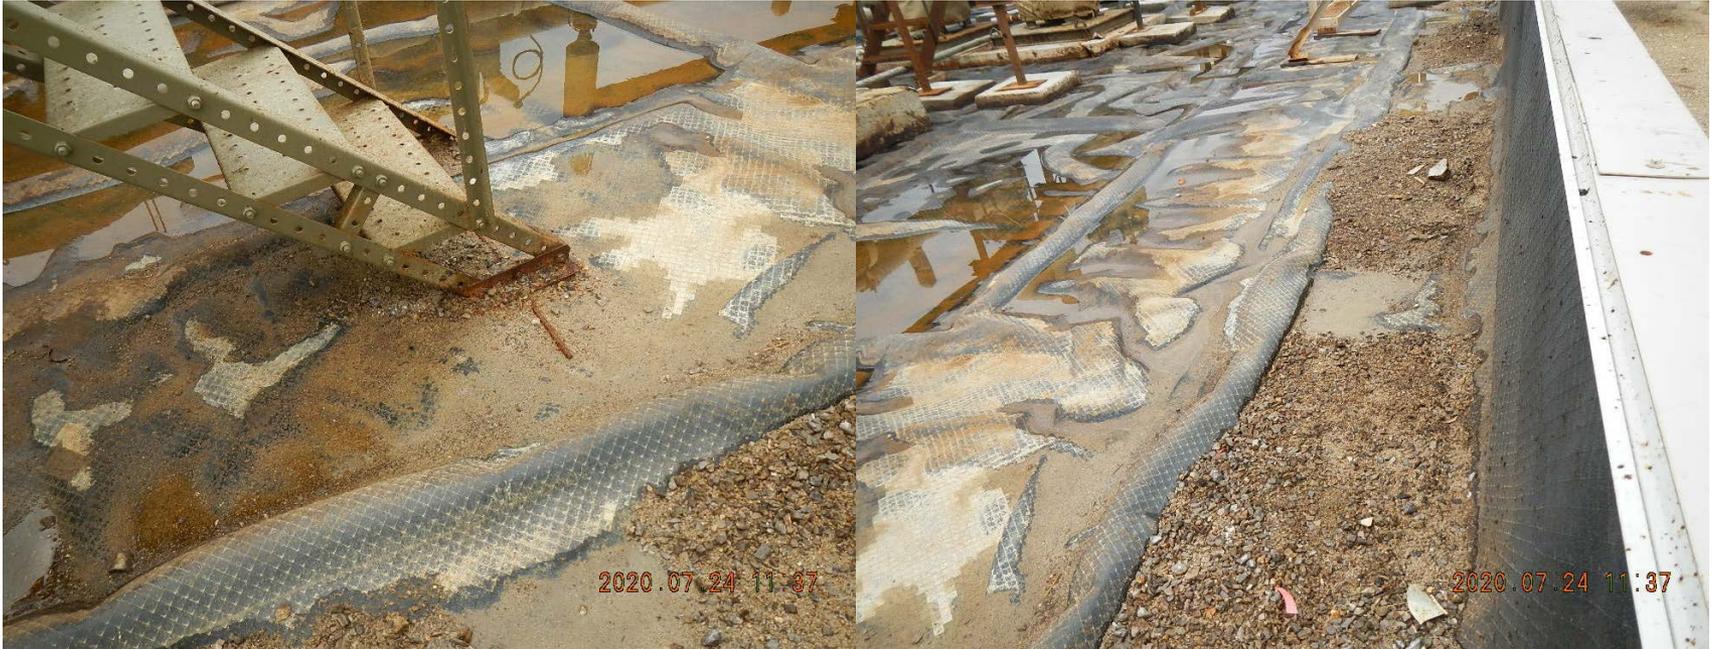
Stair supports deteriorating with rebar exposed on liner.

Concrete weight/anchor to hold liner in place deteriorating. Note the folds in liner.

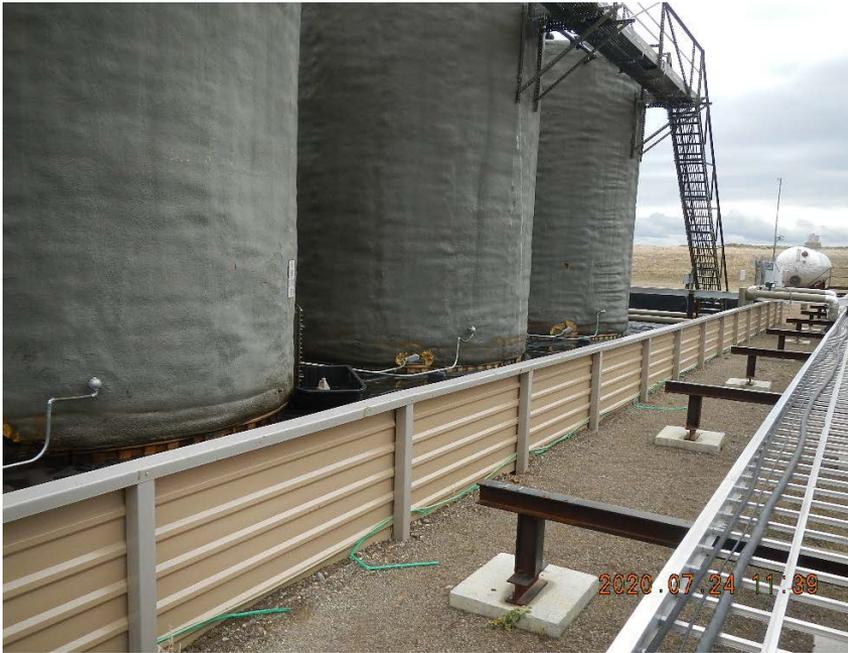
Compromised tank in left of photo. Tank #s 0601 and 0602 show insulation removed and tank exposed similar to the compromised tank.

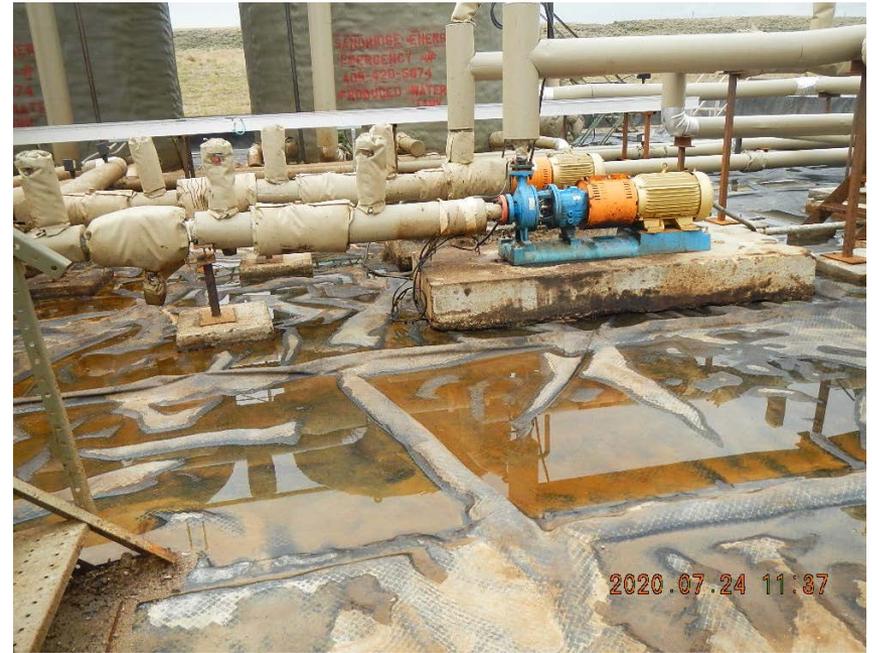
Pooling oil and salt staining has been addressed from the June 20, 2020 inspection.

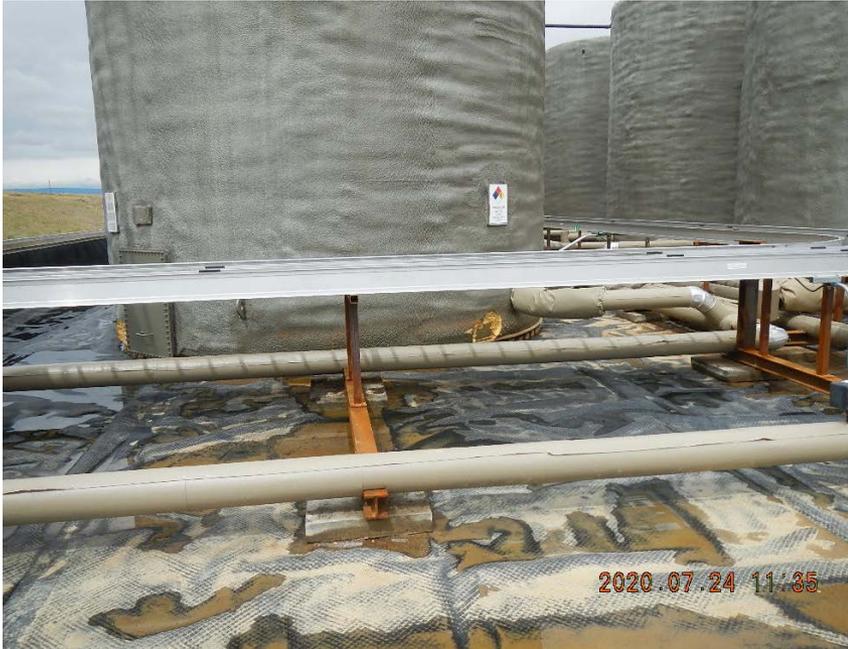
Insulation removed exposing Tank # 0601 surface.

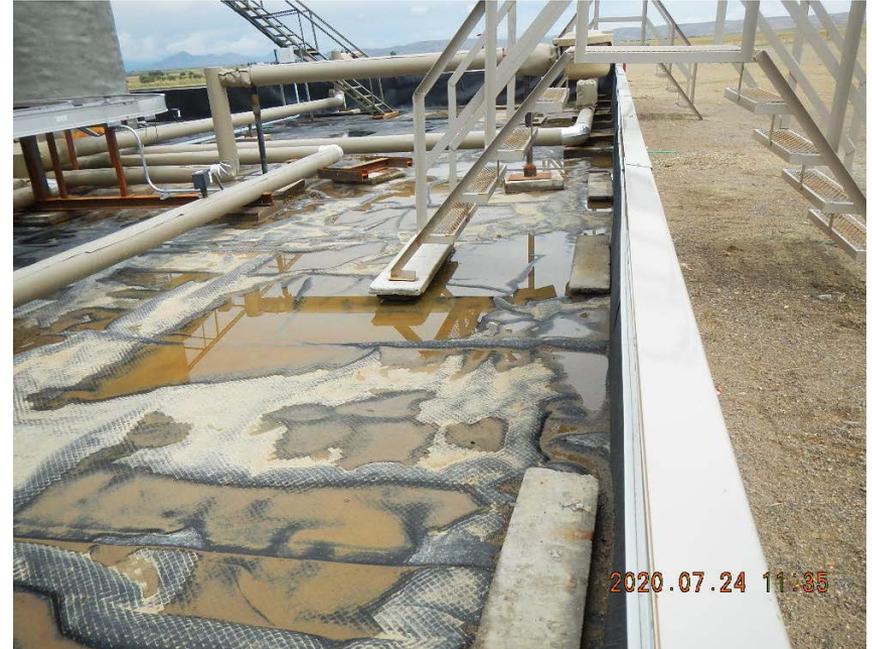
Salt staining and trash/debris has been addressed from the June 20, 2020 inspection.

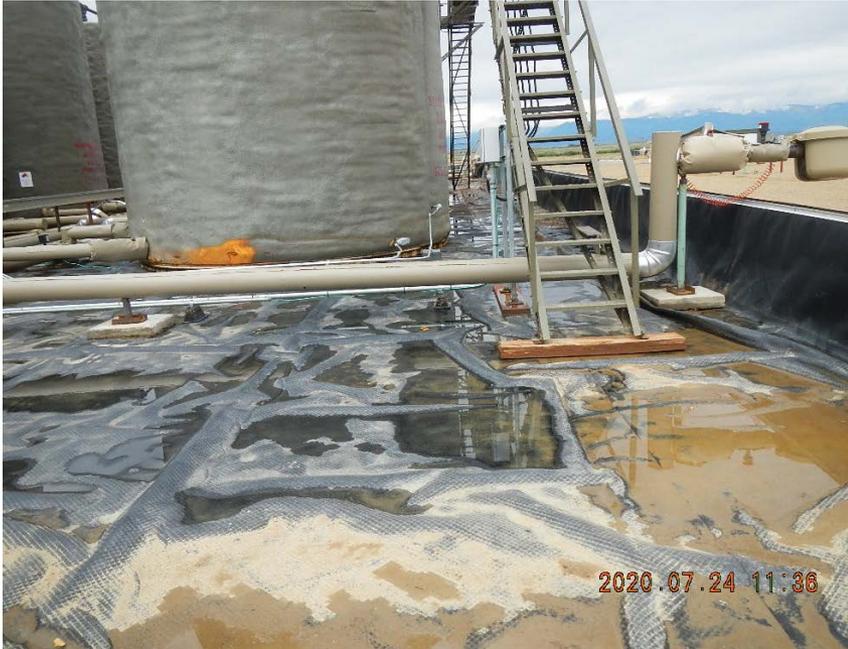
Pooling oil and salt staining has been addressed from the June 20, 2020 inspection.

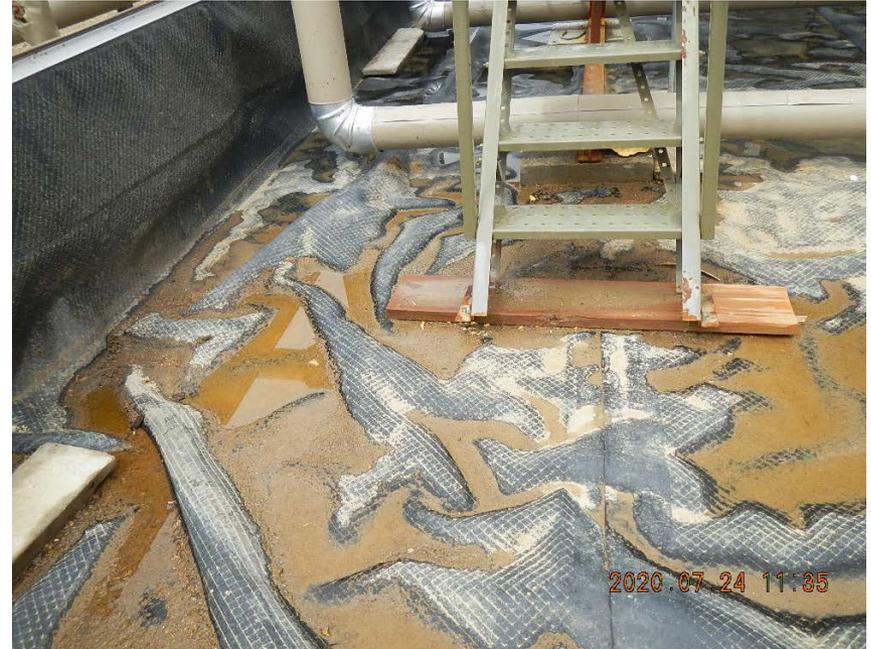
Pooling oil and salt staining has been addressed from the June 20, 2020 inspection.

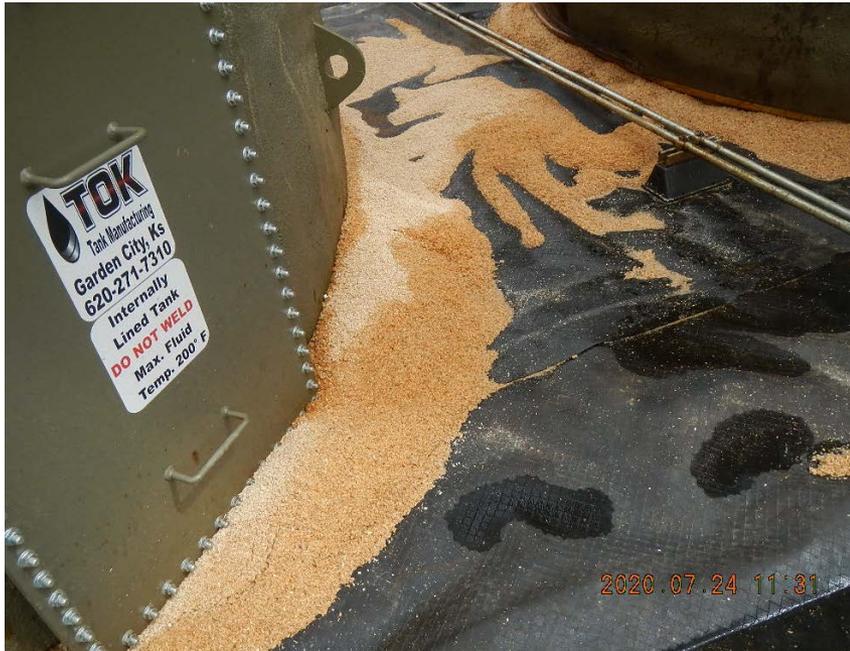
Absorbent material at the base of tanks.

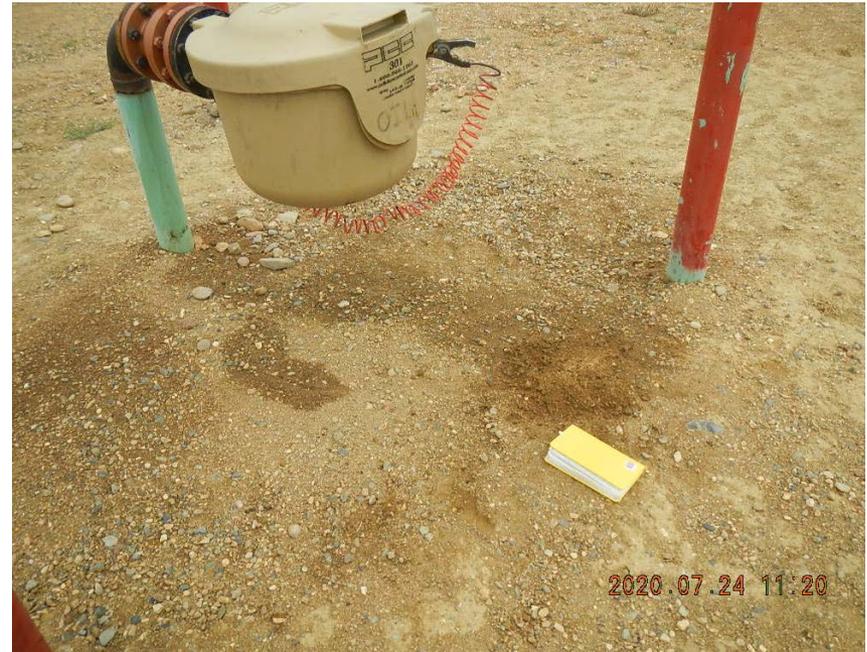
Surface staining at load out. Hydrocarbon odor noted with apparent wood fiber mixed into soil.

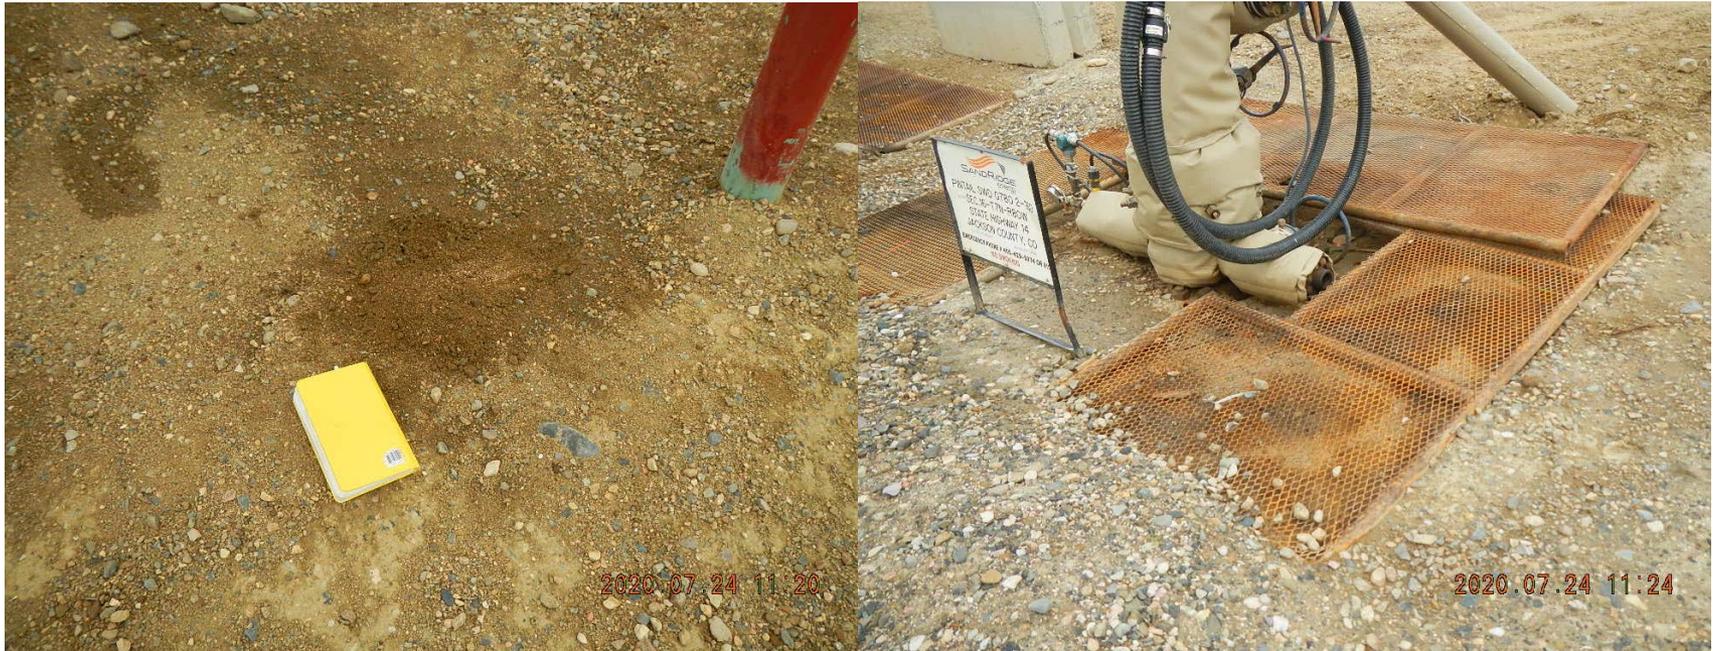
Surface staining at load out. Hydrocarbon odor noted with apparent wood fiber mixed into soil.

Surface staining has been addressed from the June 20, 2020 inspection.

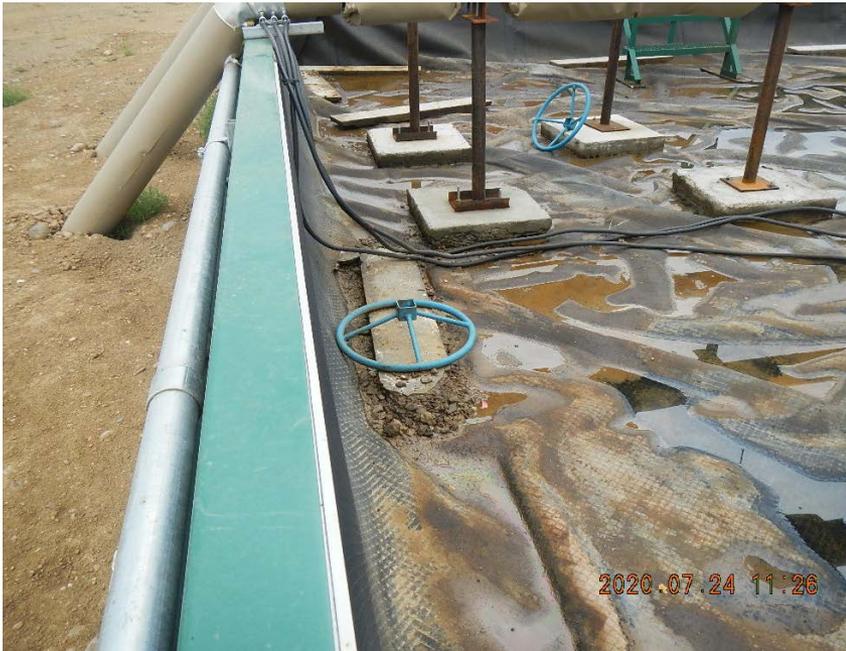
Concrete weight/anchor with rebar and valve handles with potential to puncture or compromise liner.

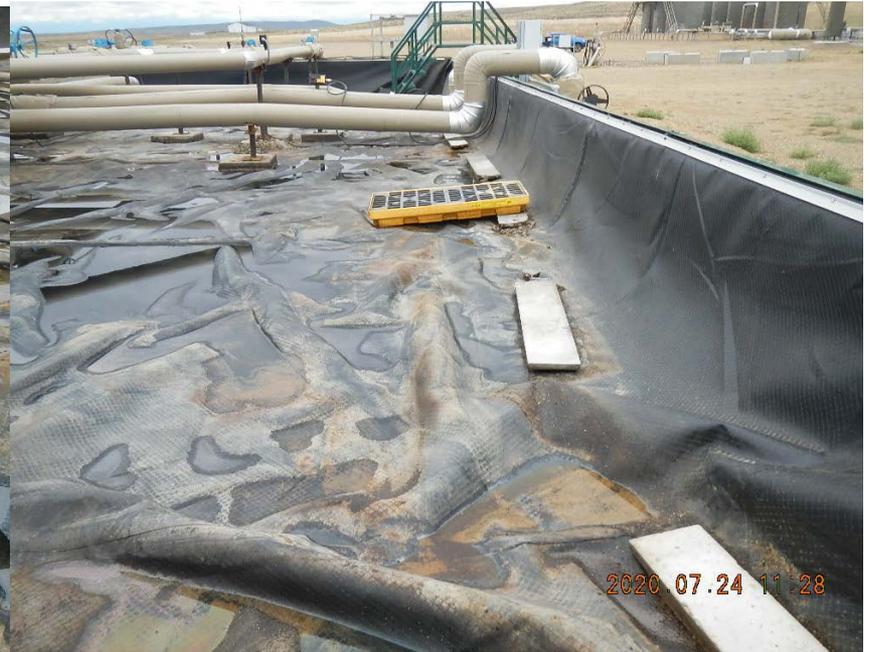
Concrete weight/anchor with other debris on liner with the potential to puncture or compromise liner. Note how liner is wind blown with folds.

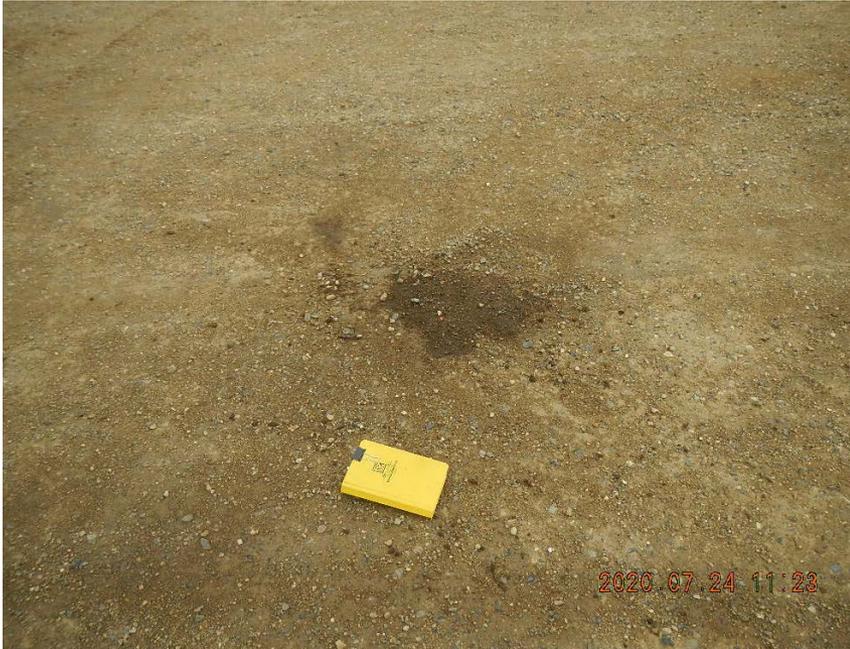
Surface staining.

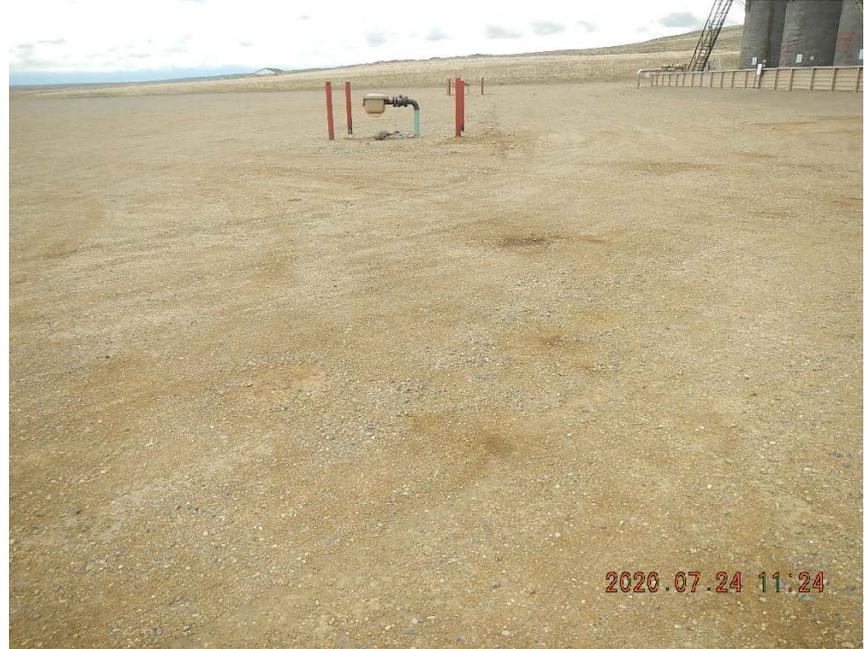
Surface staining.
