# Inspection Photos

API: 055-06221

Operator: PETROGLYPH OPERATING CO INC

Inspection Date: 7/27/2020

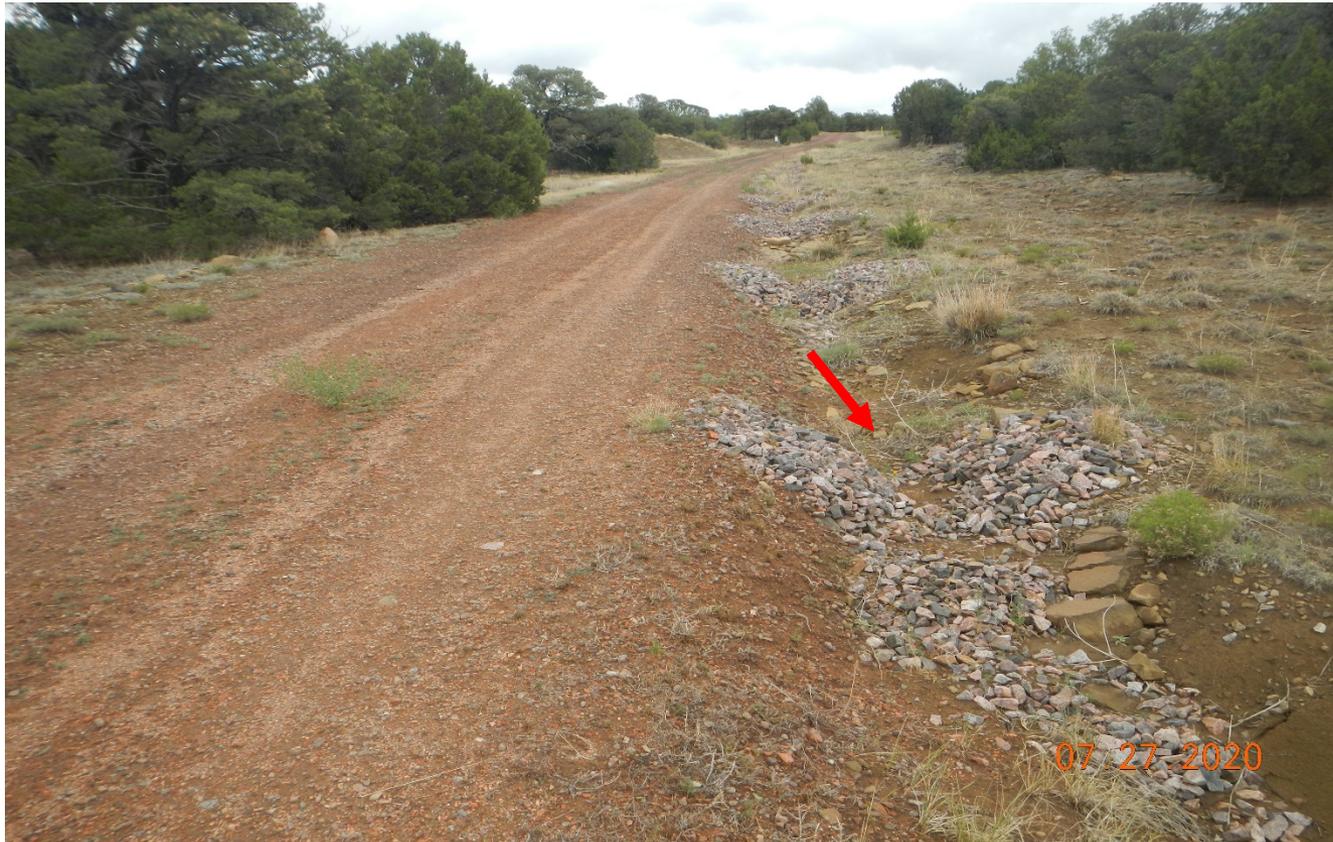
**Photo 1.** Facing southeast along the access road. Rock check dams were installed along the side of the road but have since failed. The rock has been displaced as shown by arrow.

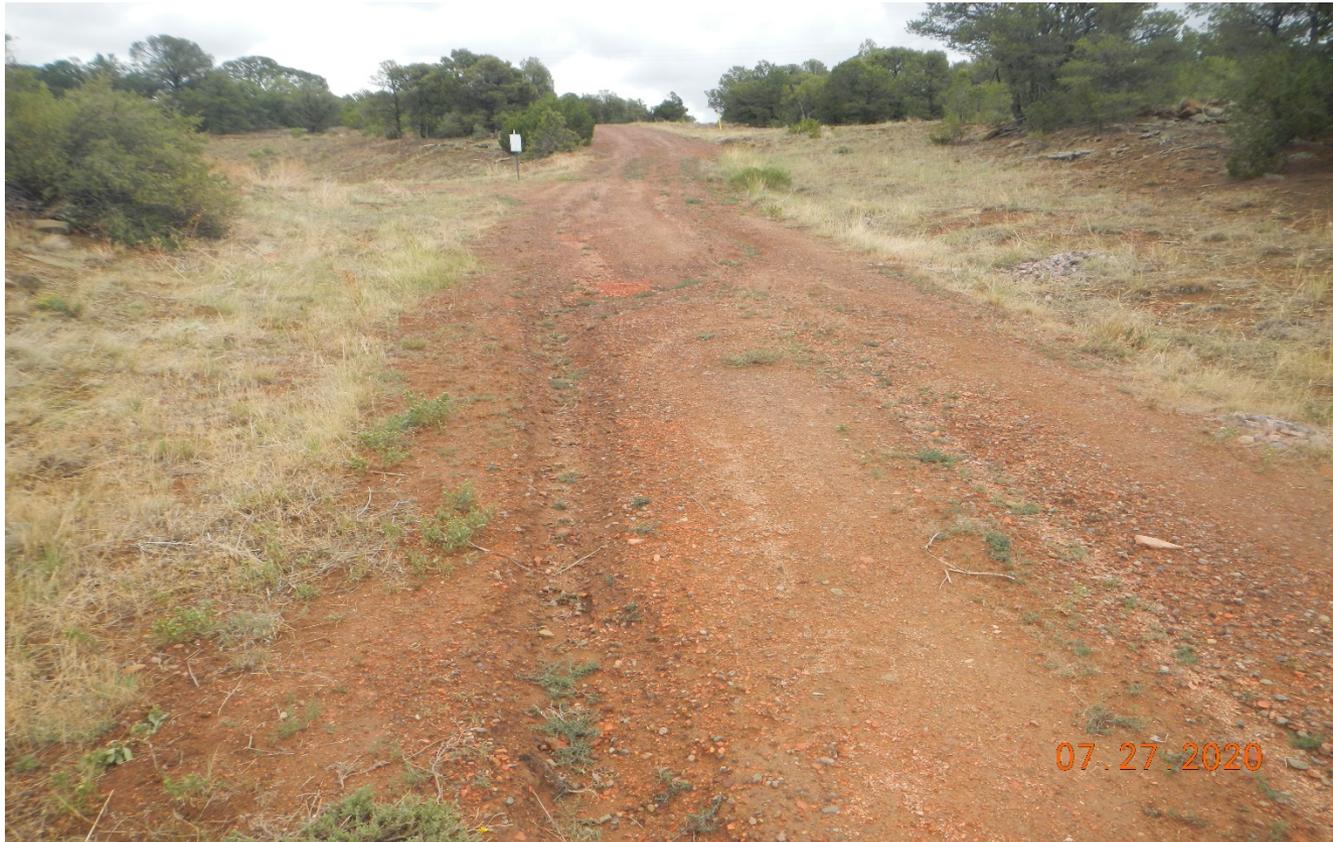
**Photo 2.** Signs of stormwater flowing down the road causing erosion near the State 7W location.

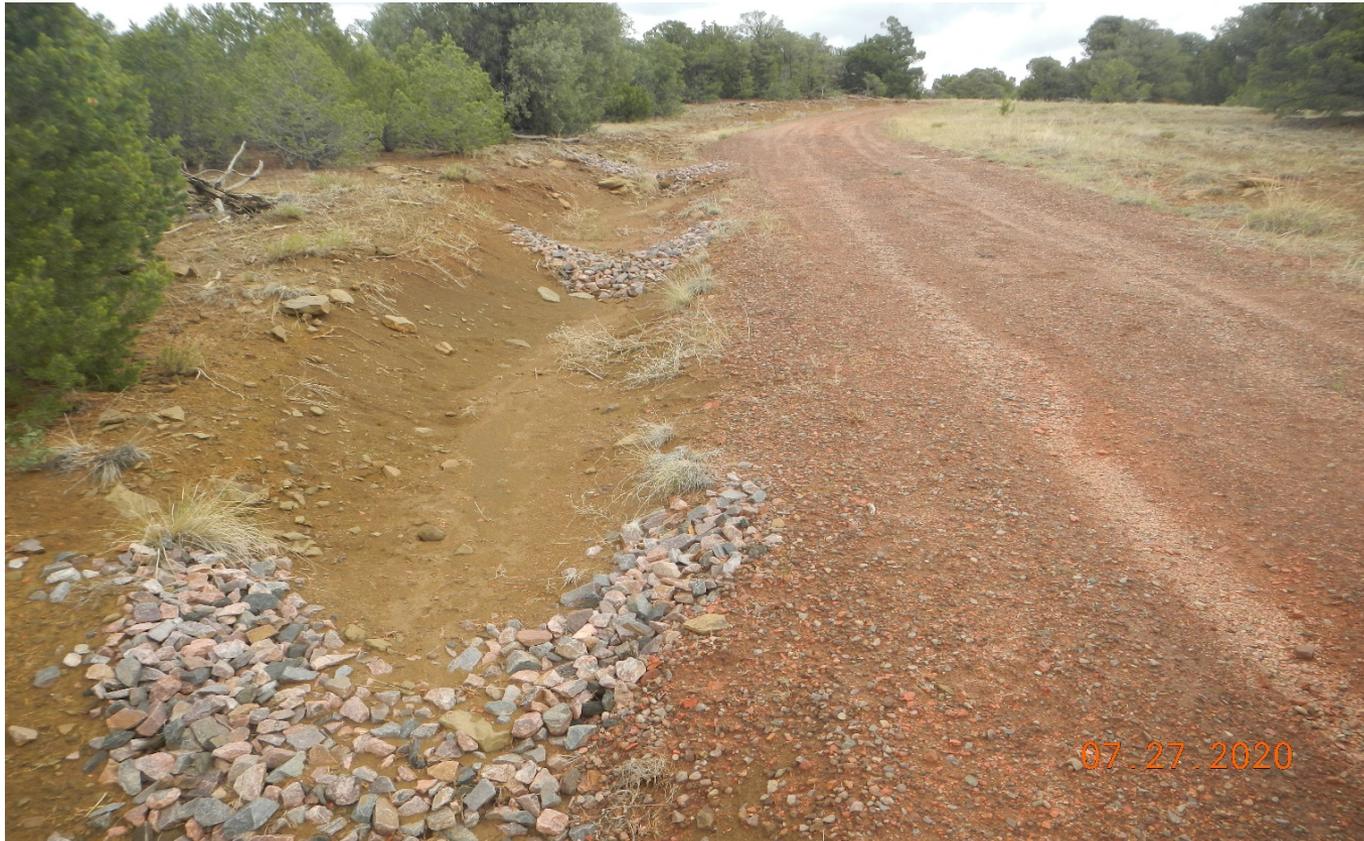
**Photo 3.** The check dams have filled in with sediment which are not maintained.

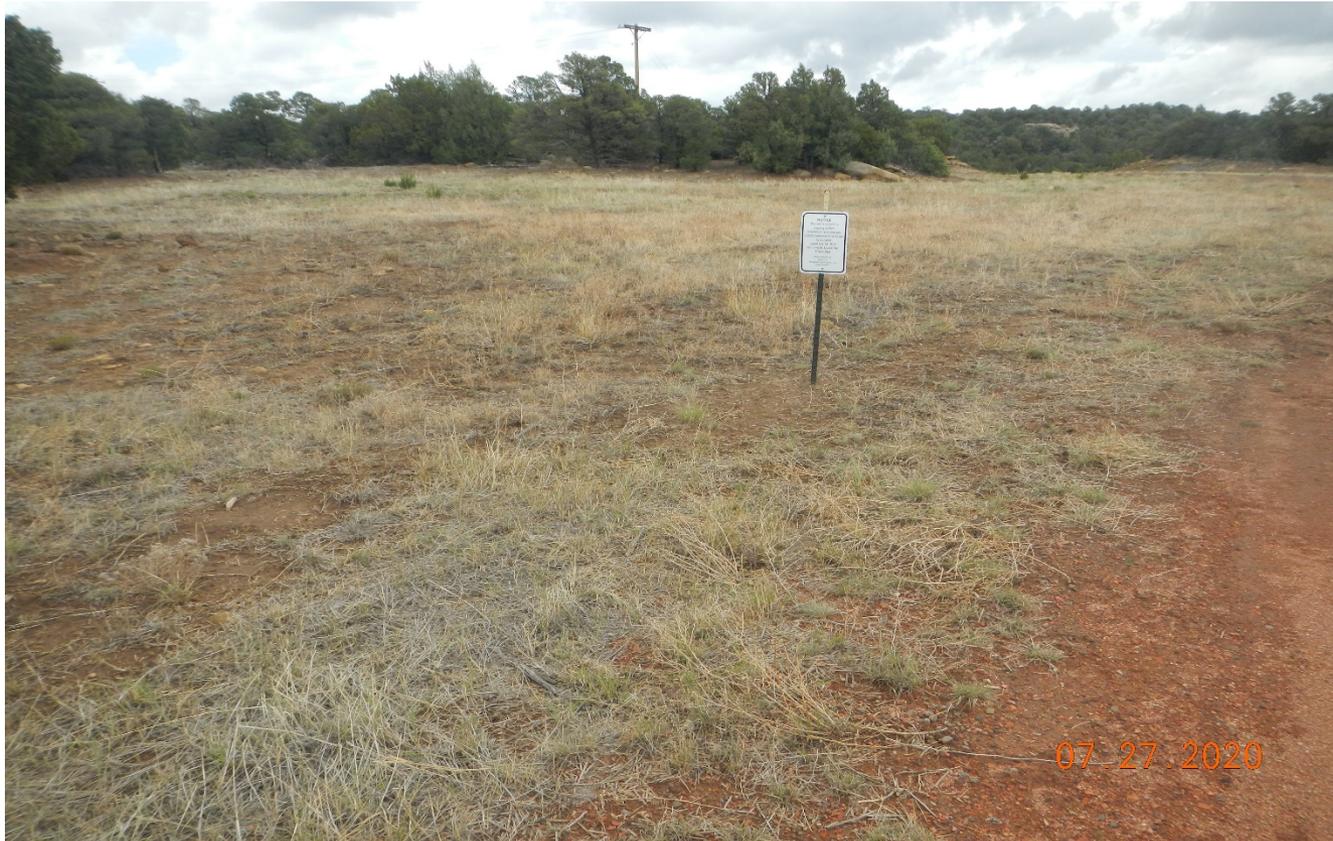
**Photo 4.** Facing east toward the location. The vegetation appears to be establishing well in areas of the location.

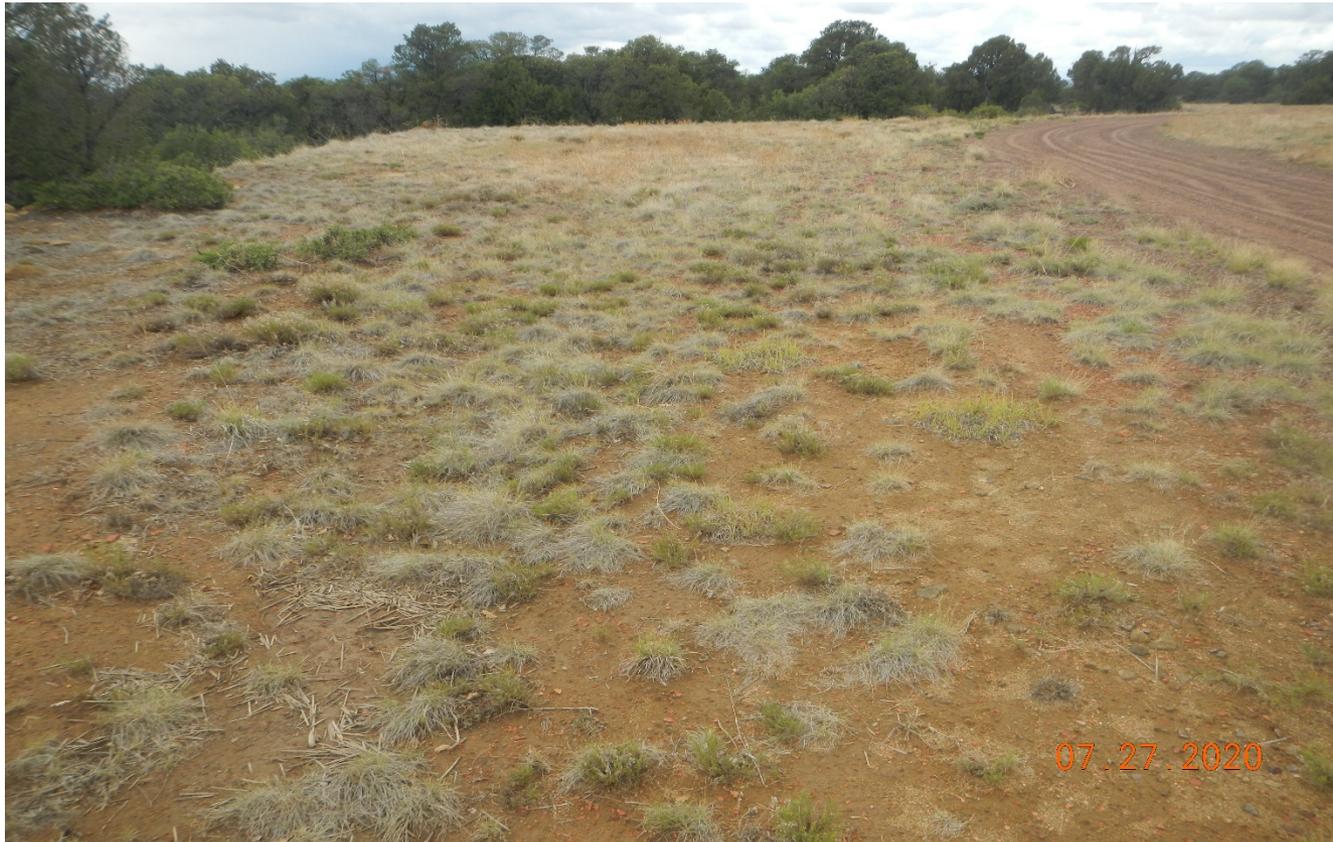
**Photo 5.** Facing northwest toward the location. The vegetation appears to be establishing well in areas of the location.

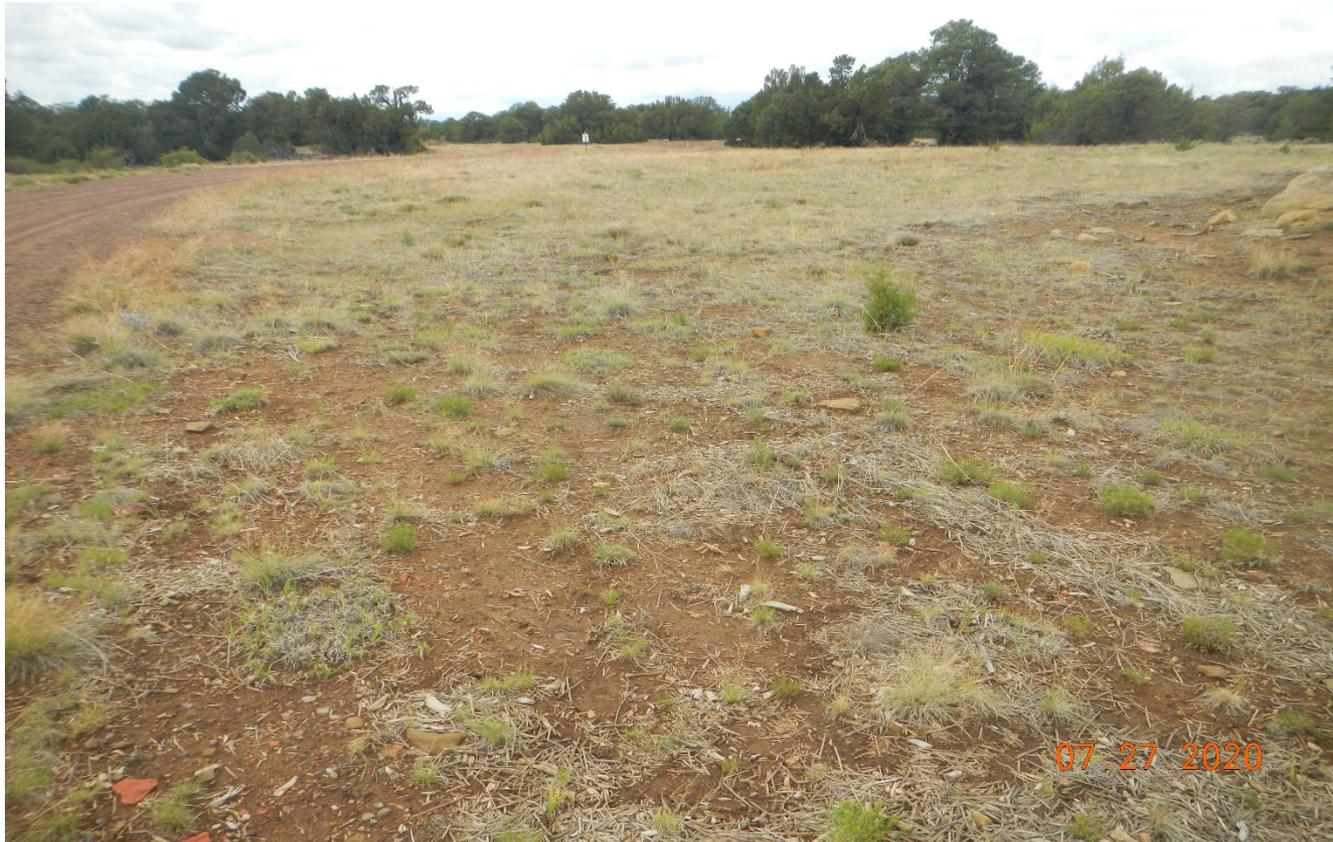
**Photo 6.** Facing northwest toward the location. The vegetation appears to be establishing well in areas of the location.

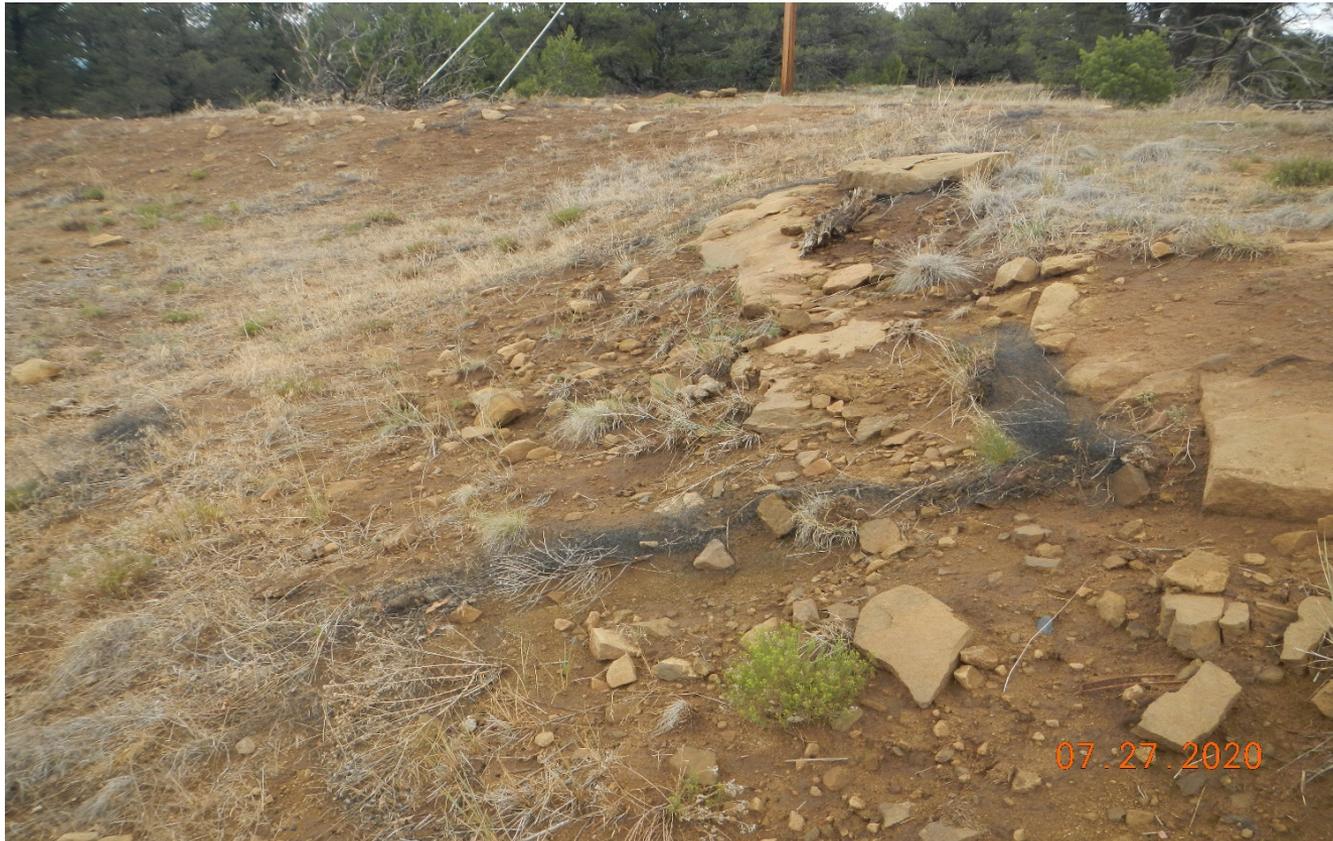
**Photo 7.** There is plastic netting debris along the southeast cut slope that needs to be removed.

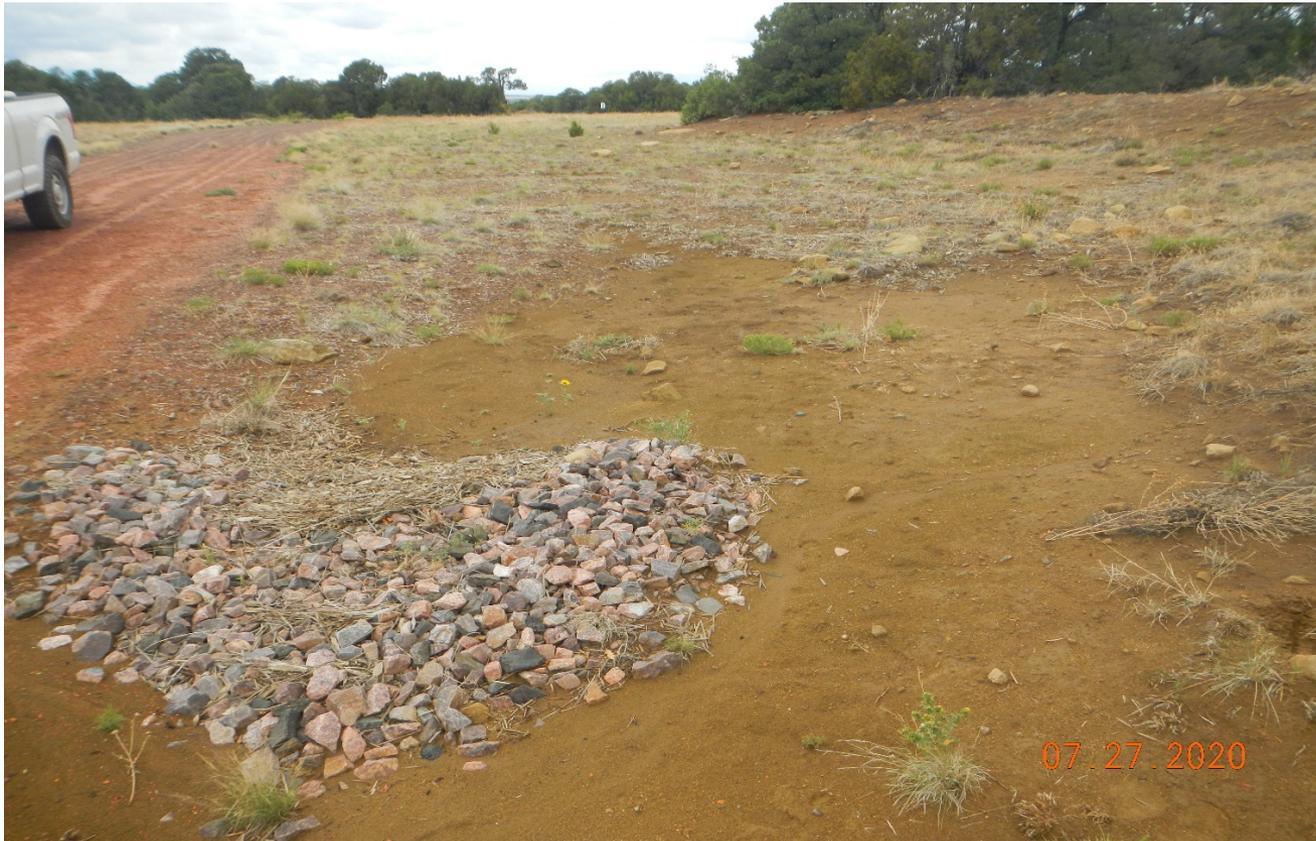
**Photo 8.** Facing northwest at the south side of the location. This area is bare of vegetation and is not stabilized.

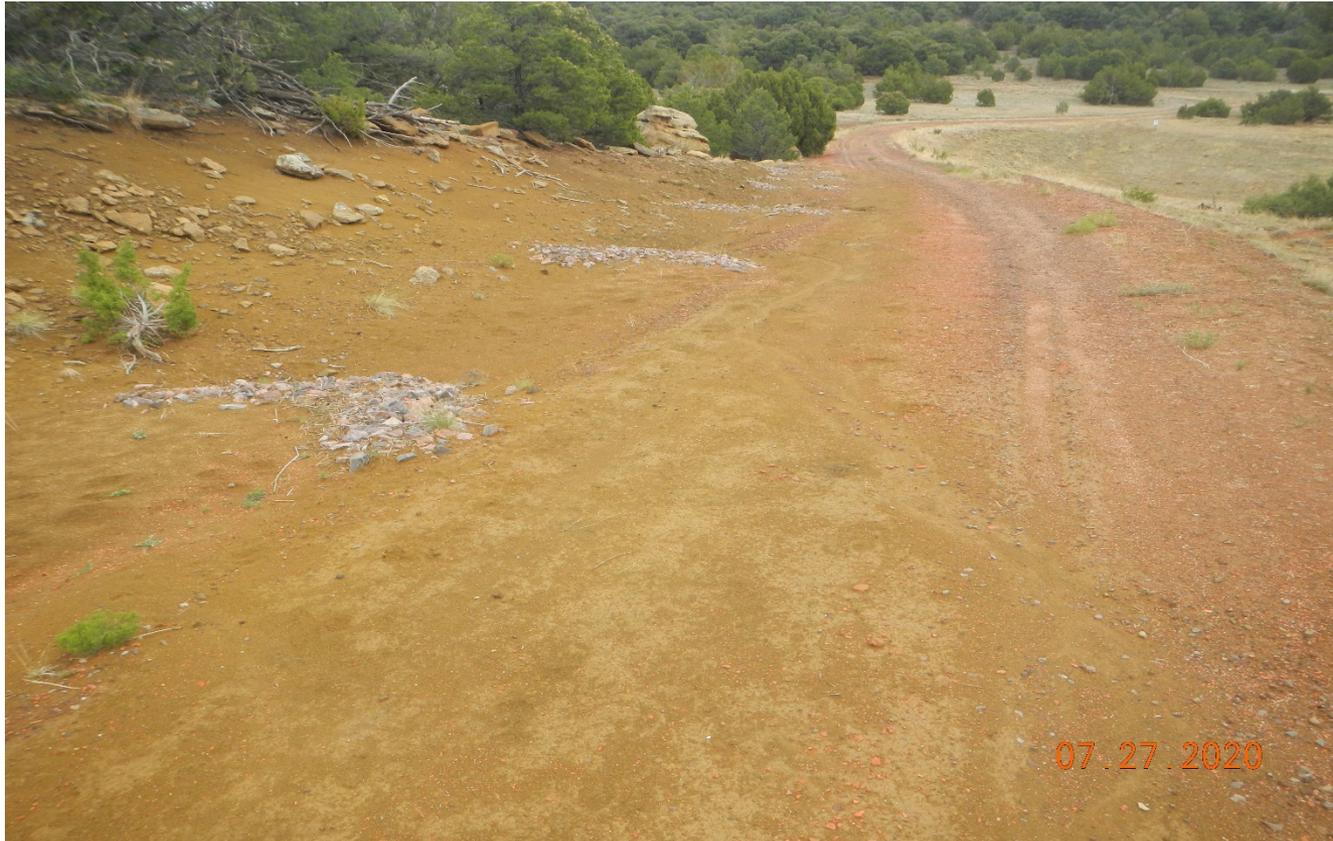
**Photo 9.** Facing southeast at the south side of the location. The access road continues toward the State 10WB. This check damn has filled in with sediment. The side of road needs to be seeded and stabilized.
