Inspection Photos
Location Name: Ikey#1
Location ID: 428987

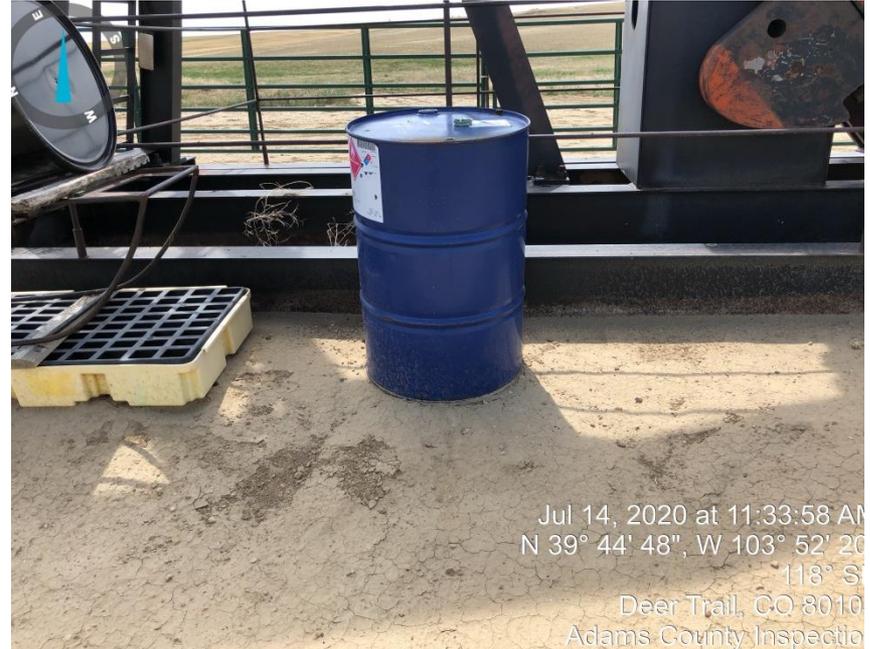
Photo#2 Corrective Action barrel need to be in secondary containment.
