Inspection Photos

Location Name: MARALEX RESOURCES INC SULFUR GULCH 9-98-10-69S98W /10NWNW

Location ID: 312654

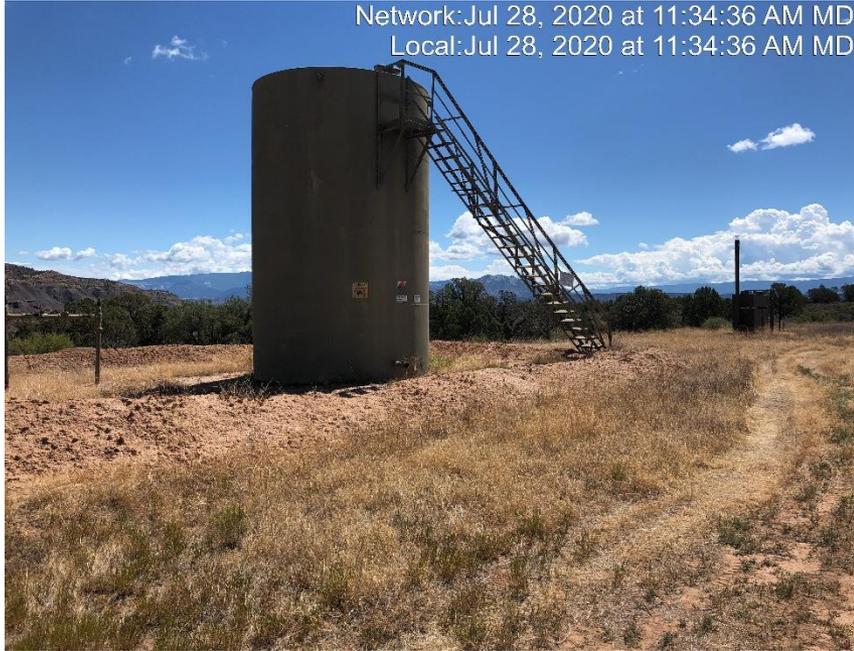
Photo #1629 from entrance to location

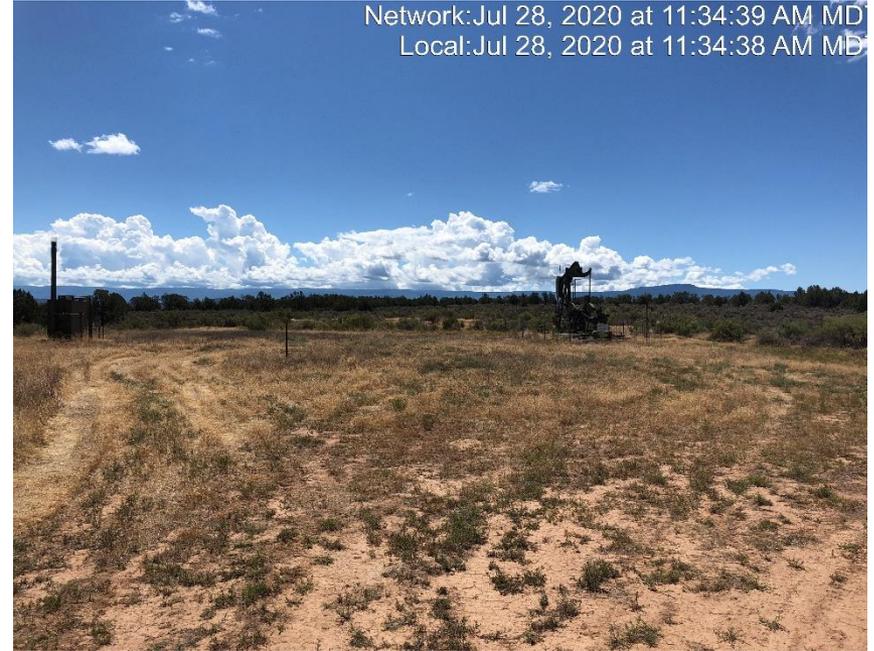
Photo #1630 from entrance to location

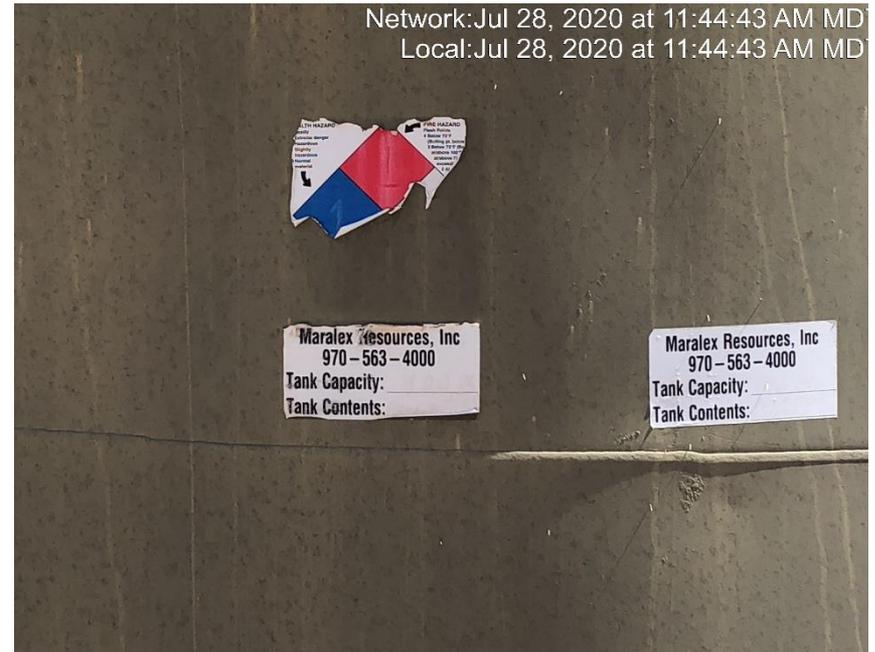
Photo #1631 Tank capacity, contents and NFPA labels weathered and not legible.

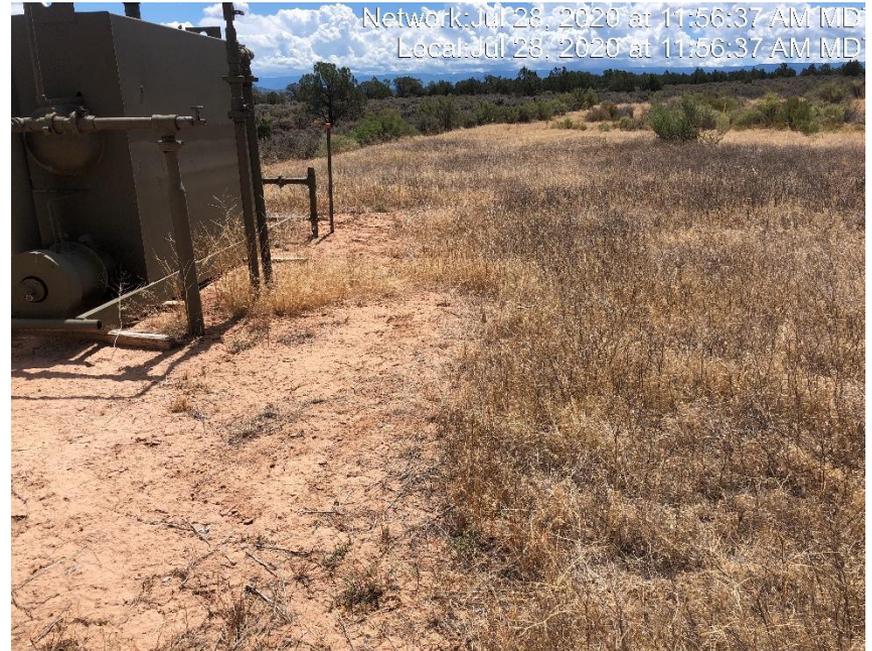
Photo #1632 Multiple places with debris on location.

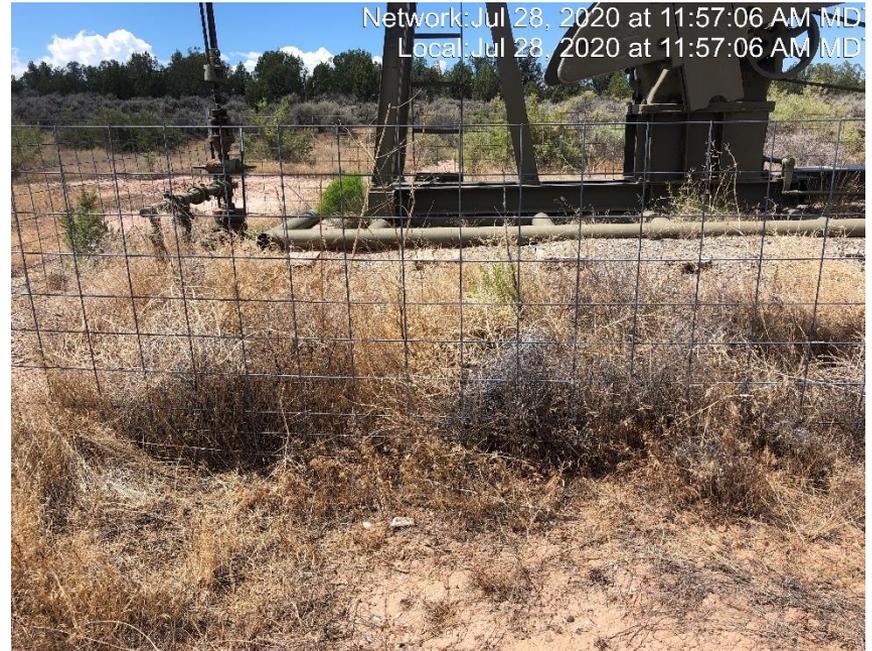
Photo #1633 Multiple places with debris on location.
