Inspection Photos

Location Name: MARALEX RESOURCES INC USA-69S98W /18NESW

Location ID: 312548

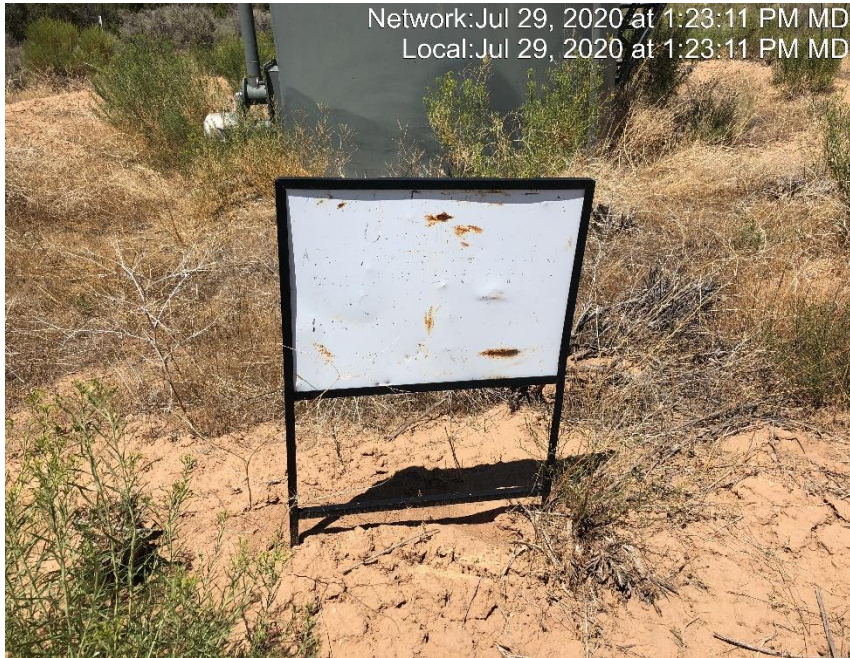
Photo #1639 Battery sign is weathered and not legible.

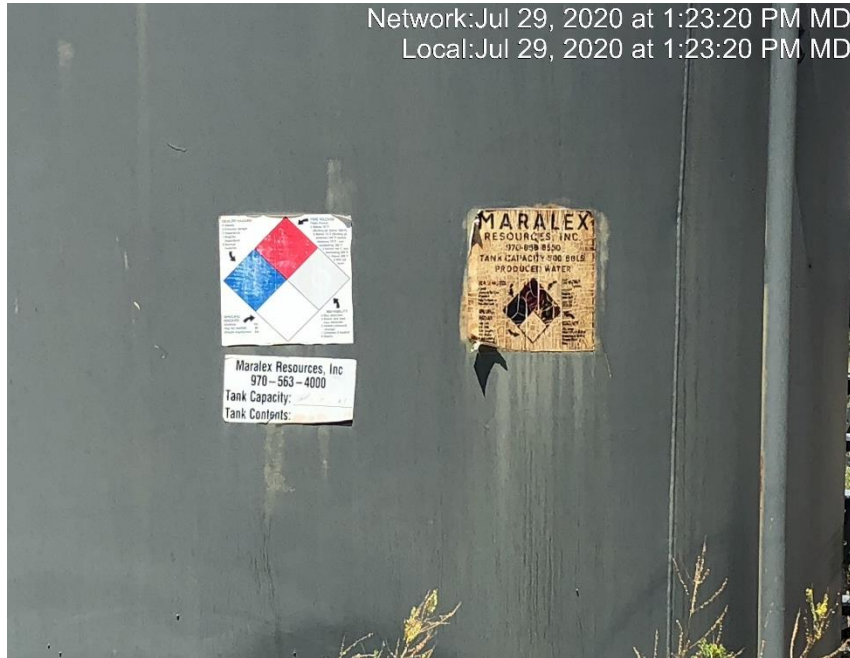
Photo #1640 Tank capacity, contents and NFPA label weathered and not legible.

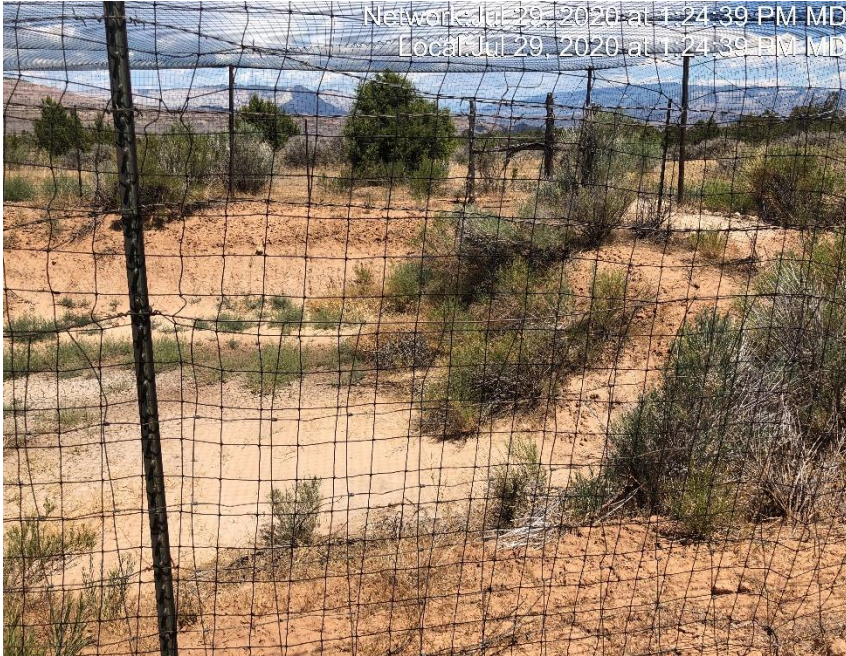
Photo #1642 Multiple places with debris on location.

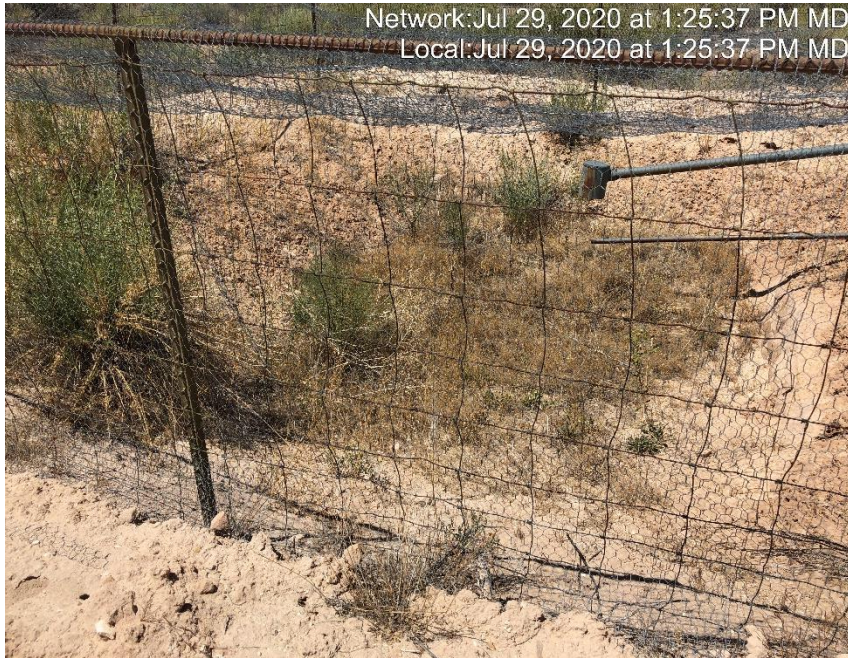
Photo #1643 Multiple places with debris on location.

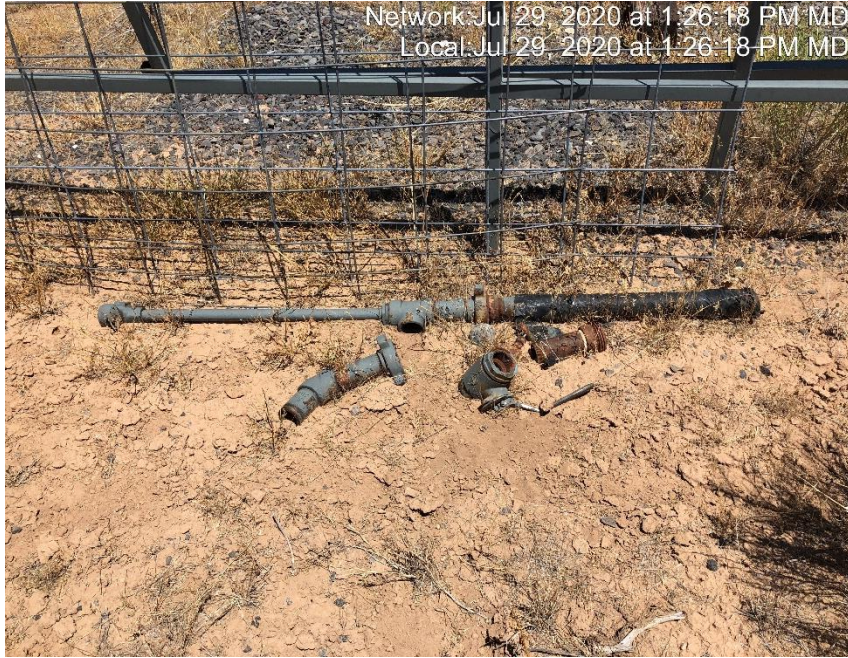
Photo #1644 Unused supplies and equipment.

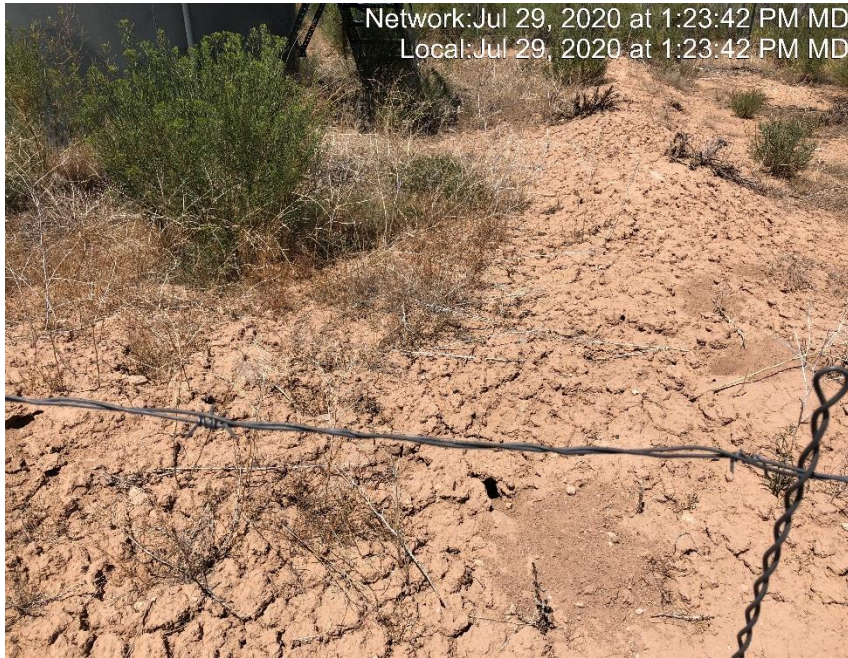
Photo #1641 Tank berm has eroded.
