# Inspection Photos

7/24/2020

Operator: TEP ROCKY MOUNTAIN LLC - 96850

Location ID: 334754

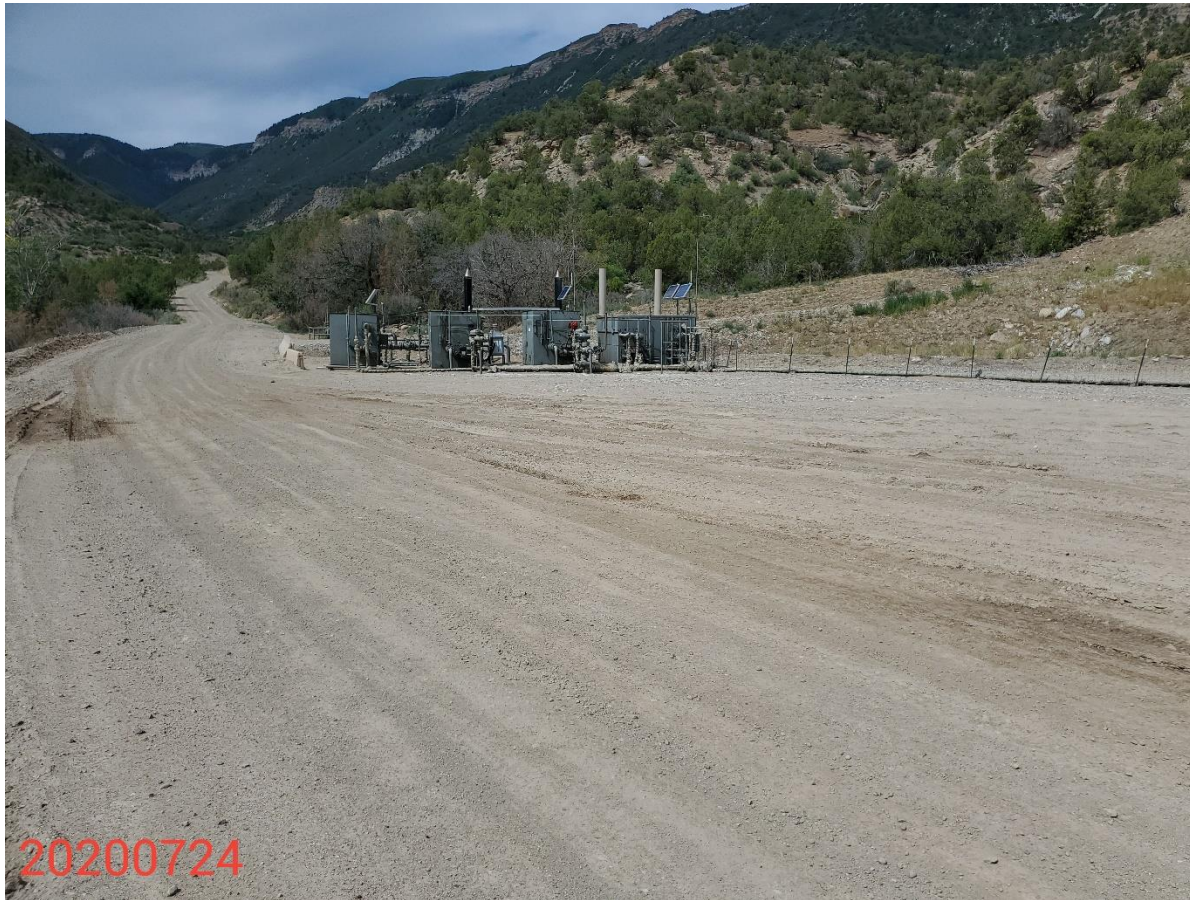
**Photo 1:** Photo taken from the east end of the production area, facing south. Photos 1-4 provide an overview of the Location from south, southwest, northwest to north.

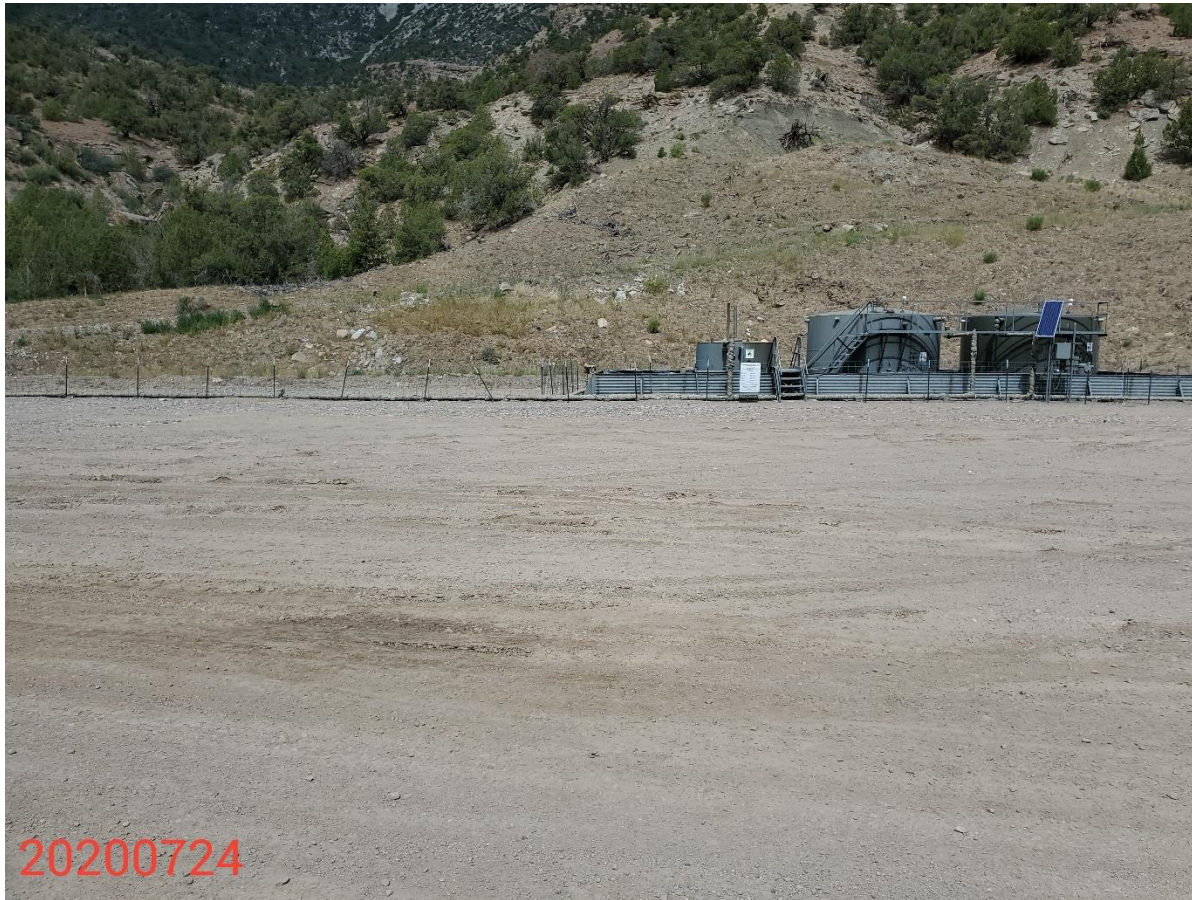
**Photo 2:** See comments under photo 1.

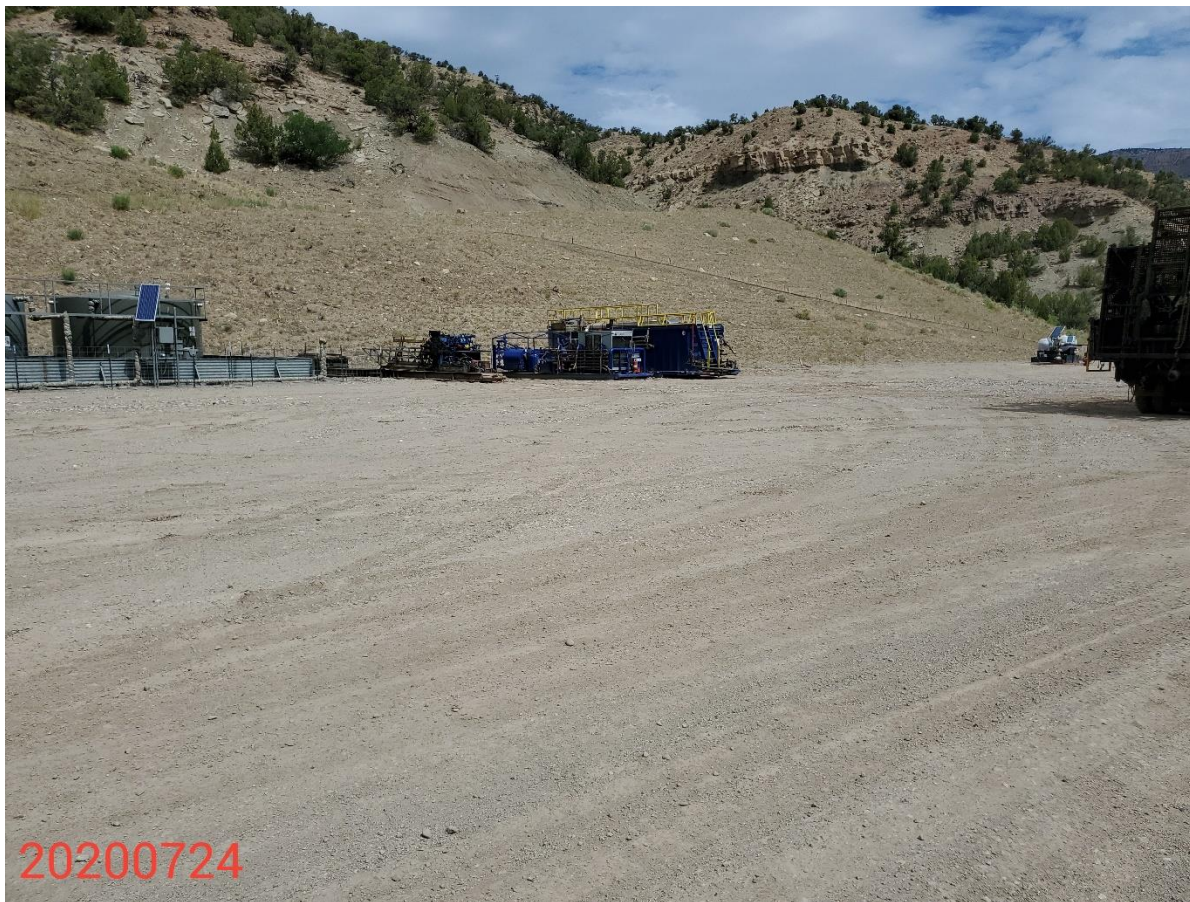
**Photo 3:** See comments under photo 1. Photo also shows unused equipment, or equipment not needed for production stored on the western areas of the Location.

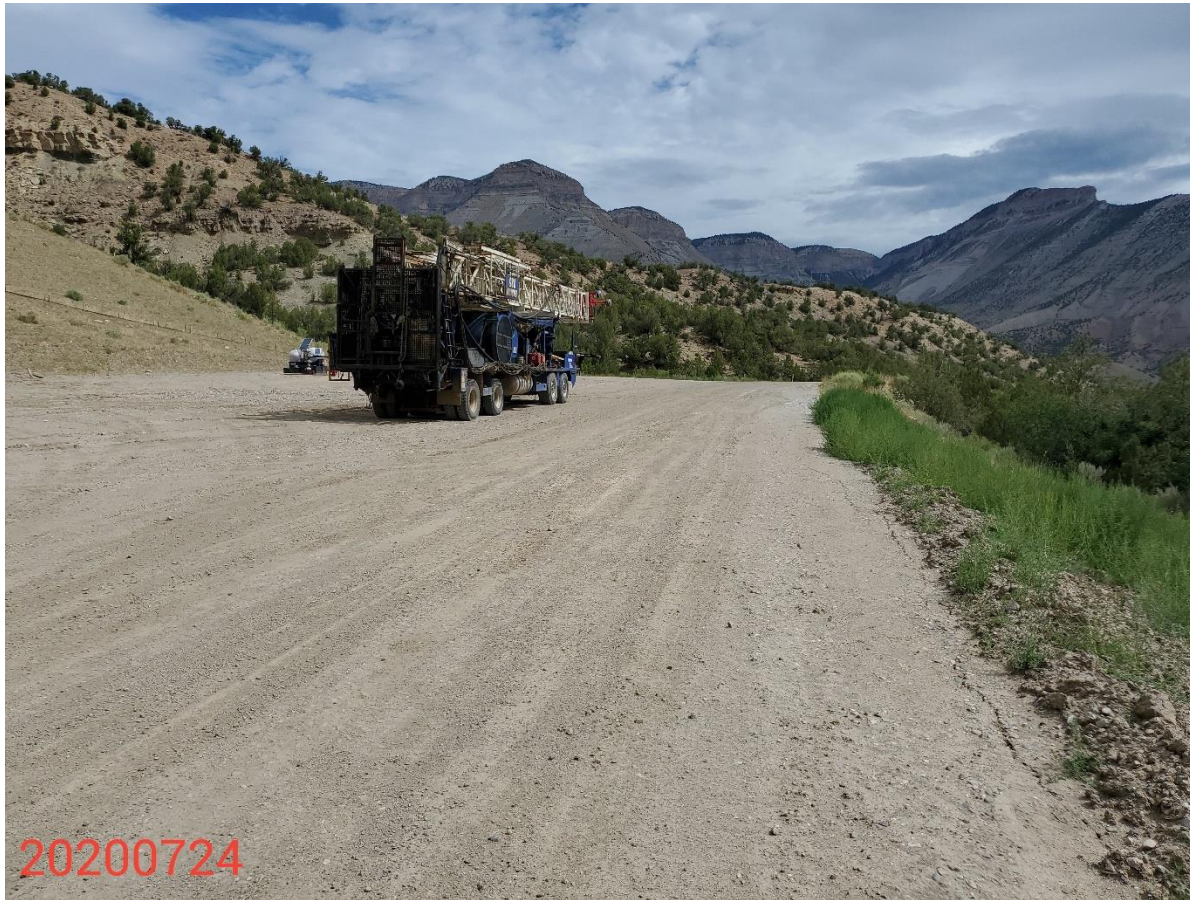
**Photo 4:** See comments under photo 1. Photo also shows unused equipment, or equipment not needed for production stored on the Location.

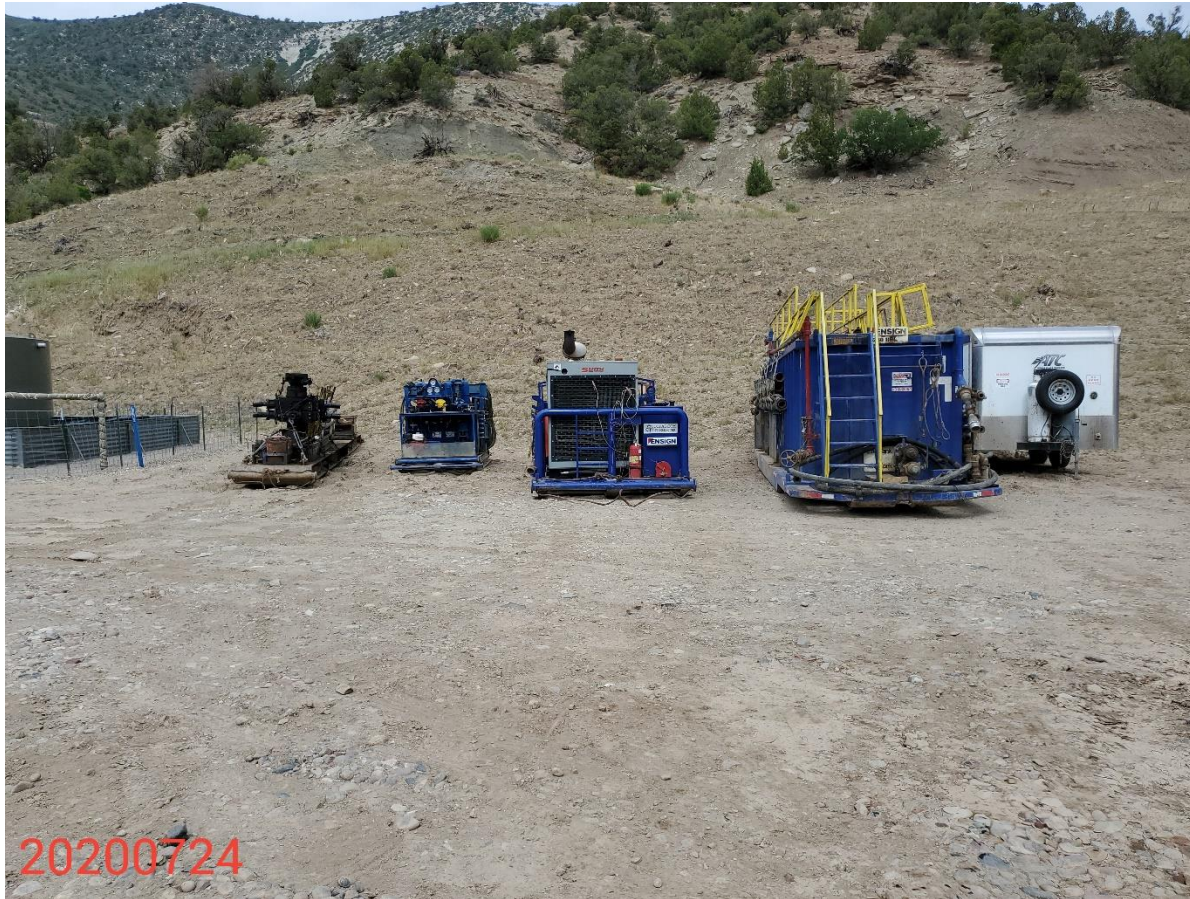
**Photo 5:** Photo taken from the west end of the Location. Photo shows unused equipment, or equipment not needed for production stored on the western areas of the Location.

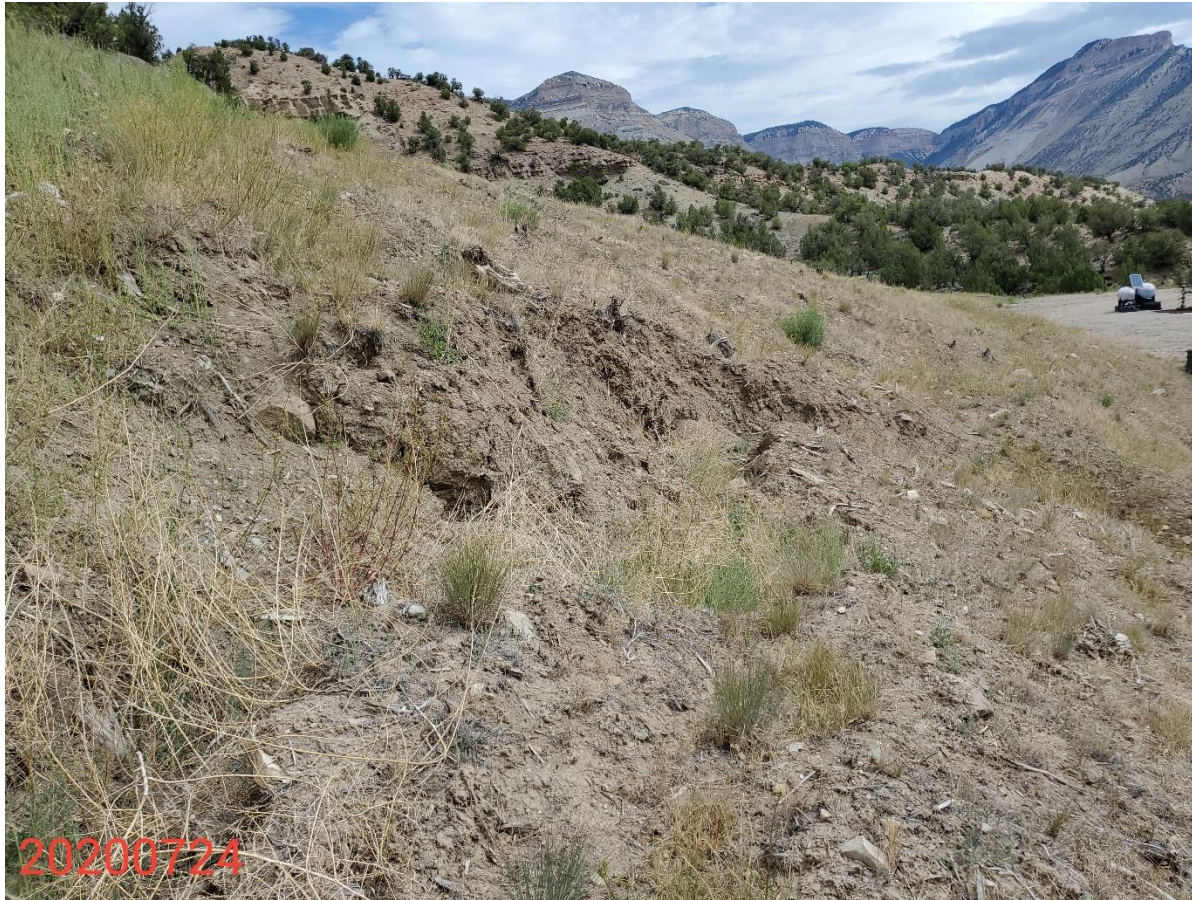
**Photo 6:** Photo taken from the southwestern interim areas, facing north. Photo shows erosion degradation on the slopes; Slopes do not appear to be sufficiently stabilized.

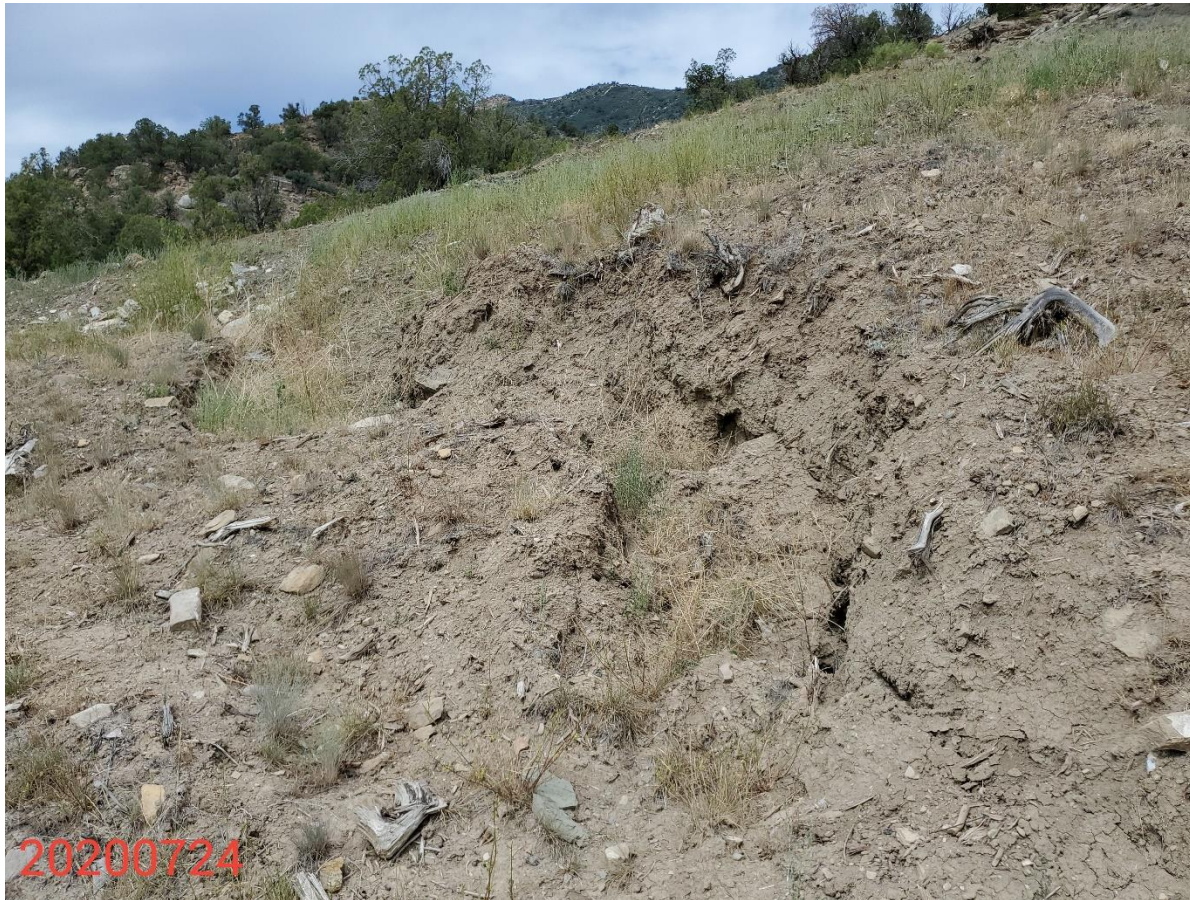
**Photo 7:** Photo taken from the southwestern interim areas, facing southwest. Photo shows erosion degradation on the slopes; Slopes do not appear to be sufficiently stabilized.
