Captiva Energy Partners LLC

Inspection Compliance Photos

Date of COGCC Inspection: May 8, 2020

Location Name: McCoy Pad 13-33

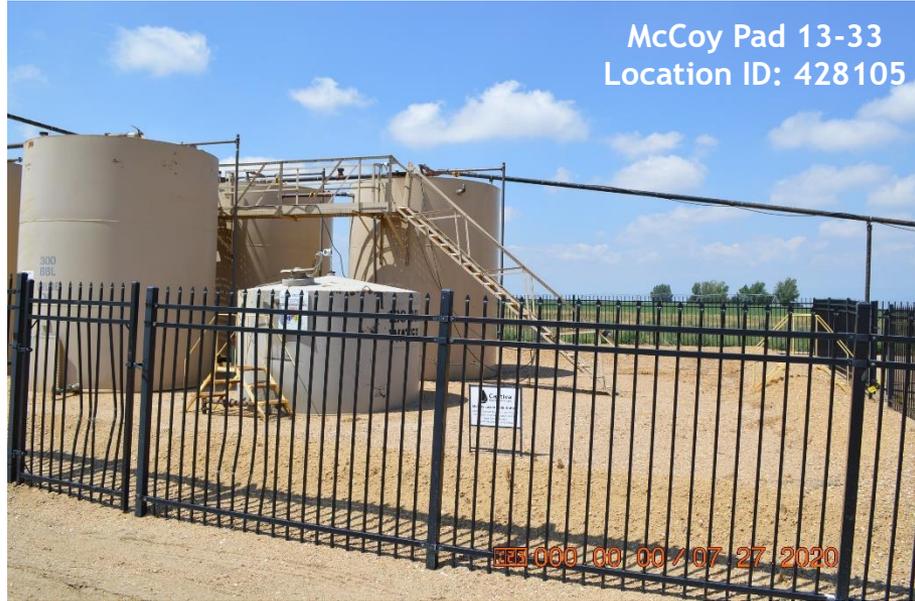
Mountain West Vegetation
Management Inc. sprayed location
weeds on June 10, 2020

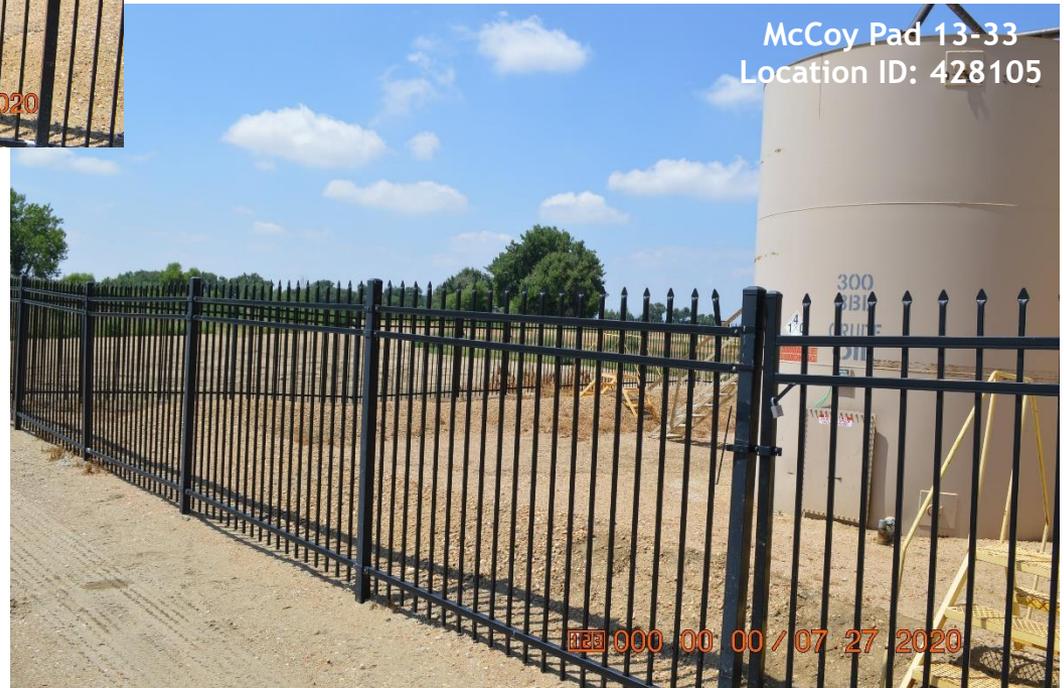
Compressor and Sump Removed

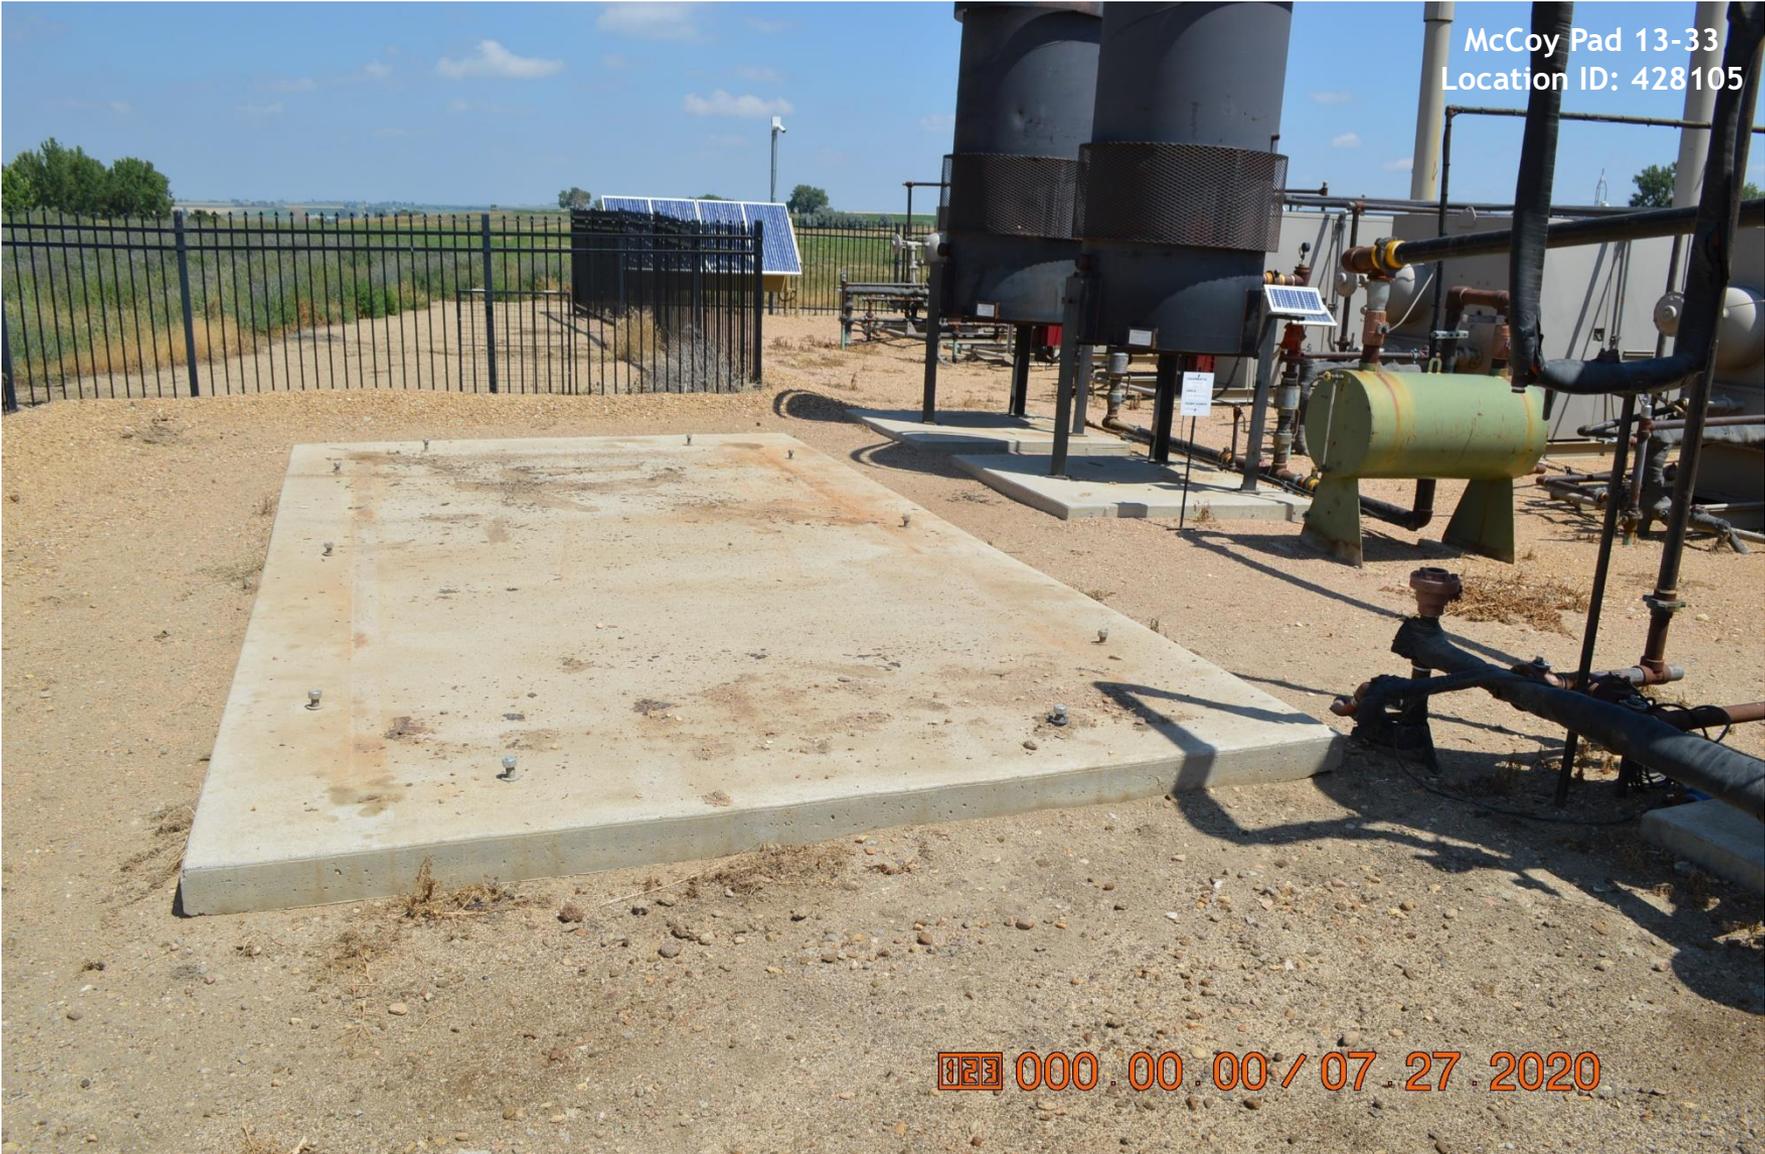
Sump and Stained Soil Removed

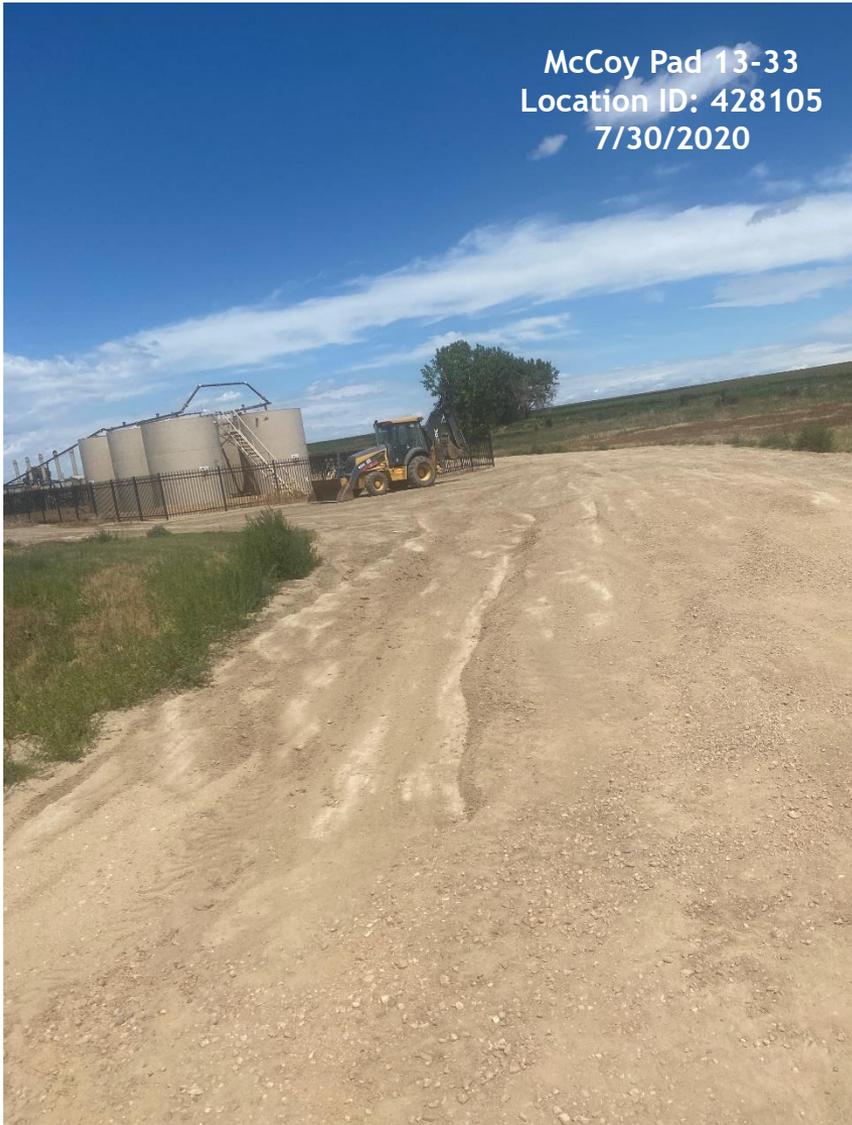
Lease road coming on to McCoy Pad 13-33 pad
(looking northeast)

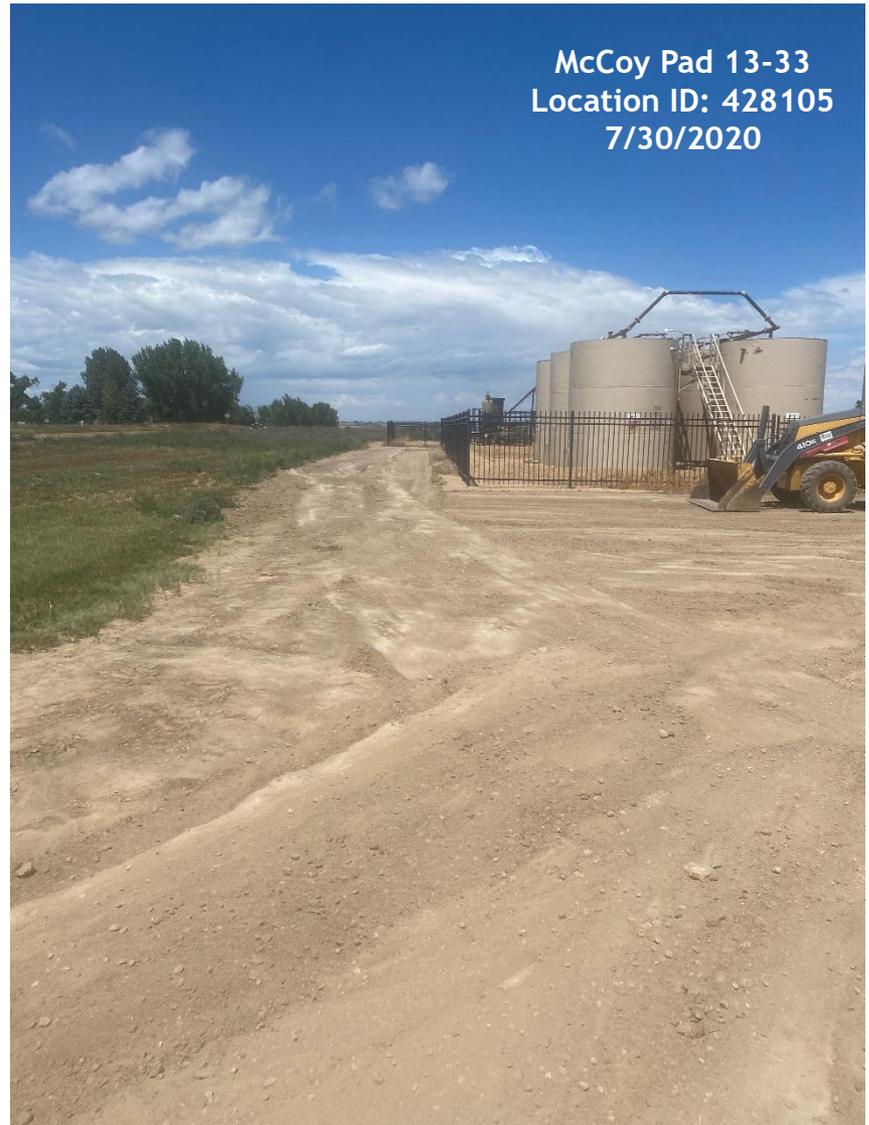
Graded drive west of tank battery
(looking north)

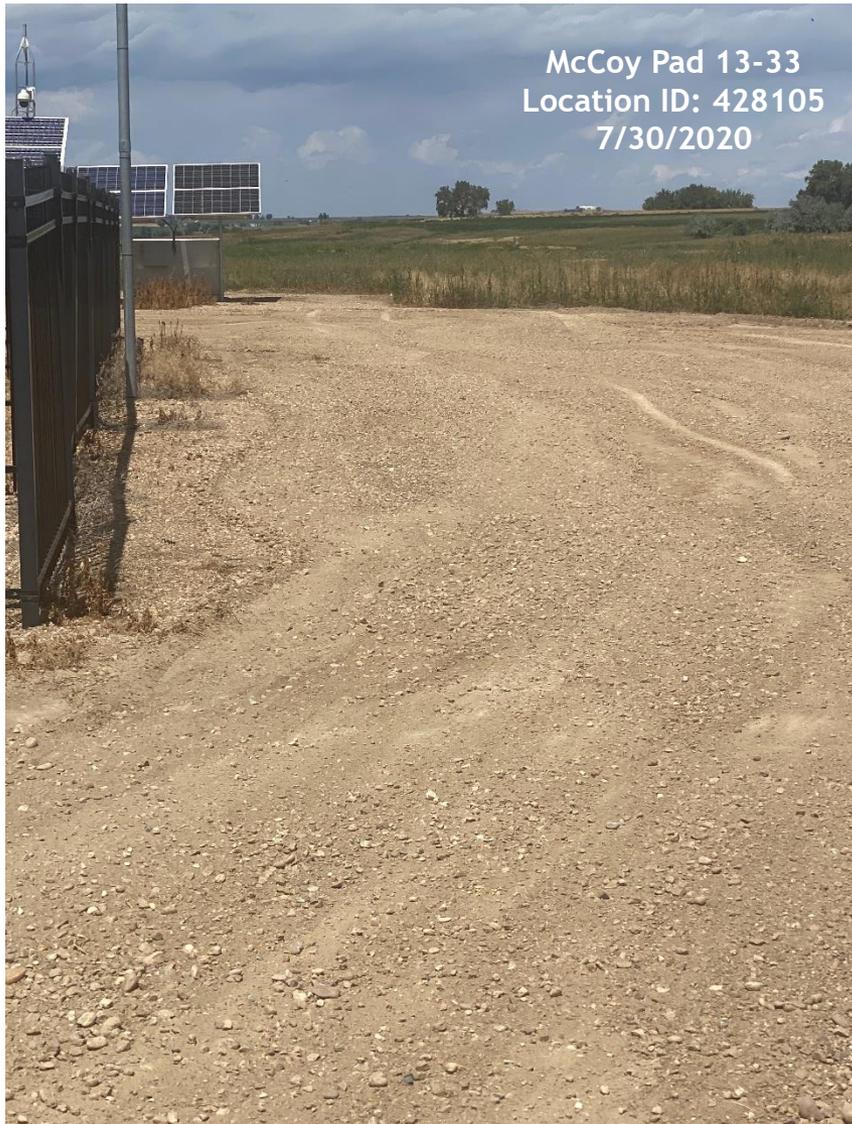
**Pad area east of wellheads
(looking north)**

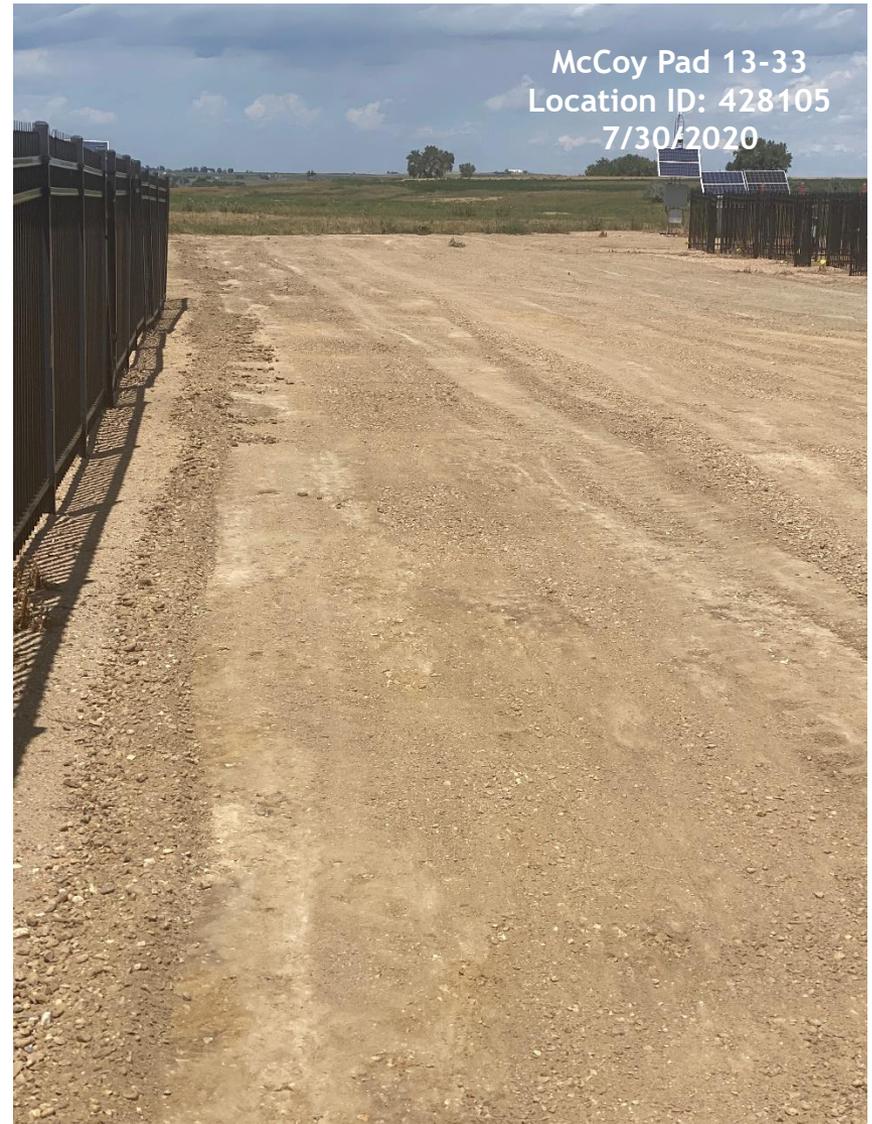
**Pad area between wellheads and separators
(looking north)**
