Inspection Photos  
Operator: ConocoPhillips  
API: 067-08199  
Date: 7/28/2020

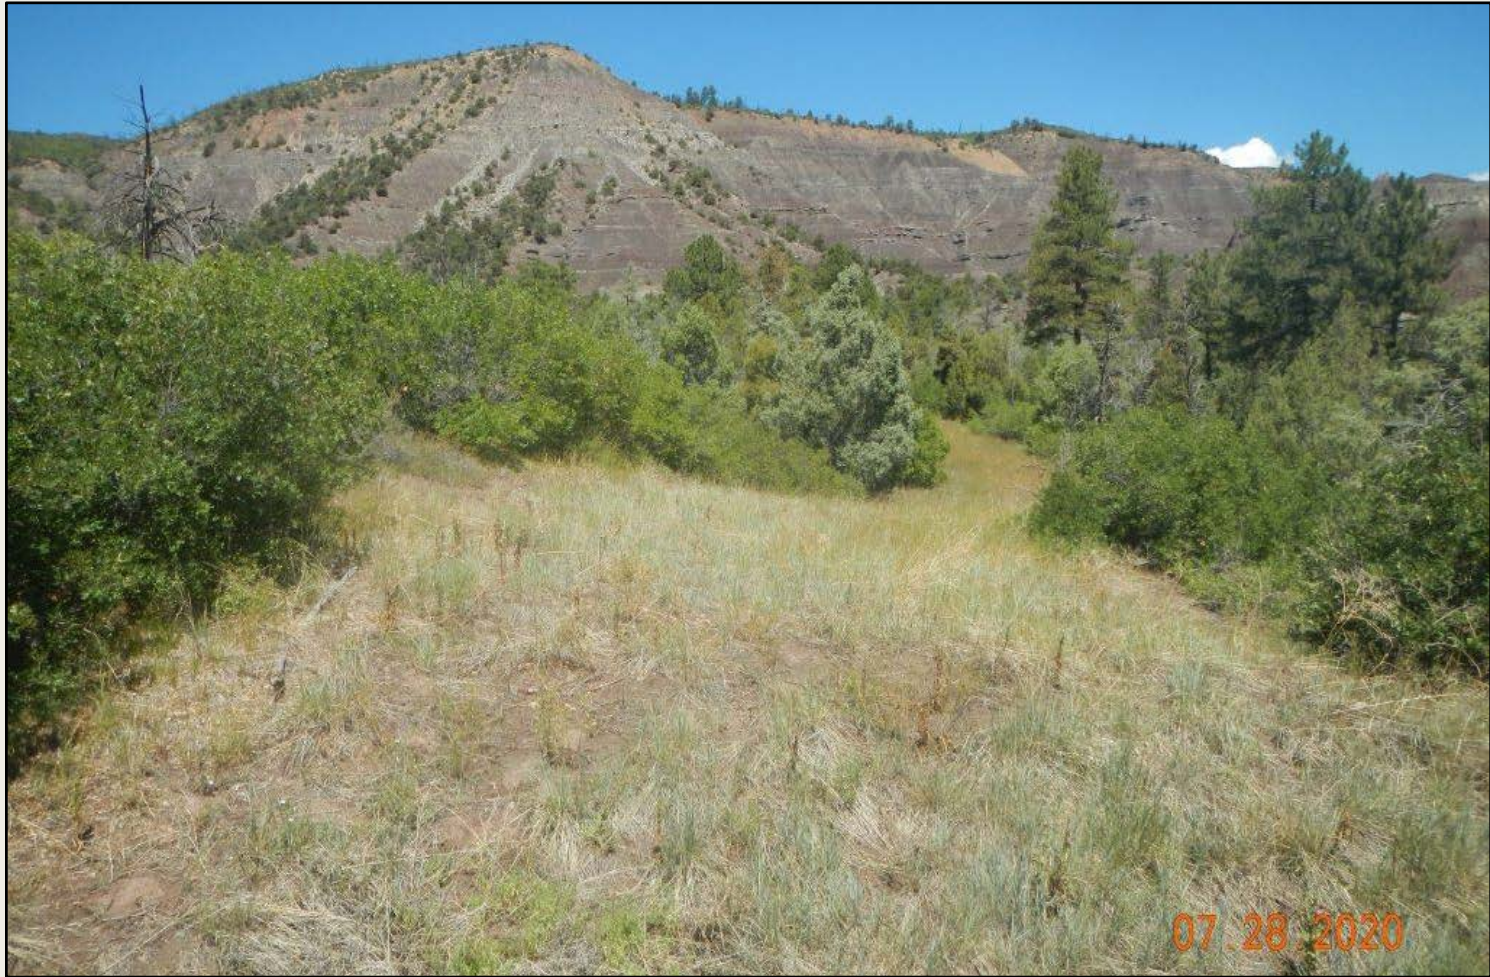
Photo 1. View of access road from the eastern portion facing westward. Revegetation is progressing with western wheatgrass, squirreltail, and smooth brome, as well as forbs such as yellow sweetclover.

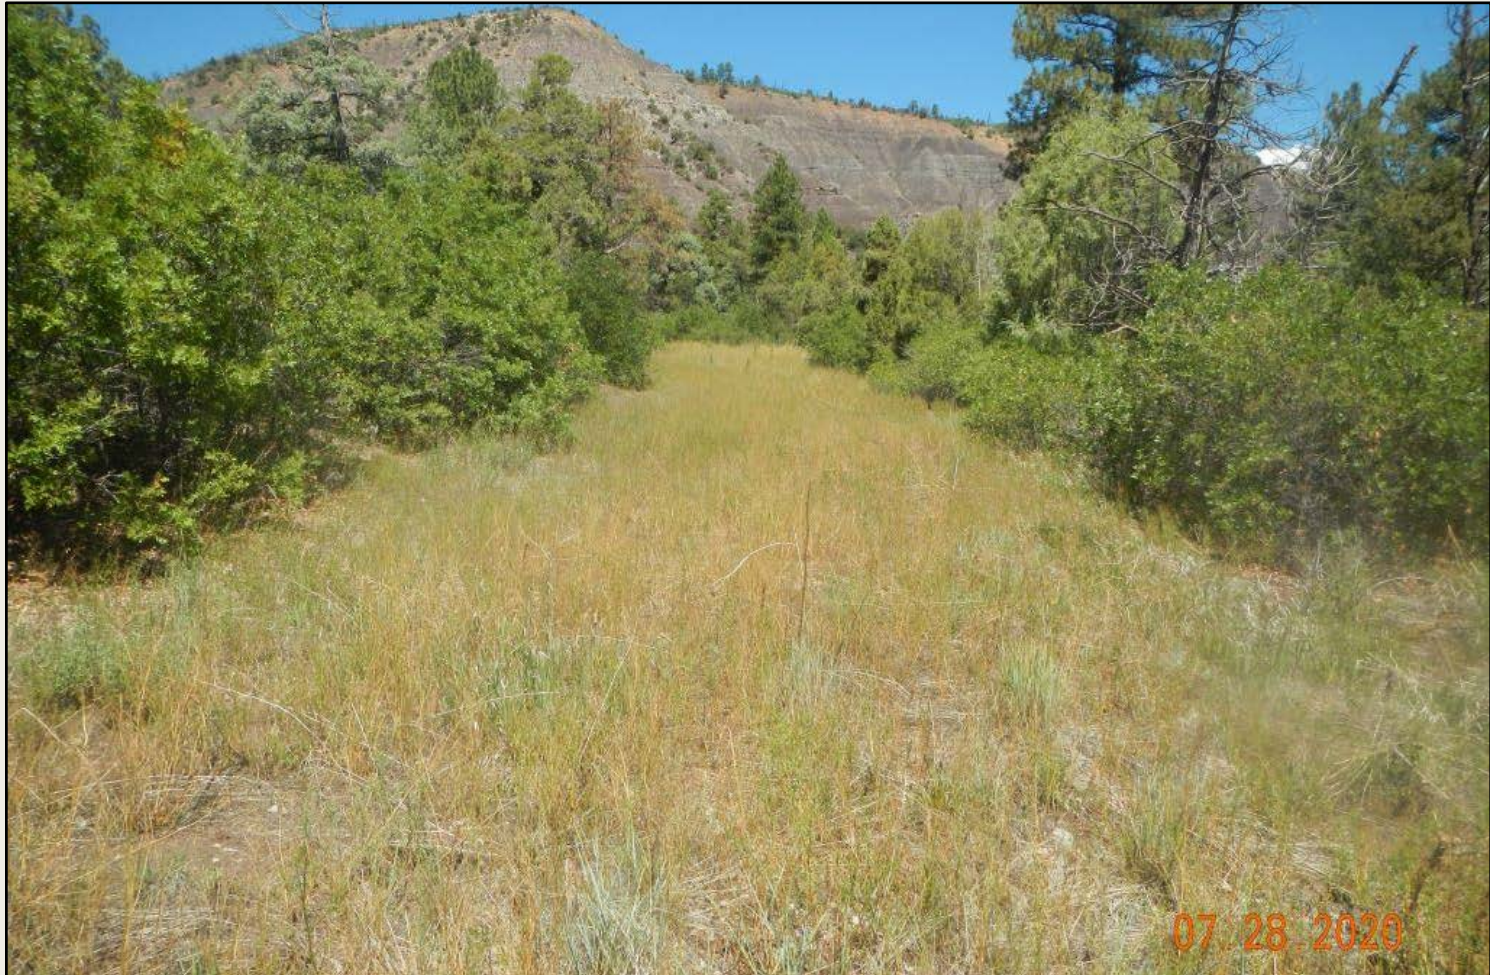
Photo 2. View of the central portion of the access road facing westward. Revegetation is progressing here.

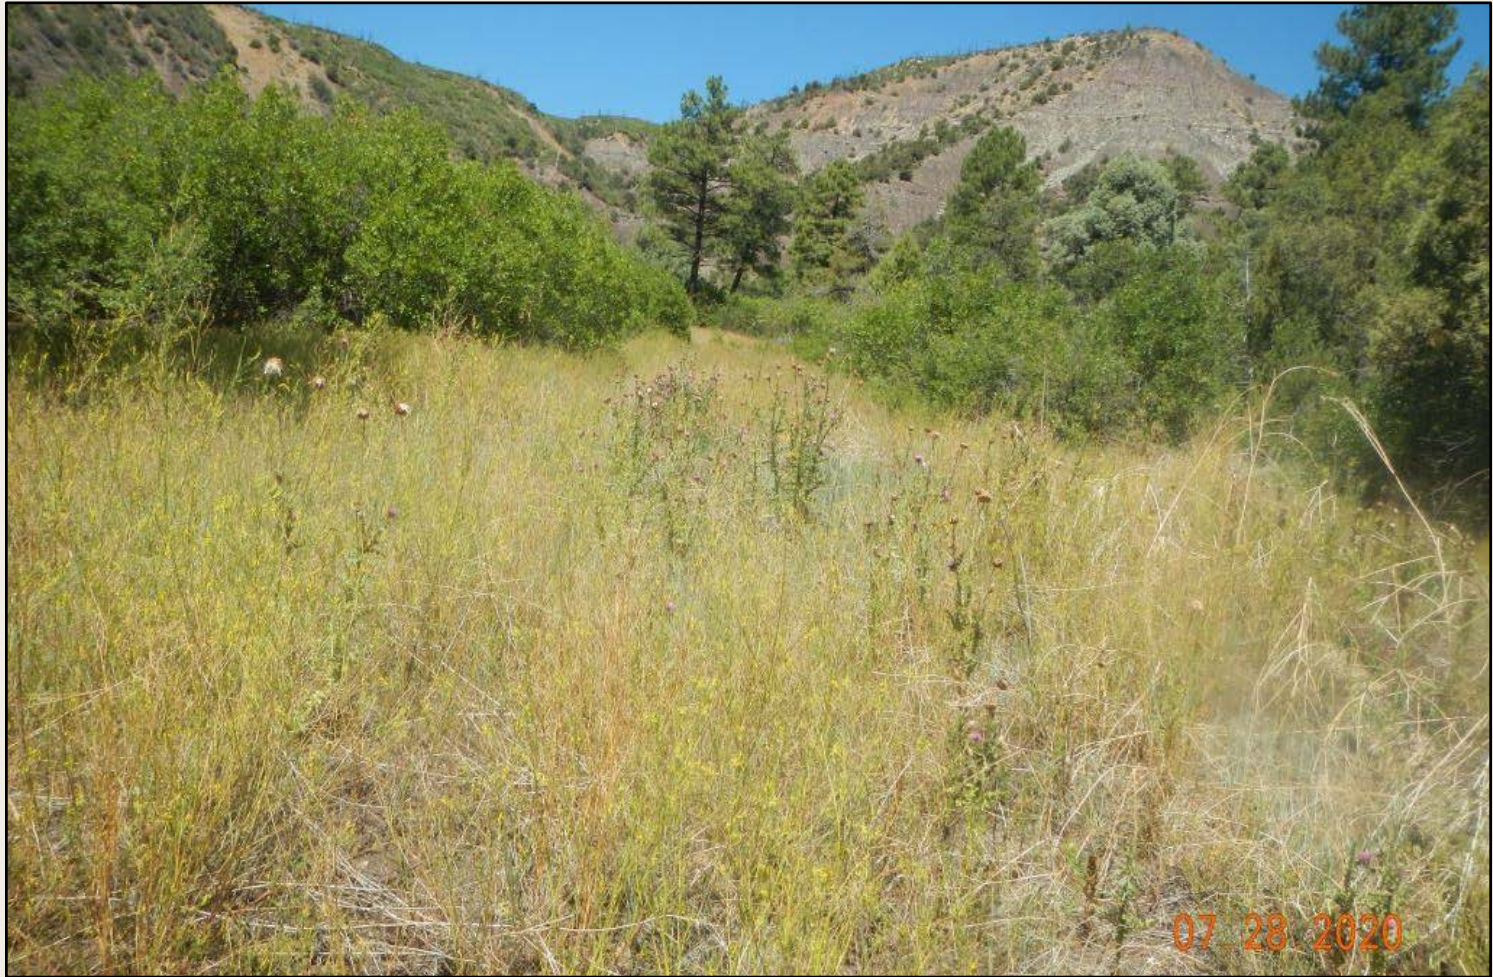
Photo 3. View of the western portion of the access road, facing northward. Revgetation is progressing, although musk thistles need to be controlled.

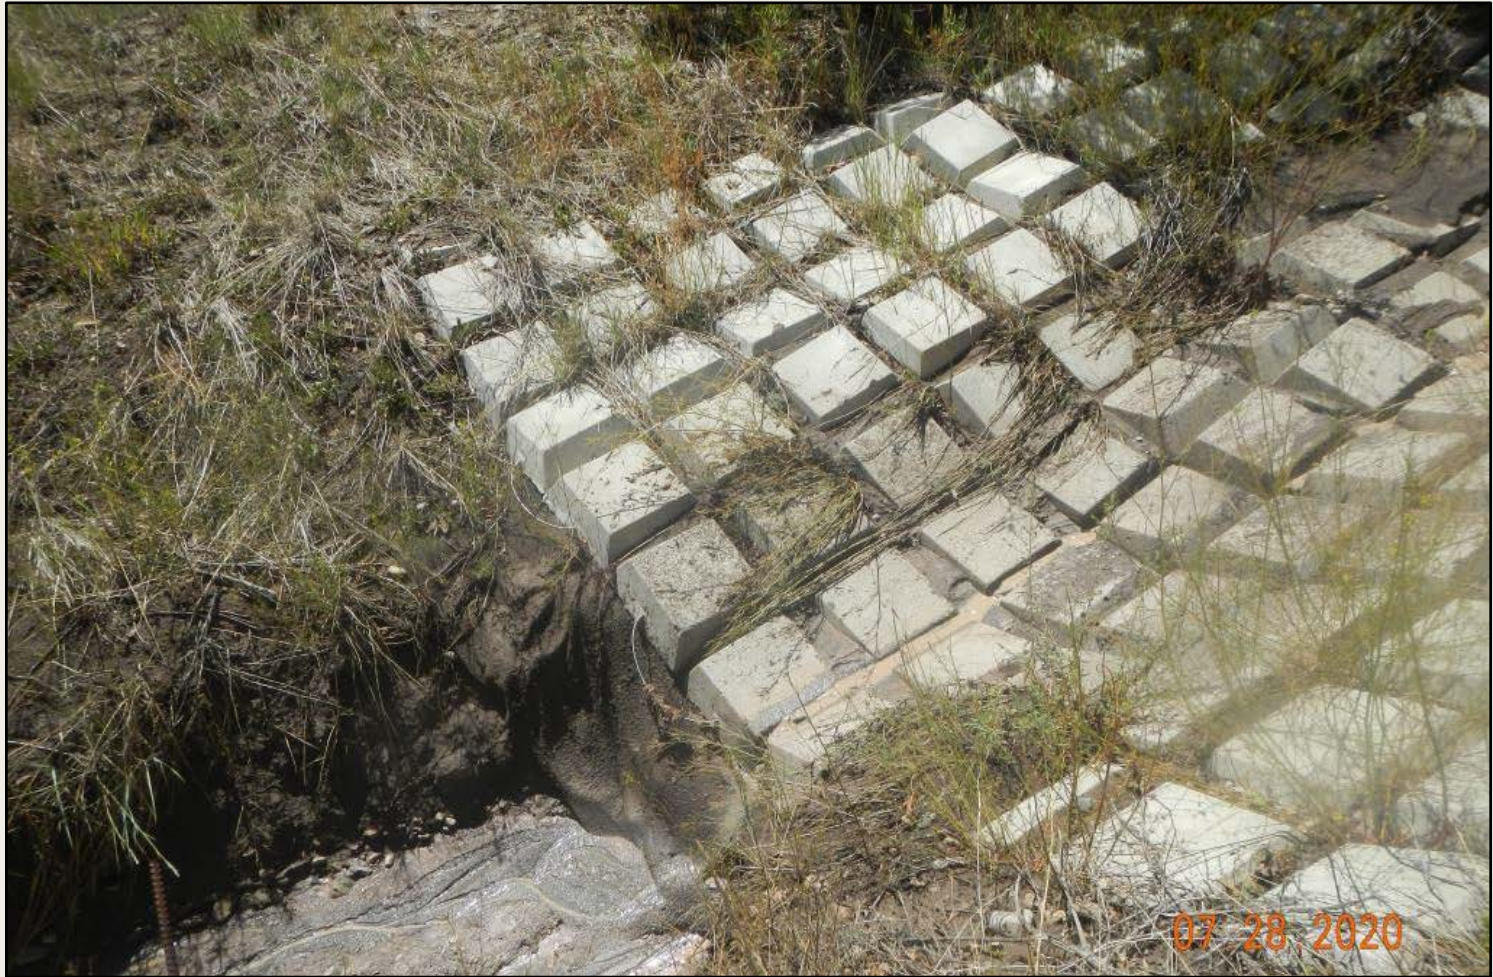
Photo 4. View of area at cement BMP, needing additional stabilization. Erosional downcutting is approximately 2.5 feet deep.

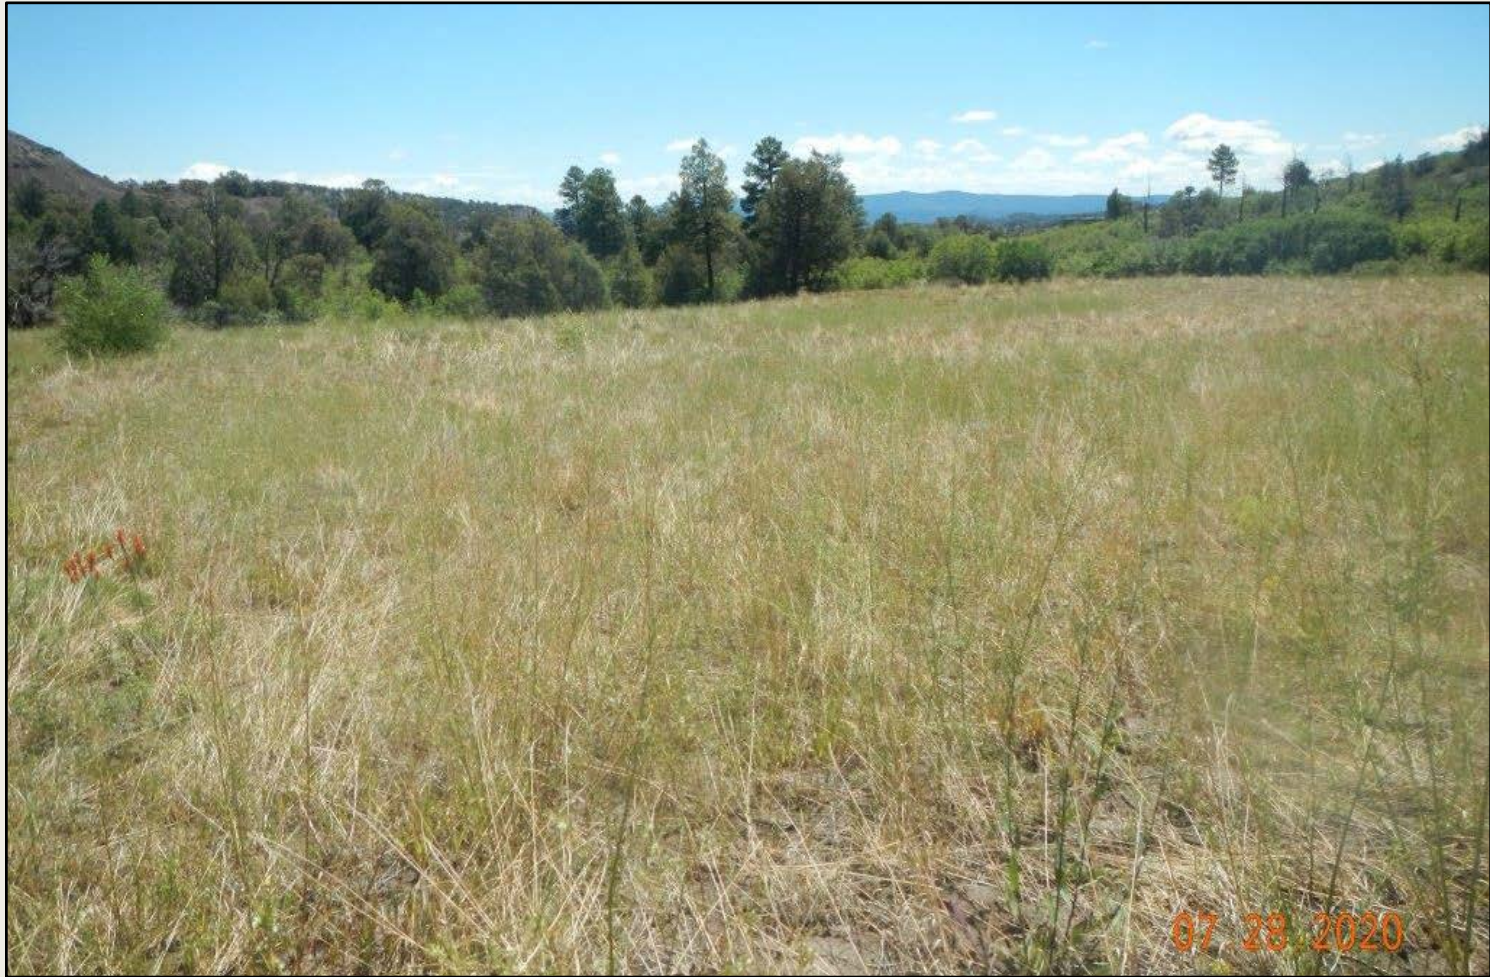
Photo 5. View of the project area from the southwestern corner facing center. Vegetation is becoming established.

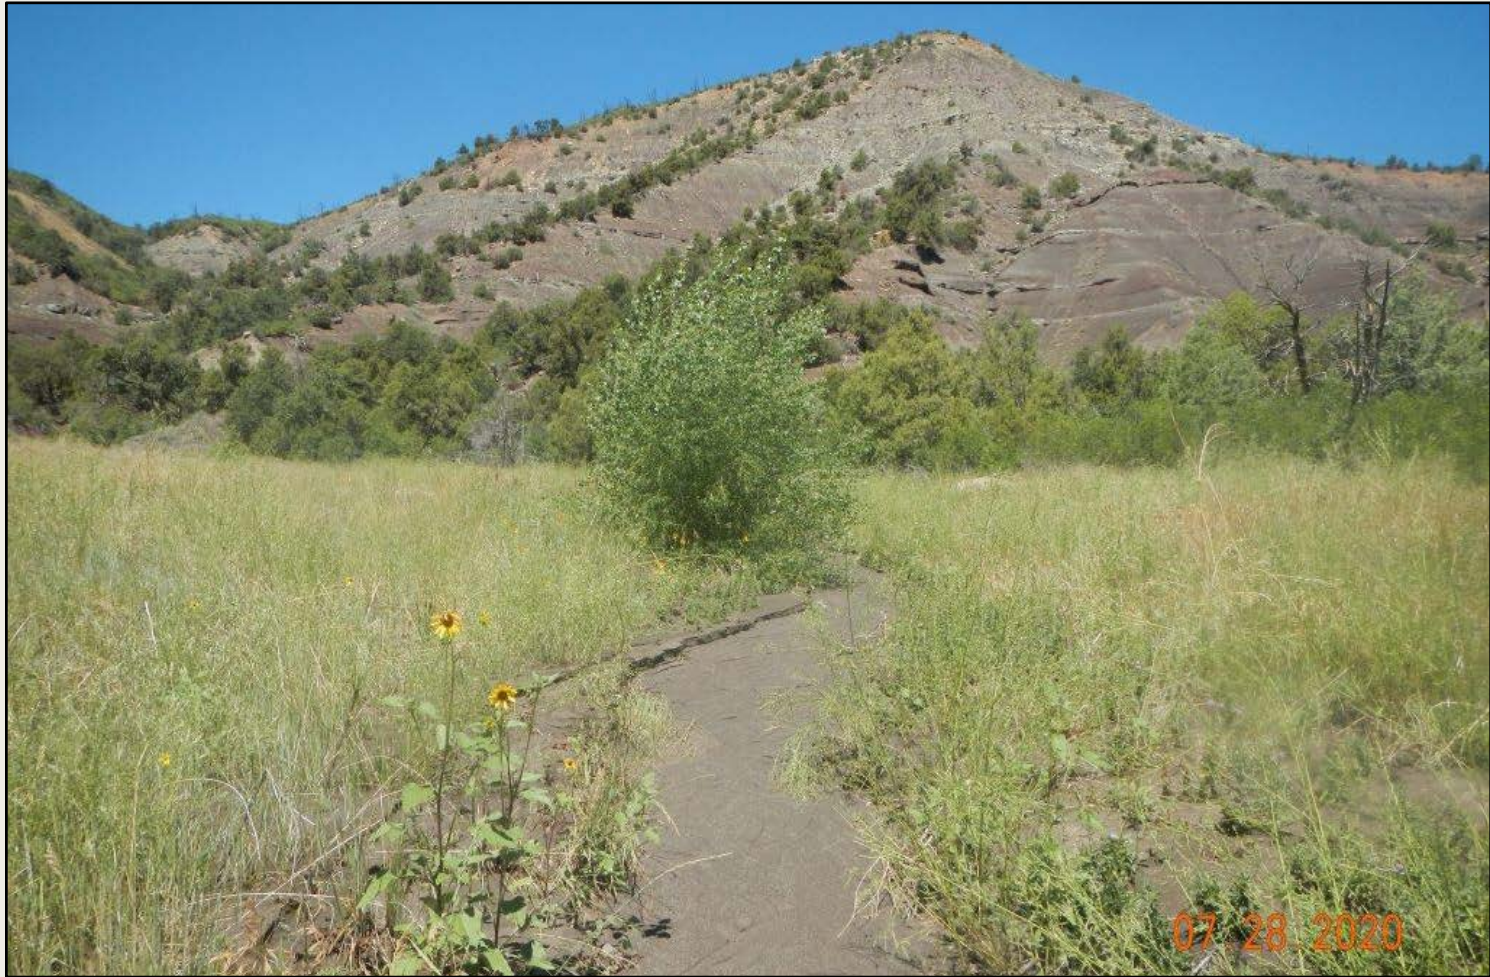
Photo 7. View of drainage channel that was re-connected at reclamation. Drainage elevation is approximately the same as up-stream elevation and appears to be functioning.

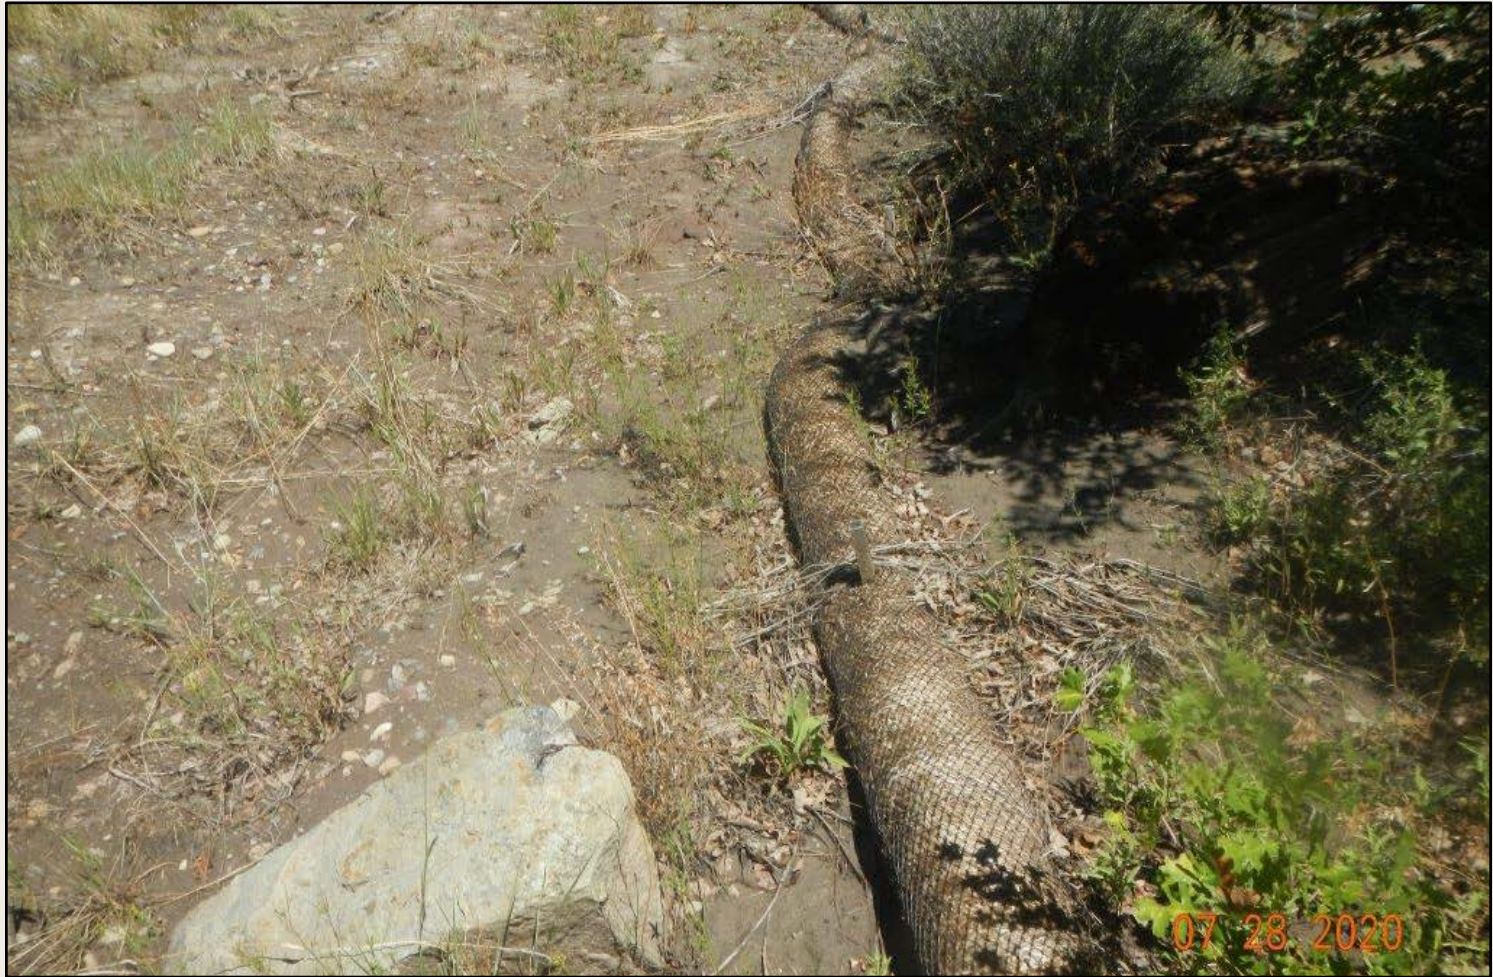
Photo 8. View of perimeter wattle that needs to be removed.
