# Inspection Photos

Operator: CHEVRON USA INC - 16700

Location ID: 382974

Garfield County, CO

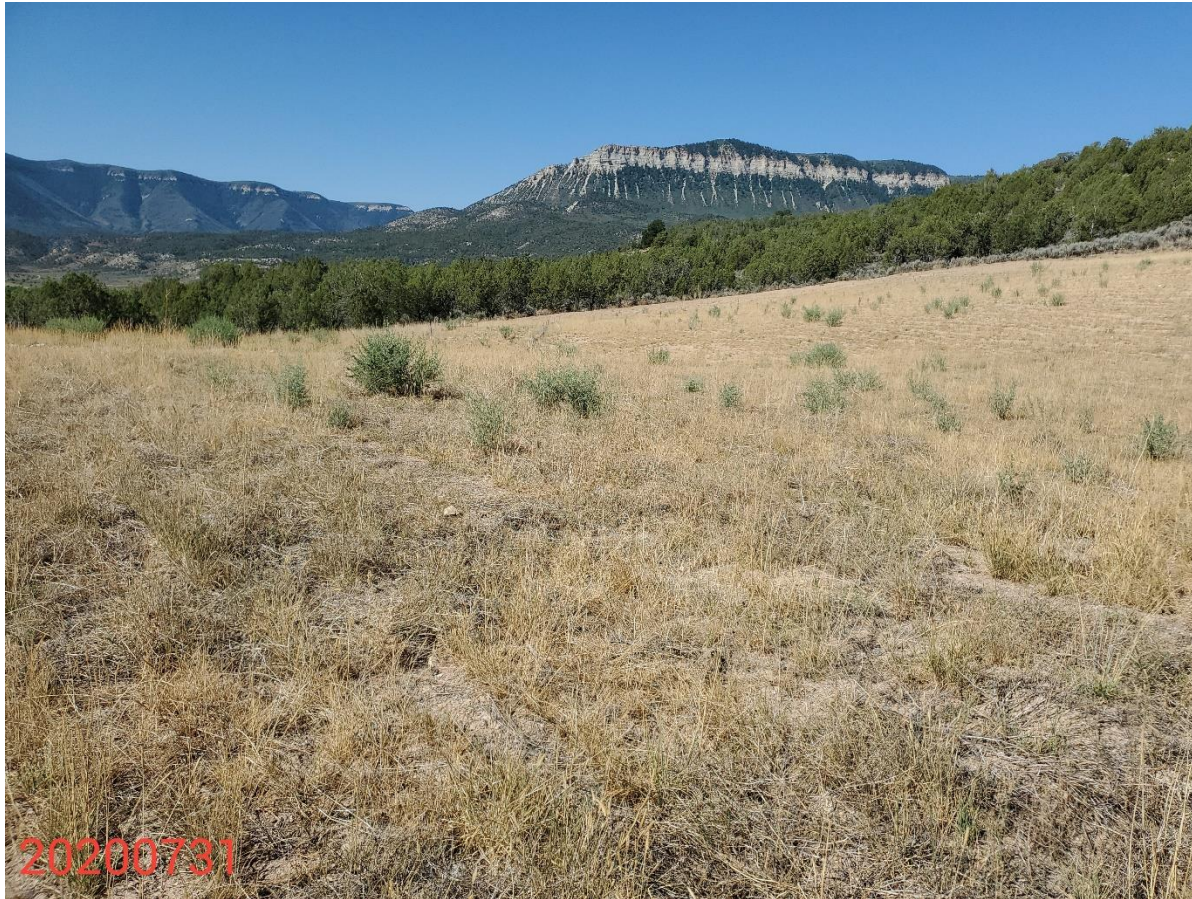
**Photo 1:** Photo taken from the east end of the location facing southwest. Photos 1-4 provide an overview of the Location and reclamation from southwest, west, northwest to north.

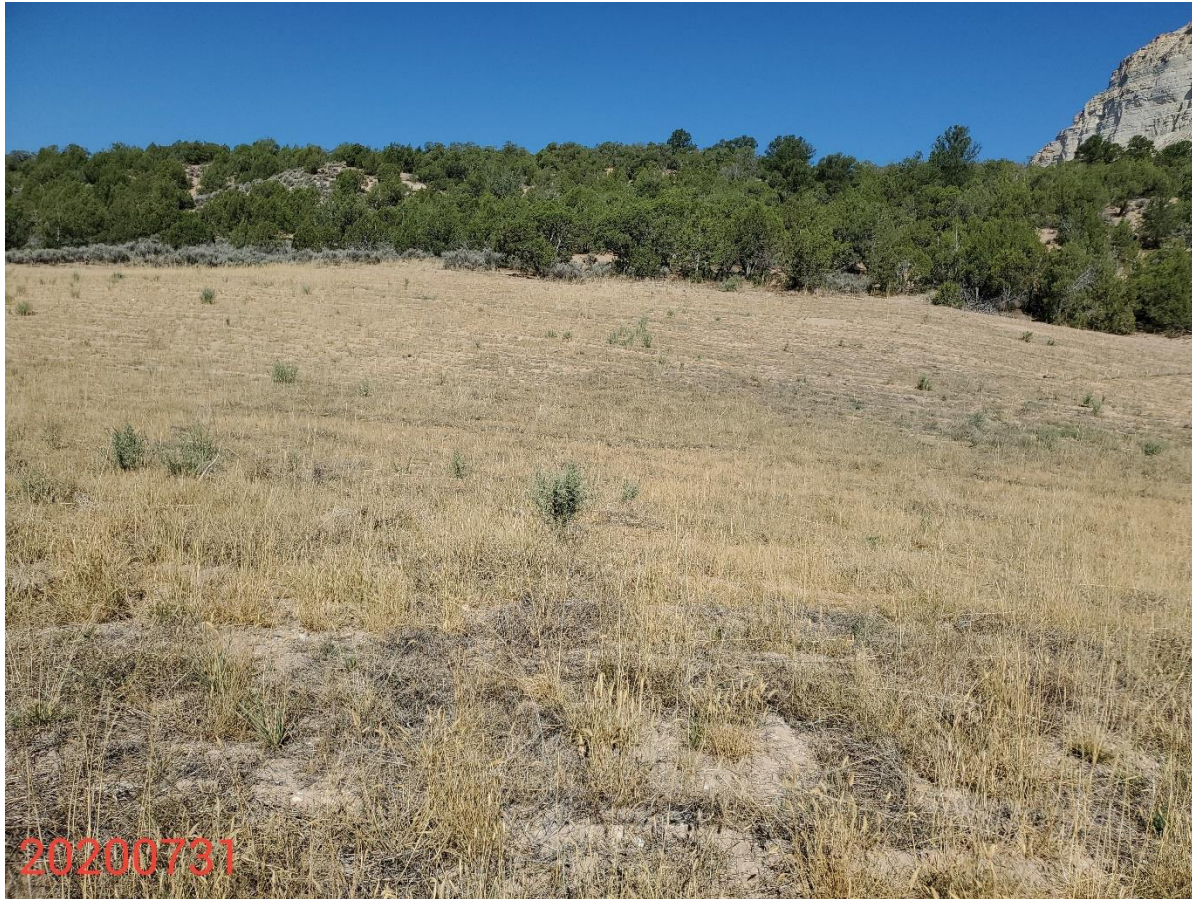
**Photo 2:** See comments under photo 1.

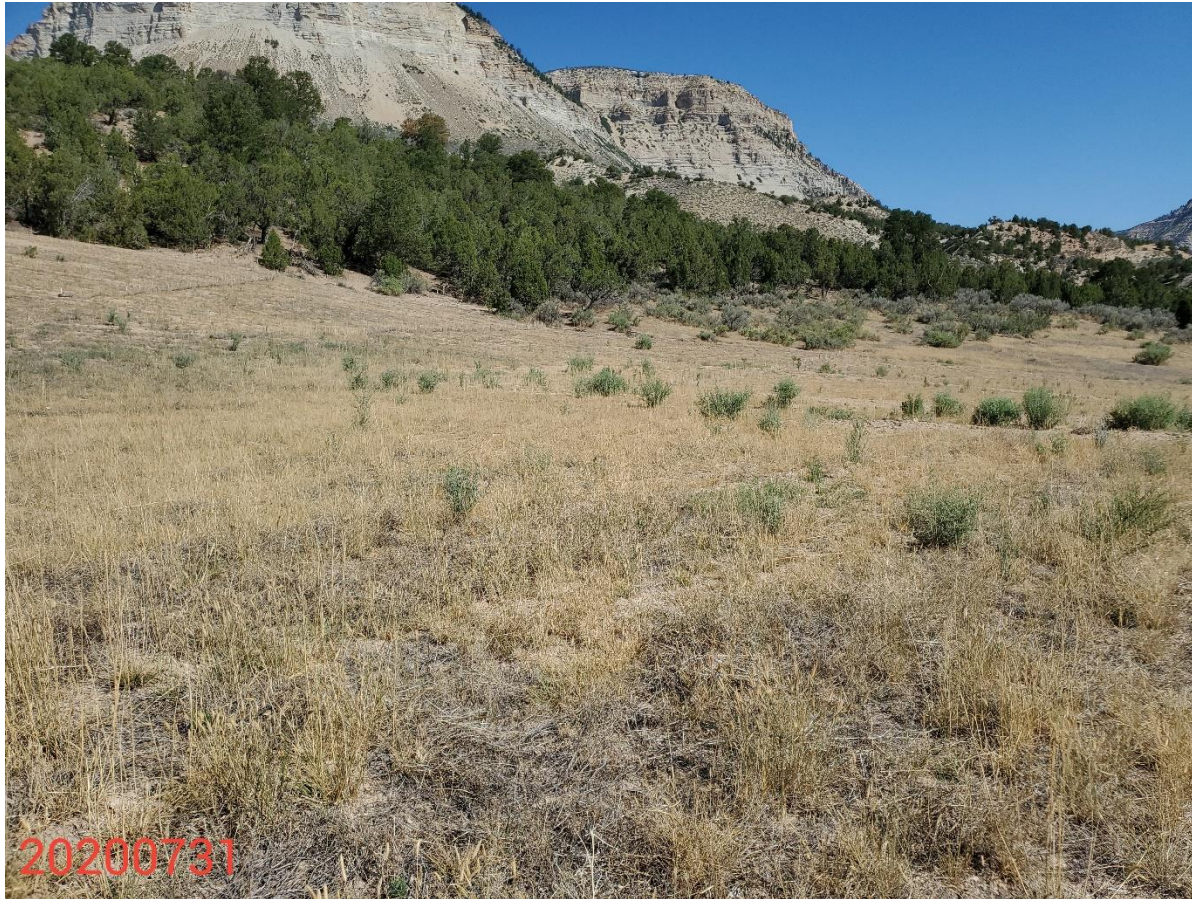
**Photo 3:** See comments under photo 1.

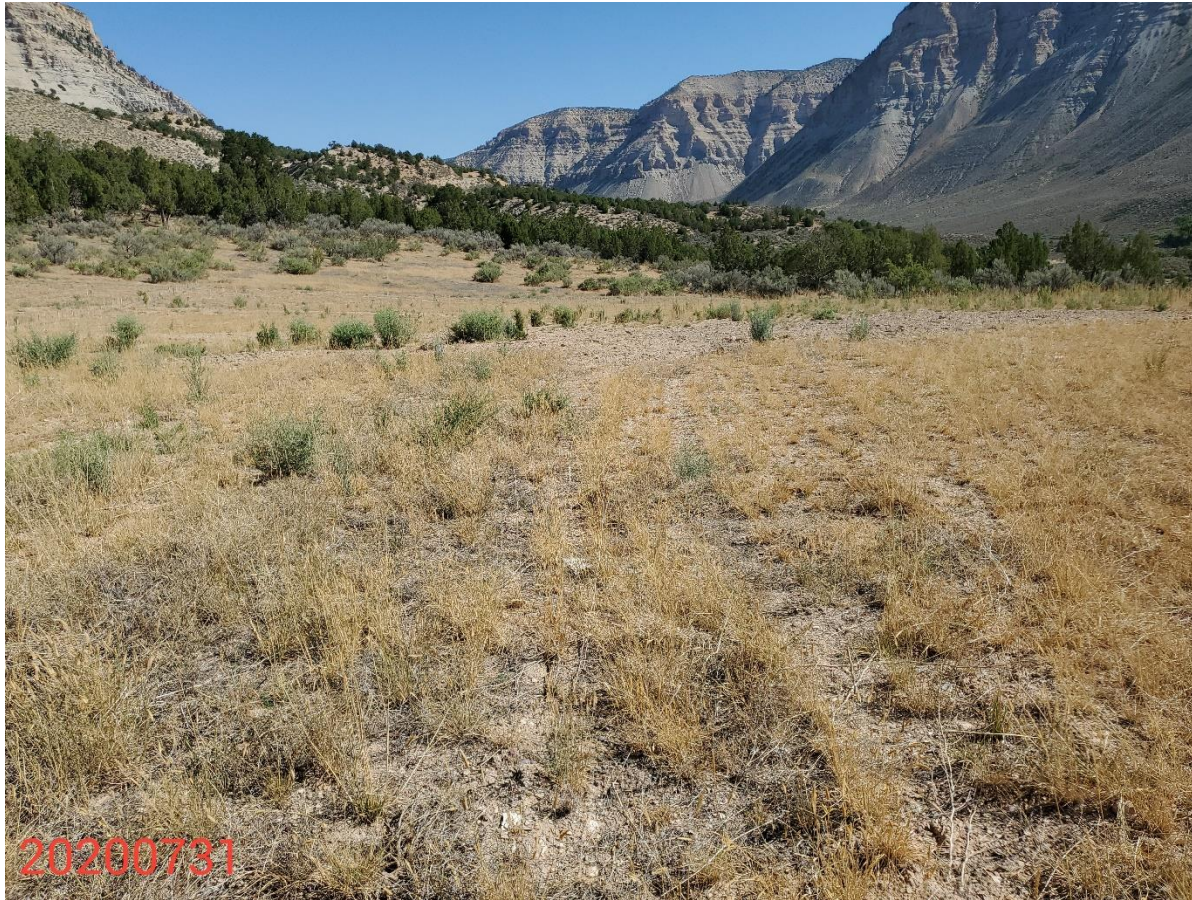
**Photo 4:** See comments under photo 1.

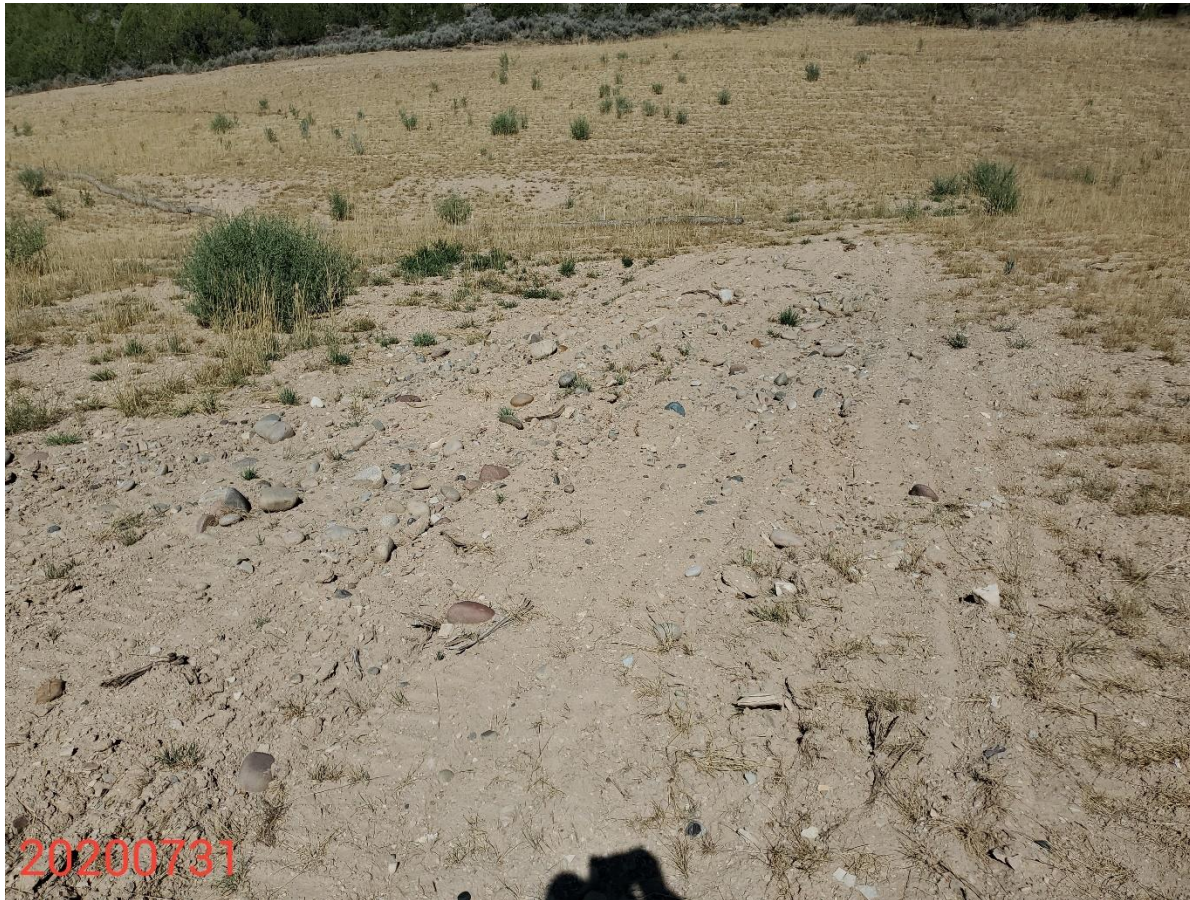
**Photo 5:** Photo taken from the northeast end of the Location, facing west. Photo shows 1 of 2 areas observed on the Location where additional reclamation activities appear to have been conducted.

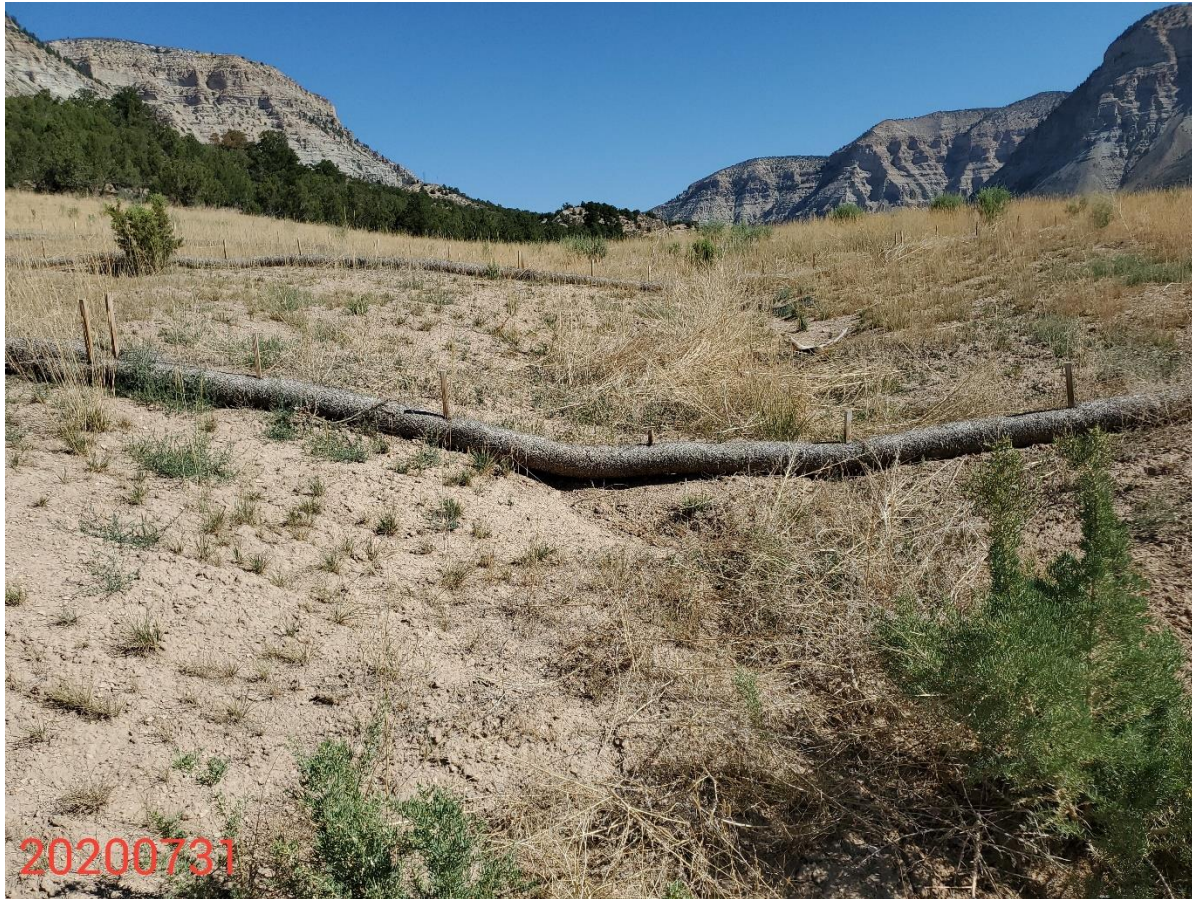
**Photo 6:** Photo taken from the south end of the Location, facing north. Photo shows wattle BMPs on Location have not been installed in accordance with good engineering practices; BMPs were placed/staked upon the soil surface, and have not been trenched and backfilled; Wattle BMPs are not in proper functioning condition. Stormwater has cut under the wattles and erosion degradation is evident

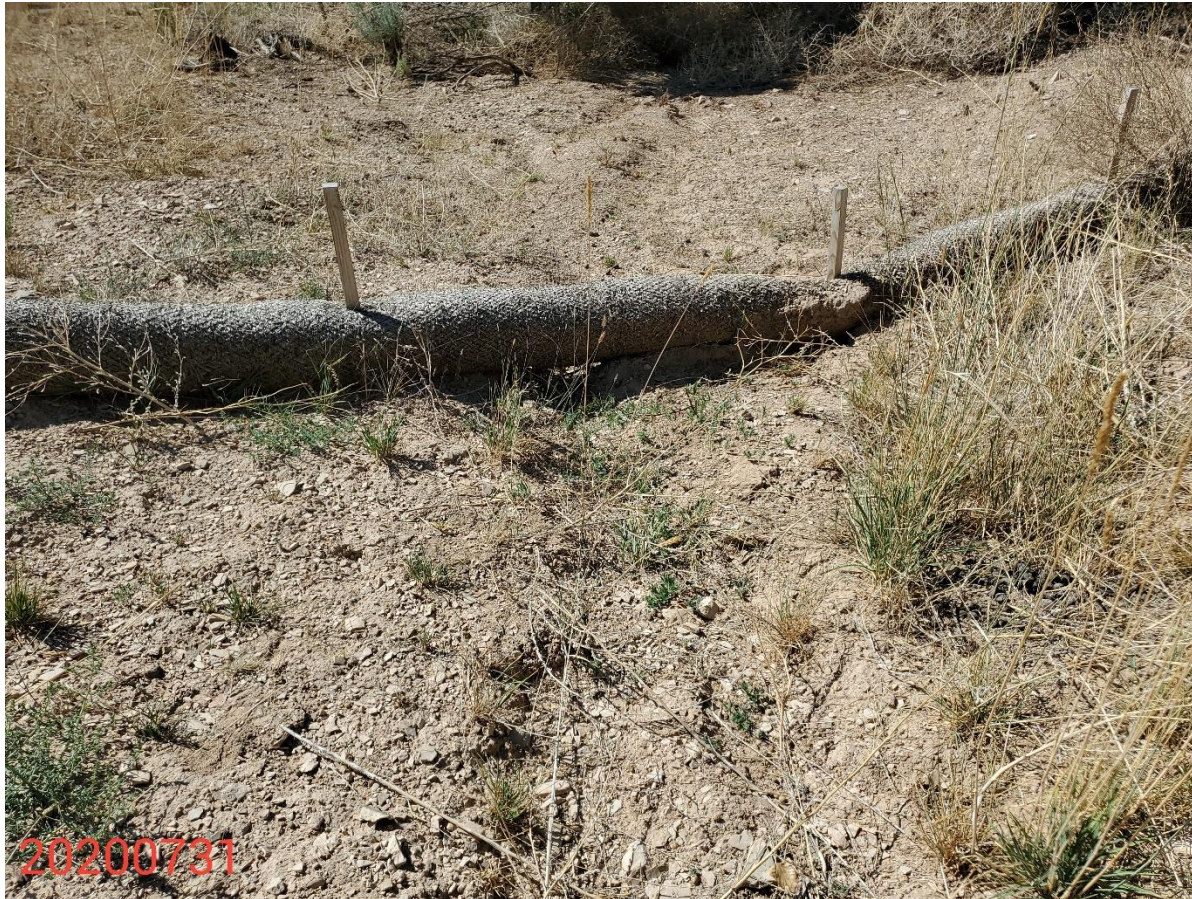
**Photo 7:** See comments under photo 6.

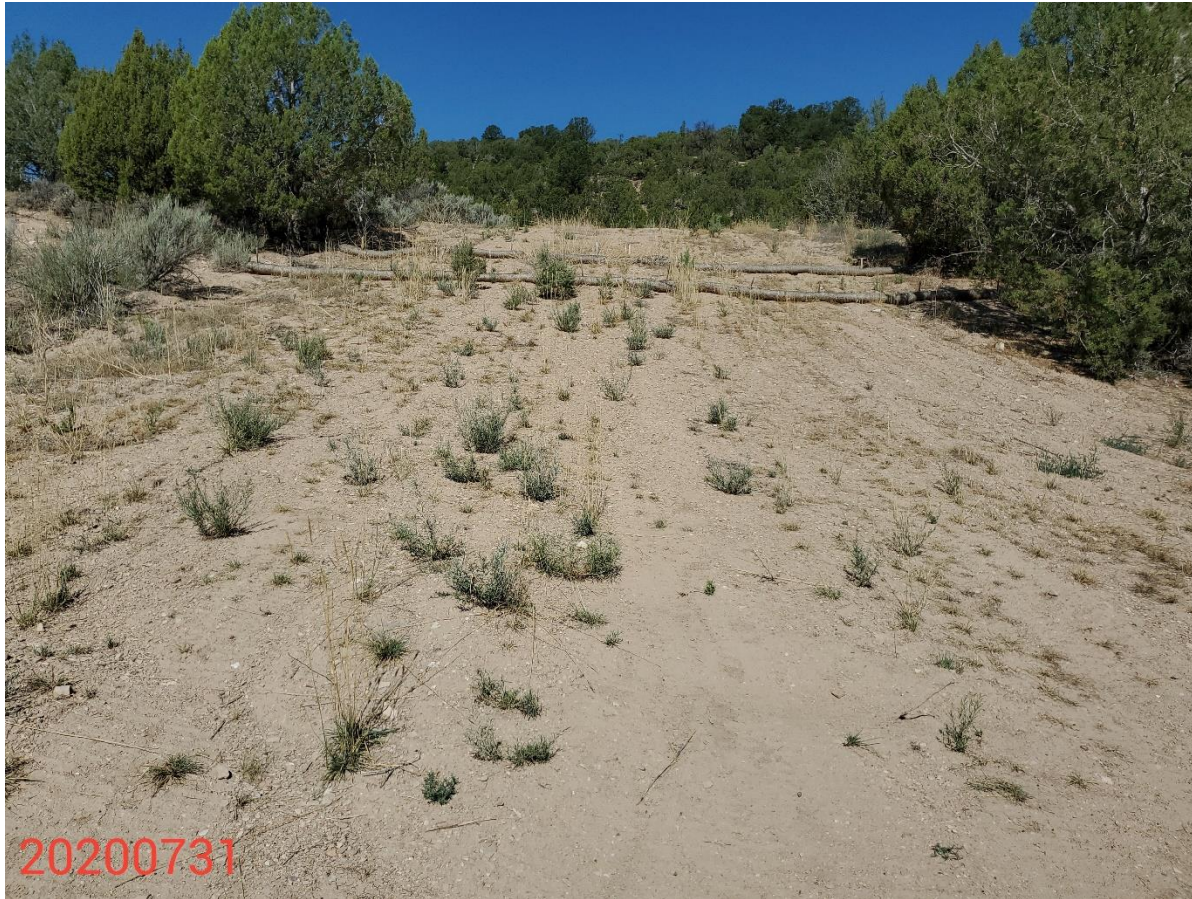
**Photo 8:** Photo taken from the access road on the north end of the Location, facing west.
