Inspection Photos
Location Name: DIXIECUP 31-12 TR
API#: 05-071-08671
INSP. #: 695103045

Location Name: DIXIECUP 31-12 TR

API#: 05-071-08671

INSP. #: 695103045

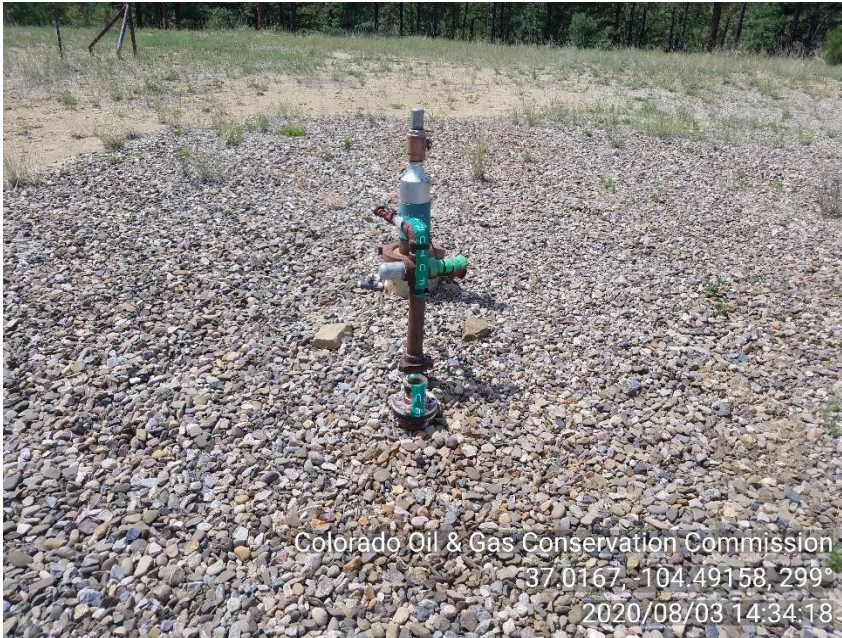
**PHOTO 3: UNUSED RISERS NEAR WEST WELLHEAD NOT MARKED AS TO WHAT ITS USED FOR AND NO LO/TO.
REMOVE OR PROPERLY MARK AND LO/TO PER RULE 603.f.
CA DATE 11-3-20.**

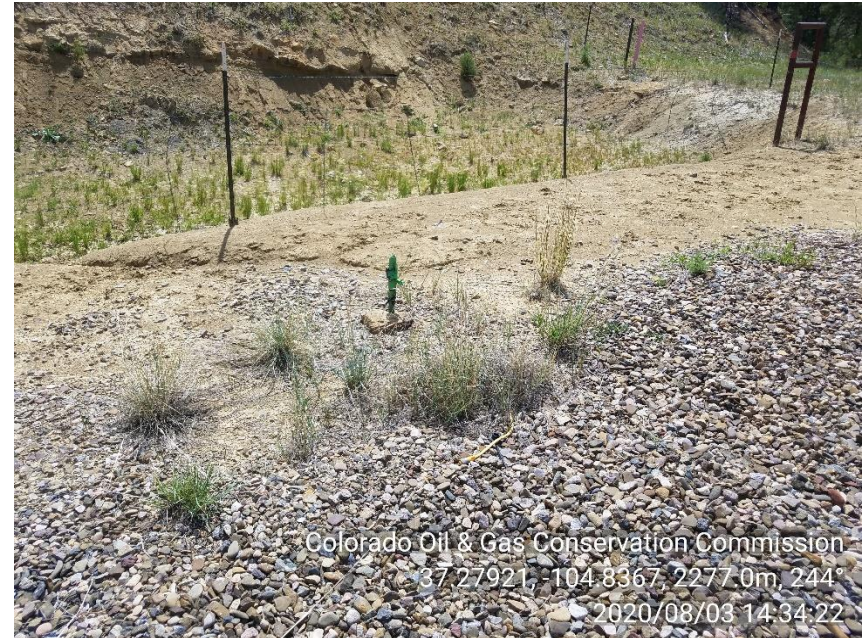
**PHOTO 4: UNUSED RISERS NEAR WEST WELLHEAD NOT MARKED AS TO WHAT ITS USED FOR AND NO LO/TO.
REMOVE OR PROPERLY MARK AND LO/TO PER RULE 603.f.
CA DATE 11-3-20.**

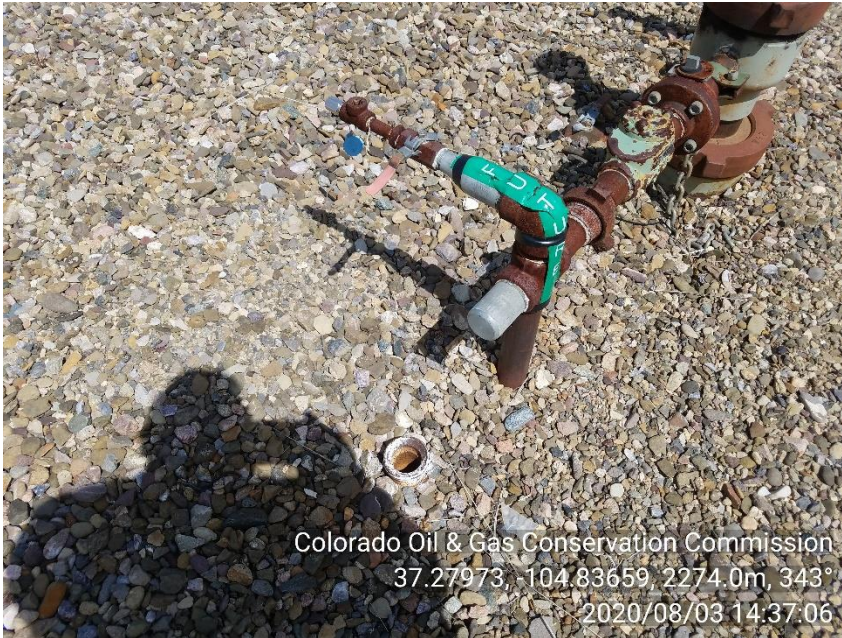
**PHOTO 5: UNUSED RISERS NEAR EAST WELLHEAD NOT MARKED AS TO WHAT ITS USED FOR AND NO LO/TO.
REMOVE OR PROPERLY MARK AND LO/TO PER RULE 603.f.
CA DATE 11-3-20.**

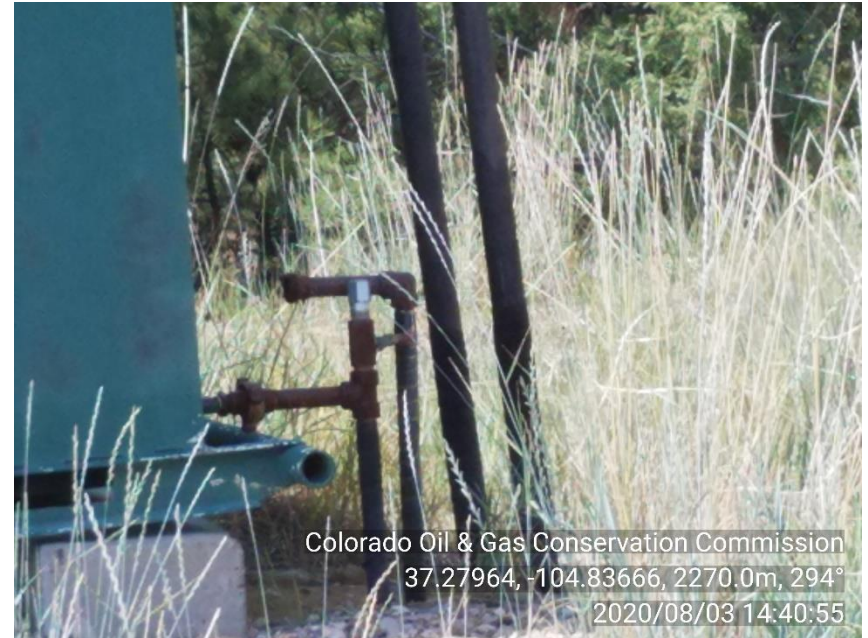
**PHOTO 6: UNUSED RISERS NEAR METER HOUSE NOT MARKED AS TO WHAT ITS USED FOR AND NO LO/TO.
REMOVE OR PROPERLY MARK AND LO/TO PER RULE 603.f.
CA DATE 11-3-20.**

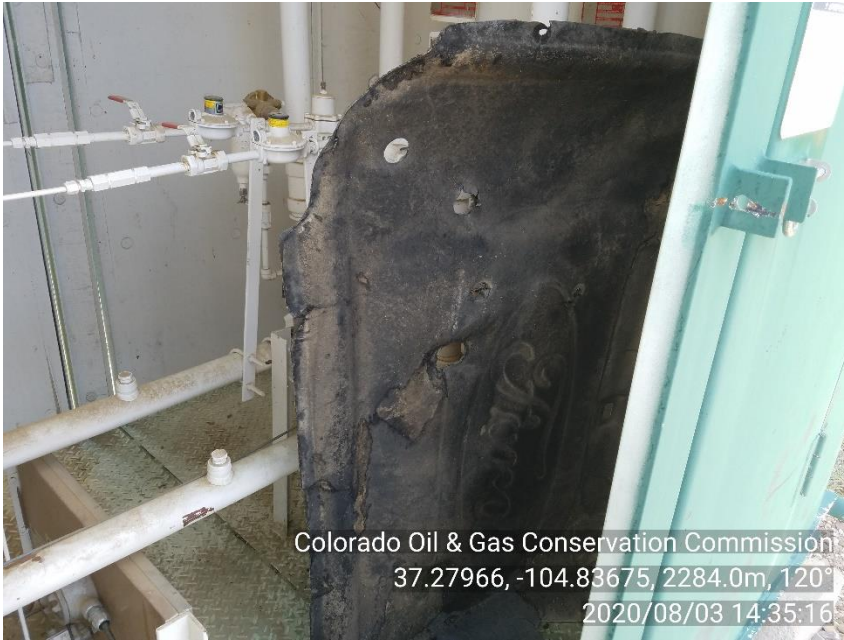
**PHOTO 7: TRASH STORED IN METER HOUSE. REMOVE TRASH
PER RULE 603.f. CA DATE 11-3-20.**

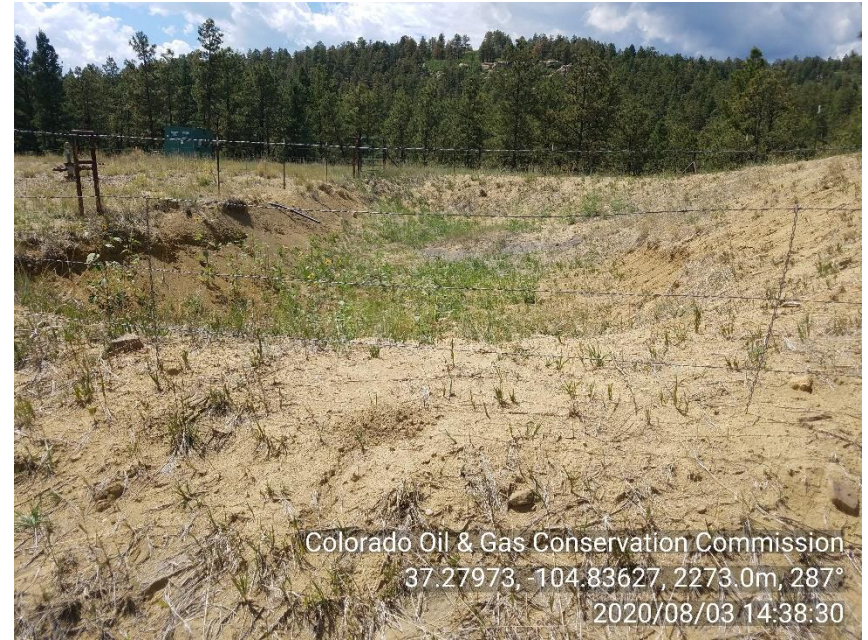
**PHOTO 8: NO FREEBOARD MARKER IN EAST PIT. INSTALL
FREEBOARD MARKER PER RULE 902.b. CA DATE 11-3-20**

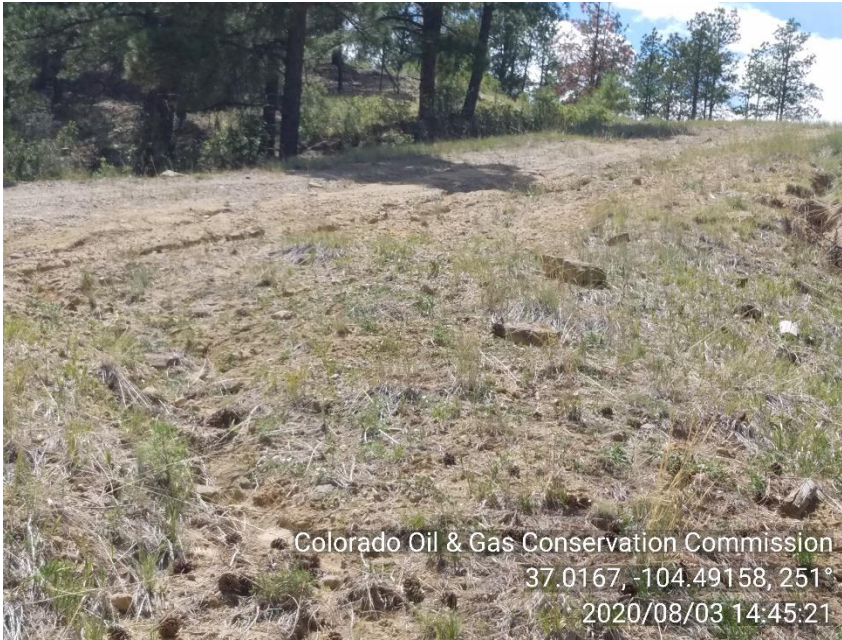
PHOTO 9: BMP'S ON ACCESS ROAD ARE FAILING AND OR IMPROPERLY INSTALLED. REPAIR AND INSTALL BMP'S TO CONTROL STORMWATER AND SEDIMENT FROM WASH DOWN ROADWAY PER RULE 1002.f.(2)C. CA DATE 11-3-20.

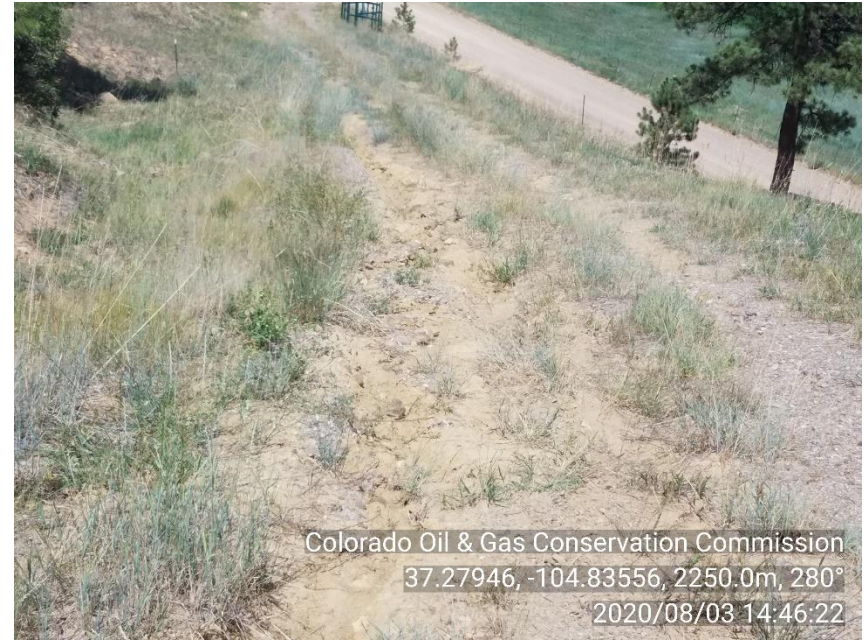
PHOTO 10: ANOTHER IMAGE OF EROSION ON ROW SEE PHOTO 9 FOR CA.

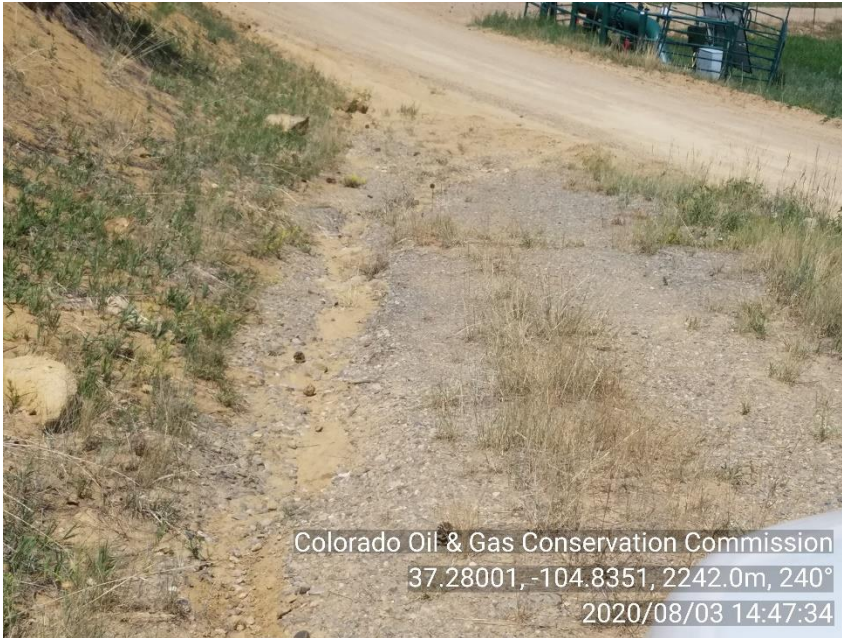
**PHOTO 11: ANOTHER IMAGE OF EROSION ON ROW SEE
PHOTO 9 FOR CA.**
