Inspection Photos

Location Name: LAVIZ 12-7 FOLLOWUP

API#: 05-071-07540

INSP. #: 695103049

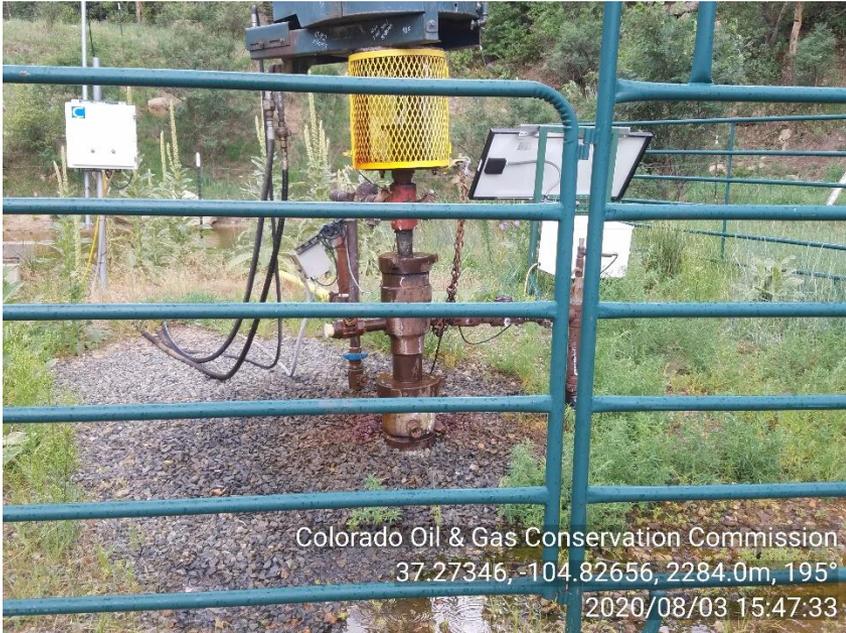
PHOTO 3: PACKING ON WELLHEAD IS LEAKING. WILL CONTACT OPERATOR BY PHONE. **Control and contain spills/releases and clean up per Rule 906.a. CA DATE 8-4-20.**
