# Inspection Photos

API: 071-07186

Operator: TIMBER CREEK OPERATING LLC

Inspection Date: 8/3/2020

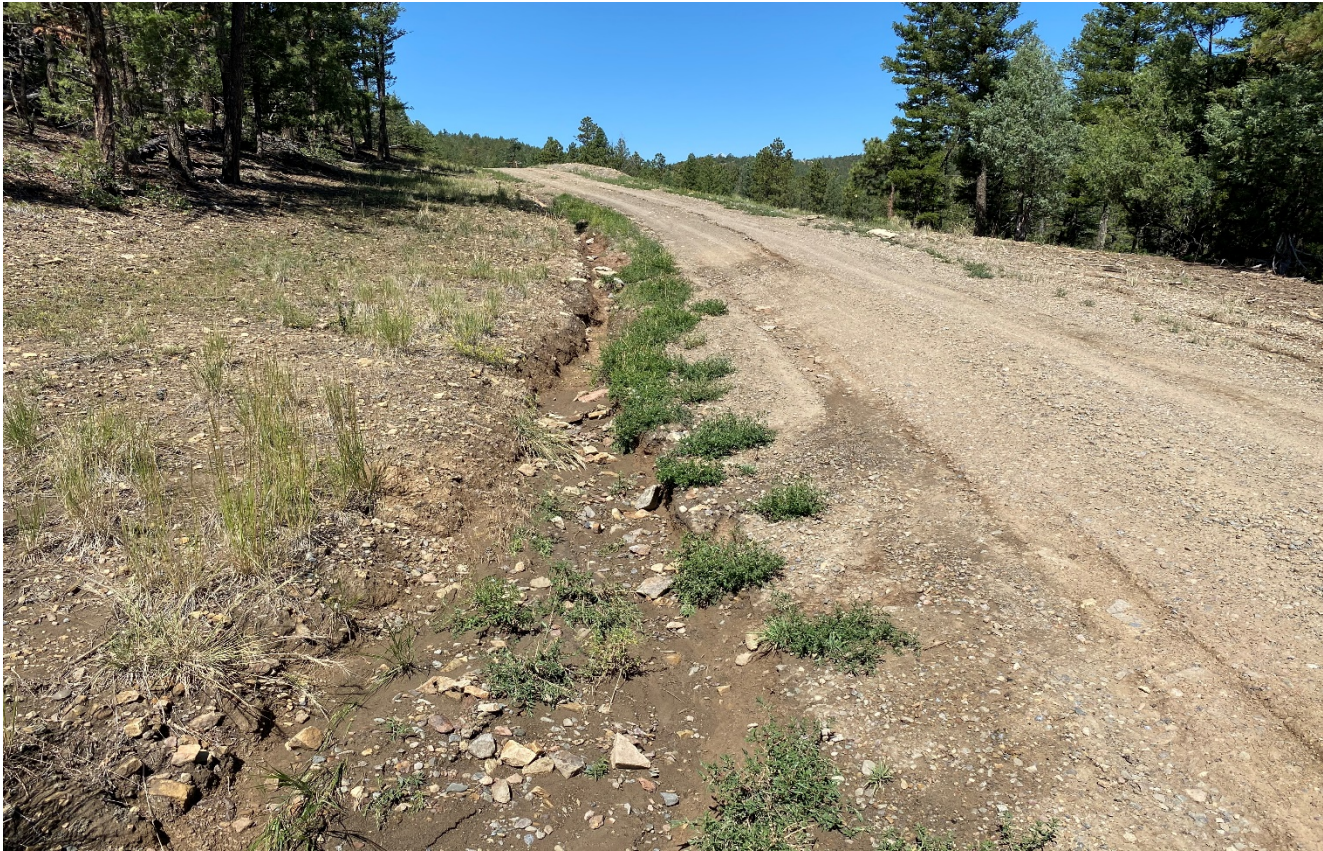
**Photo 1.** Facing west along the road near the location. Stormwater runoff from the location is directed down the road causing erosion. BMP's are needed in this area.

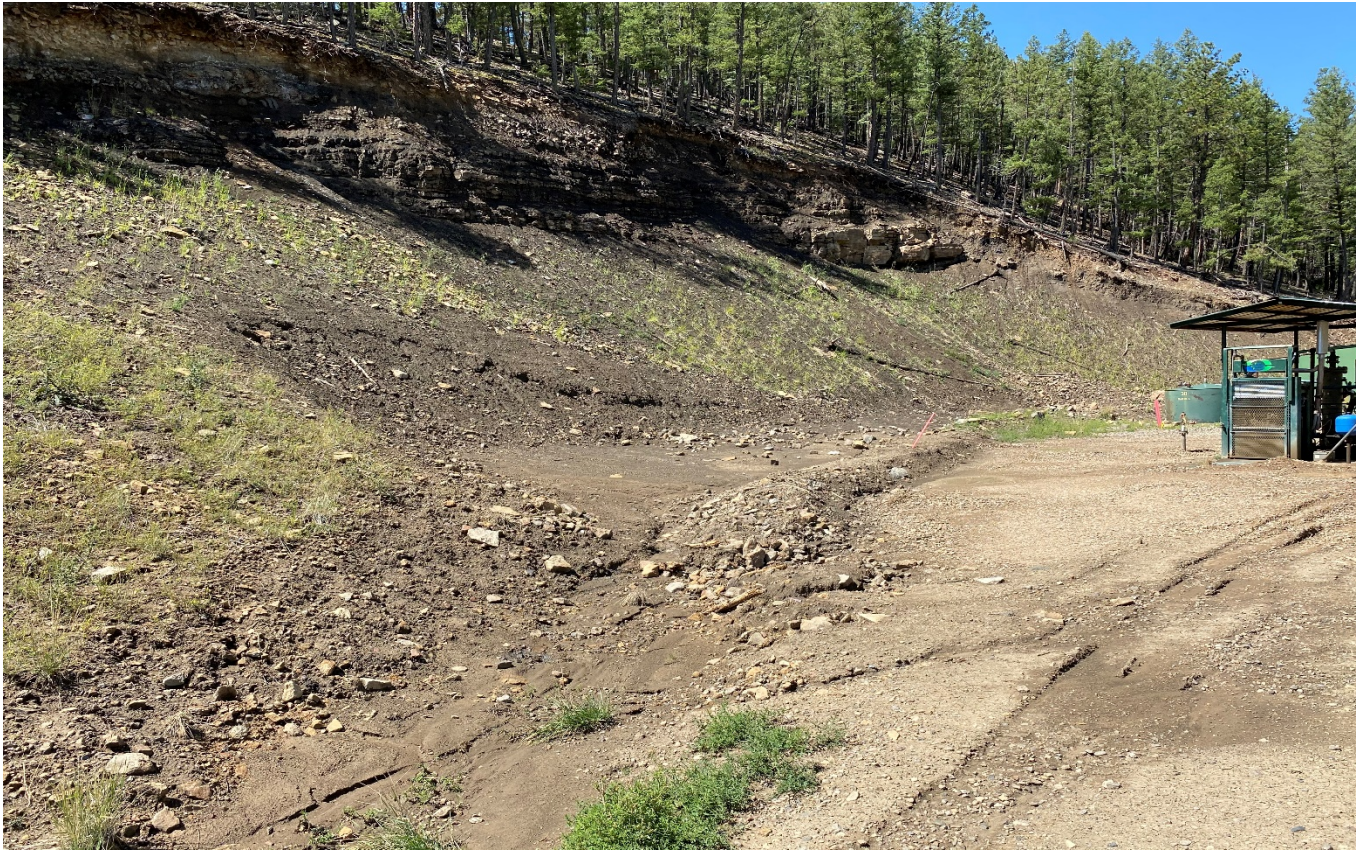
**Photo 2.** Facing southwest toward the cut slope of the location. Stormwater runoff from this area is causing erosion shown in previous photo. BMP's are needed in this area.

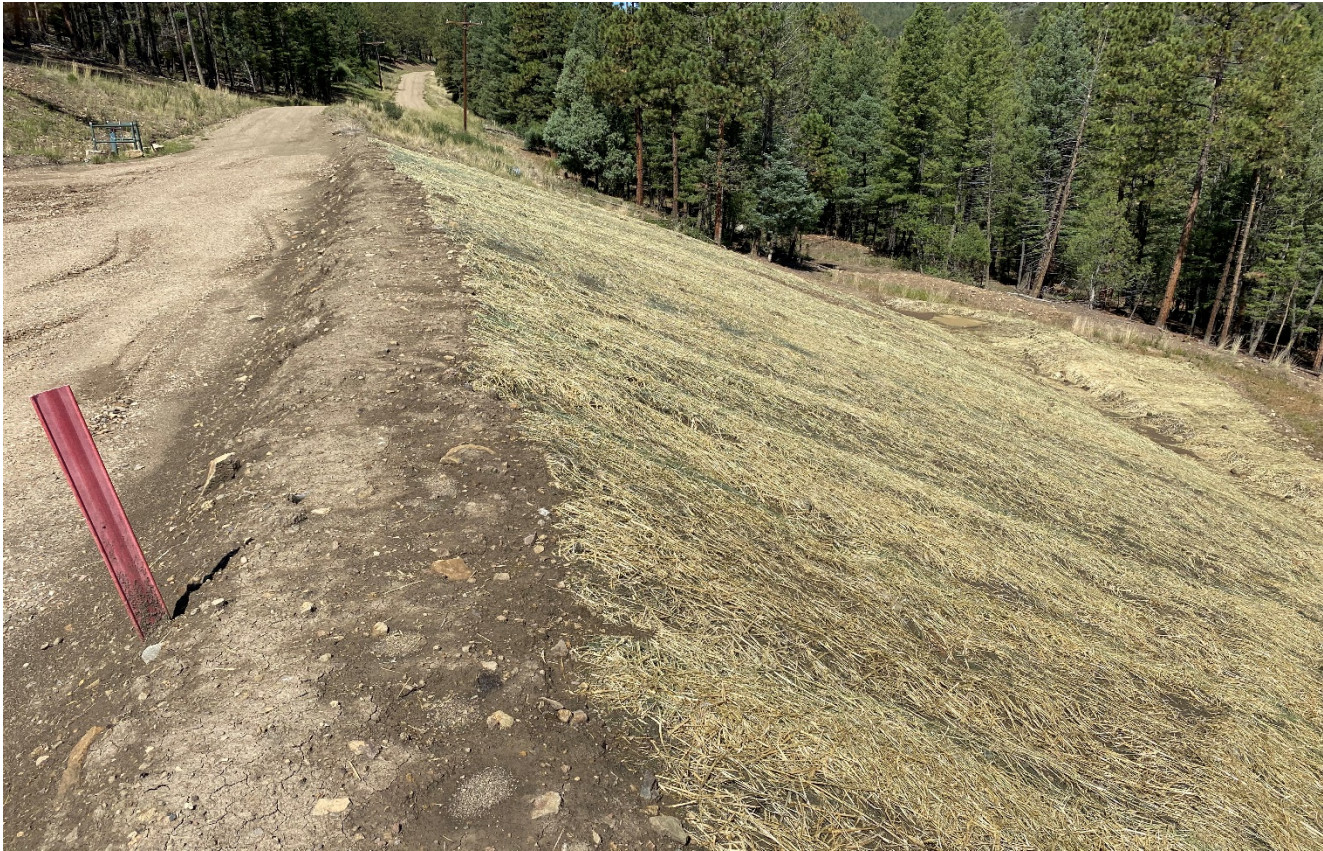
**Photo 3.** Facing northeast toward the fill slope. This area has been resloped and temporarily stabilized with straw blanket.

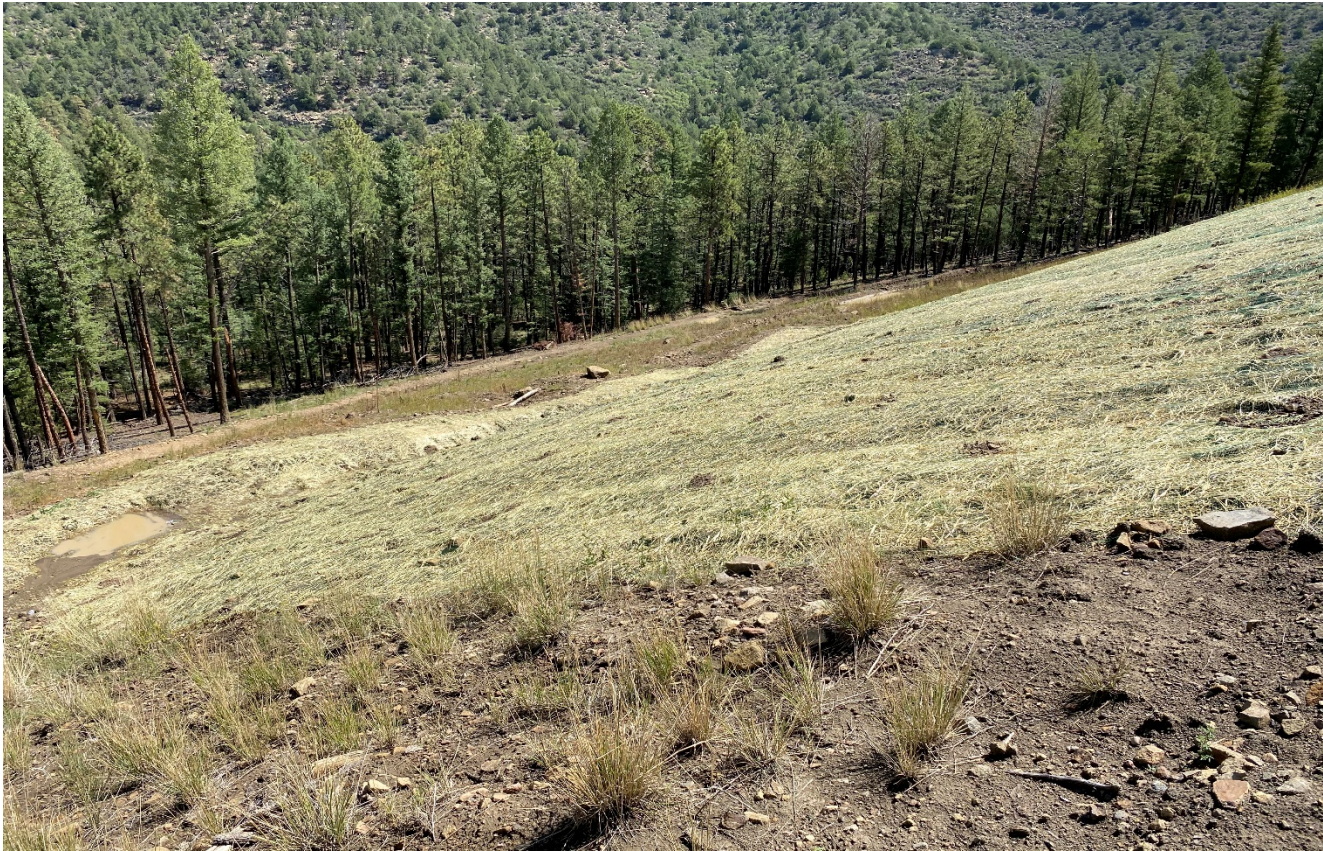
**Photo 4.** Facing southeast toward the area which was resloped and stabilized.

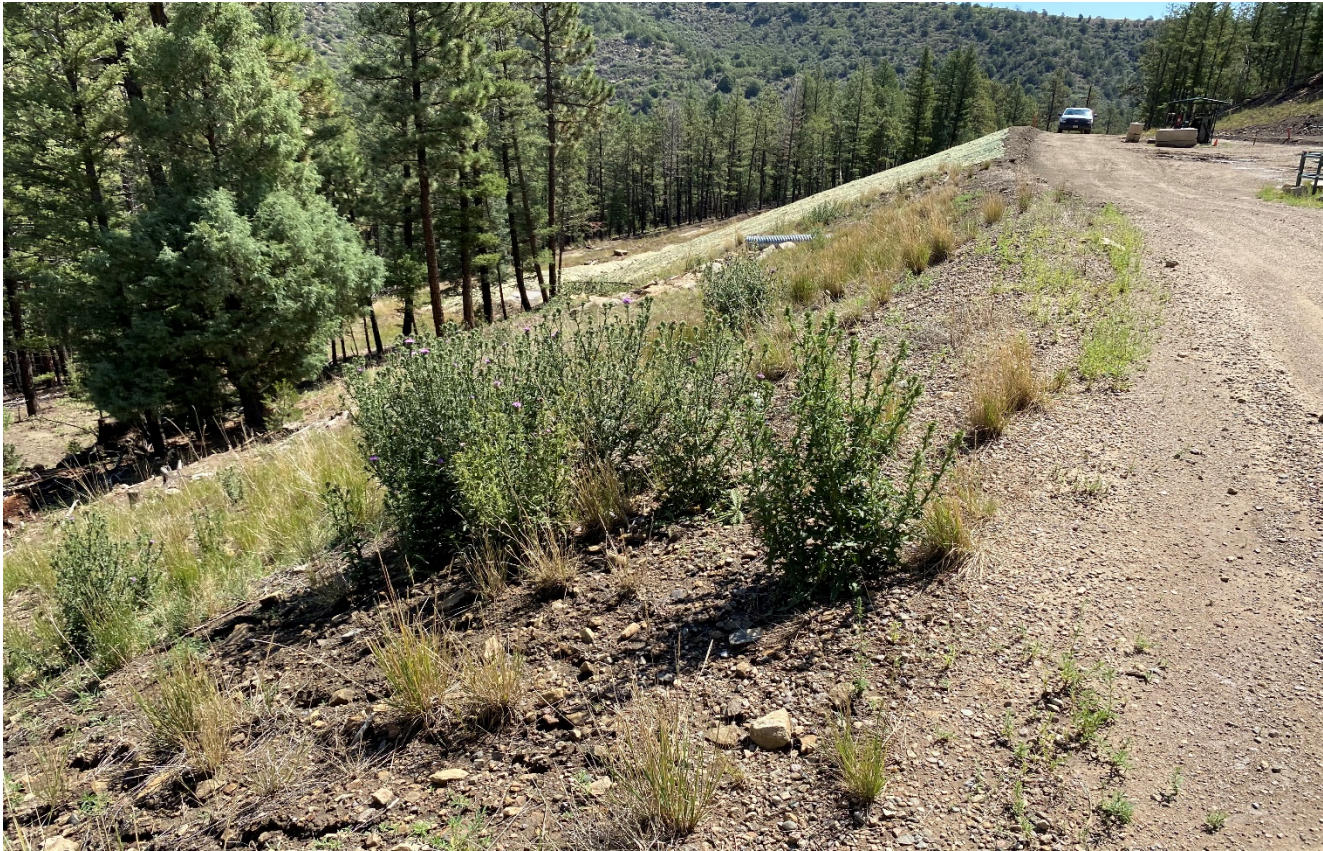
**Photo 5.** Facing northeast near the location. There is numerous Bull thistle noxious weeds in this area along the road. Also noticed noxious weeds at the base of the fill slope.

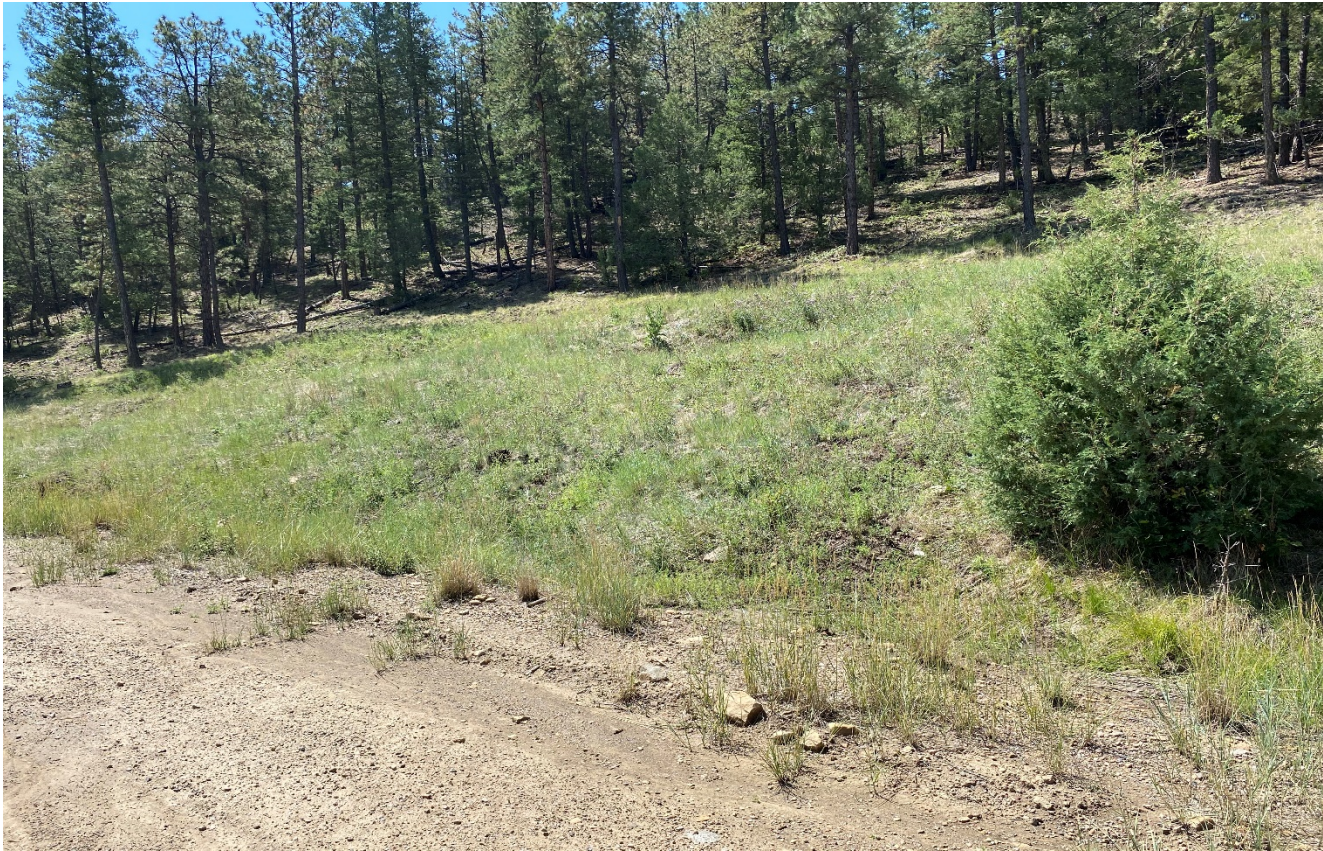
**Photo 6.** Further along the road there is an infestation of noxious weeds at Lat/Long:37.07427,-104.94714.
