Inspection Photos

API: 071-06218

Operator: MERIDIAN OIL INC

Inspection Date: 8/3/2020

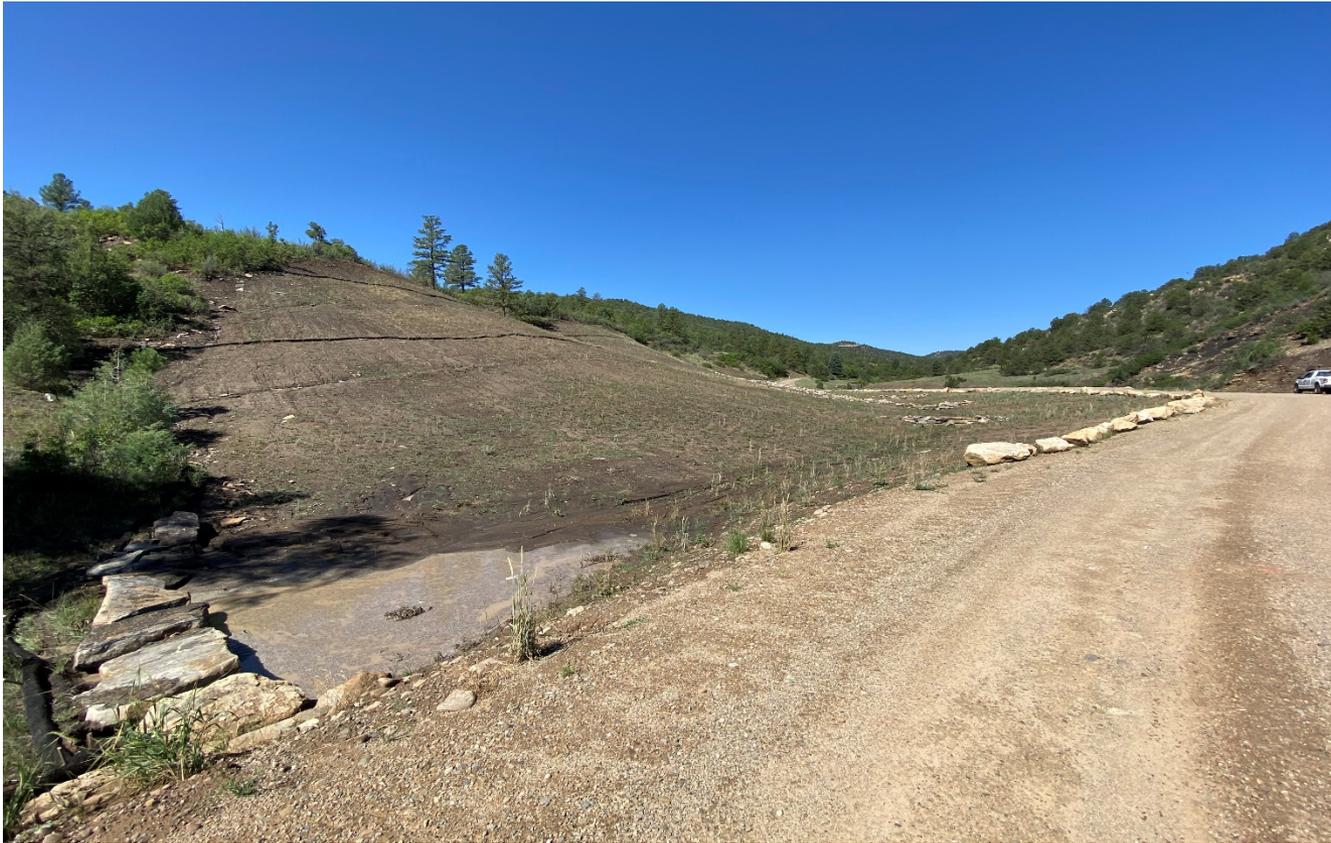
Photo 1. Facing southwest toward the location.

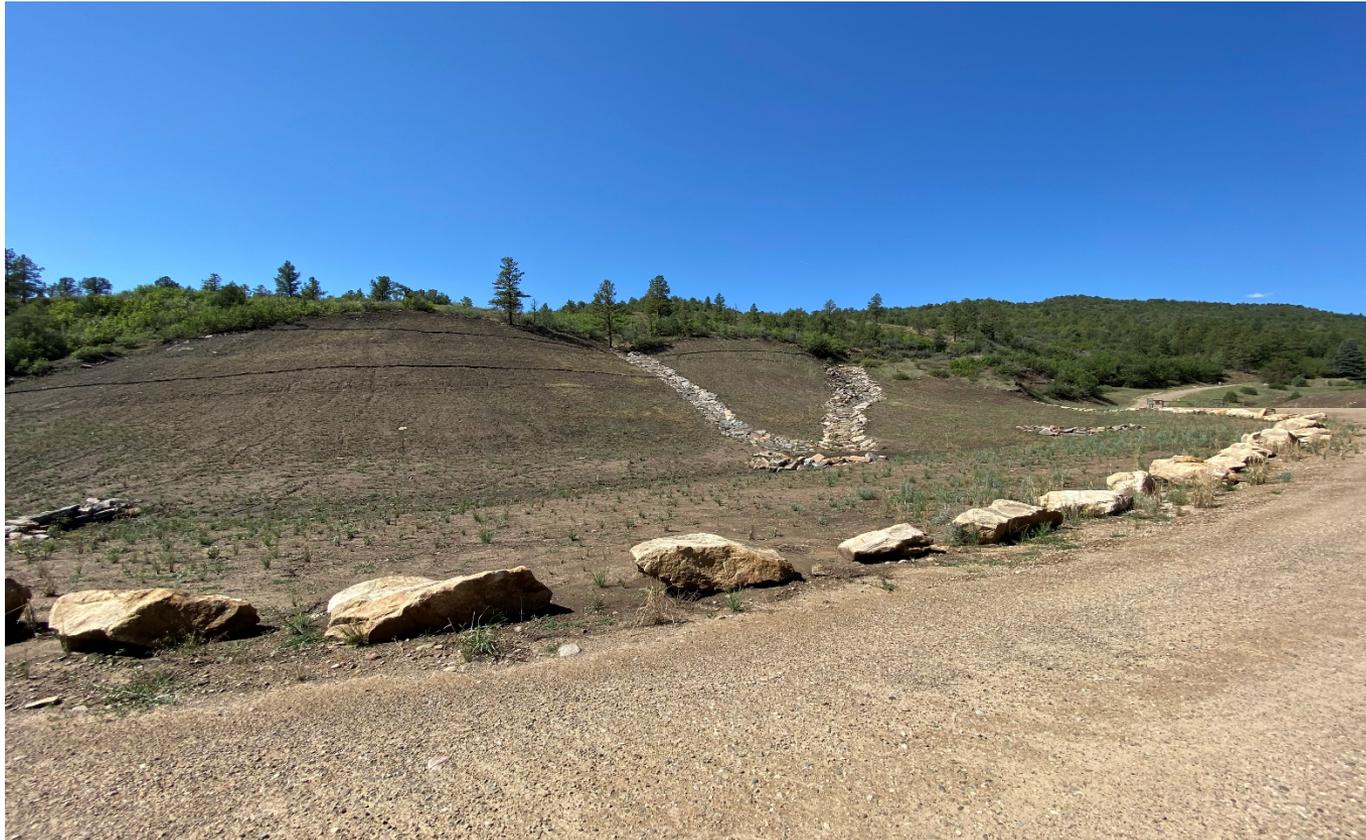
Photo 2. Facing south at the location.

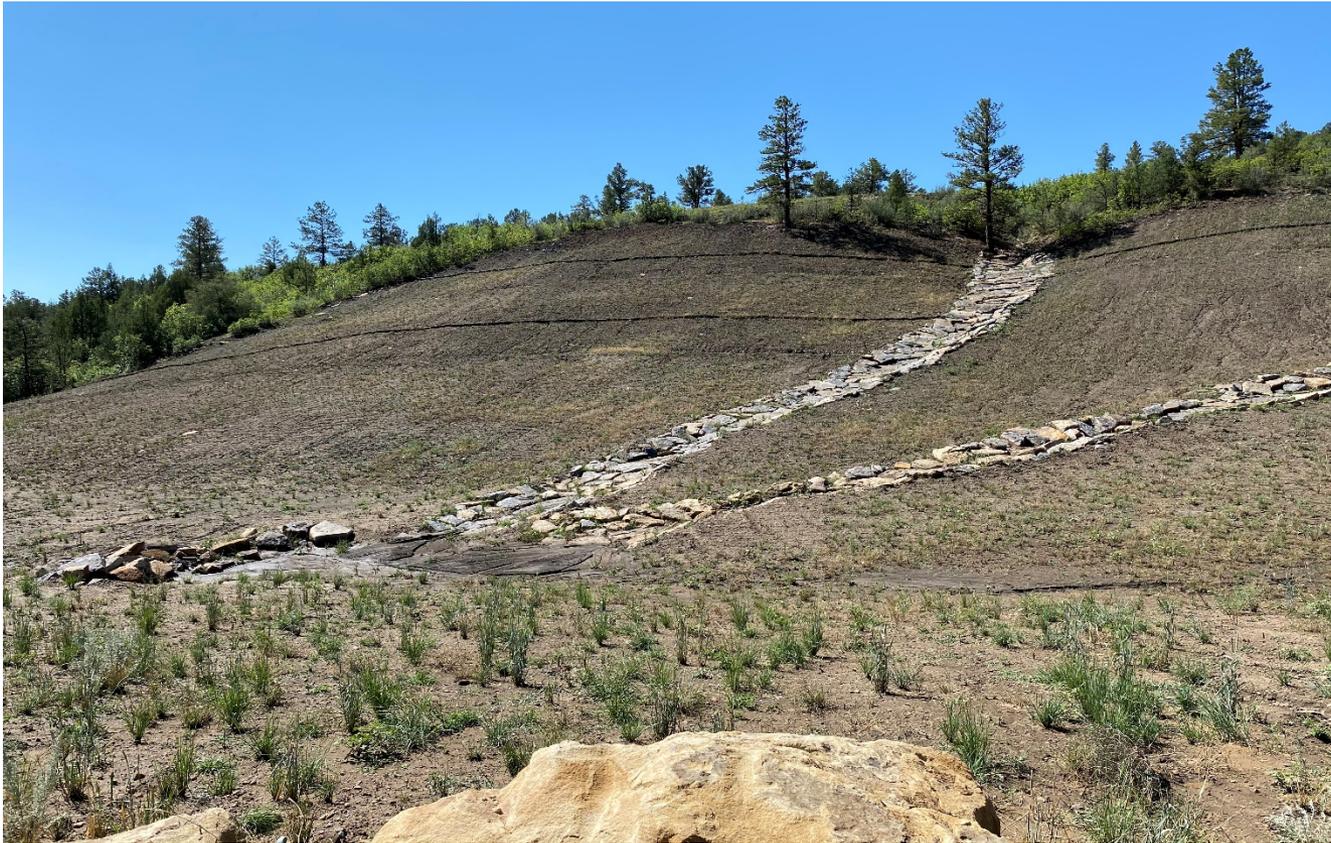
Photo 3. Facing southeast at the location.

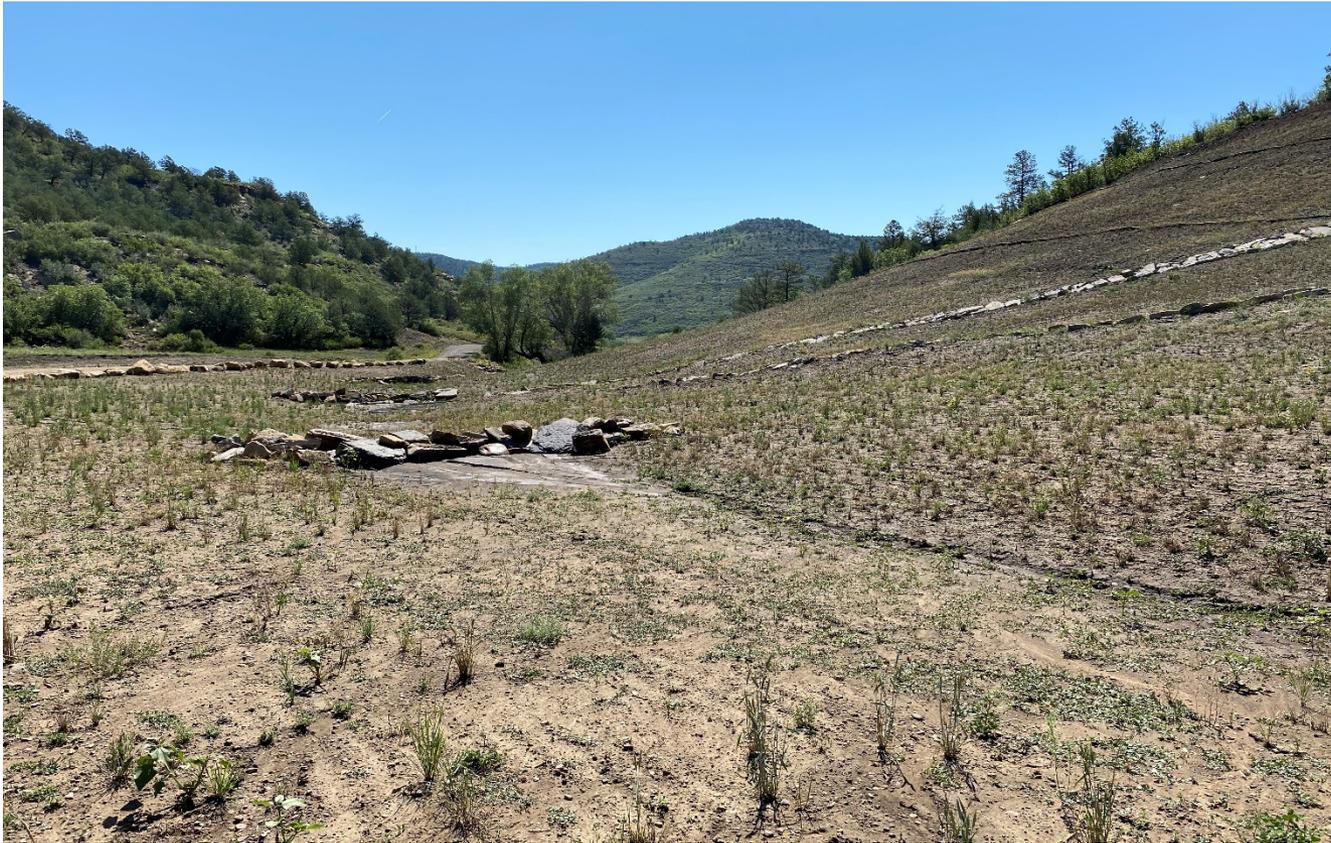
Photo 4. Facing east at the location.

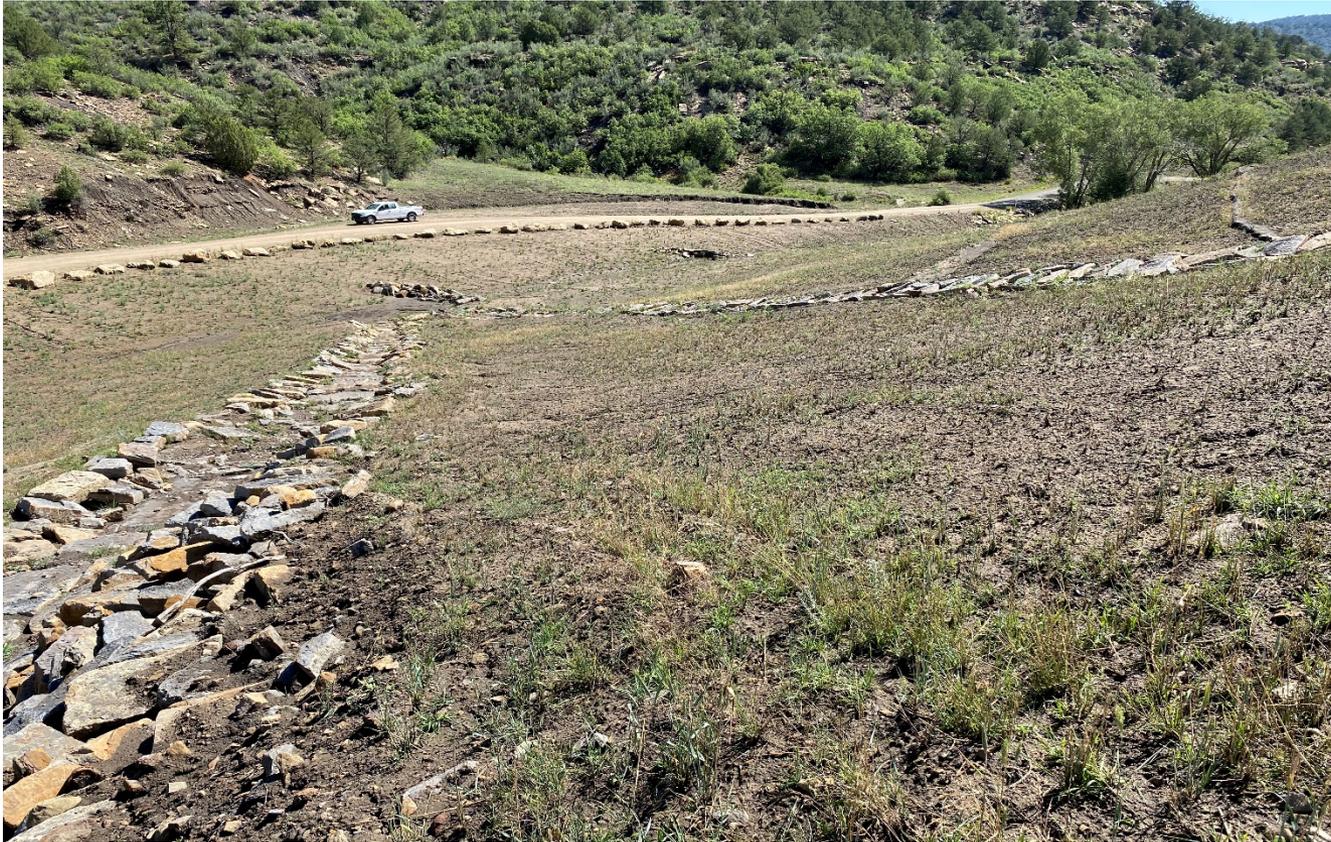
Photo 5. Facing northeast at the location from the upper portion of the location.

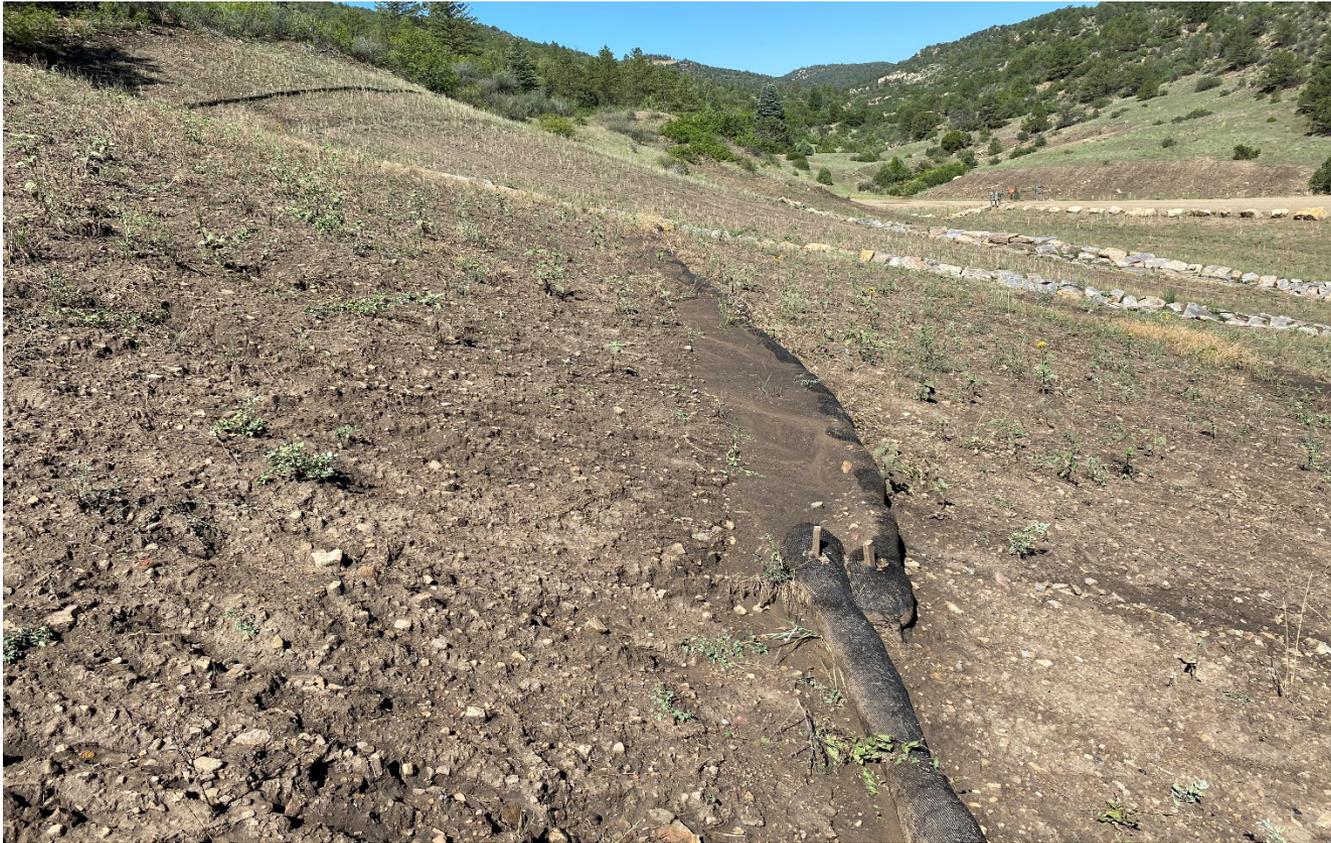
Photo 6. There are BMP's that have filled in with sediment and need maintenance.

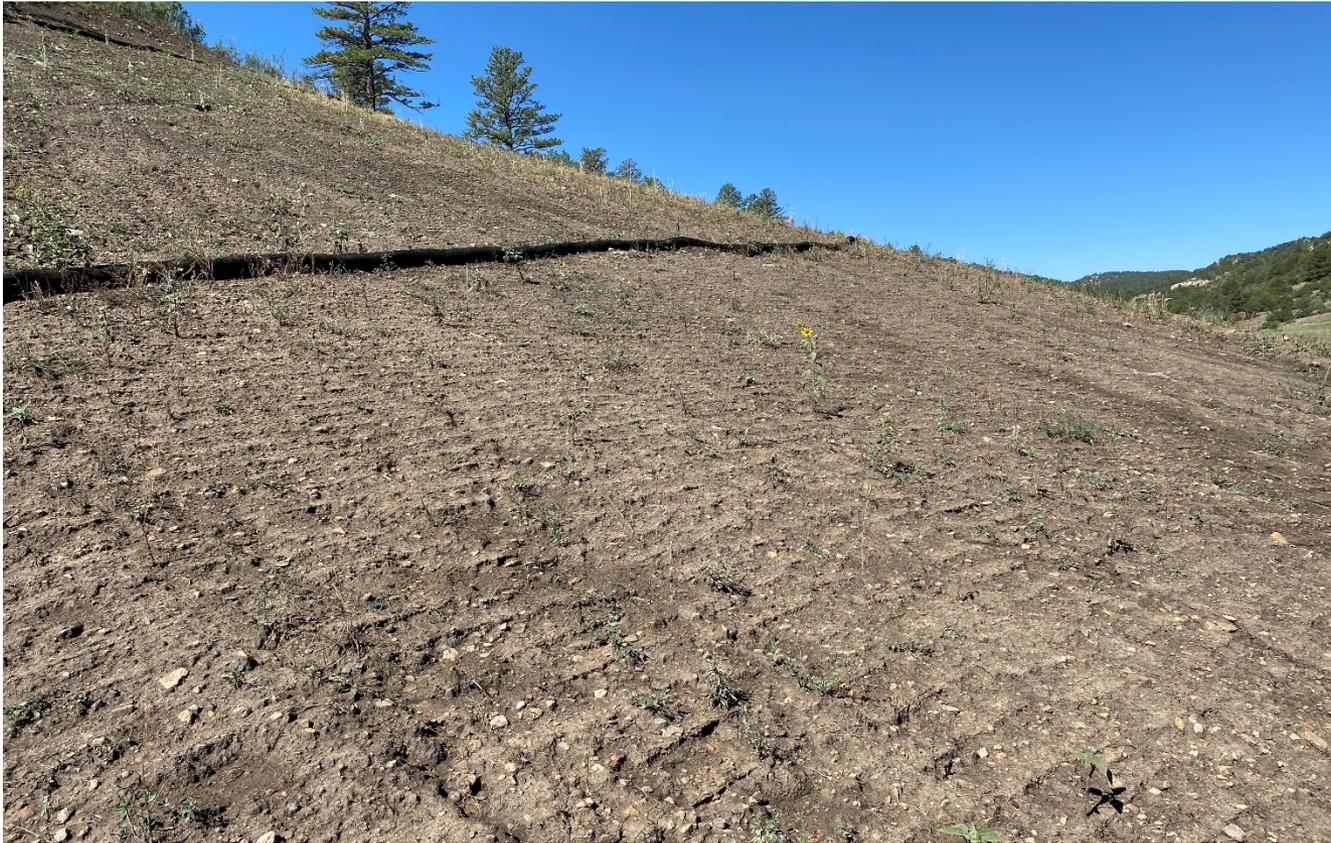
Photo 7. Facing toward the reclaimed slope. Vegetation does not appear to be establishing in areas of the location. Additional reseeding may be needed during the fall season.

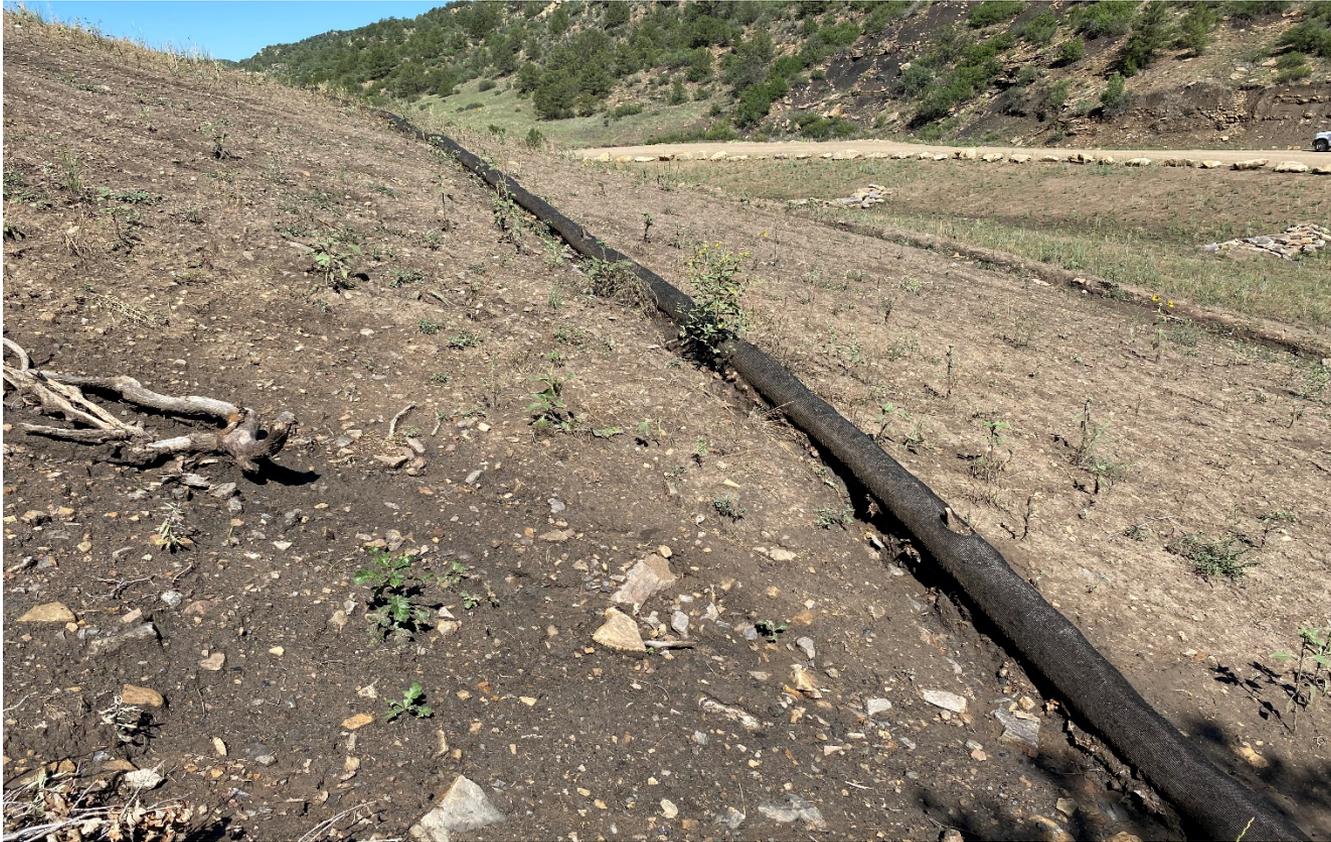
Photo 8. Facing northwest. The filtrex wattles appear to be working well but will need maintenance.
