Inspection Photos
Operator: Hilcorp Energy
API: 067-09369
Date: 7/28/2020

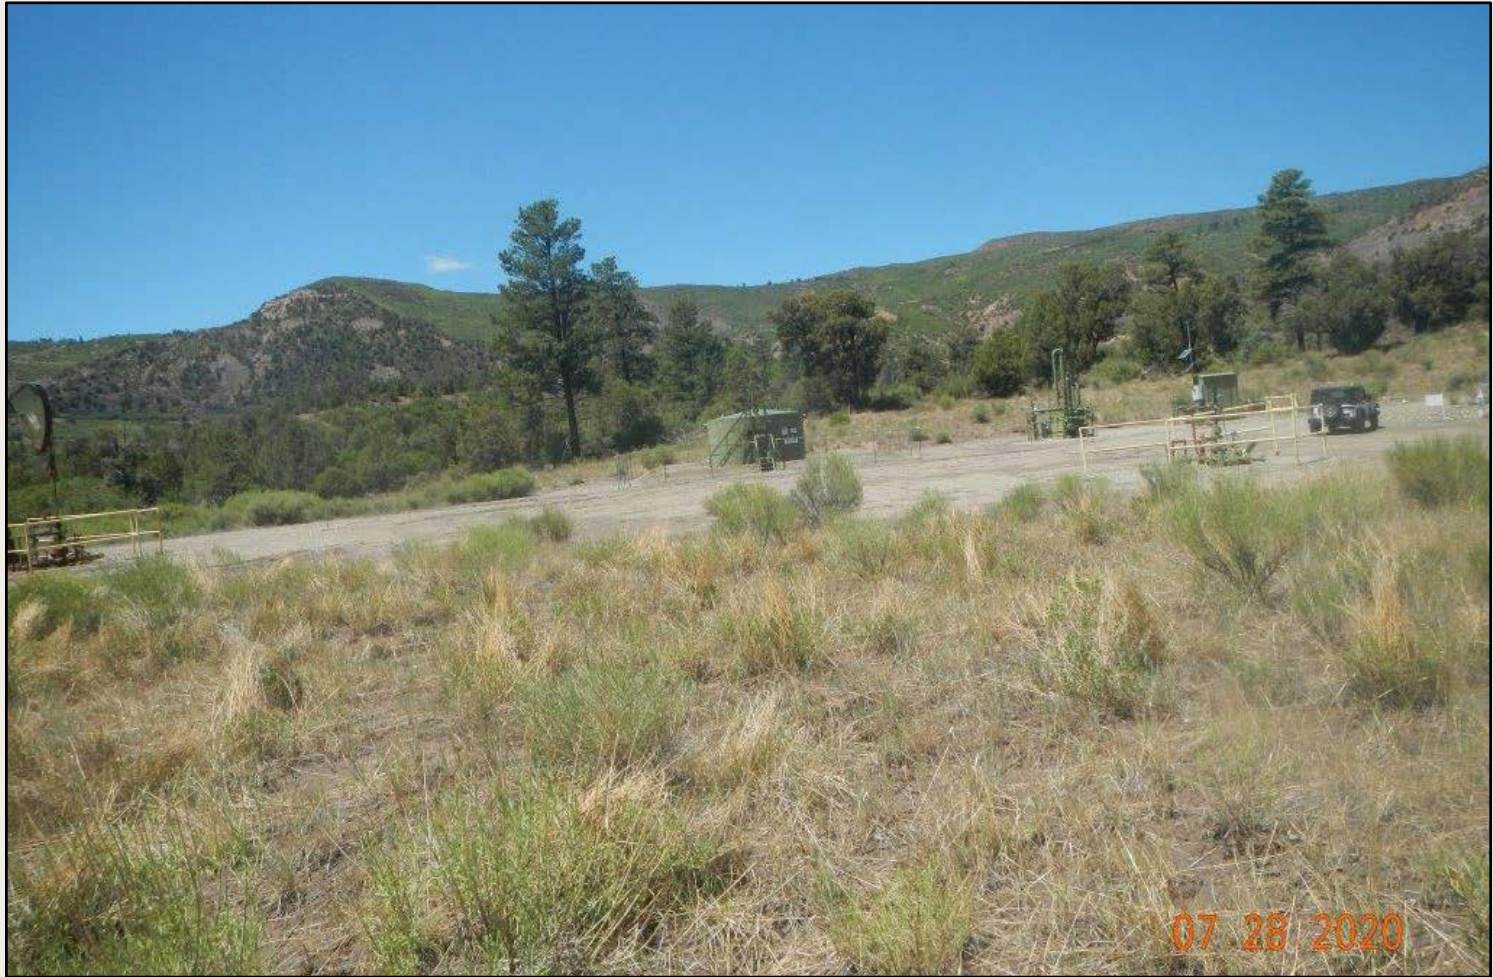
Photo 1. View of the project area from the northeastern corner facing center.

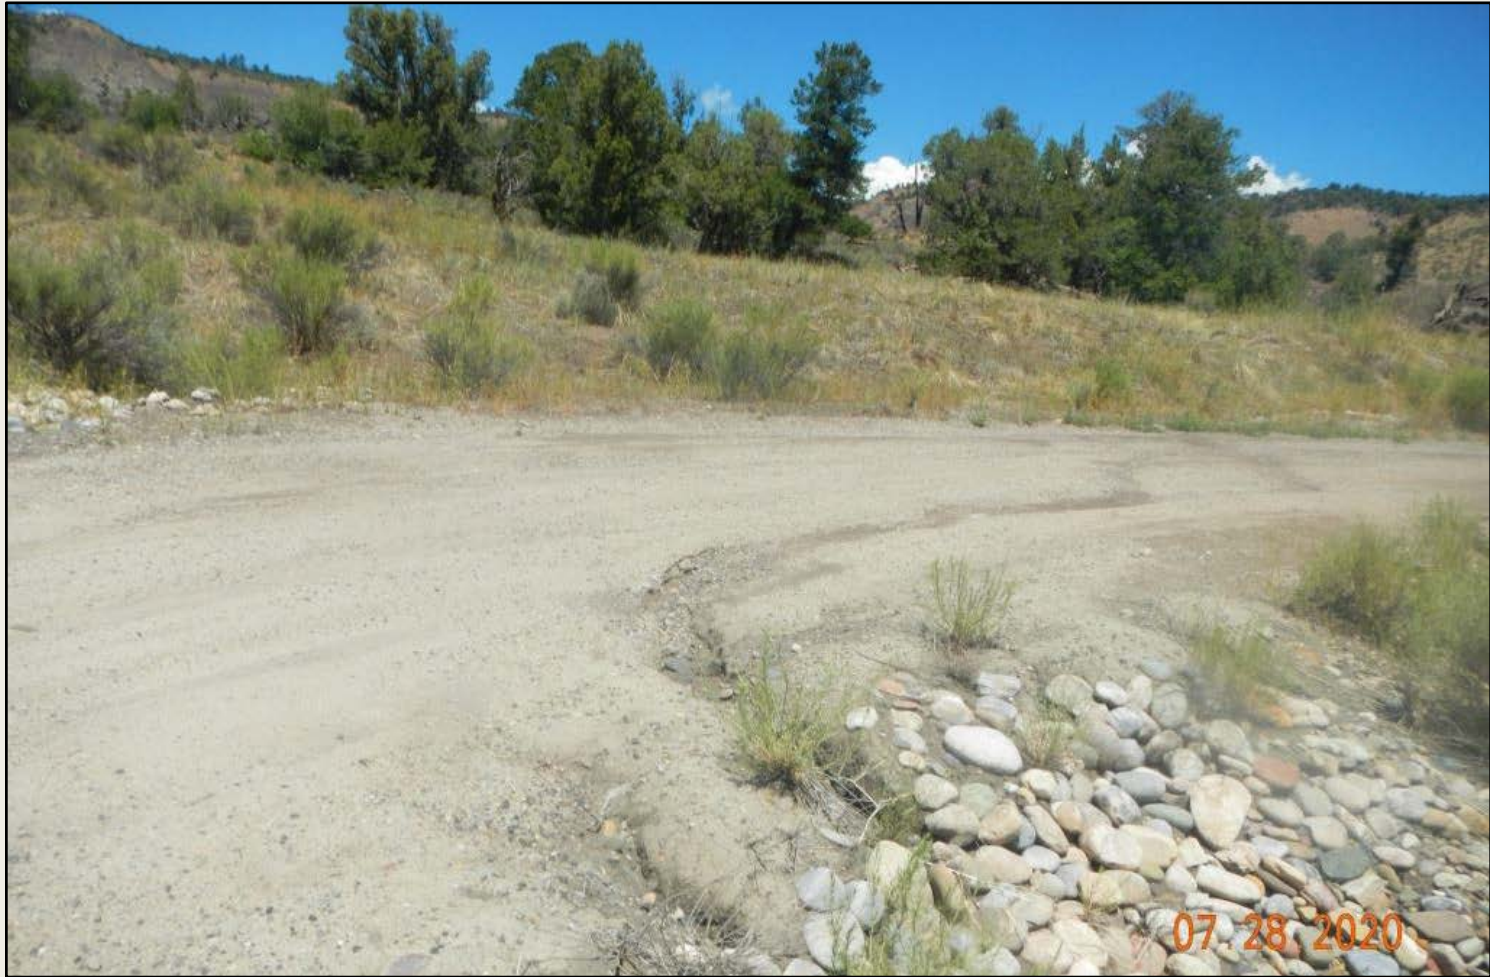
Photo 2. View of erosional channeling occurring at the well pad entrance where stormwater flows down the access road into culvert outlet (Photo 3).

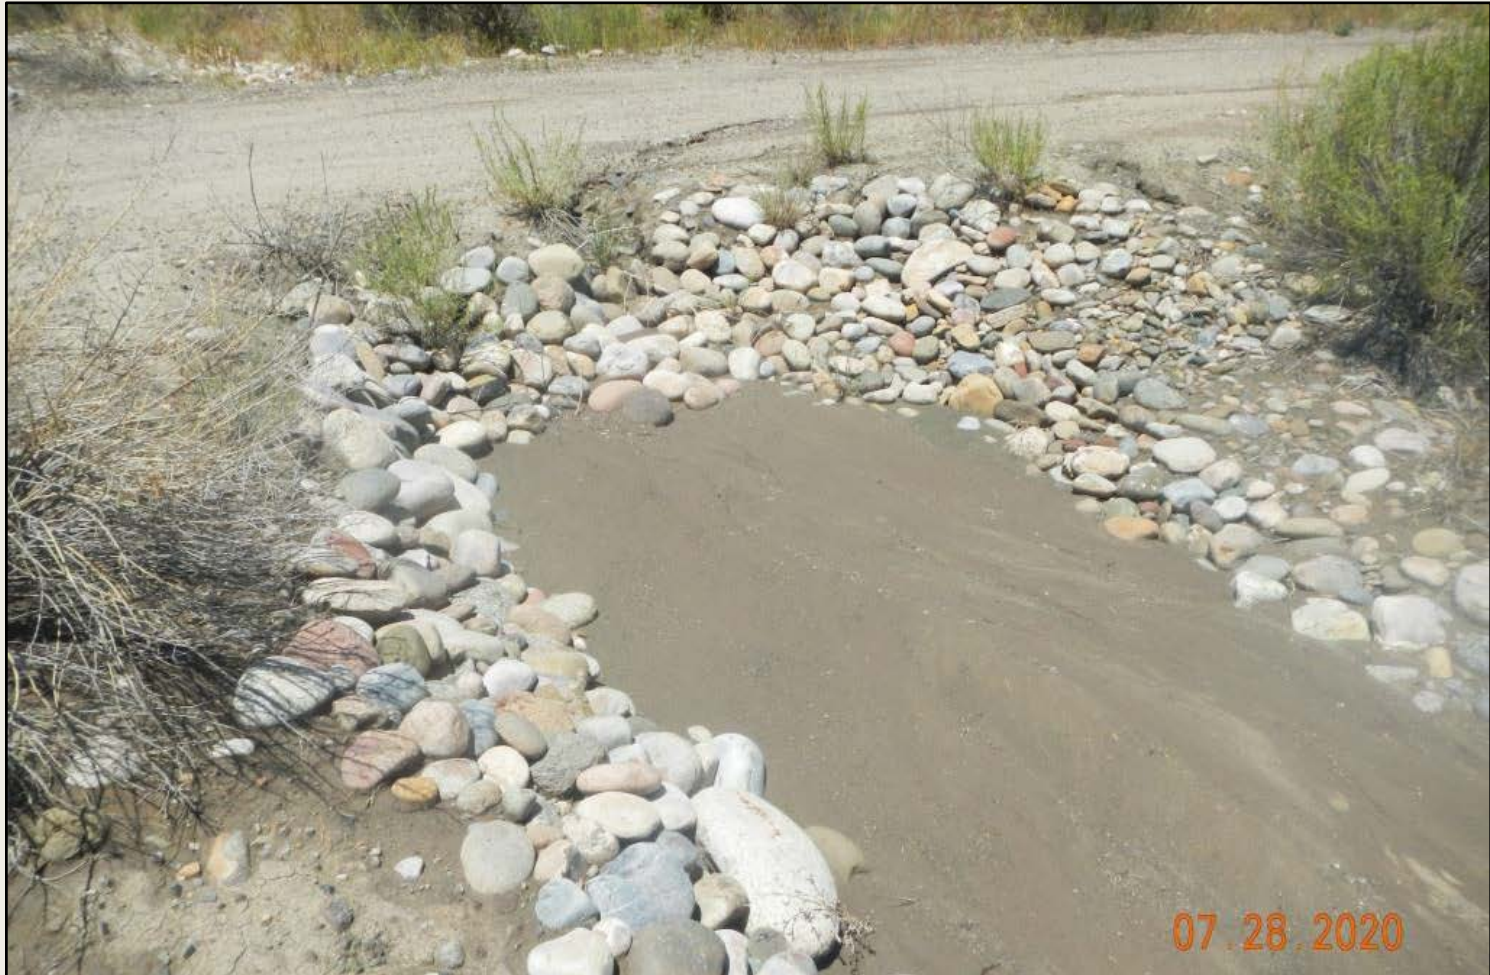
Photo 3. View of the culvert outlet at the well pad entrance. Culvert is full of sediment and needs maintenance.

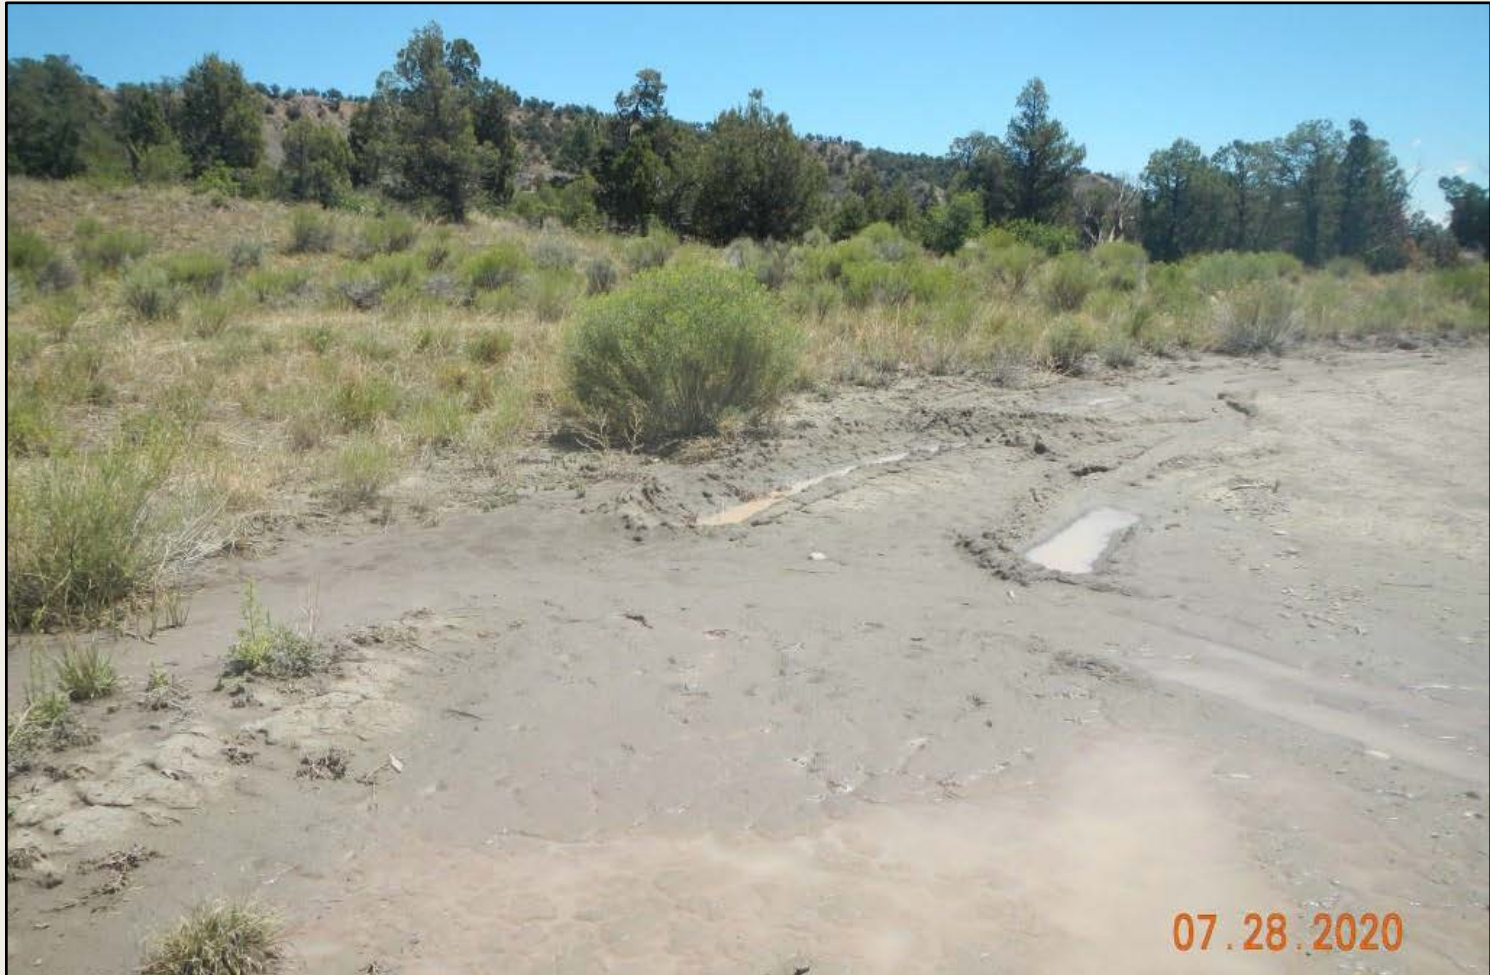
Photo 4. View of area along the well pad diversion, where diversion berm is damaged by truck tracks and erosion, and sediment is discharging onto the well pad resulting in deep rutting.

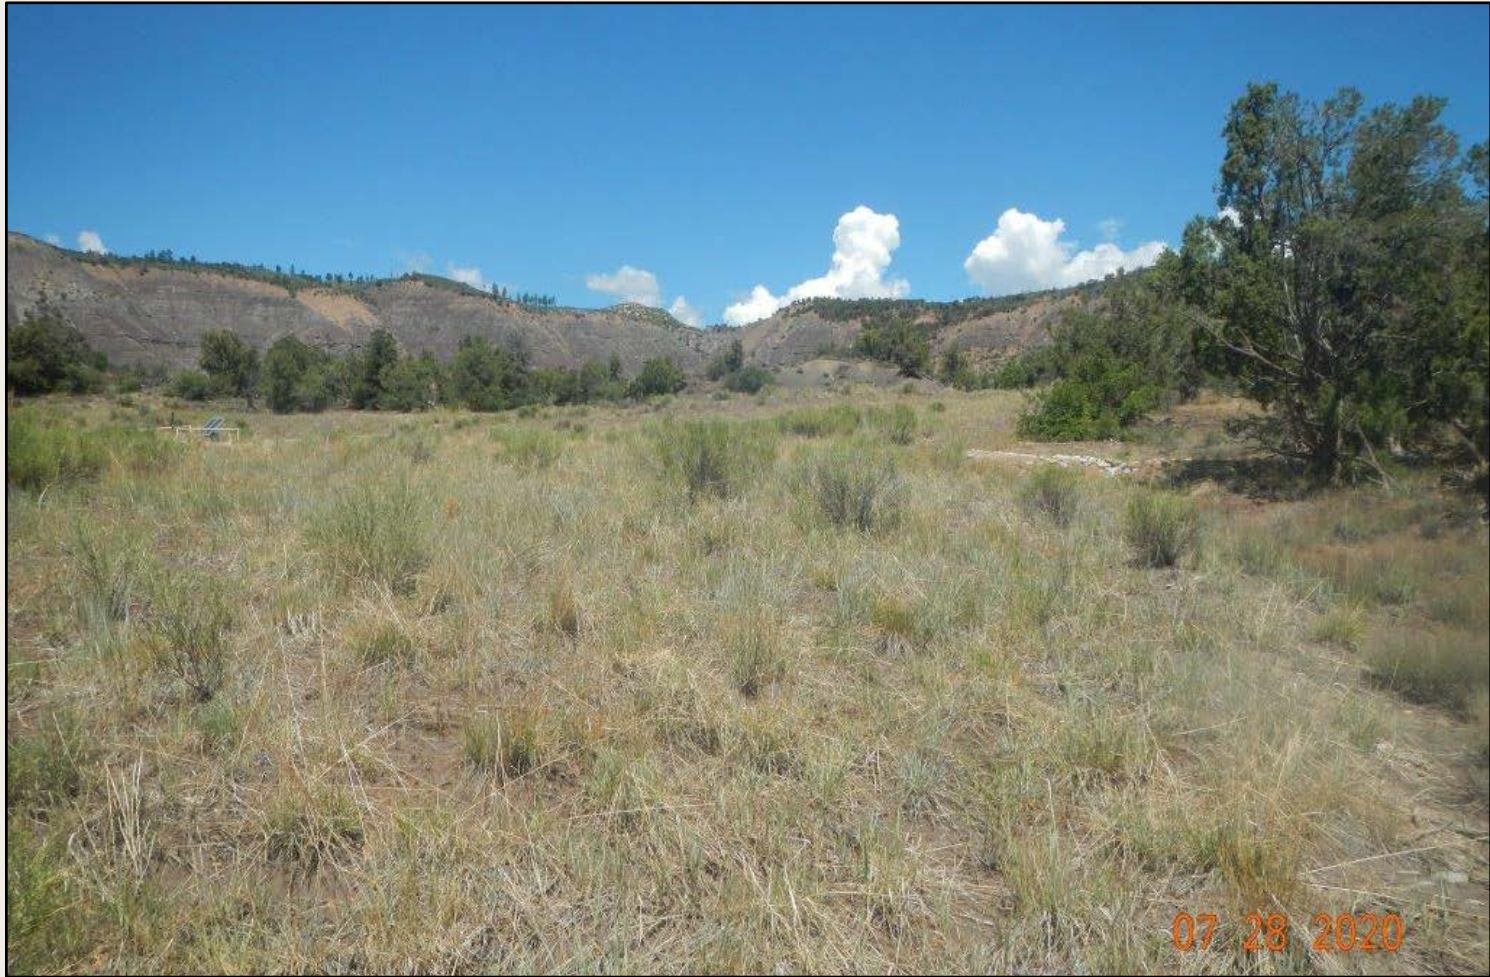
Photo 5. View of the northern project area from the northeastern corner facing westward. Revegetation is progressing within the interim reclamation areas with rubber rabbitbrush, crested wheatgrass, and western wheatgrass.

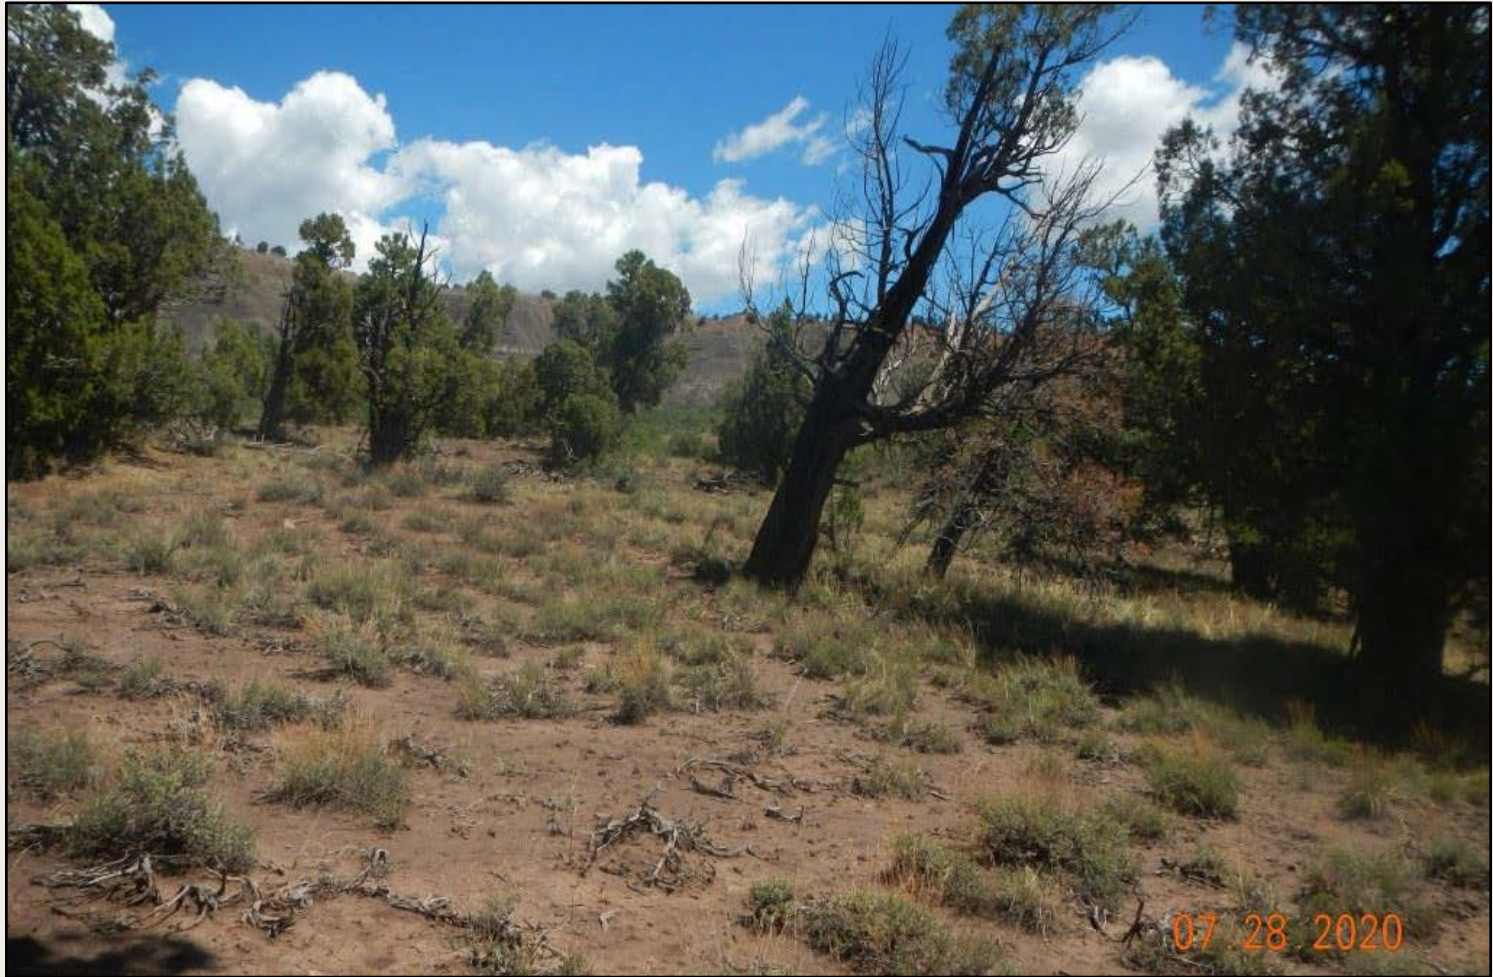
Photo 6. View of reference area vegetation comprised of pinyon and juniper woodland, with black sage, blue grama, and *Tetrandeum* sp.
