Inspection Photos

API: 071-06559

Operator: EVERGREEN NATURAL RESOURCES

Inspection Date: 8/3/2020

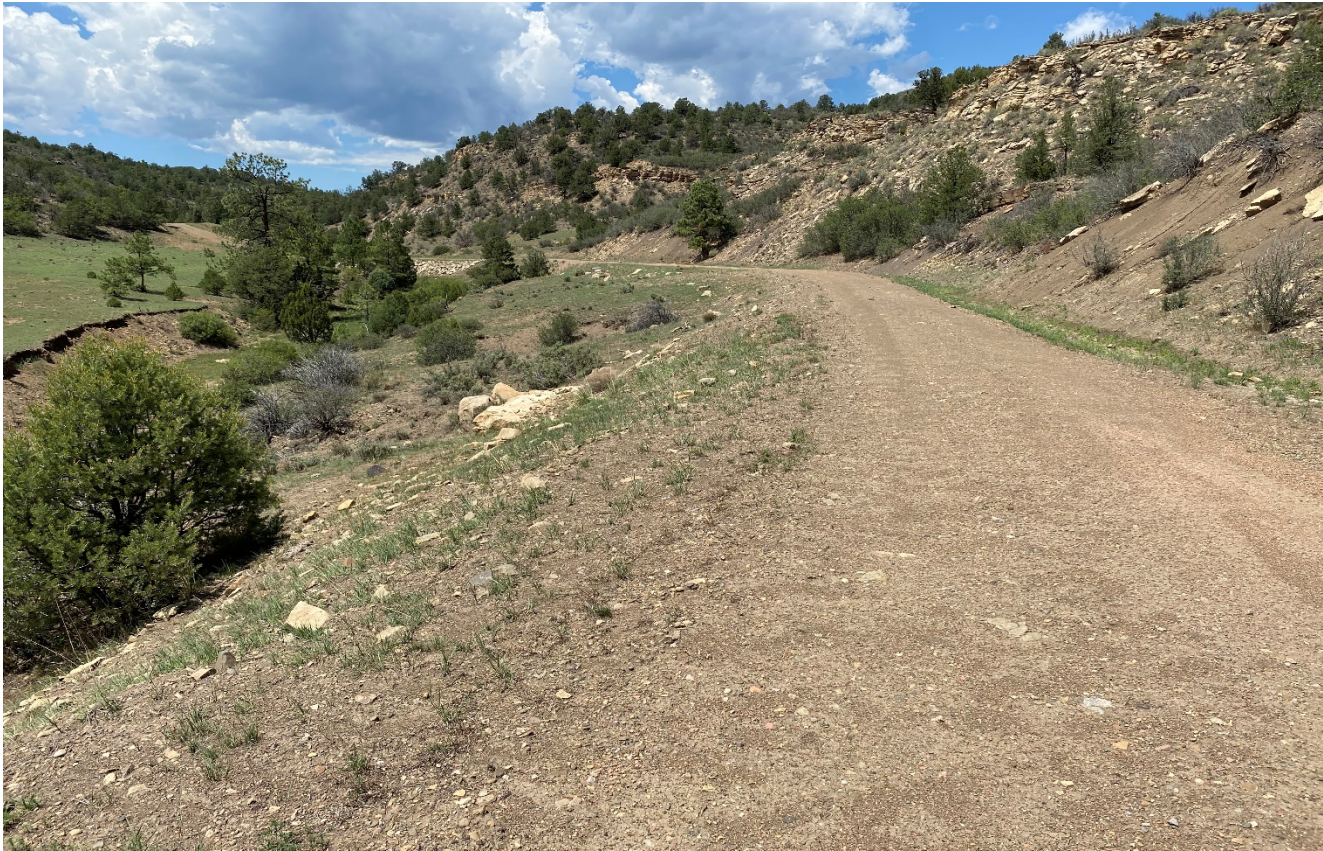
Photo 1. Facing northwest along the access road which remains by approved variance request.

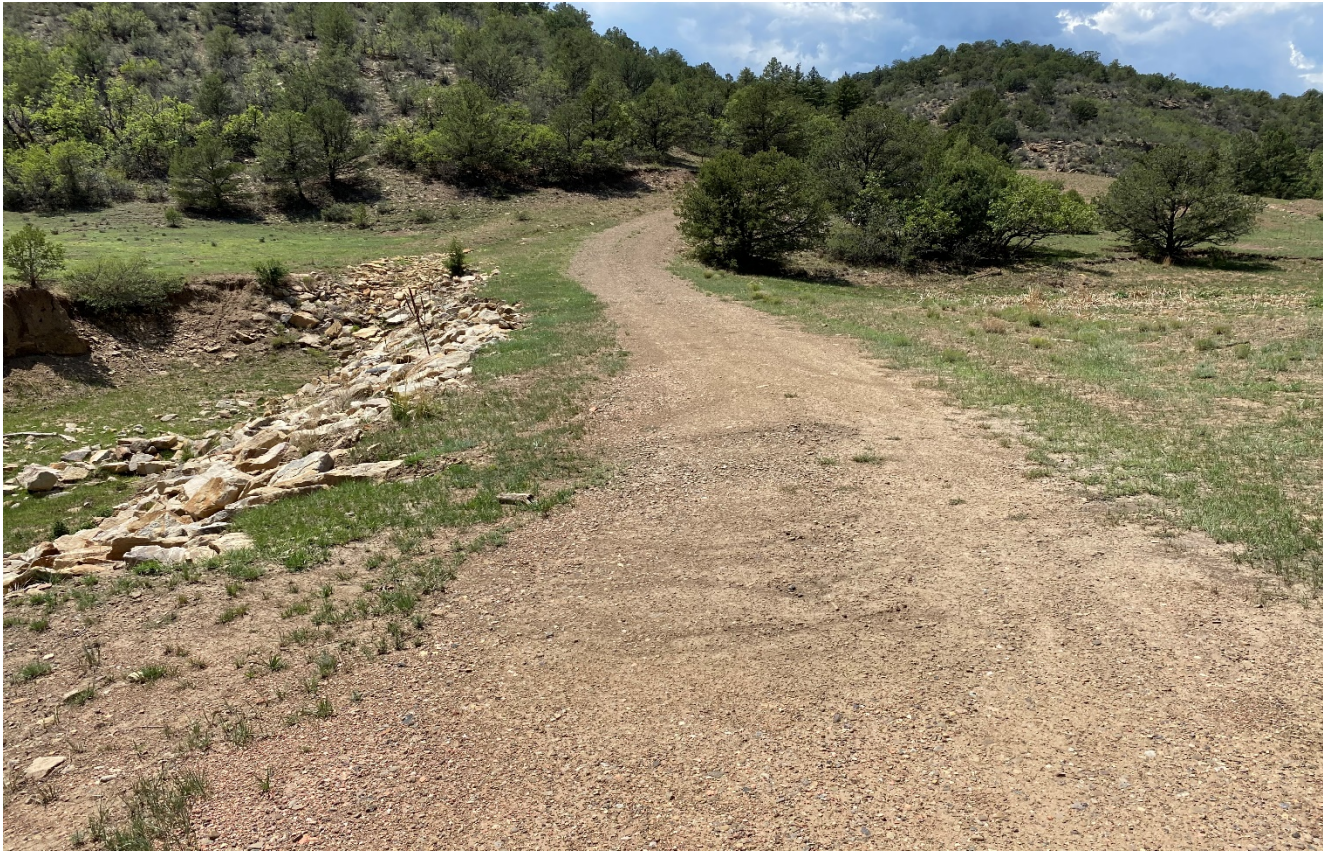
Photo 2. Facing west along the road which passes the drainage. There is concern with the small size of the culverts installed at this drainage crossing however, this area appears to be stabilized.

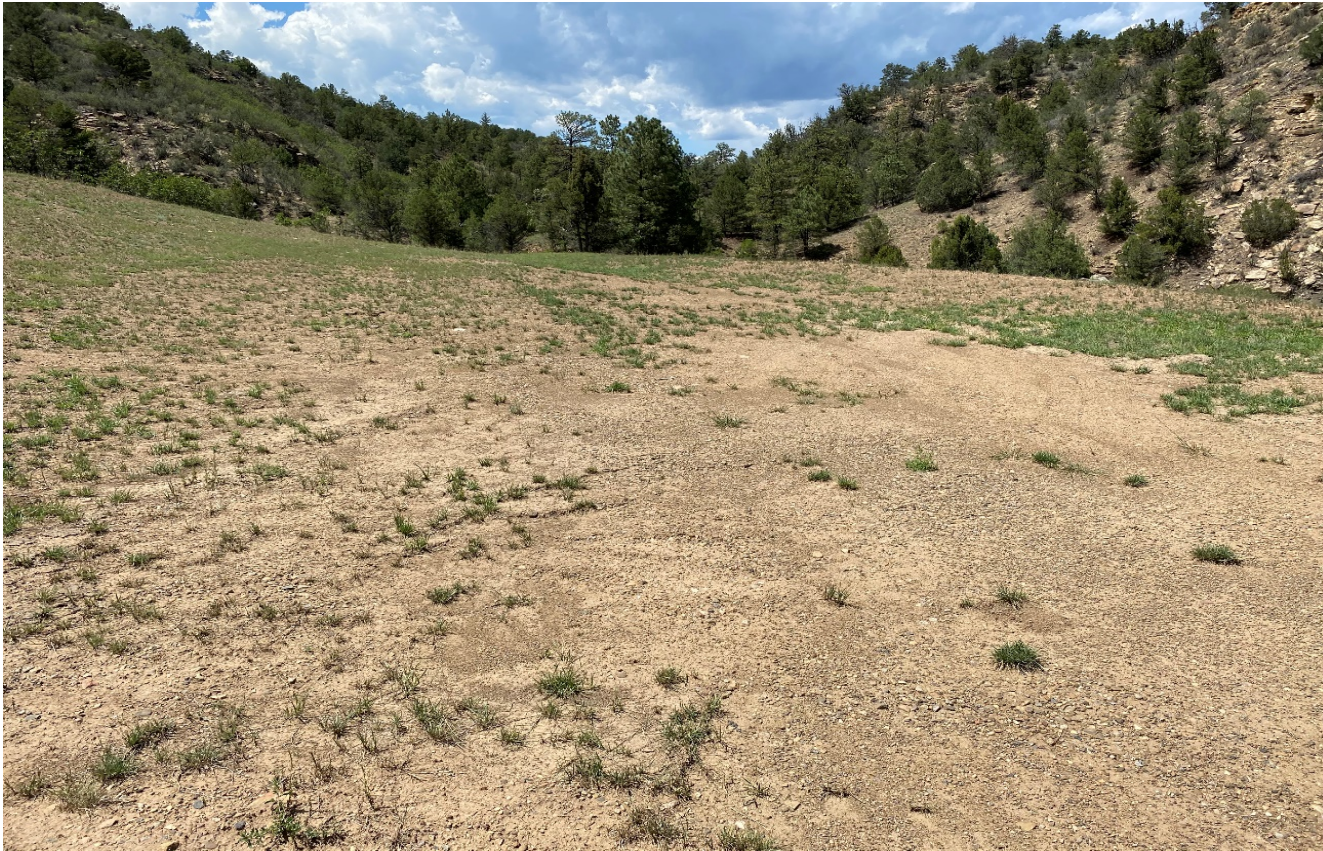
Photo 3. Facing northwest toward the location.

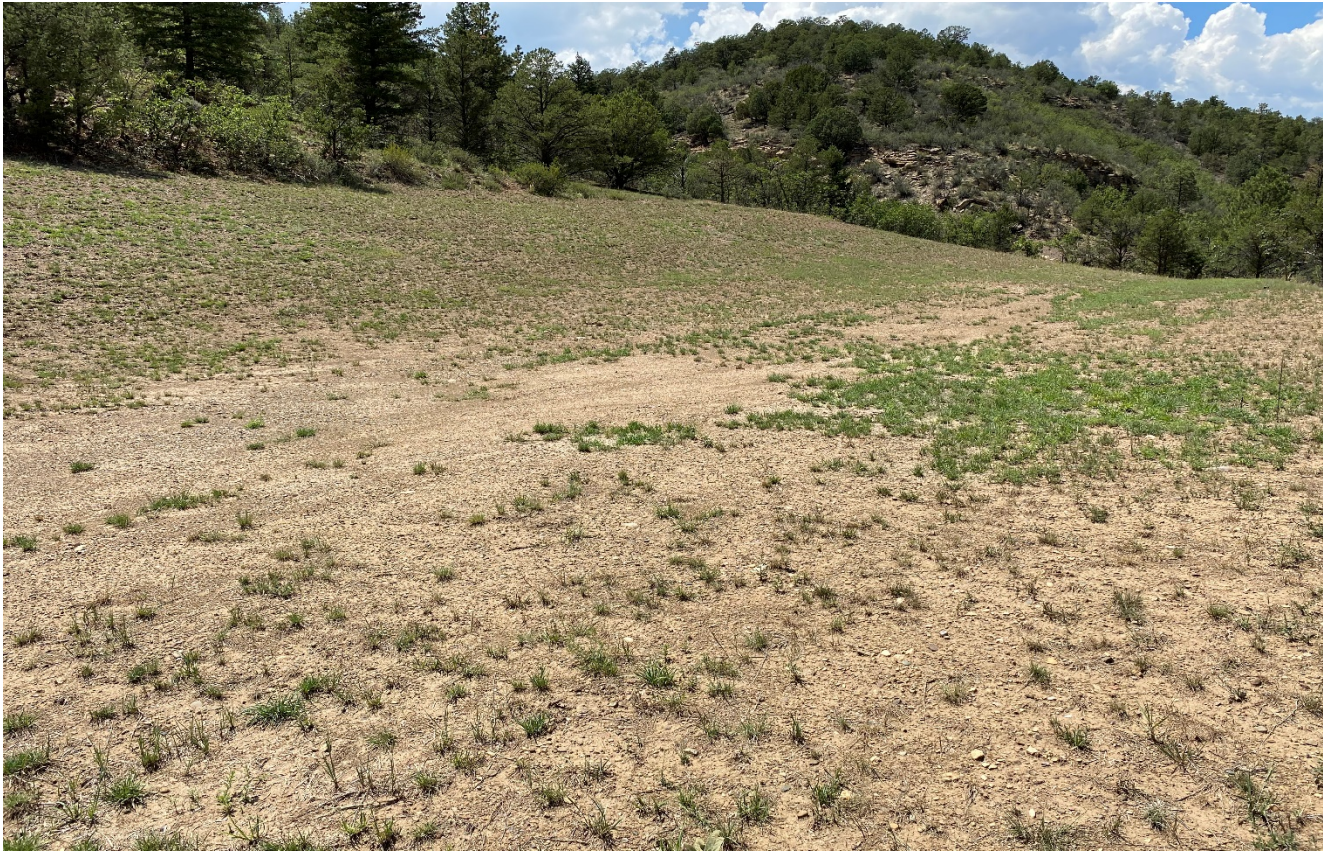
Photo 4. Facing west toward the cut slope and benched area of the location.

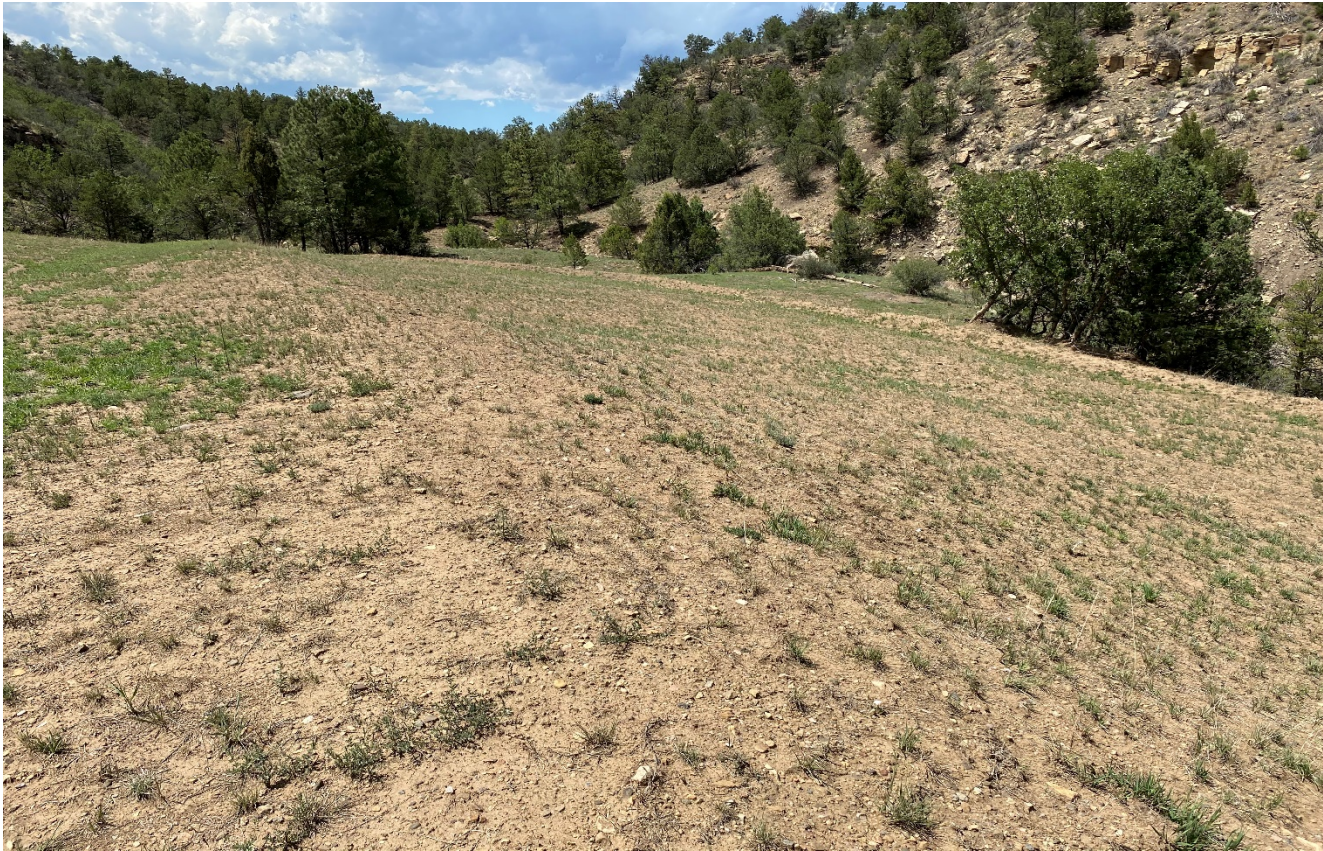
Photo 5. Facing northwest toward the fill slope.

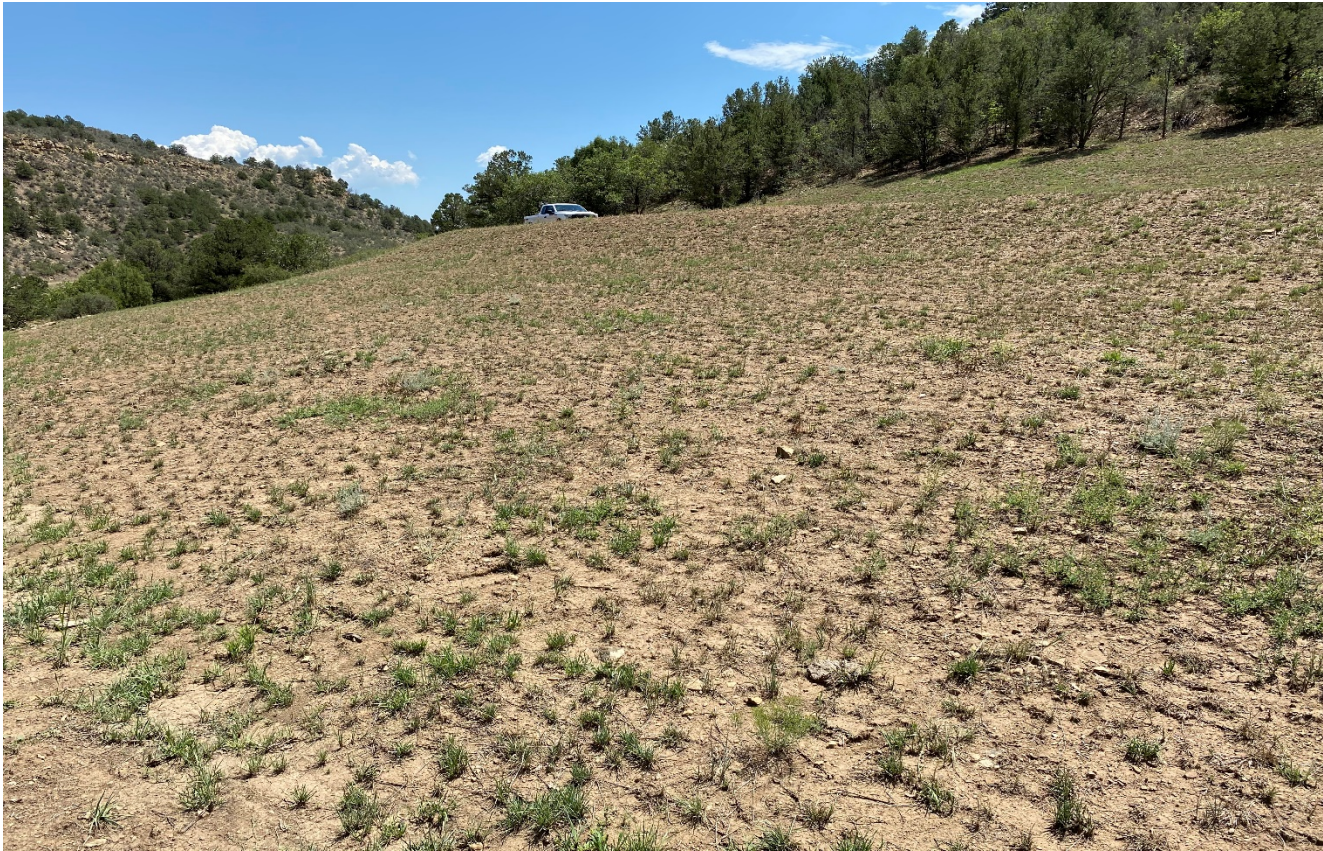
Photo 6. Facing southeast toward the fill slope standing at the bottom portion.

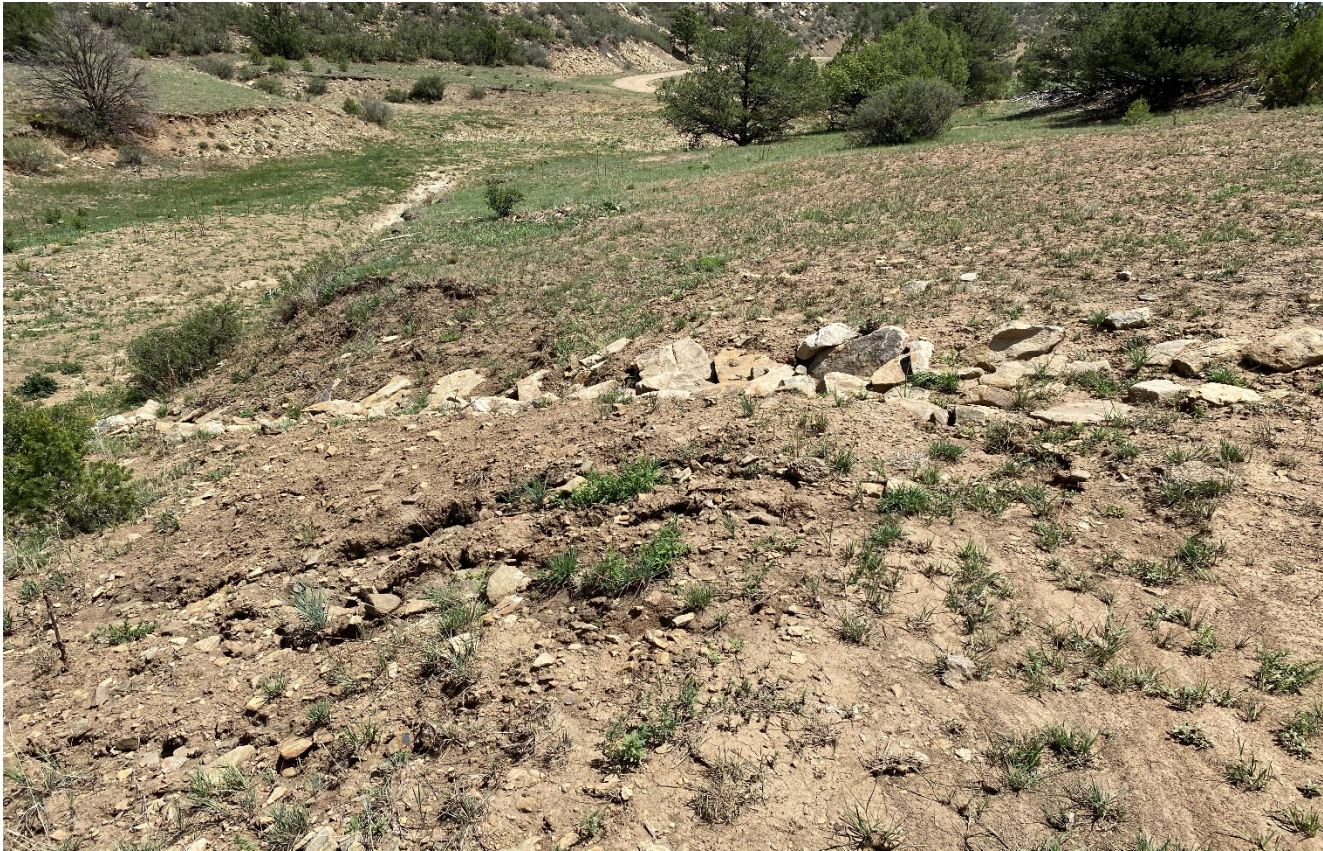
Photo 7. There is some minor erosion at the northeast side of the location. Some hand work may correct this issue.

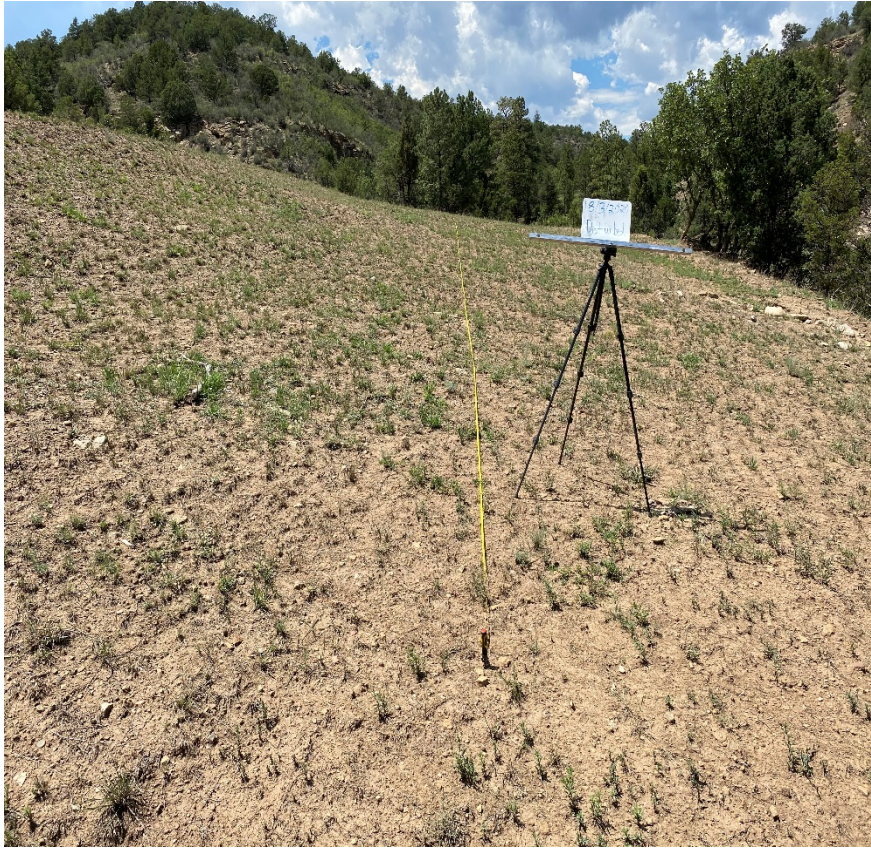
Photo 8. Facing northwest at the beginning of the vegetation transect performed at the disturbed location along the fill slope.

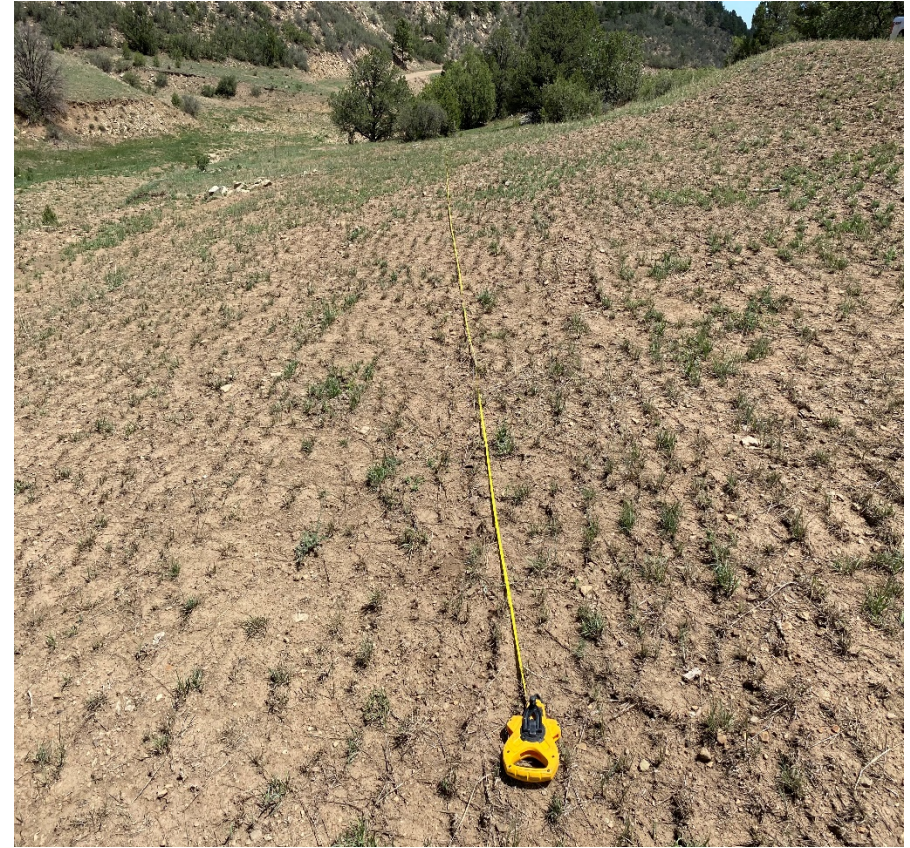
Photo 9. Facing southeast at the end of the vegetation transect performed at the disturbed location along the fill slope.

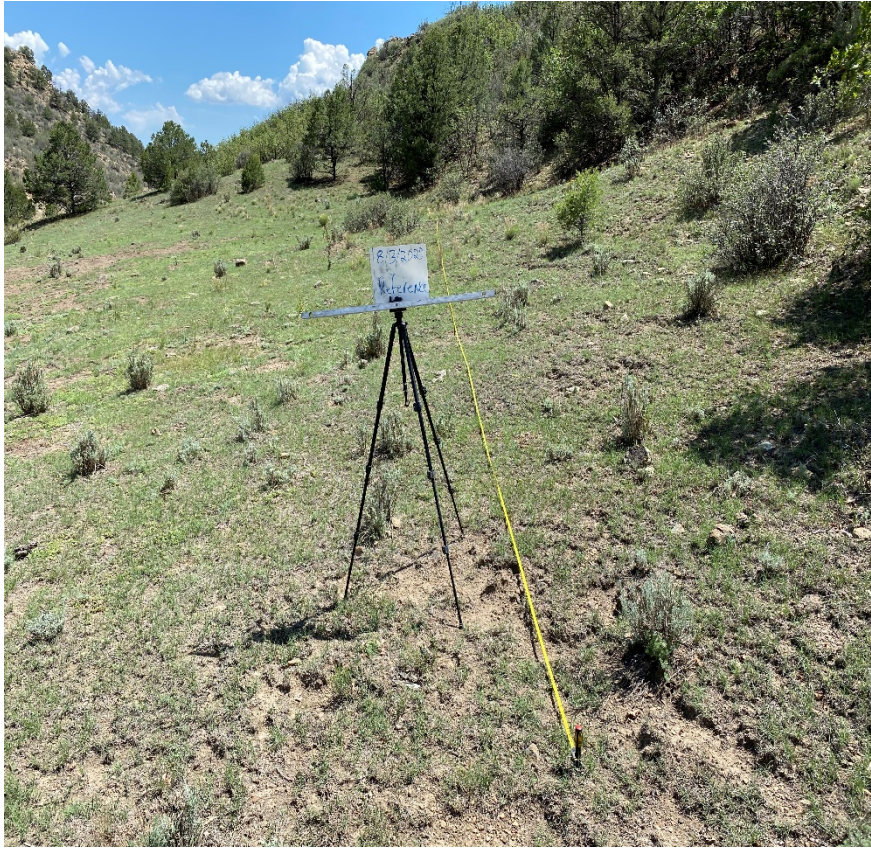
Photo 10. Facing southeast at the beginning of the vegetation transect performed at the reference area.

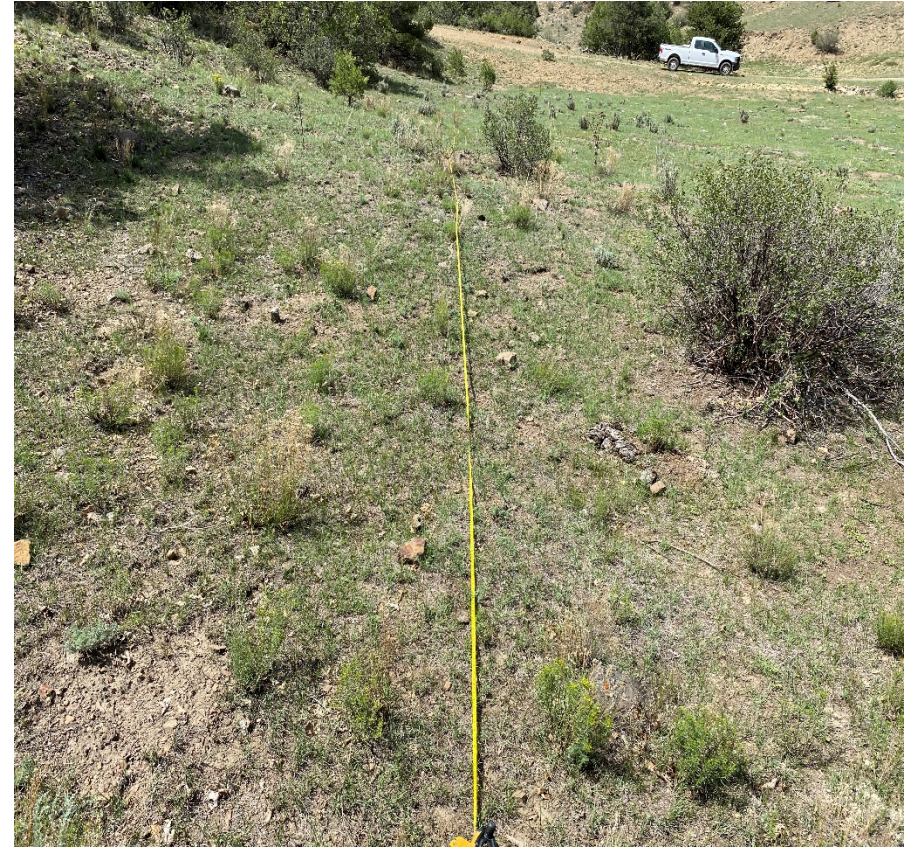
Photo 11. Facing northwest at the end of the vegetation transect performed at the reference area.
