**Inspection Photos**  
**Operator: Benson Montin Greer**  
**API: 067-06159**  
**Date: 7/28/2020**

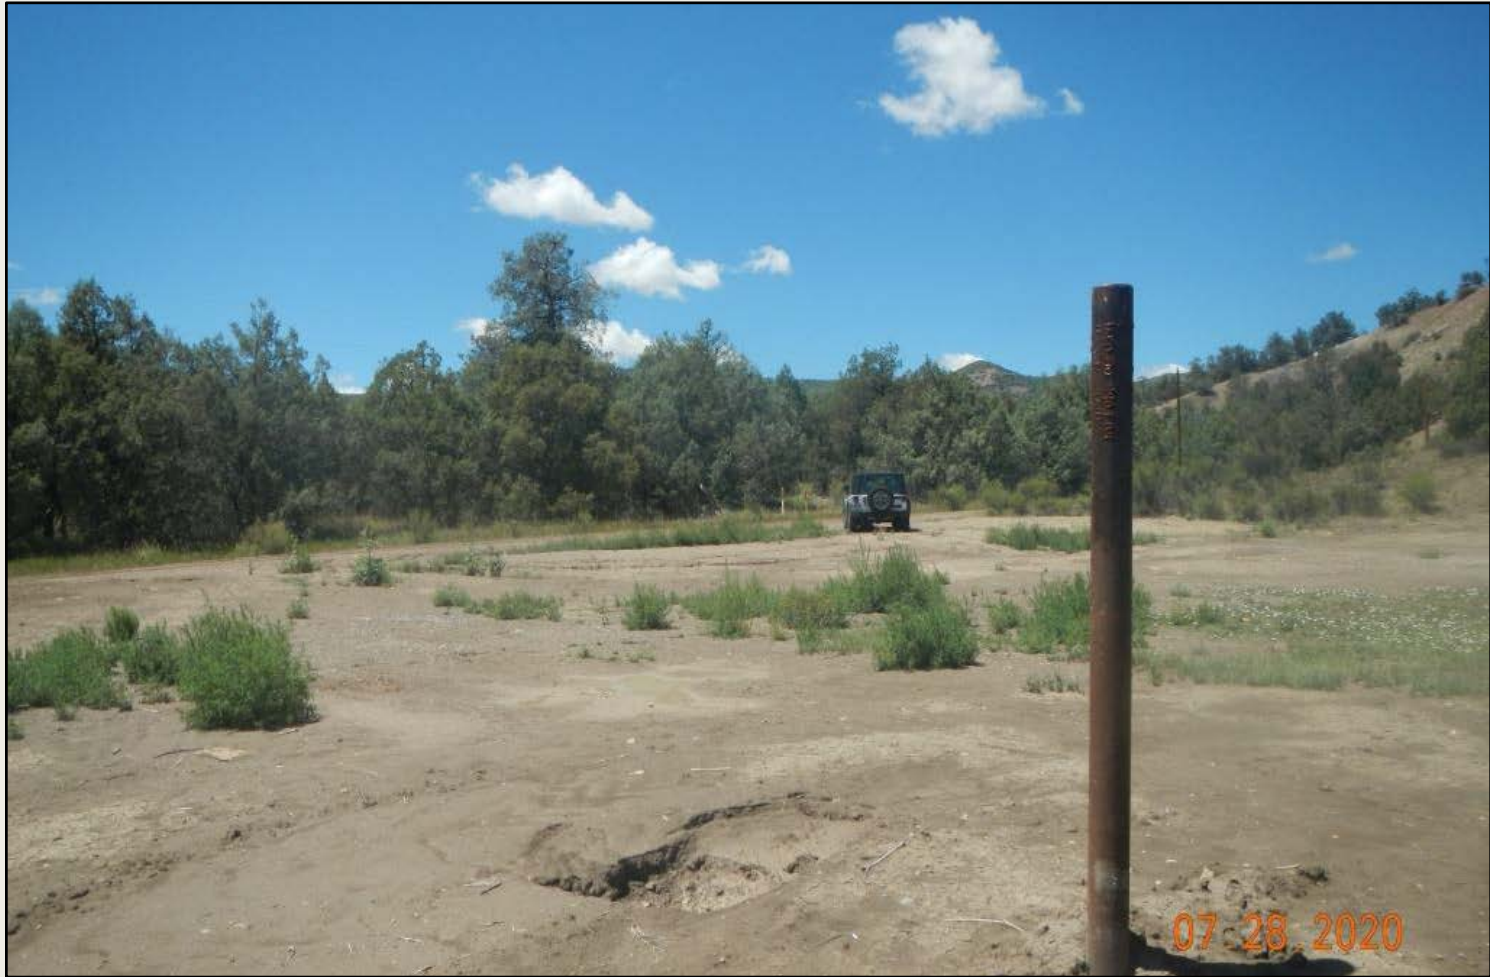
Photo 1. View of the northeastern edge facing center. Plugged well marker

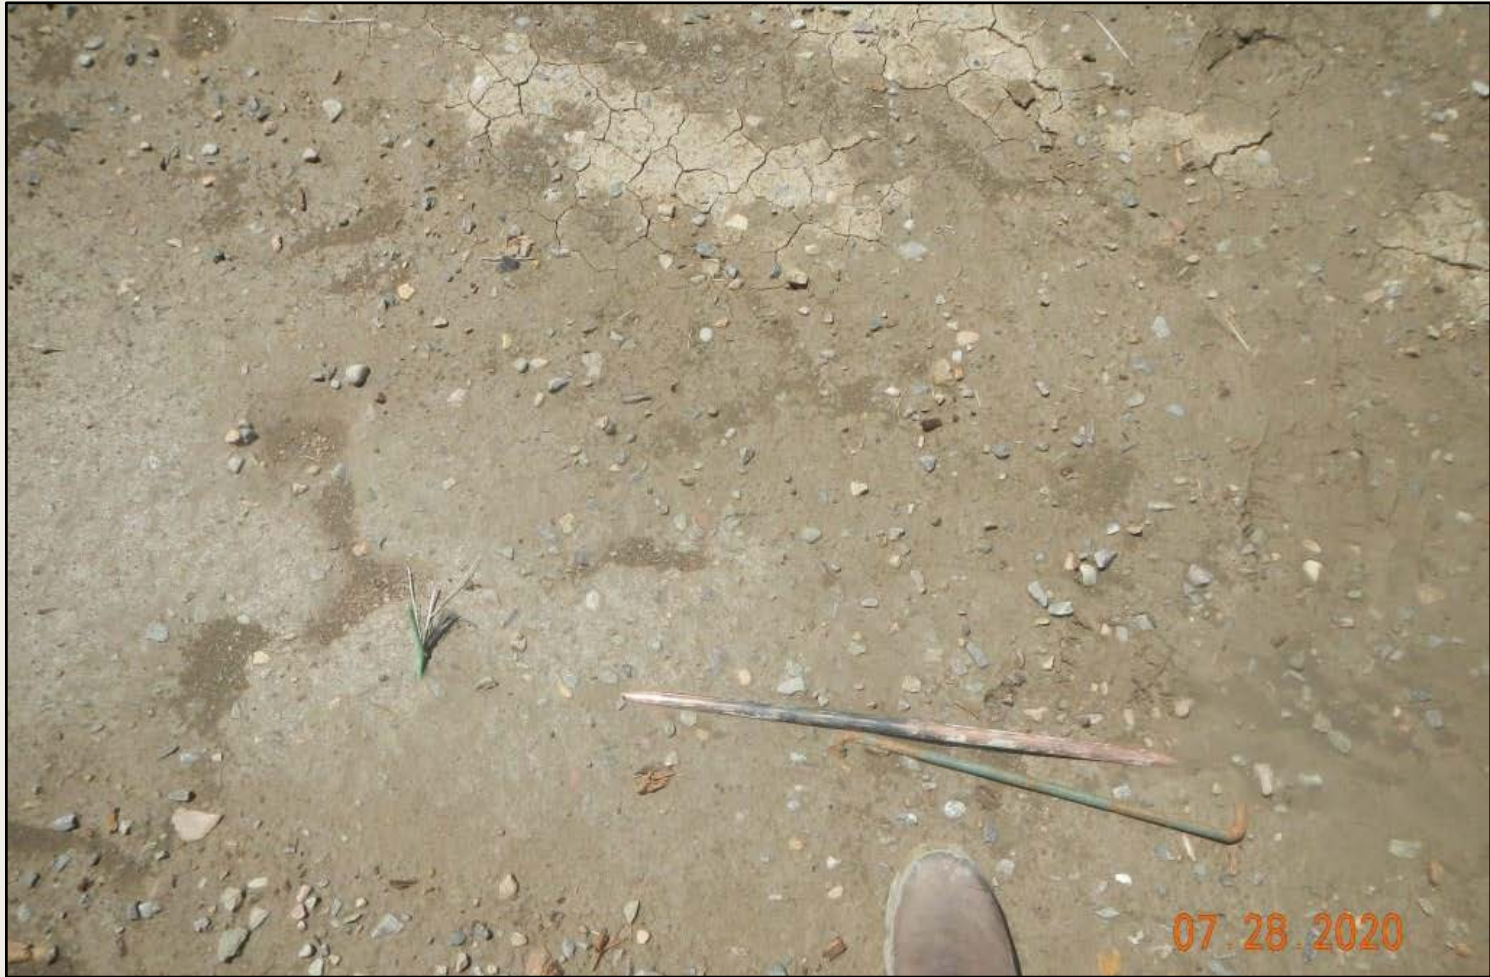
Photo 2. View of exposed pipe and wiring on the well pad, needing to be removed.

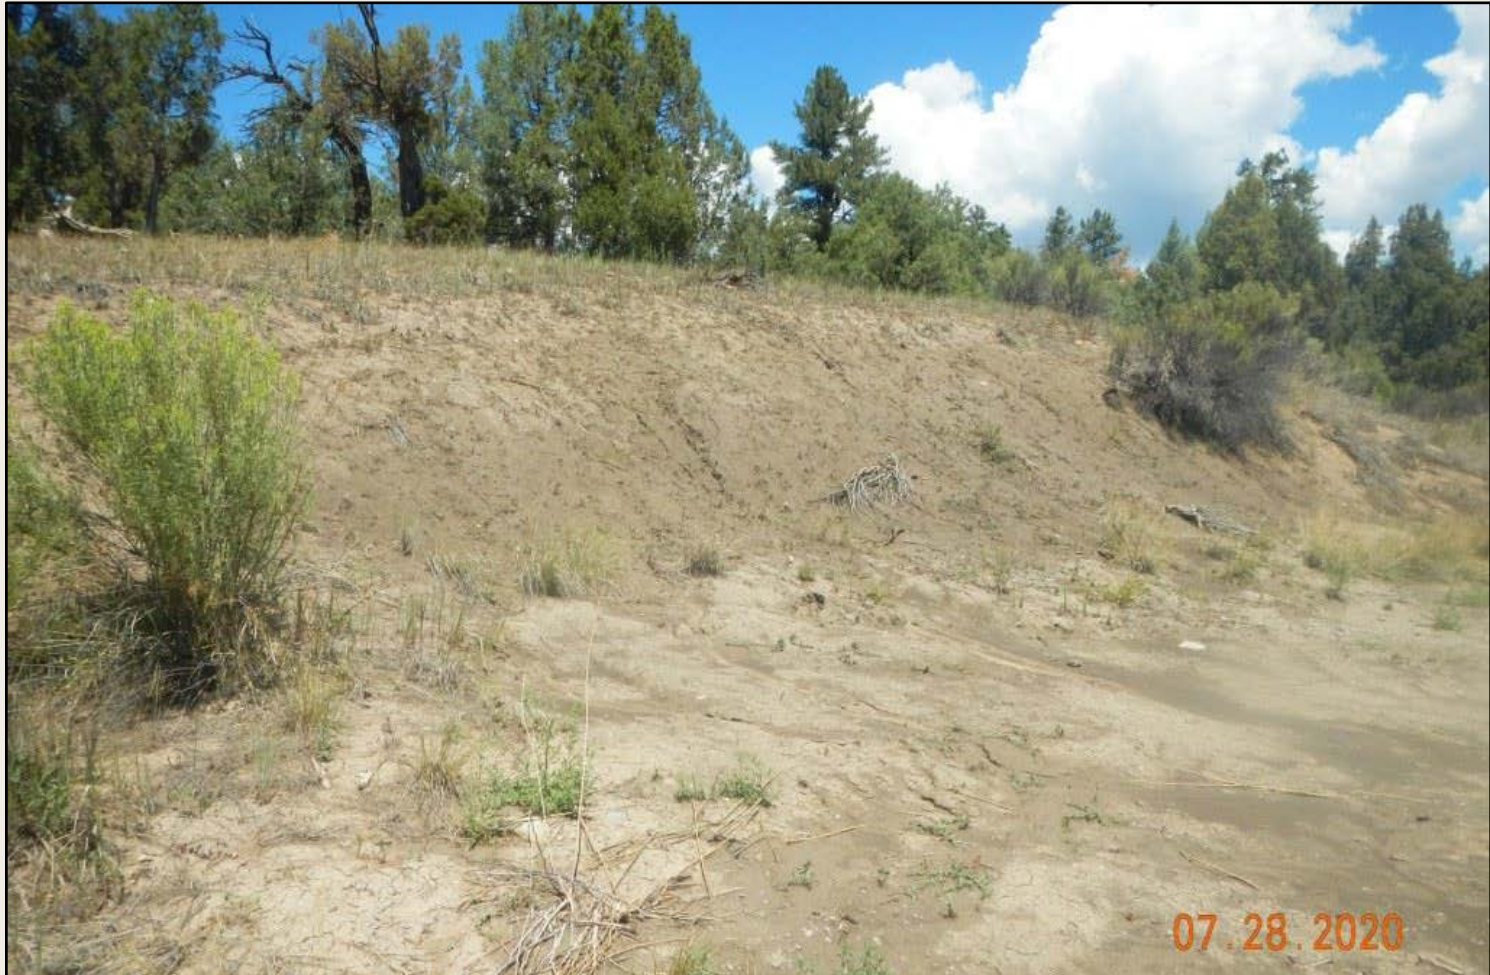
Photo 3. View of the western project area, cut-slope is not contoured or stabilized, as sediment deposition observed at the toe of the slope.

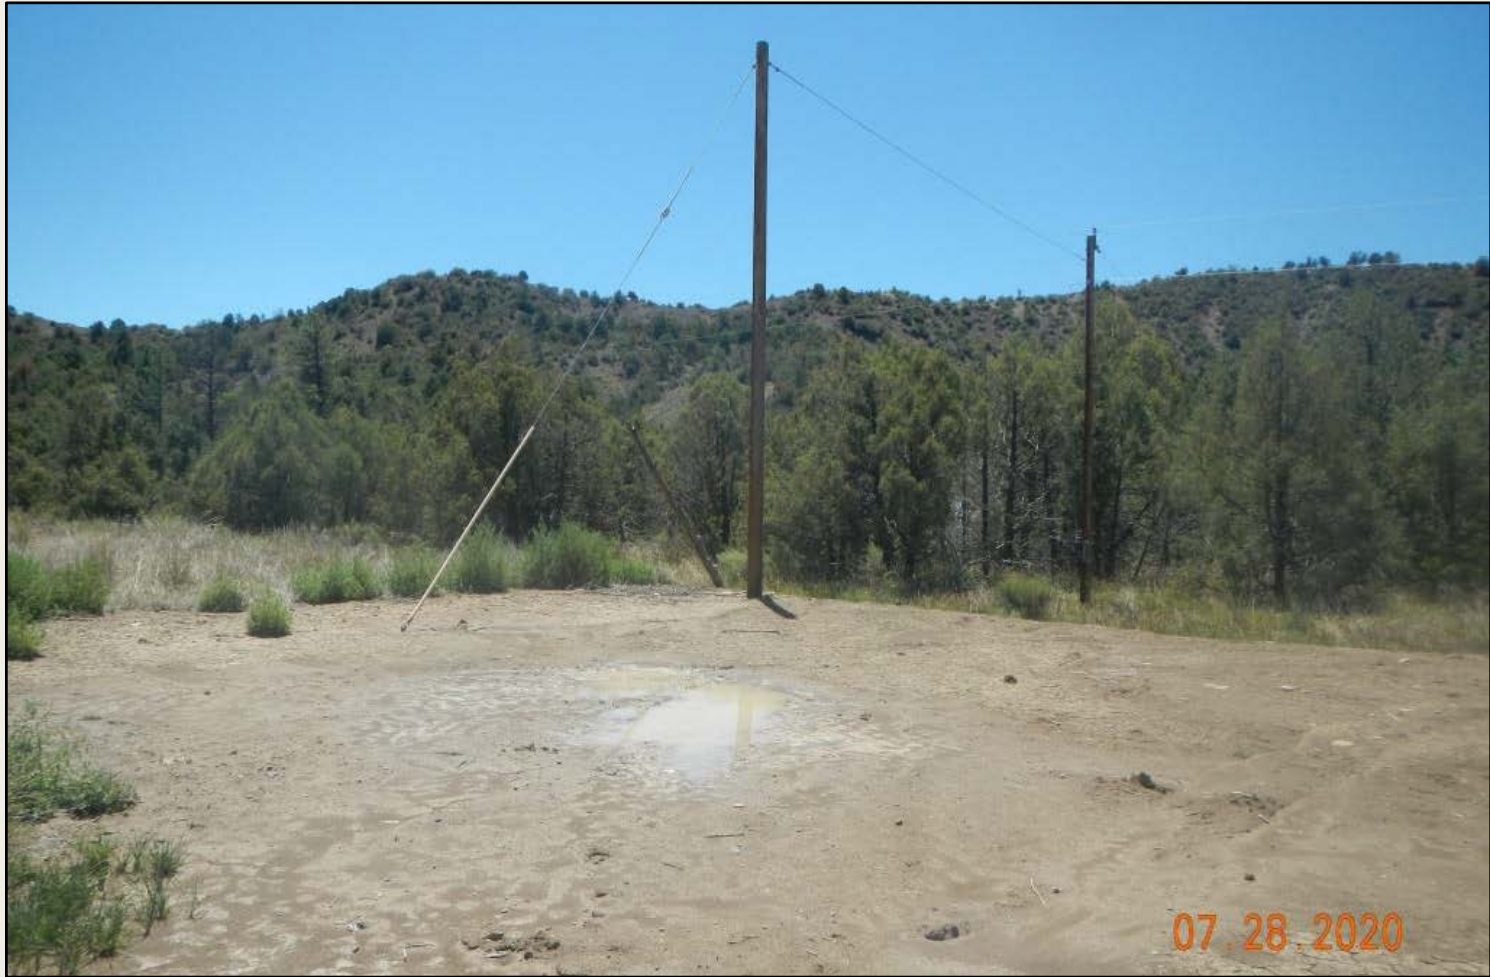
Photo 4. View of bare area in the southeastern project area, needing reclamation.

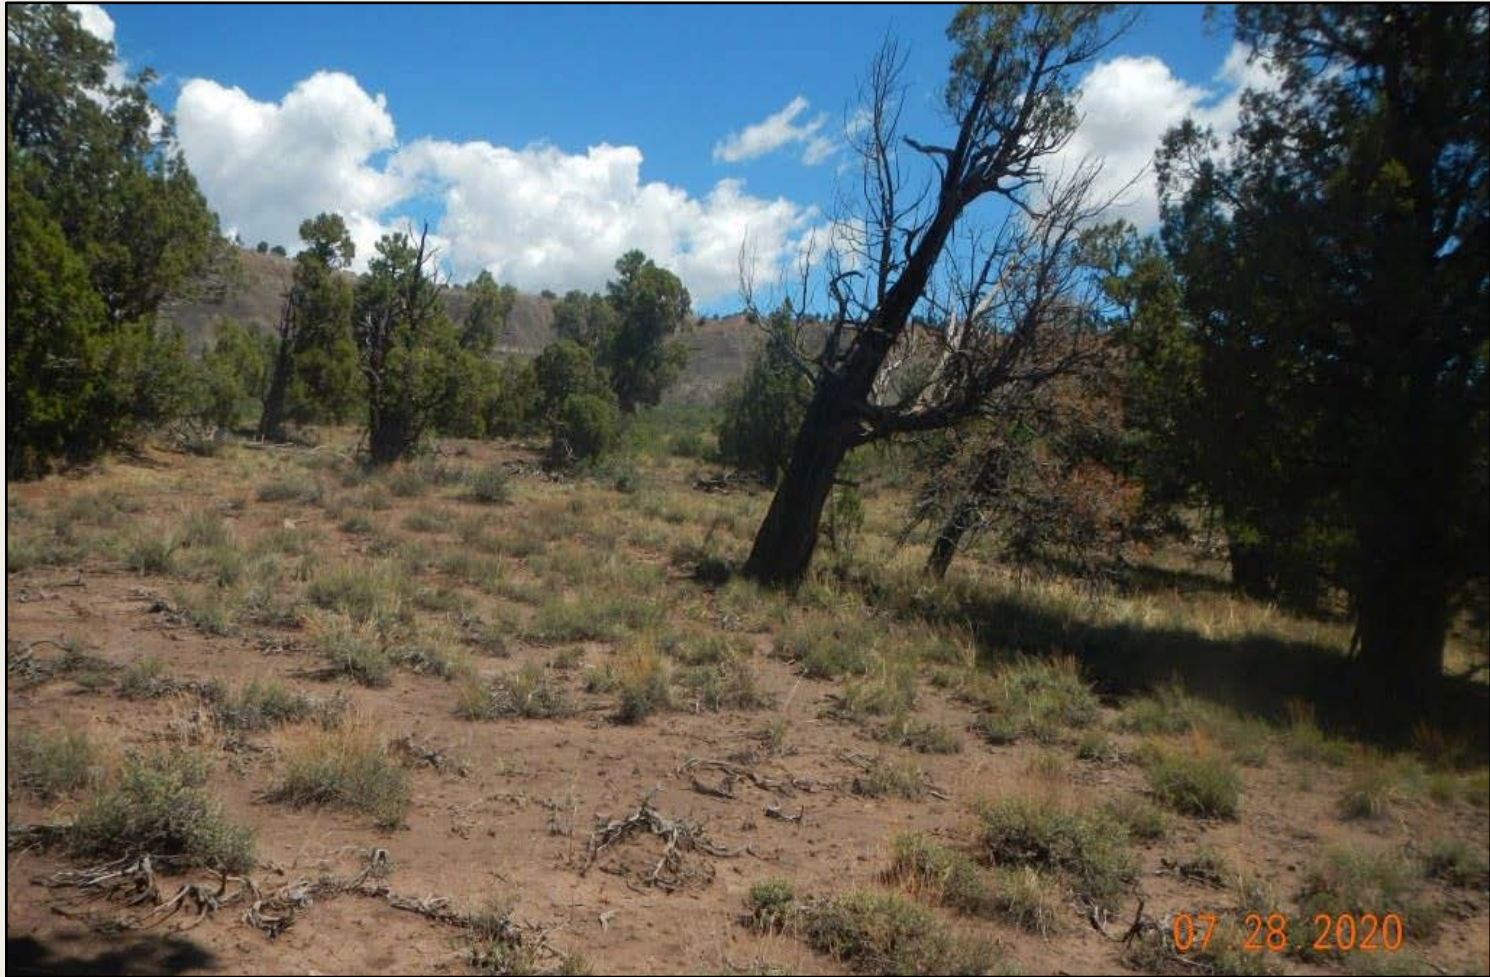
Photo 5. View of reference area vegetation comprised of pinyon and juniper woodland, with black sage, blue grama, and *Tetaneuris* sp.
