Inspection Photos
Operator: BP America
API: 067-08689
Date: 8/3/2020

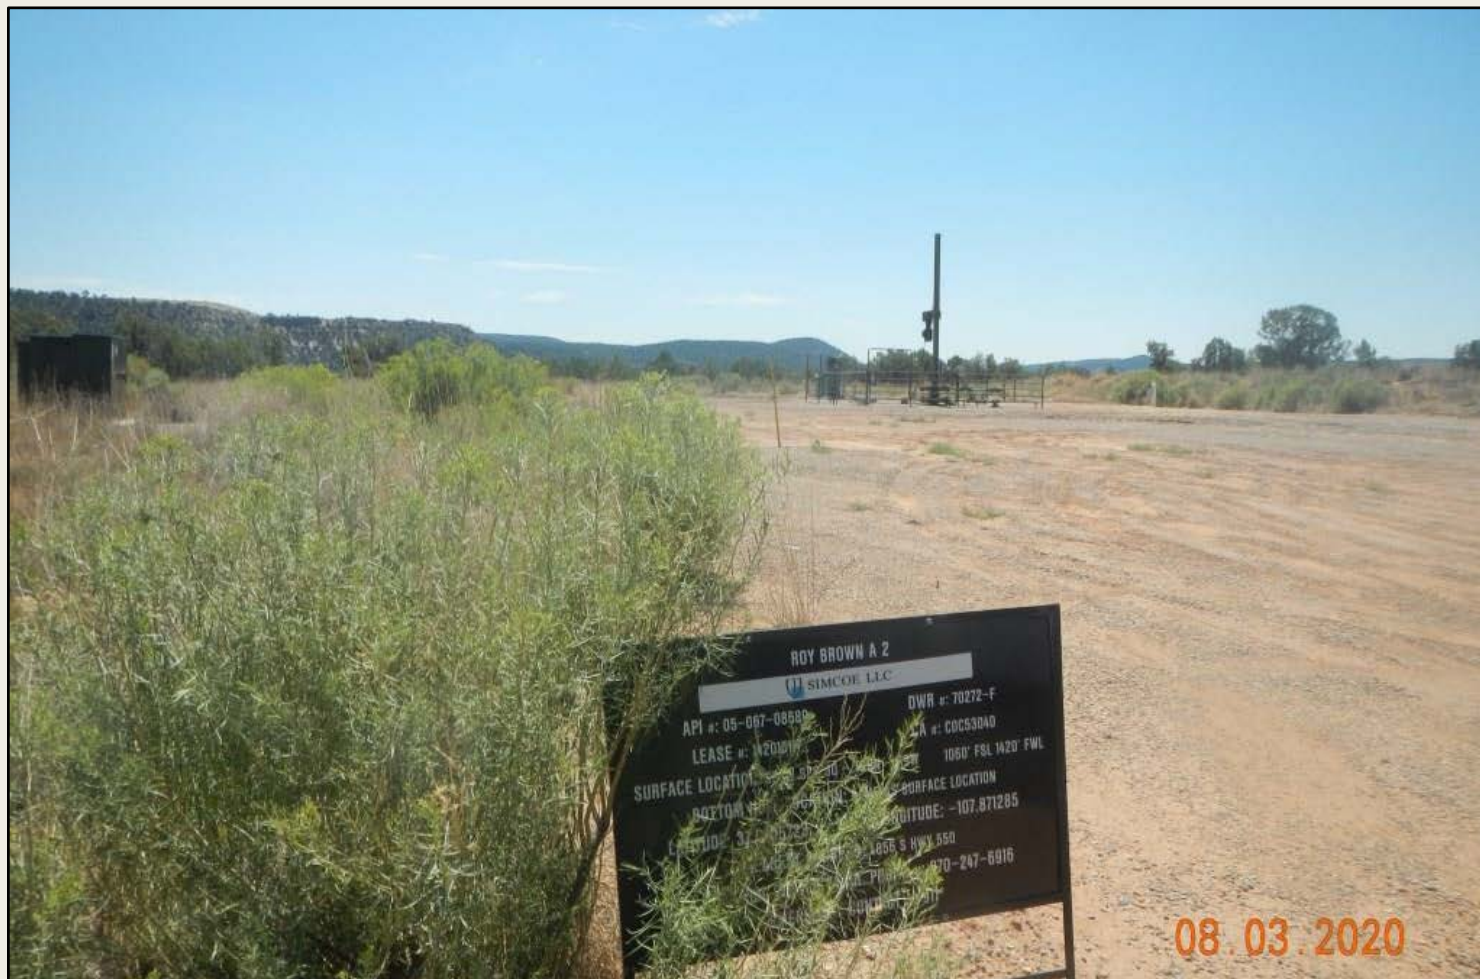
Photo 1. View of the project area from the nottheastern corner facing center.

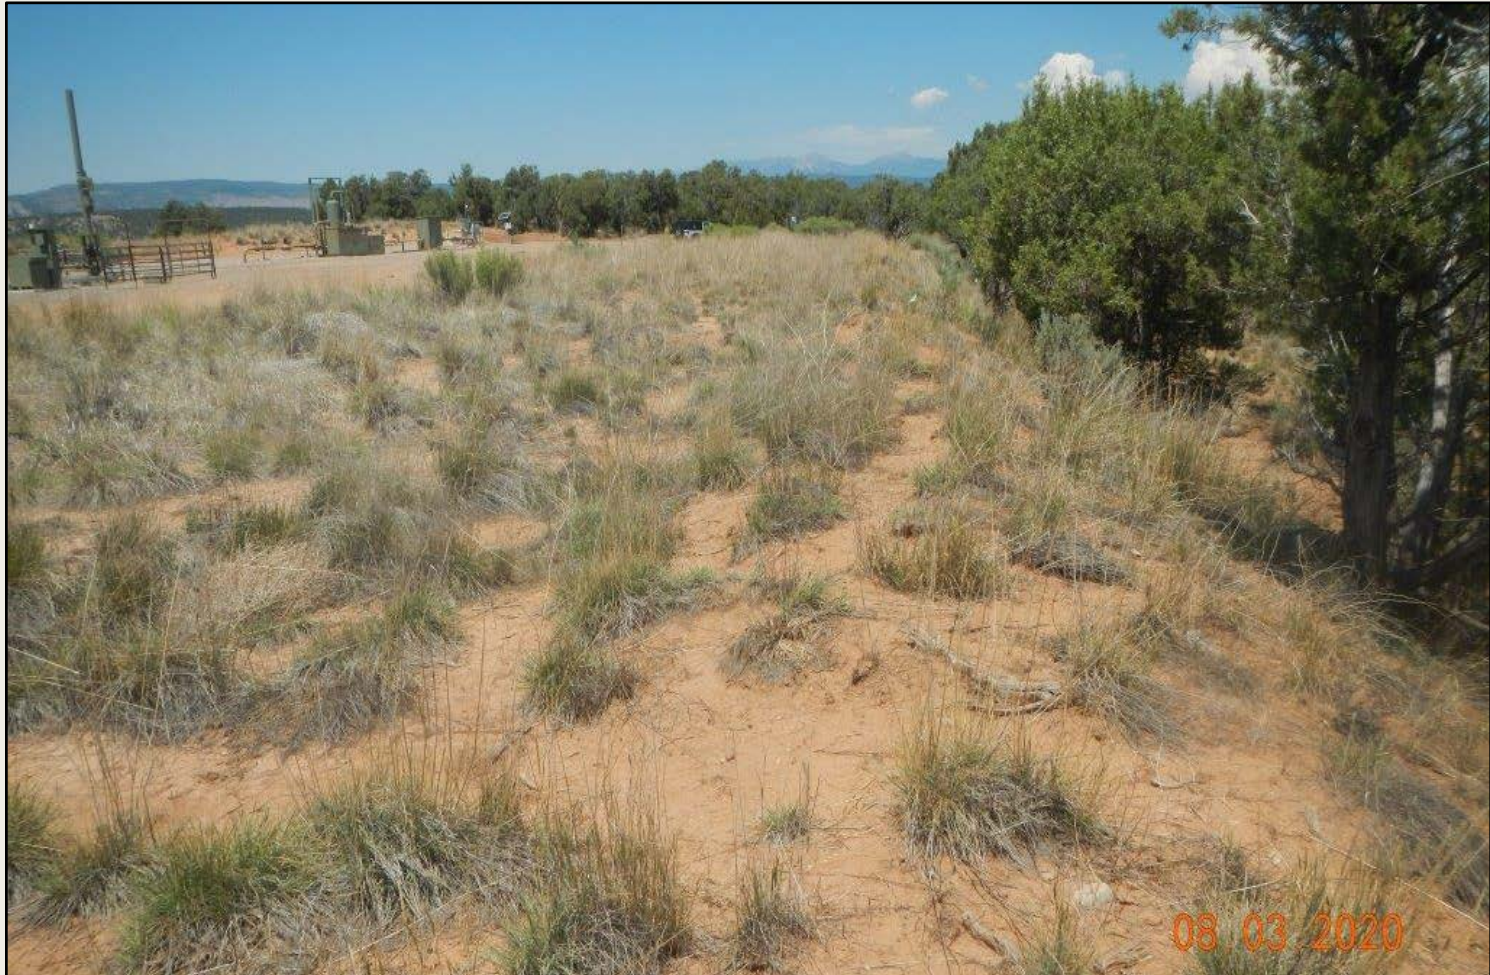
Photo 2. View of the eastern project area from the southeastern corner facing northward. Revegetation is progressing with crested wheatgrass.

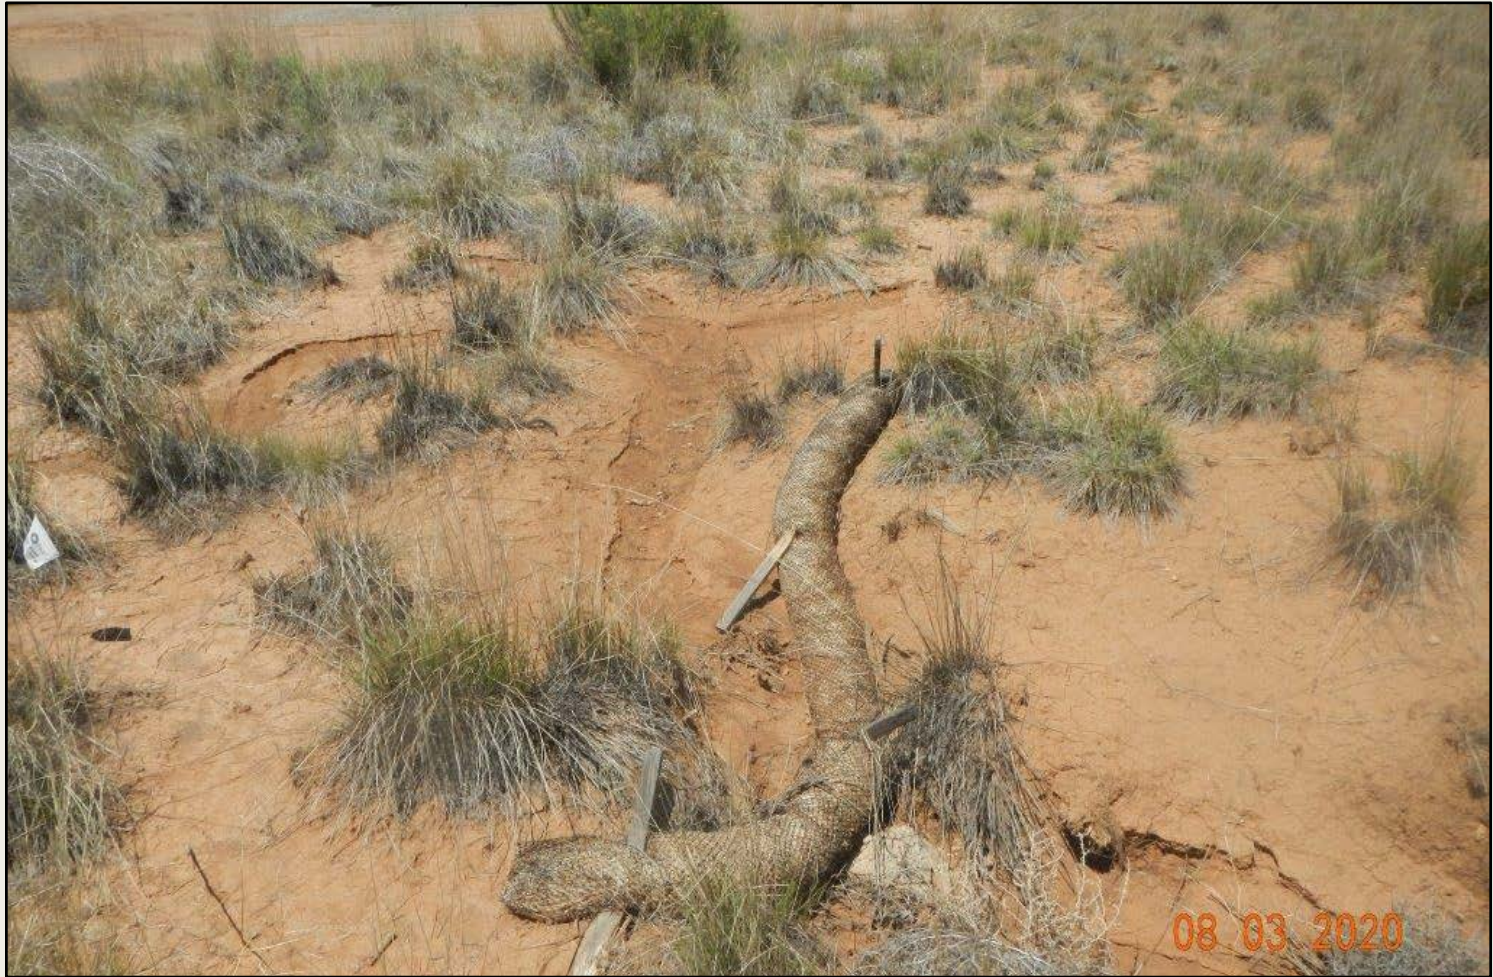
Photo 3. View of wattles that are no longer functioning within the eastern project area.

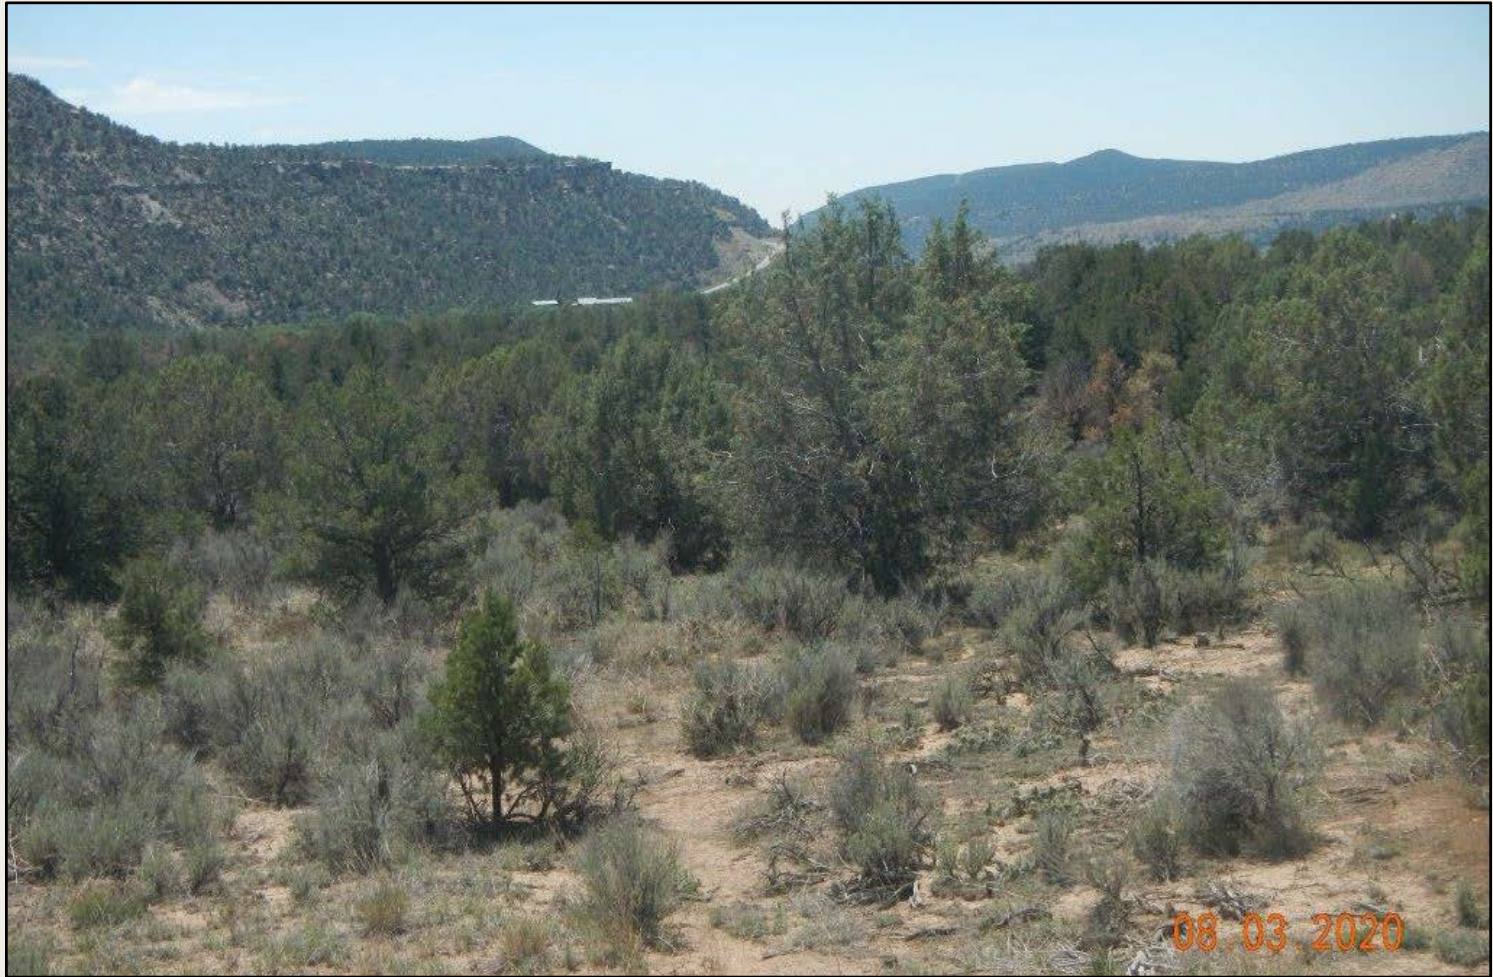
Photo 4. View of reference area vegetation comprised of pinyon juniper woodland with sagebrush and blue grama in the understory.
