Inspection Photos

8/04/2020

Operator: NONSUCH NATURAL GAS INC #
10163

Location ID: 324169
Garfield County, CO

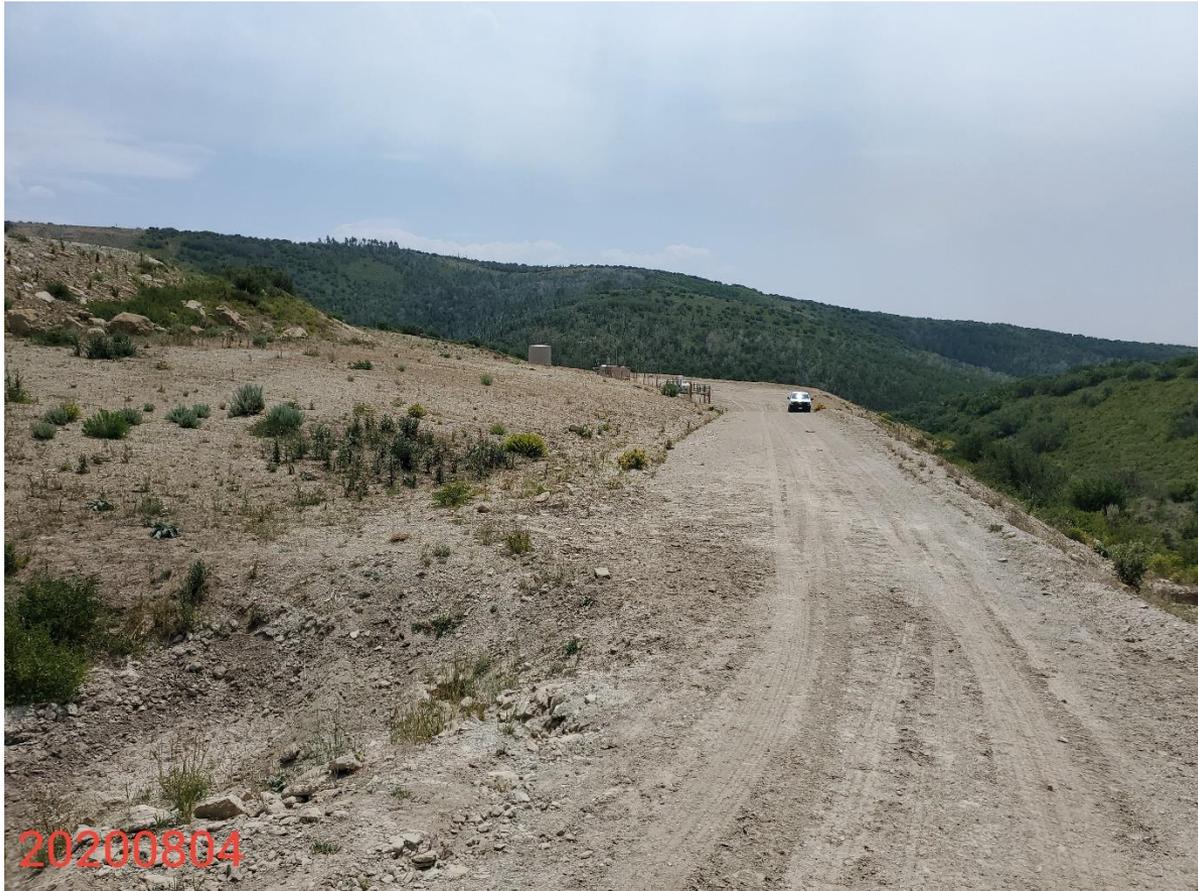
Photo 1: Photo taken from the access road north of the Location, facing south.

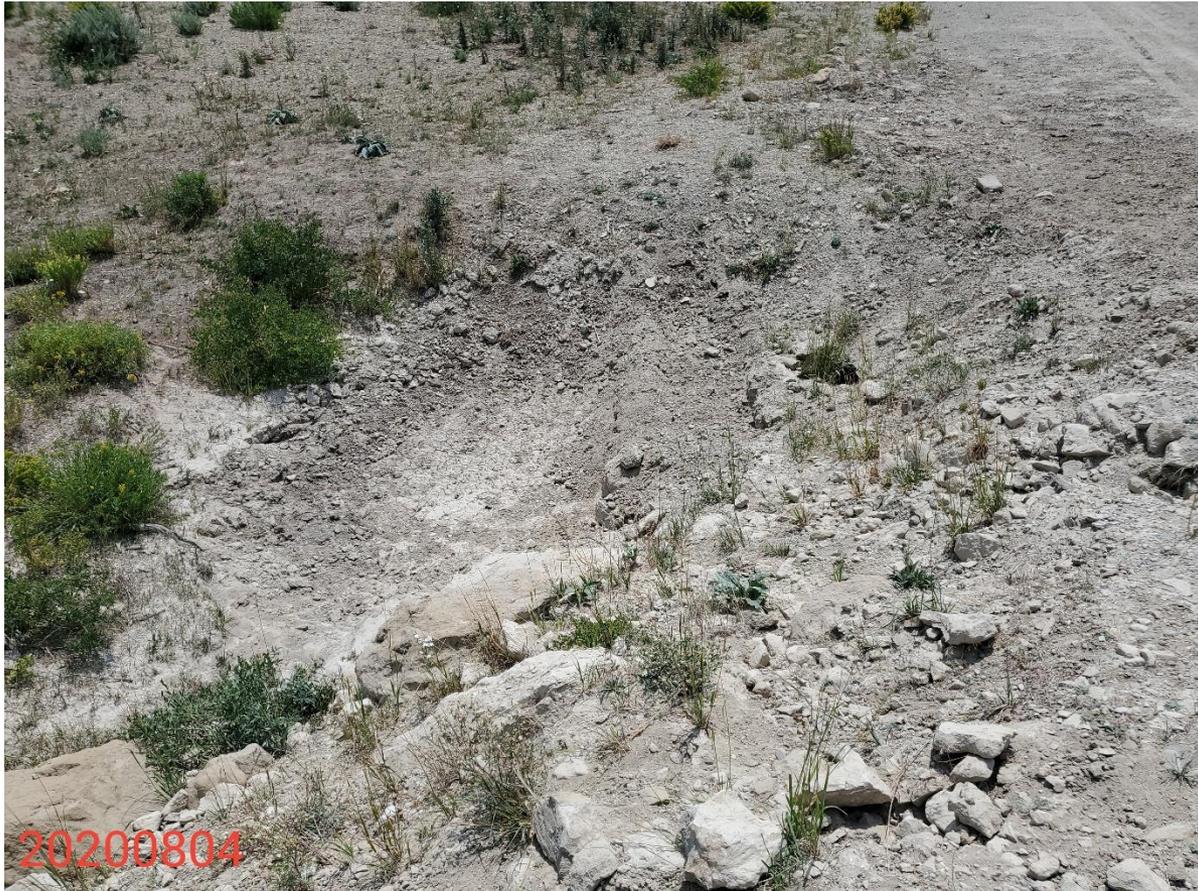
Photo 2: Photo of sediment trap on the north end of the Location.

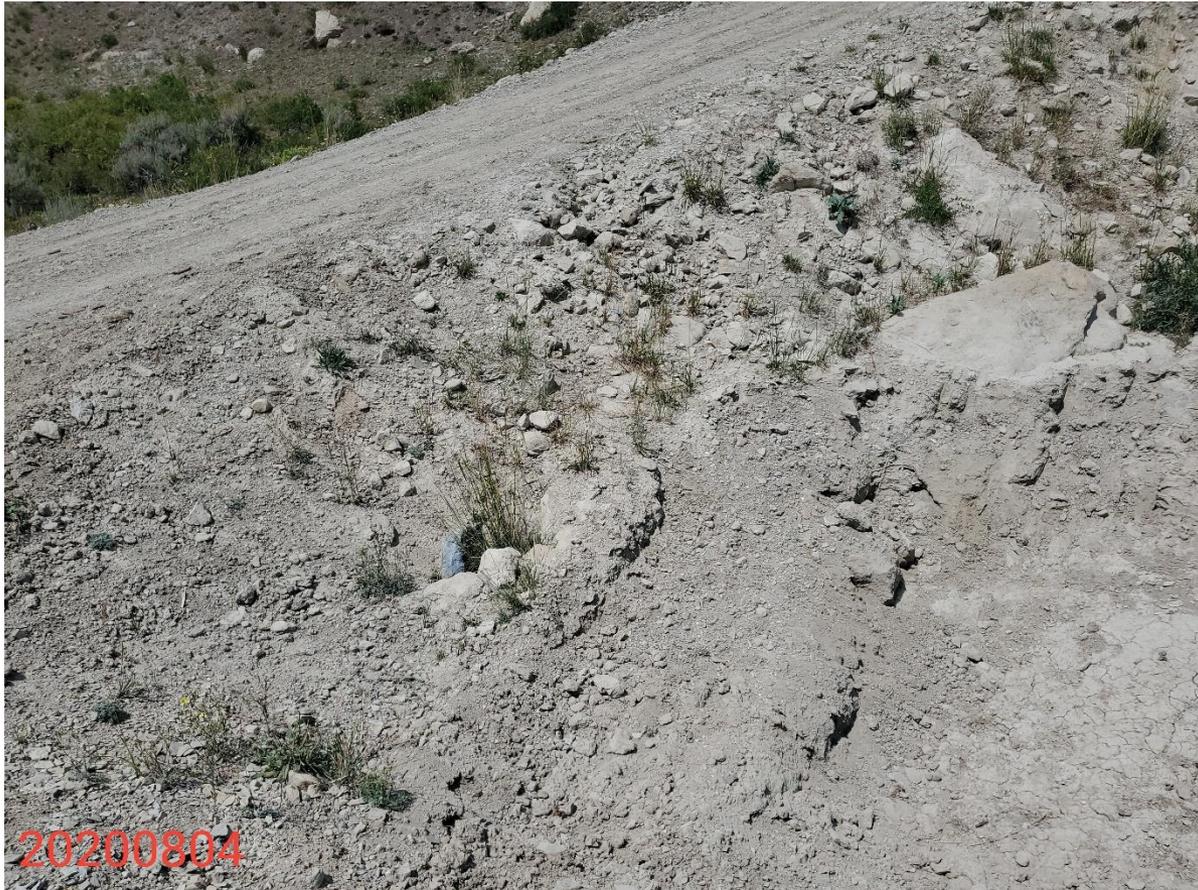
Photo 3: Photo of sediment trap on the north end of the Location.

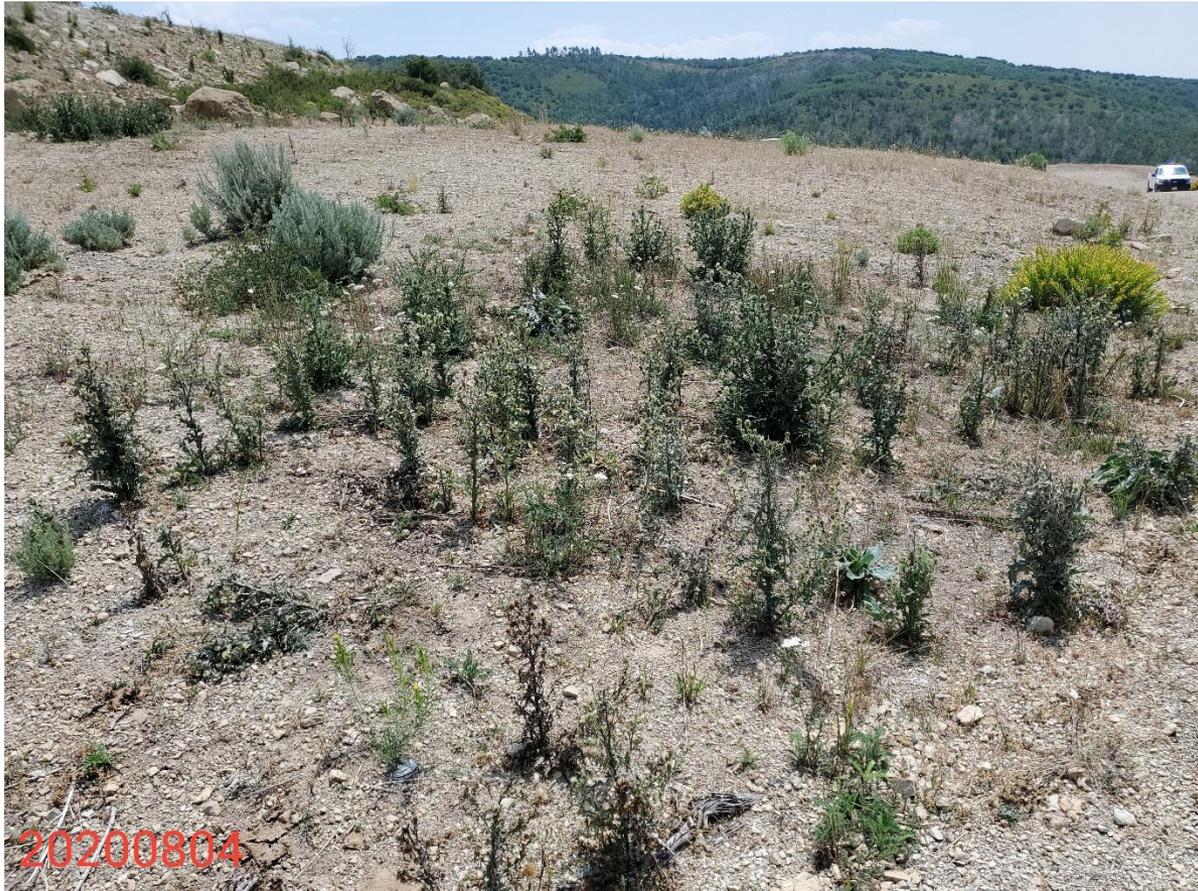
Photo 4: Photo taken from the northwest end of the location, facing south. Photo of interim areas. Photo shows interim areas is predominantly bare. Vegetation establishment is mostly noxious weeds such as Hounds tongue and Bull thistle. Some evidence of recent weed spraying evident, however weed management appears insufficient as many weeds appear to remain viable.

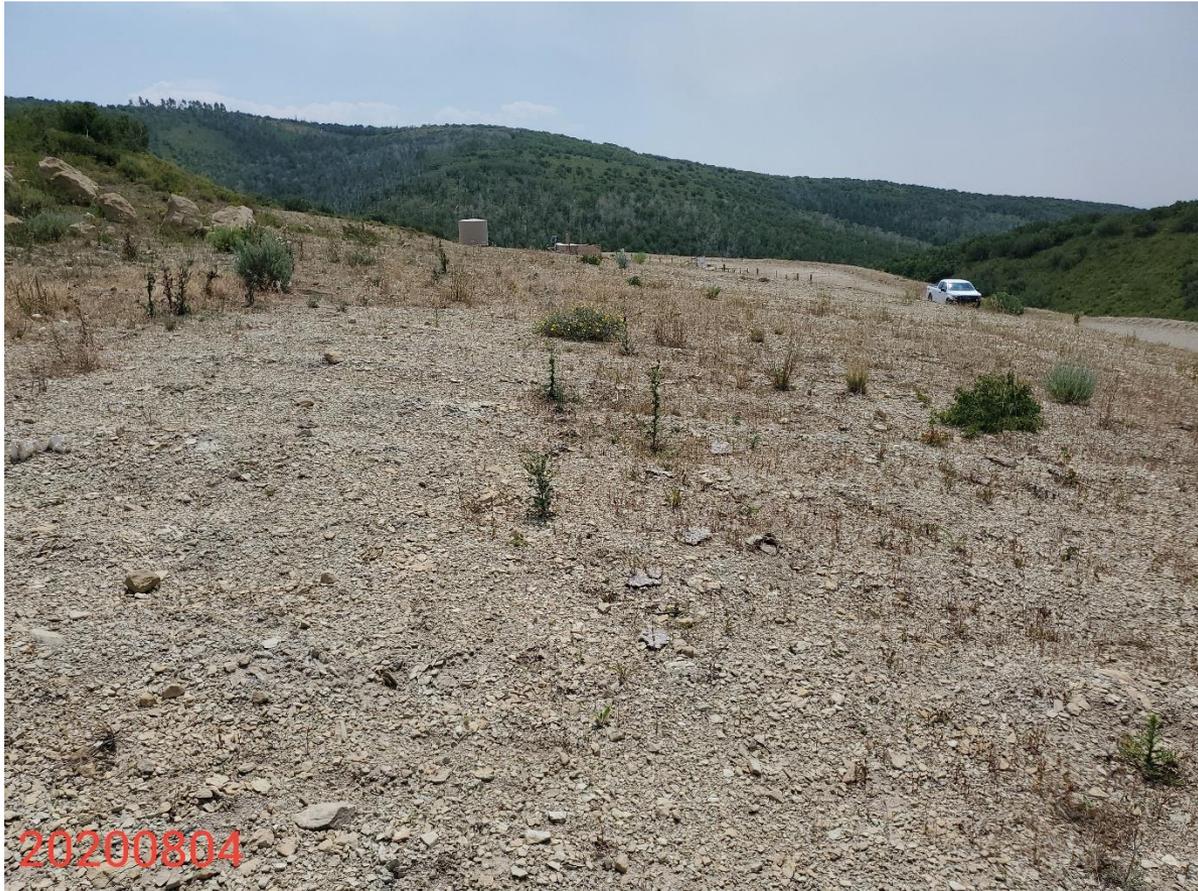
Photo 5: : Photo taken from the northwest end of the location, facing south. Photo of interim areas. Photo shows interim areas is predominantly bare. Reclamation is not progressing towards 1003 standards.

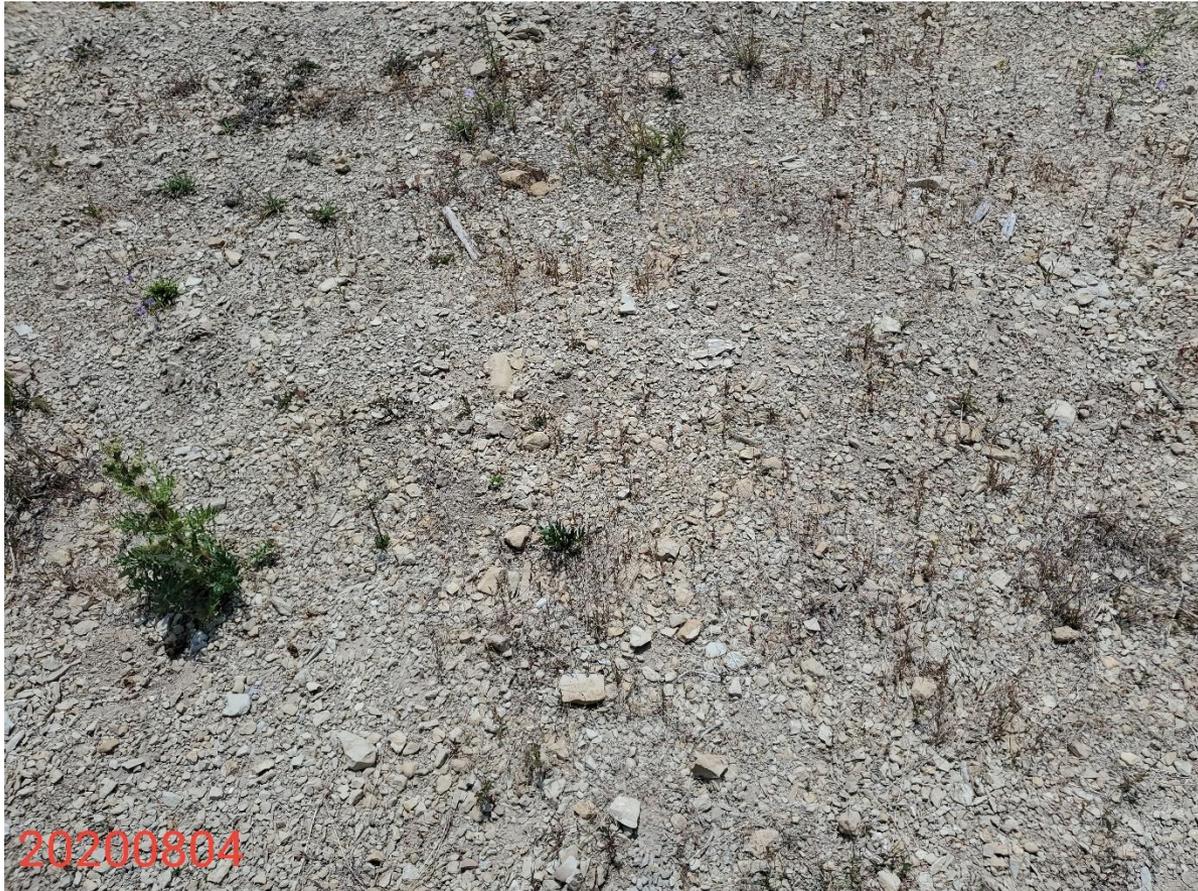
Photo 6: Photo shows soil surface of interim areas. Soils appear to be subsoils; it does not appear that the topsoil horizon has been returned to their original relative position. Reclamation is not progressing towards 1003 standards.

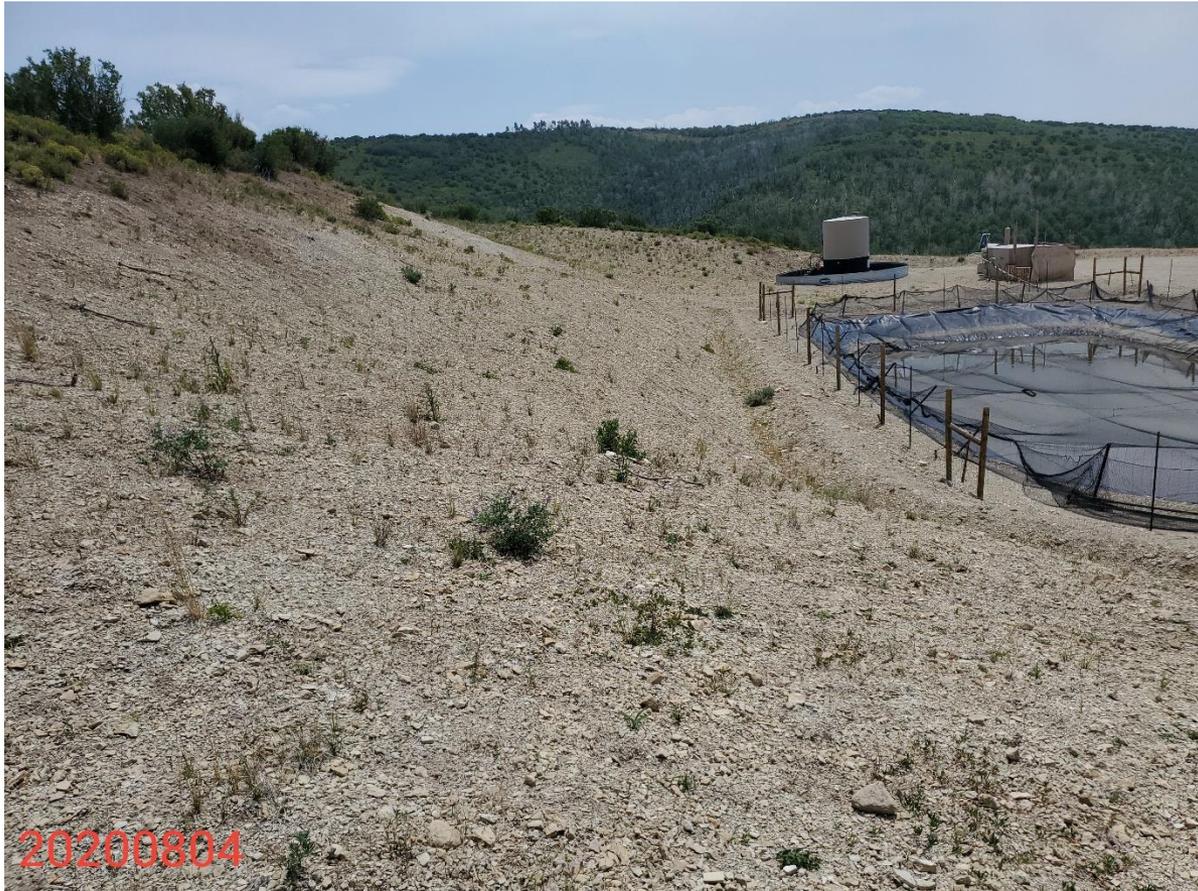
Photo 7: Photo taken from the western interim areas, facing south. Photo shows interim areas are not progressing towards 1003 standards.

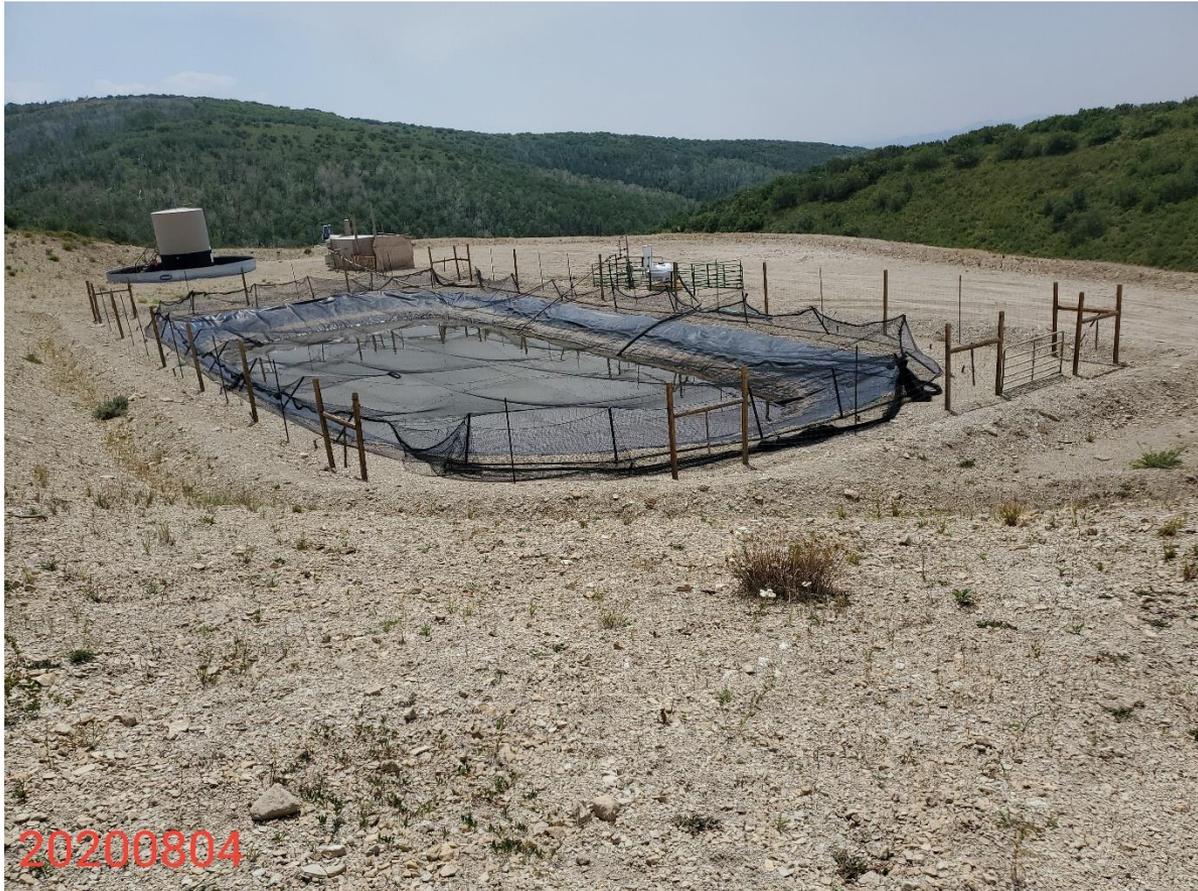
Photo 8: Photo taken from the western interim areas, facing south. Photo of production area. Photo also shows interim areas are not progressing towards 1003 standards.

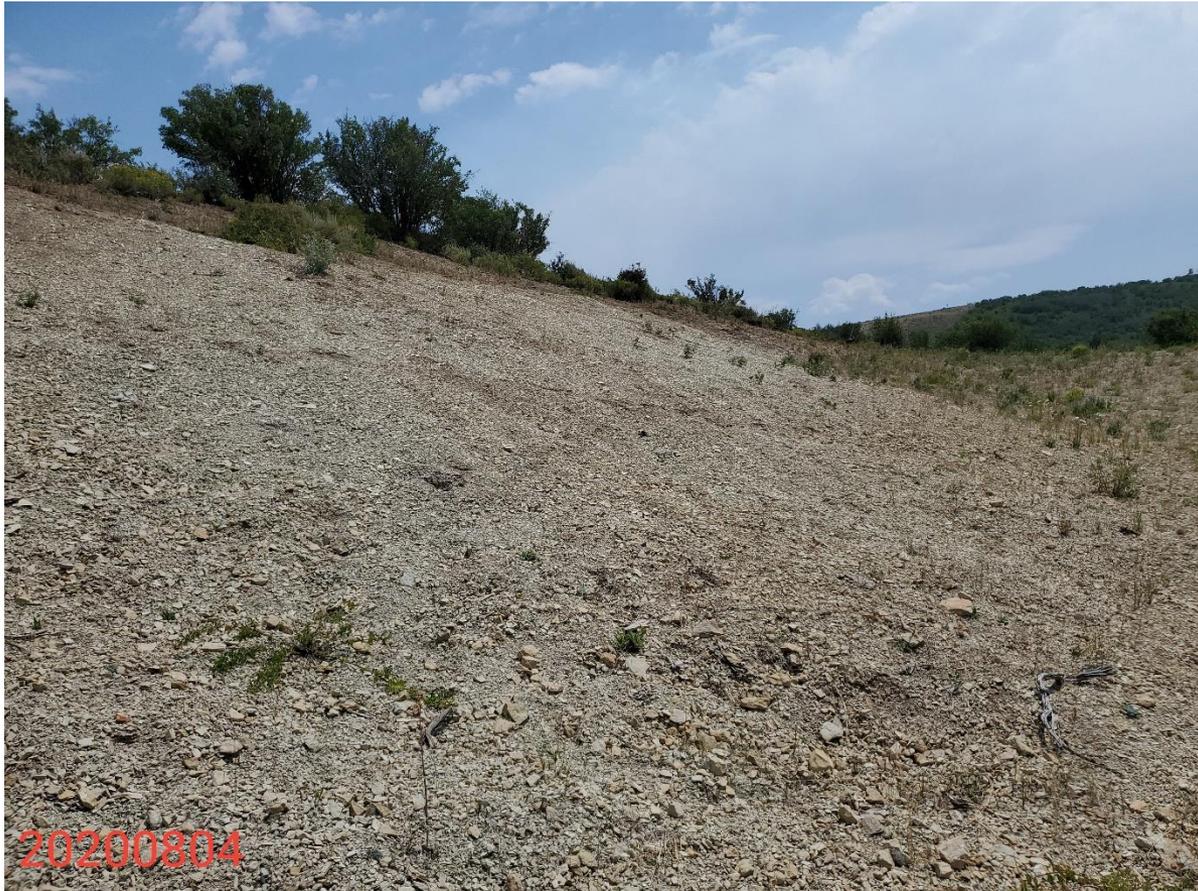
Photo 9: Photo taken from the wester interim areas. Photo shows BMPs missing or insufficient to stabilize soils on slope. Photo also shows interim areas are not progressing towards 1003 standards.

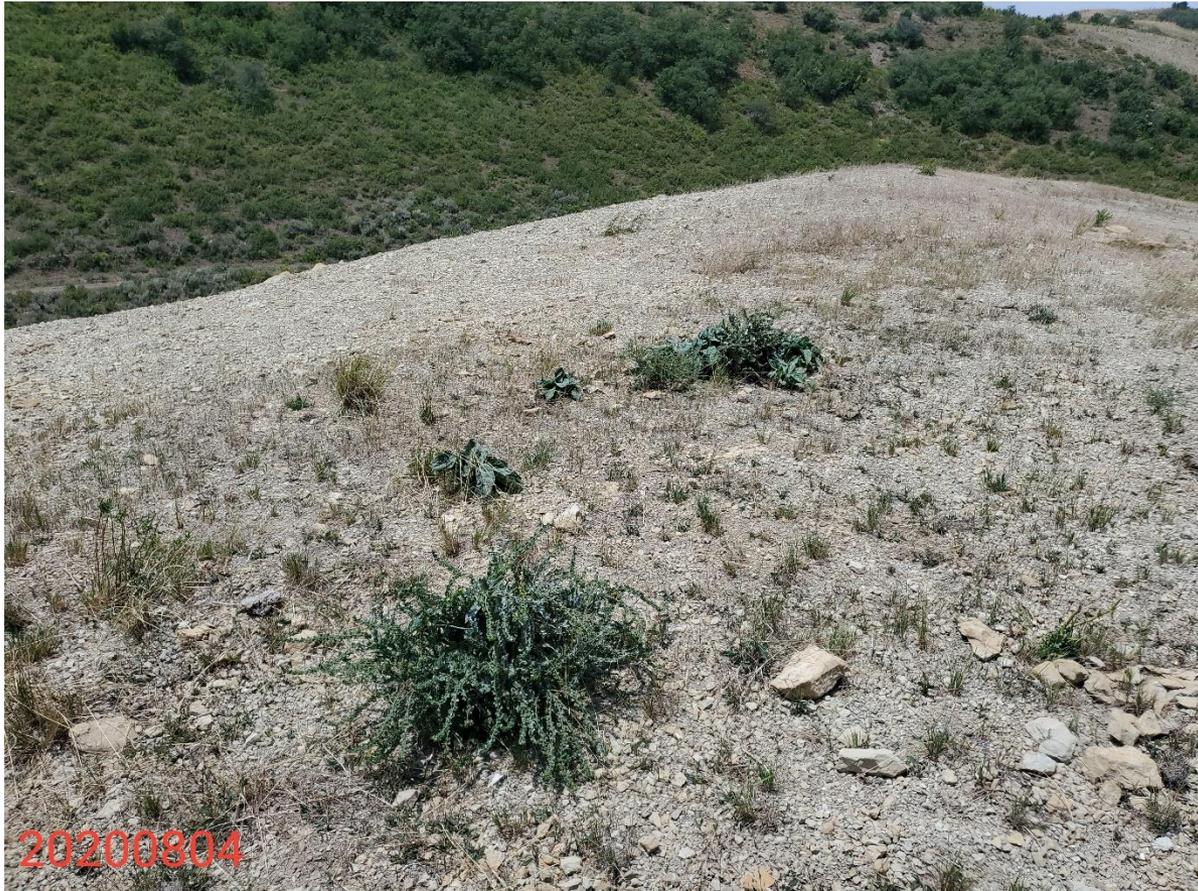
Photo 10: Photo taken the interim areas on the south end of the Location, facing southwest. Photo shows BMPs missing or insufficient to stabilize soils on slope. Photo also shows interim areas are not progressing towards 1003 standards, and noxious weeds.

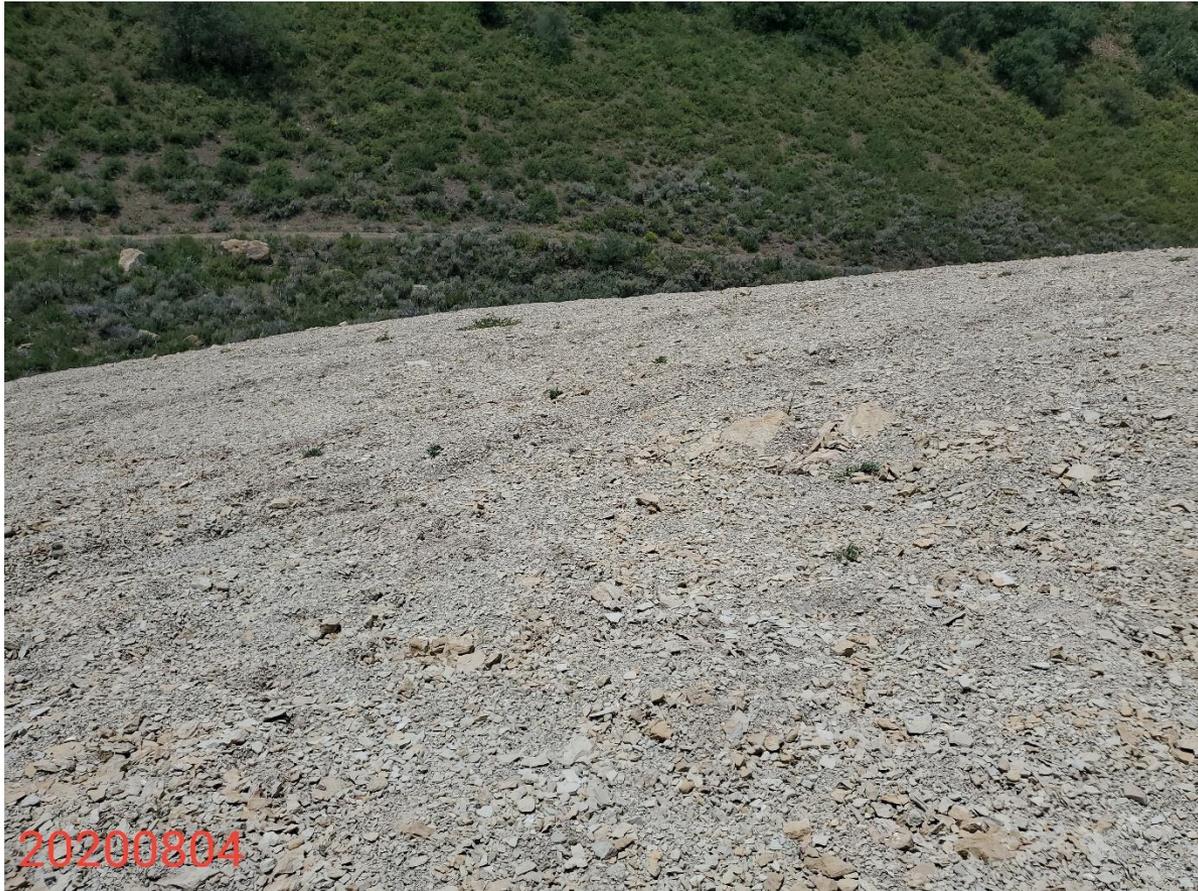
Photo 11: Photo taken the interim areas on the south end of the Location, facing southwest. Photo shows BMPs missing or insufficient to stabilize soils on slope. Photo also shows interim areas are not progressing towards 1003 standards.

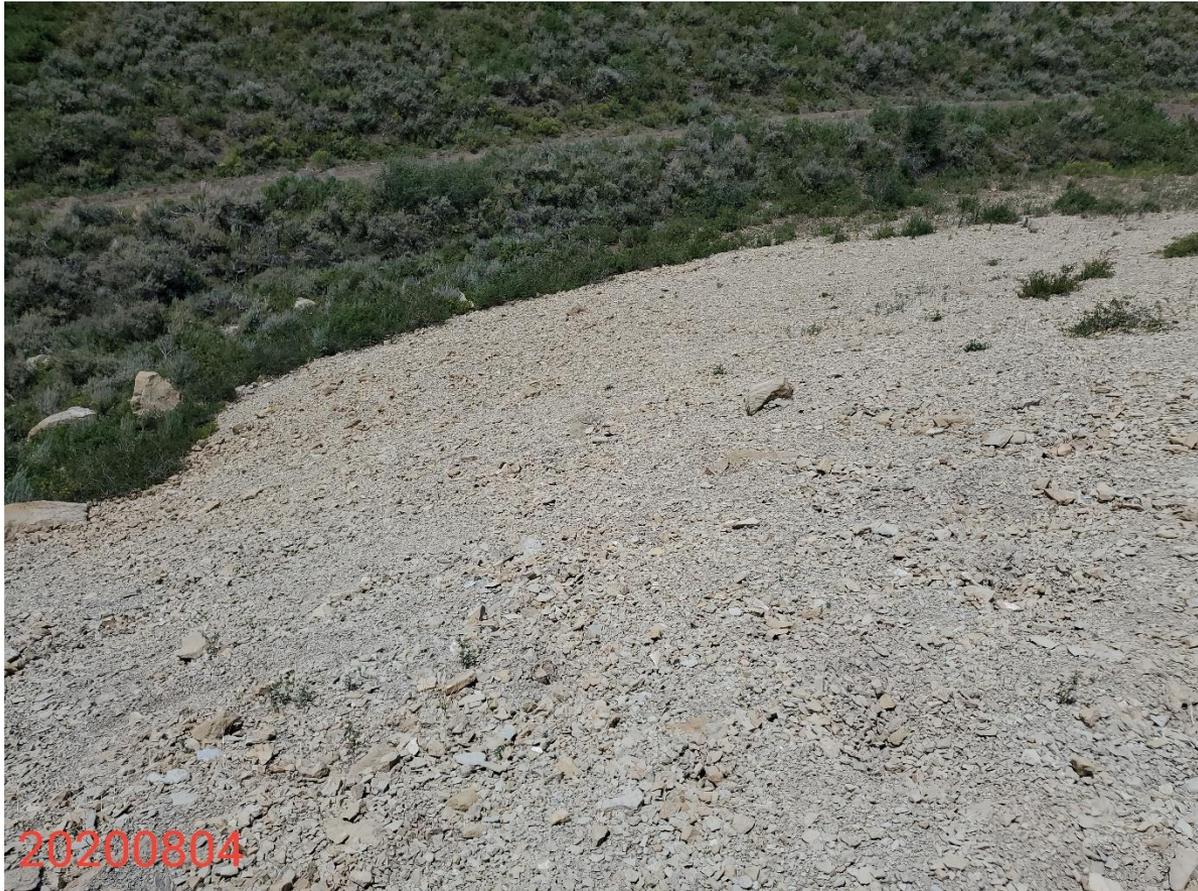
Photo 12: Photo taken the interim areas on the west end of the Location, facing west. Photo shows BMPs missing or insufficient to stabilize soils on slope. Photo also shows interim areas are not progressing towards 1003 standards.

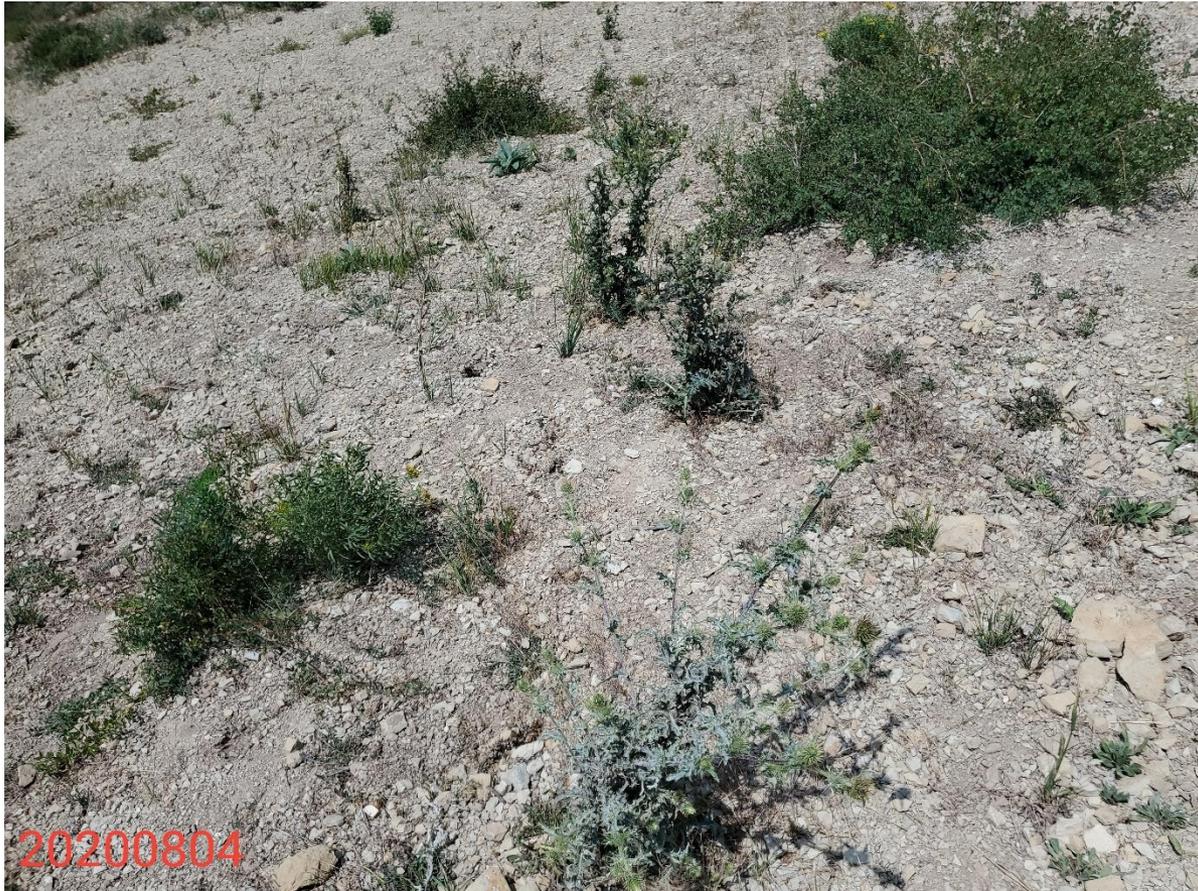
Photo 13: Photo shows noxious weeds (Hounds tongue) on the interim areas.

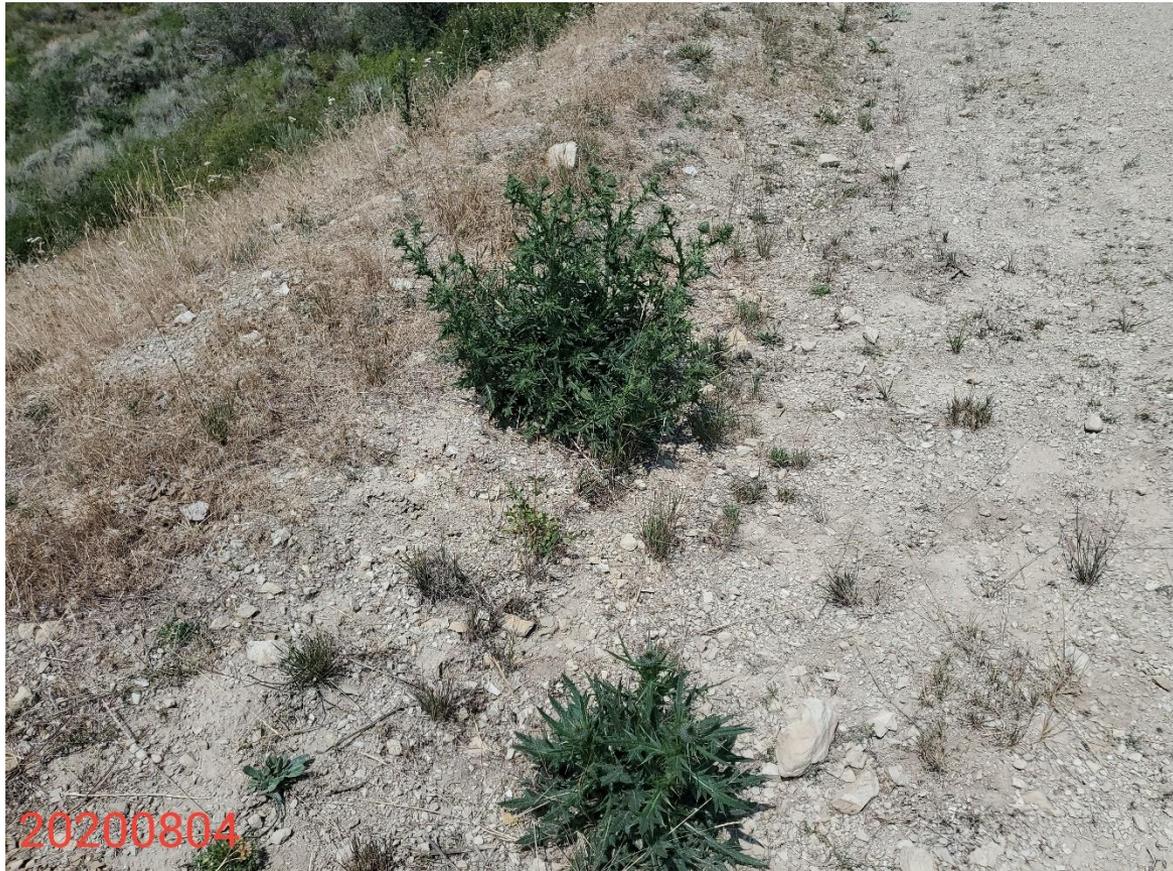
Photo 14: Photo taken from the north end of the Pad. Photo of Bull thistle on Location.
