Inspection Photos

8/04/2020

Operator: NONSUCH NATURAL GAS INC -
10163

Location ID: 324172
Garfield County, CO

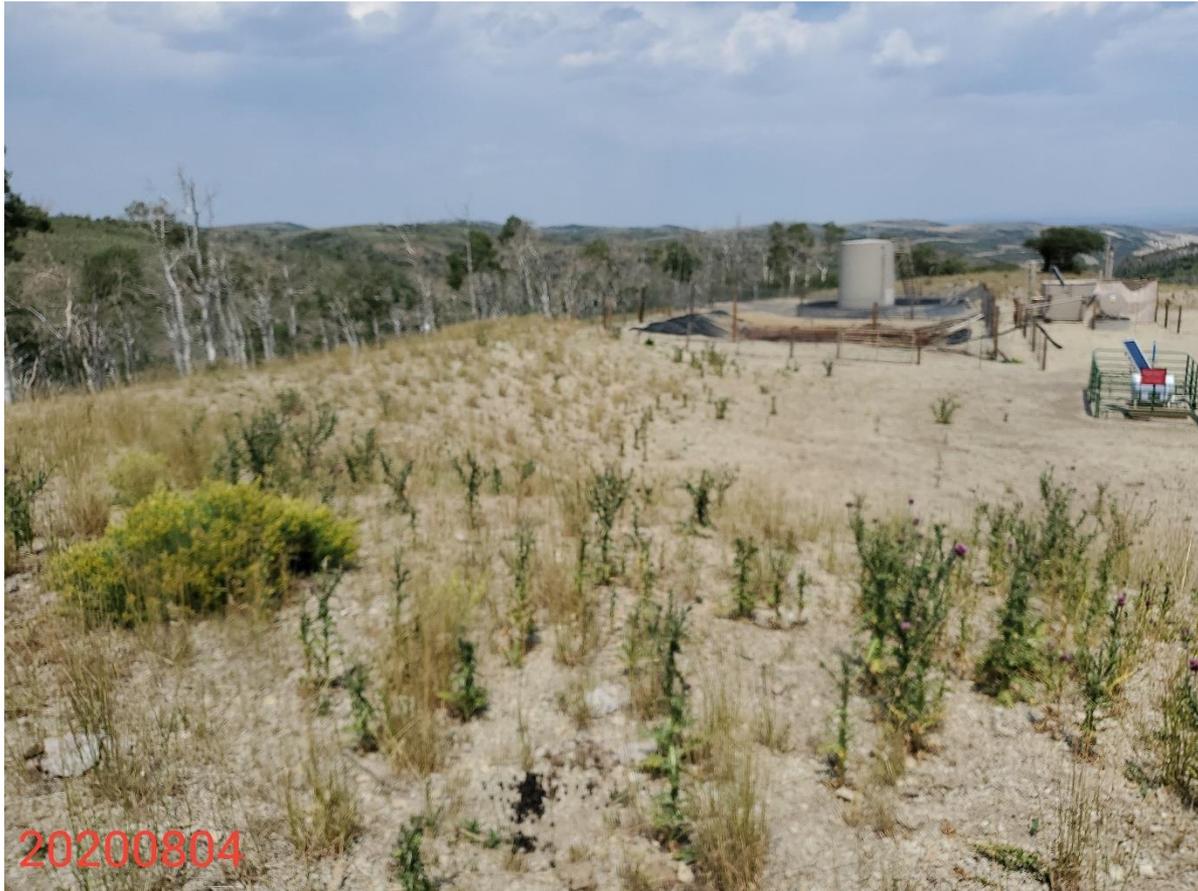
Photo 1: Photo taken from the south end of the Location, facing north. Photo 1-2 provides an overview of the Location. Photo also shows noxious weeds on Location.

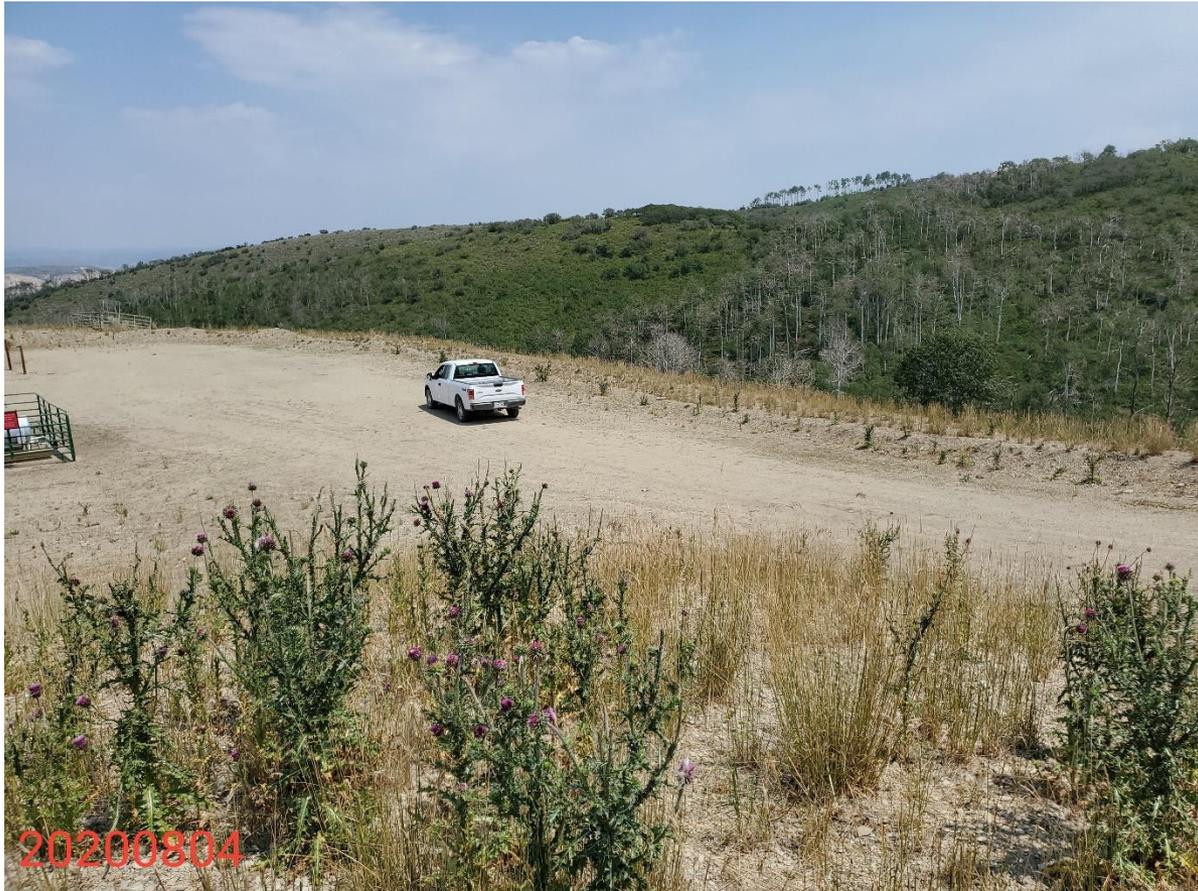
Photo 2: See comments under photo 1.

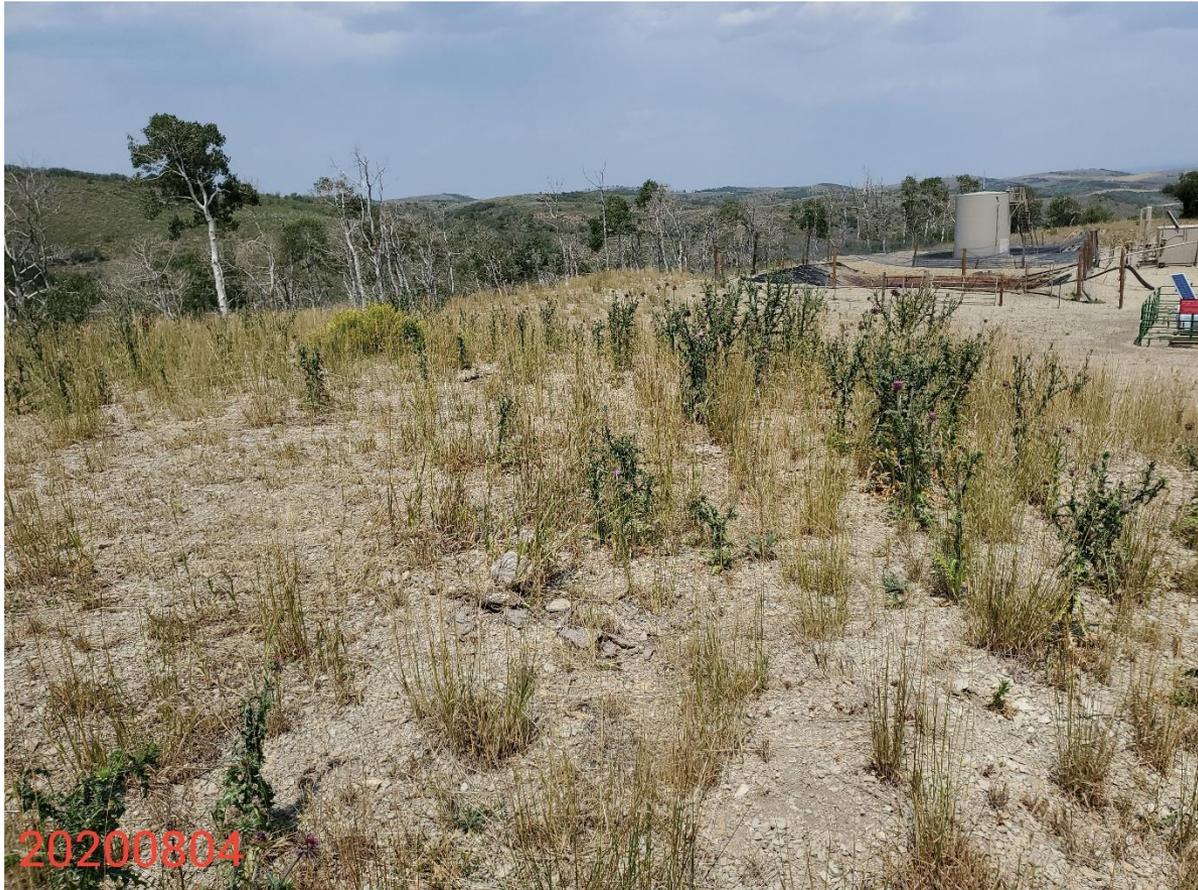
Photo 3: Photo taken from the south end of the Location. Photo shows noxious weeds (Musk thistle, Houndstongue) on the Location.

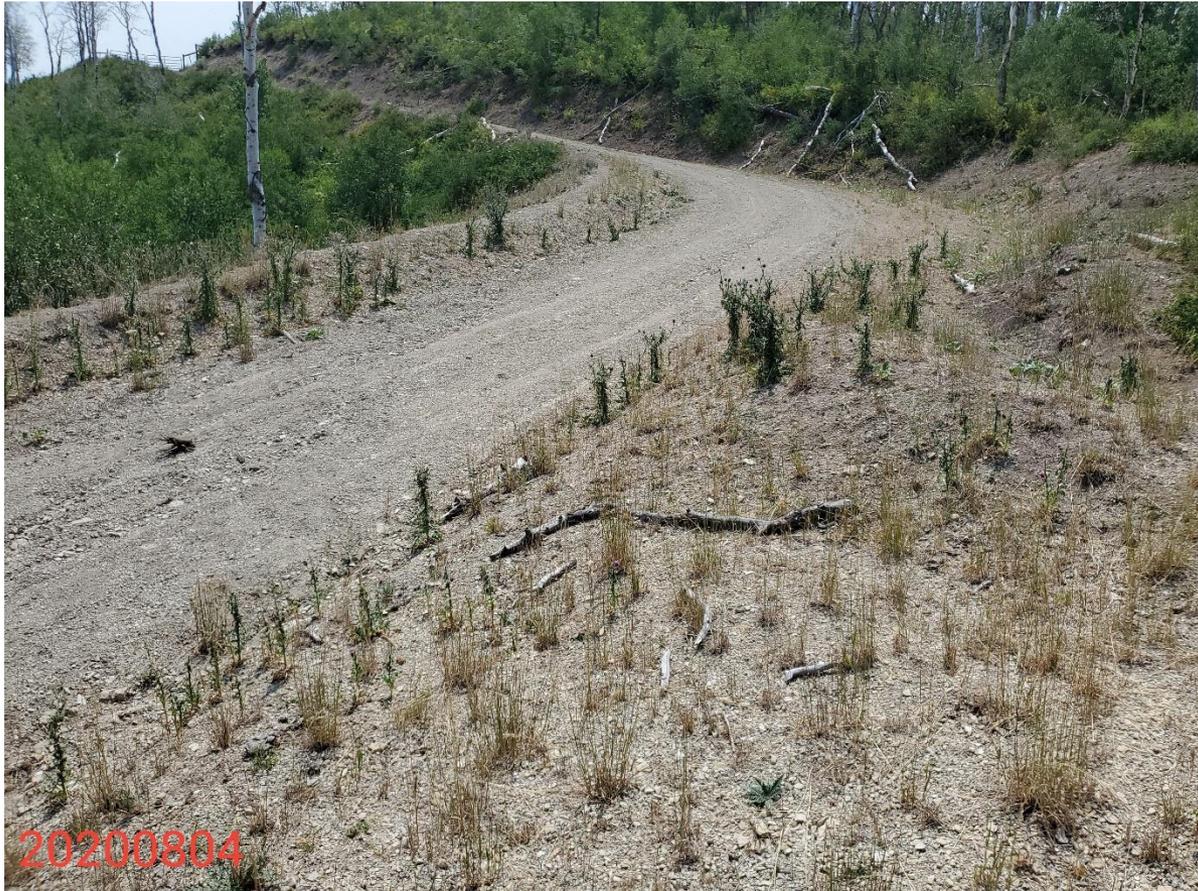
Photo 4: Photo taken from the south end of the Location, facing south. Photo shows noxious weeds (Musk thistle, hounds tongue) on the Location.

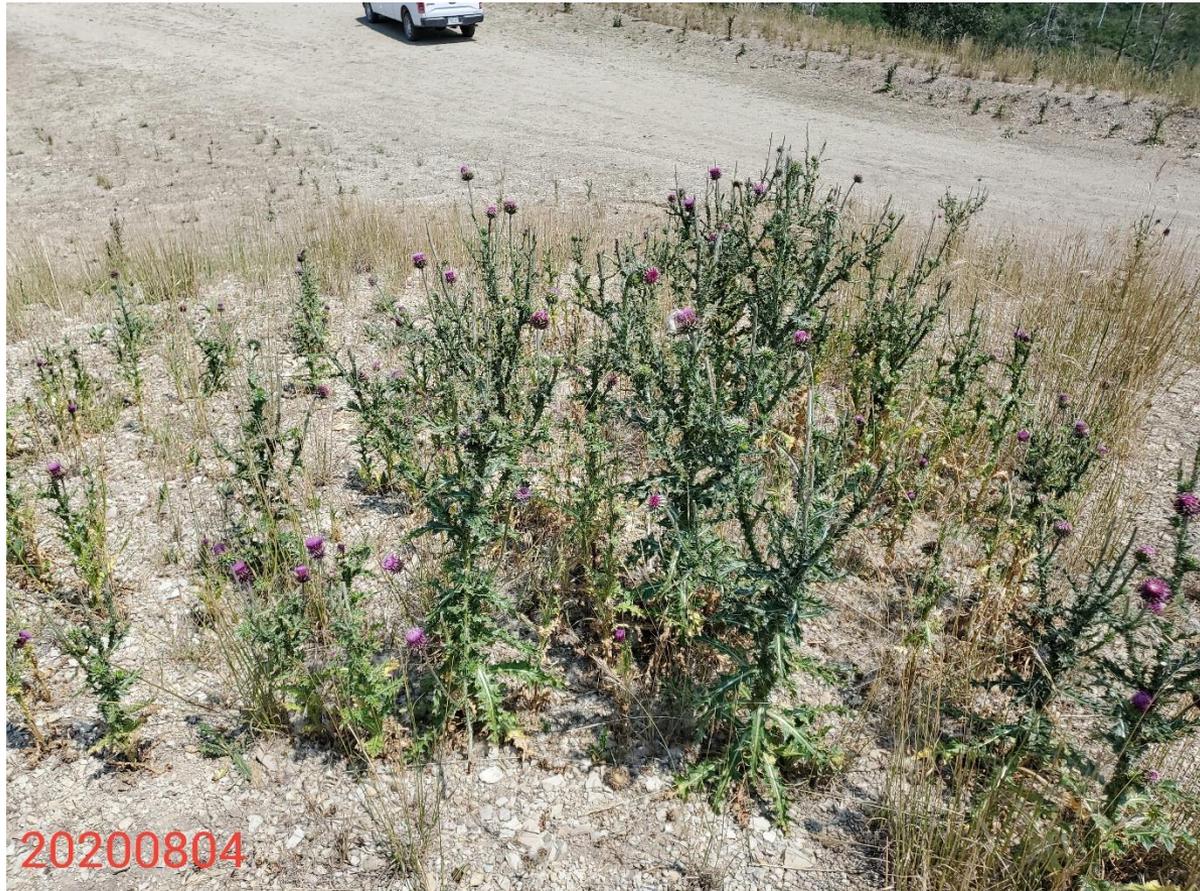
Photo 5: Photo of Musk thistle on the south end of the Location. Though evidence of senescence likely related to chemical herbicide was observed, weed management appears insufficient as large numbers of weeds observed on Location and access road remain viable.

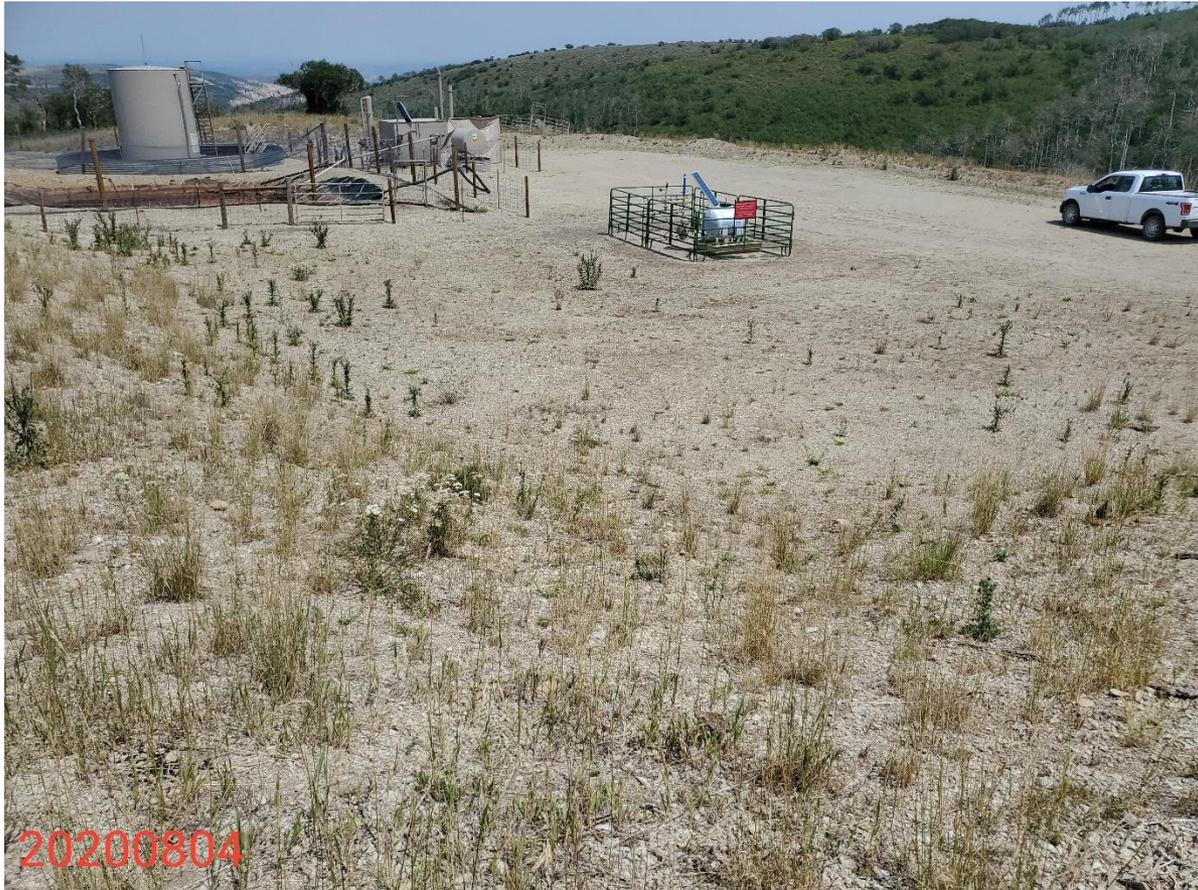
Photo 6: Photo taken from the southwest end of the location, facing northeast. Photo shows noxious weeds (dark vegetation) on interim and production areas.

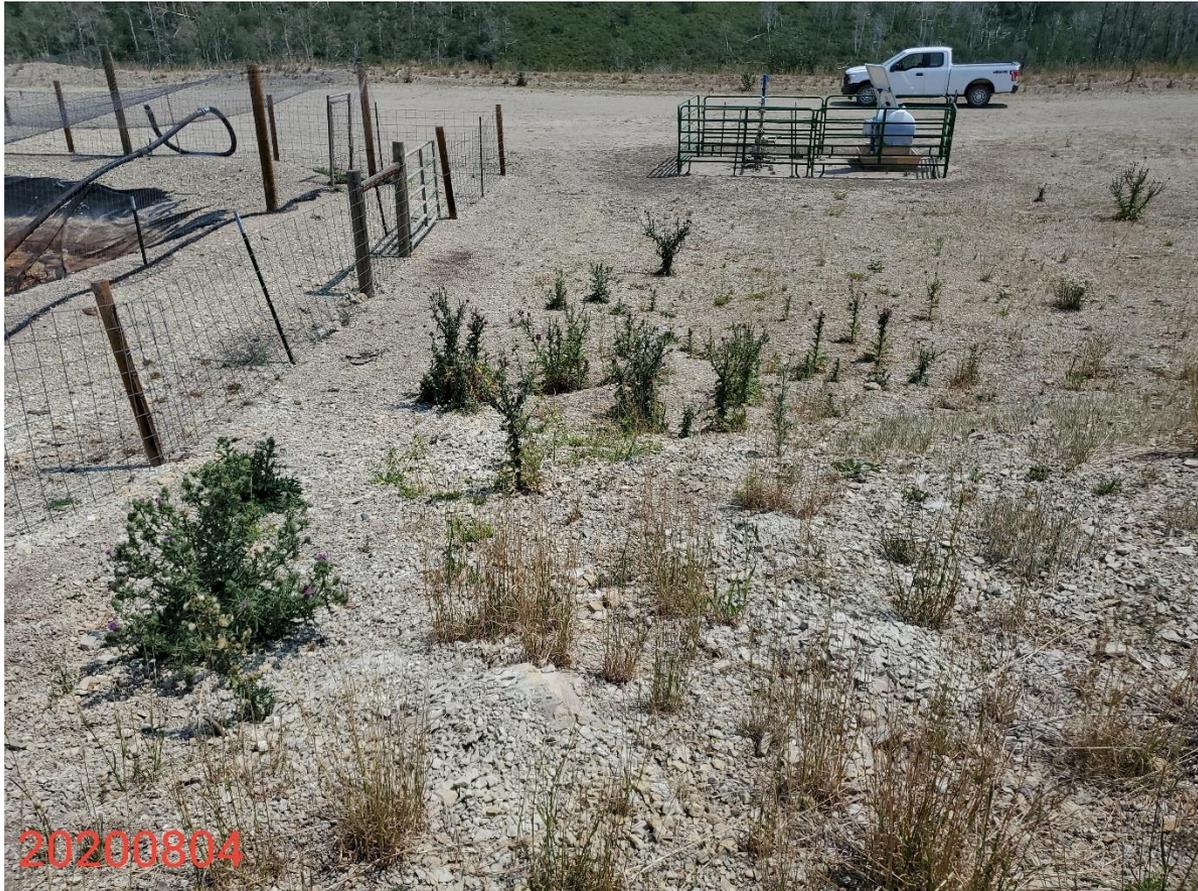
Photo 7: Continued from photo 6.

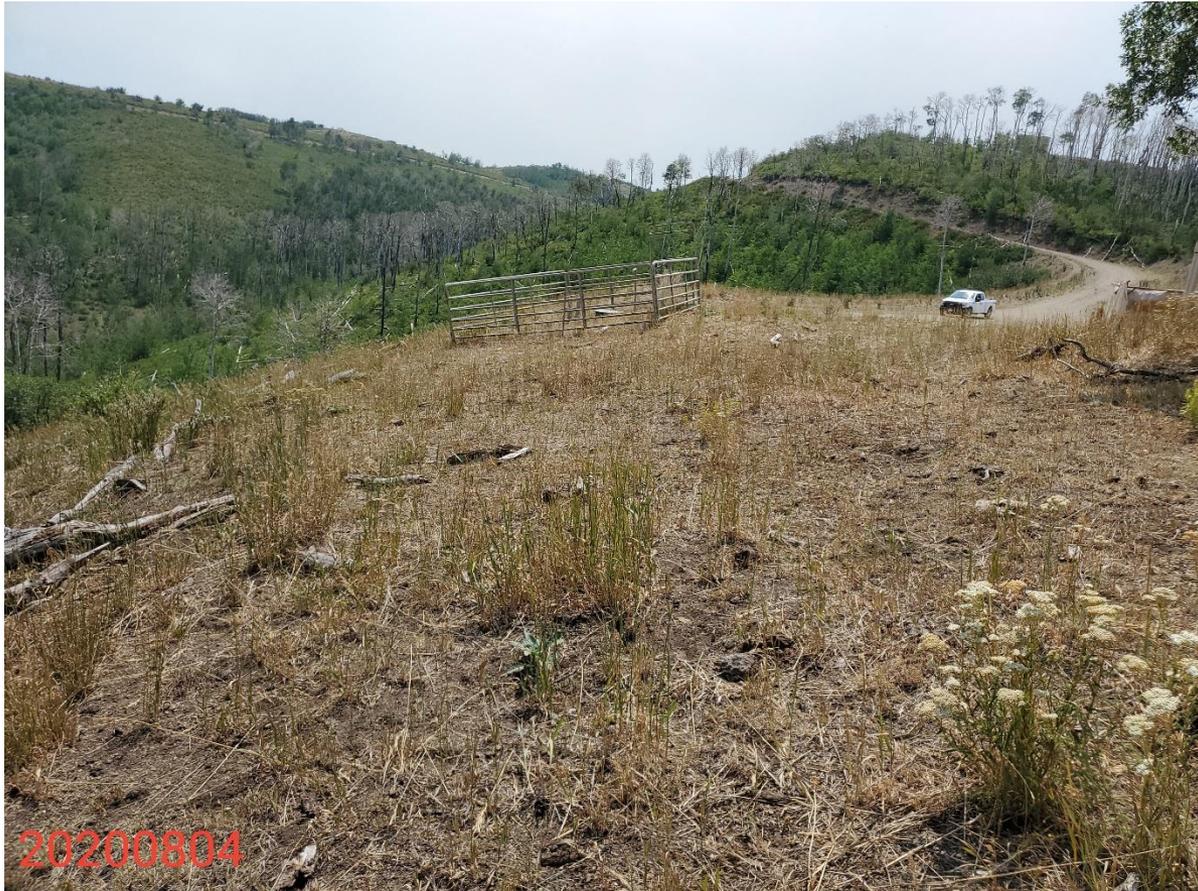
Photo 8: Photo taken from the north end of the Location, facing south. Photo shows northern interim areas of the Location; Interim reclamation appears to be progressing towards 1003 standards.

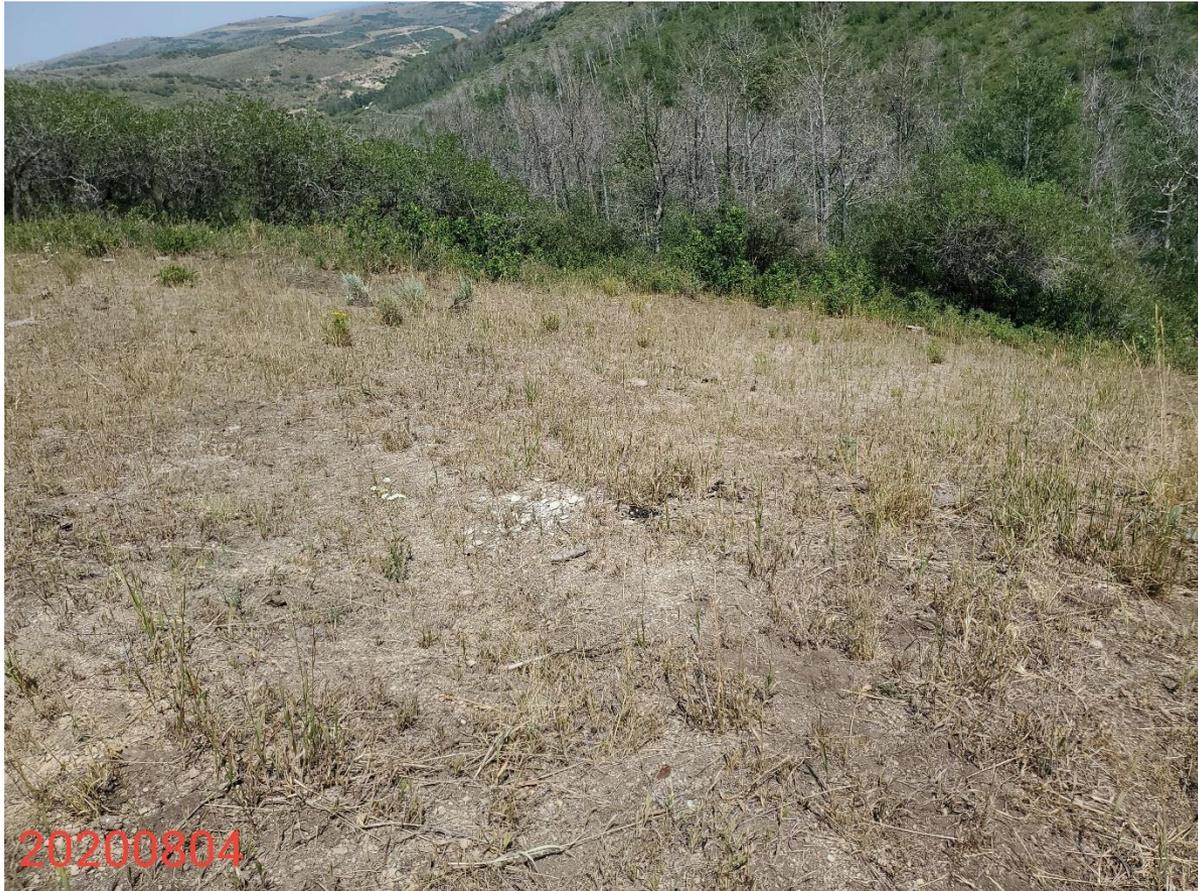
Photo 9: Photo taken from the north end of the Location, facing northeast. Photo shows northern interim areas of the Location; Interim reclamation appears to be progressing towards 1003 standards.

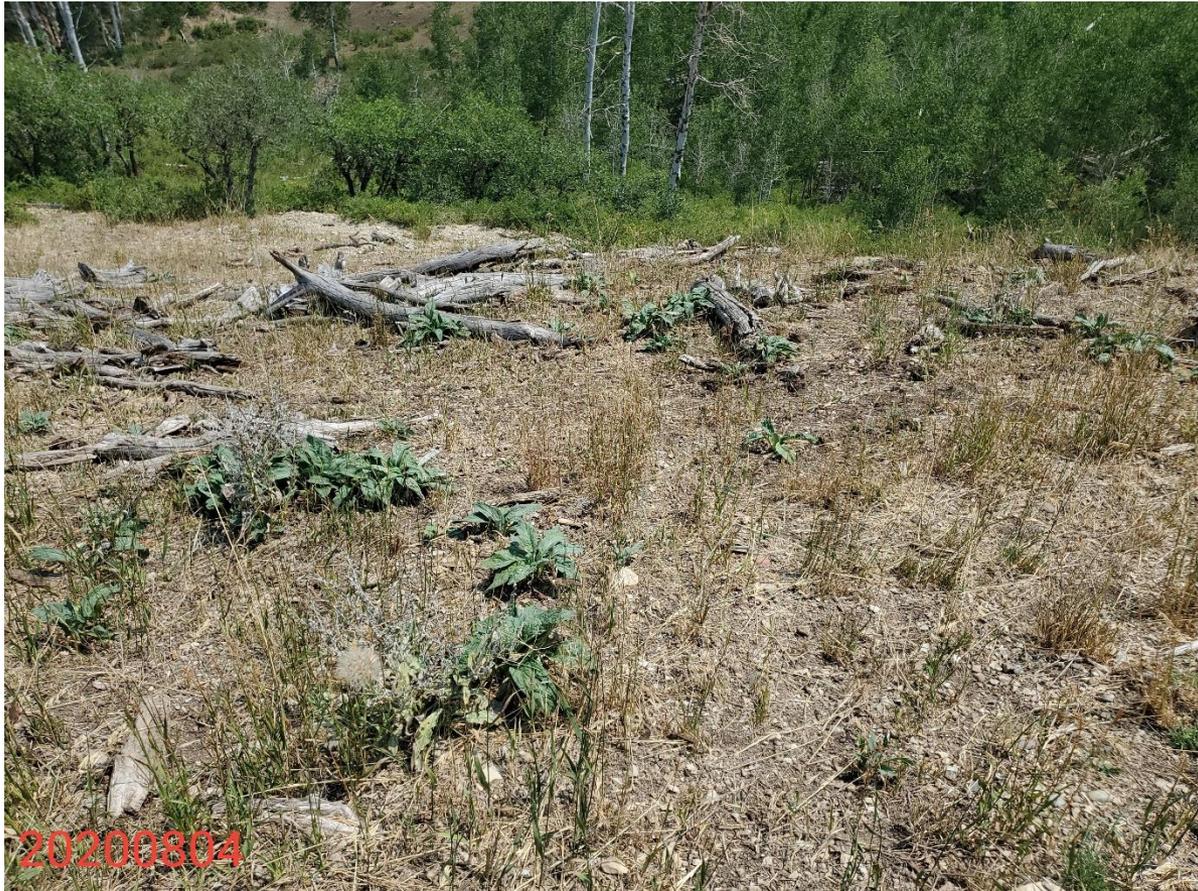
Photo 10: Photo taken from the east end of the Location. Photo shows noxious weeds (Houndstongue rosettes) on the interim areas.

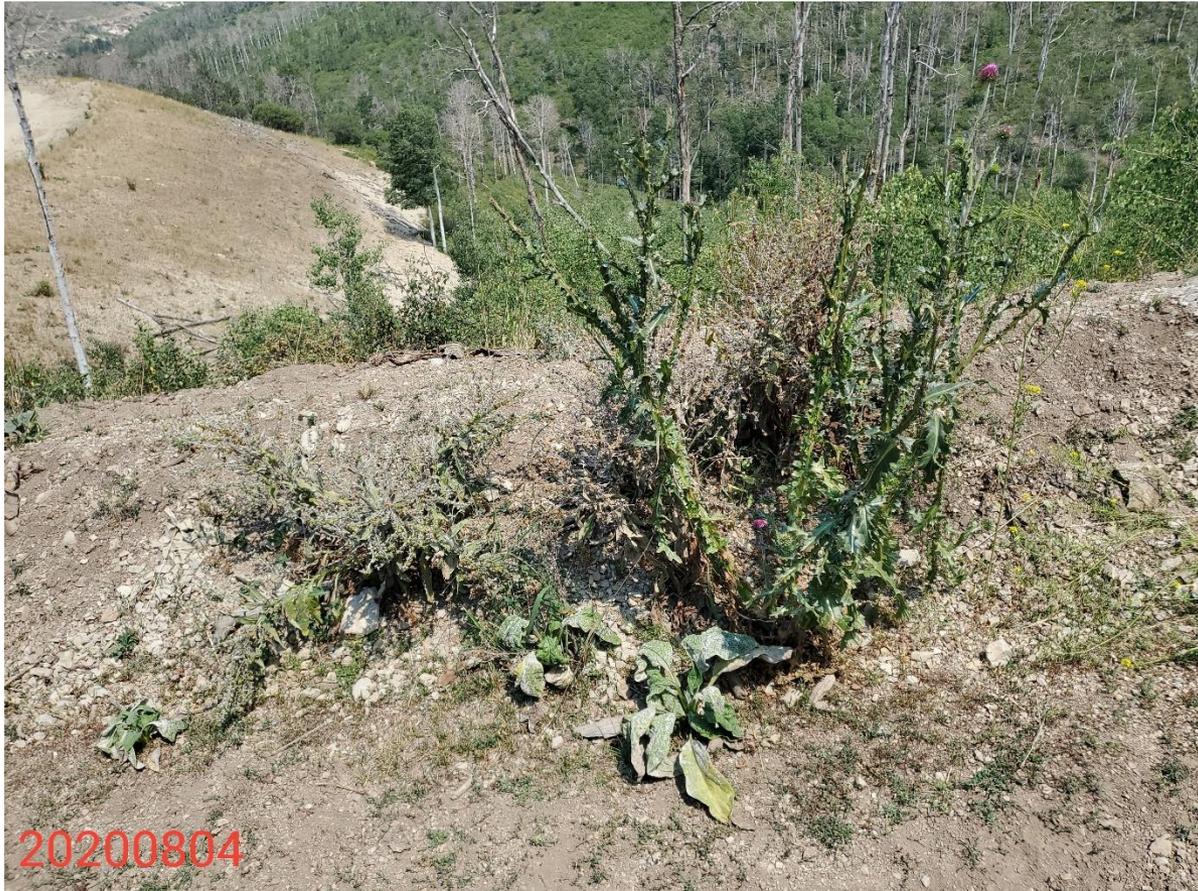
Photo 11: Photo of Musk thistle on the access road. Though evidence of senescence likely related to chemical herbicide was observed, weed management appears insufficient as large numbers of weeds observed on Location and access road remain viable.

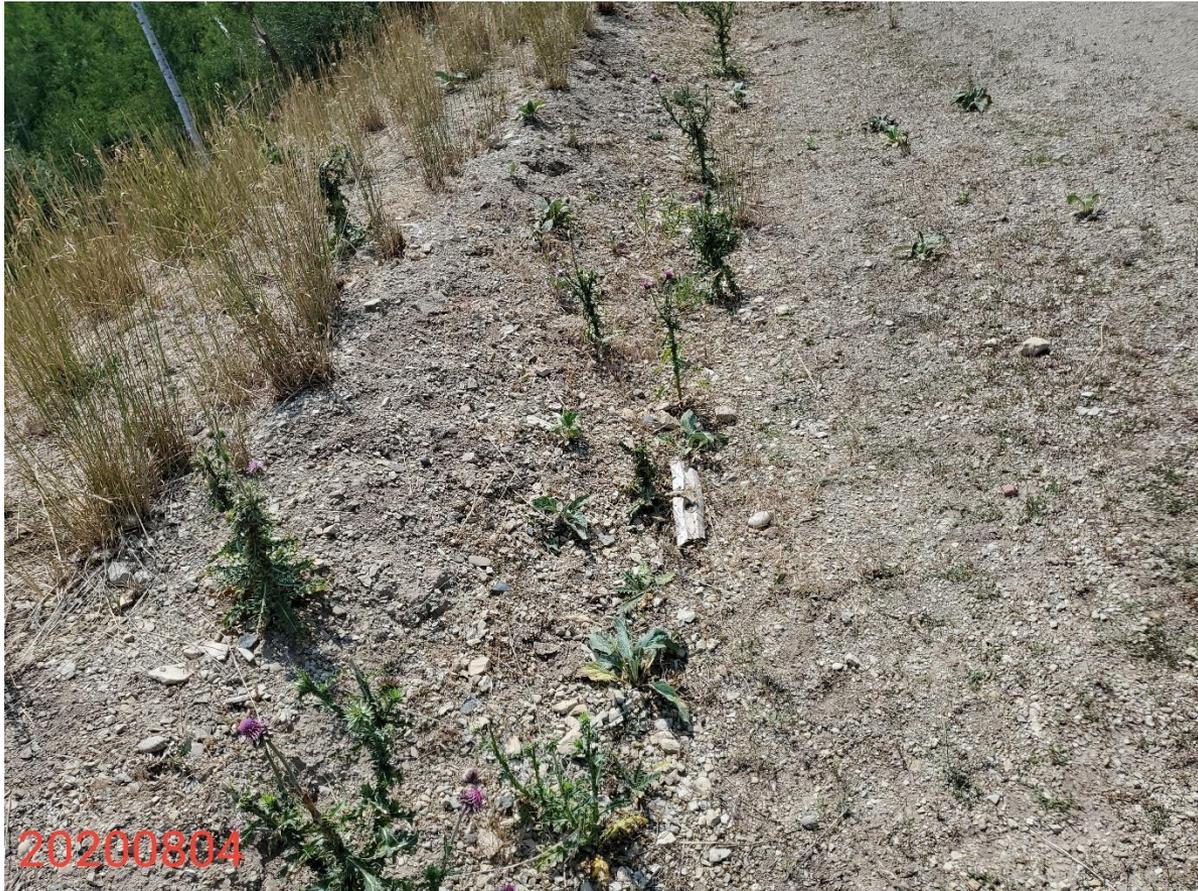
Photo 12: Photo of Musk thistle and Houndstogoe on the access road. See comments under photo 11.

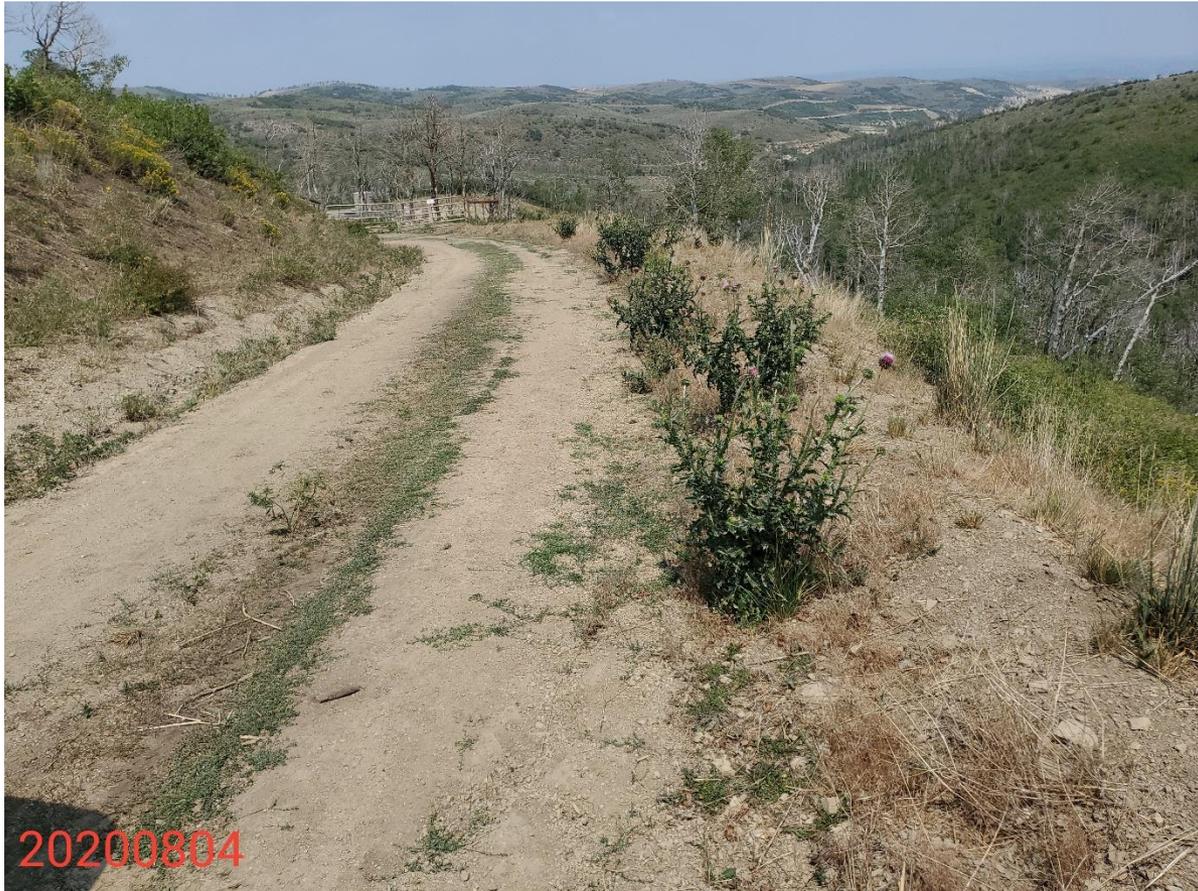
Photo 13: Photo of Musk thistle and Houndstogoe on the access road. See comments under photo 11.
