Inspection Photos  
Operator: BP America  
API: 067-08204  
Date: 8/5/2020

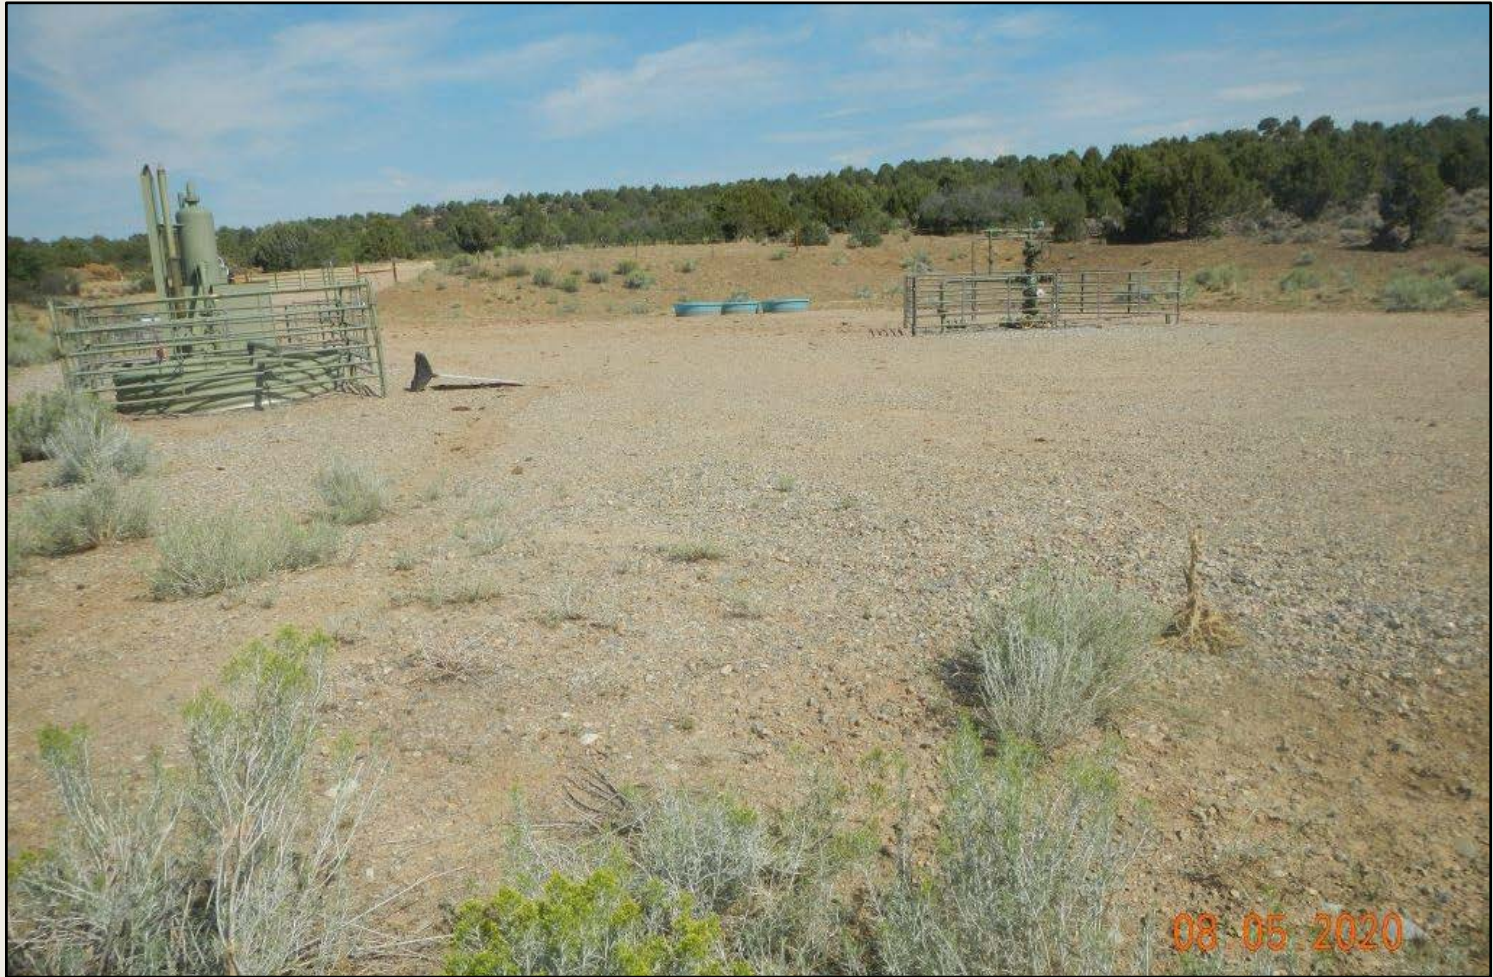
Photo 1. View of the project area from the southeastern corner facing center.

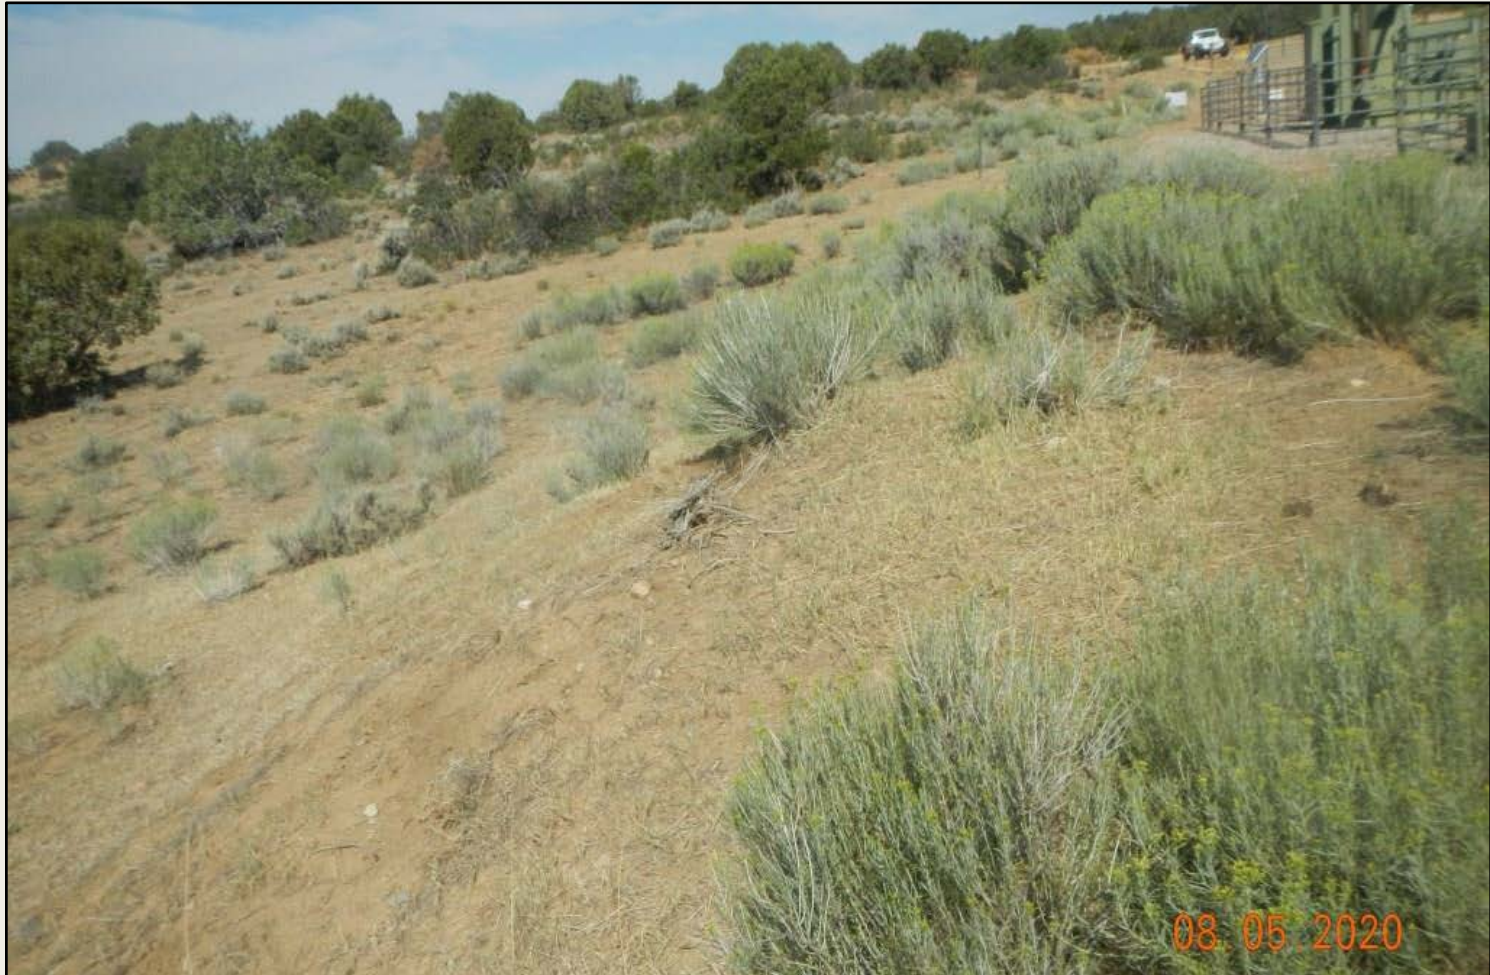
Photo 2. View of the southern portion of the project area from the southeastern corner facing westward. Revegetation is progressing with western wheatgrass, rubber rabbitbrush, and other grasses in a grazed condition.

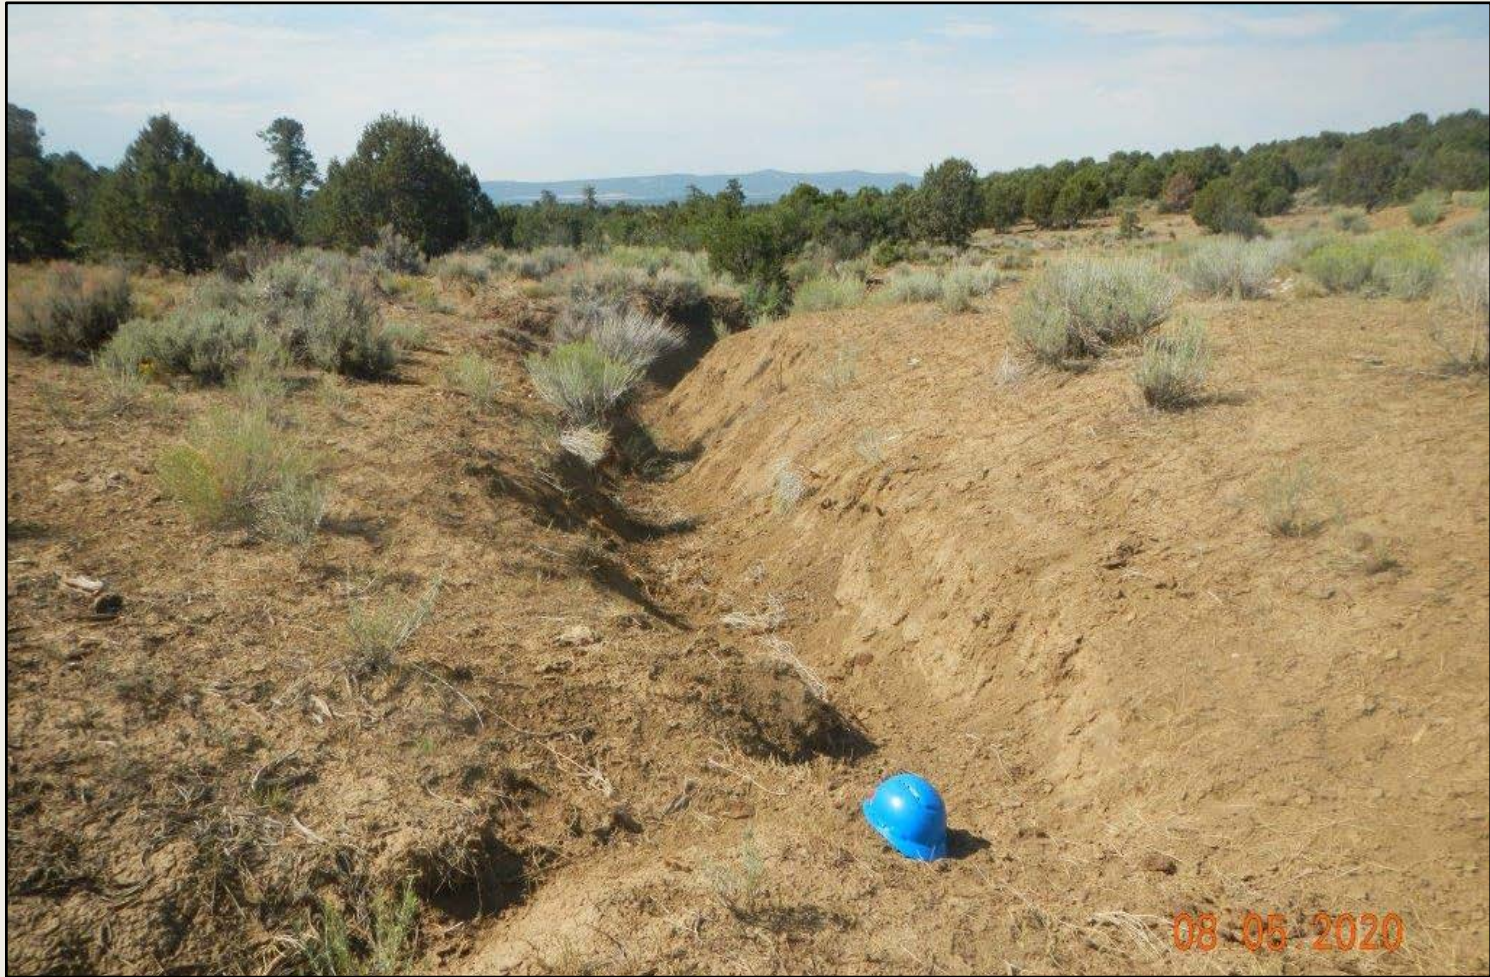
Photo 3. View of erosional headcut (approximately 3-4 ft wide and 2-3 feet deep) forming in the northeastern project area where diversion from the northern project area meets a swale flowing from the north.

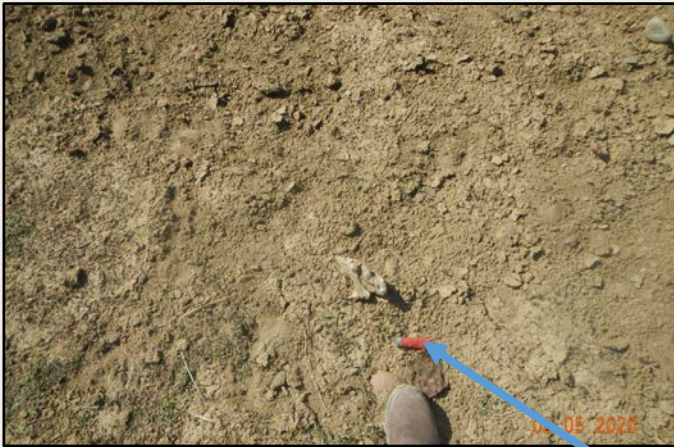
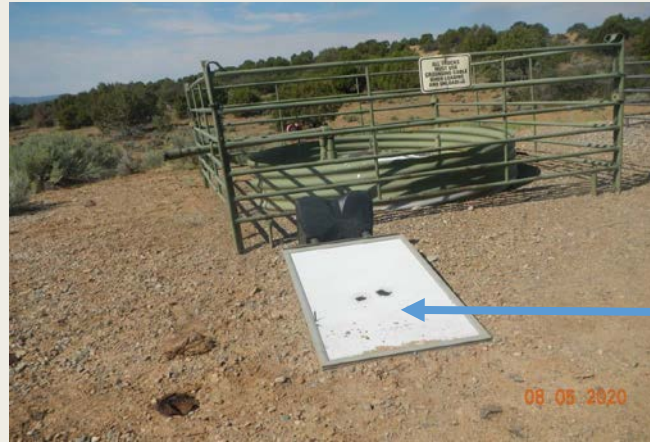
**Sign next to fired equipment with shotgun holes, that appears to be in use as a target.**

Photos 4-6. View of shotgun shells and sign next to submerged tank with evidence of shotgun holes.

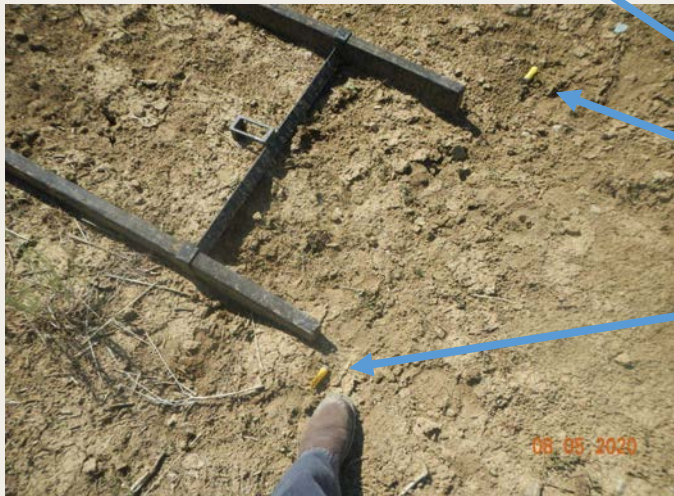
**Shotgun shells**

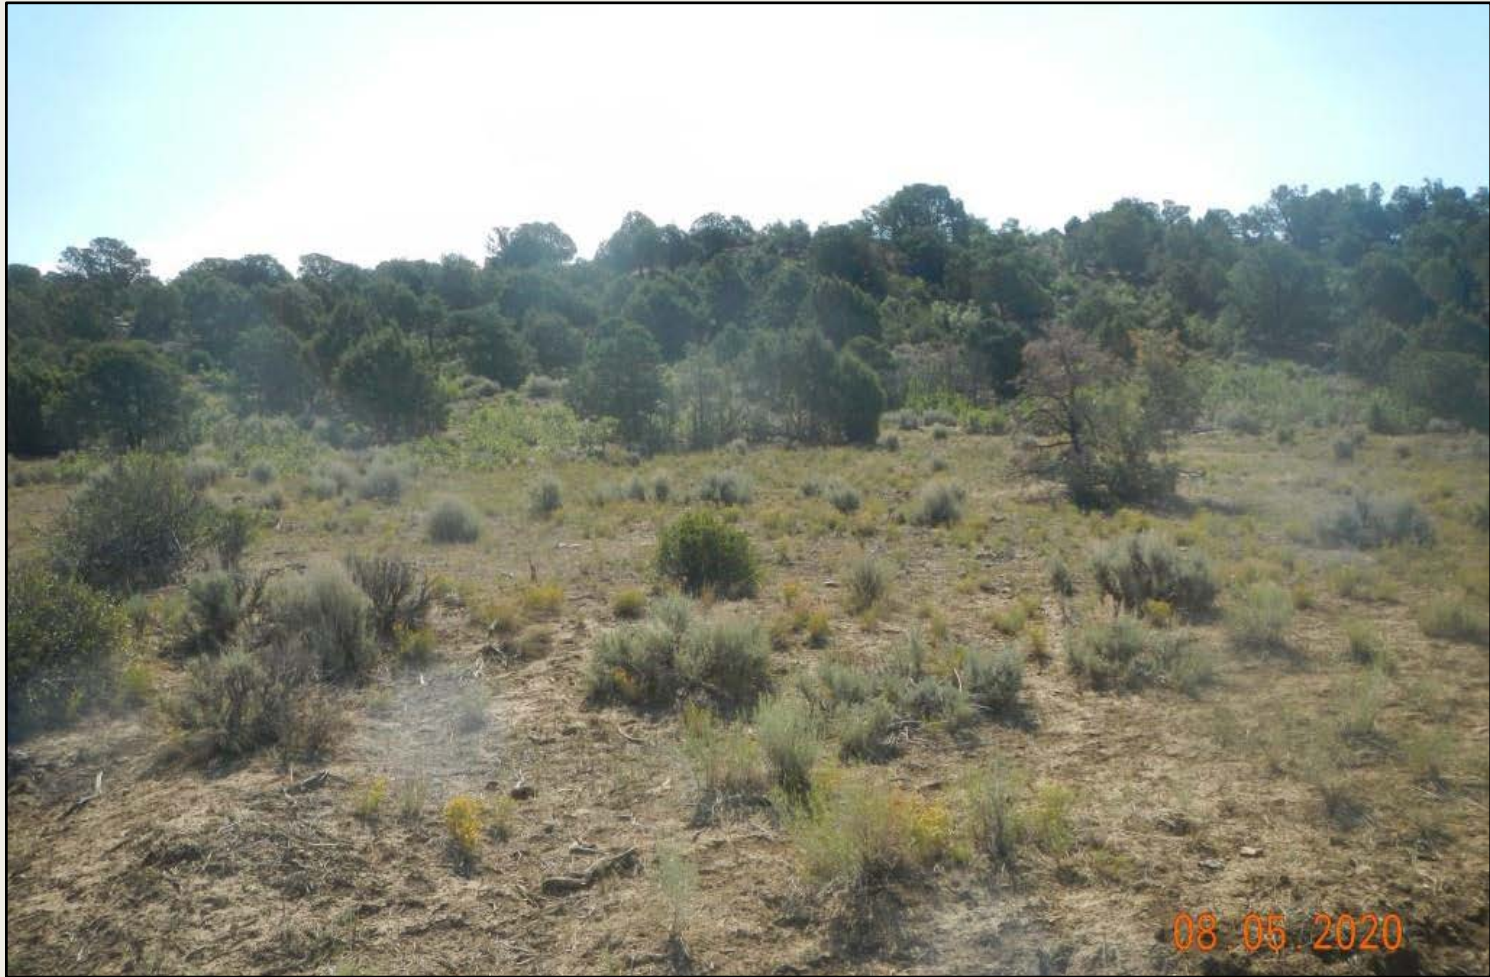
Photo 7. View of reference area mixed pinyon and juniper woodland, sagebrush, with grasses and forbs largely in a grazed condition.
