Inspection Photos
Operator: BP America
API: 067-09060
Date: 8/5/2020

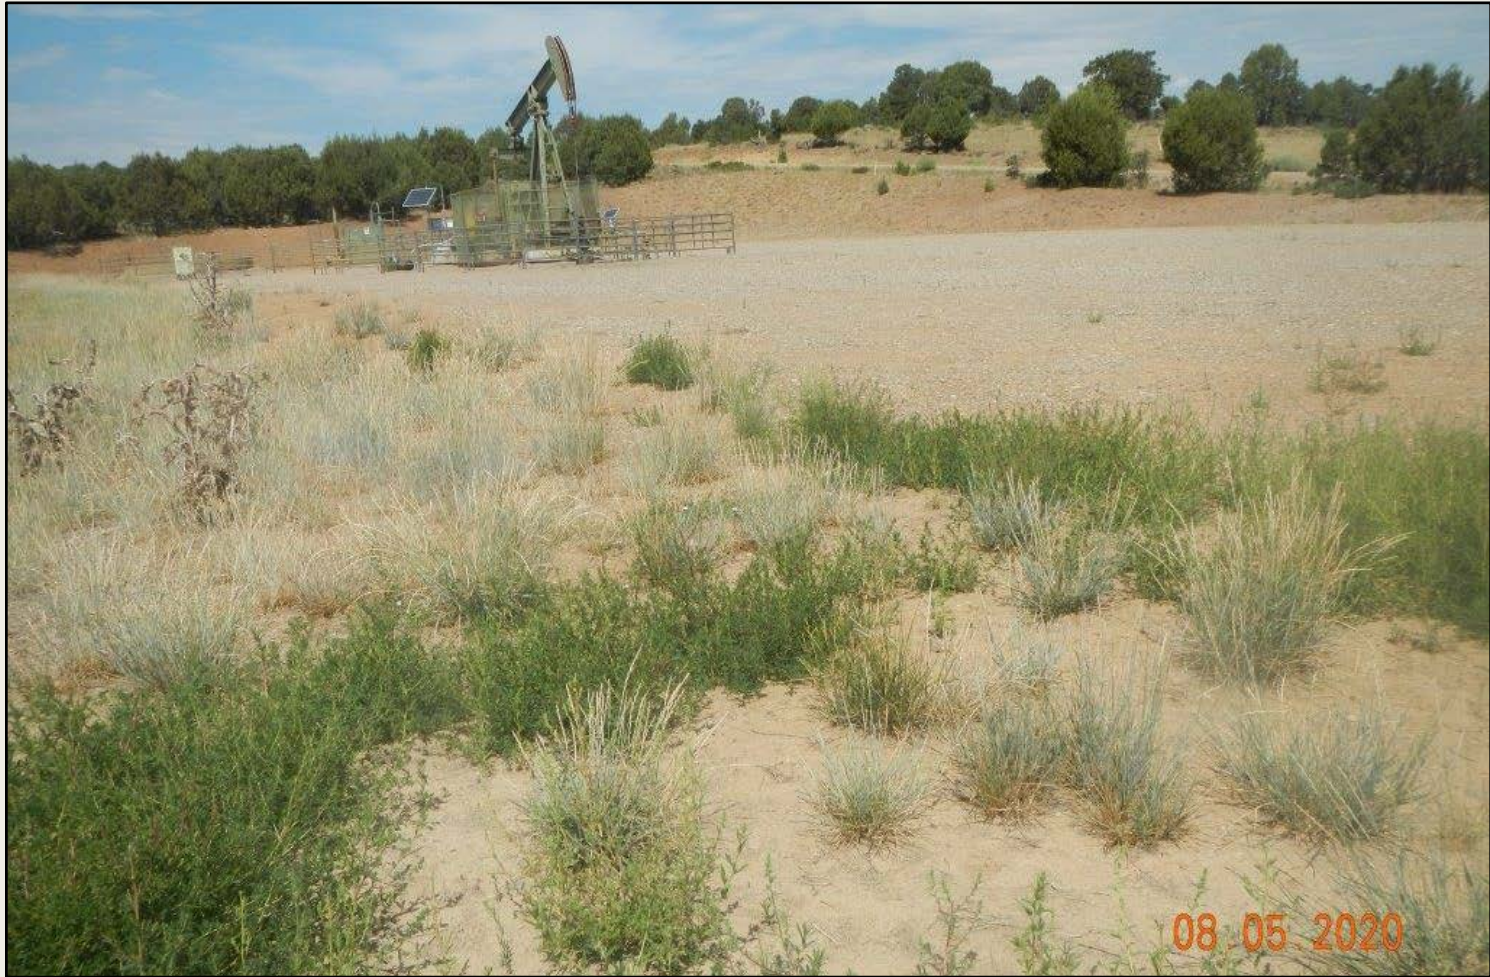
Photo 1. View of the project area from the southeastern corner facing center.

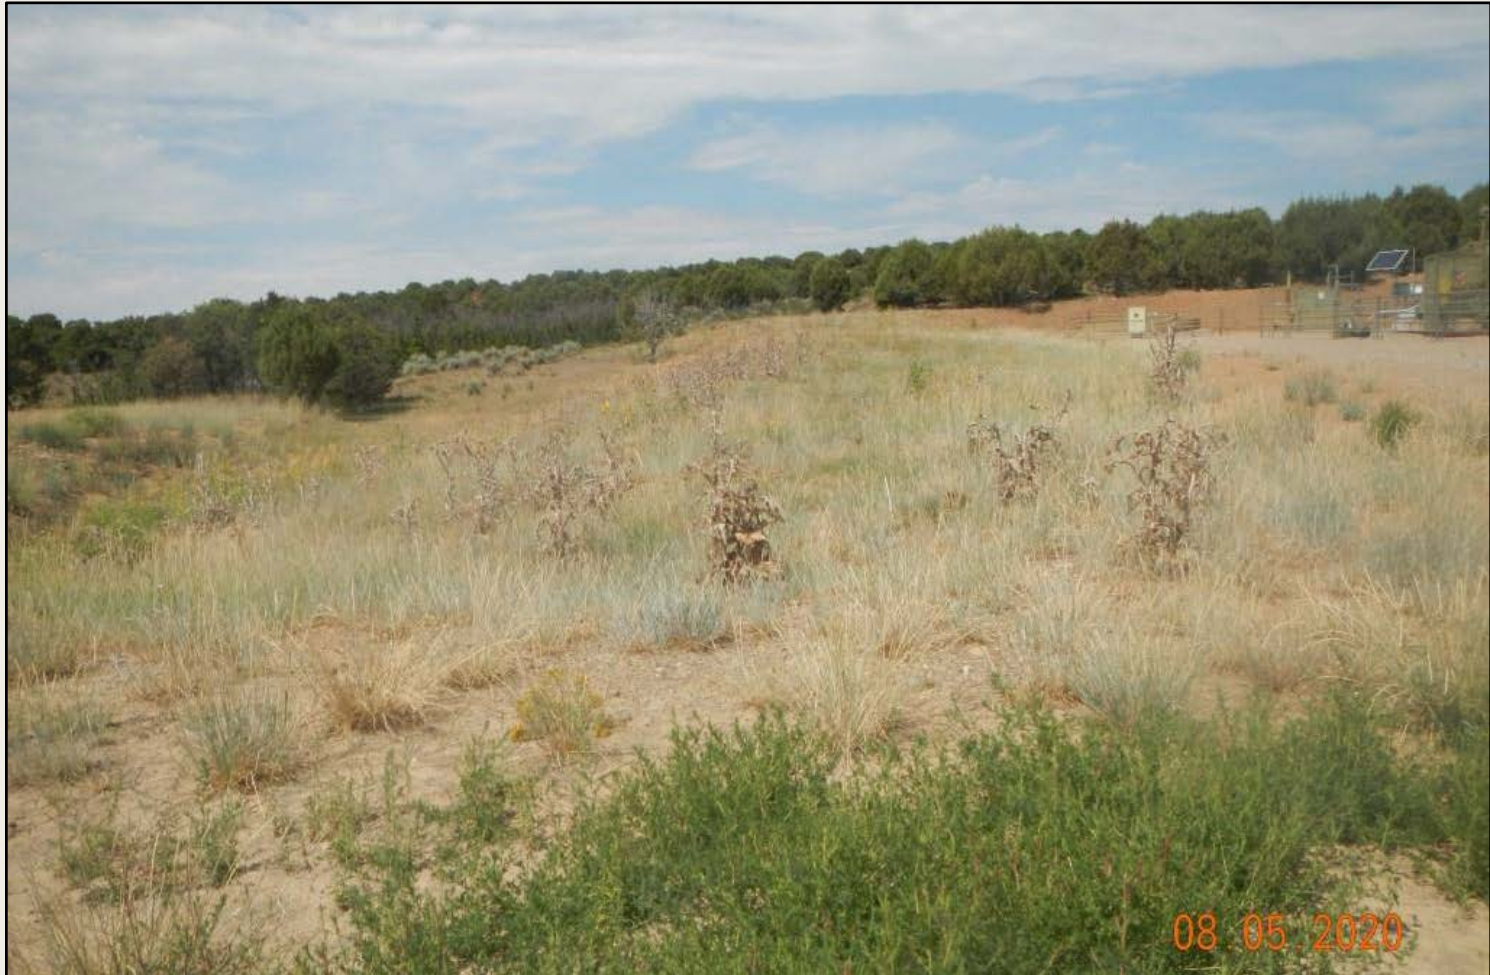
Photo 2. View of the southern portion of the project area from the southeastern corner facing westward. Revegetation is progressing with western wheatgrass, and crested wheatgrass.

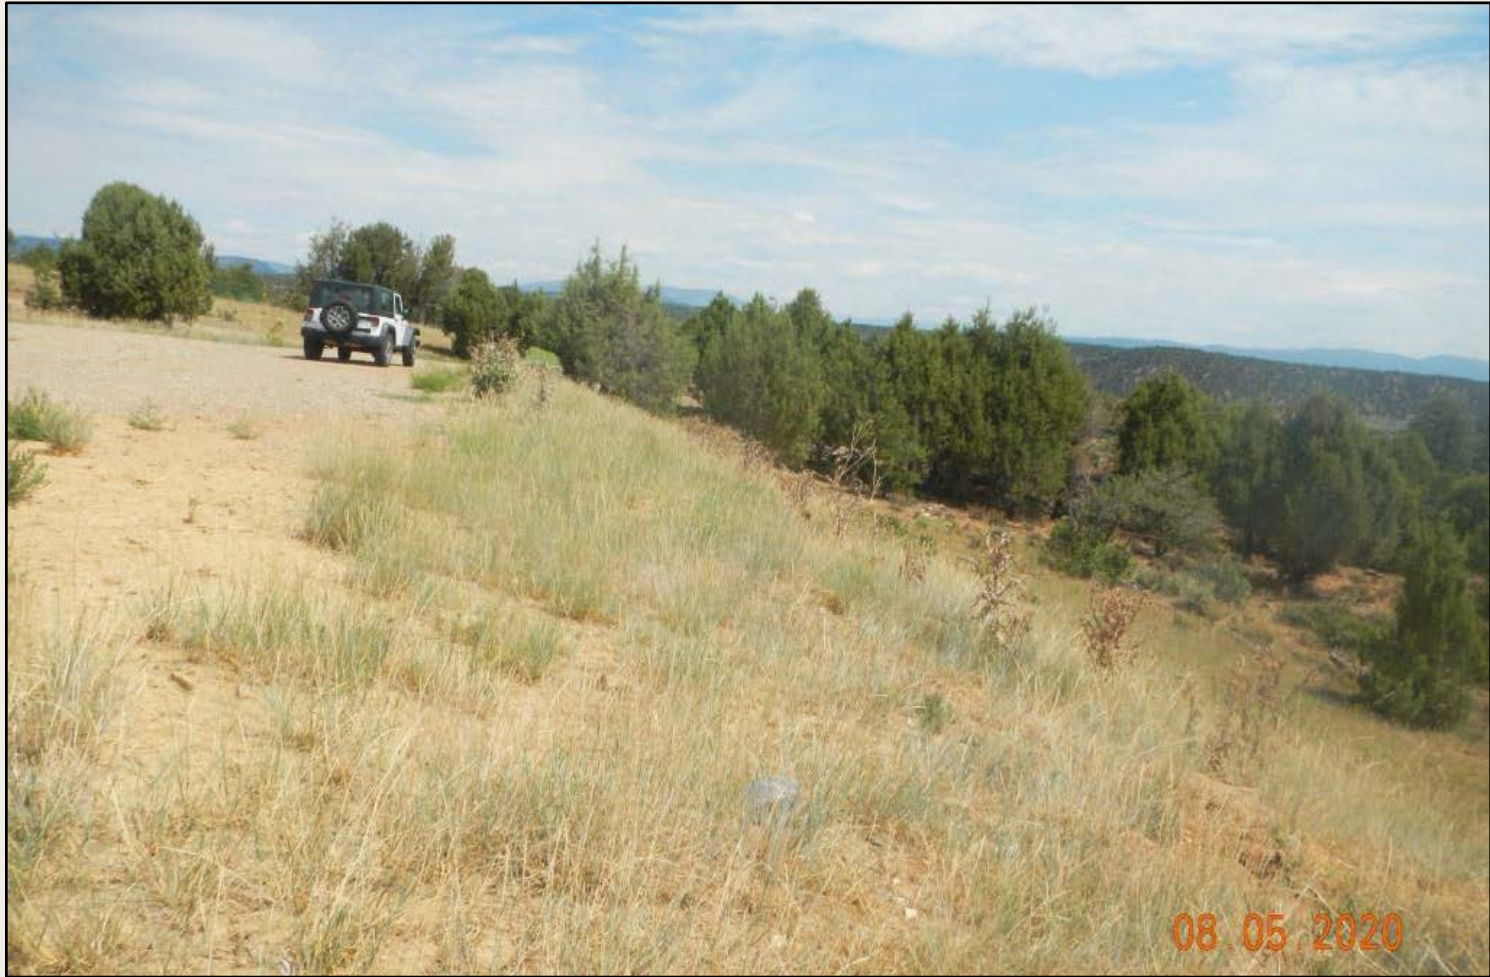
Photo 3. View of the eastern project area from the southeastern corner facing northward.

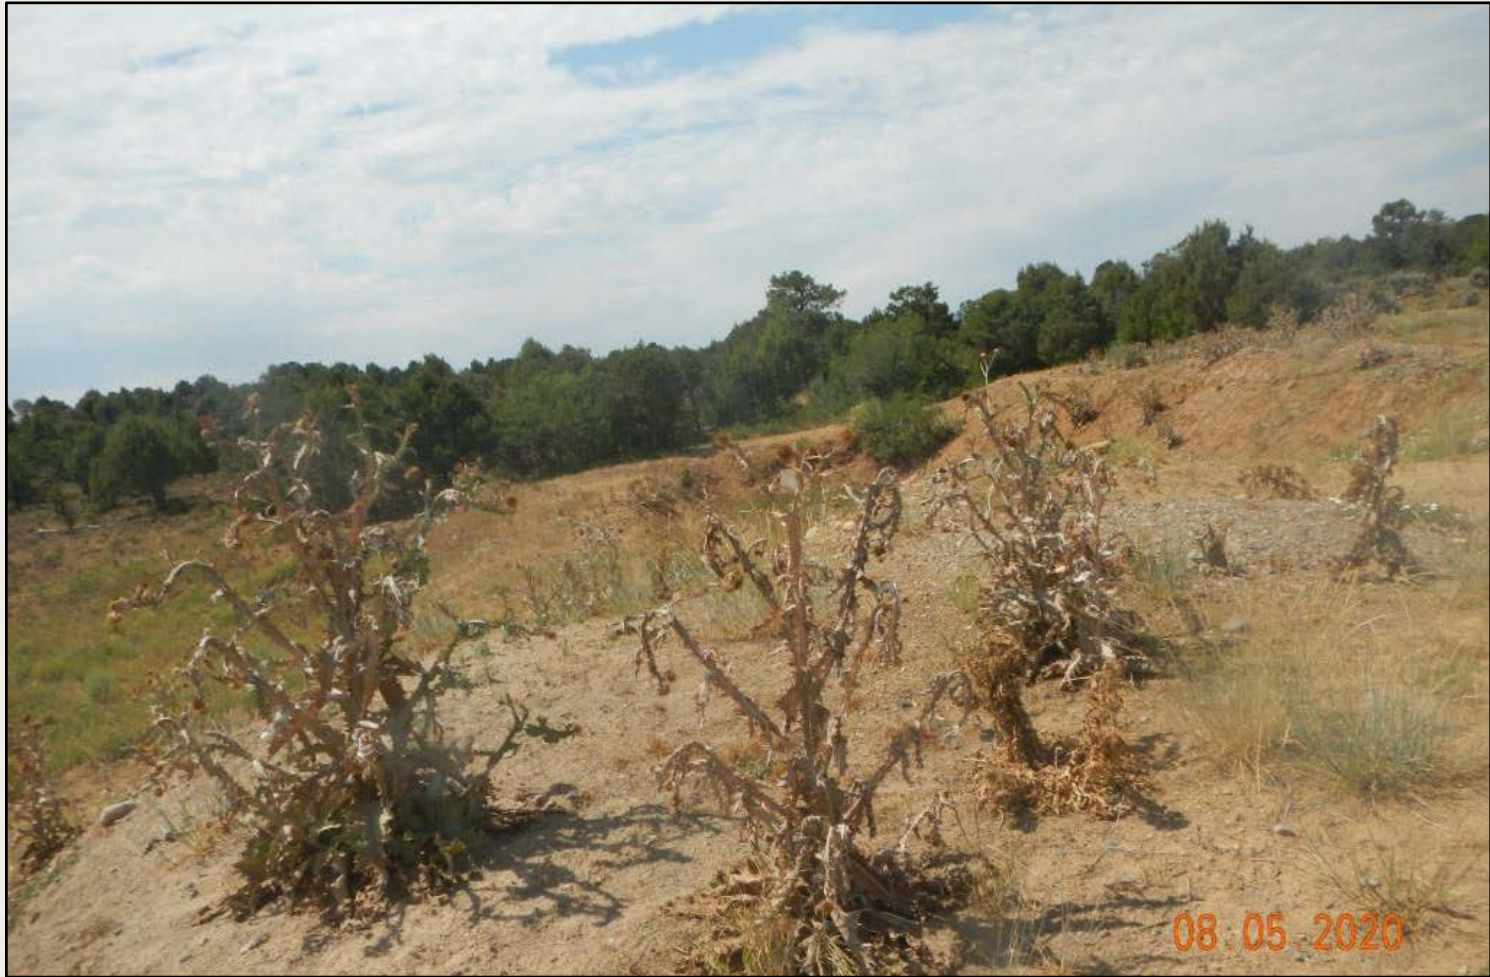
Photo 4. View of Scotch thistles within the project area that appear to be herbicide-treated (approx. 500 individuals observed). Herbicide cover appears effective; however, additional treatment will be needed due to the extent of the infestation and late flowering condition of the individuals when treated.

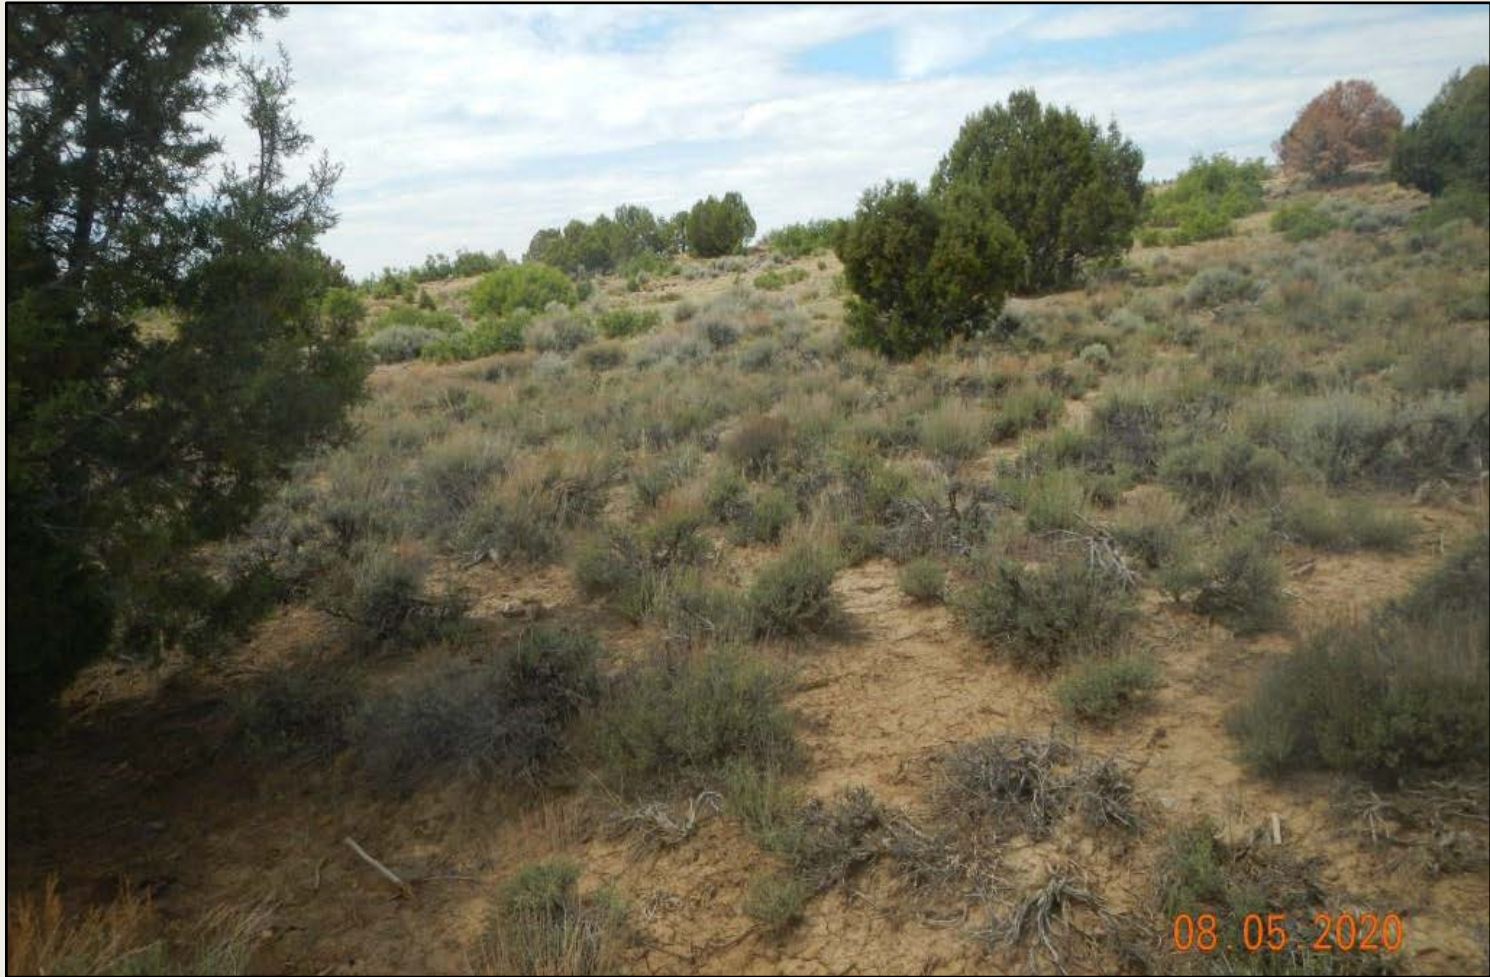
Photo 5. View of reference area comprised of pinyon and juniper woodland with understory of black sage, blue grama, gambel oak, snakeweed, and yellow rabbitbrush.
