Inspection Photos

8/04/2020

Operator: LARAMIE ENERGY LLC - 10433

Location ID: 335844

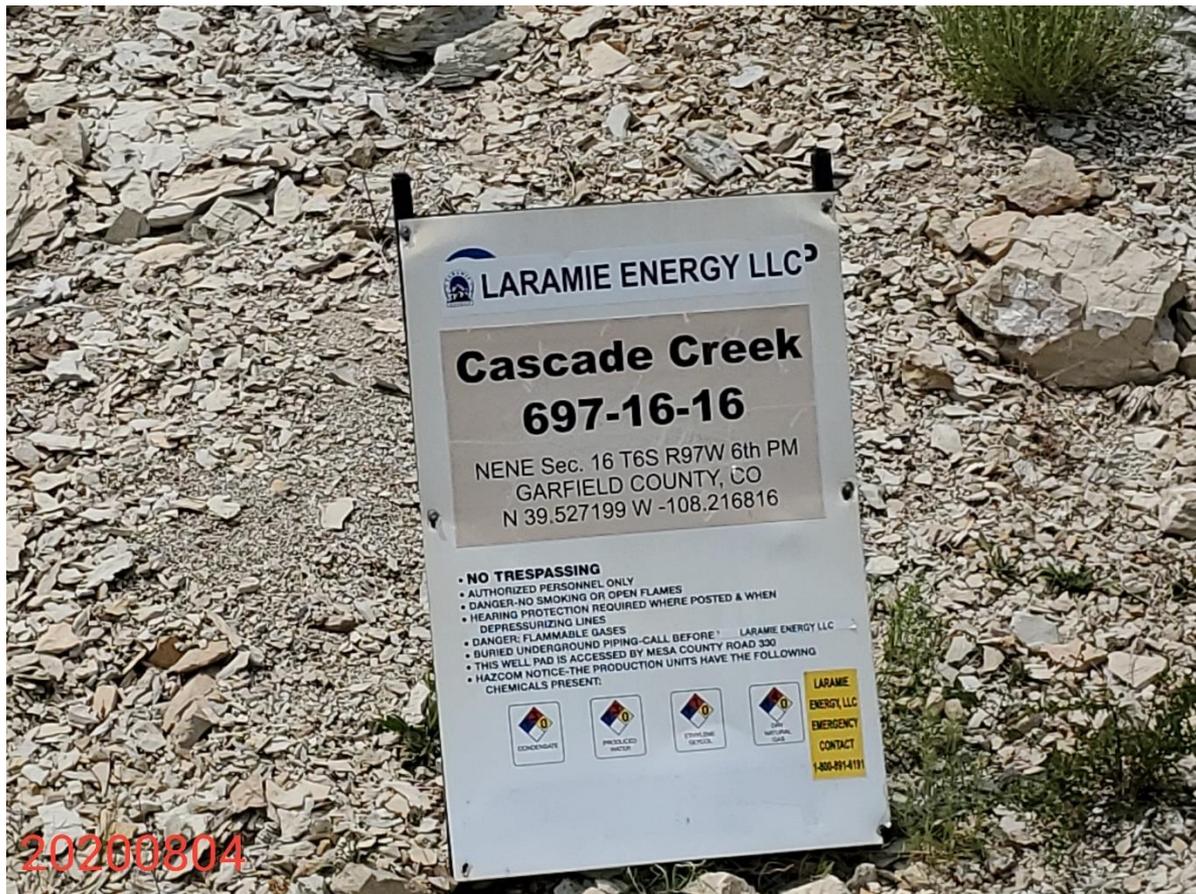
Photo 1: Photo of sign at location entrance

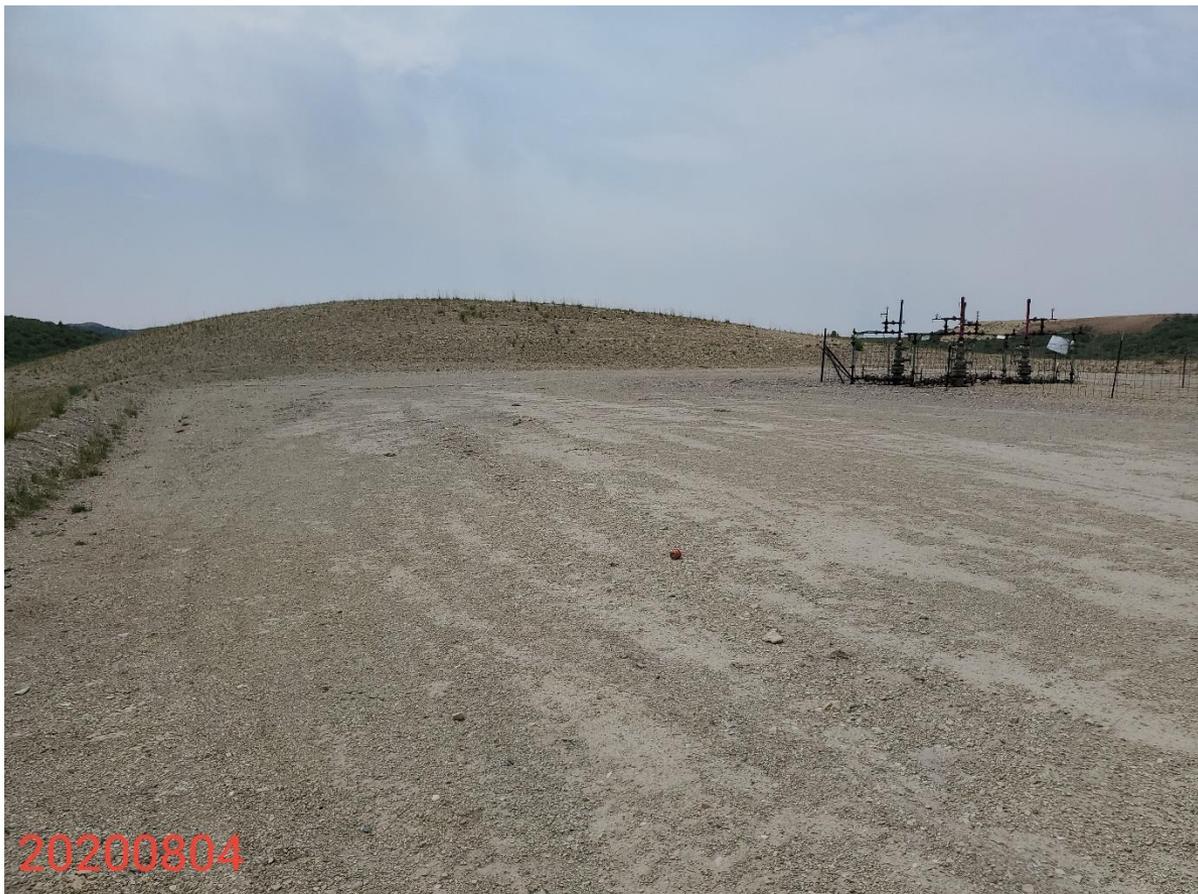
Photo 2: Photo taken from the east end of the production area, facing south. Photos 2-5 provide an overview of the Location from south, southwest, northwest to north.

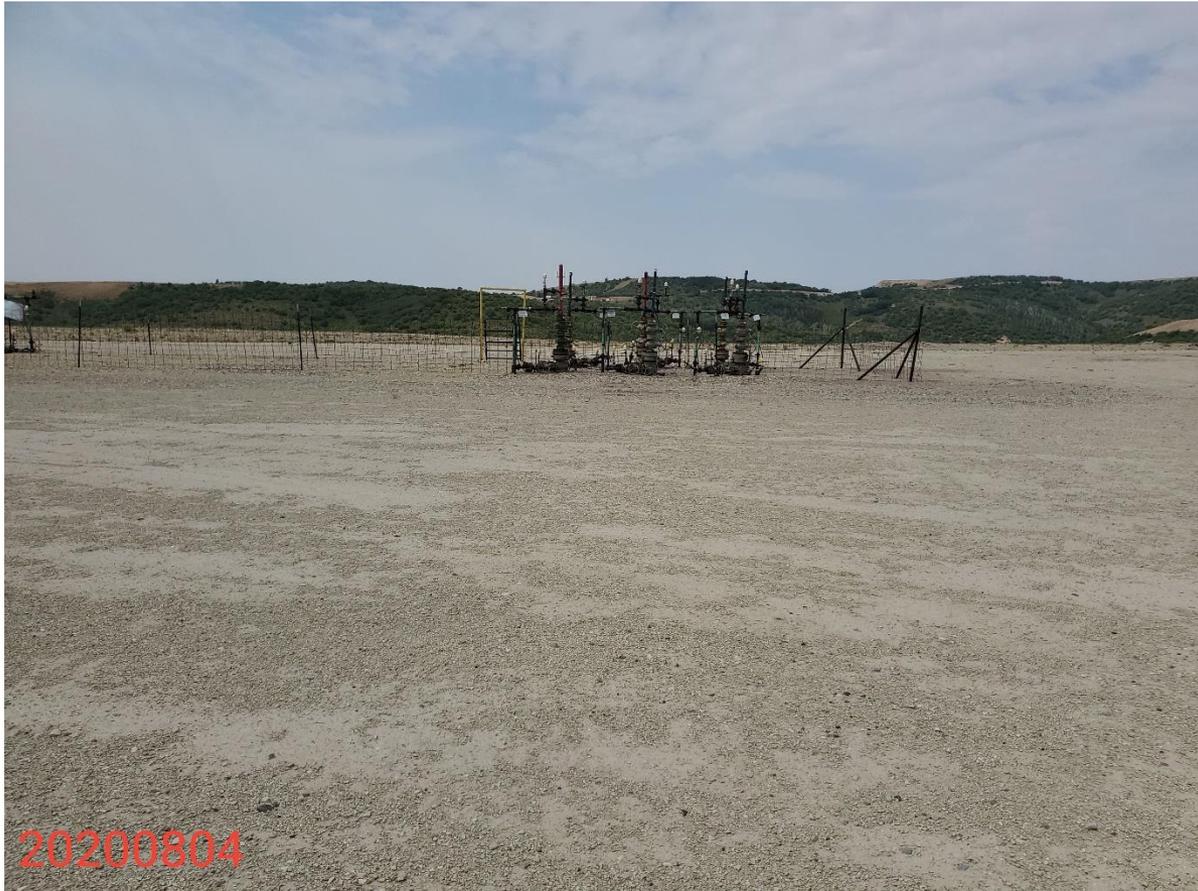
Photo 3: See comments under photo 2.

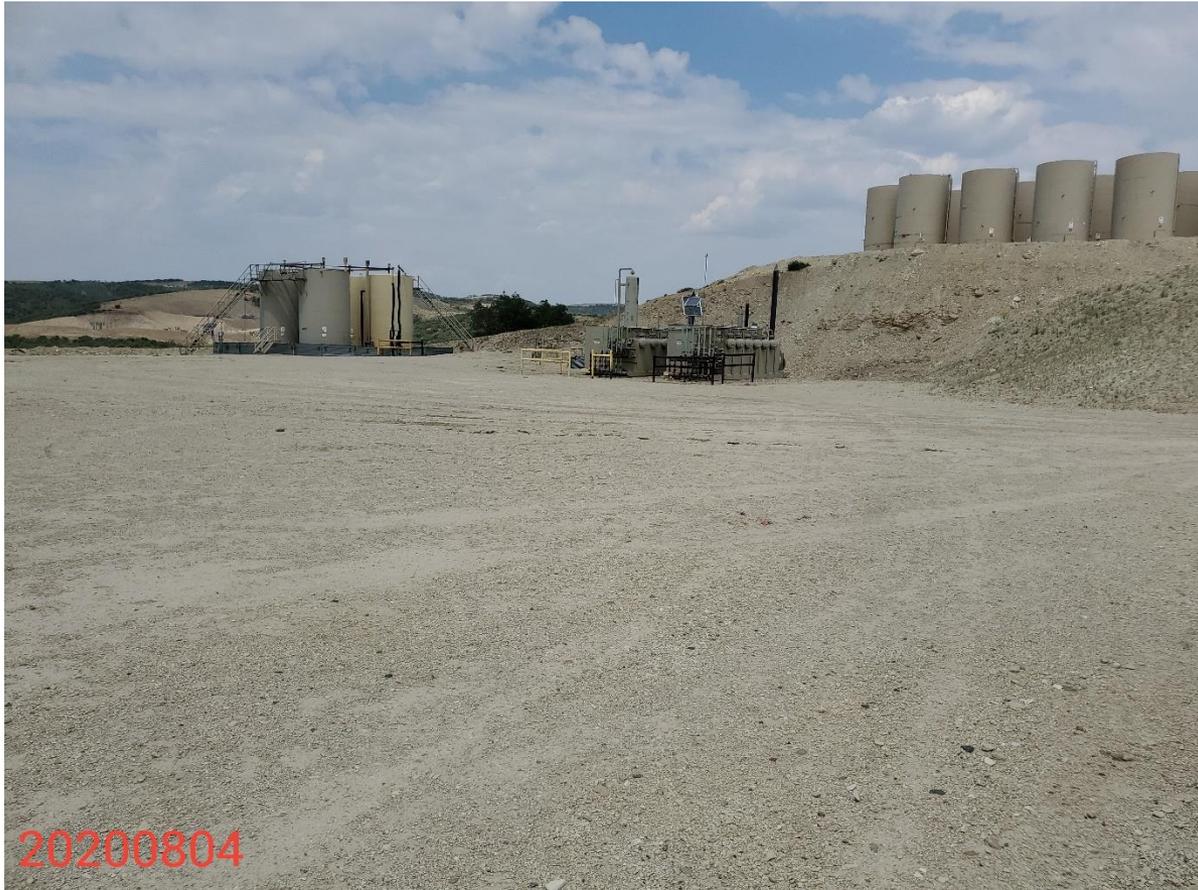
Photo 4: See comments under photo 2.

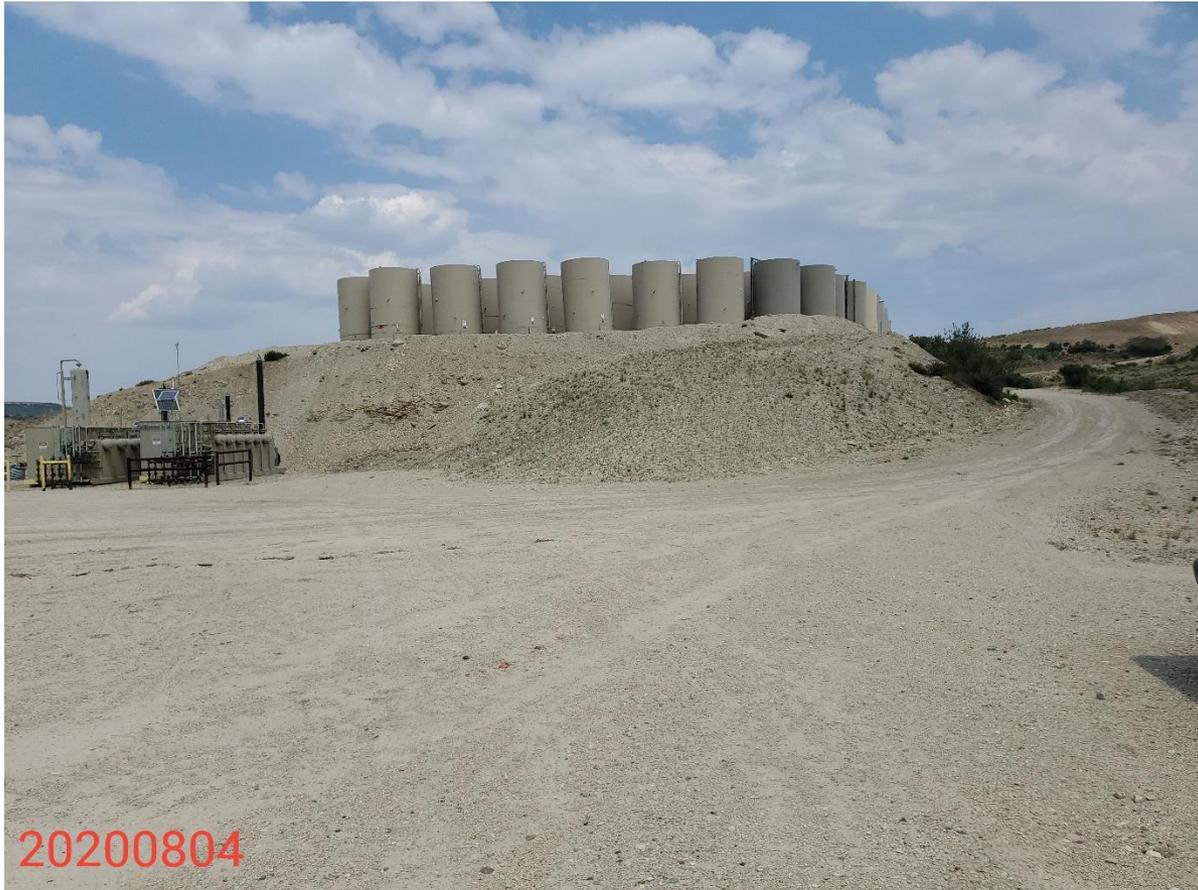
Photo 5: See comments under photo 2.

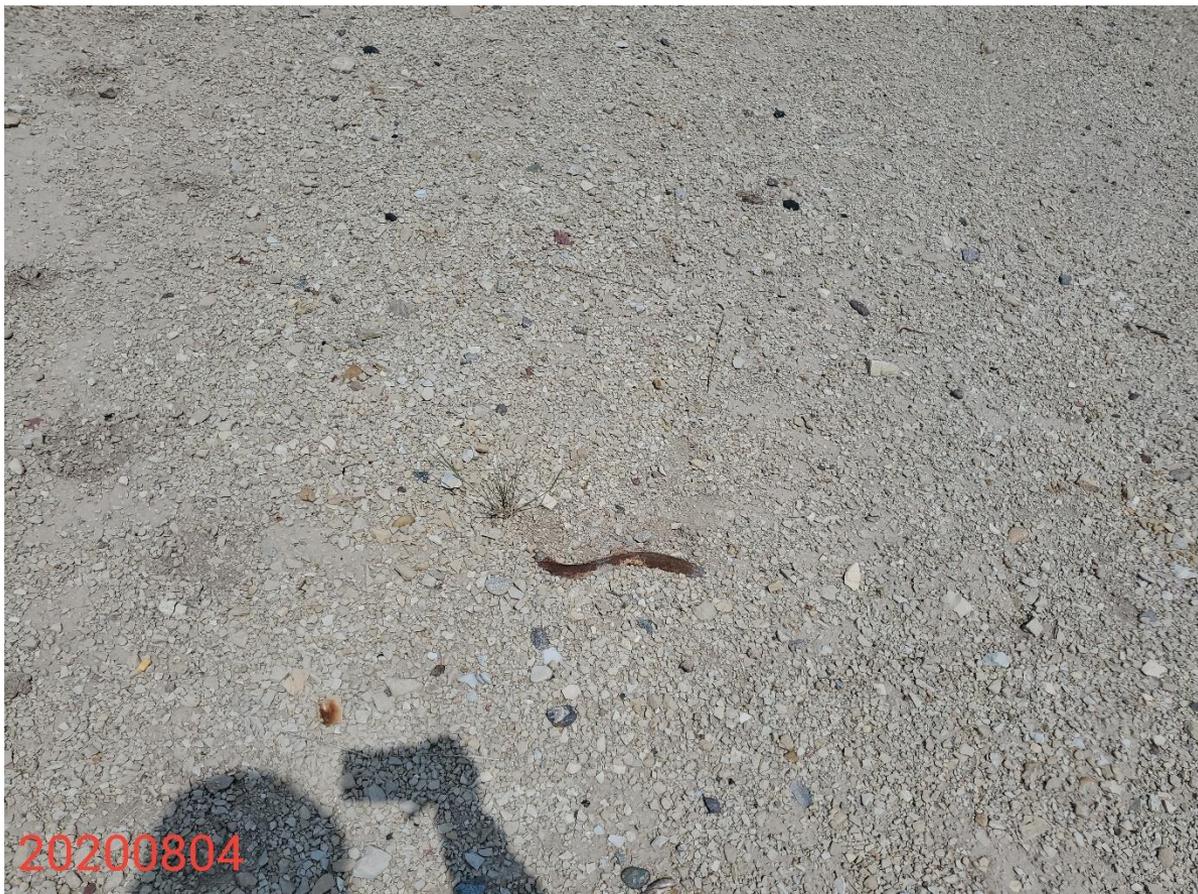
Photo 6: Photo taken from the southwest end of the Location, facing east. Photo shows unmarked anchor.

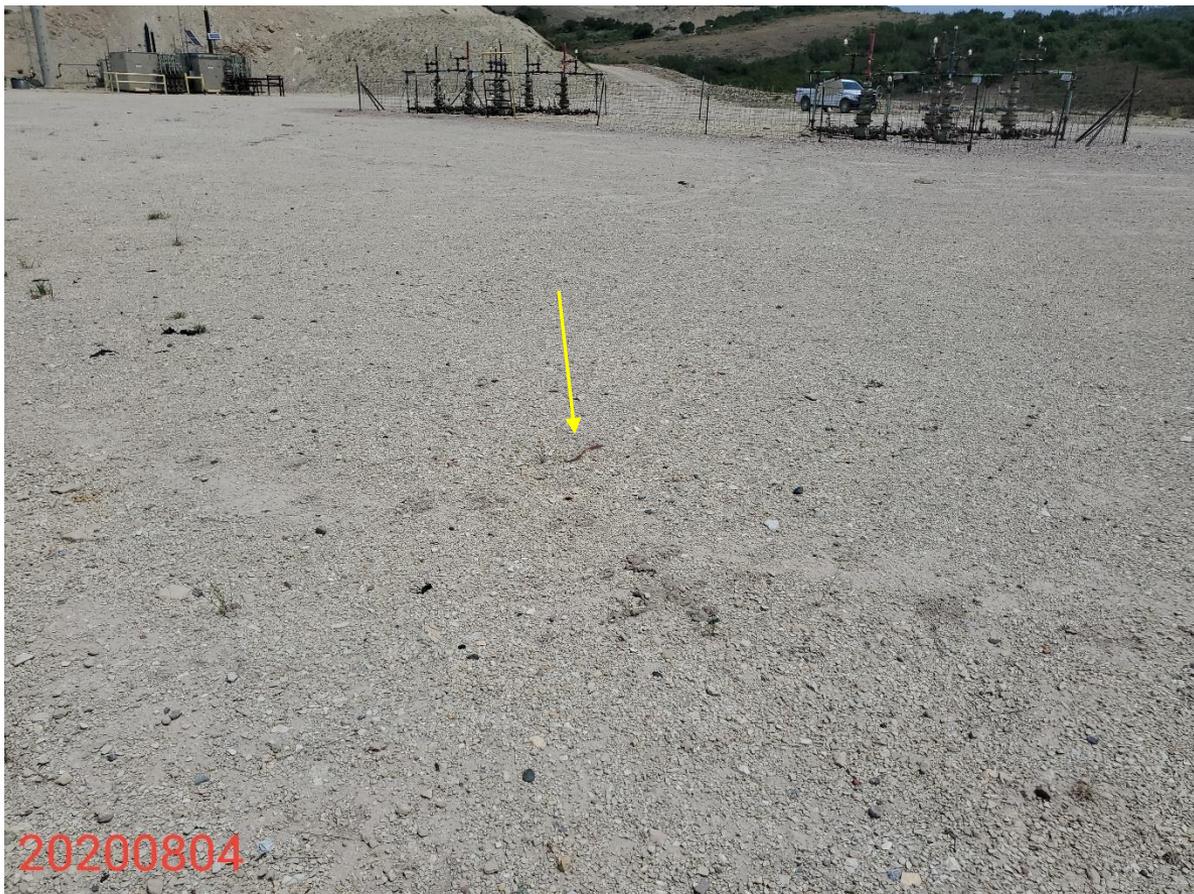
Photo 7: Continued from photo 6. Photo shows unmarked anchor location.

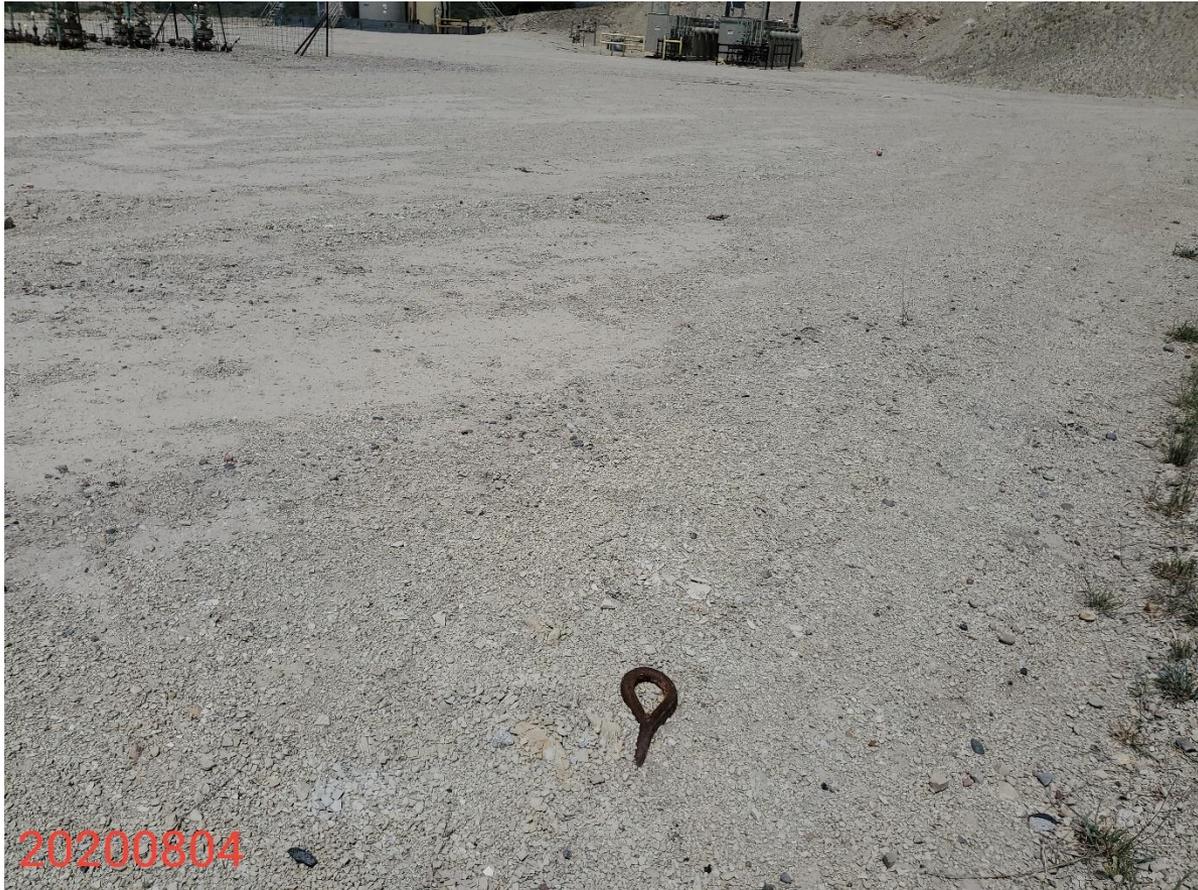
Photo 8: Photo taken from the southeastern areas of the location . Photo shows unmarked anchor.

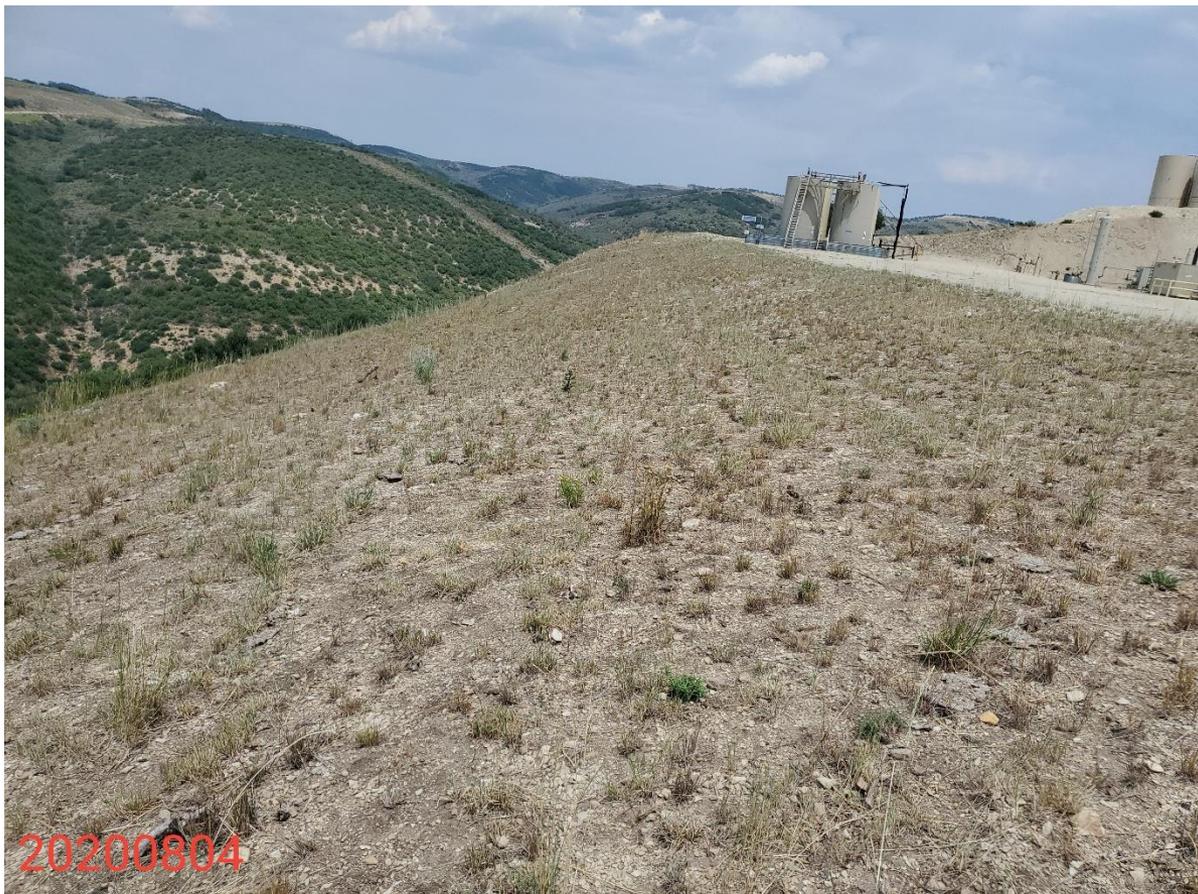
Photo 9: Photo taken from the western interim areas. Revegetation in these areas appears to be progressing towards 1000 series standards.

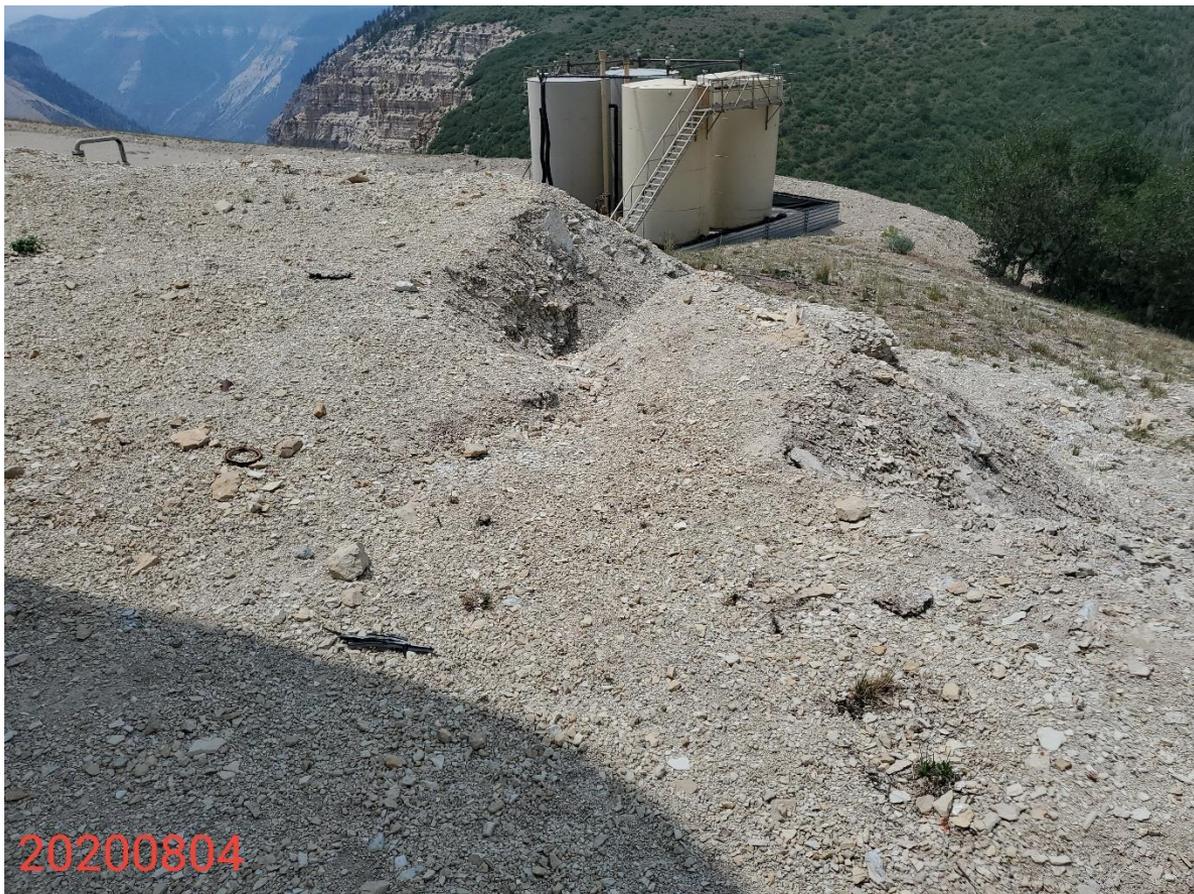
Photo 10: Photo taken from the southwestern end of the storage are of the location, facing southwest. Photo shows erosion degradation.

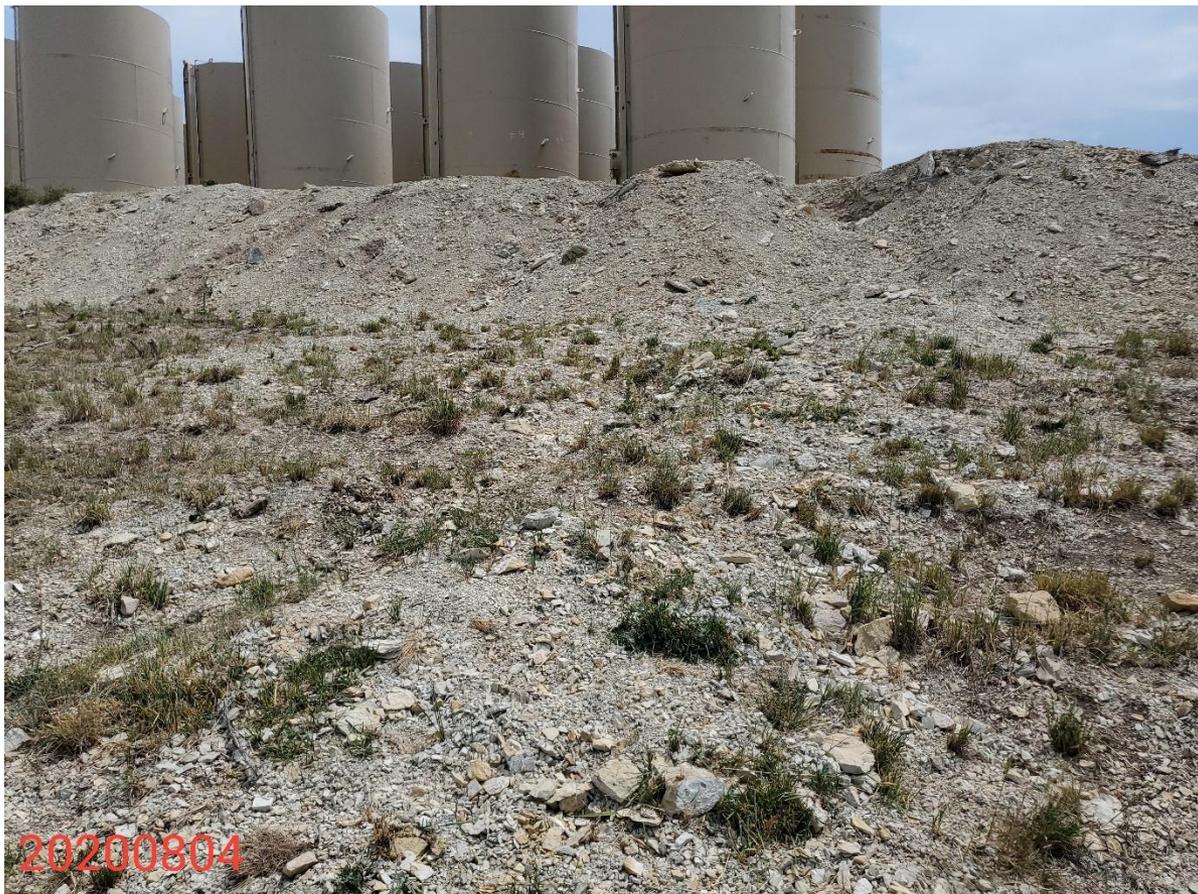
Photo 11: Photo taken from the west end of the Locaiton, facing east. Photo shows erosion degradation and sediment transport.

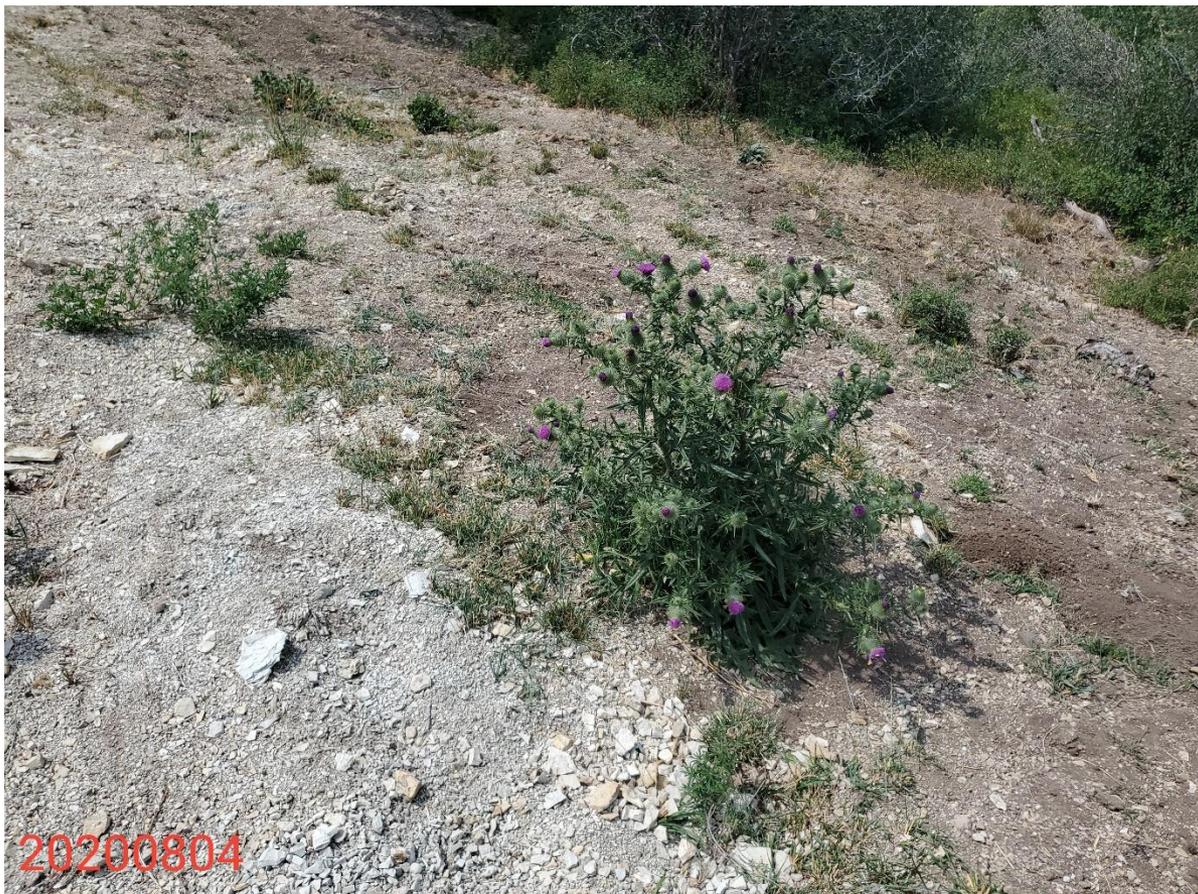
Photo 12: Photo taken from the western interim areas of the Location. Photo shows bull thistle establishing on location. This is a Colorado State listed noxious weed.

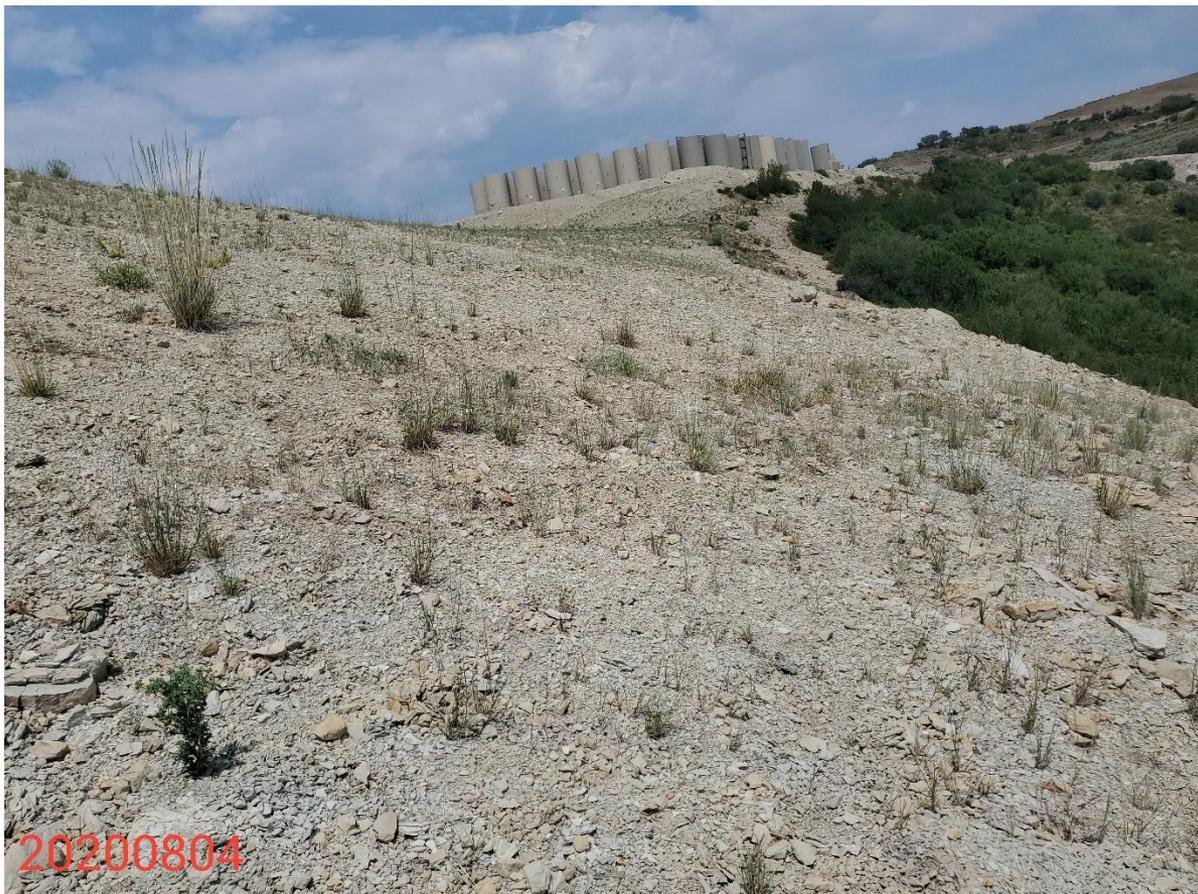
Photo 13: Photo taken from the eastern interim areas of the Location, facing north. Photo shows BMPs missing or insufficient to stabilize slopes and/or prevent sediment transport

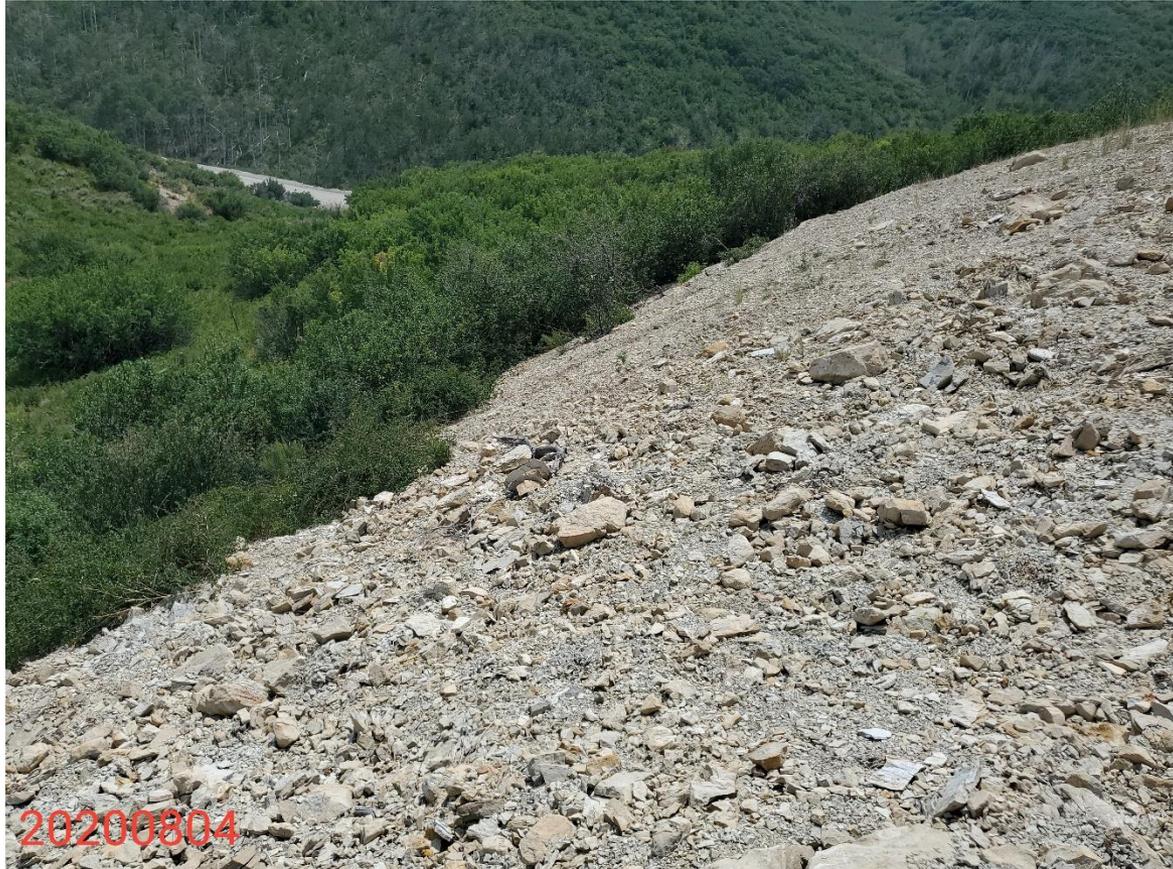
Photo 14: Photo taken from the eastern interim areas of the Location, facing southeast. Photo shows BMPs missing or insufficient to stabilize slopes and/or prevent sediment transport

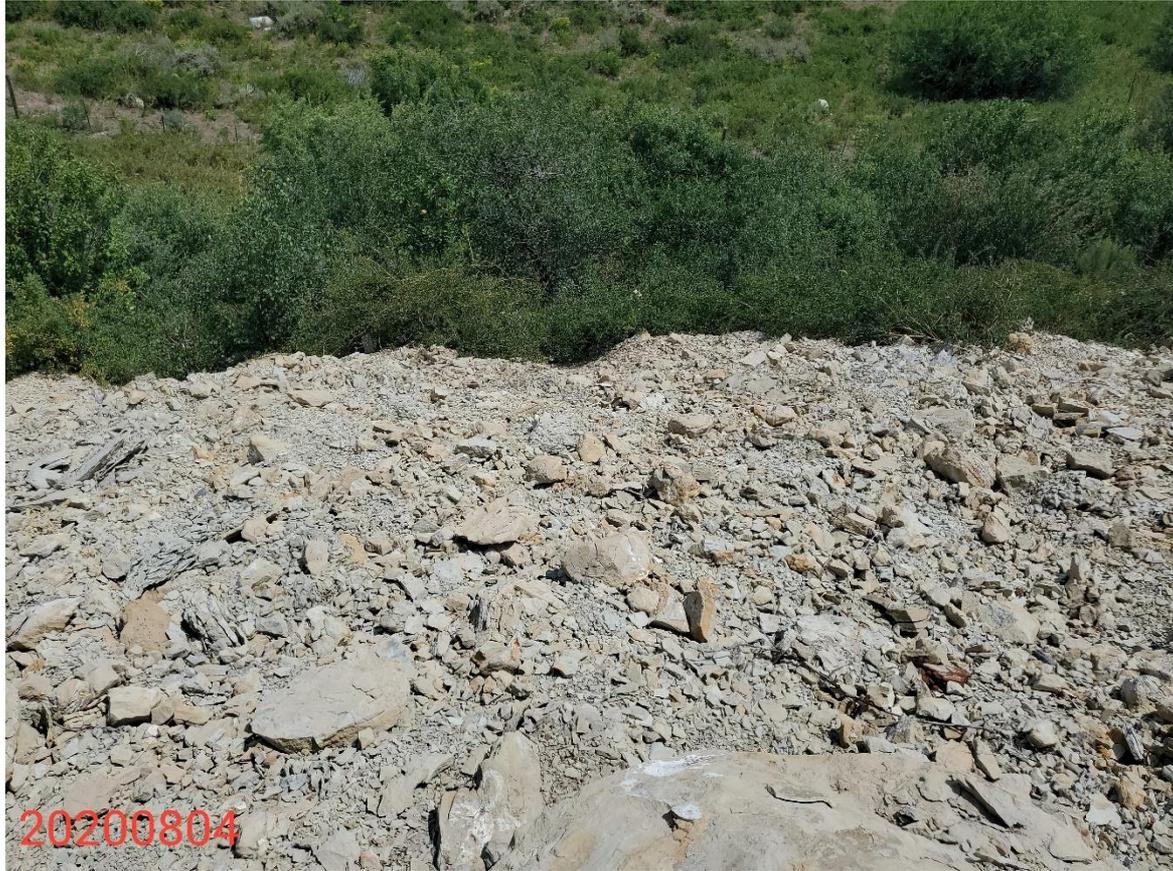
Photo 15: Photo taken from the eastern interim areas of the Location, facing east. Photo shows BMPs missing or insufficient to stabilize slopes and/or prevent sediment transport

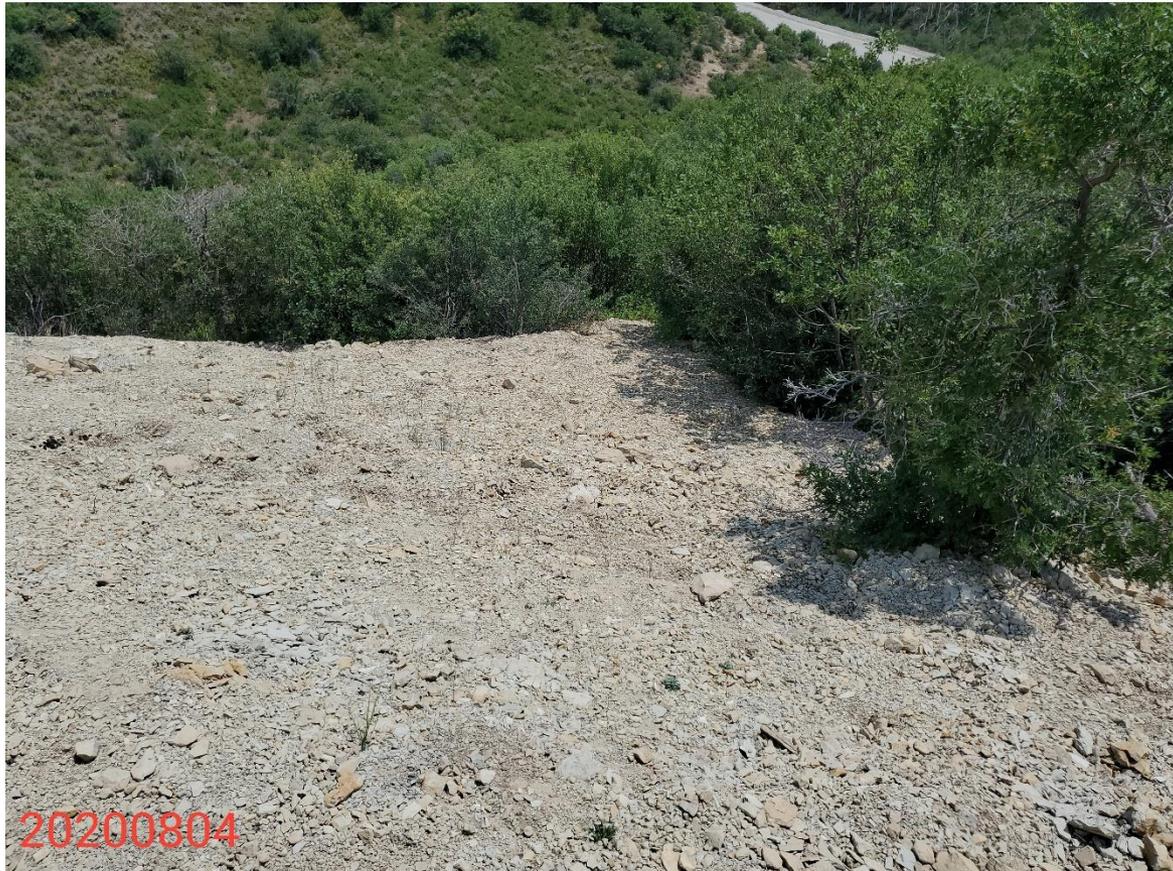
Photo 16: Photo taken from the eastern interim areas of the Location, facing east. Photo shows BMPs missing or insufficient to stabilize slopes and/or prevent sediment transport

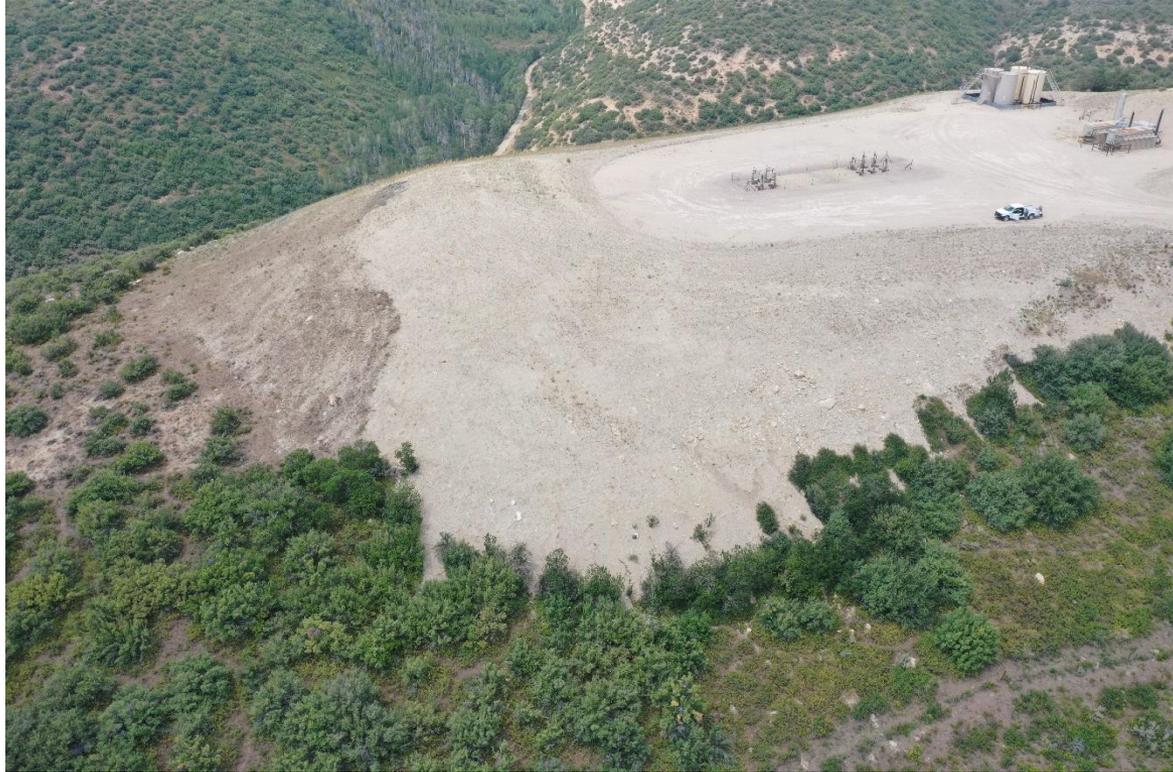
Photo 17: Aerial photo taken east of the Location, facing west. Photo shows overview of the Location and fill slopes; BMPs missing or insufficient to stabilize slopes and/or prevent sediment transport

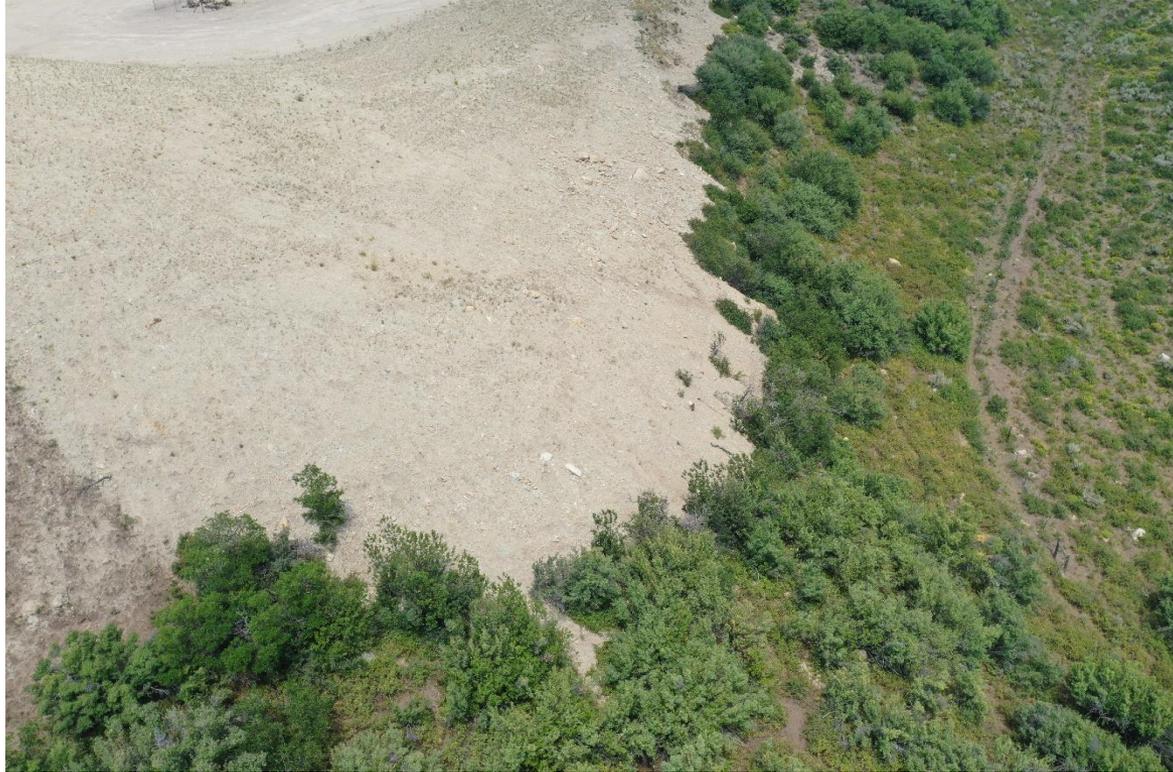
Photo 18: Aerial photo taken east of the Location, facing north. Photo shows overview of the Location and fill slopes; BMPs missing or insufficient to stabilize slopes and/or prevent sediment transport

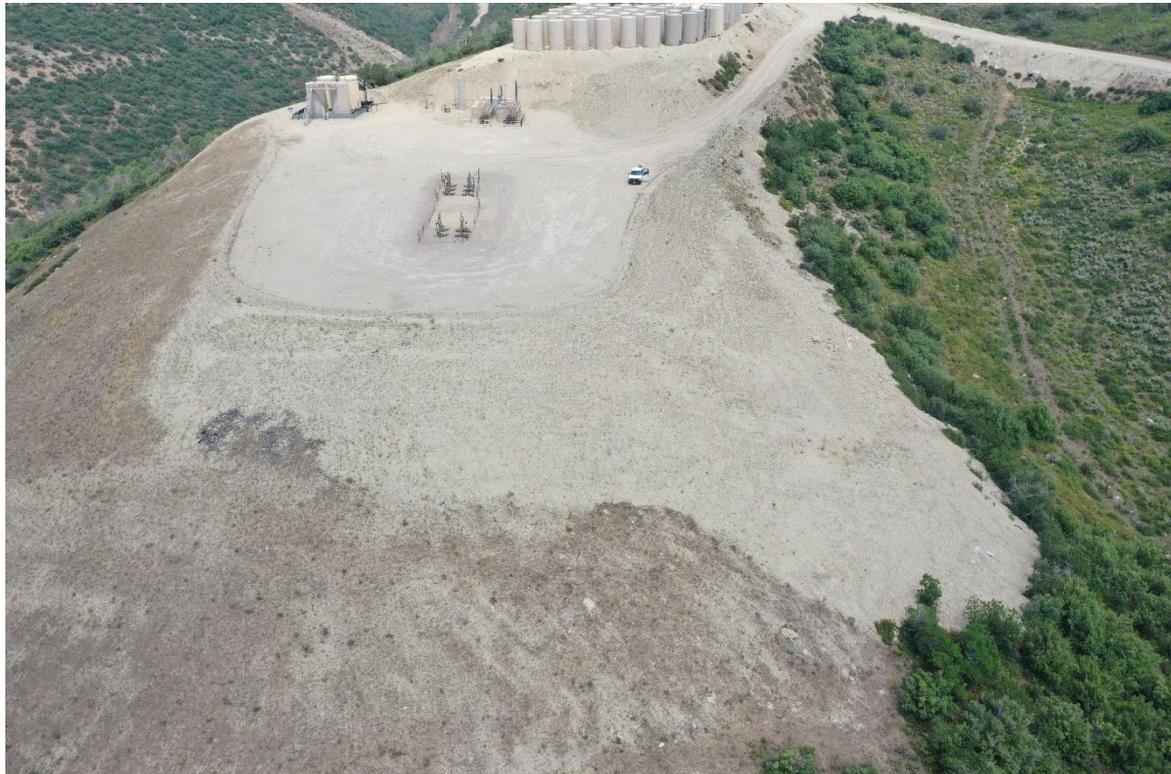
Photo 19: Aerial photo taken east of the Location, facing north. Photo shows overview of the Location and fill slopes; BMPs missing or insufficient to stabilize slopes and/or prevent sediment transport

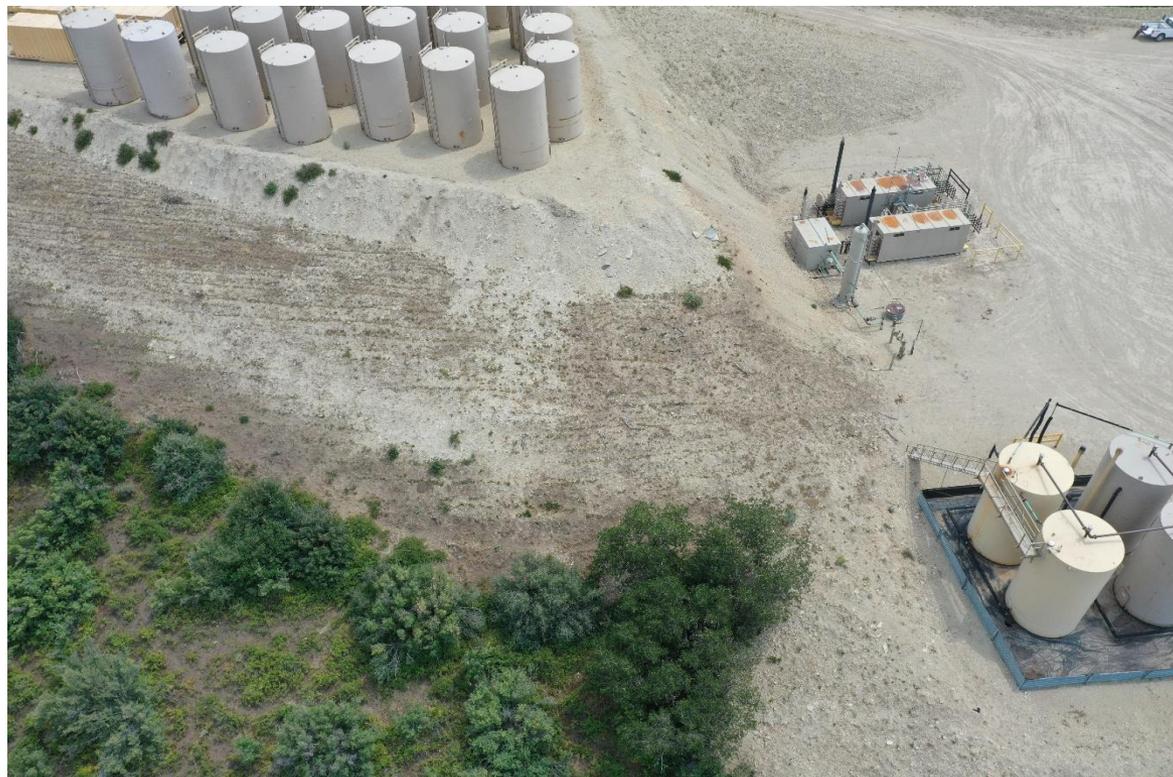
Photo 20: Aerial of the west end of the Location. Photo shows areas of erosion degradation. See photos 10, 11

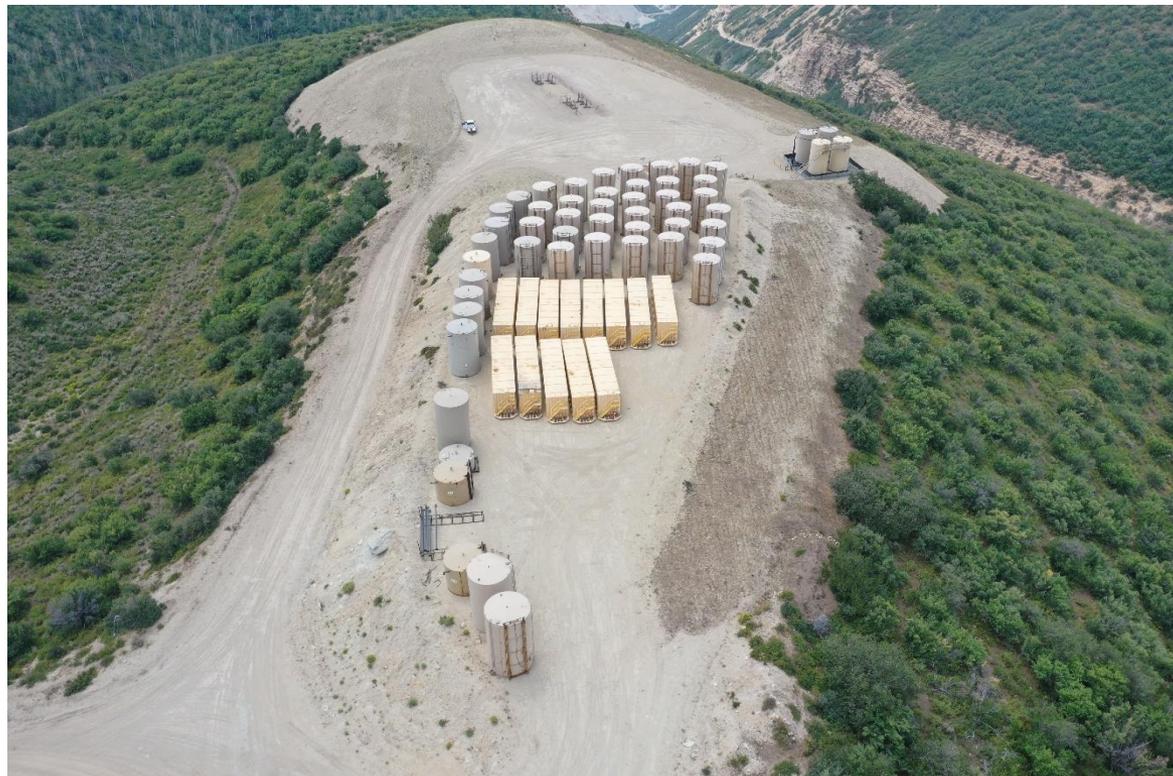
Photo 21: Aerial photo taken from the north of the Location, facing south. Photo provides overview of the Location and storage yard.
