Inspection Photos

8/04/2020

Operator: LARAMIE ENERGY LLC - 10433

Location ID: 335921

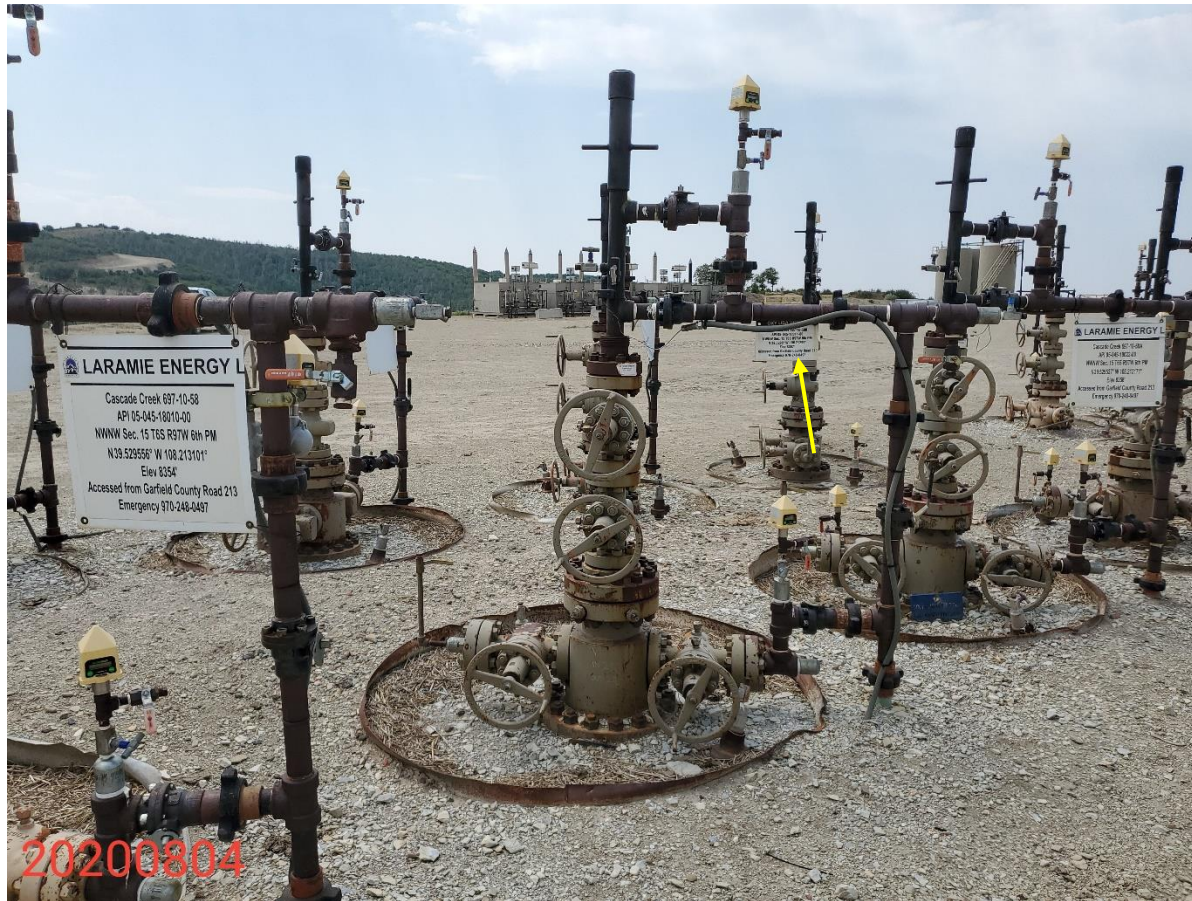
Photo 1: Photo taken from the wells on the Location. Photo shows well with incorrect Operator information.

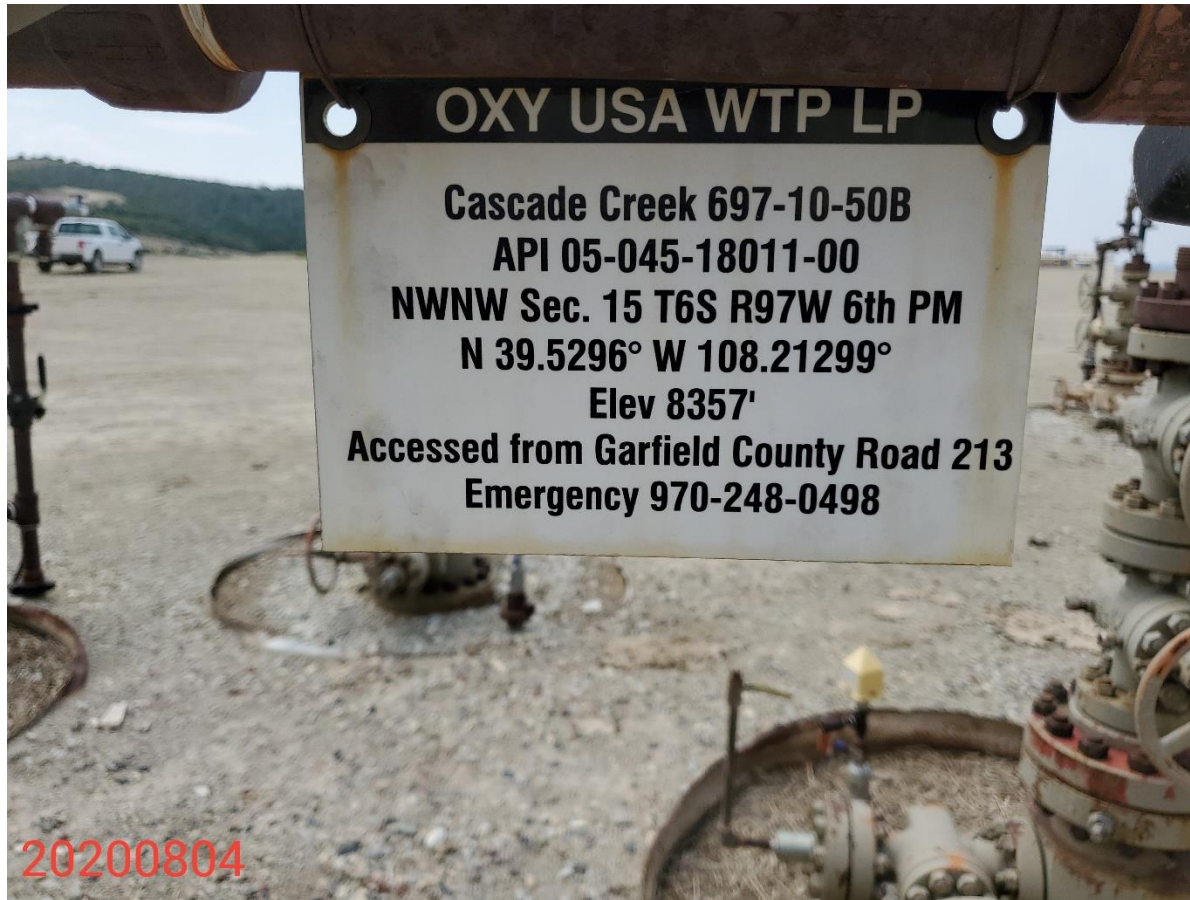
Photo 2: Continued from photo #1. Photo shows well with incorrect Operator information.

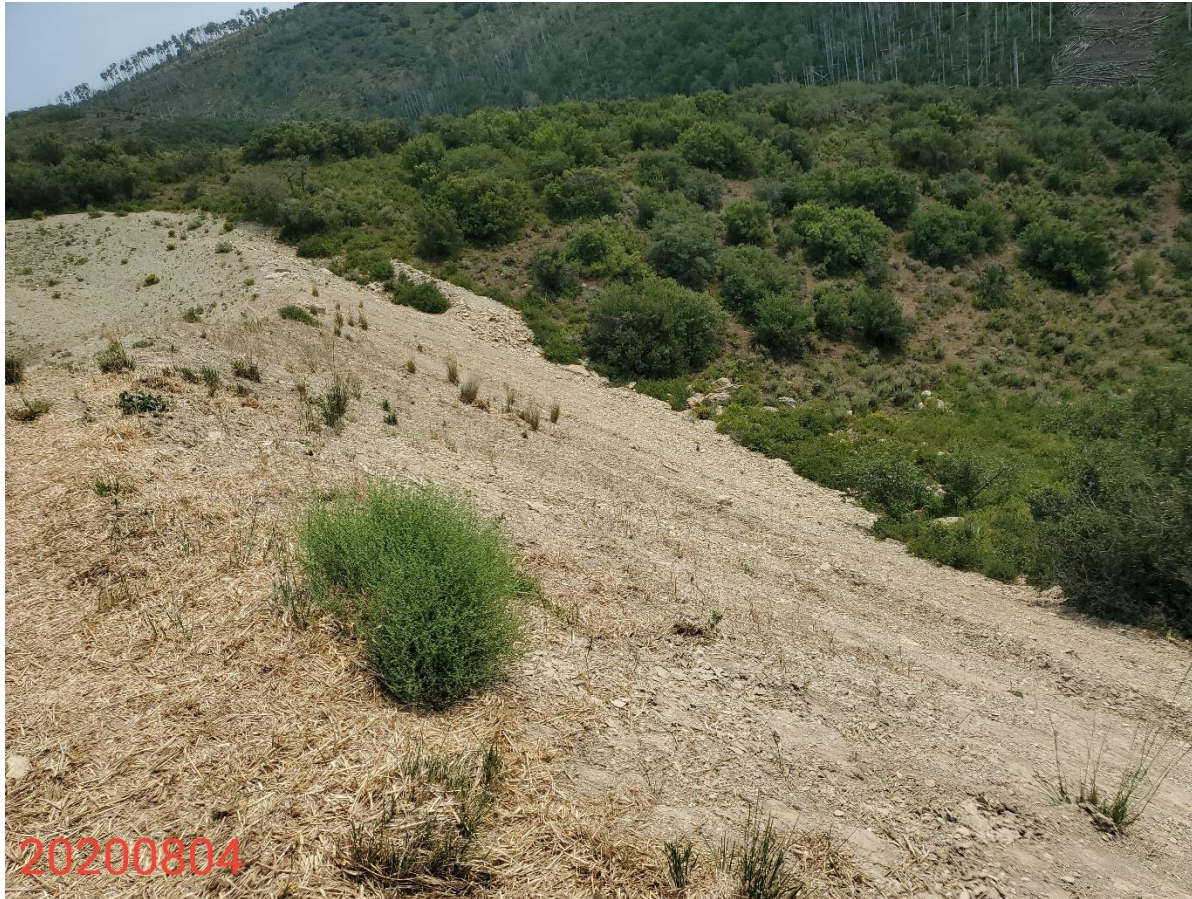
Photo 6: Photo taken from the southeast end of the Location, facing east. Photo shows areas of the Location, including fill slopes, that have not been recontoured/regraded or reclaimed to their original condition in accordance with 1003 rules. BMPs appear insufficient or missing to stabilize slopes and prevent sediment transport.

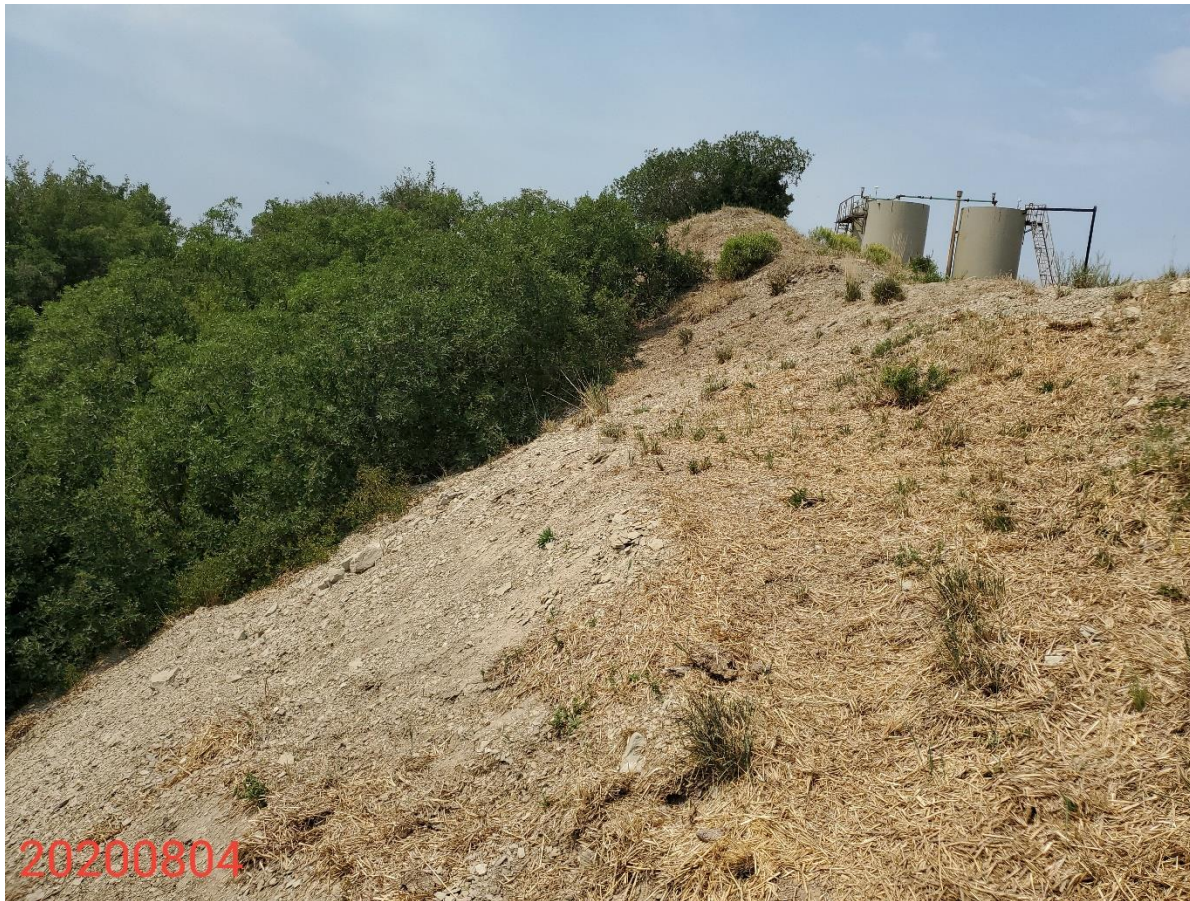
Photo 7: Photo taken from the southeast end of the Location, facing west. See comments under photo 6.

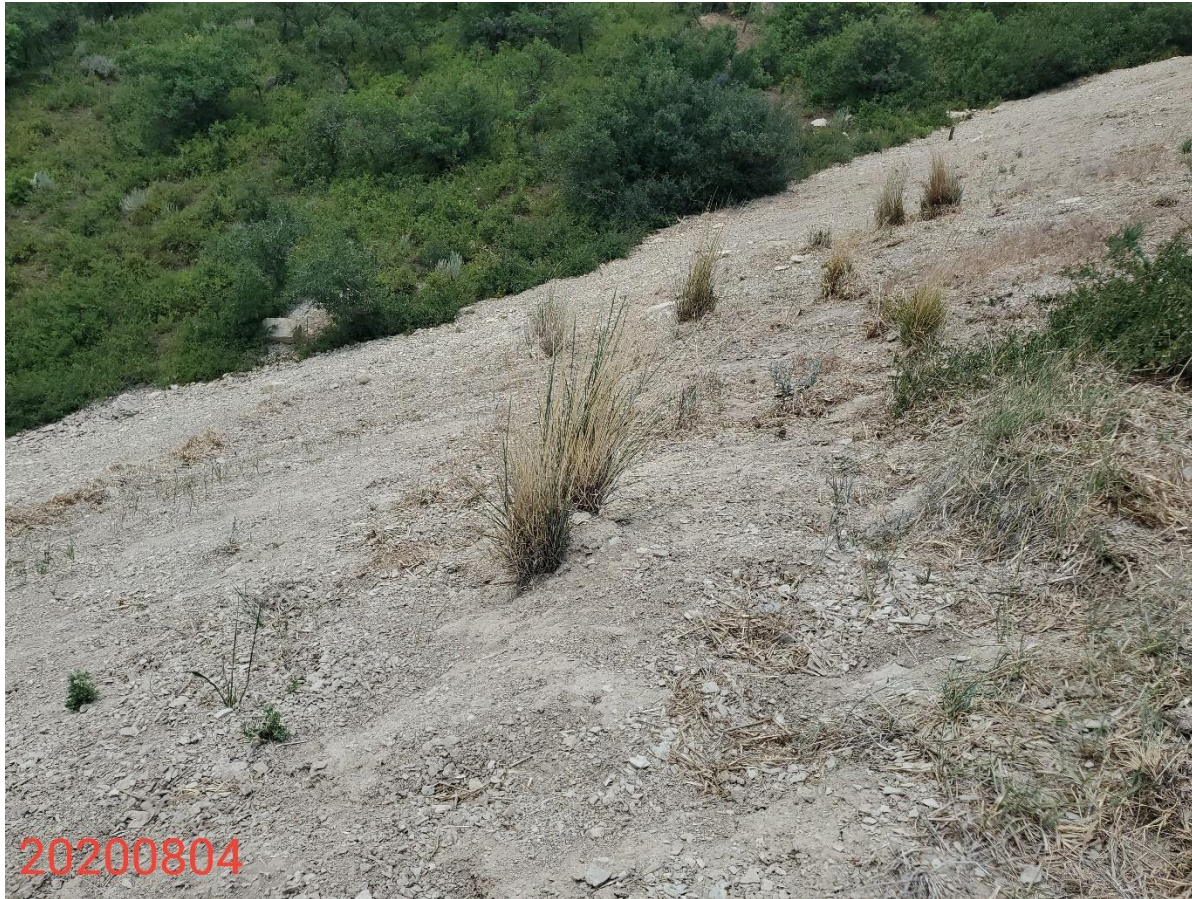
Photo 8: Photo of fill slopes on the southeast end of the Location. See comments under photo 6

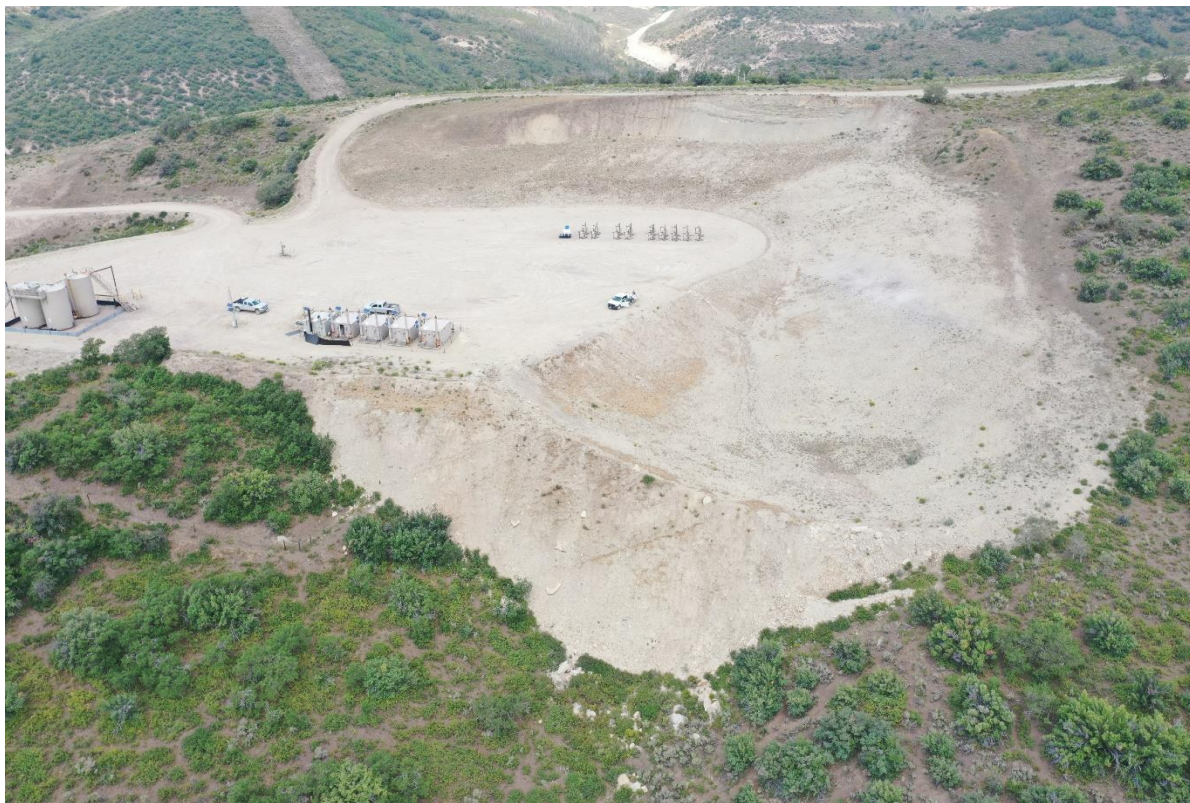
Photo 9: Aerial photo taken from the south of the Location, facing north. Photo shows areas of the Location, including fill slopes, that have not been recontoured/regraded or reclaimed to their original condition in accordance with 1003 rules. BMPs appear insufficient or missing to stabilize slopes and prevent sediment transport.

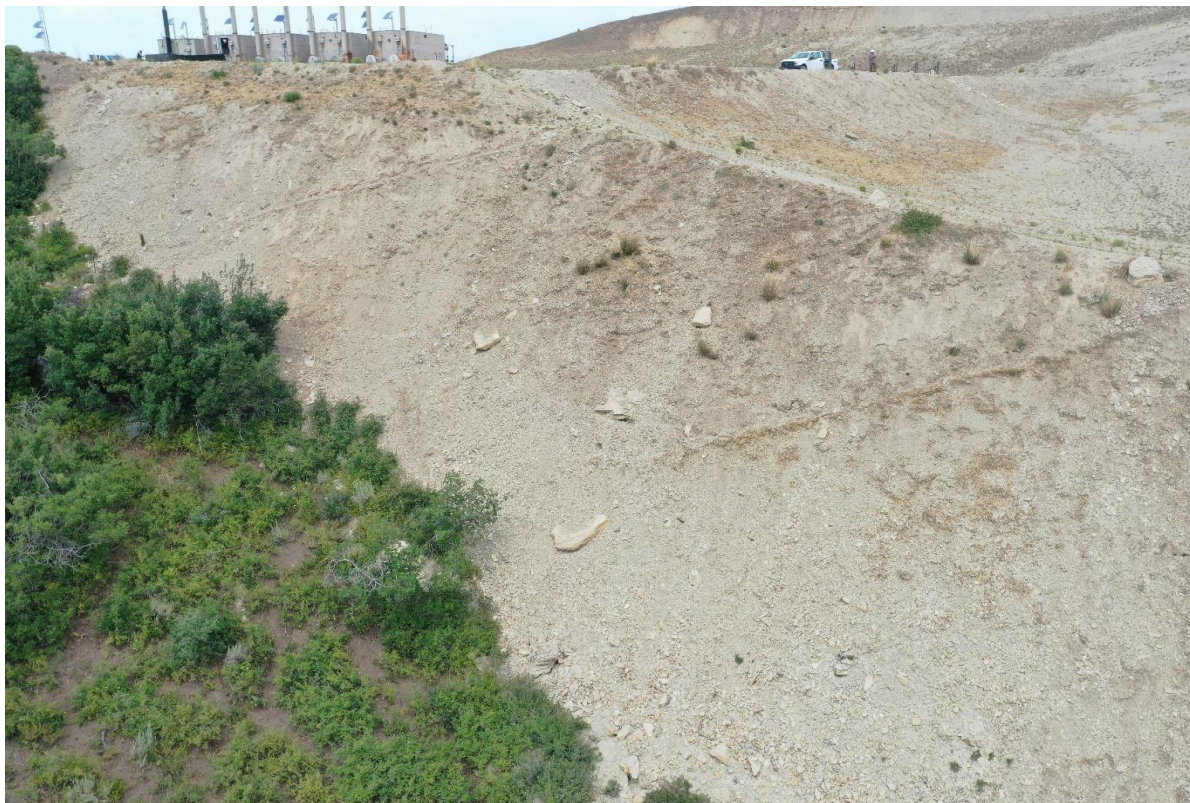
Photo 10: Photo taken from the south of the Location, facing northwest. Photo shows BMPs appear insufficient or missing to stabilize slopes and prevent sediment transport. Interim areas have not been contoured/regraded and reclaimed to their original condition.

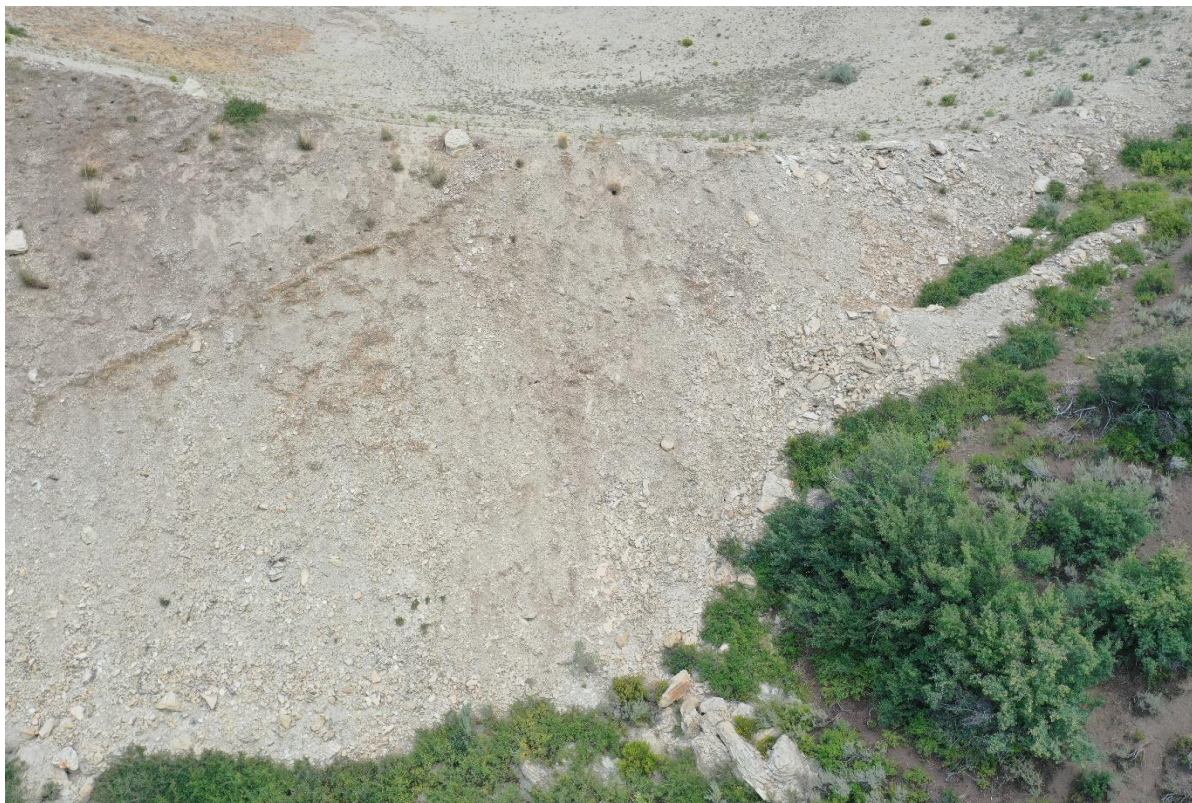
Photo 11: Photo taken from the south of the Location, facing northeast. See comments under photo 10.

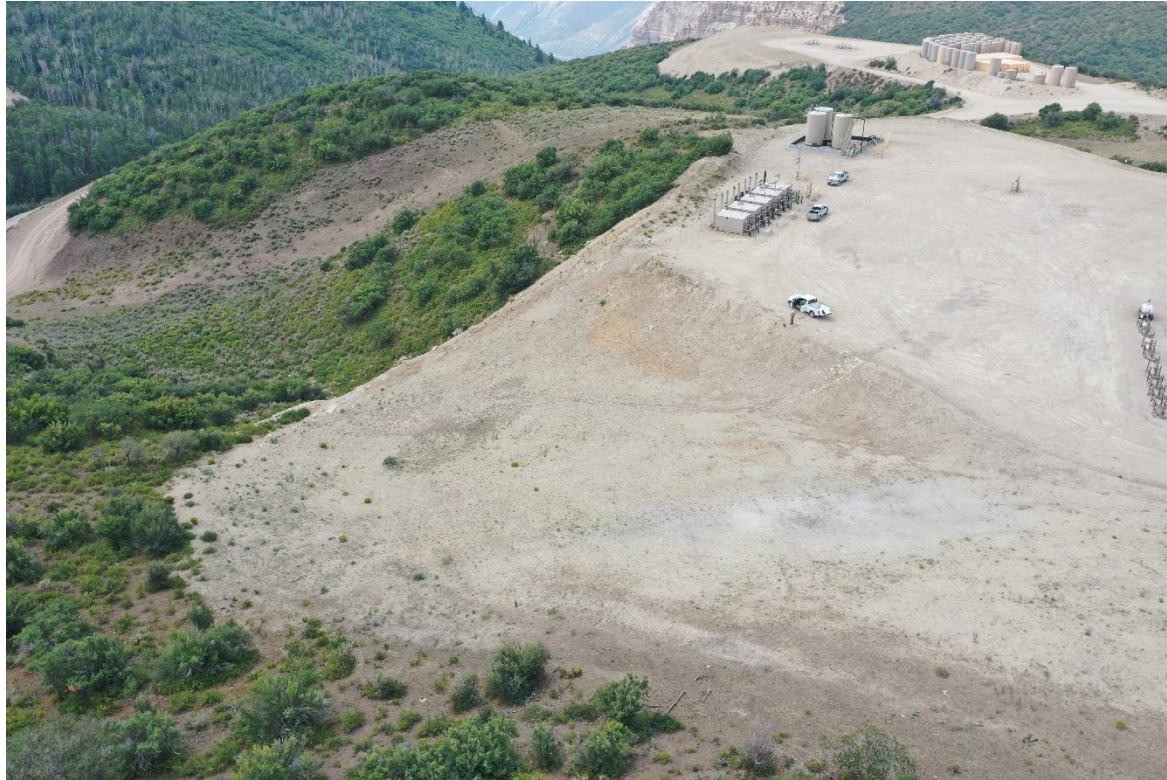
Photo 14: Aerial photo taken from the east of the Location, facing southwest. Photo shows Interim areas have not been contoured/regraded and reclaimed to their original condition.

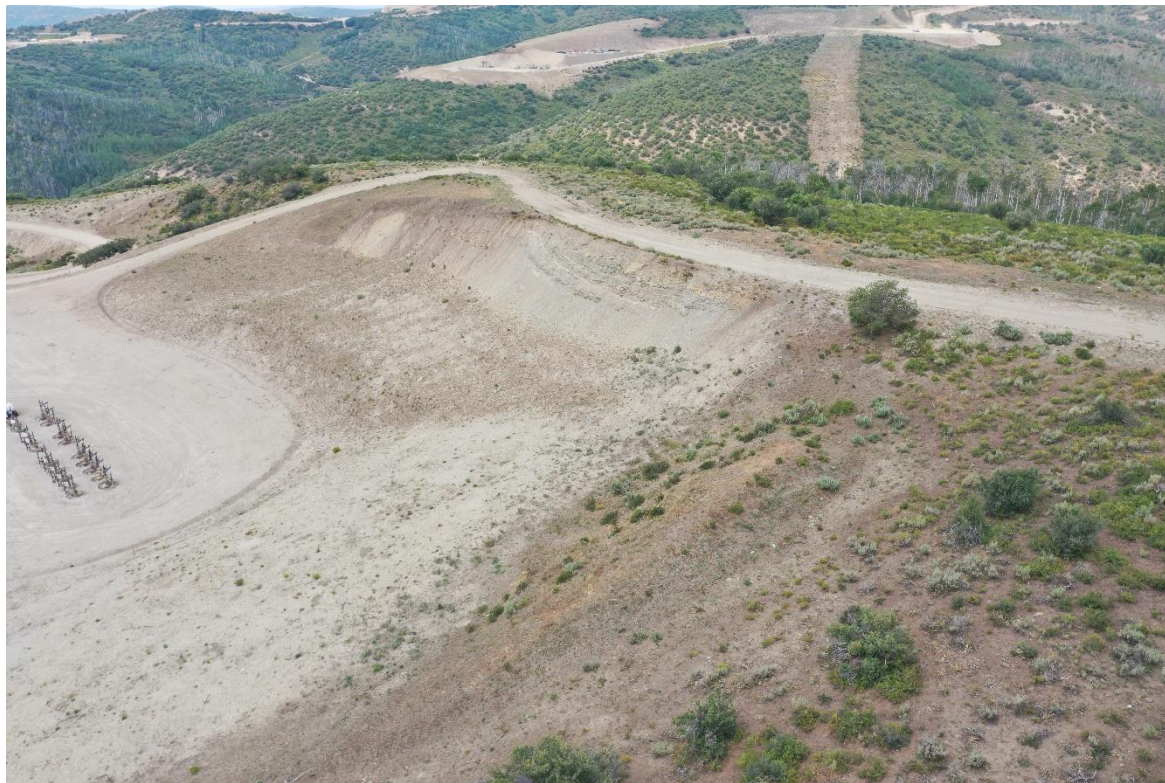
Photo 15: Aerial photo taken from the east of the Location, facing northwest. See comments under photo 14.

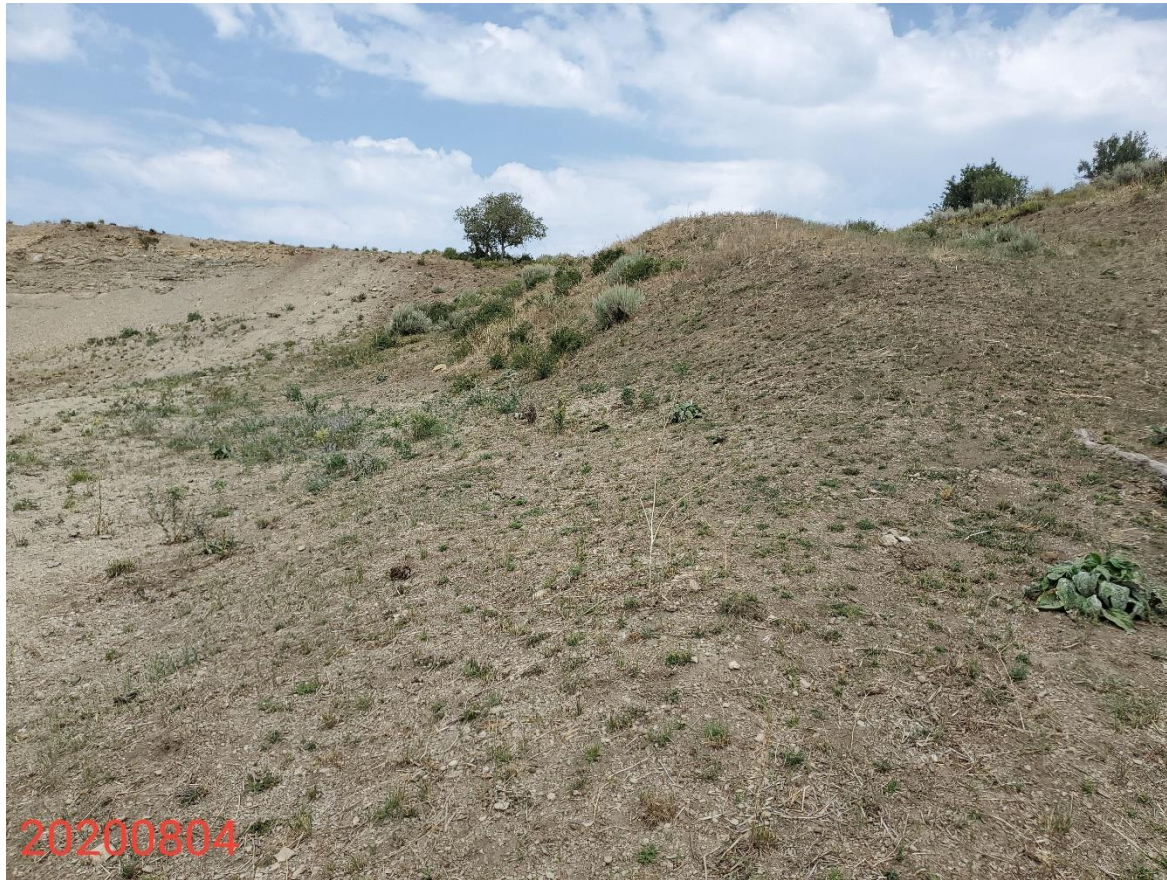
Photo 19: See comments under photo 16. Photo also shows what appears to be a topsoil stockpile

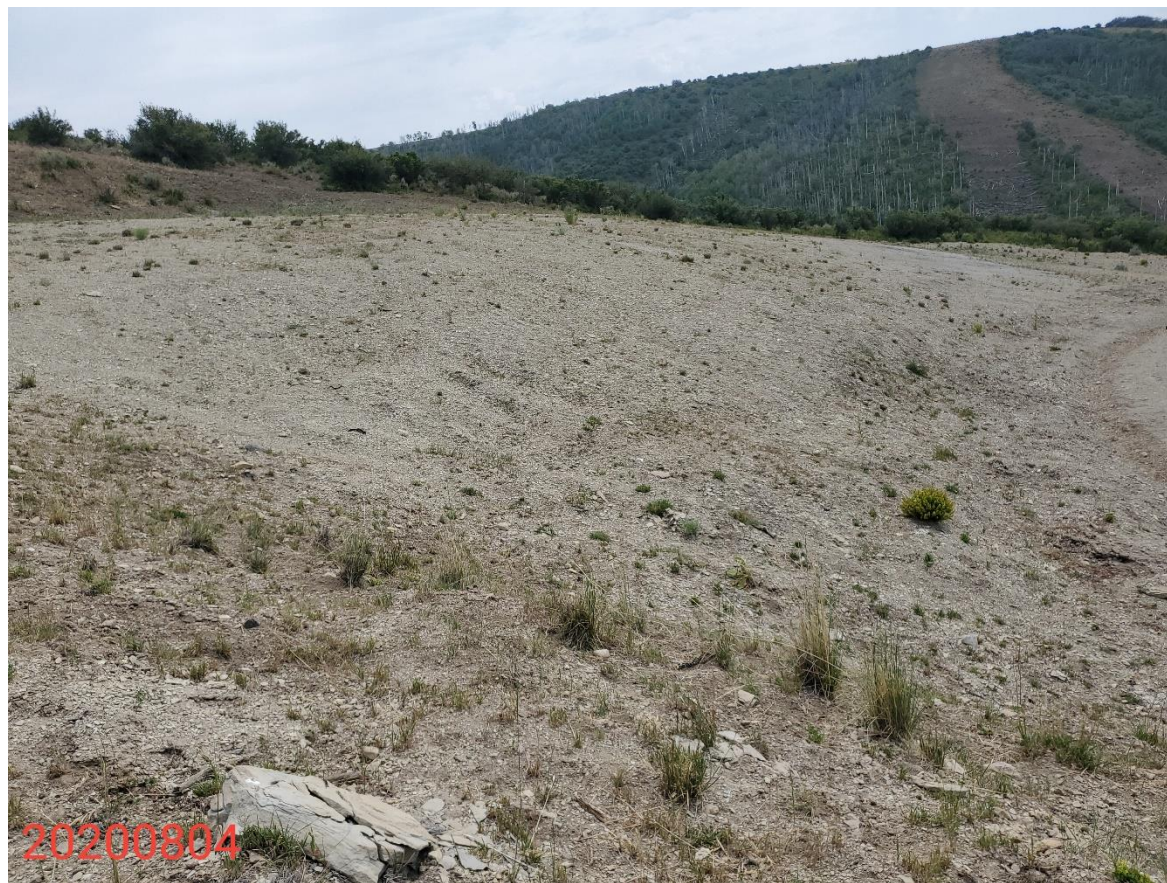
Photo 20: Photo taken from the northeast end of the Location, facing south. Photo shows interim areas. Soils at the surface appear to be subsoils; it does not appear that topsoil horizons were placed back to their relative original position.

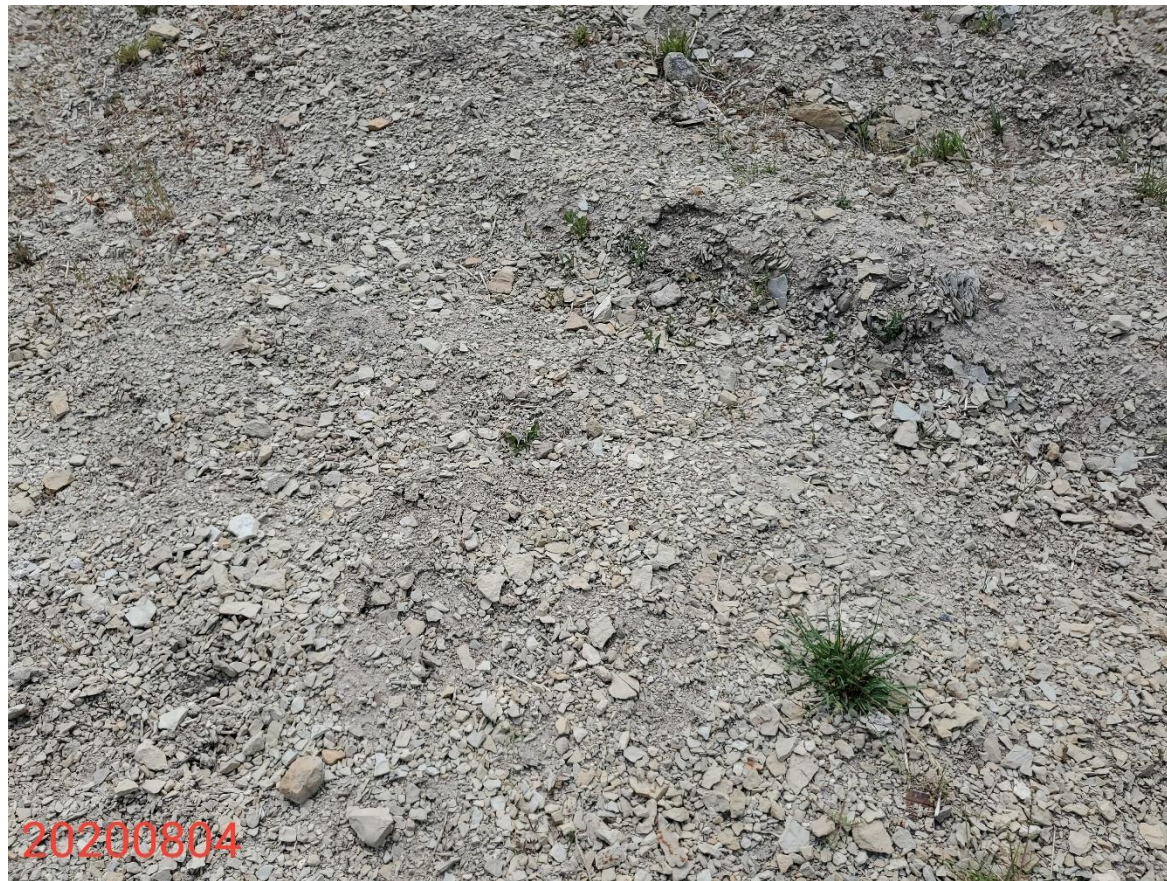
Photo 20.b: Continued from photo 20. Photo show soil surface of interim area. it does not appear that topsoil horizons were placed back to their relative original position.

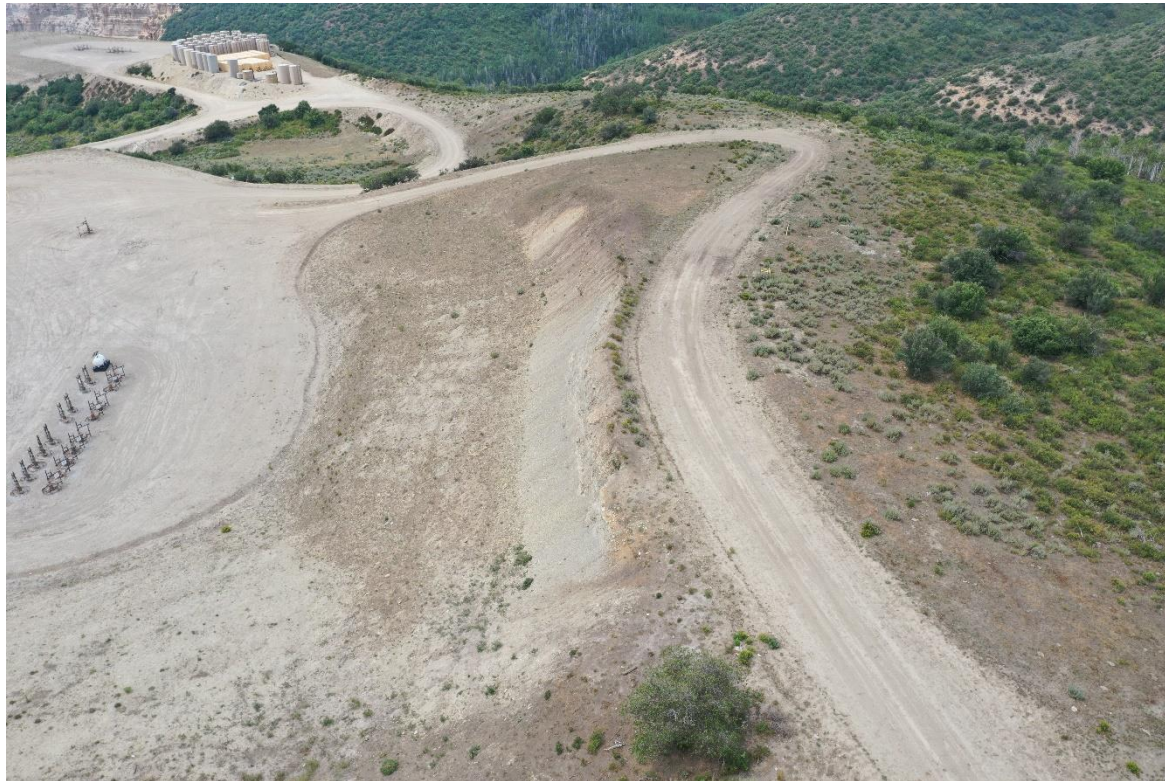
Photo 21: Aerial photo taken from the northeast of the Location, facing southwest. Photo shows cut slopes. Interim areas have not been contoured/regraded and reclaimed to their original condition.

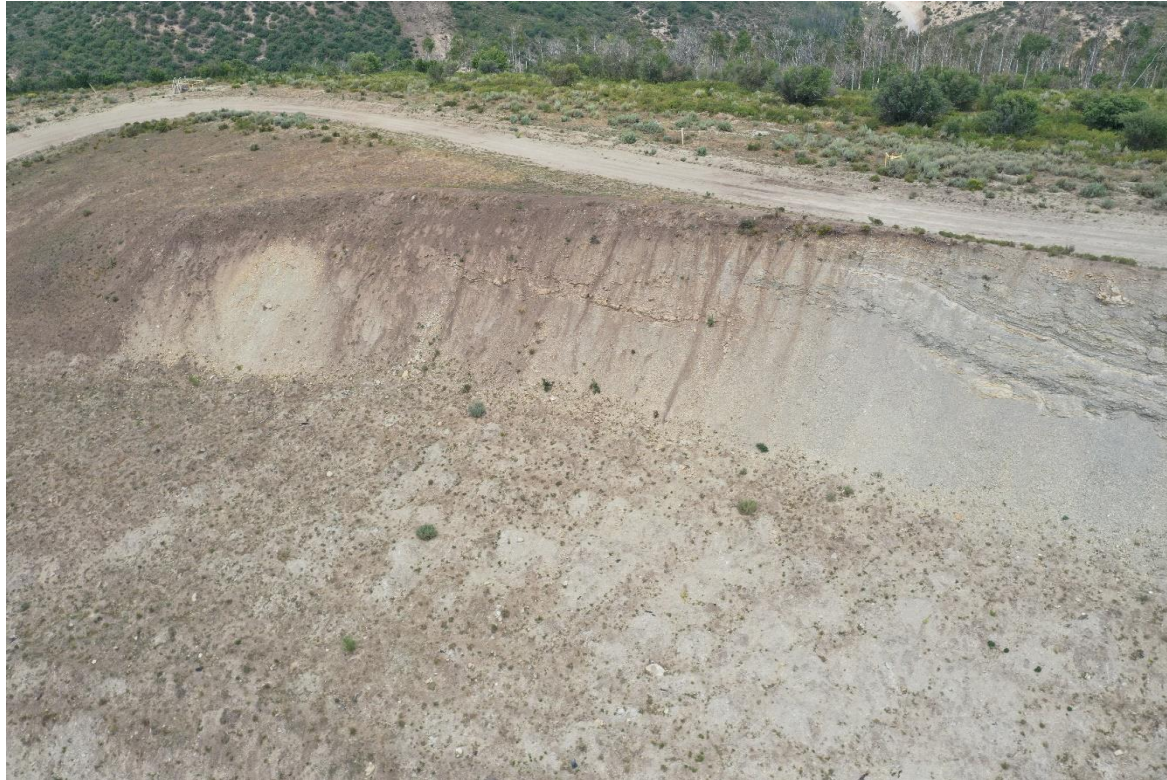
Photo 22: Aerial photo showing cut slopes on the north end of the Location, facing northwest. BMPs appear missing or insufficient to stabilize slopes. Interim areas have not been contoured/regraded and reclaimed to their original condition.

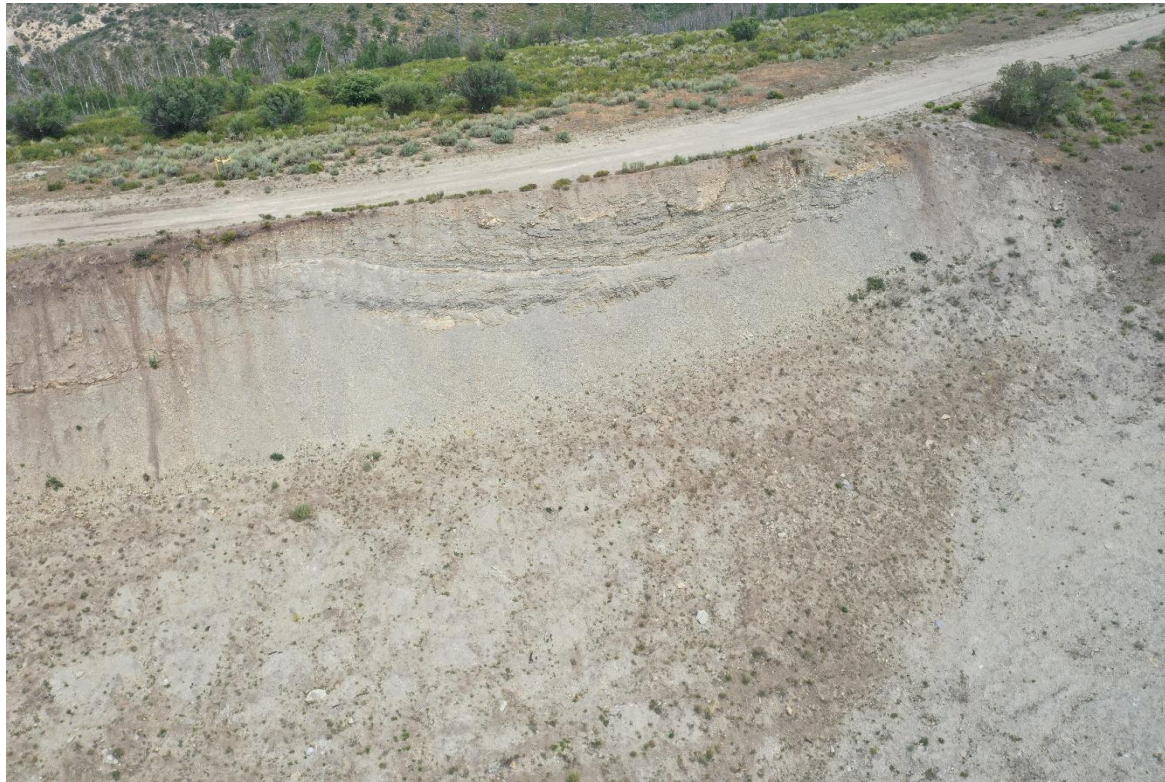
Photo 23: Aerial photo showing cut slopes on the north end of the Location, facing north. BMPs appear missing or insufficient to stabilize slopes. Interim areas have not been contoured/regraded and reclaimed to their original condition.

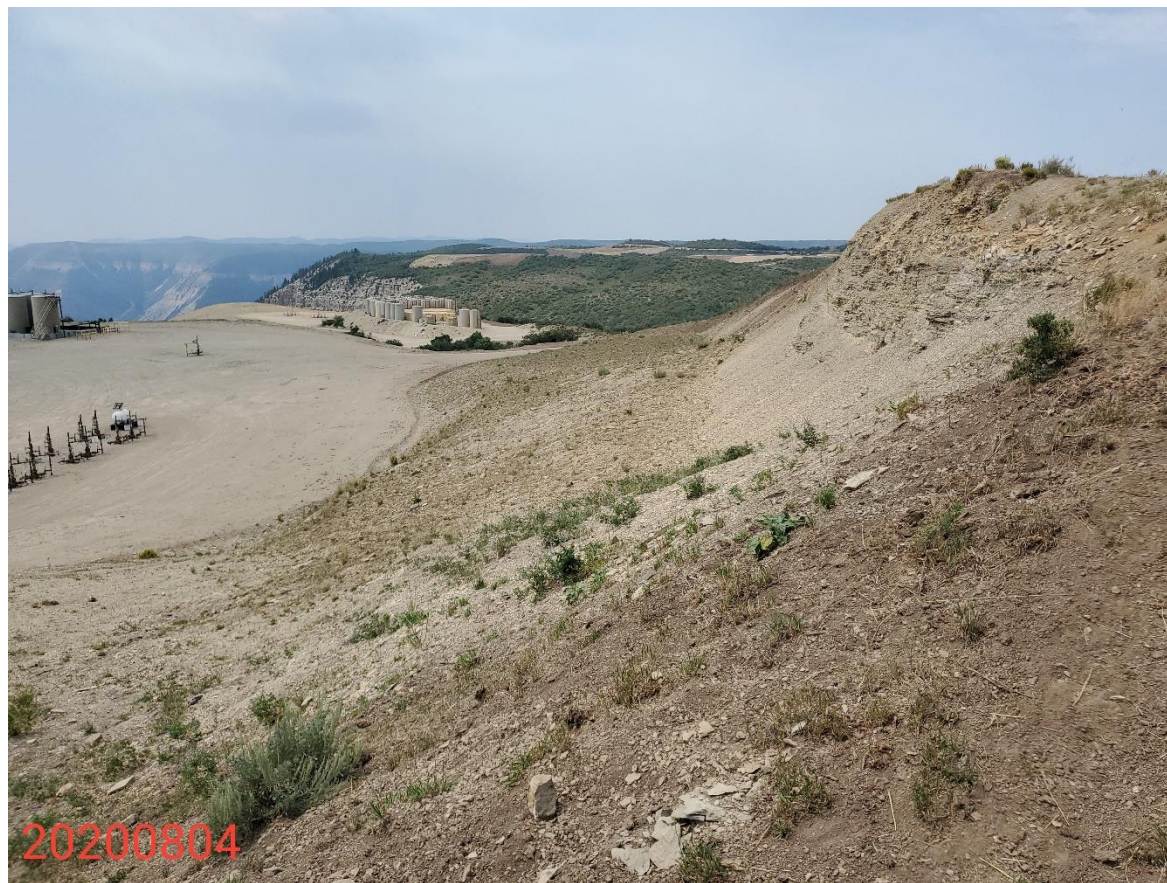
Photo 24: Photo taken from the northeast end of the Location, facing south. Photo shows cut slopes and interim areas. Interim areas have not been contoured/regraded and reclaimed to their original condition.

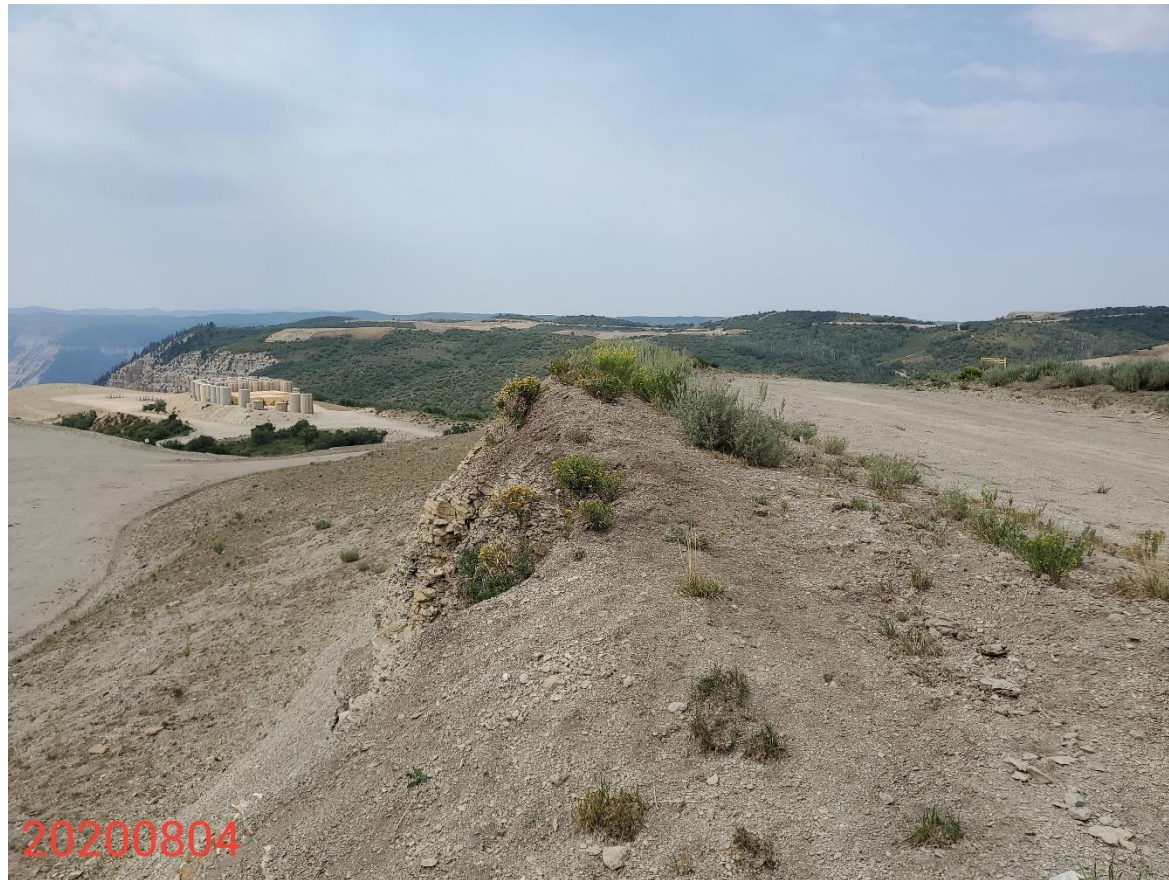
Photo 25: Photo taken from the northeast end of the Location, facing south. Photo shows cut slopes and interim areas. Interim areas do not appear to have been sufficiently recontoured/regraded and reclaimed to their original

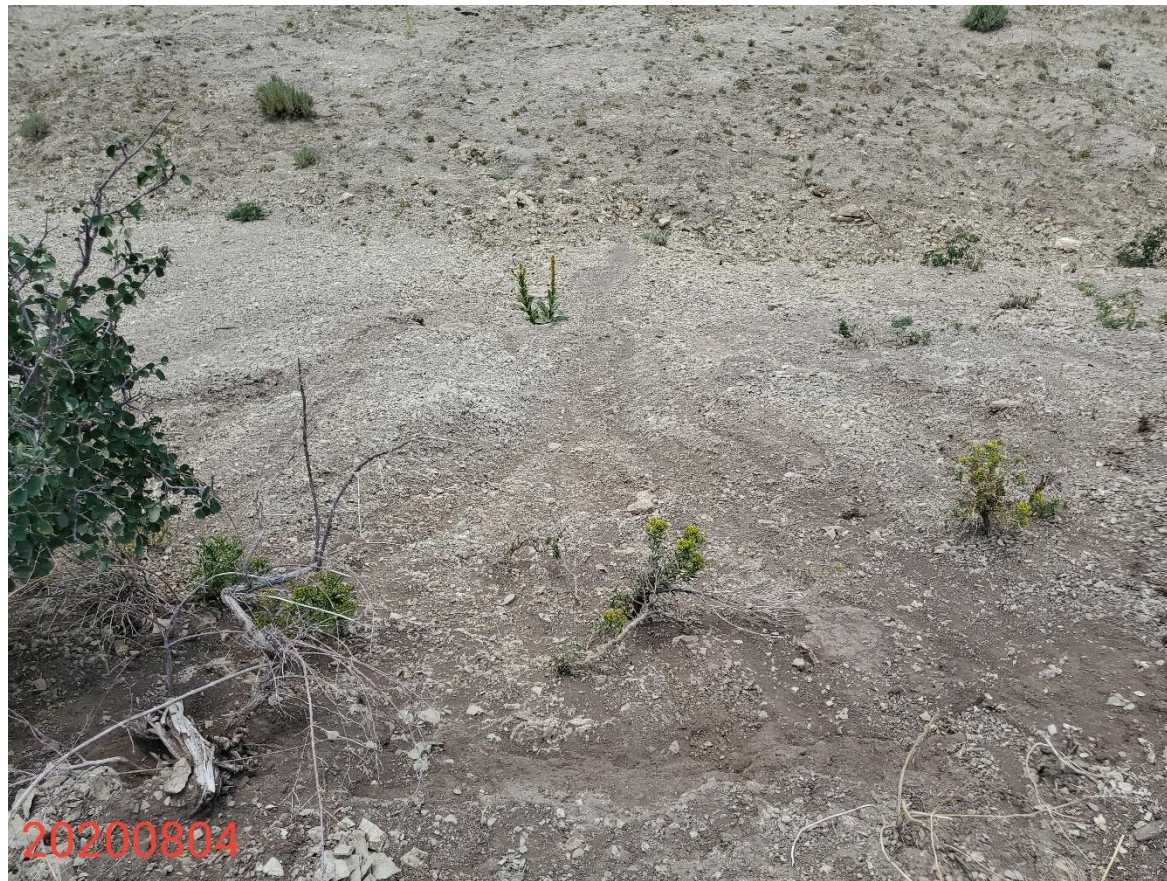
Photo 26: Photo taken from the cut slopes on the north end of the Location, facing south. BMPs appear missing or insufficient to stabilize slopes.

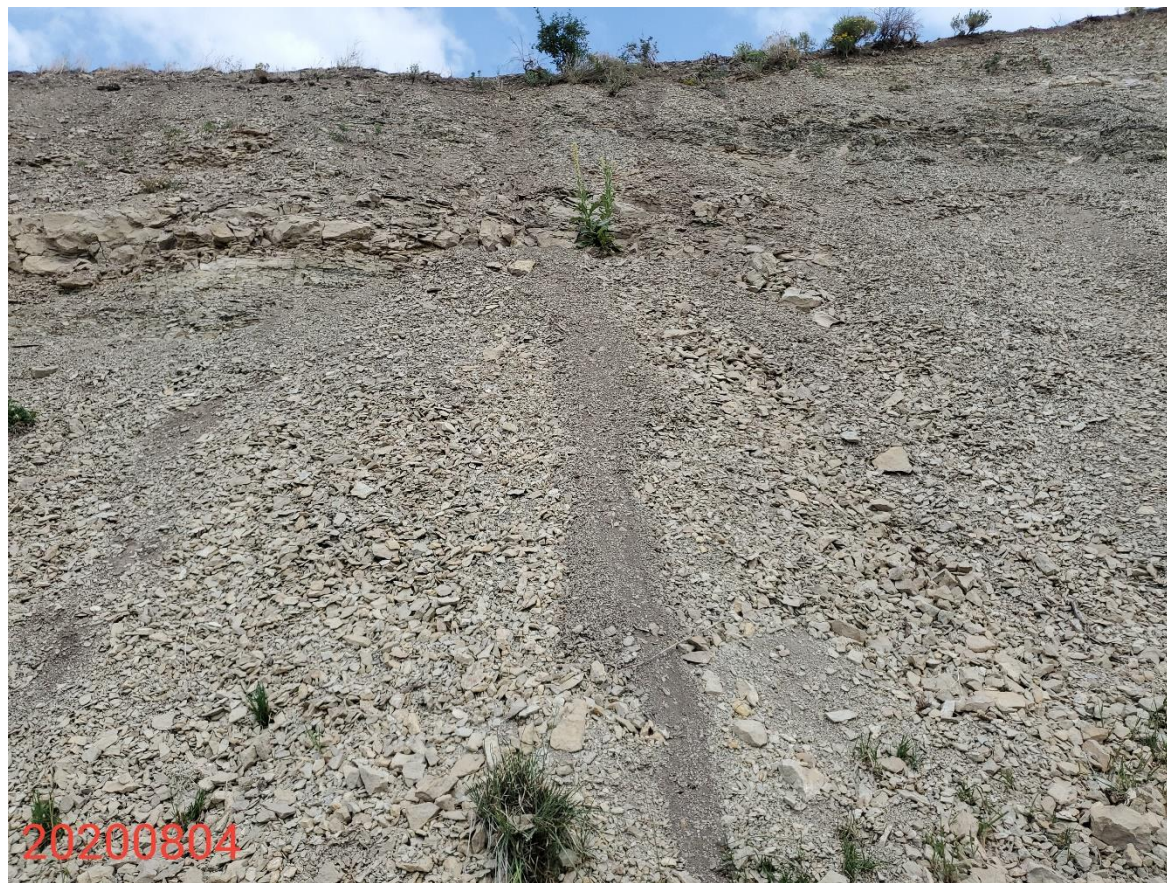
Photo 28: Photo taken from the northern interim areas, facing north. BMPs appear missing or insufficient to stabilize slopes.

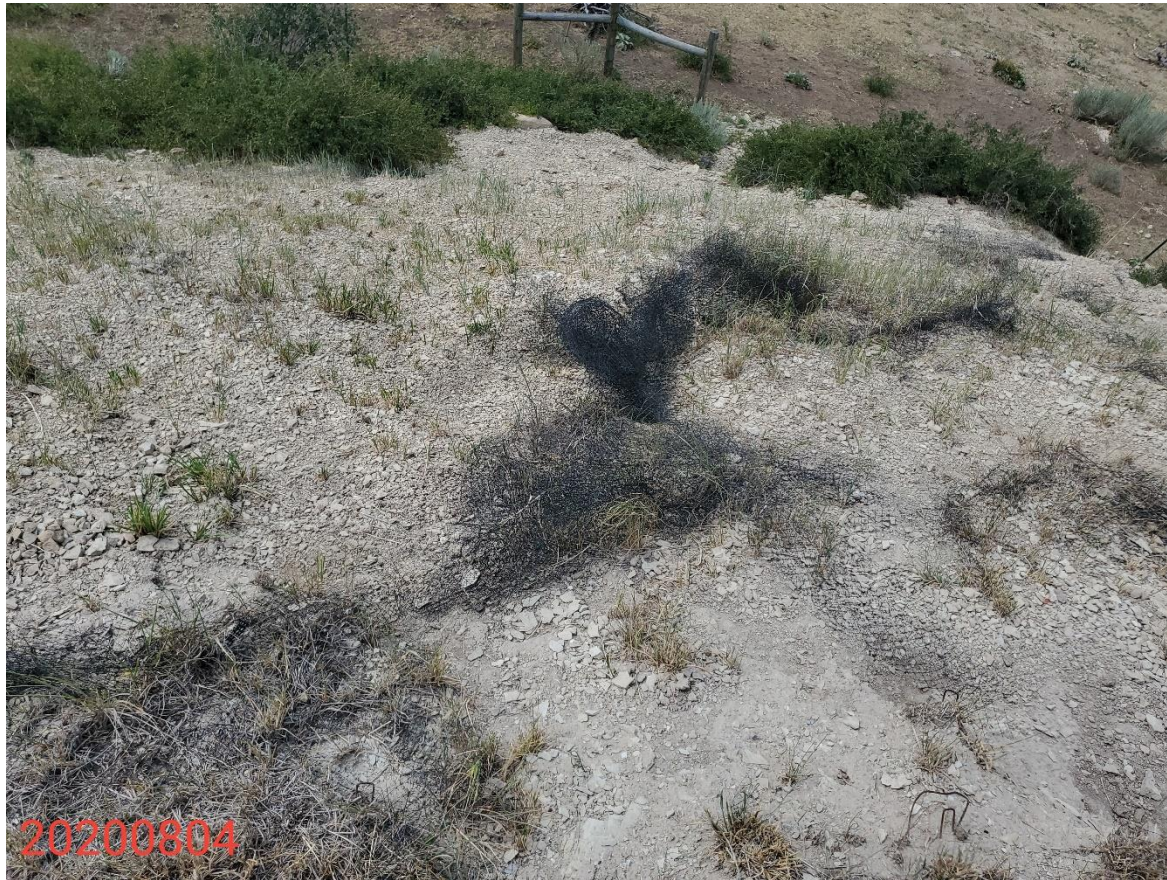
Photo 33: Photo of the slopes on the southwest end of the Location, facing south.
Photo shows erosion net BMPs in disrepair.

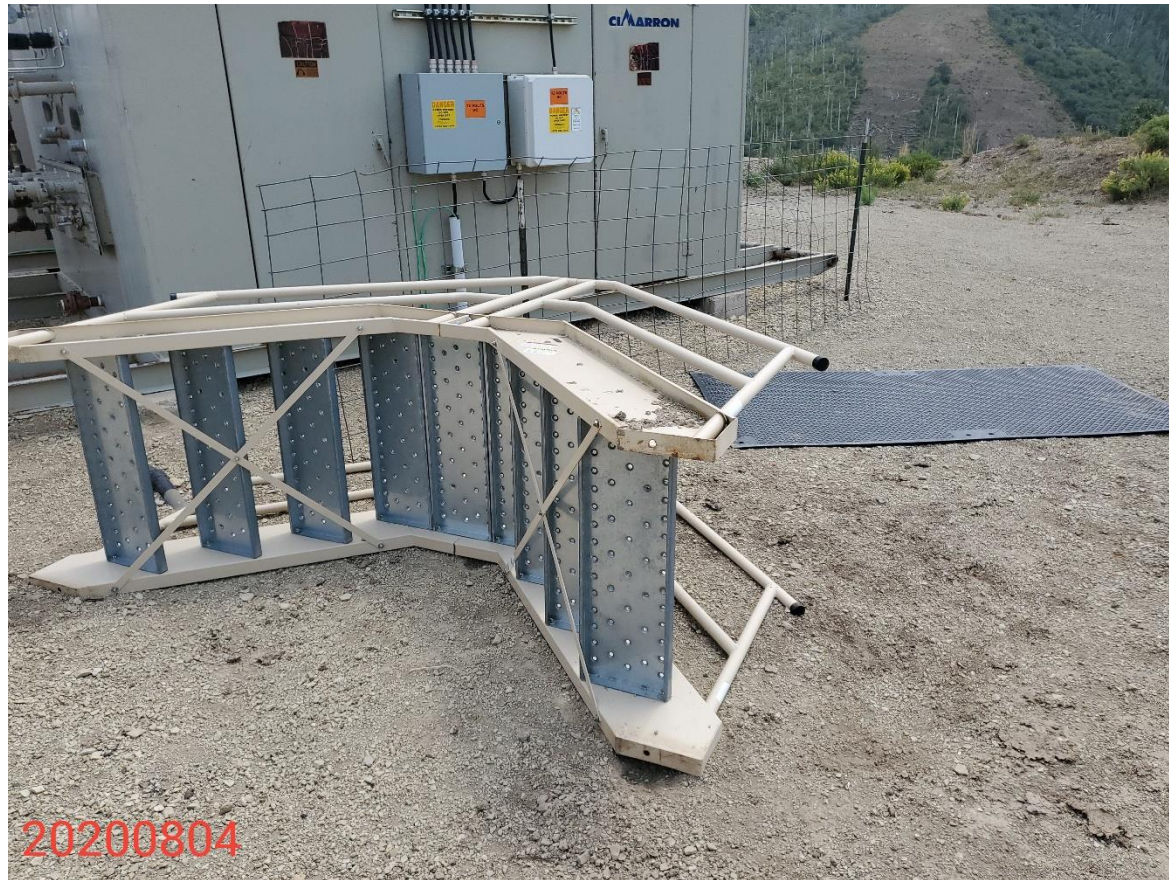
Photo 34: Photo taken from the south end of the Location. Photo shows unused equipment on the Location.
