Inspection Photos

8/04/2020

Operator: LARAMIE ENERGY LLC - 10433

Location ID: 335921

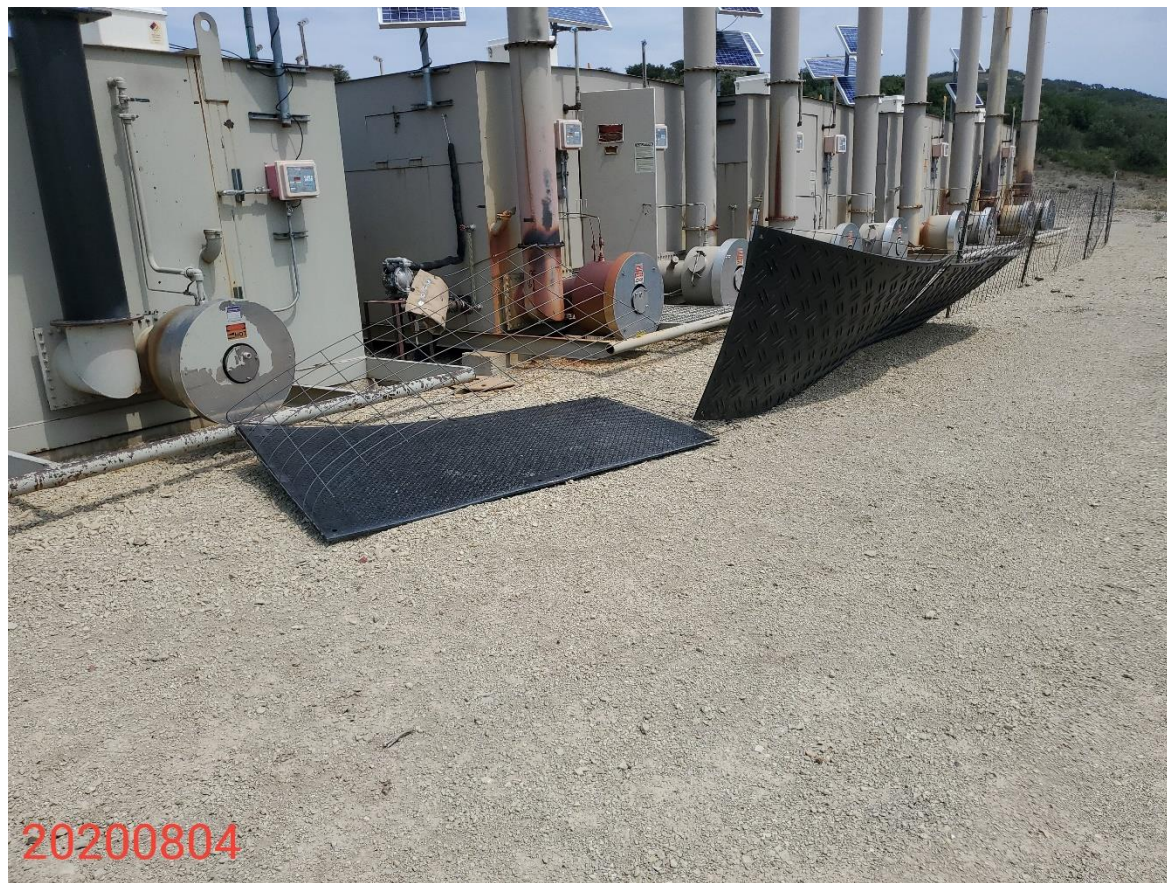
Photo 35: Photo taken from the south end of the Location. Photo shows unused equipment on the Location. Photo shows fence panels in disrepair.
