# Inspection Photos

8/04/2020

Operator: CAERUS PICEANCE LLC - 10456

Location ID: 335512

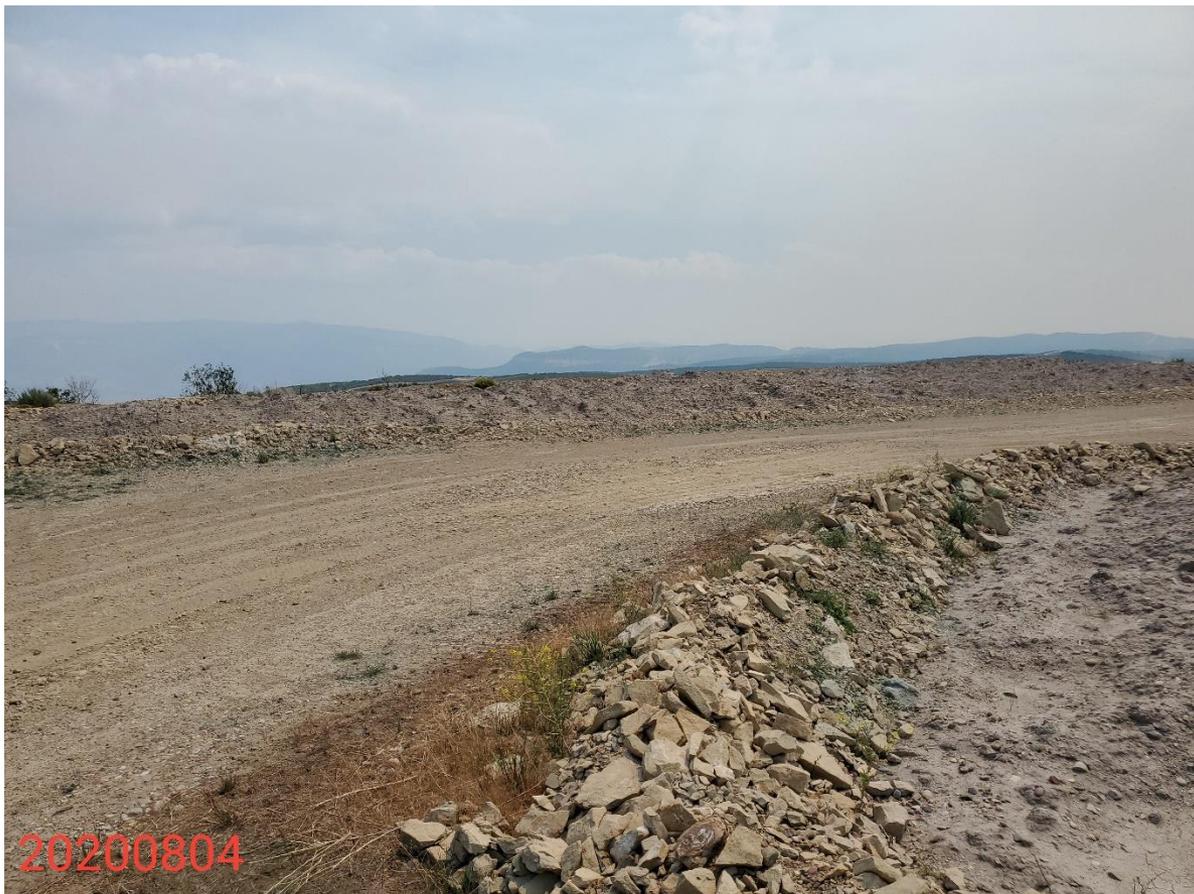
**Photo 1:** Photo taken from the north end of the Location, facing east. Photos 1-3 provide an overview of the Location from east, south to west. Photos also show drill cutting on the Location. Remediation project #11051 associated with cuttings management on the location was closed 10/2018; Interim reclamation of the Location has not been conducted.

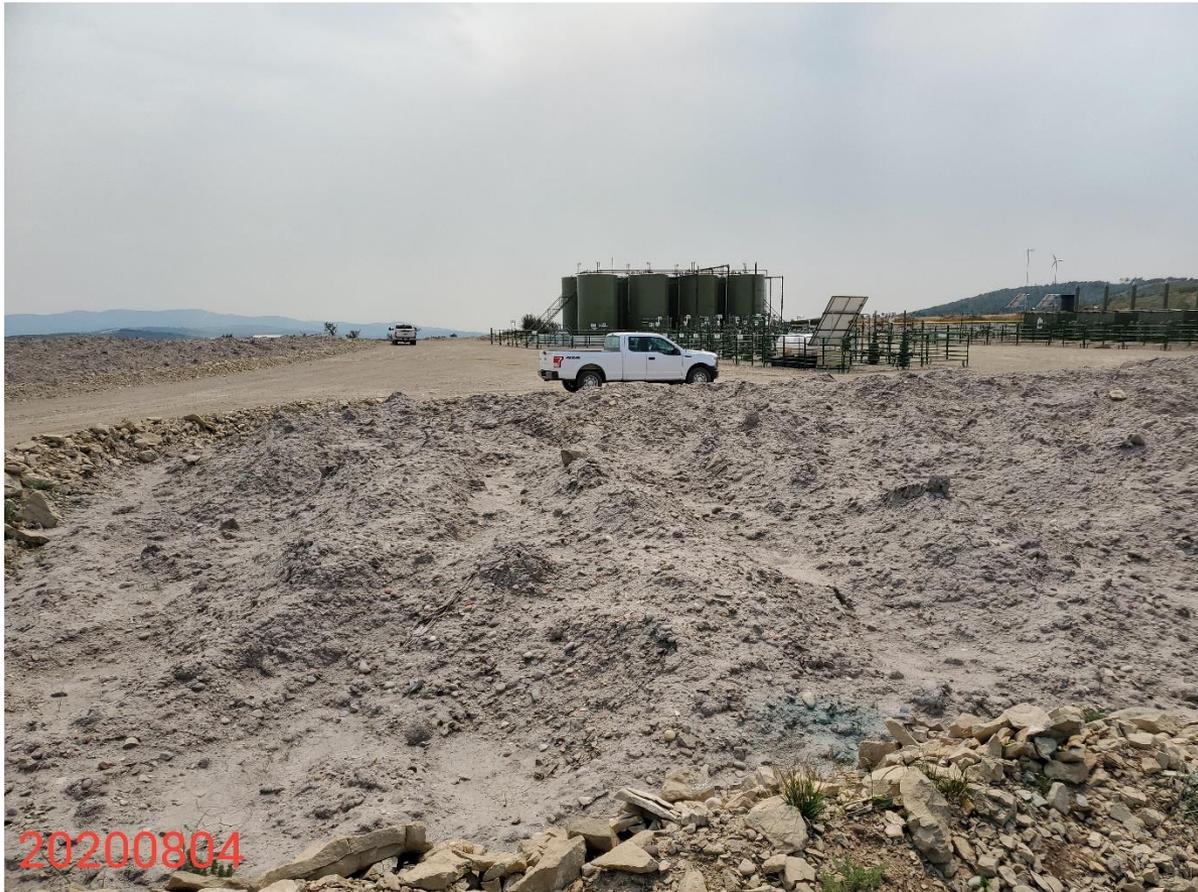
**Photo 2:** See comments under photo 1.

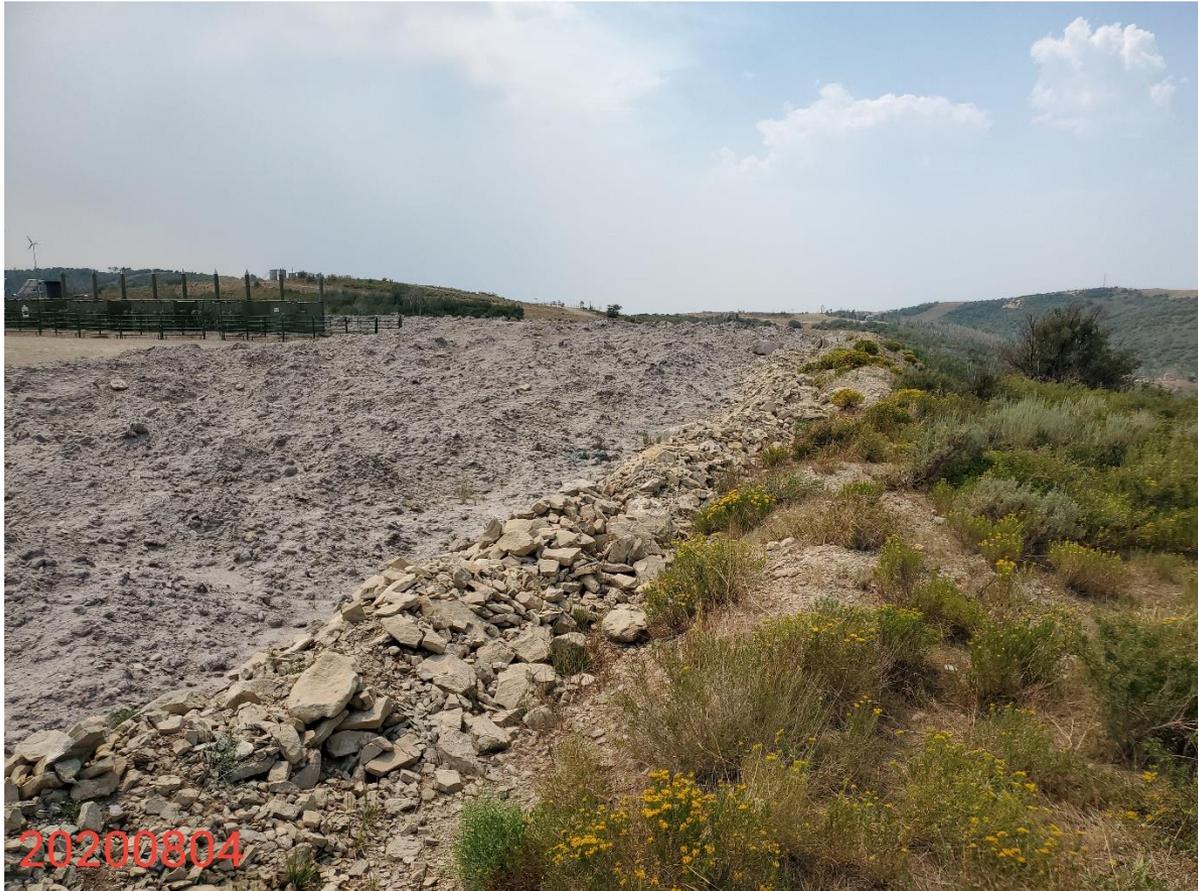
**Photo 3:** See comments under photo 1.

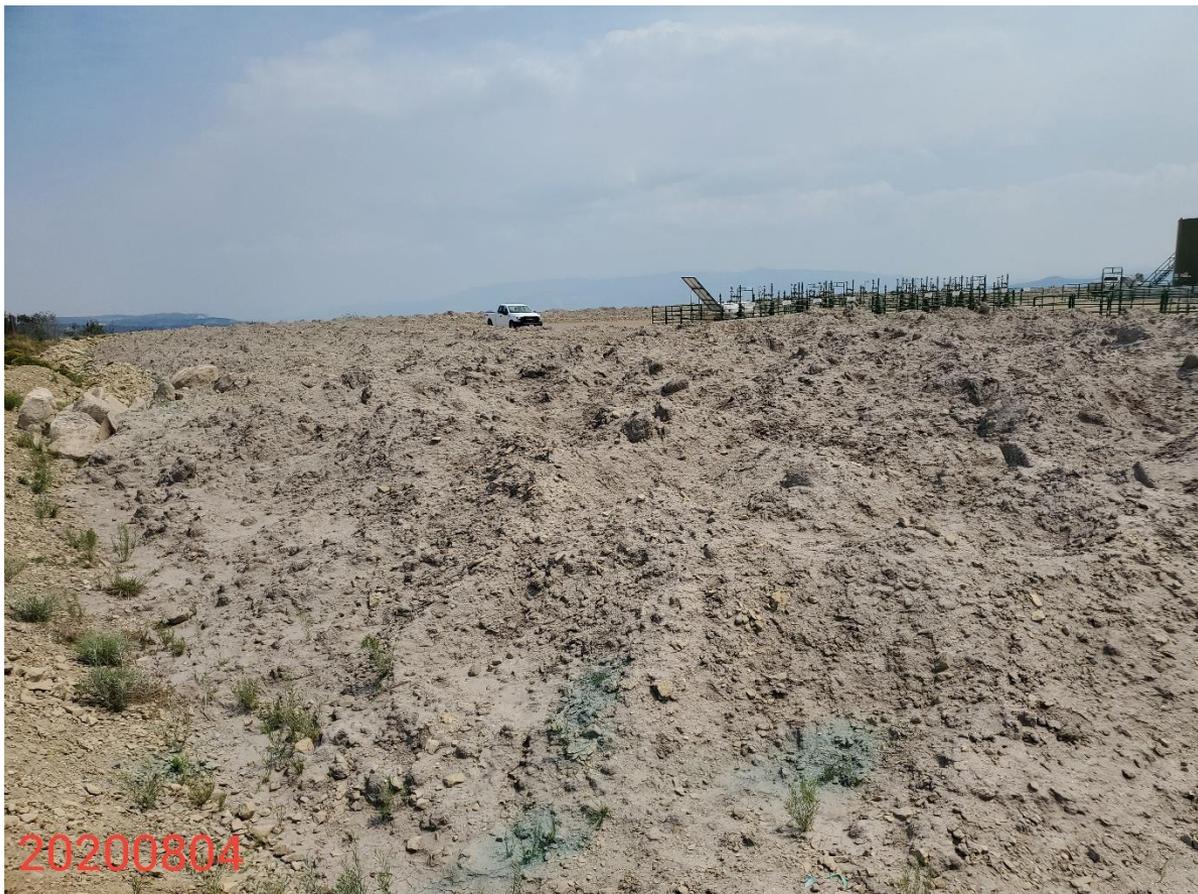
**Photo 4:** Photo taken from the northwest end of the Location, facing east. Photos 4-5 provide an overview of the Location from east to south. Photos also show drill cutting on the Location. Remediation project #11051 associated with cuttings management on the location was closed 10/2018; Interim reclamation of the Location has not been conducted.

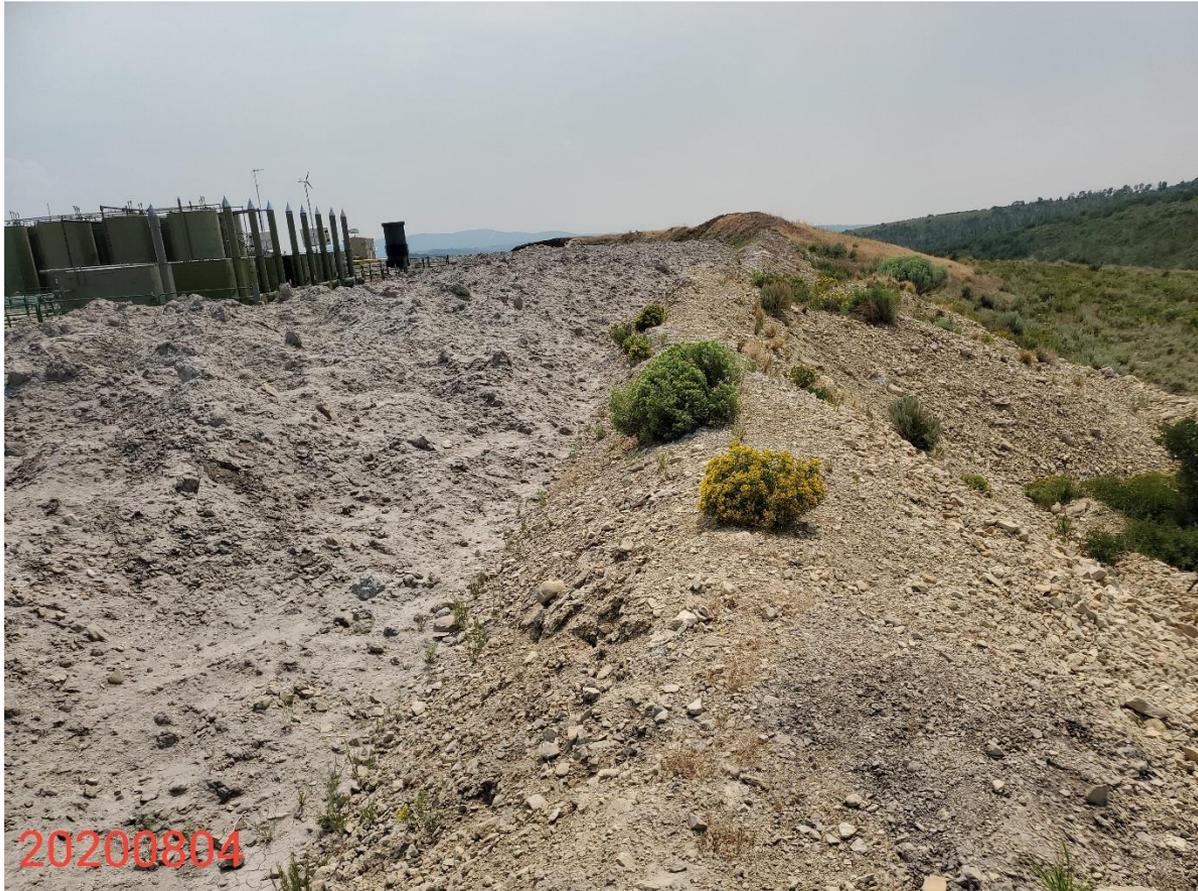
**Photo 5:** See comments under photo 4.

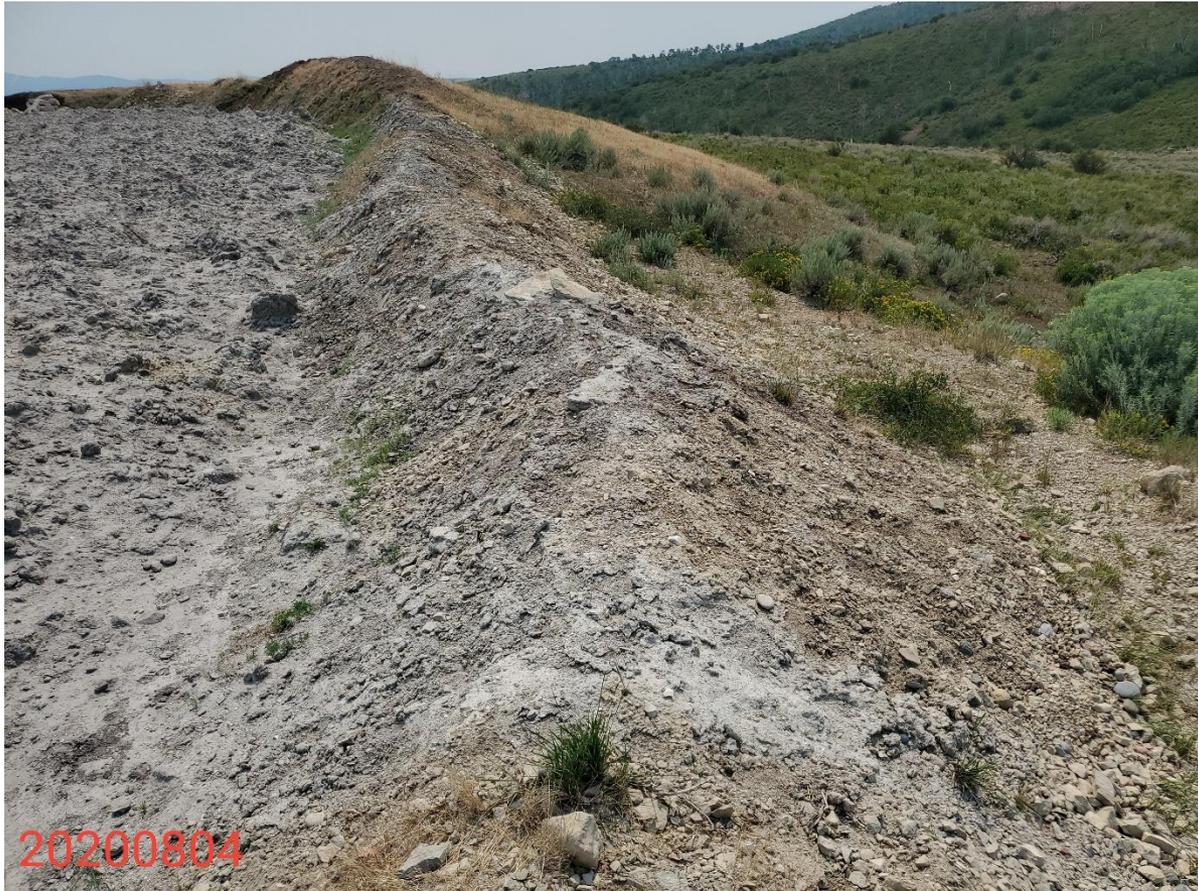
**Photo 6:** Photo taken from the west end of the Location, facing south. Photo shows areas where cuttings appear to have been pushed upon, and over the berm during management.

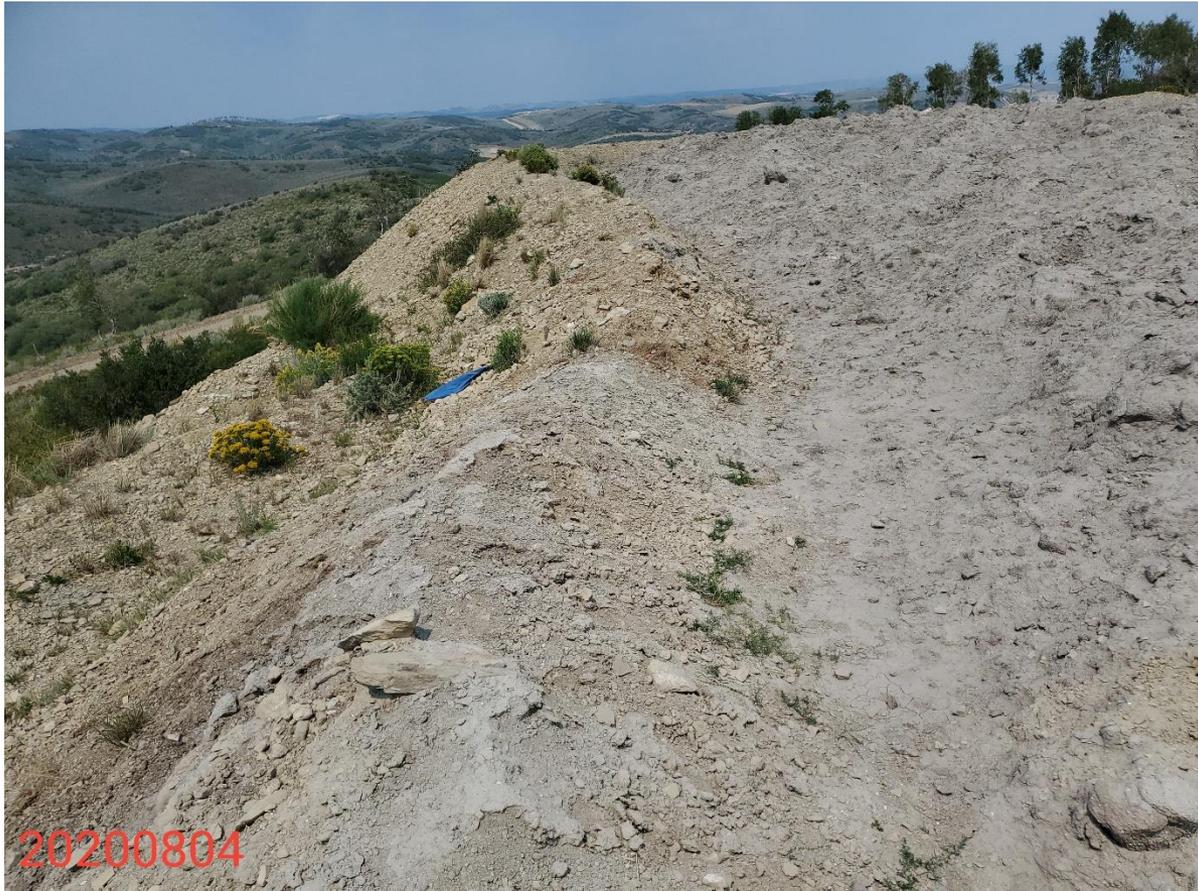
**Photo 7:** Photo taken from the west end of the Location, facing north. Photo shows areas where cuttings appear to have been pushed upon, and over the berm during management.

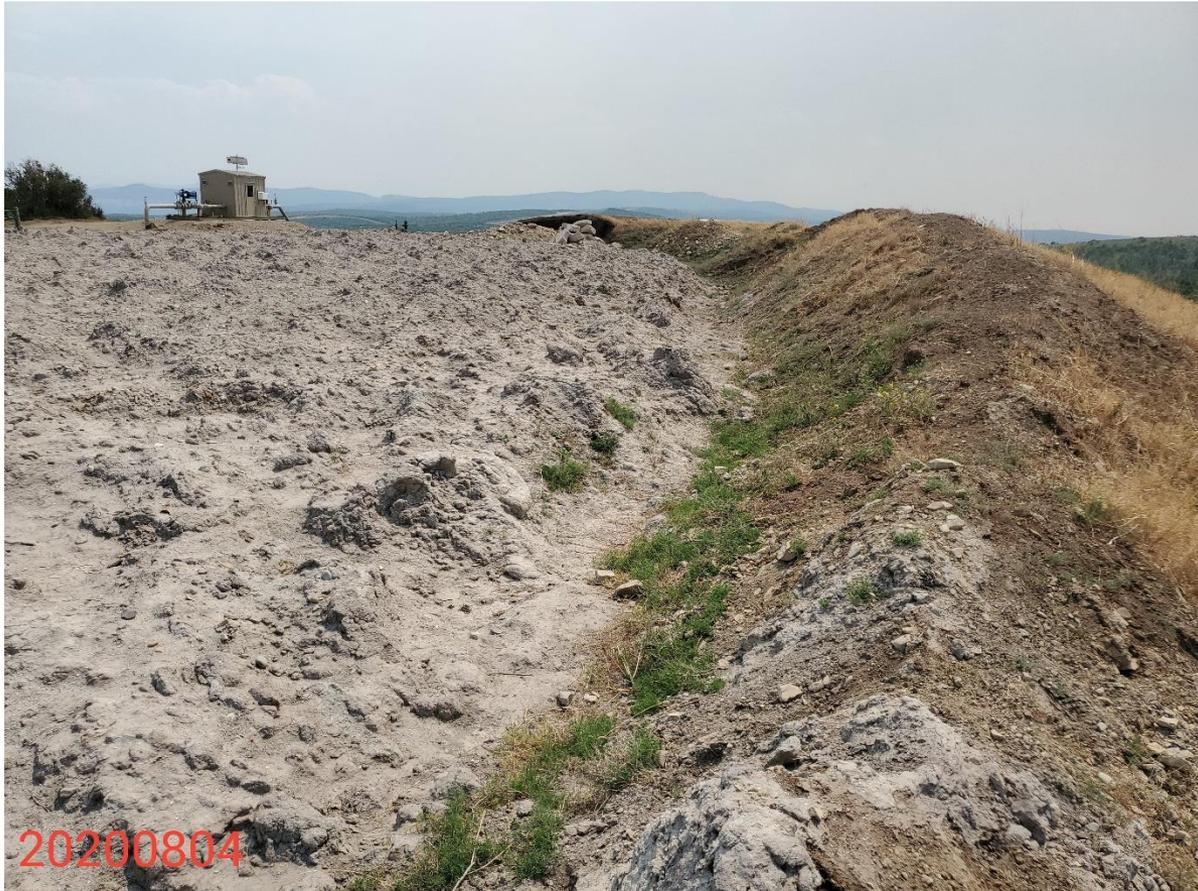
**Photo 8:** Photo taken from the west end of the Location, facing south. Photo shows topsoil stockpile and drill cuttings. There does not appear to be BMPs in place to segregate cuttings from the topsoil.

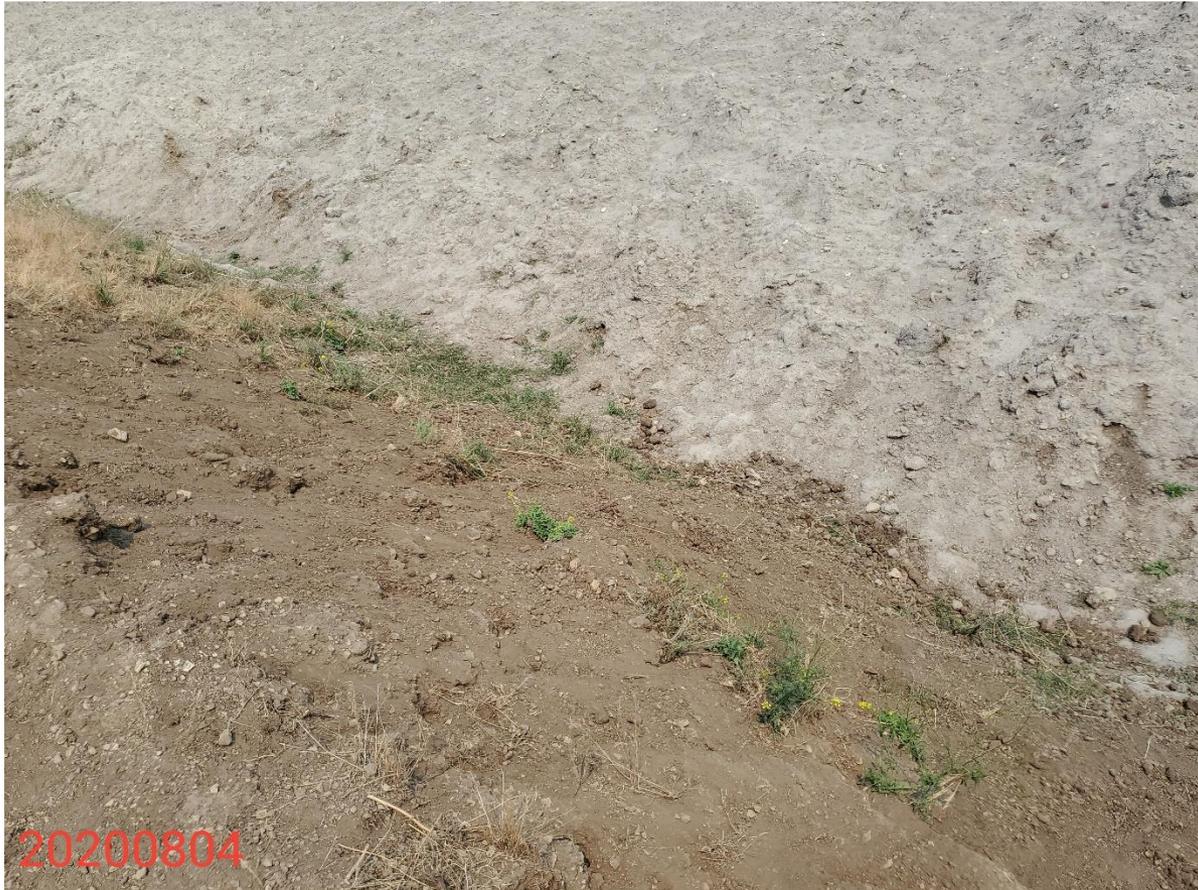
**Photo 9:** Continued from photo 8. Photo shows topsoil stockpile and drill cuttings. There does not appear to be BMPs in place to segregate cuttings from the topsoil.

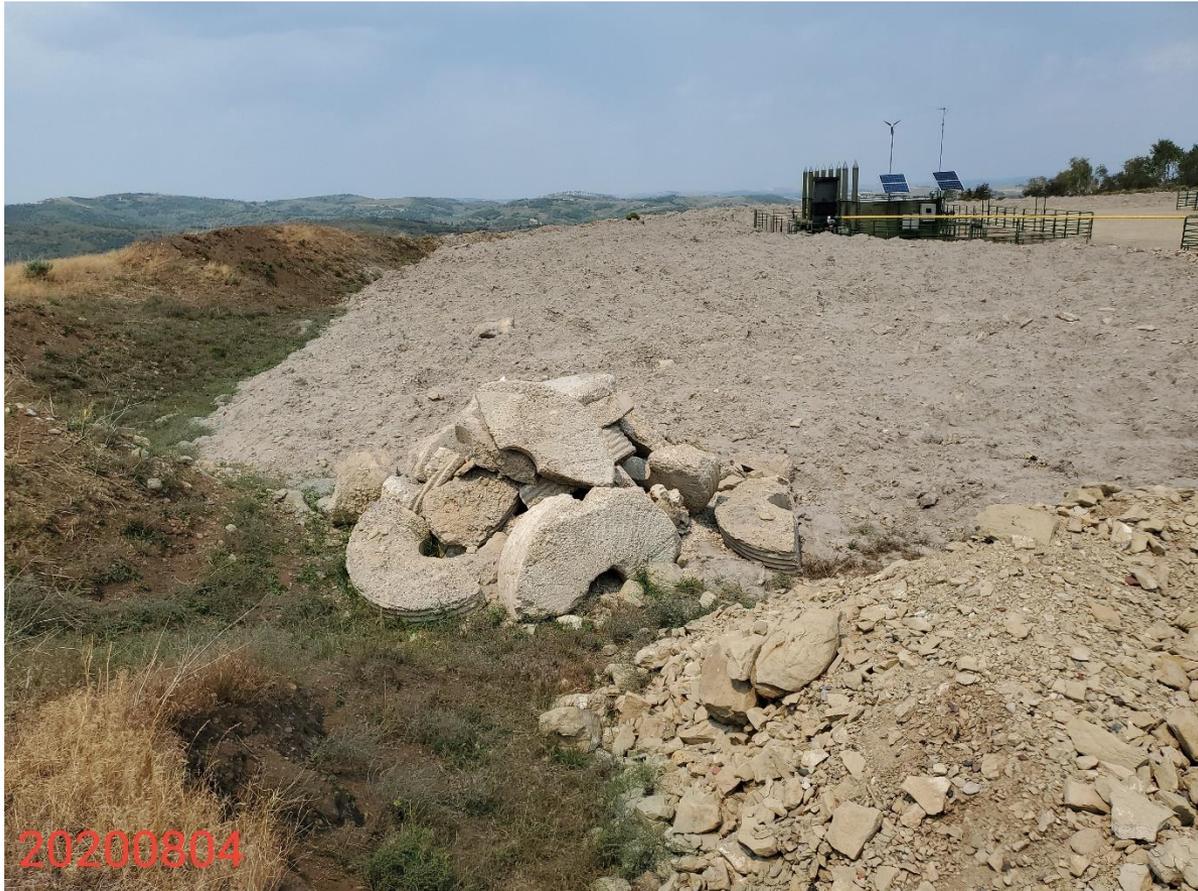
**Photo 10:** Photo taken from the southwest end of the Location, facing north. Photo shows concrete debris. Photo also shows topsoil stockpile and drill cuttings.

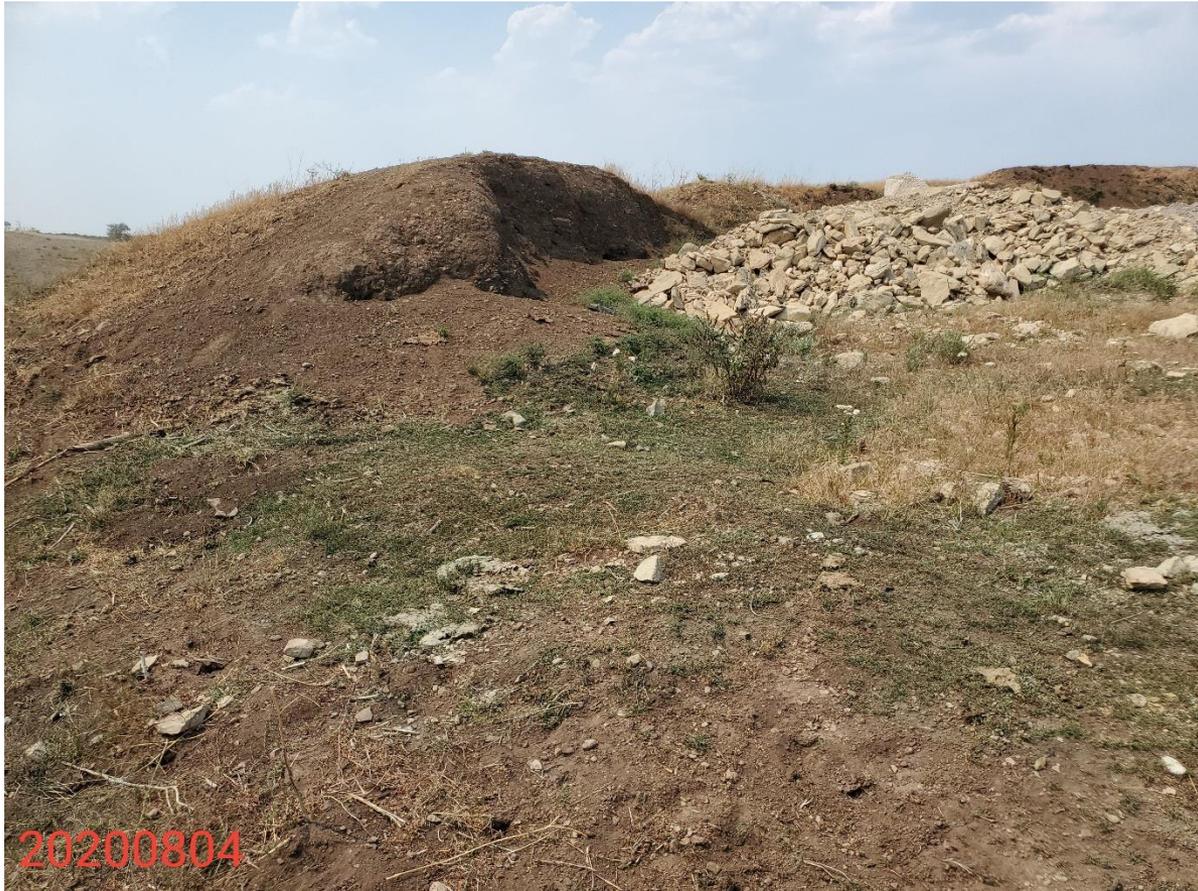
**Photo 11:** Photo taken from the south end of the Location, facing west. Photo shows topsoil stockpile

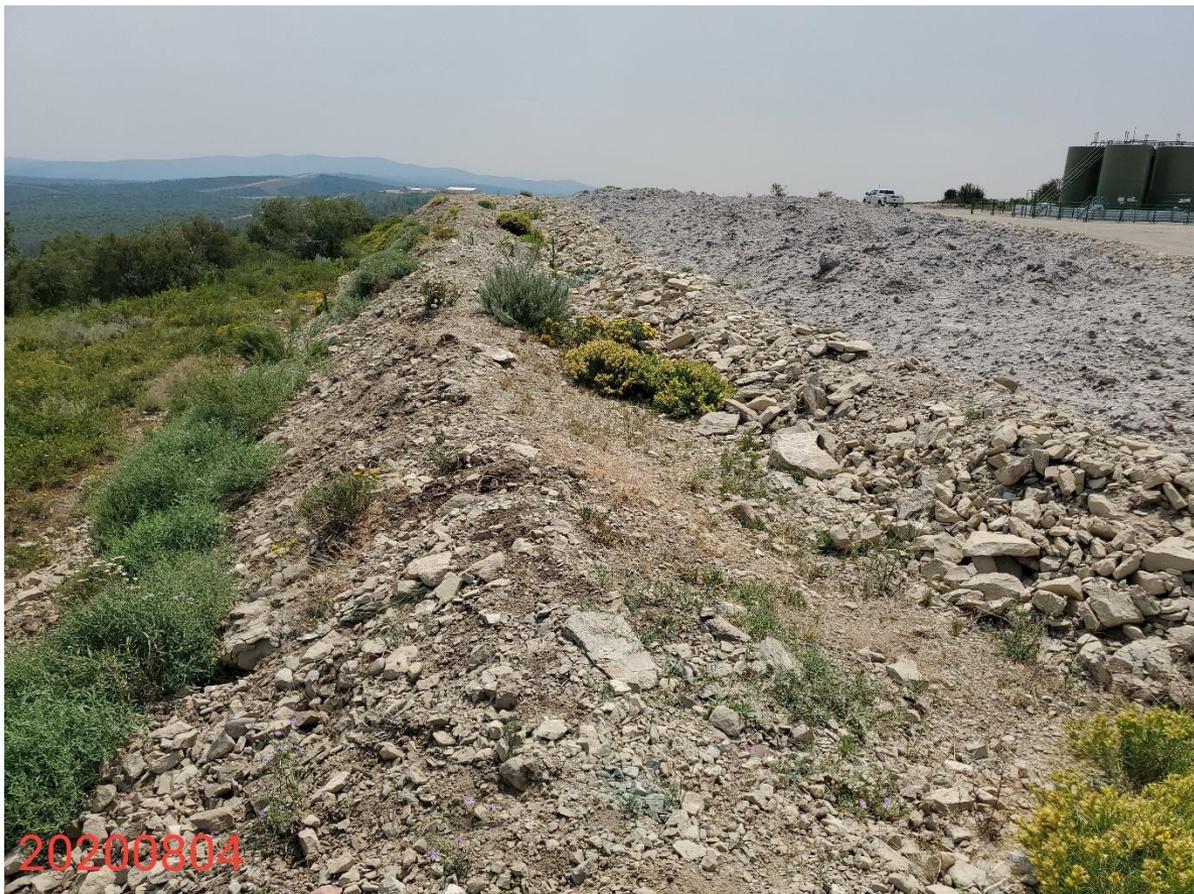
**Photo 12:** Photo taken from the east end of the Location, facing north. Photo shows drill cutting on the east end of the Location. Remediation project #11051 associated with cuttings management on the location was closed 10/2018; Interim reclamation of the Location has not been conducted.

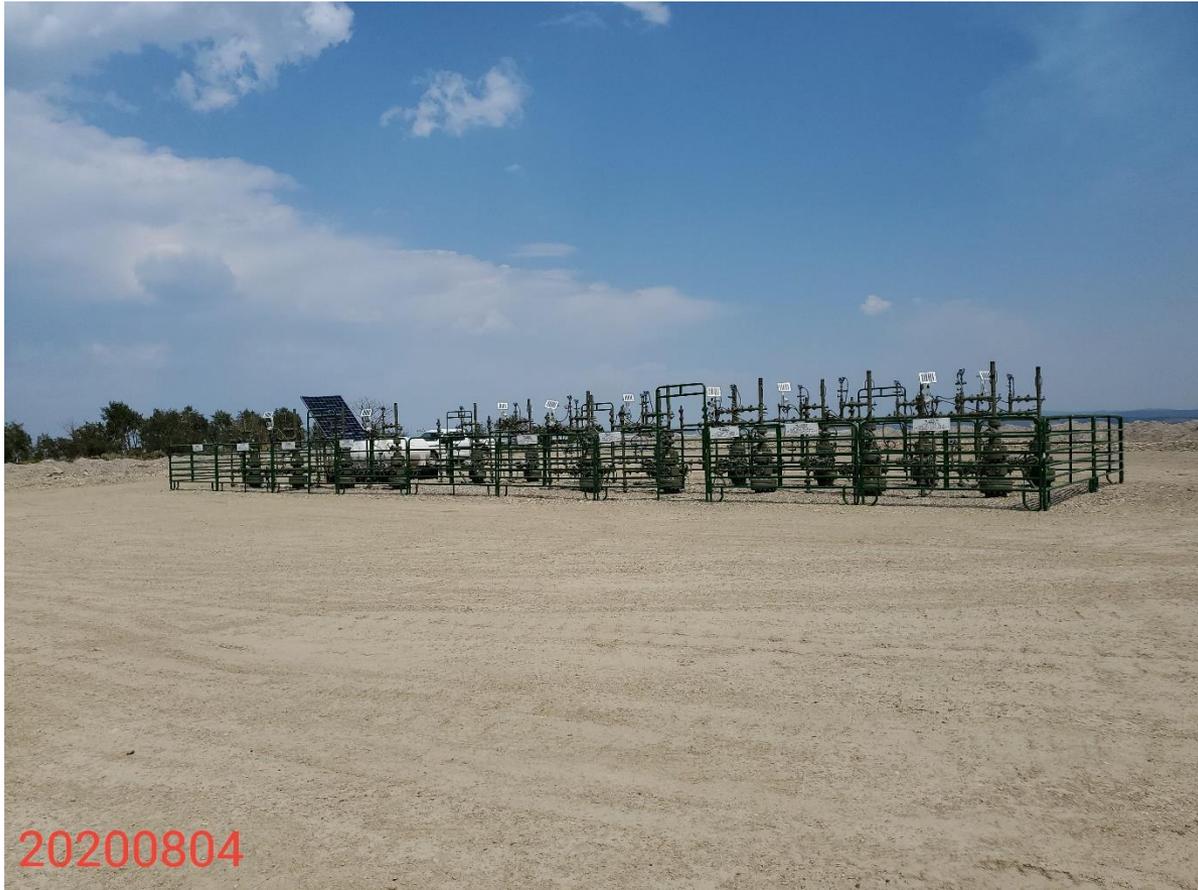
**Photo 13:** Photo of active wells on the Location.
