Inspection Photos
Operator: Hilcorp Energy
API: 067-08229
Date: 8/11/2020

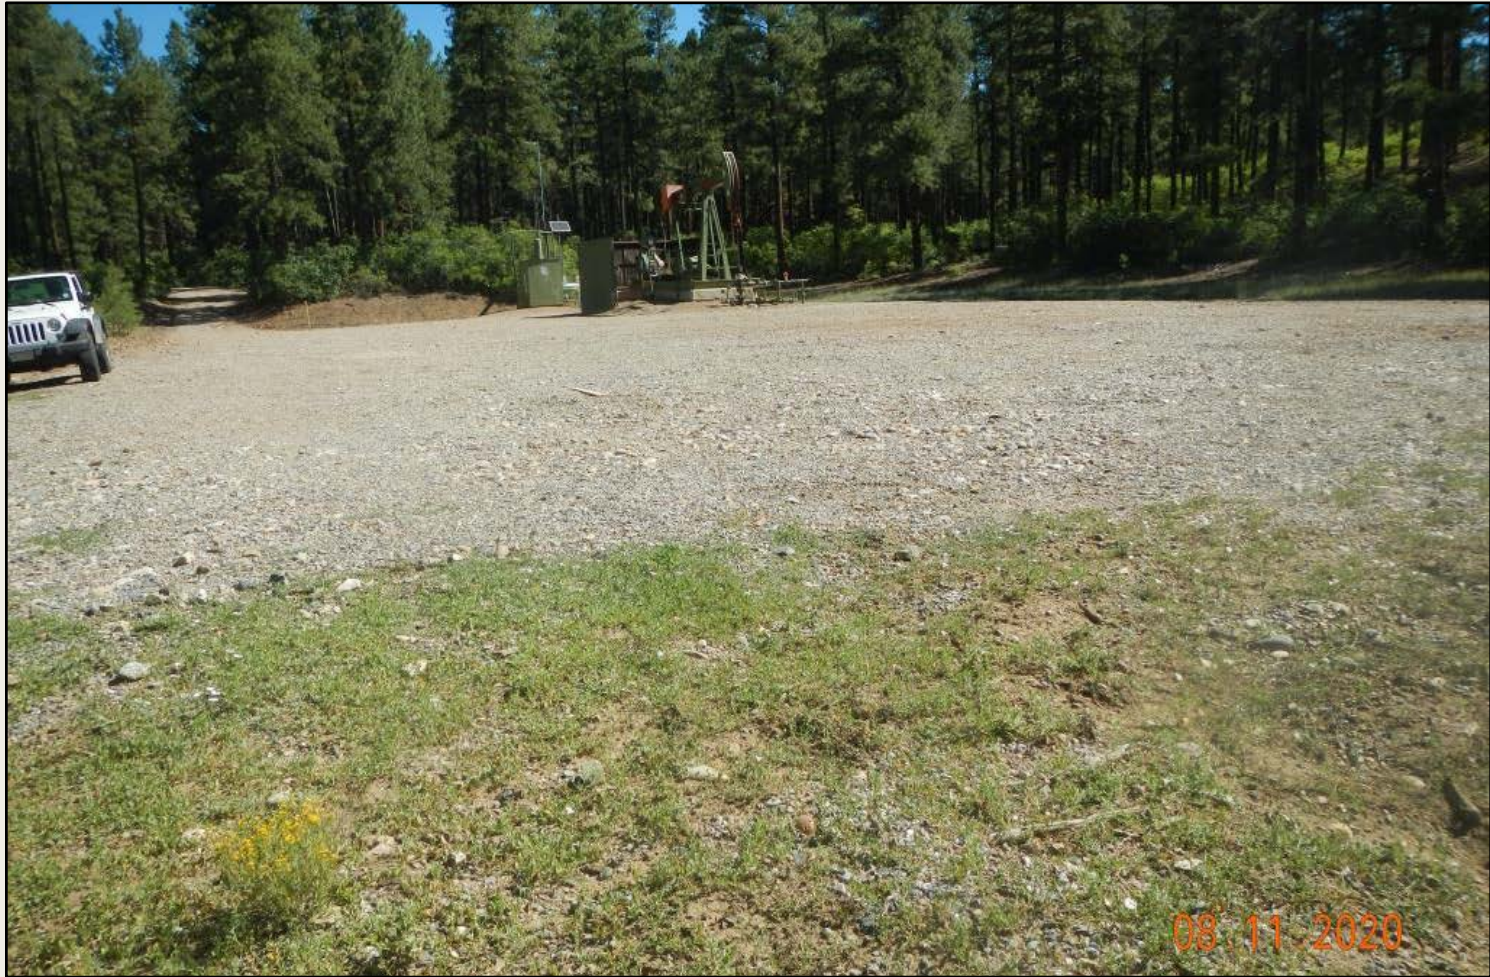
Photo 1. View of the project area from the southwestern corner facing center.

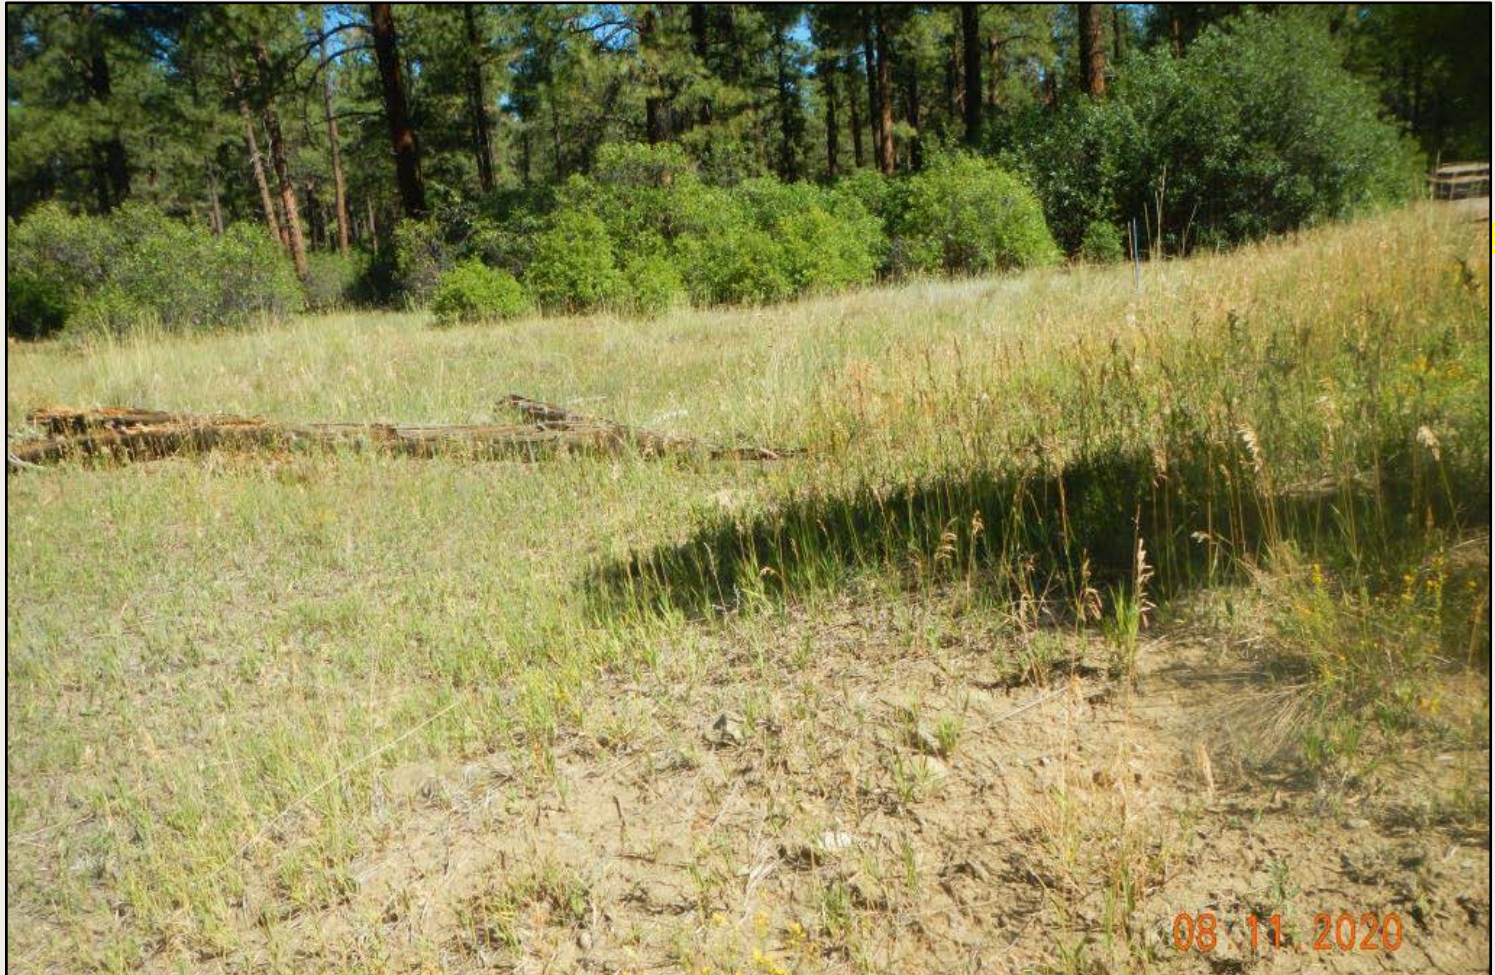
Photo 2. View of the western portion of the project area from the southwestern corner facing northward. Revegetation is progressing with western wheatgrass, and smooth brome.

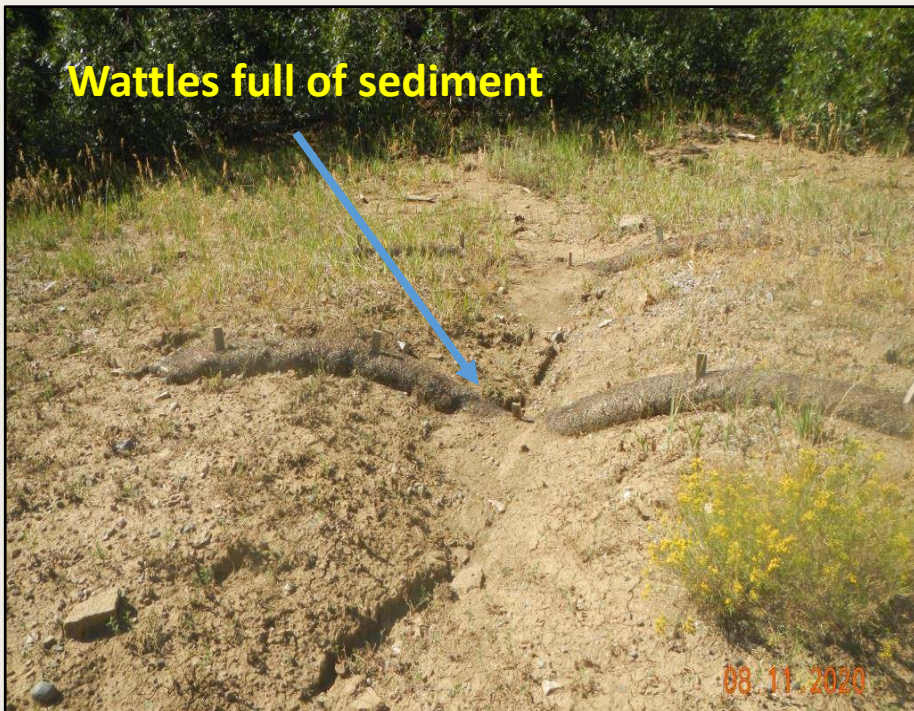
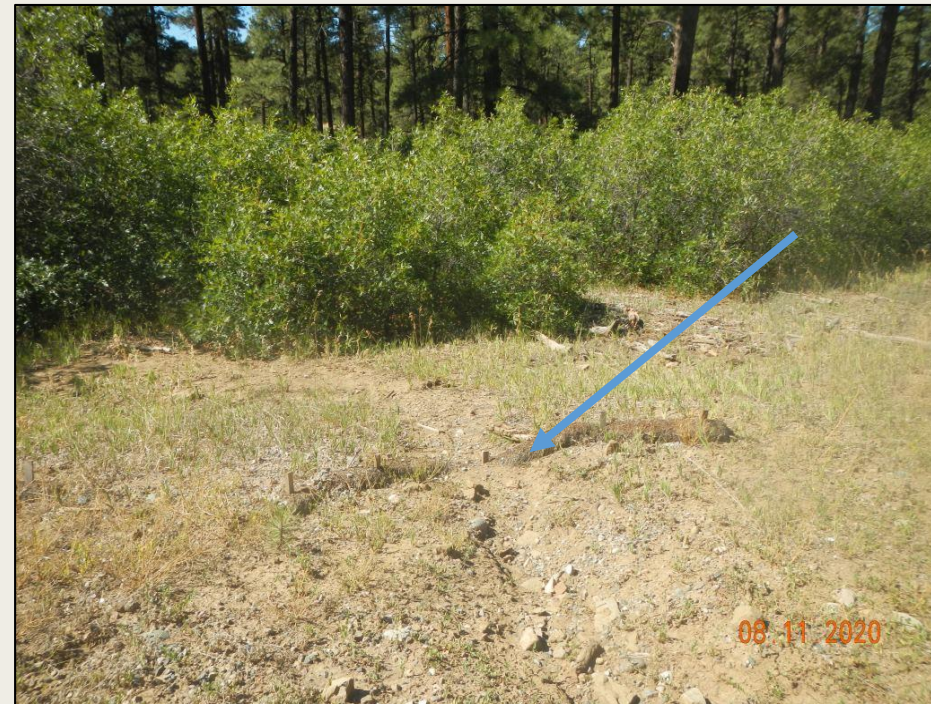
Photos 3/4. View of wattles in the southern project area that are full of sediment, displaced, and no longer functioning. Wattles are not adequate BMPs in these areas.

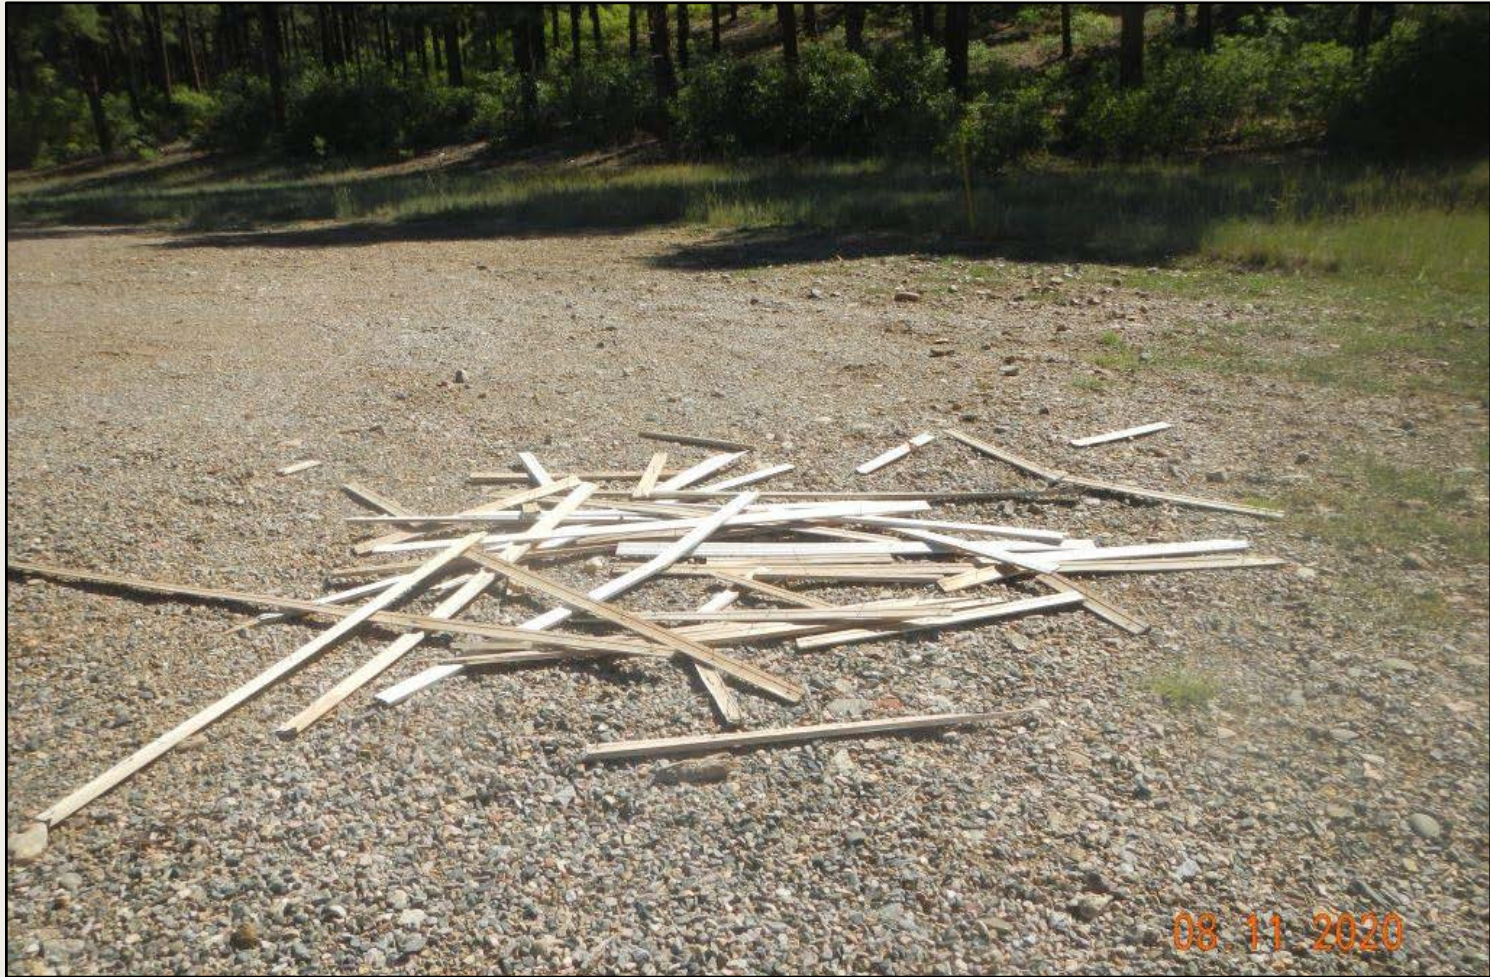
Photo 5. View of wood debris on the southern portion of the well pad.

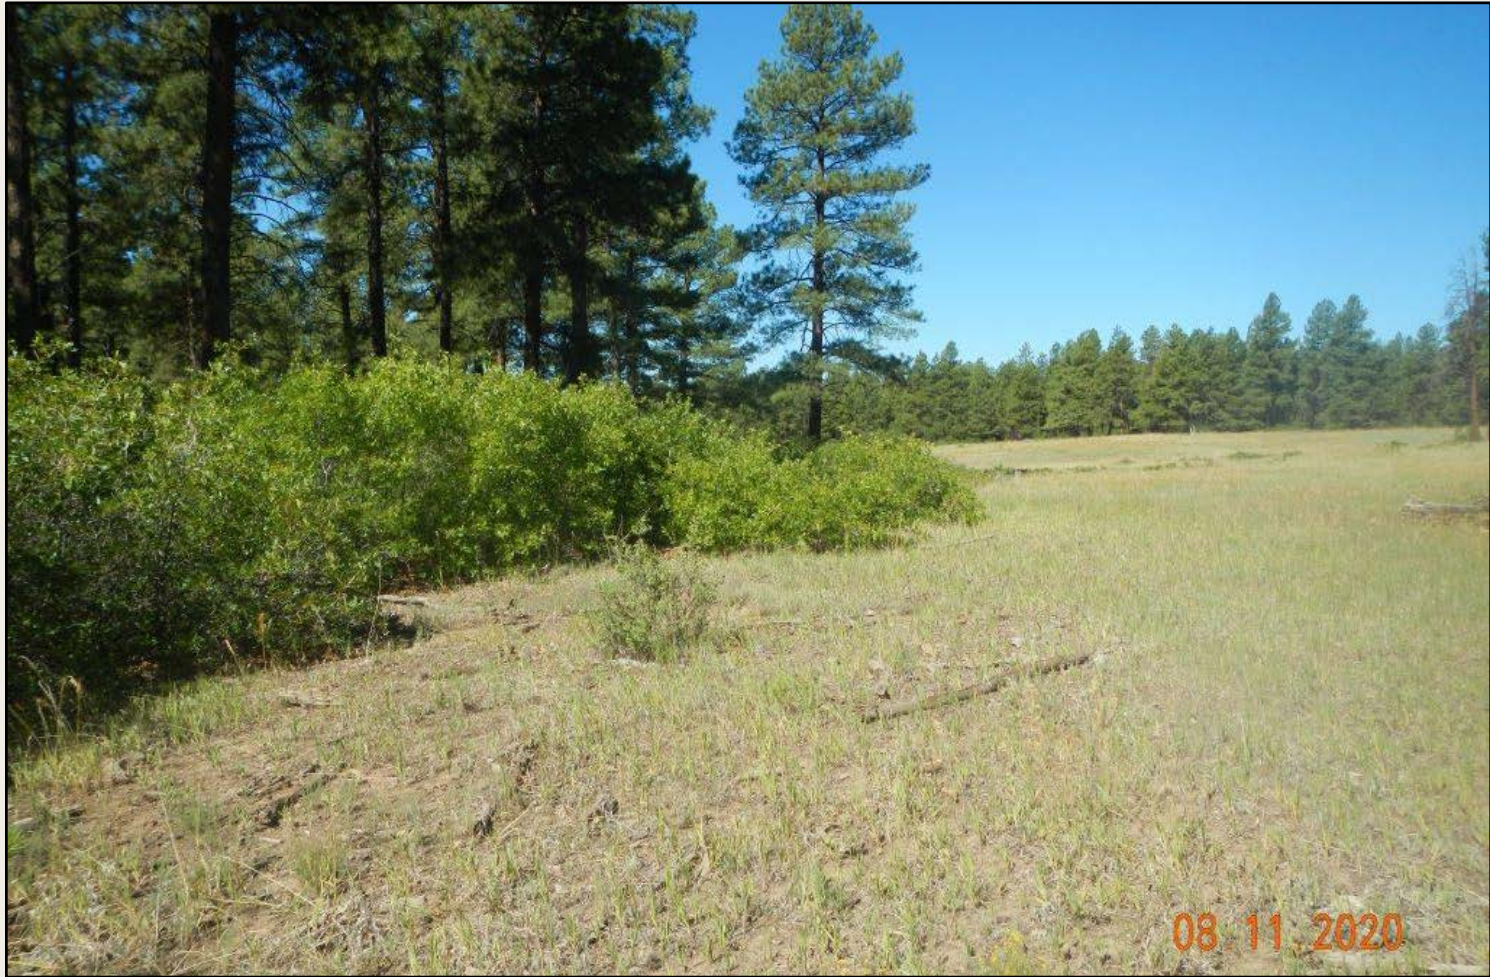
Photo 6. View of reference area comprised of ponderosa pine woodland with gambel oak understory, with a mosaic of open grassland largely comprised of smooth brome and western wheatgrass.
