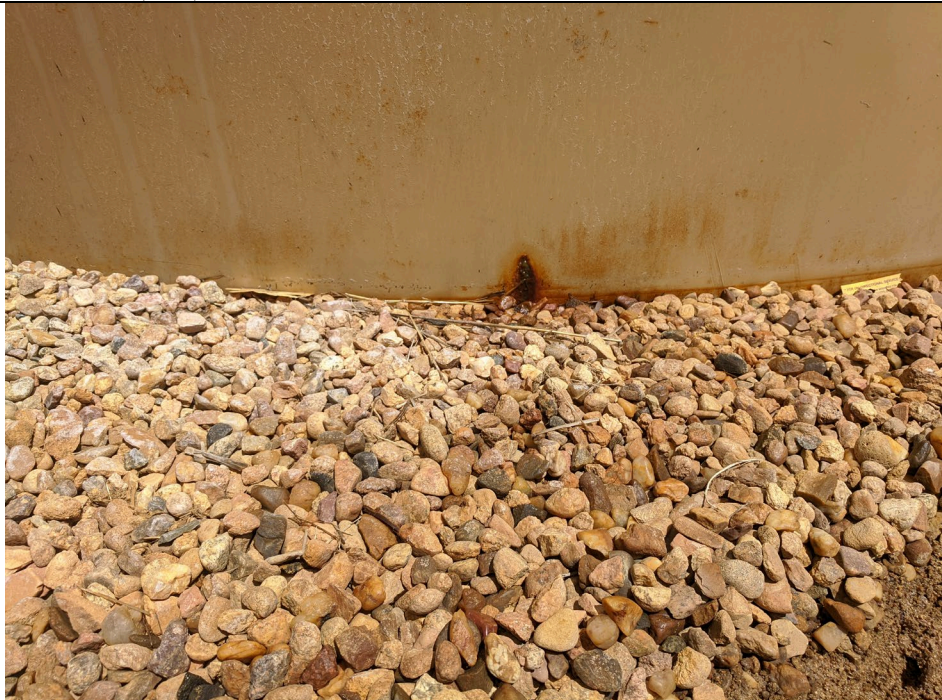
**Subject:** Photograph shows a leak identified on the southeastern side of the eastern produced water tank that resulted in the release of 19 bbls of produced water within lined secondary containment. The 400 bbl aboveground produced water tank was constructed of steel.

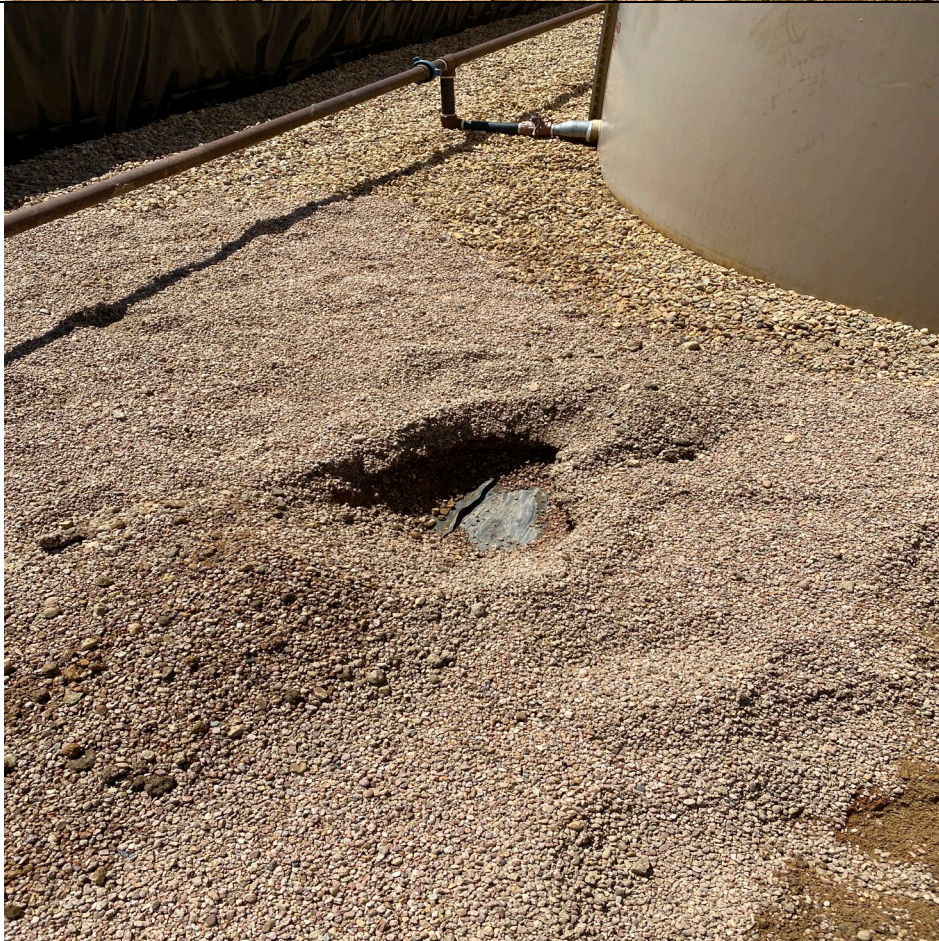
**Subject:** Photograph shows that the eastern produced water tank was removed for offsite disposal. The rock and gravel in the immediate vicinity of the tank was also excavated for offsite disposal using hydrovac equipment. Clean pea gravel was imported as backfill and placed in an approximate 6-inch lift. One test hole was dug to expose the clean liner beneath the imported pea gravel. Based on visual and olfactory observations and field screening with a PID, the area depicted in the photograph had been sufficiently remediated. However, hydrocarbon impacted rock and gravel were still observed in the area where the photographer was standing.

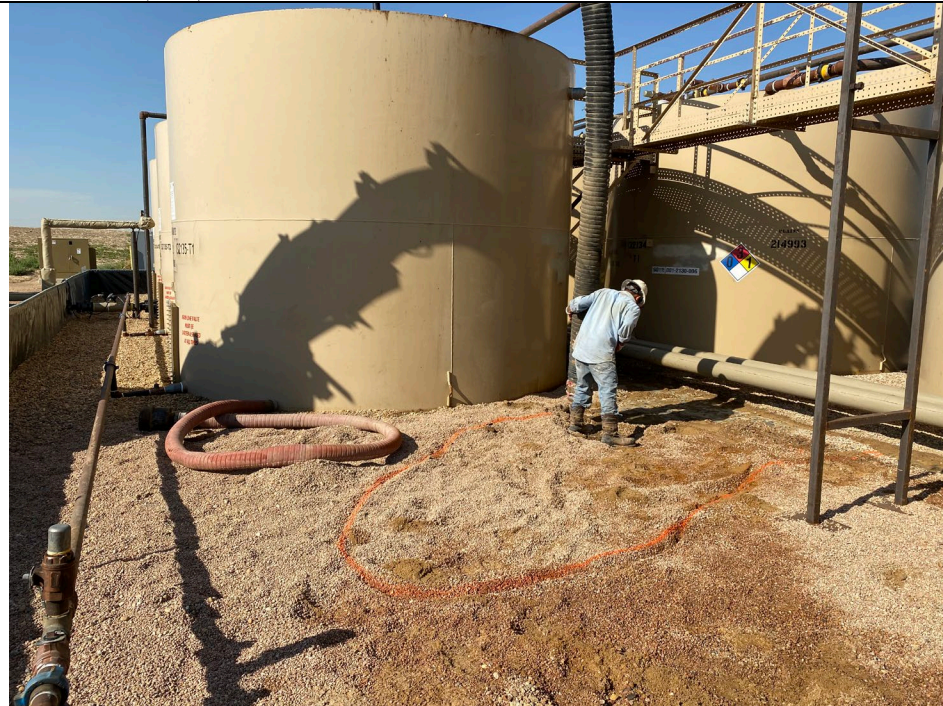
**Subject:** Photograph shows ACME Oilfield Services utilizing hydrovac equipment to excavate the remaining hydrocarbon impacted rock and gravel. Rock and gravel in the vicinity of the tank was field screened with a PID to determine the area of impact, represented in the photograph by the orange painted outline. The red hose lying on the ground is covering the area that had been sufficiently remediated (see above photo).

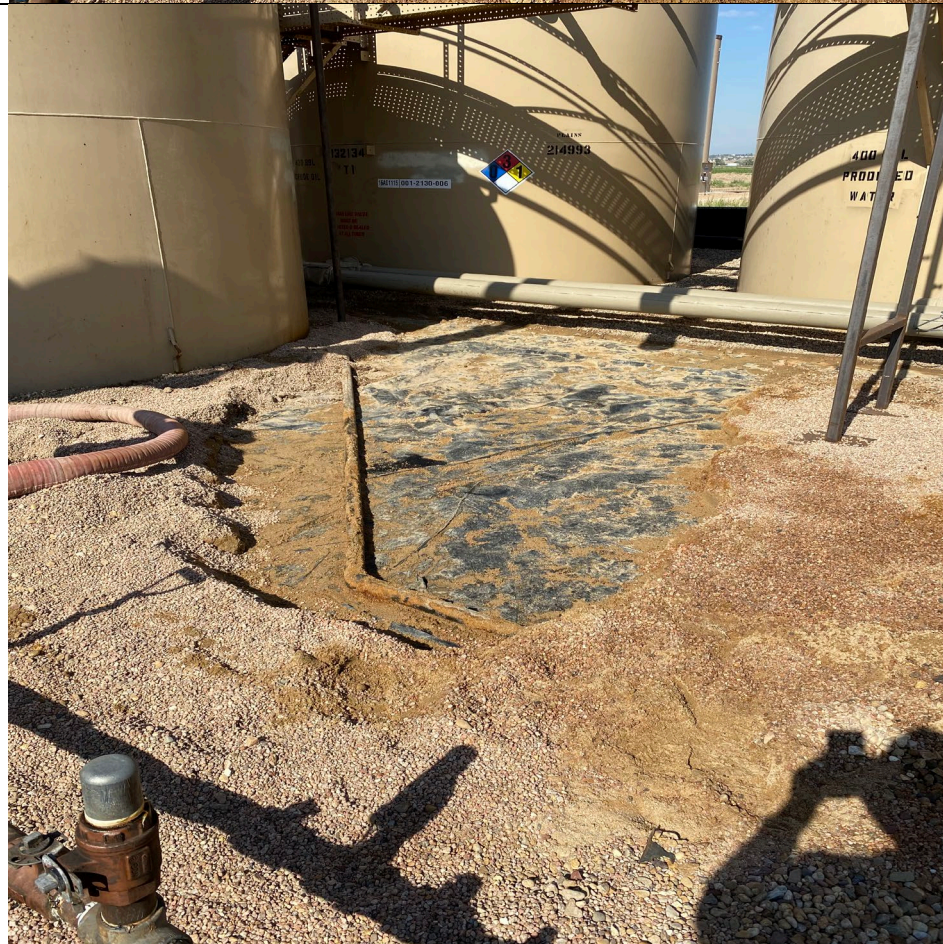
**Subject:** View of the clean liner following excavation of the hydrocarbon impacted rock and gravel. The depth of rock and gravel measured between 4 inches and 6 inches.

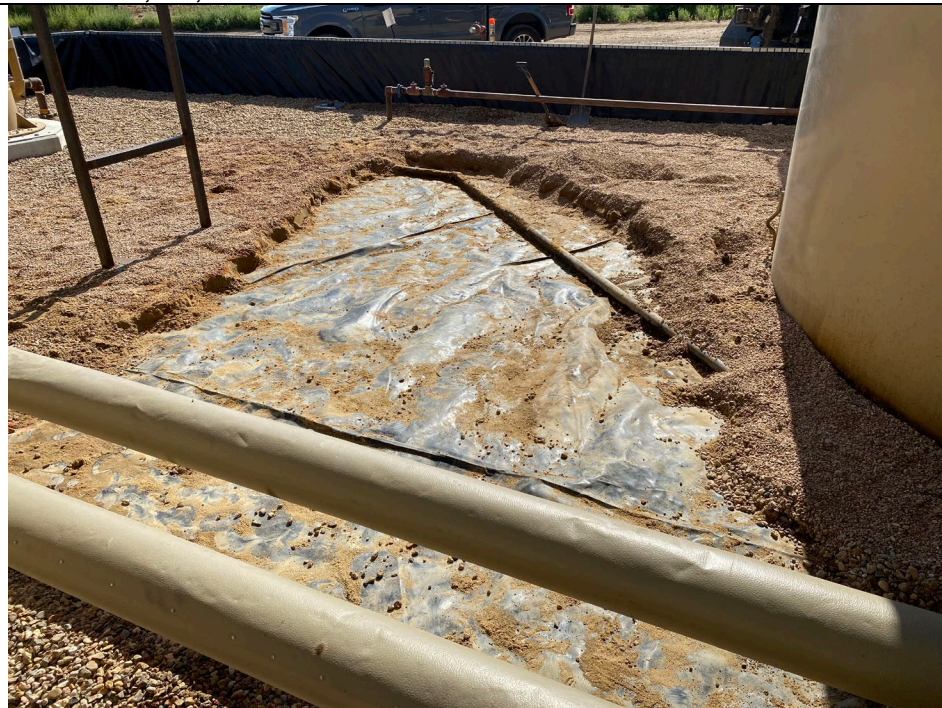
**Subject:** View of the clean liner following excavation. The excavation area was bell shaped and measured 18 feet wide on the west perimeter, averaged 10 feet across, and 5 feet wide on the east perimeter. It measured 18 feet in length. Between 7/14/20 and 8/12/20, approximately 8 cubic yards of hydrocarbon impacted material were excavated from within secondary containment. See Figure 2 for an illustration of the combined excavation area.

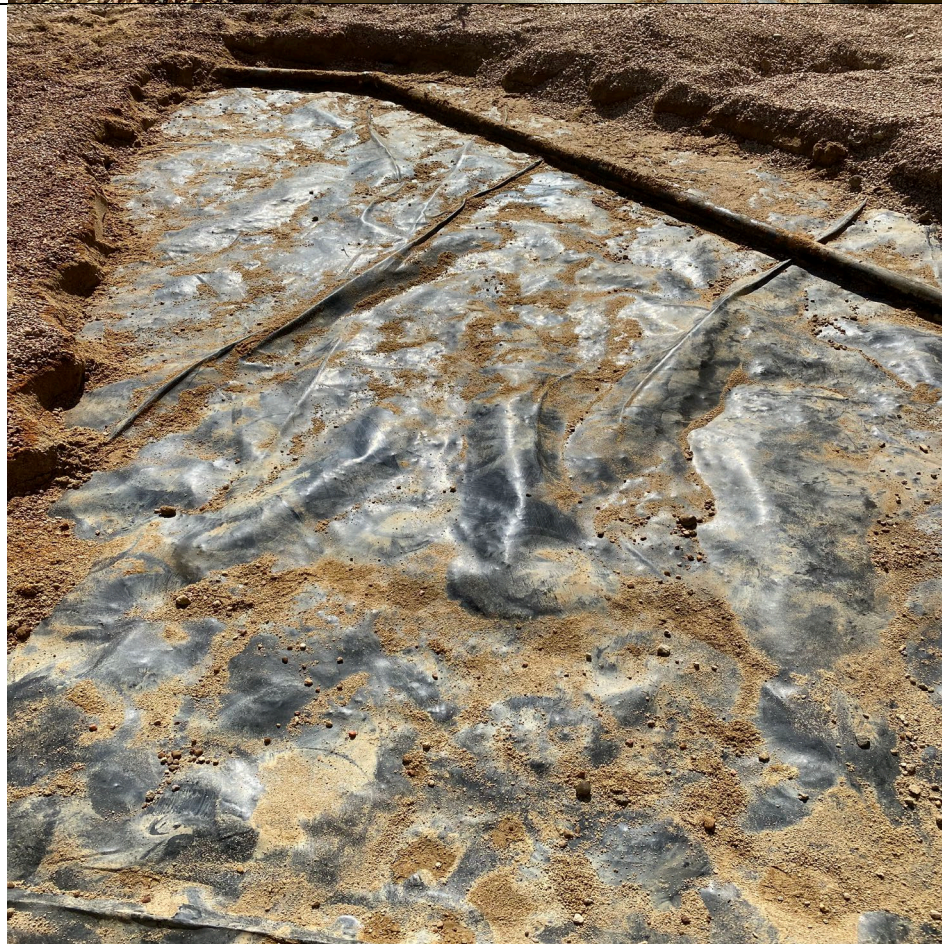
**Subject:** View of the clean liner following excavation.

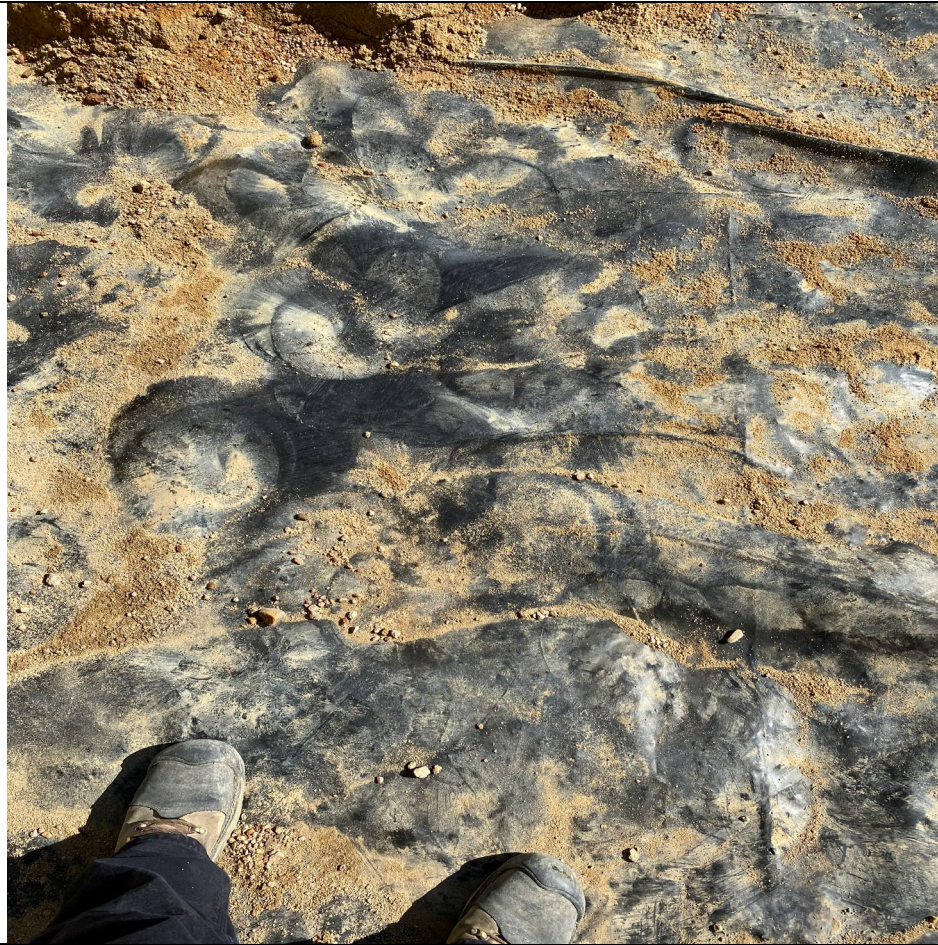
**Subject:** Downward view illustrating the liner's integrity. There were no leaks observed.
